# Meadow View, Bourton Road Frankton Warwickshire

ARCHAEOLOGICAL MONITORING AND RECORDING

Archaeology Warwickshire Report No 19131  
NOVEMBER 2019

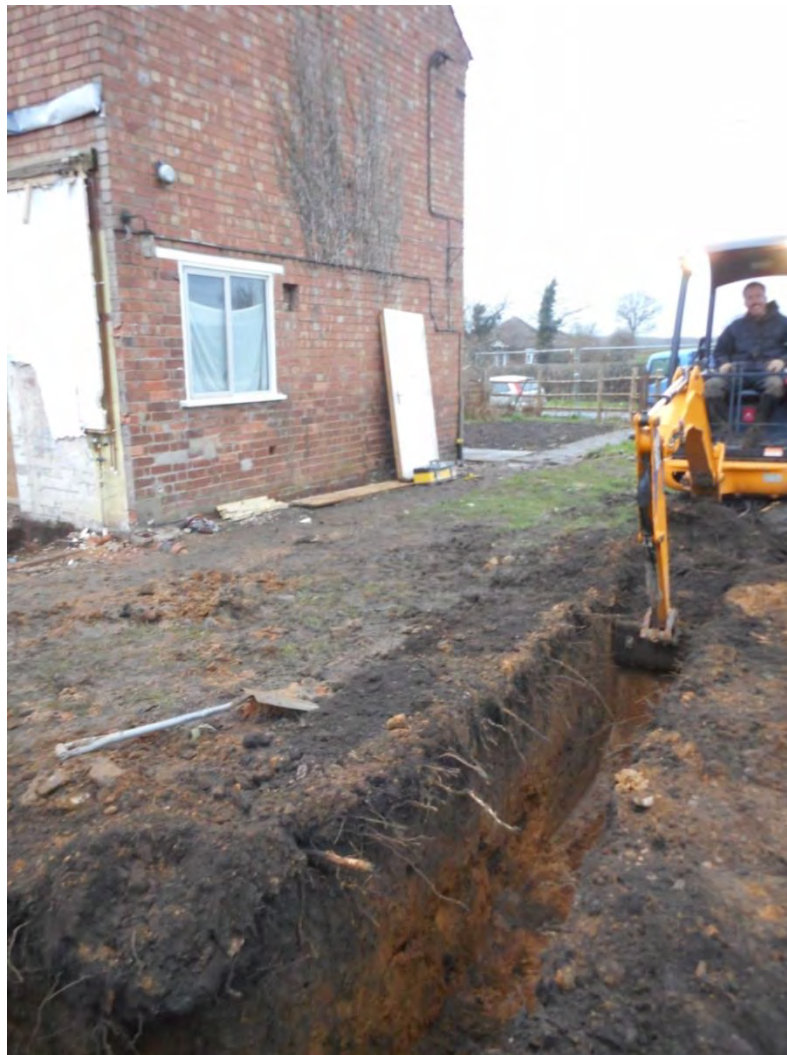
1: Excavation of foundation trench

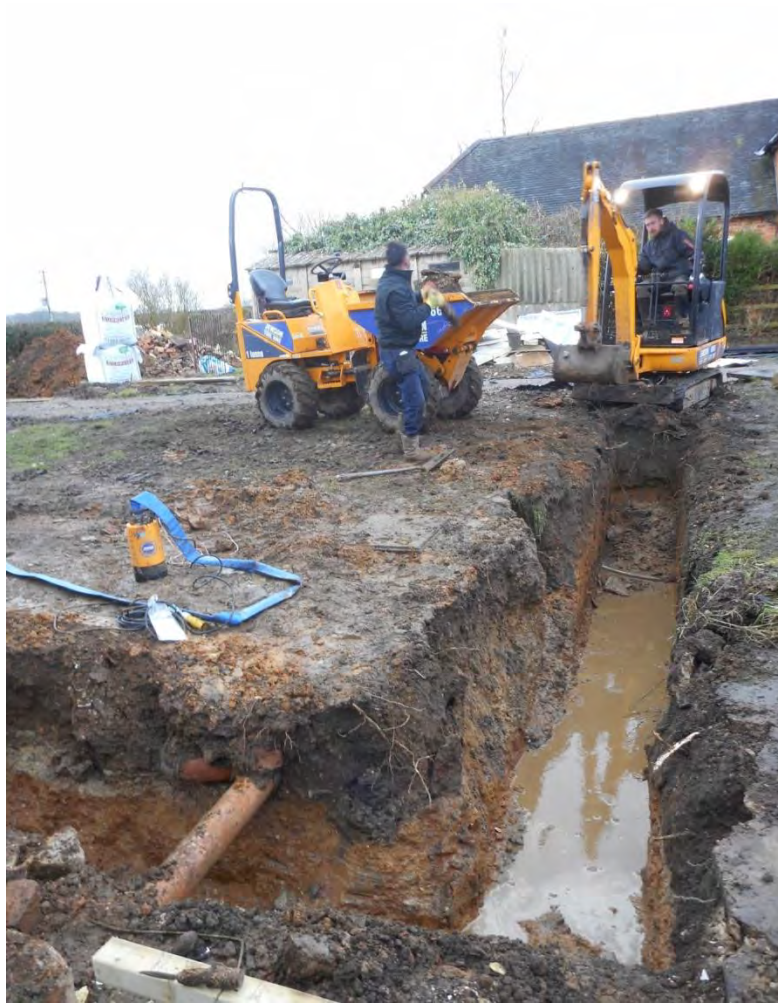
- 5.2 A simple deposit sequence was recorded during groundworks, this was derived from geological natural sand and gravel and the historic use of the site for domestic and horticultural functions. The natural deposits associated with Dunsmore sand and gravel were overlain by a simple sequence of subsoil (2, 6) overlaid by topsoil or garden soil. Garden soils (1) contained fragments of ceramic building material including brick and tile fragments. A burst water pipe resulted in water ingress into the trenches and obscured parts of the trench (Photo 2).

2: Excavation of trenches showing services and deposit sequence

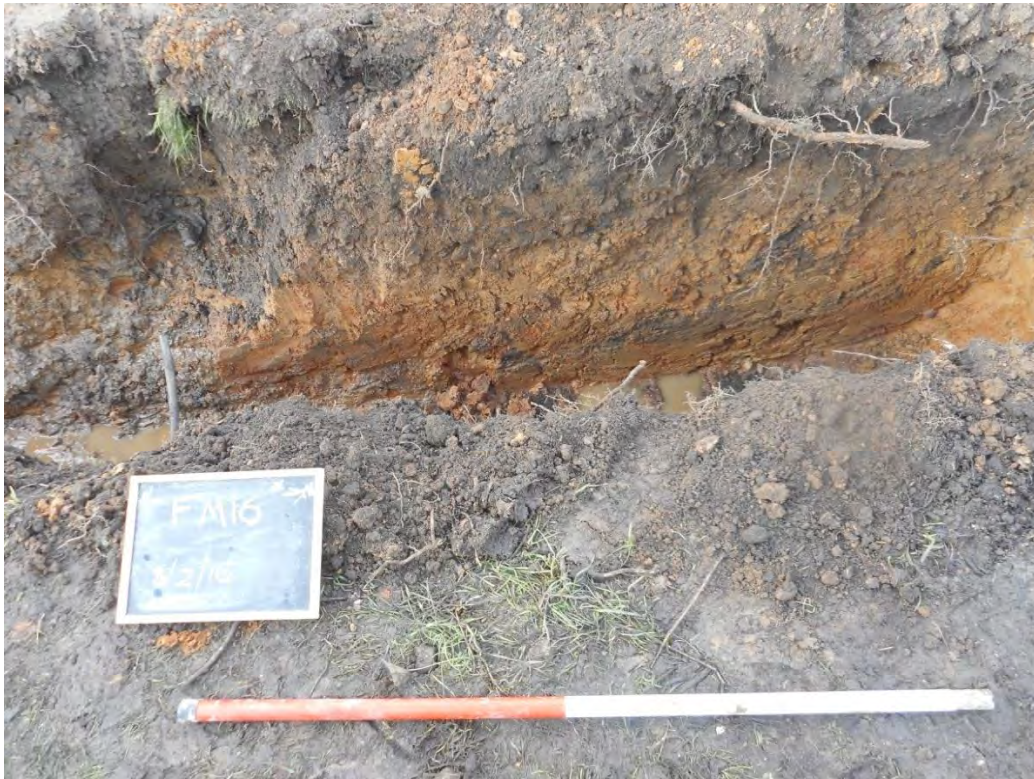
- 5.1 The geological natural was recorded in the observed trenches as a layer of yellowish brown sandy clay (3). The natural geological deposit was recorded at a depth of 0.5m below the current ground surface. At greater depths the natural layer contained increasing amounts of sand and gravel.

3: View north-west towards existing house showing natural
