The Coach and Horses Daventry Northamptonshire

ARCHAEOLOGICAL RECORDING

Archaeology Warwickshire Report No 2028

FEBRUARY 2020

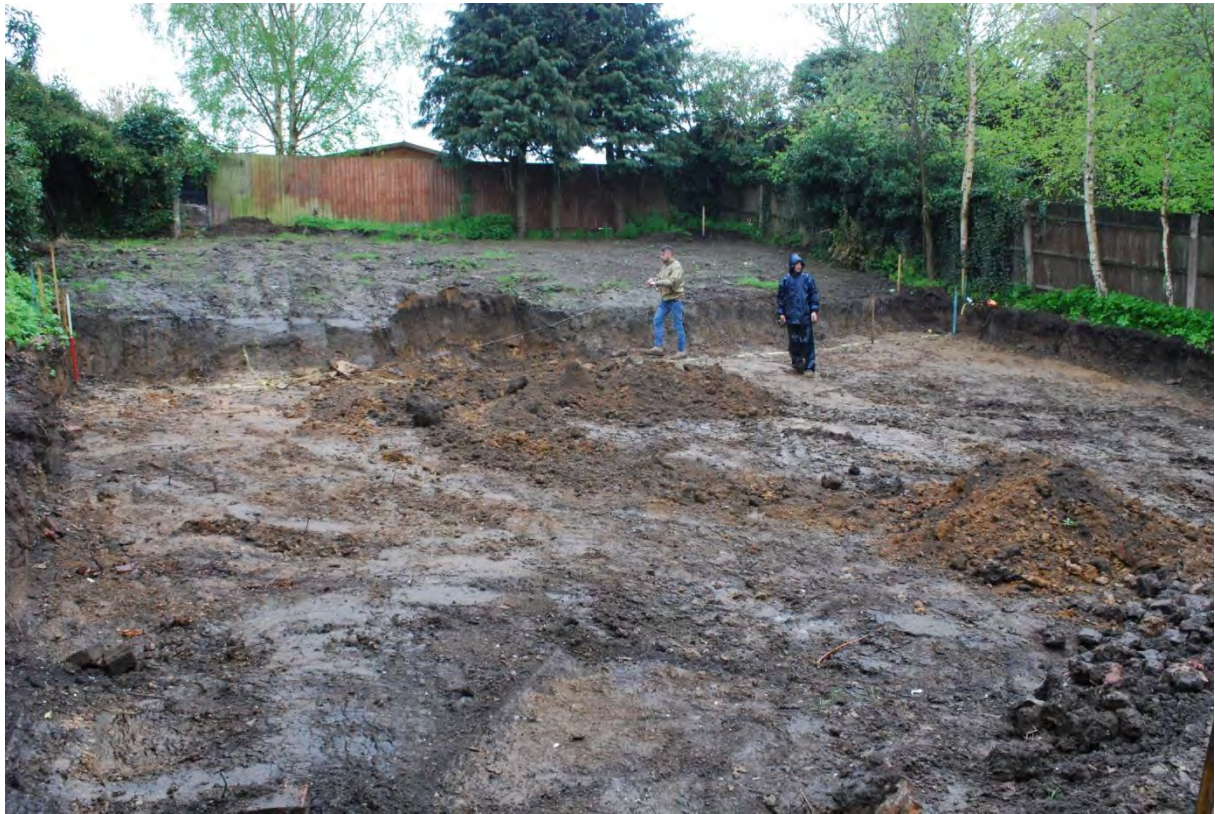
1: Footprint of new houses and garden area undergoing ground reduction

- 5.1 The ground for the house plots and gardens to their rear was reduced in depth using a tracked excavator with a toothless bucket, generally to a depth of c.0.50m (Photo 1; Fig 7). The geological natural yellow silty clay (102) was exposed over the entire area stripped. It was overlain by a yellowish-brown silty clay subsoil layer (101) with occasional stone fragments varying in depth from 0.10m to 0.30m. It did not continue in the area closest to the inn, suggesting that it had previously been truncated here. The topsoil (100) varied in depth from 0.12m to 0.25m. The topsoil and subsoil deposits followed the slope of the ground down from south-east to north-west. As the ground had already been reduced to geological natural and no features had been recorded it was not necessary to monitor the excavation of the footings within the geological natural.

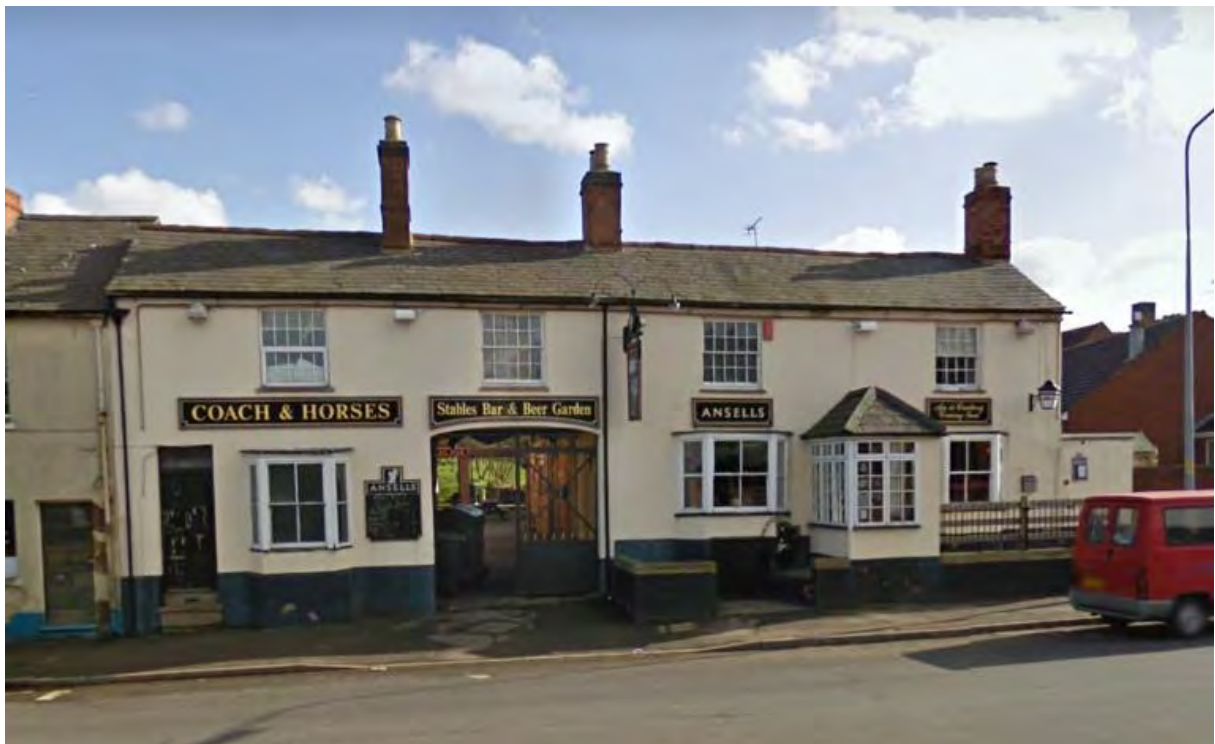
2: The front of The Coach and Horses, prior to work being undertaken (Google Streetview)

- 5.14 The bar originally occupied the whole width of the front of the ground floor, but had been substantially stripped and new internal walls constructed to form an entrance corridor from the central front door by the time of the survey. To either side of the entrance were two bay windows, the north-west one was the original timber casement (Photo 10), but the other had been replaced by a new UPVC unit.

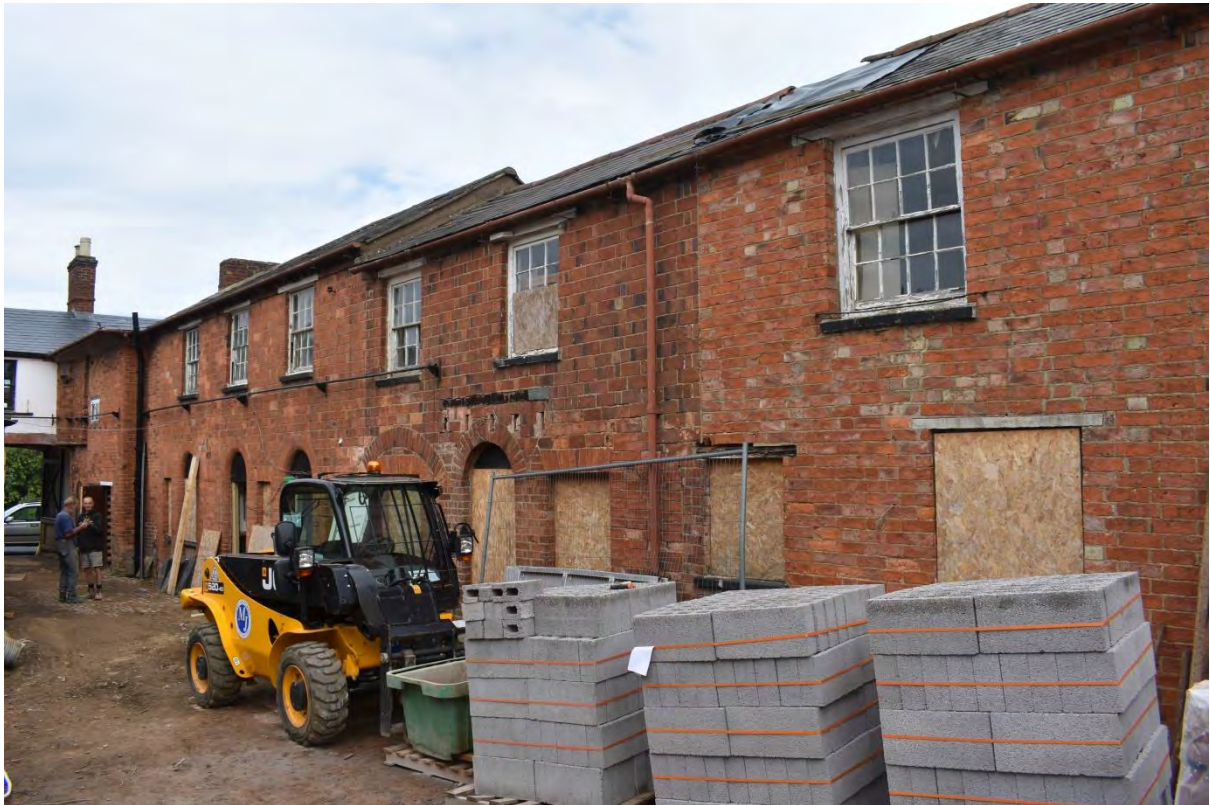
3: General view of the front of the stables with the three phases visible as changes in the roof height and the bricks used

- 5.7 The stables occupy the north-eastern side of the courtyard and consist of a three phased building. The stables had formerly been modified from their original build into cottages, and latterly into an open-plan function room for the pub so most of their original structure had been lost. The stables are constructed from red brick with a course of dentil corbelling below the slate roof topped with ceramic ridge tiles (Photo 3). The earliest phase is built against the back of the street front building and its elevation on to the courtyard has three round headed doors on the ground floor that are flanked by narrow, square headed windows and three sixteen-pane sash windows on the first floor above the doors (Photo 4). The doors jambs are constructed from bullnose bricks to protect the horses and the ground-floor windows have flat segmental brick arches while the upstairs windows have timber lintels below the eaves. From the top of the windows and doors the building front is constructed using the pattern of a Flemish garden bond, but with the bricks laid as shiners and rowlocks in a modified 'rat-trap' bond.

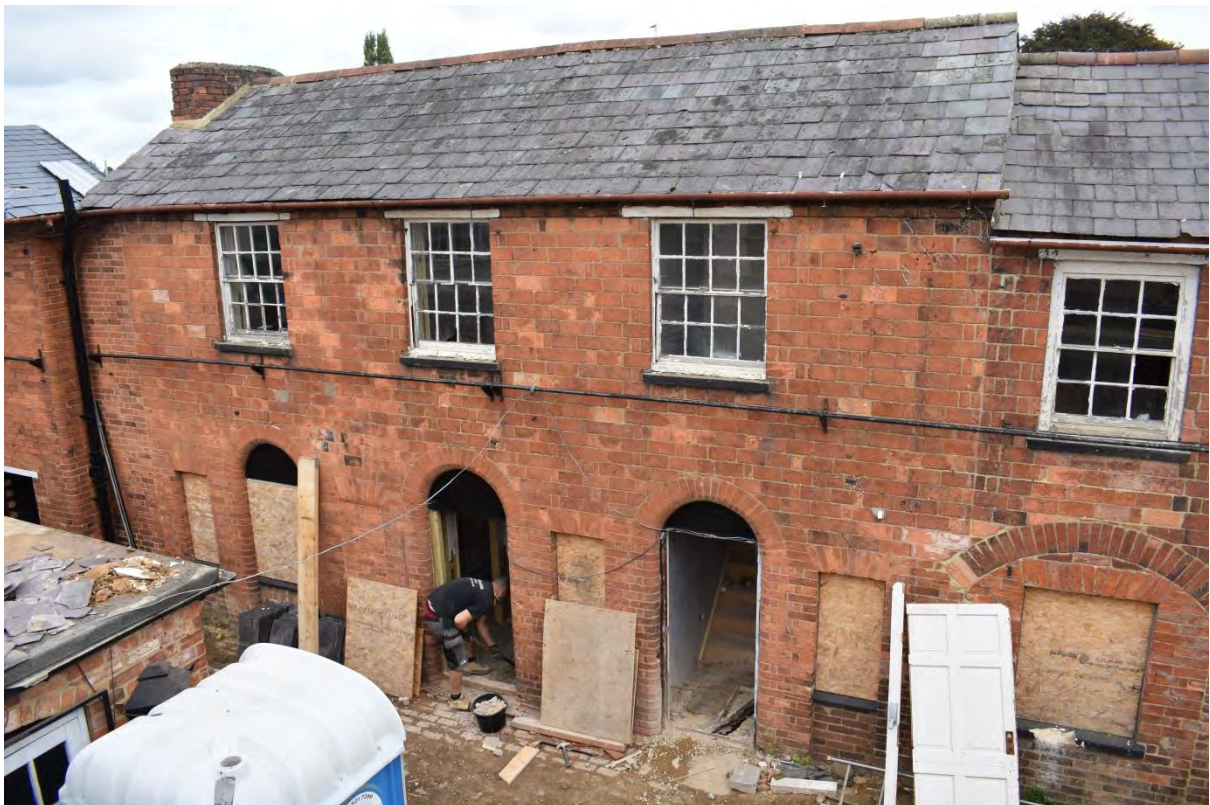
4: Phase 1 of the stables building

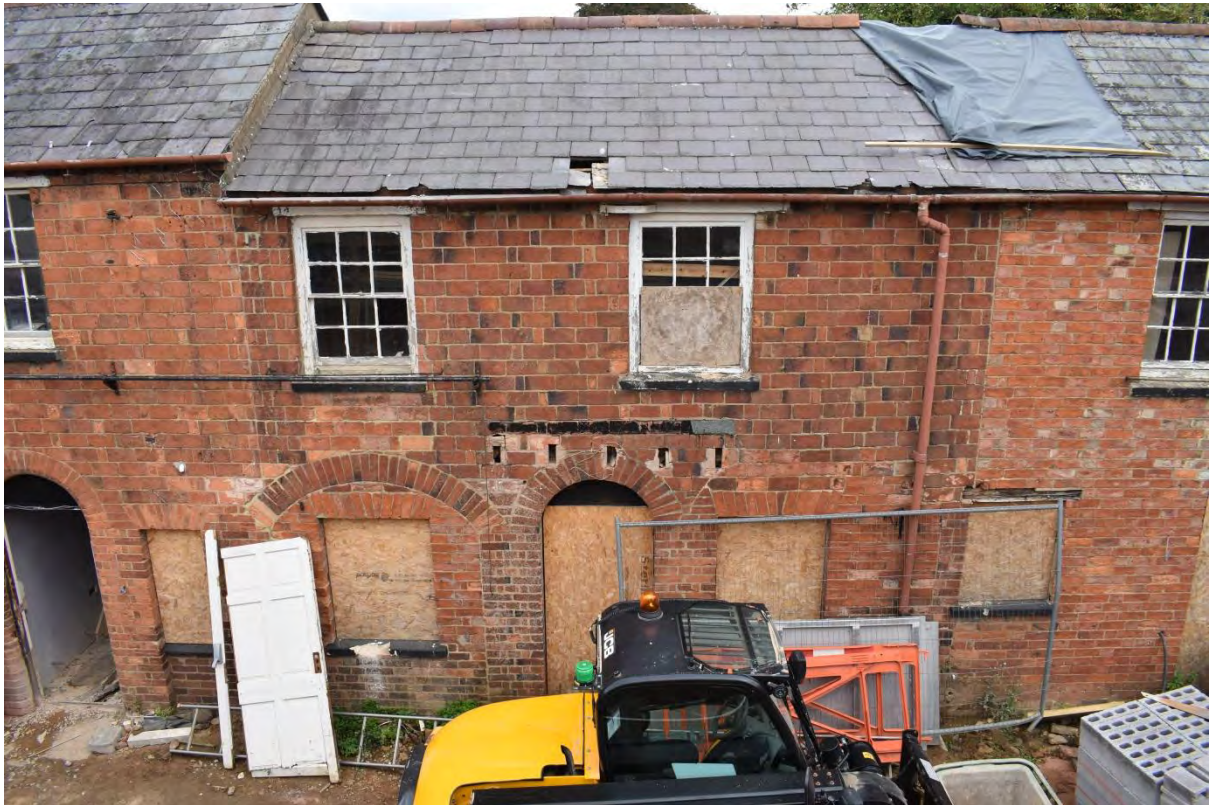
5: Phase 2 stables building

- 5.8 The Phase 2 stable is constructed against the south-east end of the Phase 1 building and is a similar two-storey red brick construction with a slate roof and ceramic ridge tiles (Photo 5). The upper part of the building is built in the same modified 'rat-trap' bond to try and match with the earlier building.

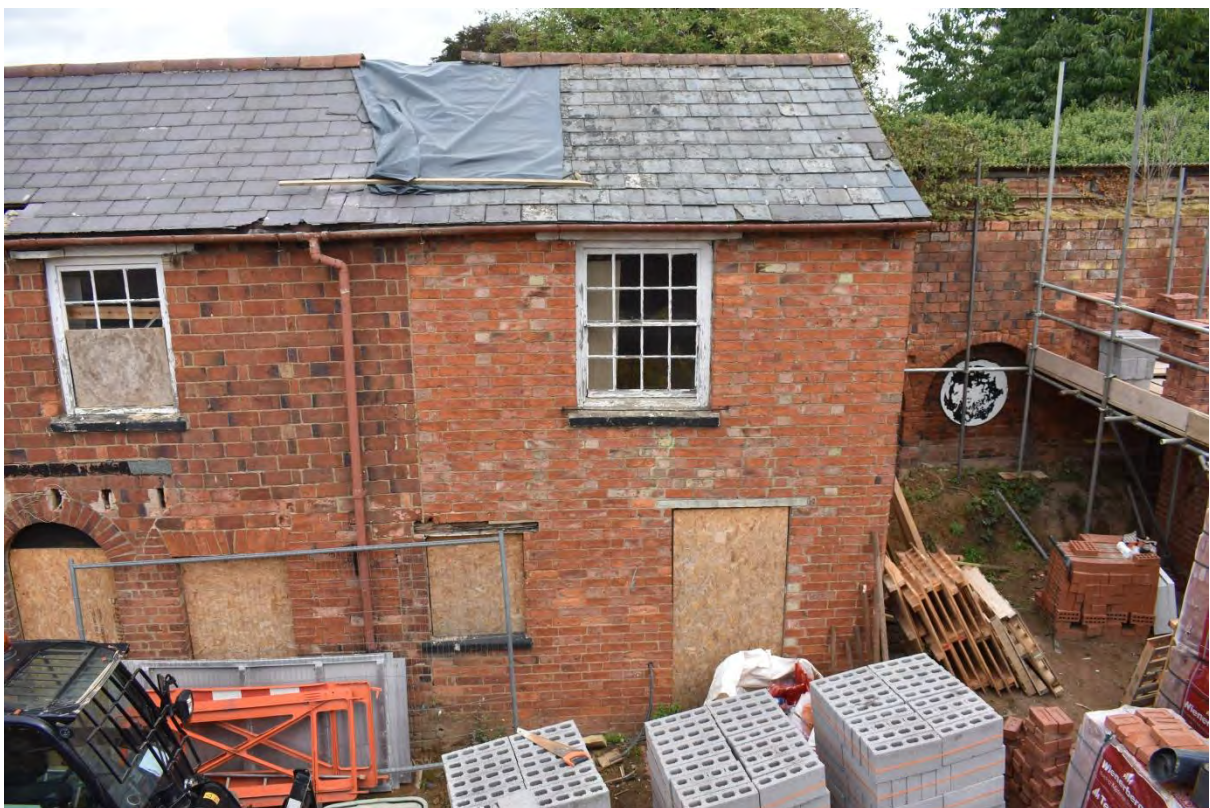
6: Phase 3 stable block

- 5.10 The latest phase of the stable block is a small red brick block built against the south-east end of the Phase 2 building (Photo 6). It is of a lighter-coloured red brick than the Phase 2 building, with a slate roof and ceramic ridge tiles and has an offset blocked door and window on the ground floor and a central sixteen pane sash window on the upper floor. A building is shown in this position on the Ordnance Survey First Edition map of 1884, so this block must have been added prior to this date.

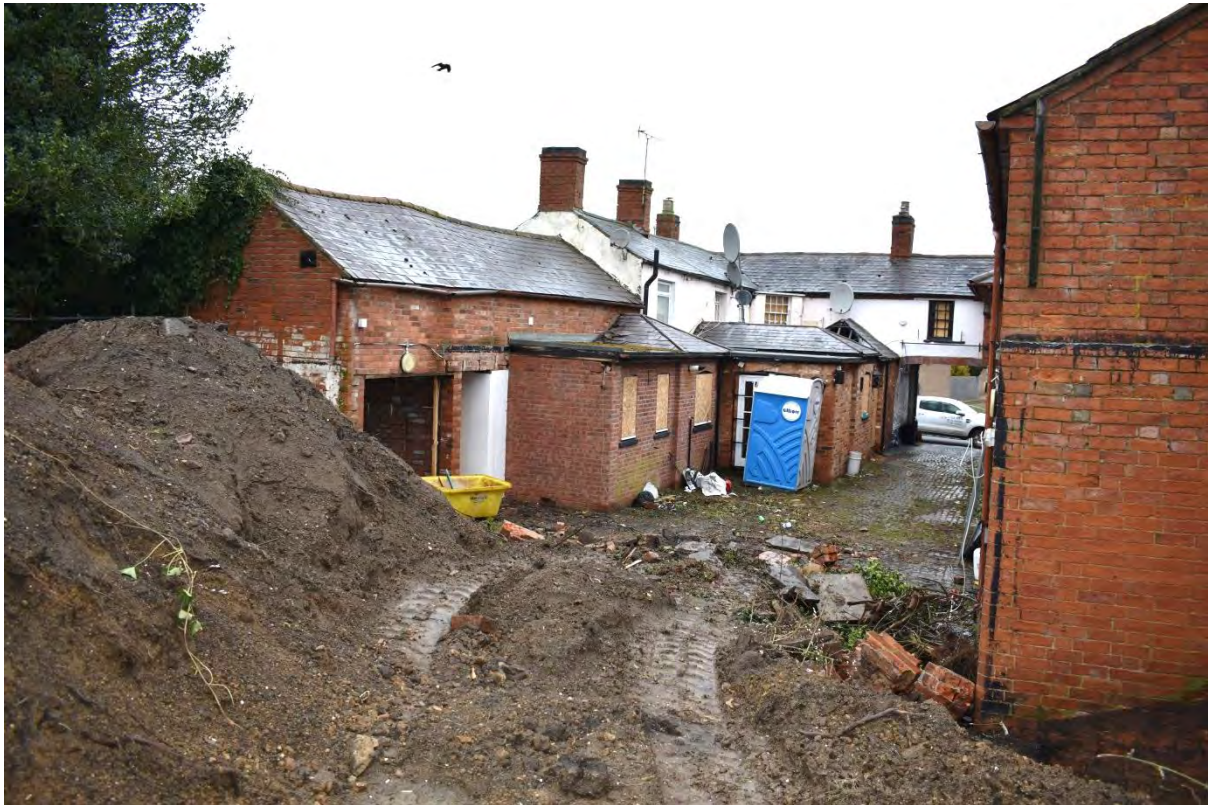
7: The south range showing the rear extension

- 5.11 The south range extends from the south-east end of the main pub building and consisted of a former coach house, which had been converted into a kitchen and toilets. It was brick built with a slate roof and ceramic ridge tiles (Photo 7). By the time this survey took place the roof had been removed and the interior was partially stripped, so there are no surviving structural details (Photo 8). Its removal did reveal the brick chimney for the cast iron fireplace and ovens recorded in Room 2 of the public house (see below).

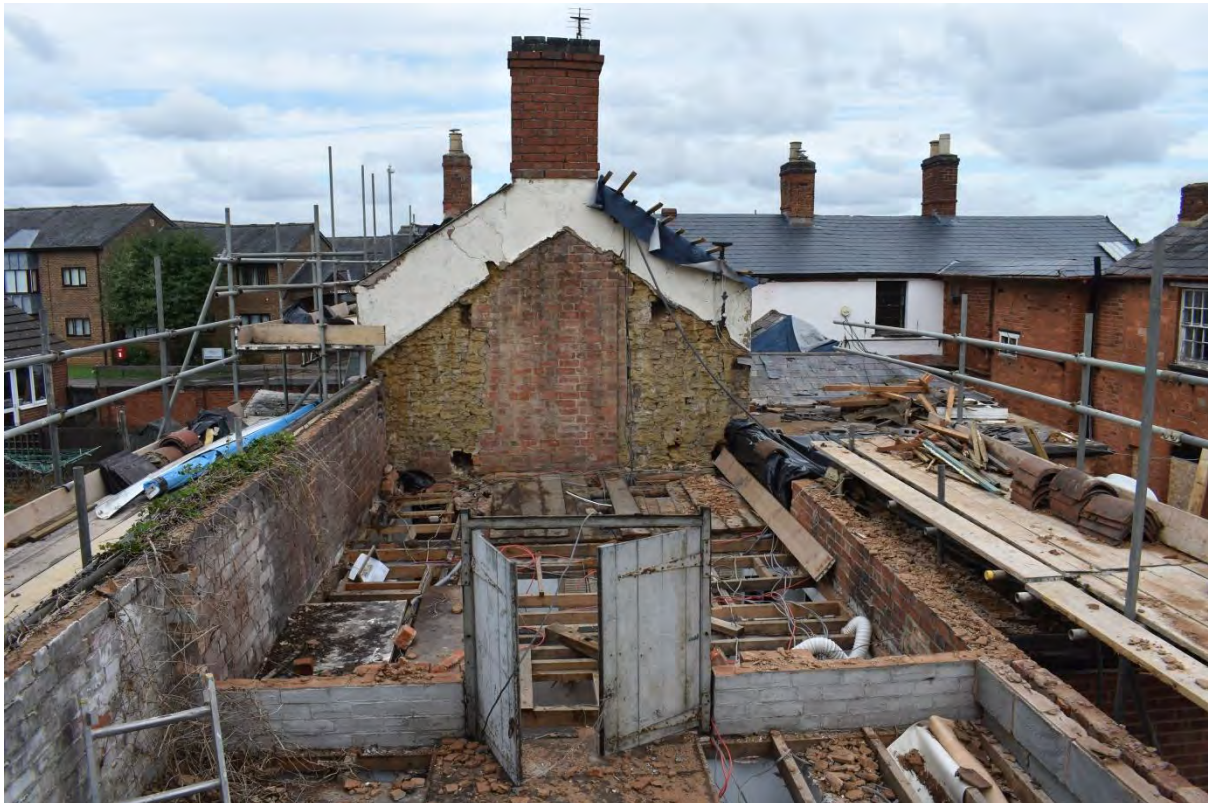
8: The brick chimney for the fireplace and ovens in ground-floor Room 2 and the partial demolition of the south-east extension

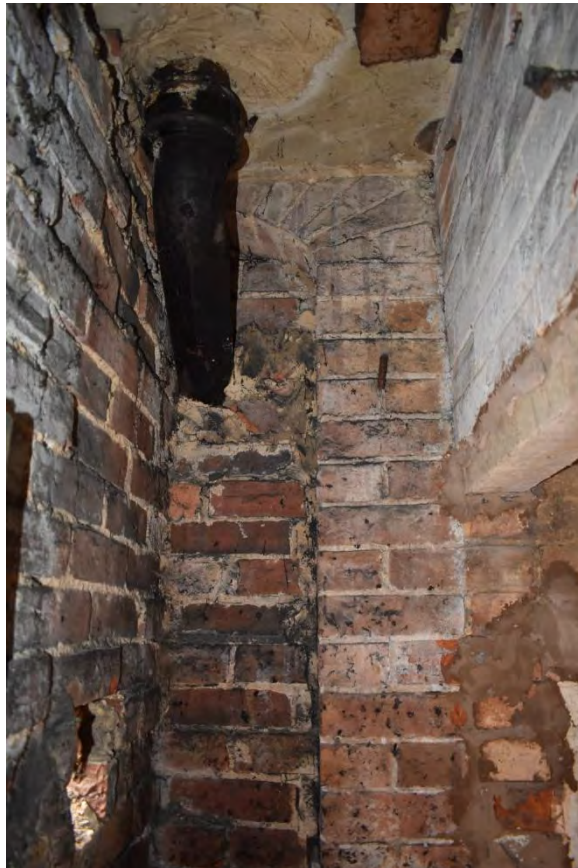
9: Addition to rear of adjacent building encroaching into archway

- 5.12 To the north-east of the main public house building is an adjacent property, possibly an individual house, perhaps that of the original landlord, which appears to have been converted into use as part of the pub. This building was extended to the south-east in brick. The exterior brickwork suggest that this happened in two phases. A small square brick-built block was added against the rear of the building before the stables were built as the earliest stable block butts against its south-east end. It encroached into the archway from the street to the rear courtyard and narrowed the entrance by c.0.3m (Photo 9).

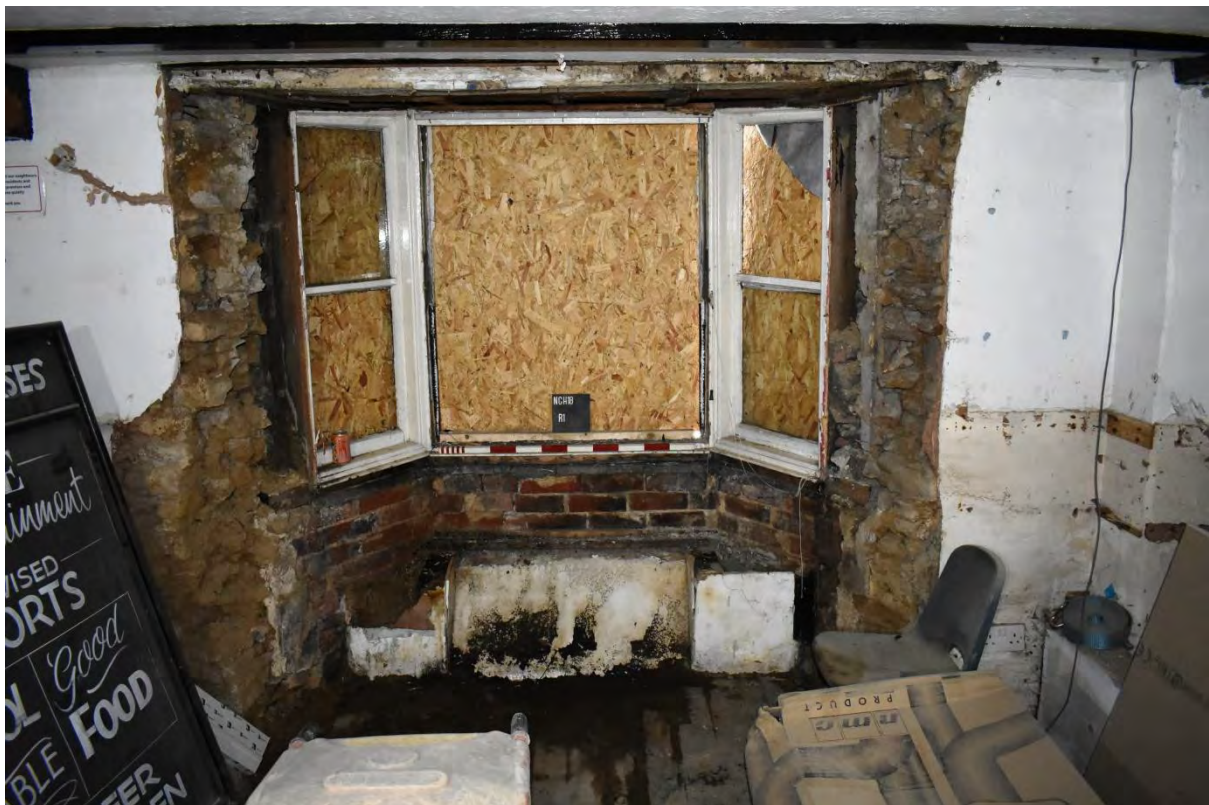
10: The original bay window in the northern part of the bar (Room 1)

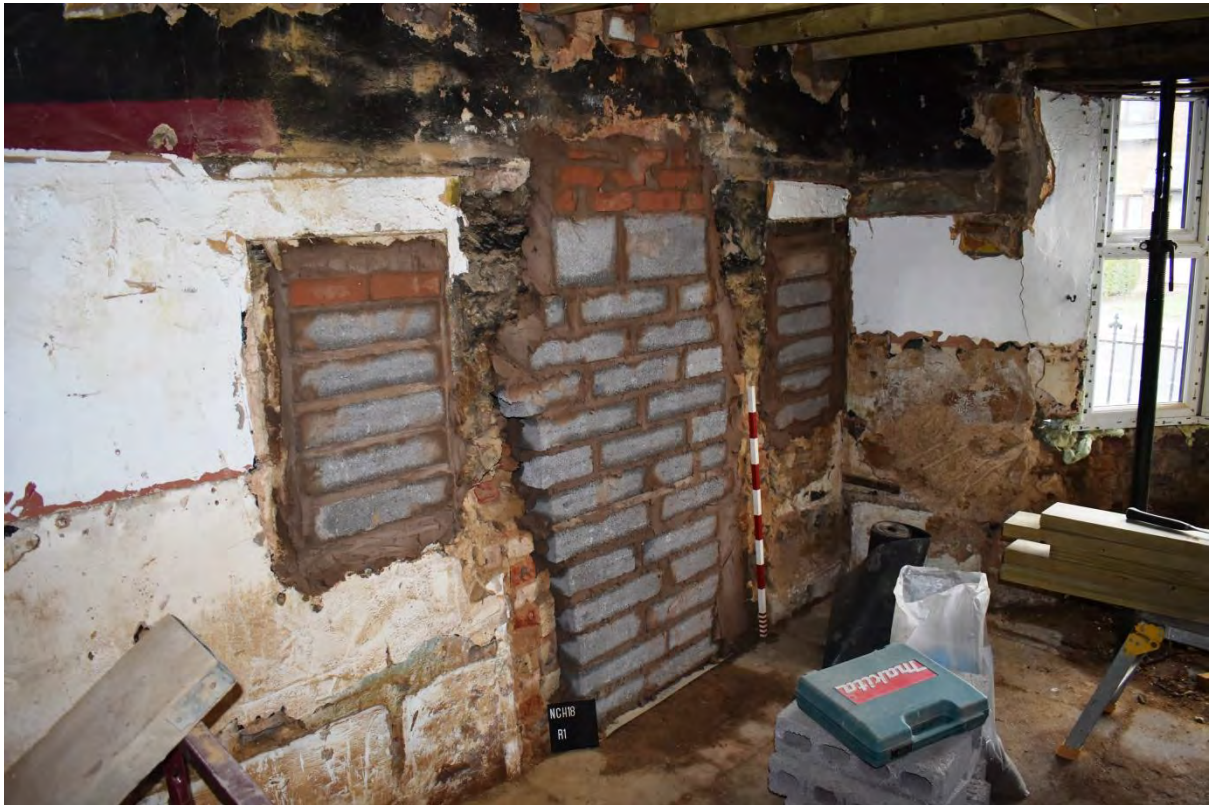
11: Blocked fireplace and alcoves in southern part of the bar (Room 1)

- 5.15 The walls were stone or brick-built but plastered and painted, although the south-west wall had been partially stripped during the removal and blocking of a former fireplace (Photo 11). The floors differed across the room with the north half constructed from floorboards, the central access area had a concrete floor and the south-east corner had large rectangular slates (Photo 12). The ceiling had been removed across most of the room, but where it did survive it showed it was originally painted lath and plaster that was covered by modern plasterboard and fake painted wooden beams were added (Photo 13). Room 1 had a spiral brick staircase into the cellar (Photo 14).

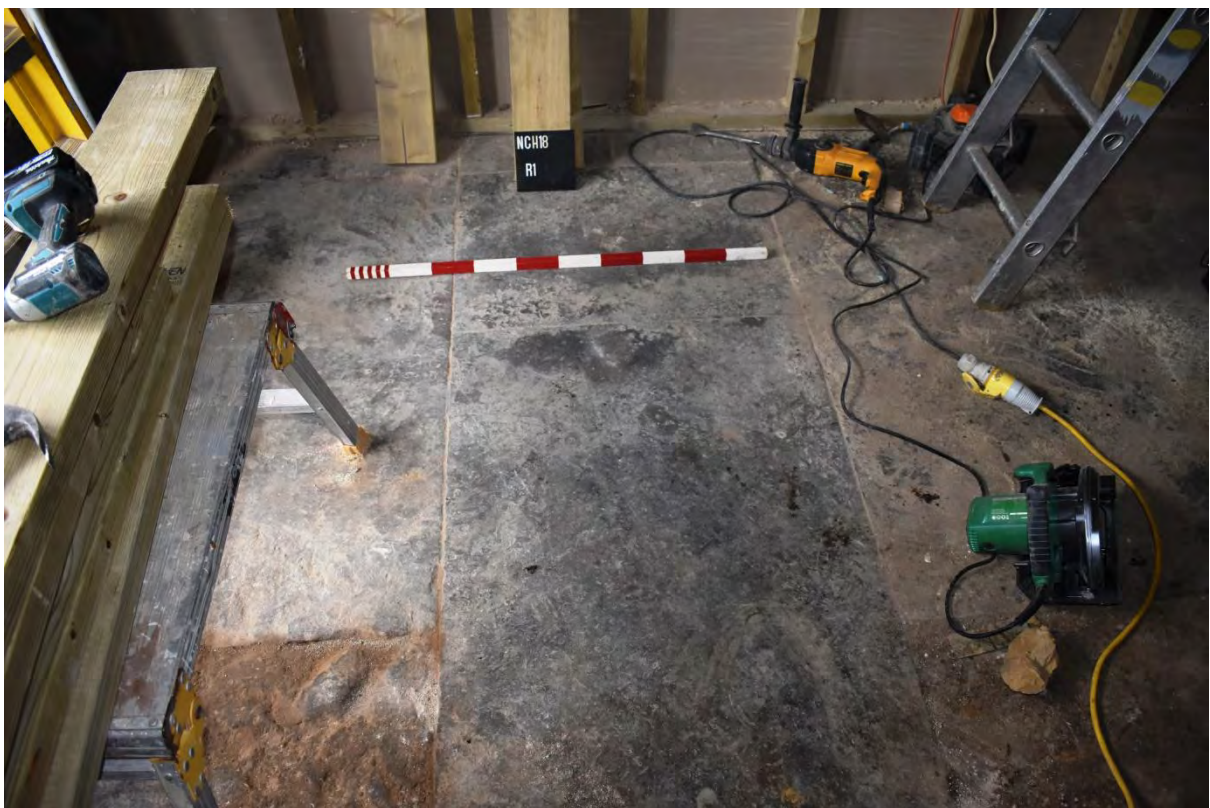
12: Slate floor in southern part of the bar (Room 1)

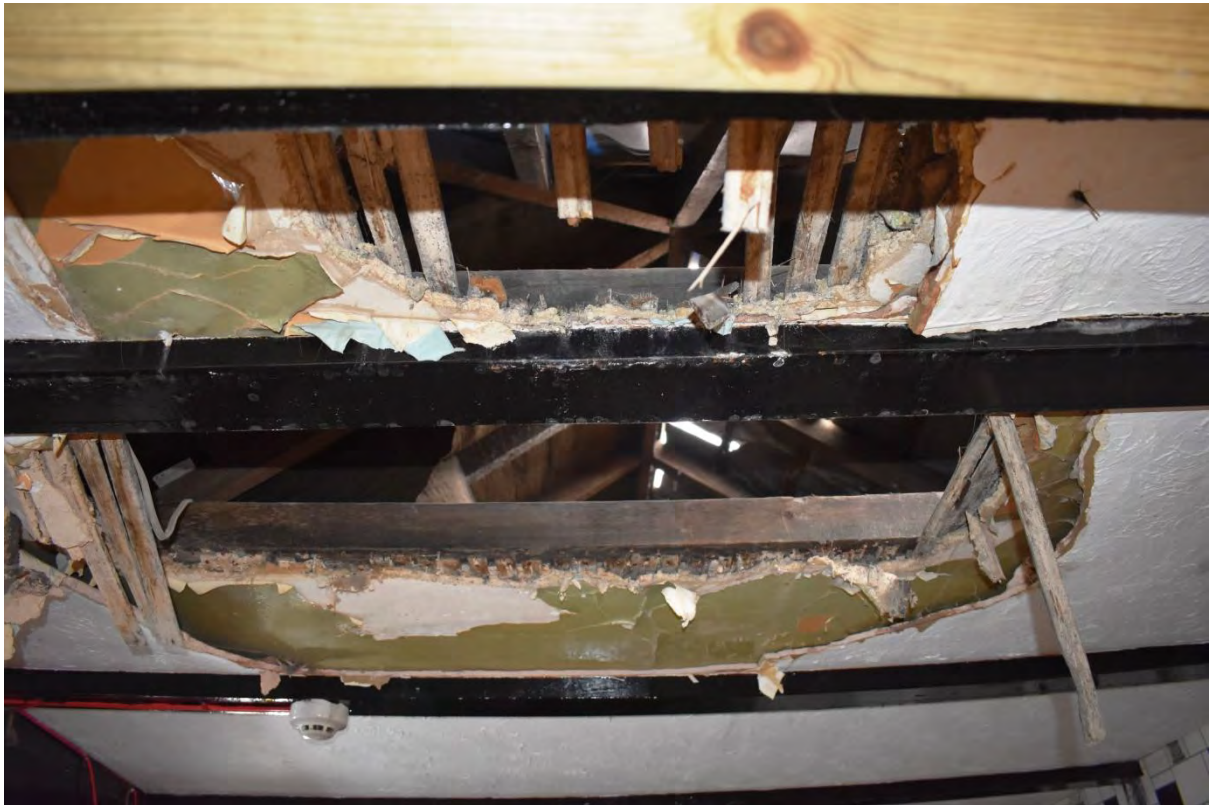
13: The ceiling in the bar (Room 1) during demolition showing the original lath and plaster ceiling that was replaced by modern plasterboard and fake beams

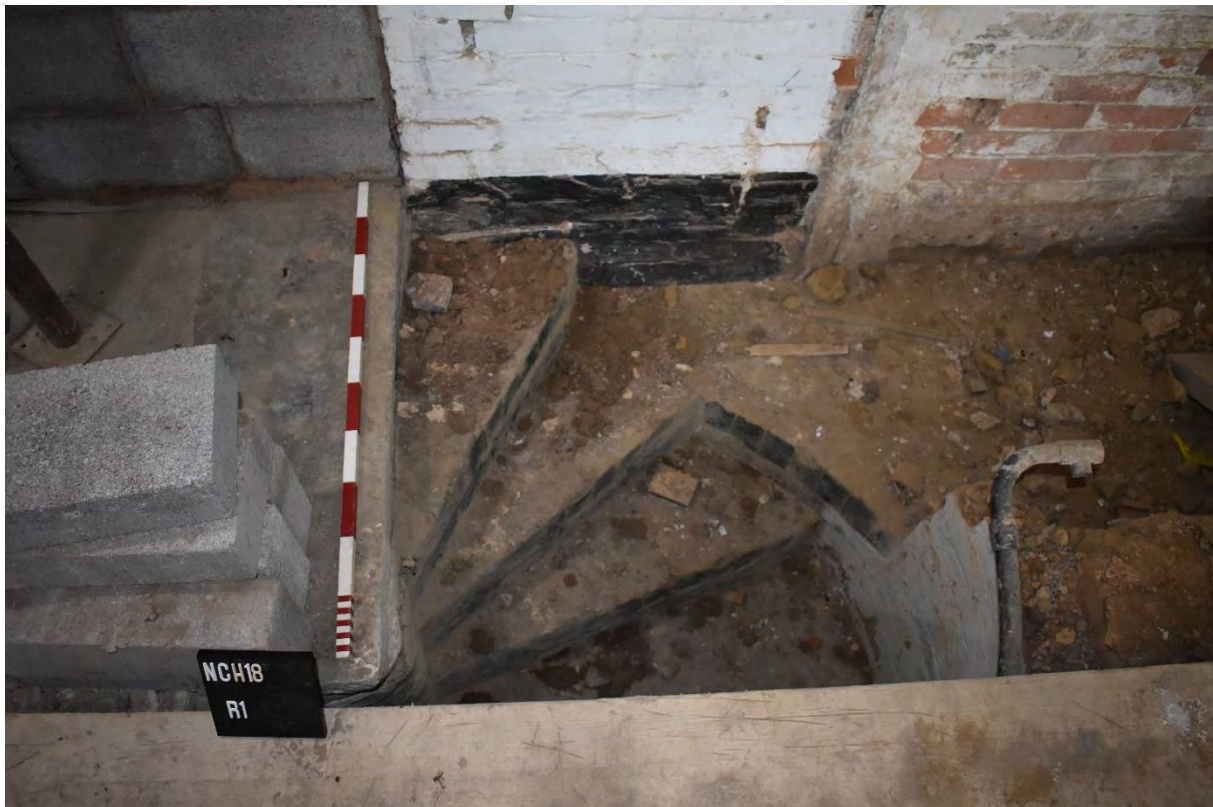
14: Upper part of spiral staircase into cellar

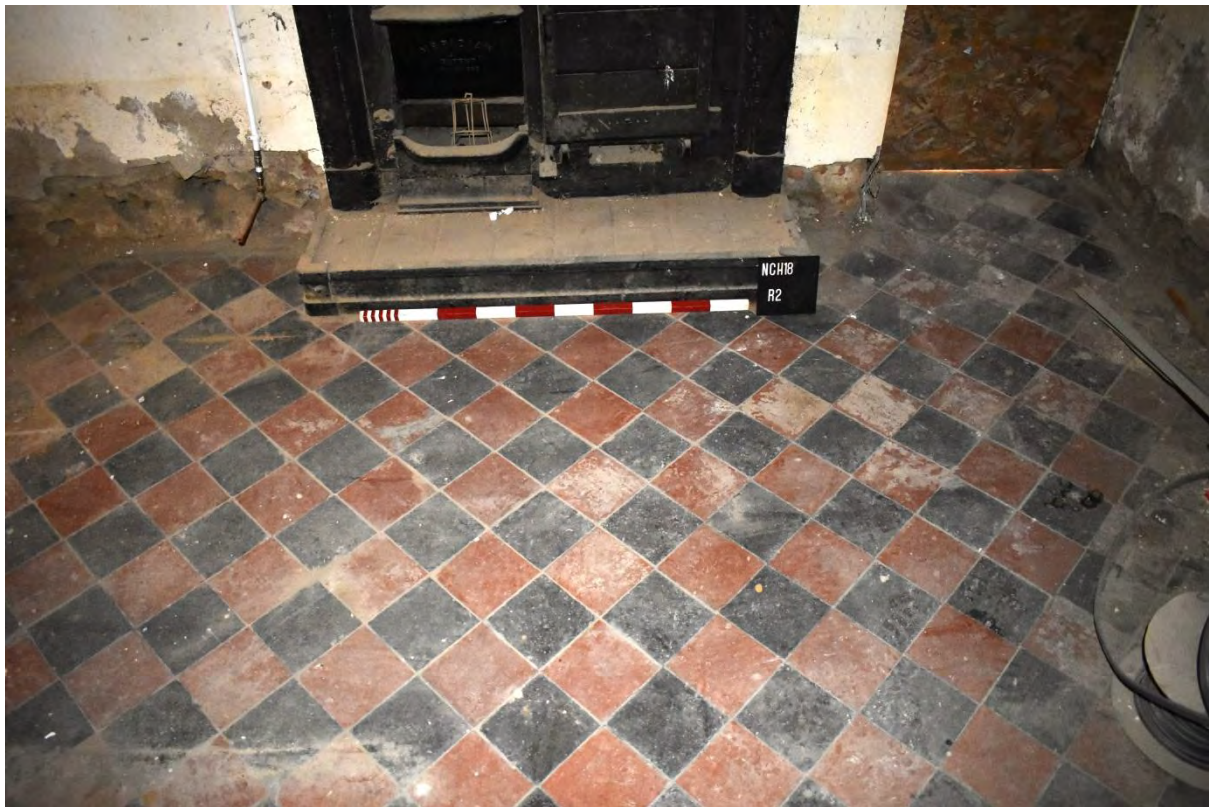
15: Tiled floor in the rear bar (Room 2)

- 5.16 The modern extension was added to make the rear room the same width as the bar and provide a dining area. This discussion will only include the original part of the building, which was a narrow rectangular range extending south-east from the southern end of the building. It was brick built with plastered walls and a red and black tiled floor set in a diamond pattern (Photo 15), which may be original. An intact 19th-century cast-iron fireplace and triple oven survived in the south-east wall. It had a mantle and

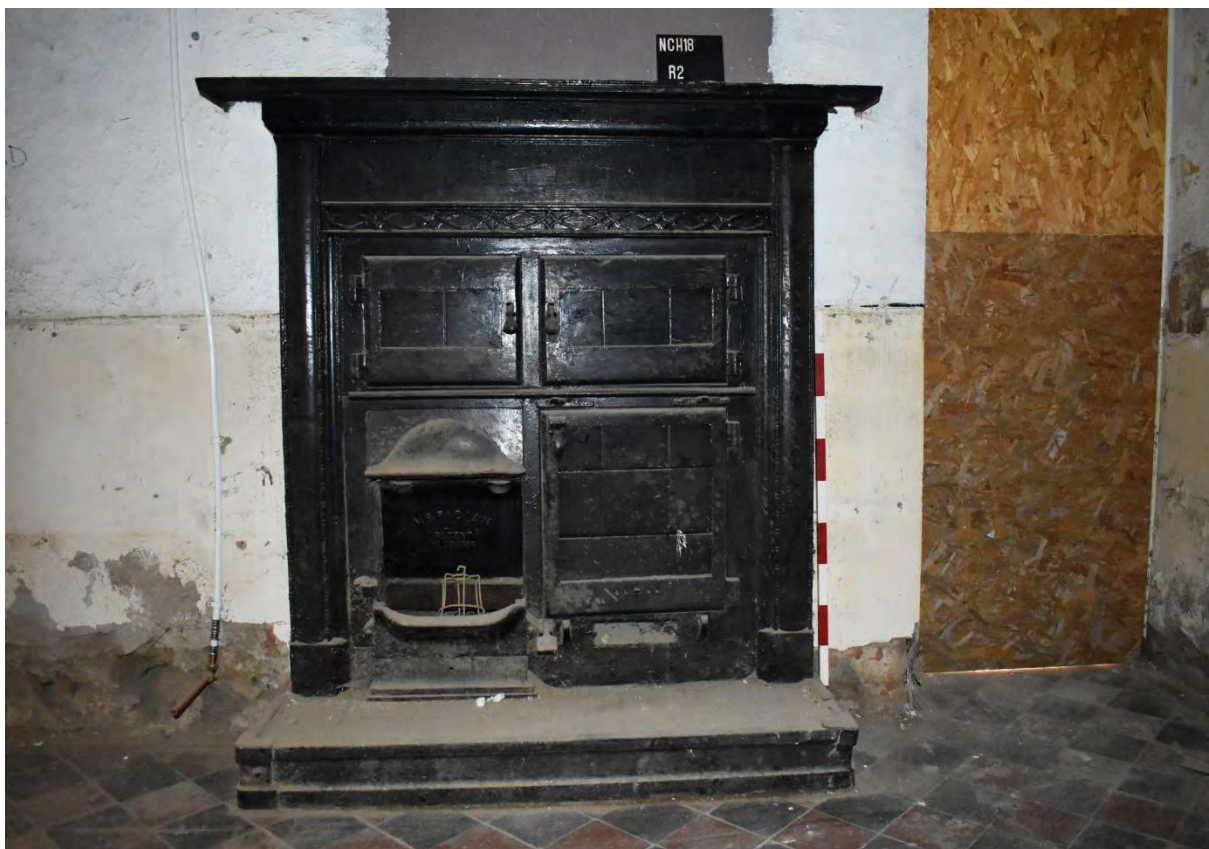
16: Cast iron fireplace and oven in rear wall of Room 2

hearth and the oven doors had tiled inserts (Photo 16). The rear of the fireplace has the words 'MERIDIAN PATENT with a patent number that could not be discerned.

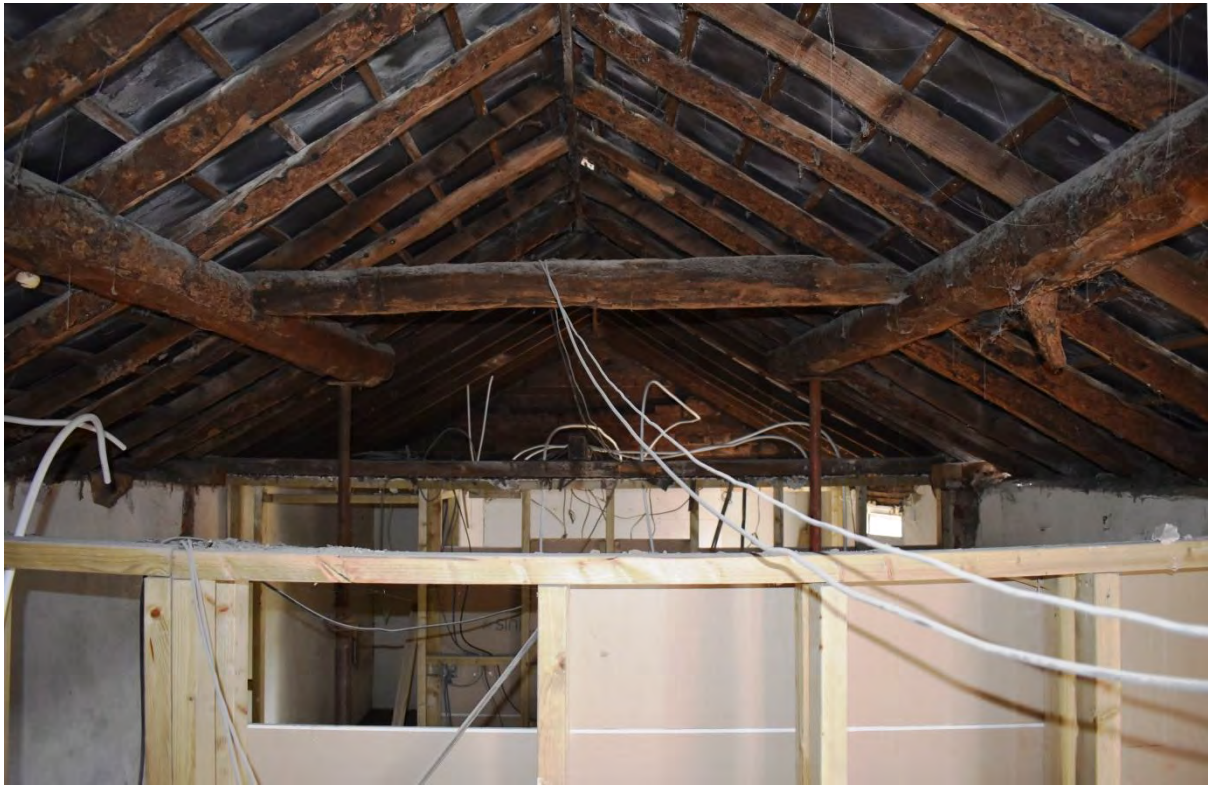
17: Roof structure of the stables

- 5.18 The stables had previously been converted from stables to cottages and then the ground floor of the majority of the space opened up and converted to a Function Room, so little of the original building survived or was visible, although some parts of the original roof structure did survive (Photo 17). The original roof was constructed from roughly rounded timbers, with the purlins rebated to take the rafters and the cross beams and a small area of the original lathe and plaster ceiling survived (Photo 18). The first floor, the majority of which was not accessible, was still subdivided by brick walls. The floor above stabling was typically used for hay storage etc but the chimney breast on the north-west wall and the fireplace and copper shown on the architect's plan in the Phase 2 first floor building, but removed by the time the recording took place, suggests domestic use.

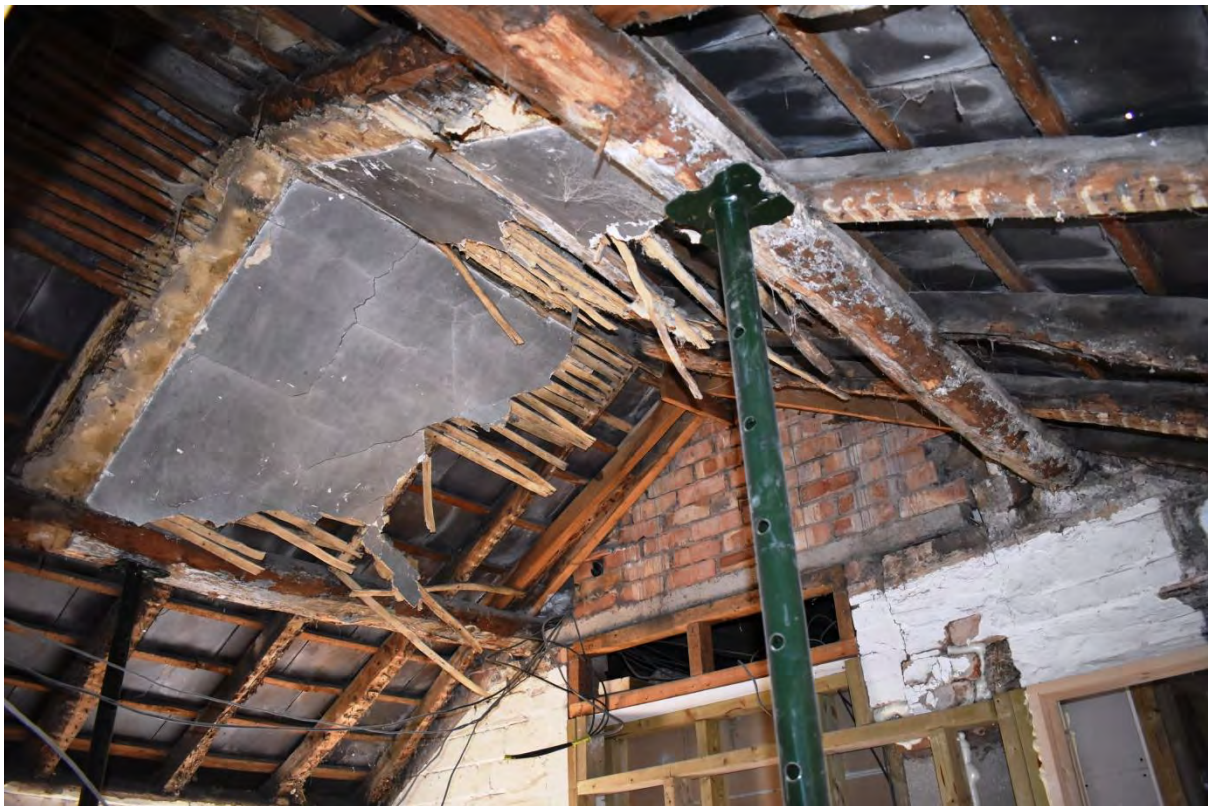
18: Last surviving fragment of the original lath and plaster ceiling in the stables

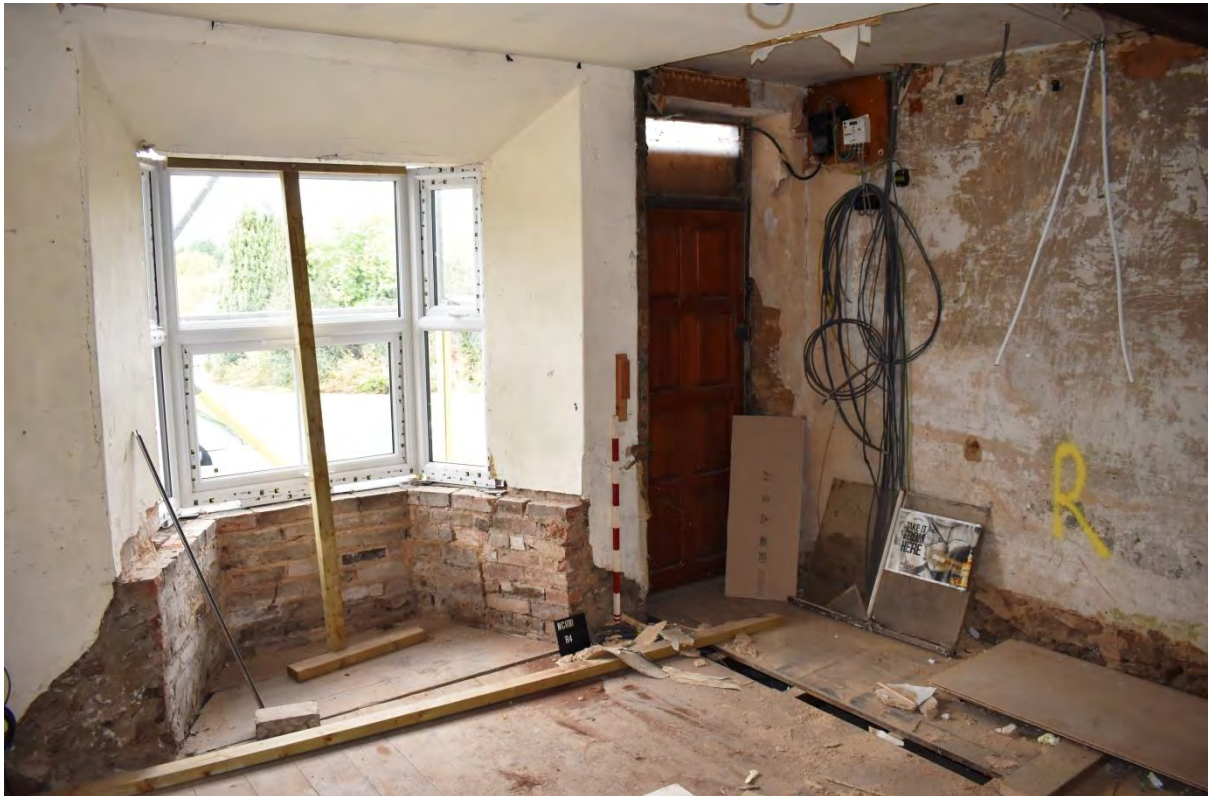
19: The replacement window and front door in Room 4

- 5.20 This room extended the full width of the building and includes the bay window and front door (Photo 19). The walls and ceiling are plastered stone and the floor is constructed from modern boards. At some point a wall had been added to create a narrow entrance corridor from the front door to the rear of the property, but this has been removed. This room is likely to be the full footprint of the property as shown on the 1835 map, subsequently extended to the rear in brick prior to the erection of the stables.

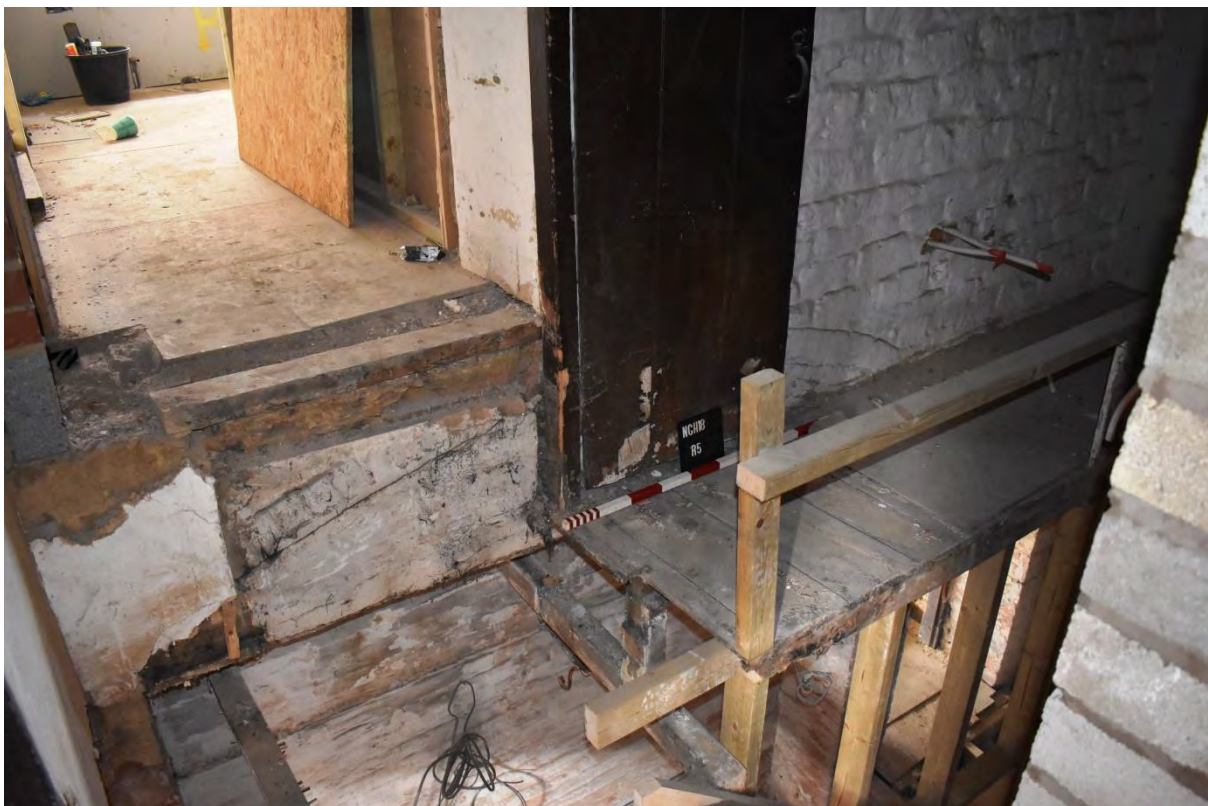
20: Original rear stone wall of the adjacent building and blocked archway visible on the half landing (Room 5)

- 5.21 A set of new wooden stairs has been inserted against the south-west wall of Room 6, although they are a replacement for an earlier wooden staircase that led to a half landing and accessed two bedrooms. The bedrooms were not accessible during the survey as the stairs were only partially complete. The stairs were inside the small extension between the rear of the original building and the early phase of the stables and the rear stone wall of the original building was visible on the half landing (Photo 20).

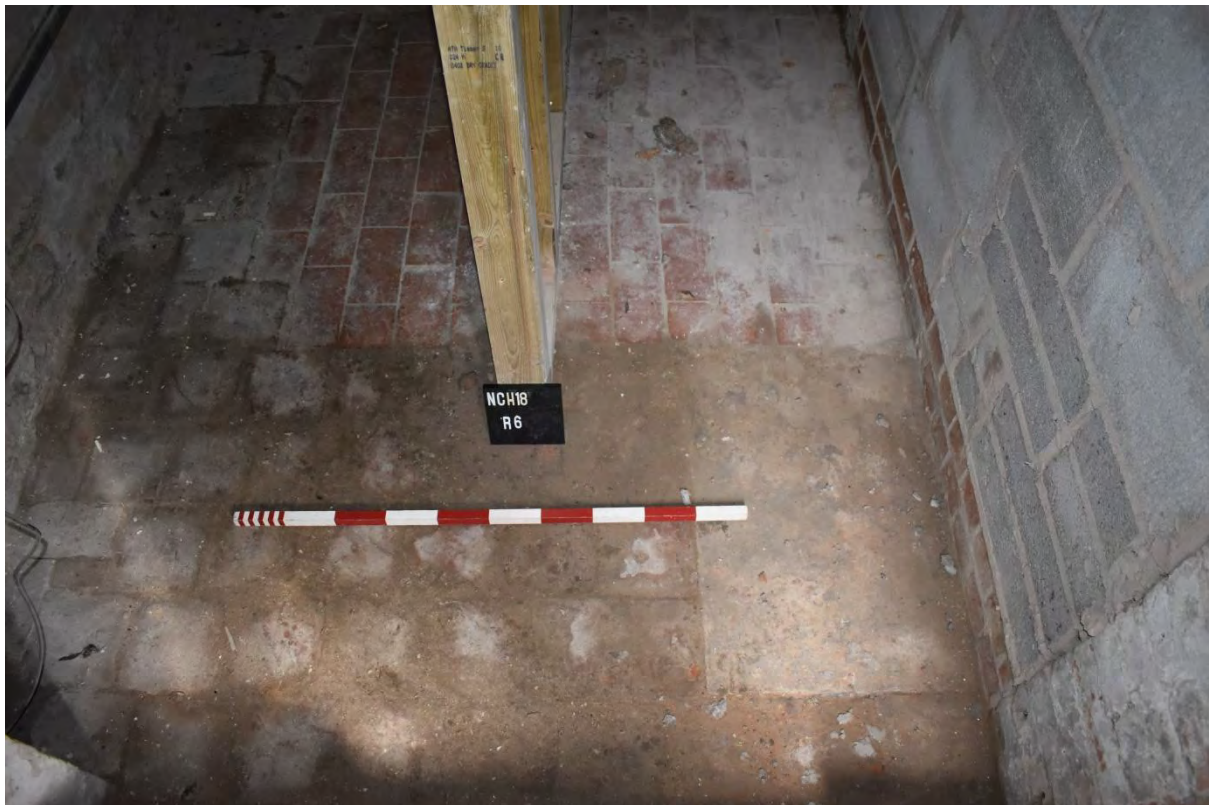
21: Brick and tiled floor of Room 6 and new internal walls added for this renovation

- 5.22 A small brick-built room with brick and tiled floor (Photo 21) and some surviving lath and plaster ceiling. It is possible that this room was a scullery. The stairs to the half landing (Room 5) rise from within this room. The north-west wall has an infilled, recessed arch, the top of which is visible on the half landing above. This suggest that at some point rooms 4 and 6 formed an open plan space. A narrow, round-headed brick-arch passage-way leads to the rear of the adjacent Room 7.
