The Coach and Horses Daventry Northamptonshire

ARCHAEOLOGICAL RECORDING

Archaeology Warwickshire Report No 2028

FEBRUARY 2020

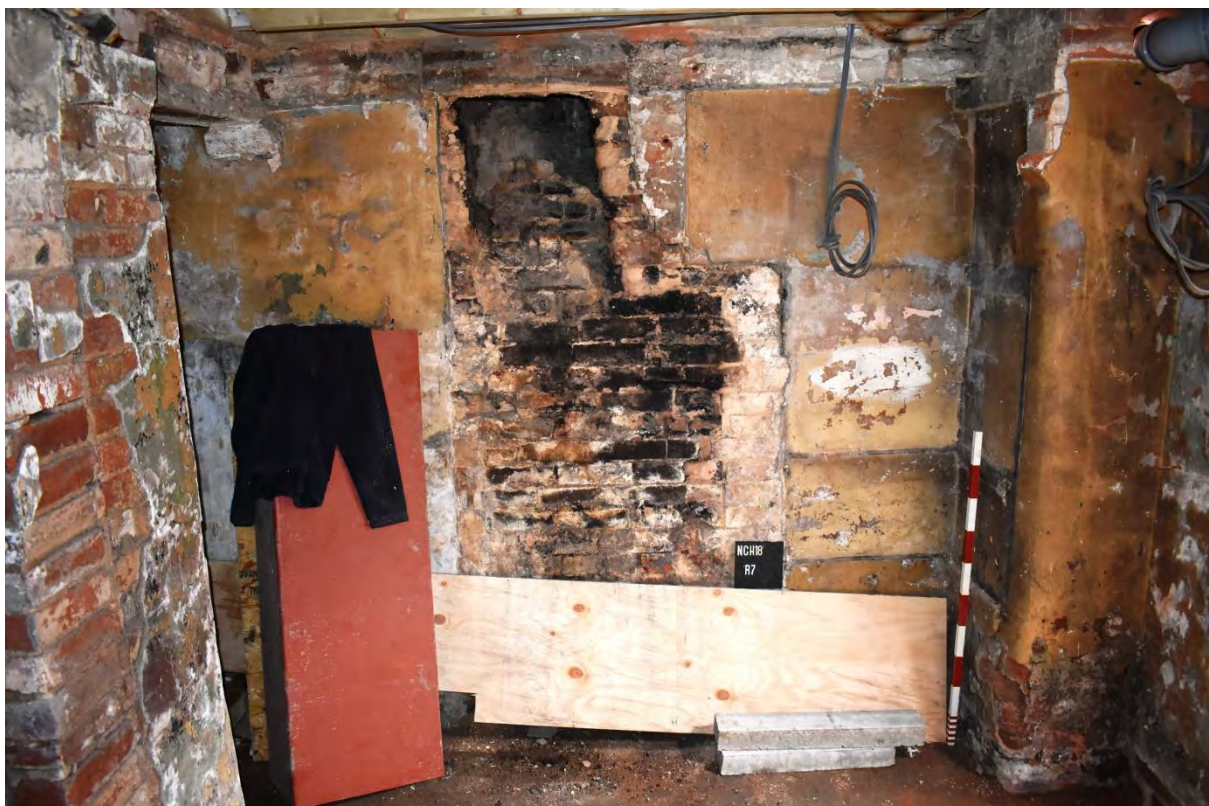
22: The north-east wall of Room 7 showing the chimney from the removed fireplace

- 5.23 This forms the rear of the small extension on the rear of the street front building and it is brick built with a ceramic tiled floor. The walls are plastered, but the ceiling had been removed. A fireplace has been removed from the south-east wall (Photo 22). The fireplace suggest that this room was the former kitchen. The room is split into two by a brick dividing wall with the rear part of the room having a raised timber floor. The rear part is accessed through the arched passageway from Room 6 and through a square-headed door from the front half of the room. There are no surviving internal fixtures or fittings to suggest a function for the rear part of the room.

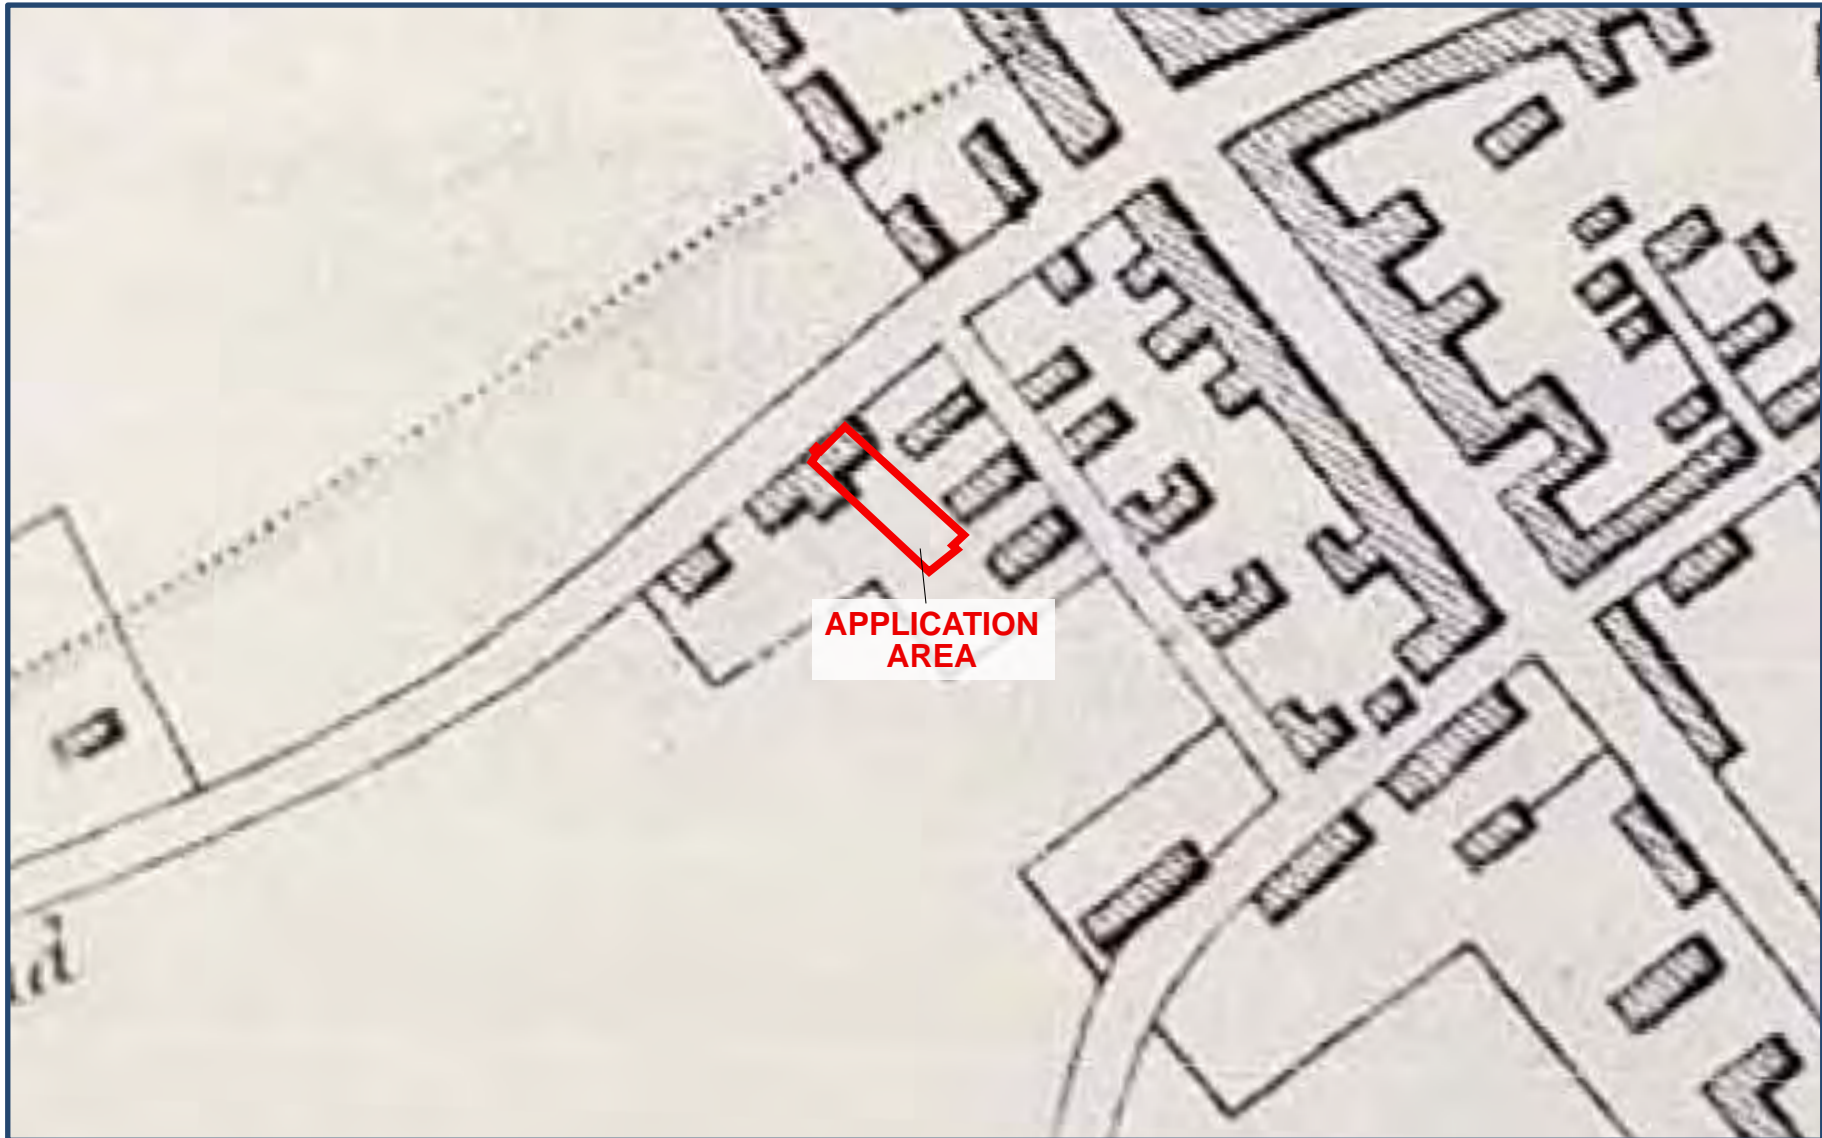
Fig 4: Detail from 1835 Borough map of Daventry

- 3.3 Historic mapping held in Northamptonshire Archives suggests that this part of Daventry was largely undeveloped until the early 19th century. The Inclosure map of Daventry of 1803 shows the block of land in which the Coach and Horses lies as being parcelled off from the rest of the area and belonging to T Miller (NCRO Inclosure map 2240; Fig 3). An 1846 addendum in the Inclosure Act Award states that plot 313, owned by Thomas Miller, was '*Now covered with houses and buildings divers owners* (NCRO D/2752)'. The reduced bounds of Daventry Borough map (1835; Fig 4) shows a small number of buildings along the road frontage and indicates that medieval burgage plots only extended as far as the eastern side of St James Street (Greenall 1999, 16). This would seem to contradict the suggestion that the Coach and Horses has its origins in the 18th century, but in fact belongs to the early 19th century. It may be that the landlady who suggested it was constructed in 1736 may have meant 1836, which would seem to concur with the map evidence
