Blackbird Cottage Whitacre Heath Warwickshire

ARCHAEOLOGICAL MONITORING AND RECORDING

Archaeology Warwickshire Report No 1994
AUGUST 2019

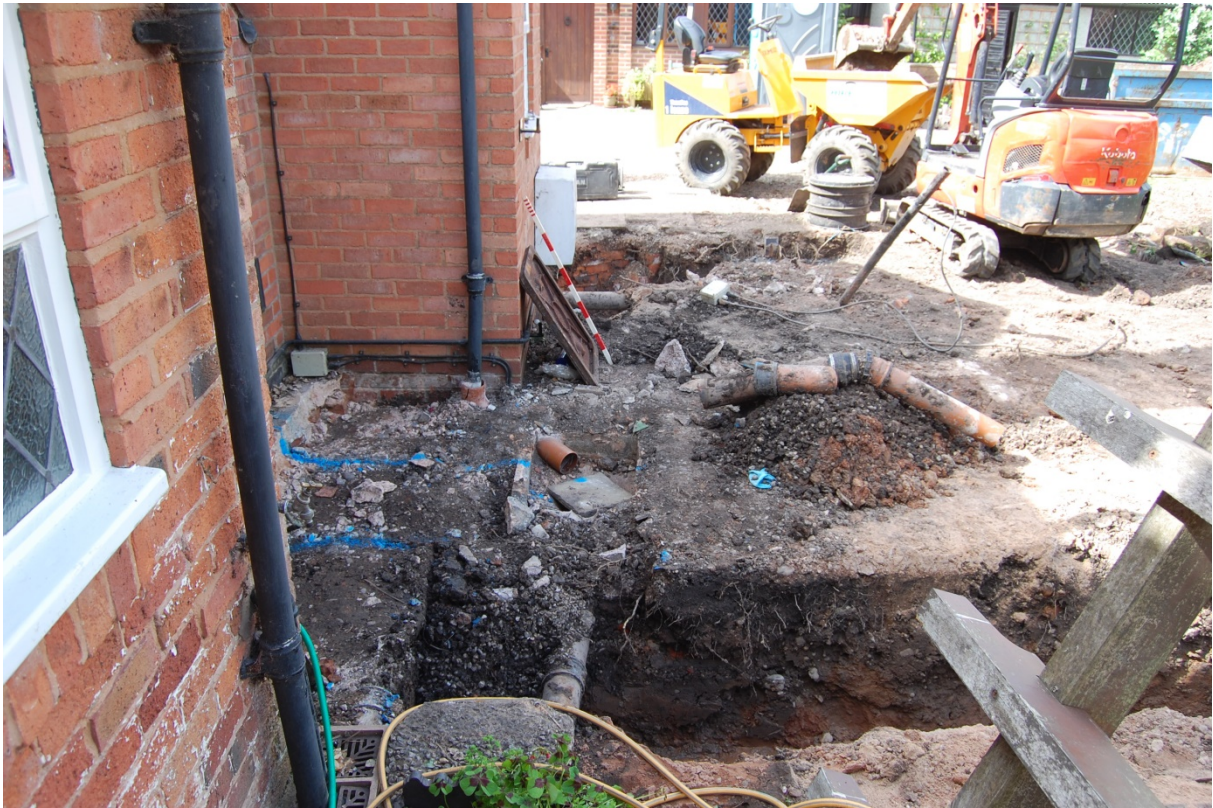
1: General view of trenches, looking north

- 4.5 The foundation trenches for the new extension were excavated by a machine using a toothless bucket to a depth of at least 0.8m or to the natural geology. Foundation trenches next to the extant buildings were hand dug. The eastern trenches were due to be excavated within the pond and with agreement from the planning archaeologist were not observed (Photo 1, Fig 3).

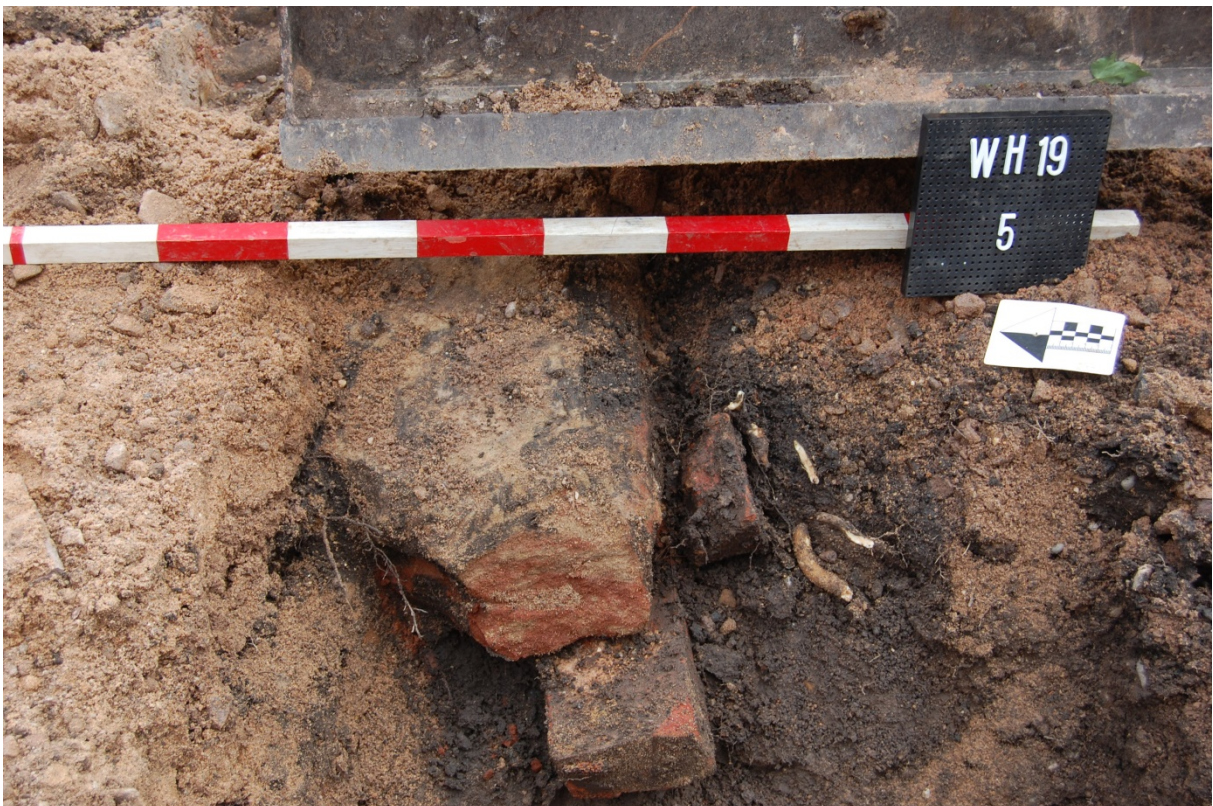
2: Sandstone and brick rubble

- 5.2 Overlying the natural was 0.4m to 0.65m of dark grey silty clay garden soil (2) with occasional fragments of brick, tile and in places sandstone blocks. A concentration of substantial sandstone blocks was recorded in the foundation trench (4, 5). The red sandstone blocks were found roughly in a line (NE/SW) although they were not continuous and were not thought to be structural (Fig 3). One block had a brick adhered to the base suggesting it was part of a demolished structure (Photo 2). A single sherd of Midlands Blackware pottery of 17th-19th century date, was retrieved from the garden soil.

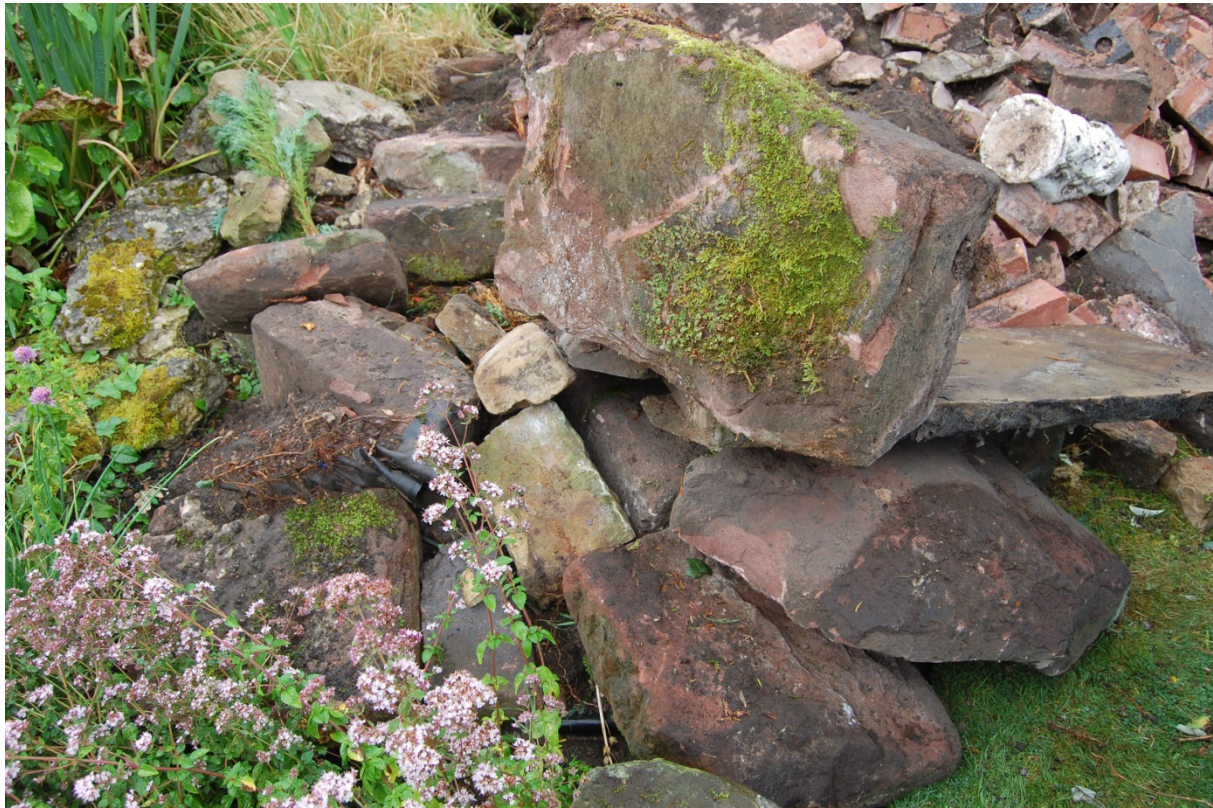
3: Sandstone blocks adjacent to the pond

- 5.3 A number of dressed sandstone blocks were also observed on the spoil heap from the initial surface clearance, and around the current pond (Photo 3). The householder was not aware of the origins of these stones as they were in-situ when she took ownership of the property.

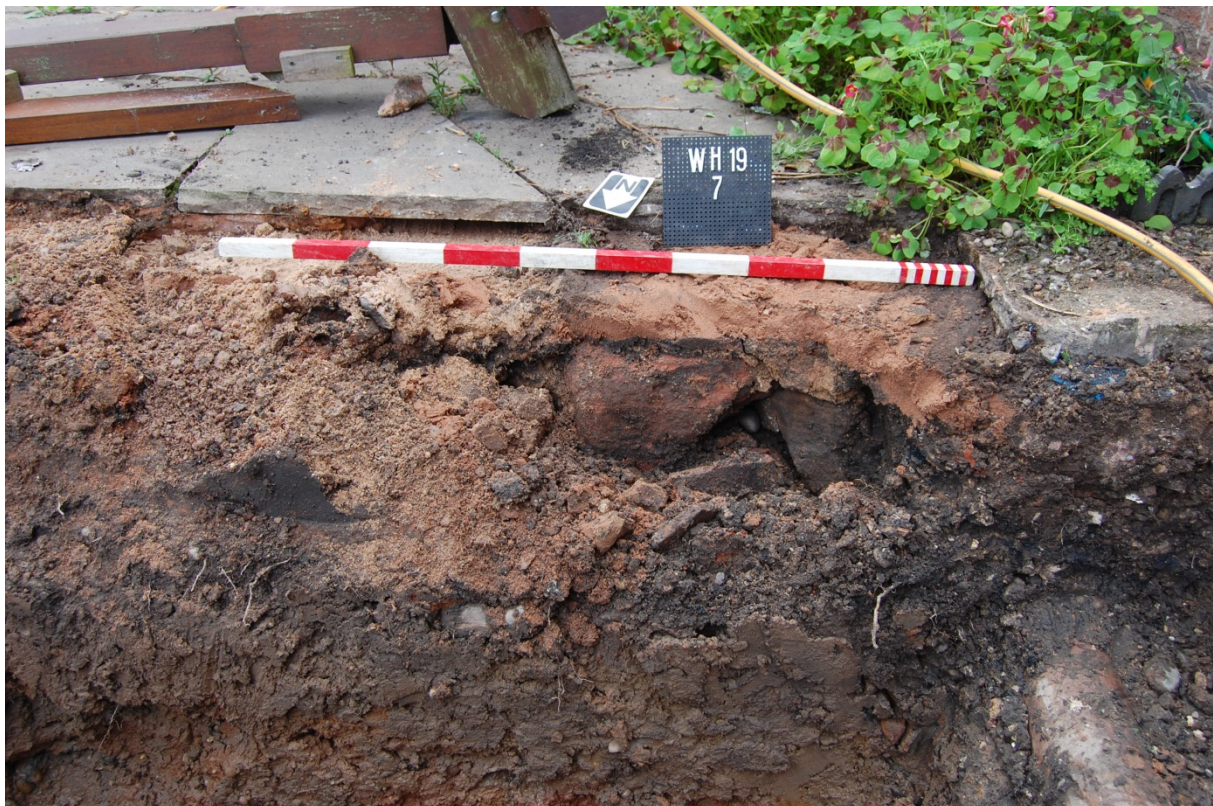
4: Sandstone blocks visible in section

- 5.4 Further sandstone blocks (7) were recorded in the SW corner of the foundation trench (Fig 3). They survived in the section only and therefore it was not possible to discern if they represented further demolition rubble or were part of a wall (Photo 4).
