**Our Reference**            **ZHS19**  
**Planning Ref**            **TBC**  
**HER Ref**                 **WSM71955**

## **ARCHAEOLOGICAL ASSESSMENT**

### **High House Farm, Mappleborough Green, Studley**

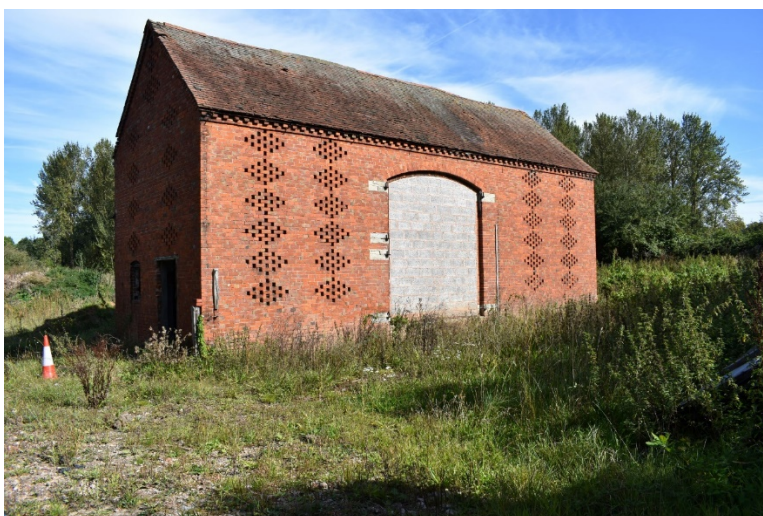
Threshing Barn

The development site is within a farm complex which is depicted on the First Edition Ordnance survey map of 1888 (Landmark 2003, digital edition). The farm was arranged with a farmhouse to the north and two barns on the east and west of a farmyard to the south of the farmhouse. A further building is shown to the north and in front of the farmhouse is a circular driveway. The eastern barn is L-shaped. Photographs from the site visit carried out on the 13<sup>th</sup> September 2019 indicate that there was a threshing barn to the west (photo below) and a cart shed with granary above to the east (L-shaped building). The extant barns appear to be early to mid-19<sup>th</sup> century in date and the pattern of ventilation spaces (as shown on the threshing barn image) are nice examples of these.
