THE MOAT HOUSE

Archaeological Observation at The Bishop's Palace, Alvechurch, Worcestershire

Report 1059

The Moat House: Archaeological Observation at the Bishop's Palace, Alvechurch, Worcestershire

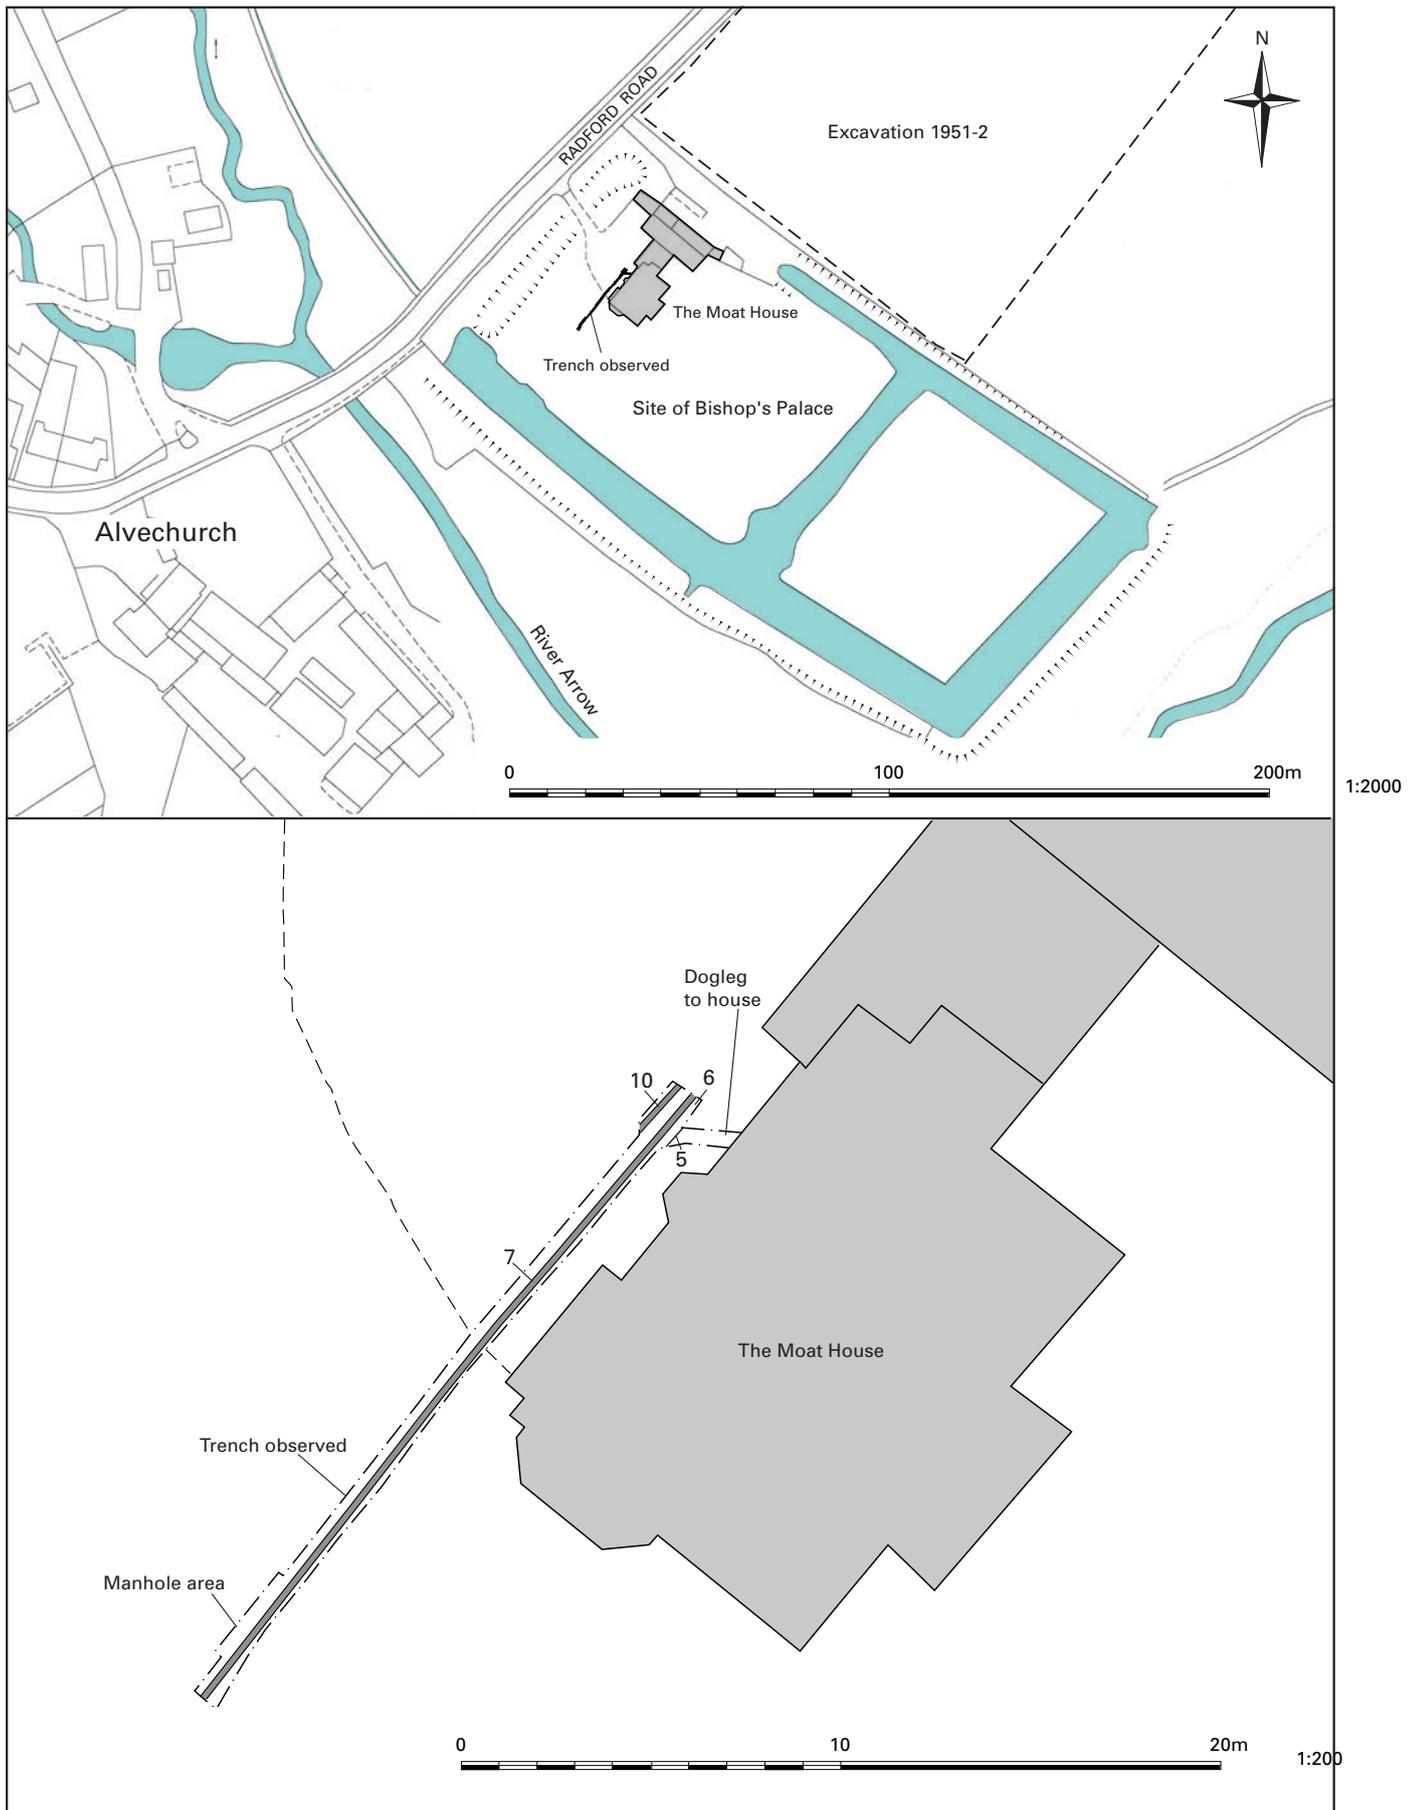
Fig 2 Trench observed

4.1 The groundworks consisted of the excavation of a manhole and trench for the replacement drain using a tracked mini-excavator with a toothless bucket (Figs 2-7). The trench measured 0.50m wide by 1.10m-1.25m deep, being deepest in the area of the new manhole (Fig 5) where it also widened out to c0.85m for a c2.5m stretch. The majority of the trench was cut entirely within the fill of a pre-existing pipe trench and thus did not expose any earlier deposits. This was apart from a widened area for the new manhole at the south-west end of the trench (Fig 5), and the dog-leg stretch running west from the north-east end of the pre-existing pipe towards the house (Figs 6 & 7).

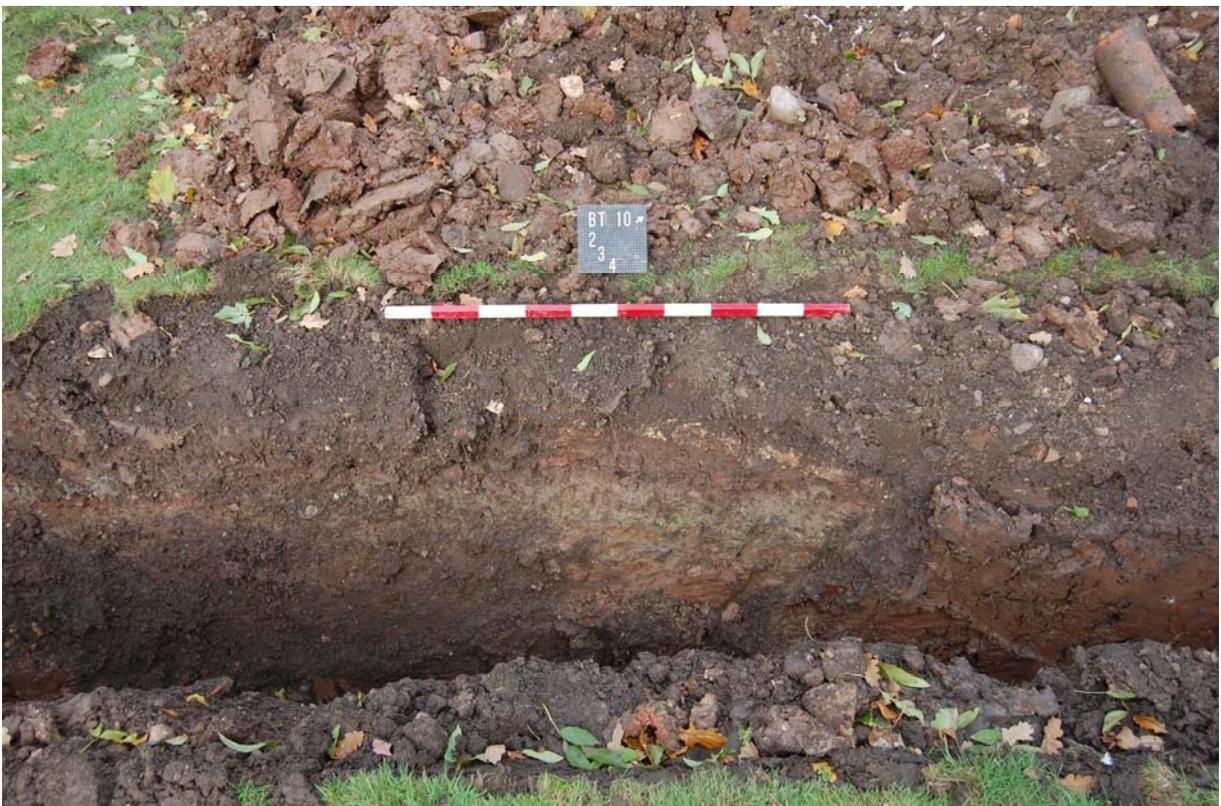
Fig 5 New manhole area looking north-east, layers 1-4

4.2 In the area of the manhole (Fig 5) the geological natural strong brown clay (4) was recorded at c0.54m below the existing ground surface. This was overlain by a c0.10m thick layer of greenish grey sandy clay (3) that may itself have been a variation of the geological natural. Layer 3 was overlain by a c0.14m thick layer of greyish brown clay loam (2) that contained frequent small fragments of ceramic roof tile (not retained) and mortar flecks. This probably represents demolition material derived from a former building within the contemporary garden soil. Layer 2 was cut by the pre-existing sewer pipe trench, aligned roughly south-west to north-east. It was backfilled with a ceramic pipe (7) that lay at c1m below the existing ground surface. The pipe was overlain by a mixed deposit of greyish brown clay loam, strong brown clay and ash (6) from which a single sherd of 19th century willow pattern pottery and an iron object were noted. Pipe trench fill 6 was overlain by the c0.30m thick layer of dark greyish brown clay loam of the existing garden soil (1).

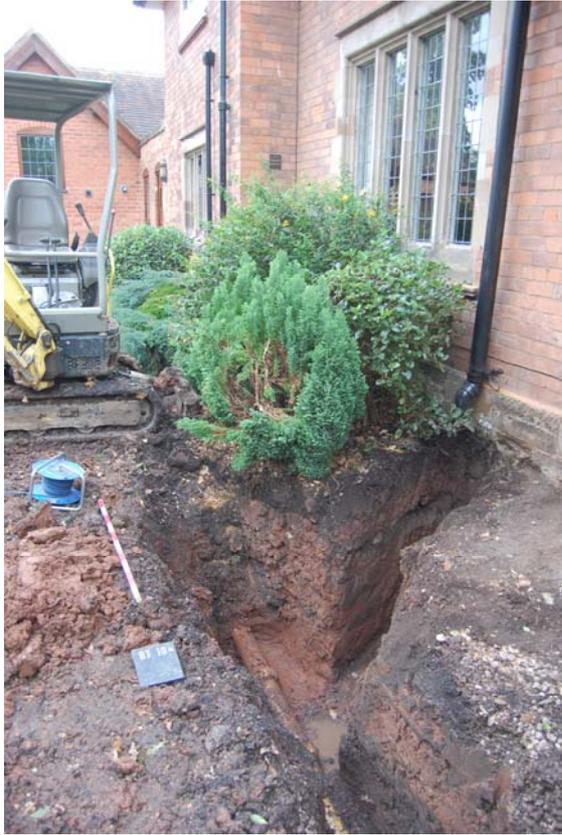
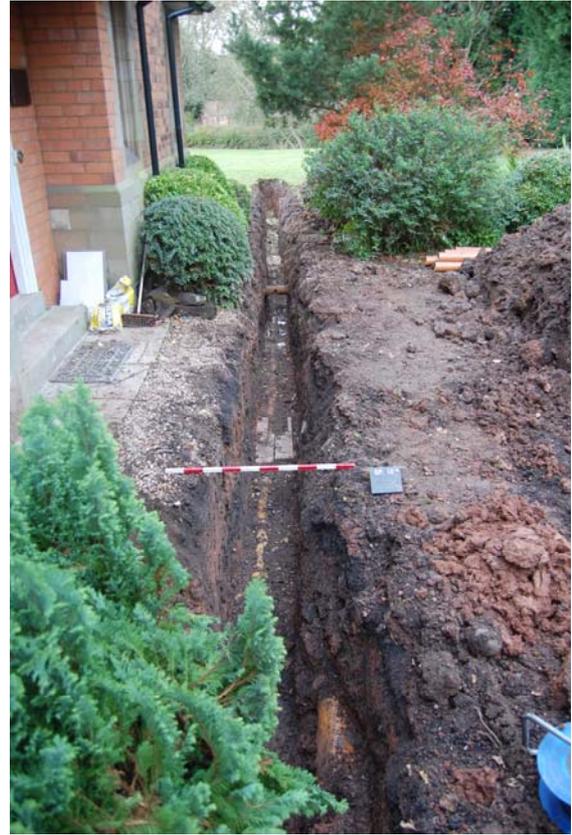
4.3 In the dog-leg trench (Figs 6 & 7) geological natural strong brown clay (4) was recorded at c1m below the existing ground surface. A further pipe trench (8) ran aligned roughly south-west to north-east, parallel to pipe 7 and slightly north-west of it. Pipe trench 8 had a ceramic pipe (10) in its base overlain by a backfill (9) identical to trench fill 6. Pipe trenches 5 and 8 were thus probably contemporary. Trench fill 9 was overlain by the c0.24m thick dark greyish brown clay loam (11) of the existing flower bed.

Fig 6 Dog-leg trench looking north-east

Fig 7 Trench looking south-west
