Rectory Barns Dorsington Warwickshire

ARCHAEOLOGICAL OBSERVATION AND RECORDING

Archaeology Warwickshire Report No 1793
OCTOBER 2017

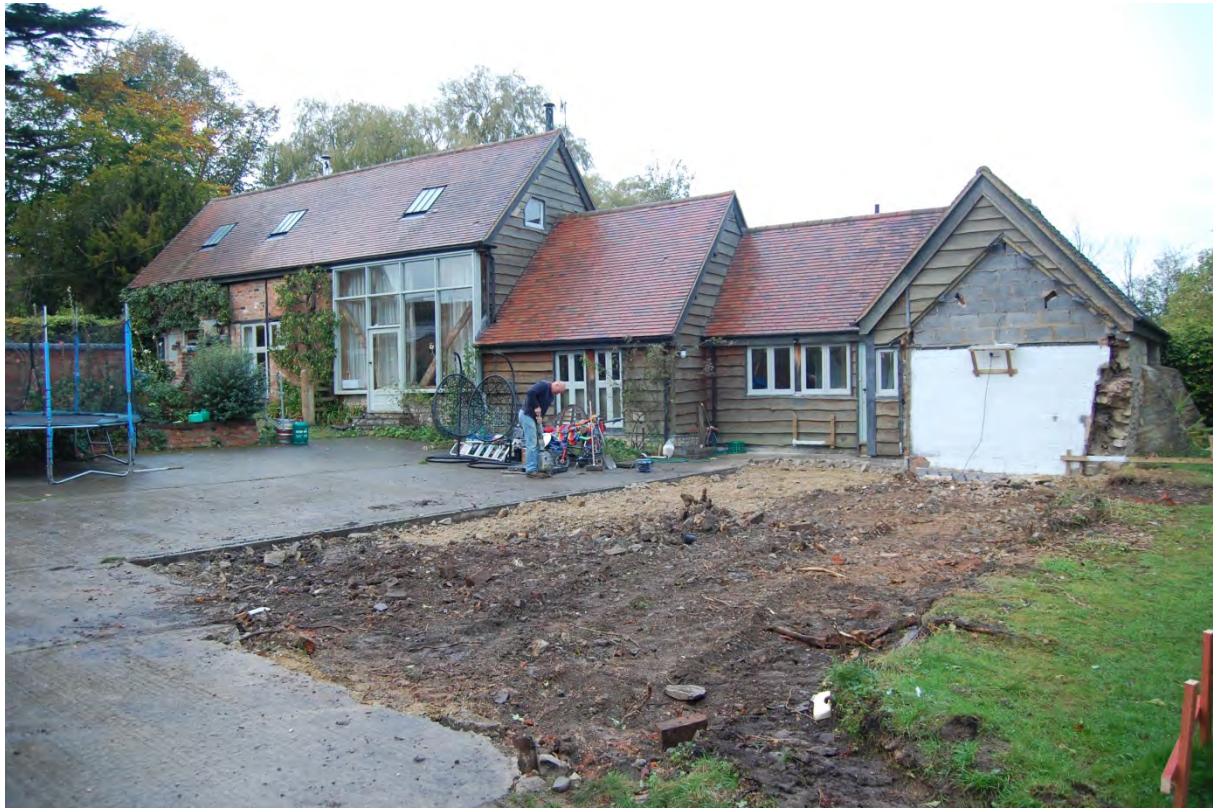
1: Site prior to foundation trenches being excavated

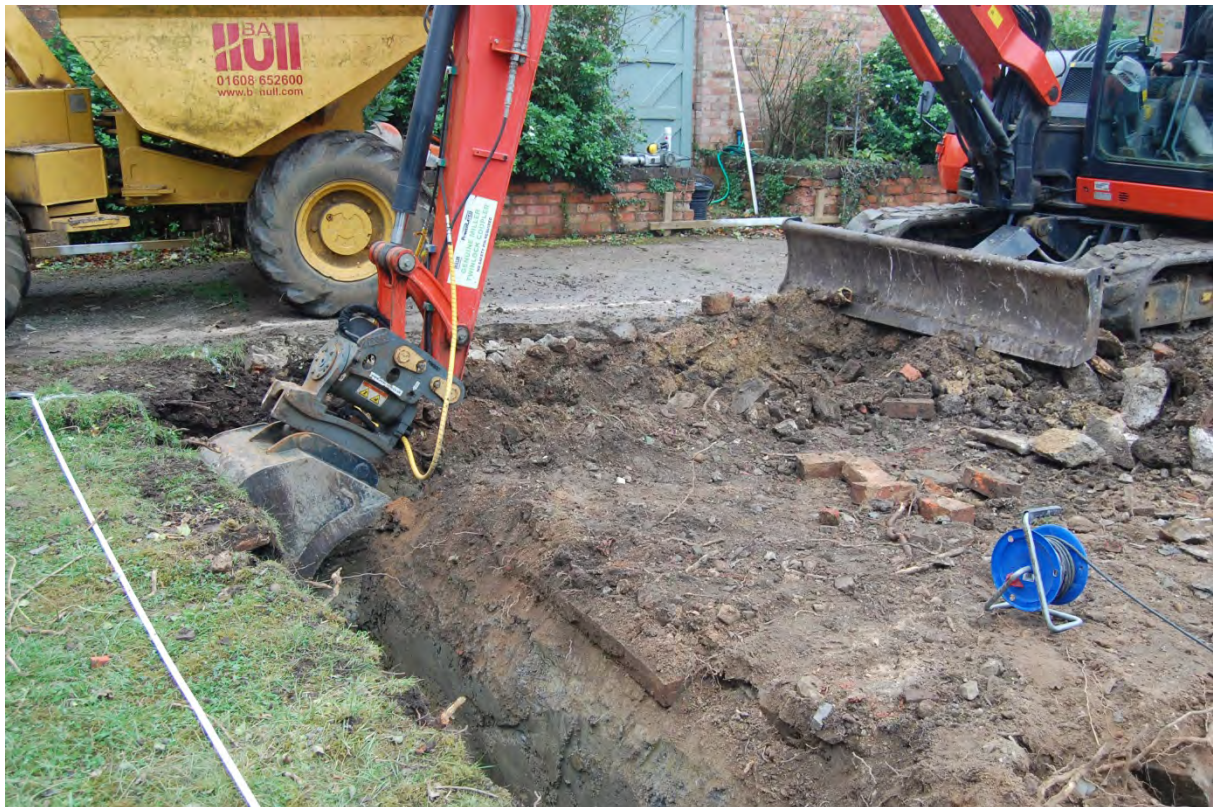
- 5.3 The remains of the limestone footings (2) of the former northern building were visible in the section, to a depth of 0.50m below ground. Further to the south the remains of a brick floor (5) were visible below c.0.10m of demolition rubble, presumably the former floor of the southern, brick-built, outbuilding. Large amounts of tree roots were visible below the level of this floor, suggesting the close proximity of a former ash tree had significantly destabilised the building. A brick wall visible on the south side of the southern trench (10) is likely to have been the footing of the southern wall of the former brick building.

2: Brick floor 5 in section

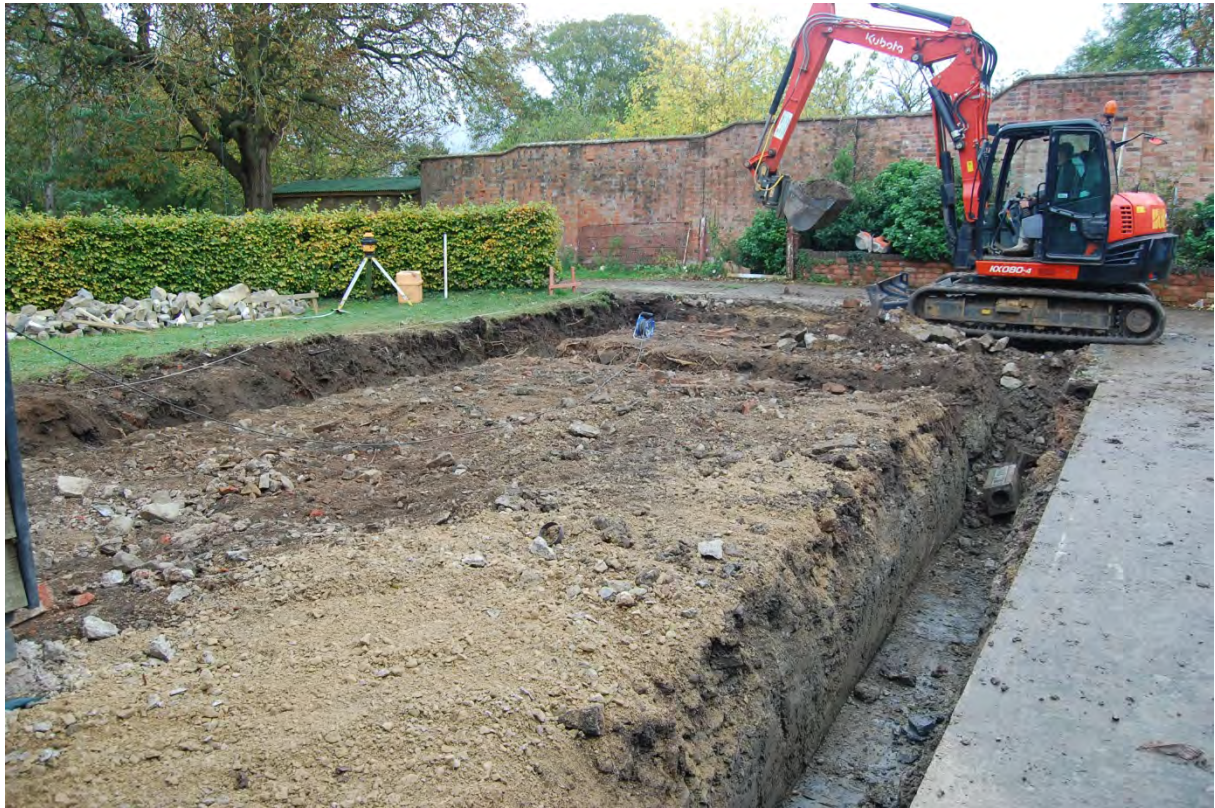
- 5.2 The internal footprint had already been reduced by 0.25m as part of the process of demolition and clearance of the site. The concrete that had formed the yard surface in the area of the new area of buildings had partly been broken up and removed. The trenches for the new building were excavated with a 360° excavator fitted with a toothless bucket to a depth of 1.50m from the level of the surrounding ground.

3: Trenches under excavation

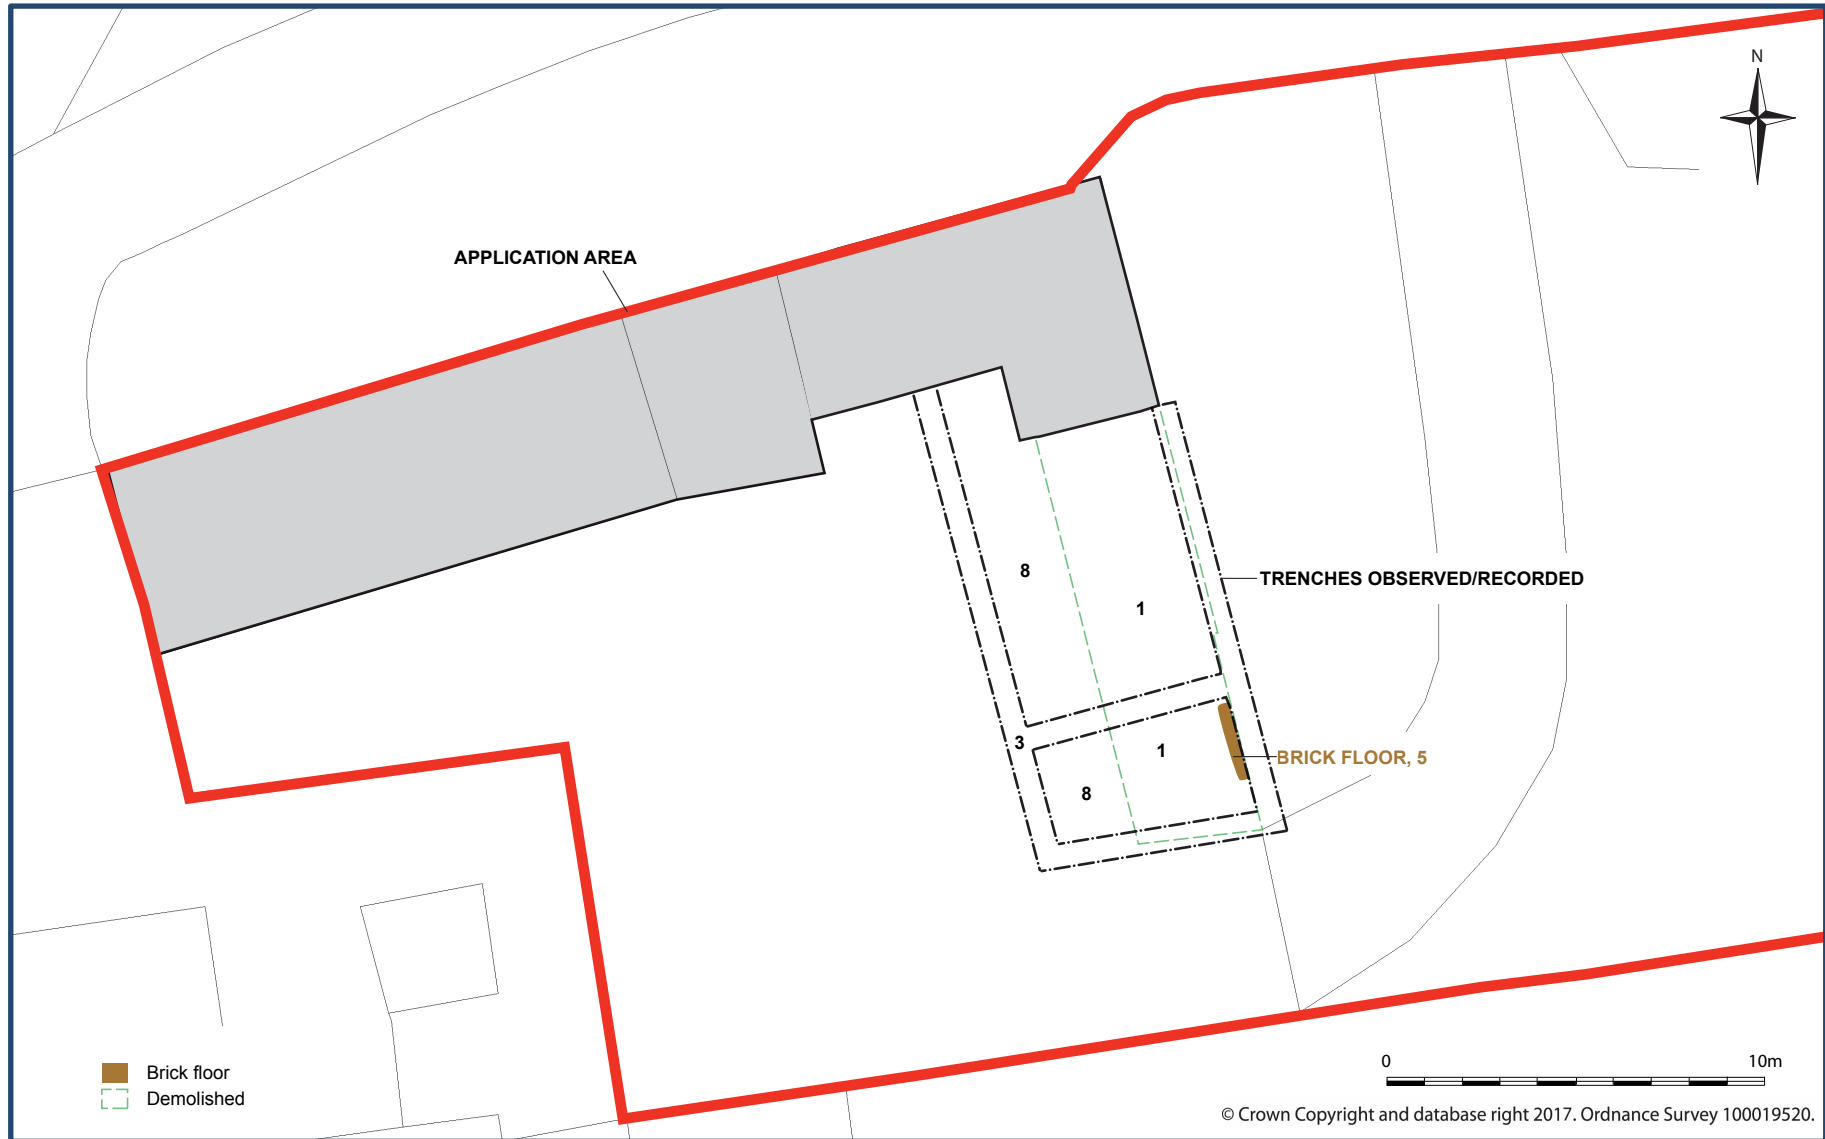
- 5.2 Geological natural Lias clay (3) was recorded at a depth of c.0.45m below present ground level on the eastern side of the building and was overlain by 0.15m of grey claim loam subsoil (6), itself overlain by 0.25m of topsoil, mixed with root fragments, bricks and limestone fragments (4). On the western side the natural clay was overlaid by 0.40m of grey clay mixed with large rounded stones (9).

- 5.4 On the western side of the building layer 9 was overlain by a band of topsoil nearest the standing building, but elsewhere directly by modern hardcore (8) for the concrete yard surface (7), the remains of which were broken up and removed the same day as the new footings were excavated.

Fig 3: Location of trenches observed and recorded
