2 Main Street Long Lawford Warwickshire

ARCHAEOLOGICAL WATCHING BRIEF

Archaeology Warwickshire Report No 1976
SEPTEMBER 2019

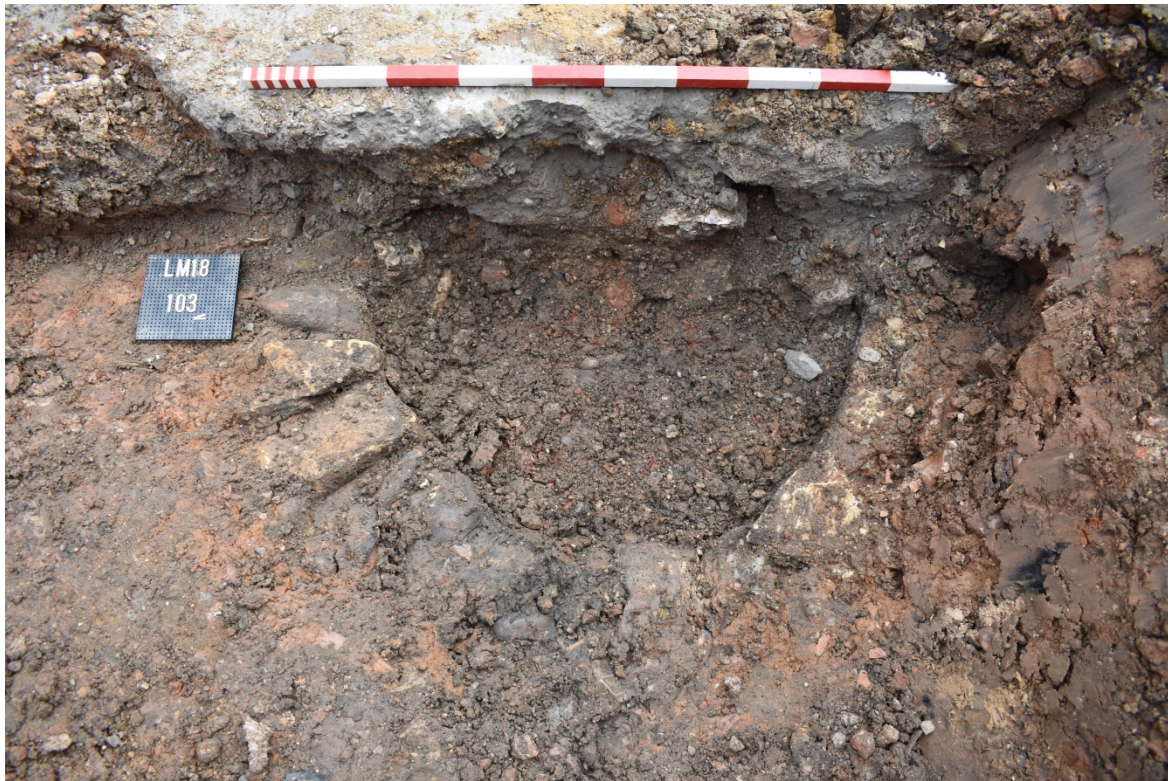
1: Well 103

- 5.1 Geological natural was red clay with occasional pebbles (101).
- 5.2 Stone-lined well 103, c.0.9m dia, in the south-east corner of the site (cut 102) corresponds to a pump depicted on the First Edition Ordnance survey map of 1889 (Fig 3). The greyish brown sandy clay backfill (104) contained 19th to 20th century modern glazed ware (MGW), post medieval slip ware (PMCW) and rubble.
- 5.3 Cess pit 109 (3m x 1.50m) contained a 'black' organic fill (110) which yielded 19th - 20th century finds. It was overlain by black layer (106).
- 5.4 Undated pit 107 (1.70m x 0.80m) was too deep and unsafe to excavate and characterise further.
- 5.5 A dark grey clay layer (100) lay across the area examined.

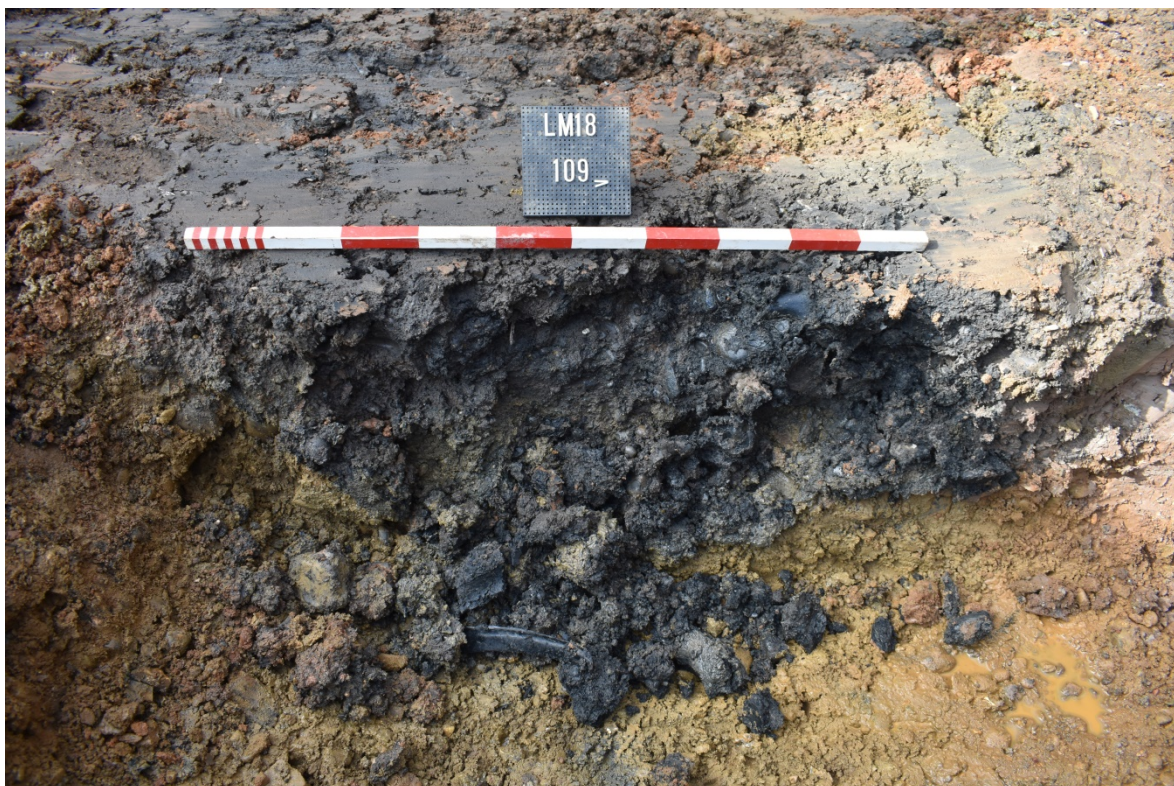
2: Cess Pit 109

A stone lined well, depicted on the 19th Century mapping as 'pump' was backfilled in the 20th Century. A 20th Century cess pit yielded leather shoes, an iron pick and yellow glazed pancheon sherds.
