Harpers Hill Jewellery Quarter Birmingham

Archaeological Excavation

Archaeology Warwickshire Report No 2140

MAY 2021

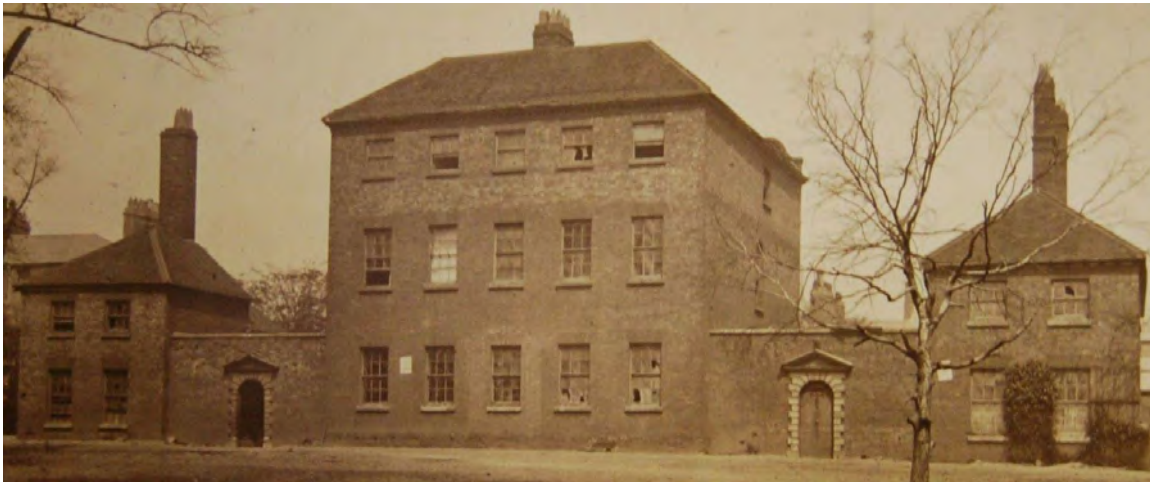
1: Harpers Hill House, c.1872

- 3.10 George Demidowicz has reconstructed plans of the villa in 1775, 1825, 1855 and 1872. A photograph purportedly dating from 1872 must have been taken just prior to its demolition as some windows are shown broken on the elevation (Photo 1). The main house is shown as a roughly square building, of three stories (and cellar beneath) with five windows to each floor on the south side. The 1775 mapping and elevation drawing shows the main house with two-storey pavilions either side, each joined to the house by walls pierced with a rusticated doorway under a pedimented arch (see Fig 4). The pavilions have tall chimneys and are likely to have been the kitchens and bakehouse. This southern façade appears to have continued unchanged into the 19th century, though by 1824 the areas either side of the house have been built up further and by 1855 a new outbuilding has been erected to the north-east of the main block of housing. The final plan of c.1872 suggests the footprint has increased significantly to the west. The house is recorded in rate books as void in 1871, so it is likely it was demolished shortly after this.

- 5.9 The early 1870s photograph of the house shows some of the panes of glass in the windows broken, but otherwise the house intact, with the roof fully tiled. It is likely that demolition took place in a reversal of the order of the construction of the house, with the roof tiles being removed first and demolition of the building from the attic level downwards to ground floor, and taking out the upper part of the cellar walls. The relative lack of roof tile and bricks from the excavations suggest that a comprehensive salvage programme took place. Cellar walls were demolished to various heights, some standing to c.0.75m, others demolished to ground level e.g. footing 27, and others robbed out to leave only a foundation cut or robber trench e.g. 86. The fill of this (87) contained a few fragments of thin window glass and two fragments of 18th-century pottery.

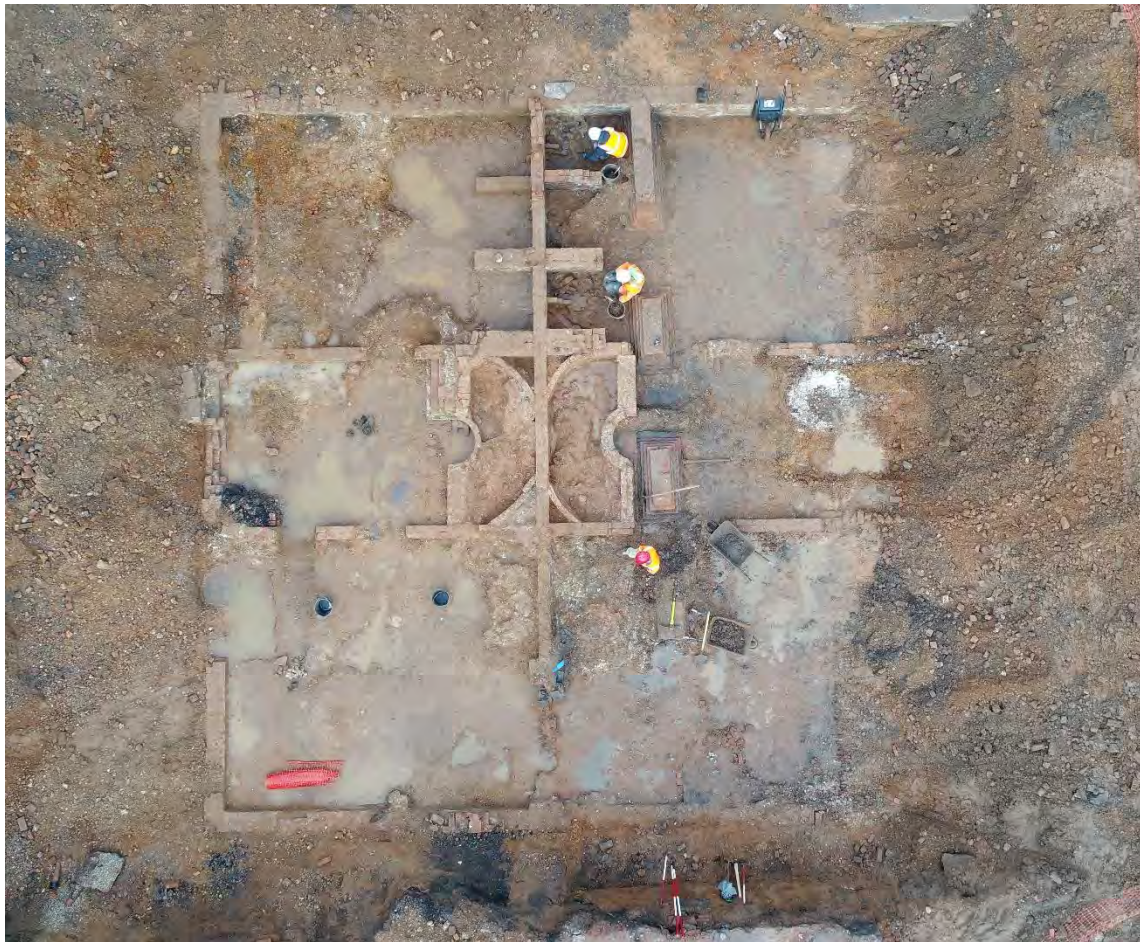
2: Overhead shot of the cellars of Harpers Hill House

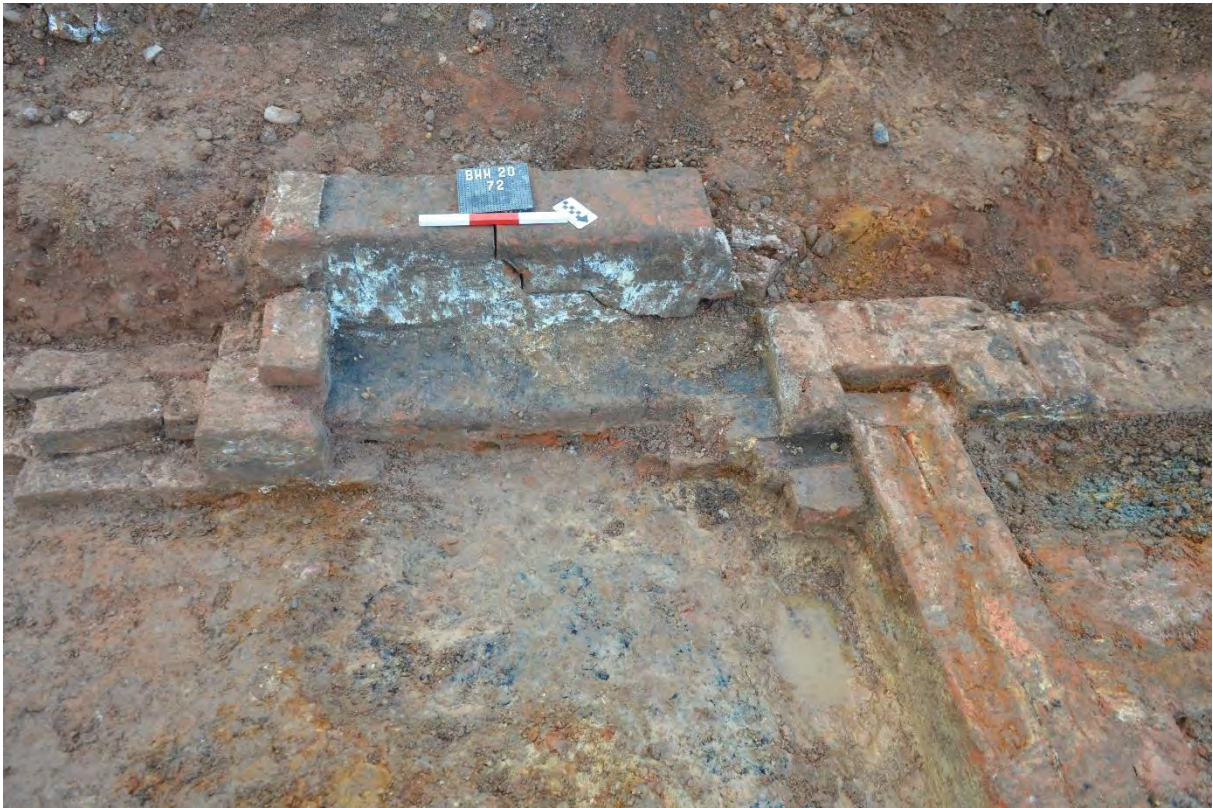
3: External steps into west cellar

- 5.3 In each of the semi-detached footprints the building appears to have had three rooms, which is likely to reflect the arrangement of rooms at ground-floor level, and indeed would correspond with the dimensions mentioned by Bernan, if Watt's writing apartment was the north-west room of the house at ground-floor level. In each side the southern cellar room was the largest, with an interior of c.5.8m x 4.8m. The central room is the smallest (c.3m wide) and the northern room 4.20m wide. The rooms are divided by double-skin brick walls (15, 23, 36, 52, 55, 70, 80/119, 108). In the western part of the house there is a brick threshold (67) between the southern and middle room, and a doorway between the walls 15 and 80 between the middle and northern room. This latter doorway has an *in situ* iron pintle (143) on the north side of wall 80, suggesting a door opening inwards into the northern room. There is no evidence for doorways on the eastern side of the building but a great part of this area has been destroyed by the later factory building. Walls 80 and 36 thicken to three bricks in the area closest to the central dividing wall 16. On the better-preserved western side of the building the central room has evidence of external access in the form of the lower

part of a staircase (72; Photo 3), which was likely to have been mirrored on the eastern side but has since been destroyed.

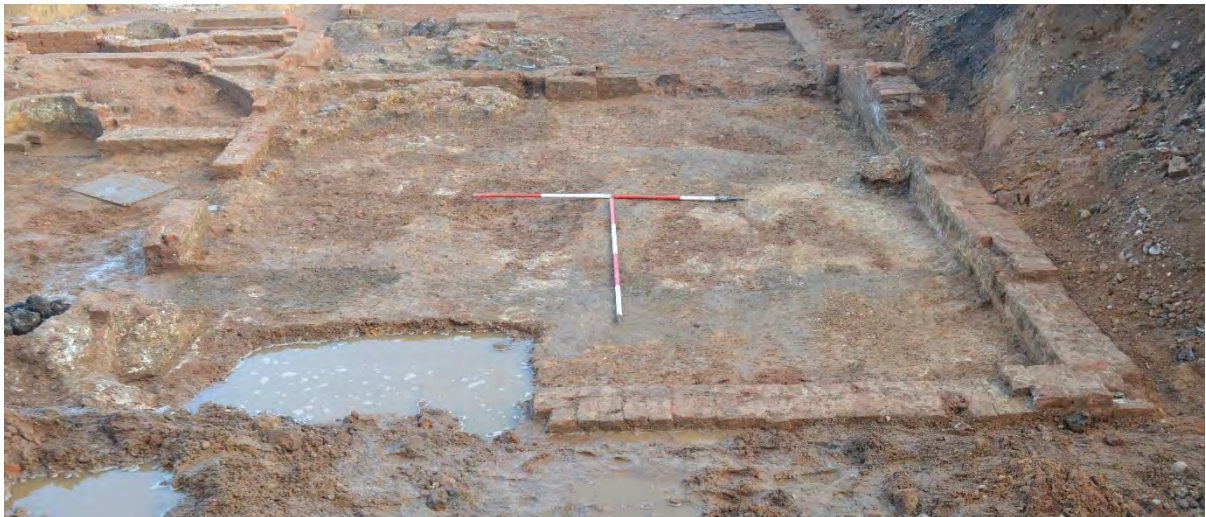
4: South-west cellar, compact lime mortar floor base (53)

53	Area of sub-floor in SW room of cellar, fine lime mortar, overlaying natural, located at the southern corner of the building (room 'a'), 0.02m deep, with possible compacted sand and gravel.	<3.0	<4.0	0.02	Base layer of lime mortar overlaying natural
54	Cut for building foundations. It extends approximately 0.53m below the average natural layer level, forming basement level.	c.14.0	c. 13.0	0.53	= 35
55	Continuation of line of wall (23) in western part of building. Abutted by wall section (56). It is an internal wall, and two courses wide, situated between central spine 16 and side wall 26 .	6.0	0.23	0.35	Primary internal wall of cellar
56	Section of wall is internal to the structure but 3 bricks wide, abutting stairs (57) and wall (55). Bricks = 0.23m x 0.11m x 0.09m. Pale brown lime mortar at 68 and steps.	1.15	0.34	0.35	Secondary internal wall of cellar associated with staircase
57	Brick structure, probably forming stairs, located	1.12	0.76	0.51	Secondary stairs into western cellar

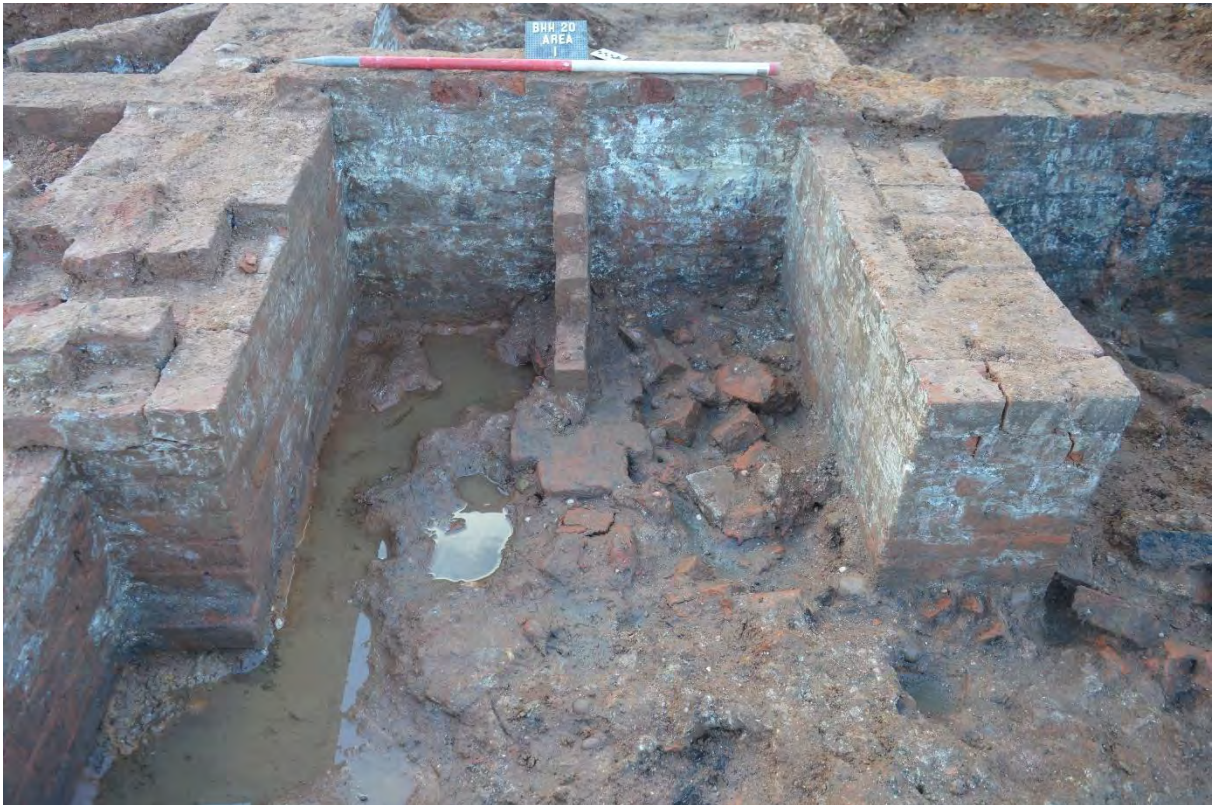
5: Support wall standing on extant remnant of brick floor between walls 36 and 74

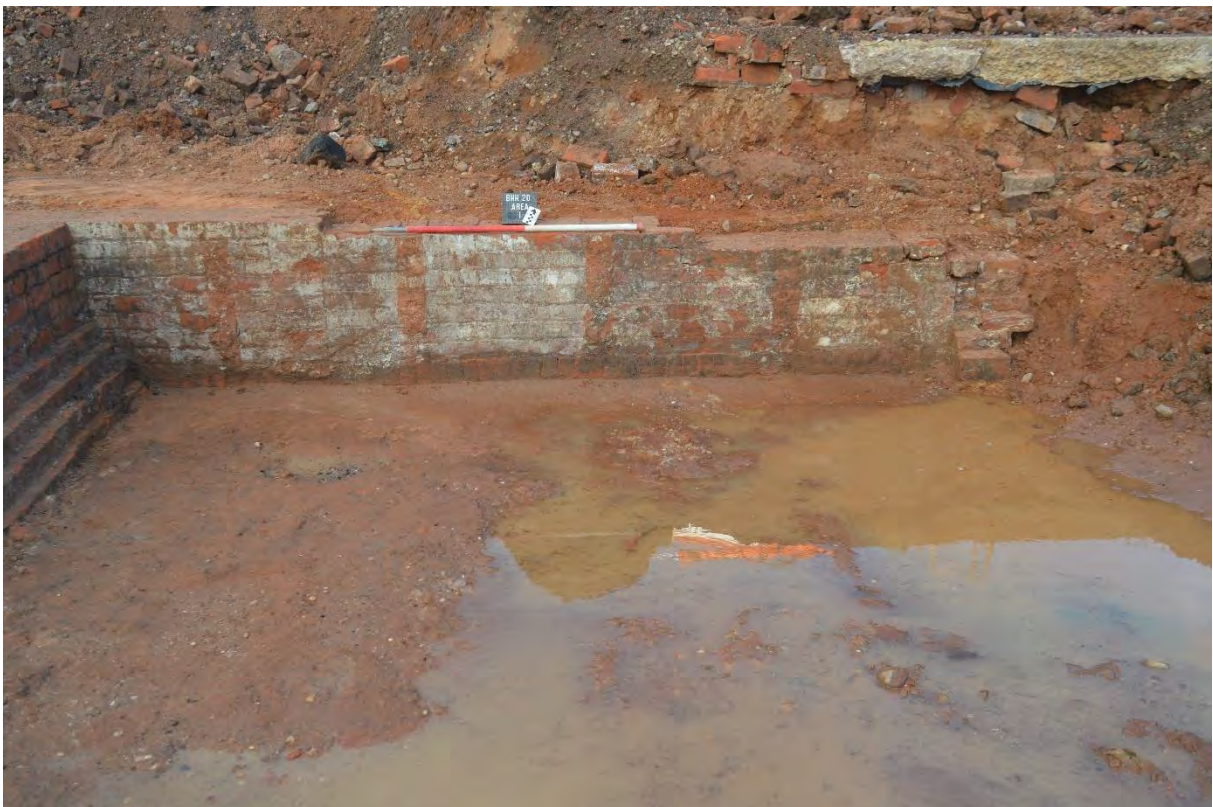
6: North wall of cellar with scars of brick support walls

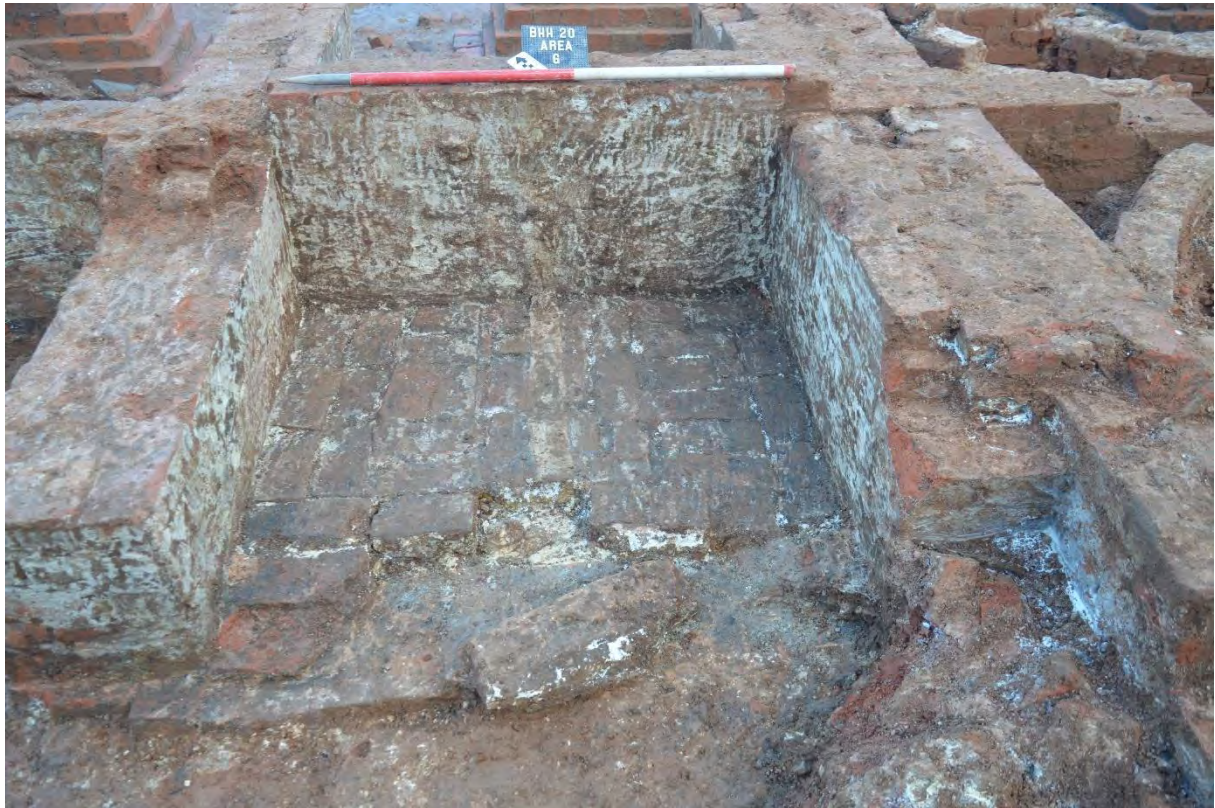
7: Whitewashed walls in larger compartment, brick floor 97

hence the face of this wall was not fully exposed. The majority of the walling appears to have been whitewashed, as is traditional in a cellar (Photo 7).

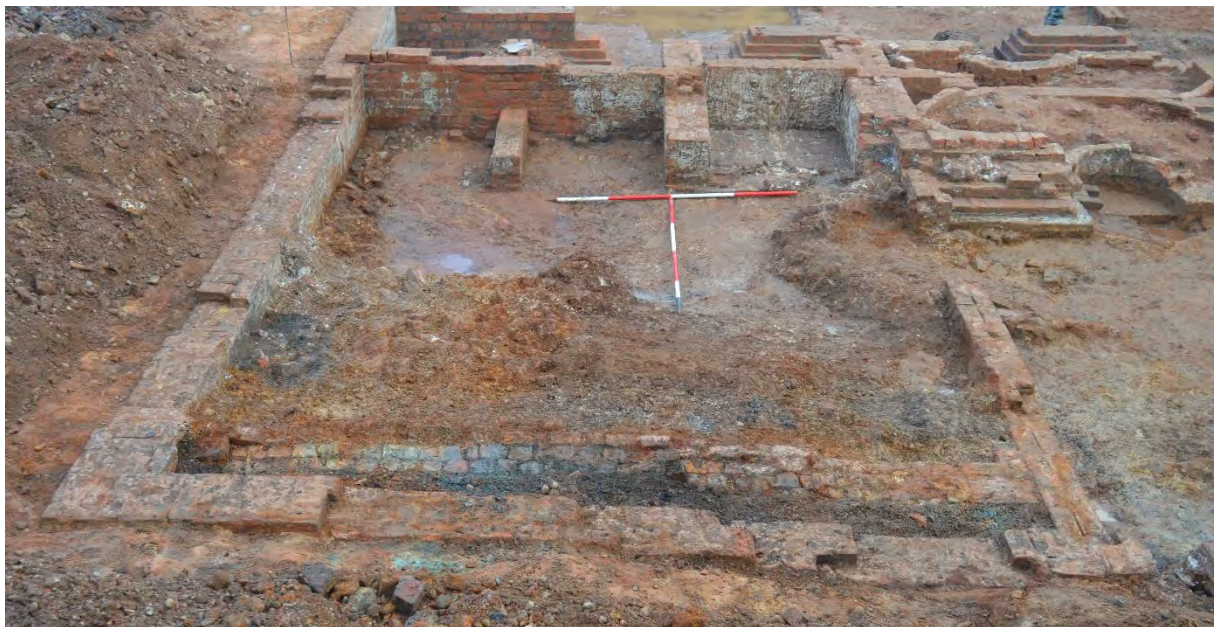
8: NW room of cellar, external wall 26 and parallel wall 27, in foreground

- 5.6 In the northern room of the western house the remains of a 0.35m wide wall (27) parallel to the outer wall 26 had been robbed to its lowest course. The proximity to the outer wall suggests it was not structural but may have been the base for a low bench for storing something such as beer barrels. In the southern room of the eastern cellar a foundation trench (86) suggests something similar may have existed in this room.

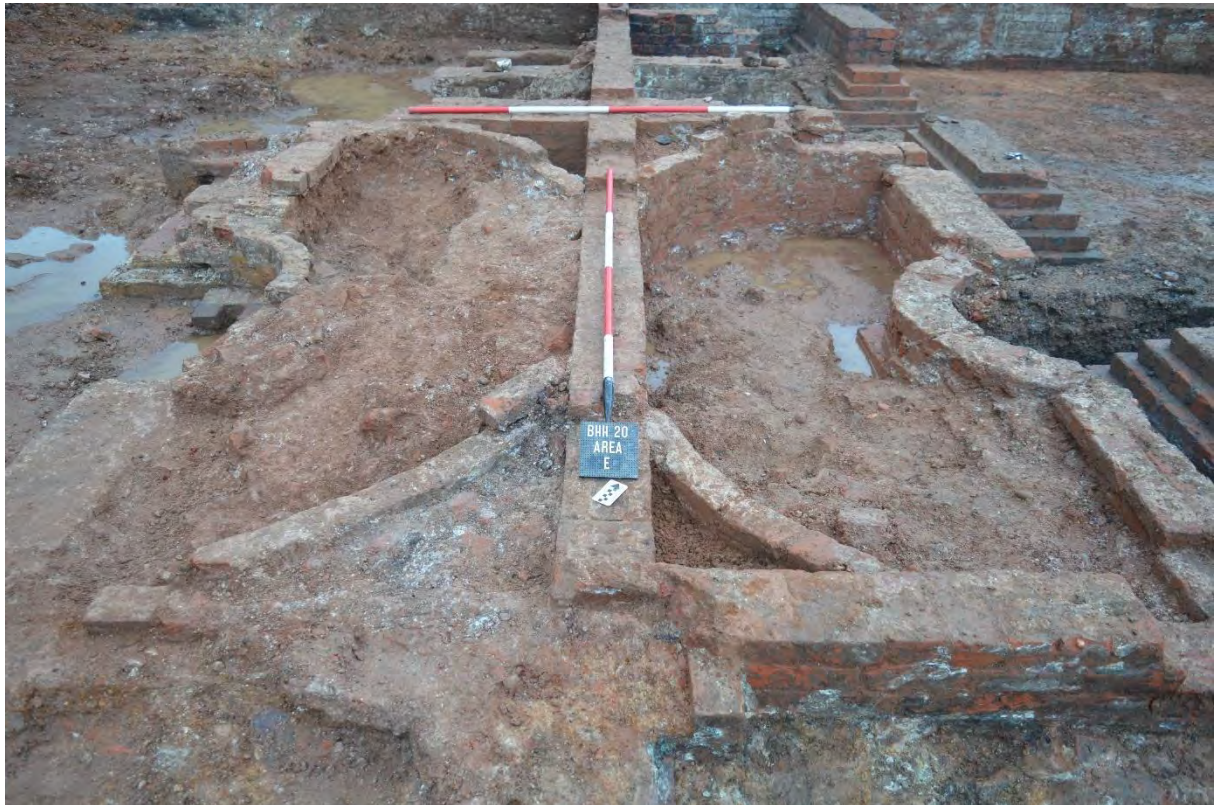
9: Central part of cellars with later walls to support half-spiral staircase

- 5.7 In the central part of the house a series of later brick walls were inserted (Photo 9), in some instances directly over pre-existing brick floors. In all cases they appear to have been constructed using light brown lime mortar, in contrast to the redder mortar used in the primary walls. The Phase 2 remains are confined to the central part of the building; photographs show the chimneys of the house being central to the building rather than on the outer walls. However, the absence of chimney breasts and the remains of coppers suggest that the cellars did not have fireplaces and were not used as kitchens or sculleries, which likely were in the outer pavilions either side of the main building. It appears that in the second phase the access to the cellars changed, with internal half-spiral staircases being inserted against the central spine wall (16) that divided the two cellar complexes. This is most clear in the western side, where the remains of a series of brick steps (57) were recorded (Photo 10). On the eastern side this area has been obliterated by later factory-related construction. It seems that these stairways curved around, and were supported, on walls 68 and 56 in the west, and 19, 20 and 99 in the east. If the cellars are rough mirror images then wall 19 would have formed part of the steps into the eastern cellar. At the rear were single-brick wide curving walls (25 and 58 in the west and 24 and 59 in the east). In both instances the staircases would have led to a doorway at the rear of the entrance hall on the ground floor.

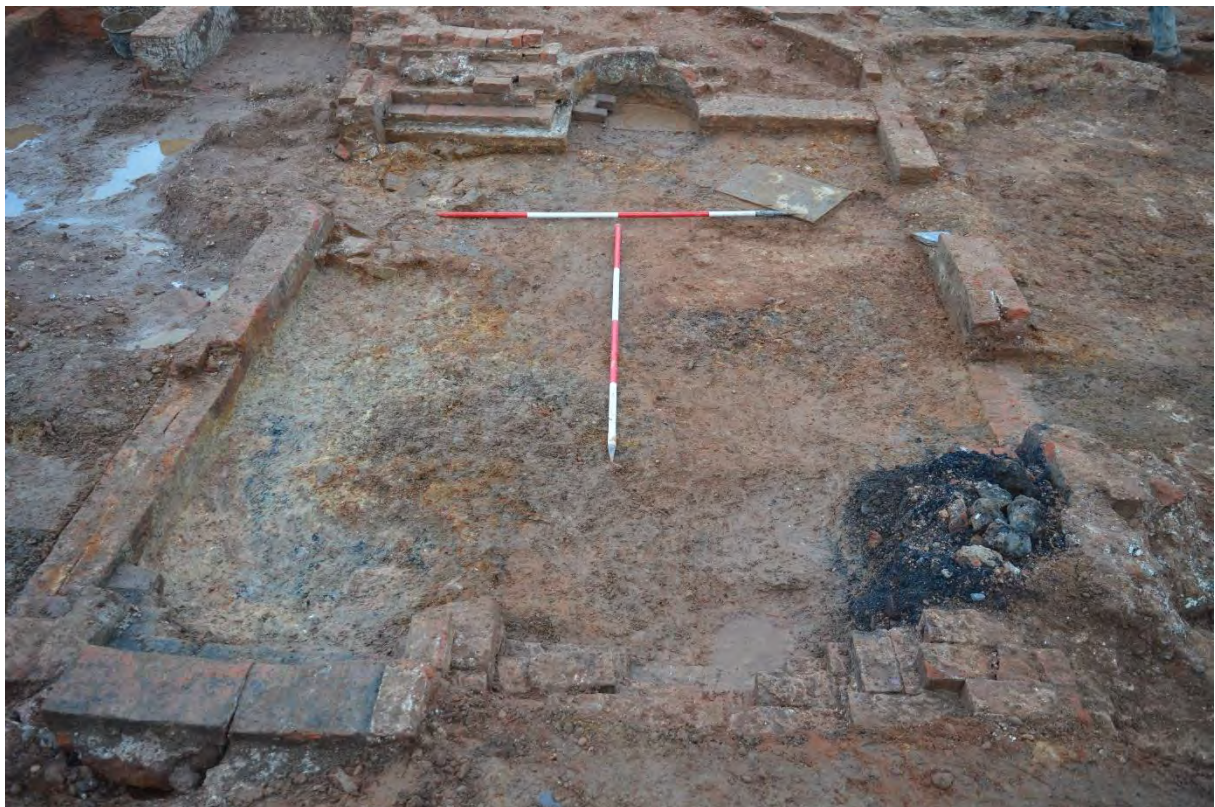
10: Steps 57 (upper left), coal deposit in corner of middle cellar western room

- 5.8 A small area of coal (133) survived in the SW corner of the central western cellar, suggesting part of this room may have been a coal cellar prior to the house's demolition. Floor 76, in the SE cellar room, has an area of bricks that appear to delineate a rectangular space and the surrounding brick flooring was overlaid with a thick layer of charcoal-rich material (94) suggesting there may have been a stove or boiler located in this area (Photo 11). Although James Watt attempted to heat part of

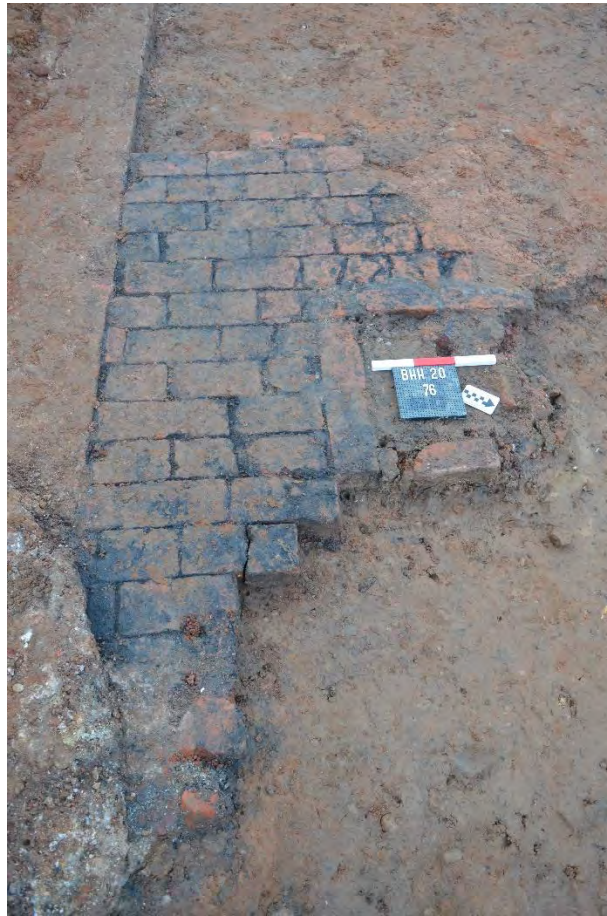
11: Floor 76 in SE cellar room

76	Brick flooring in east corner, stained with charcoal. It abuts wall 30/51 .	1.90	1.07	0.12	Brick flooring – part of eastern cellar floor, SE room
77	Flooring within C-shaped 20 . Appears to be below wall 20 – robbed?	1.95	0.70	0.12	Flooring – cellar, remnant in middle room of eastern cellar
78	North wall of house, western part – a continuation of 17 . Formed the rear wall to the property. Is abutted by 27 and 142 .	5.76	0.41	0.45	Brick wall – N wall of house/cellar, continuation of 17
79	Brick floor remnants in room D, located at the west corner of the room.	0.18	0.17	0.11	Remnant of brick floor – in middle room of western cellar
80	Section of brick wall – a continuation of line of 15 , NE wall of room D.	2.20	0.25	0.30	Brick wall – part of western cellar
81	NE doorway between rooms D and G.	0.83	0.19	0.05	Doorway in W cellar
82	Brown, pebbly silty sand layer – area H. Underlies rubble 66 and charcoal 85 .	-	1.36	0.40

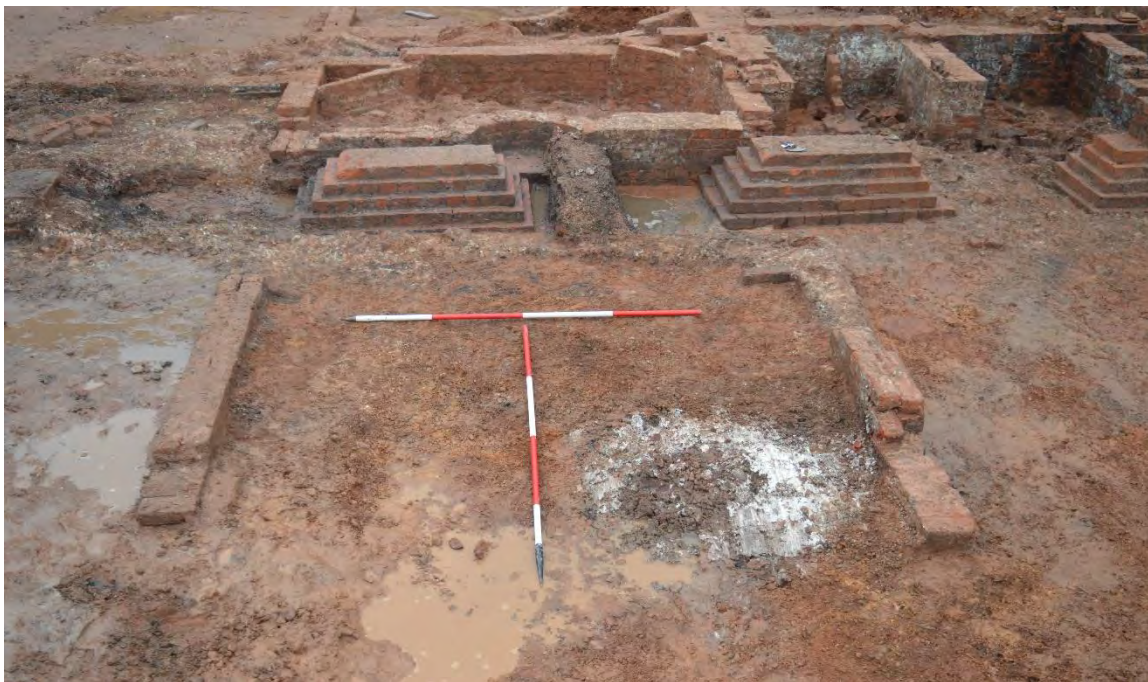
12: Lime-filled feature 101

- 5.10 In the east side of the central eastern cellar a circular cut (101) c.1.3m in diameter, and filled with a sticky pale grey mixture of lime and clay (102; Photo 12) could have been an infilled well but was not investigated further due to the presence of the lime.

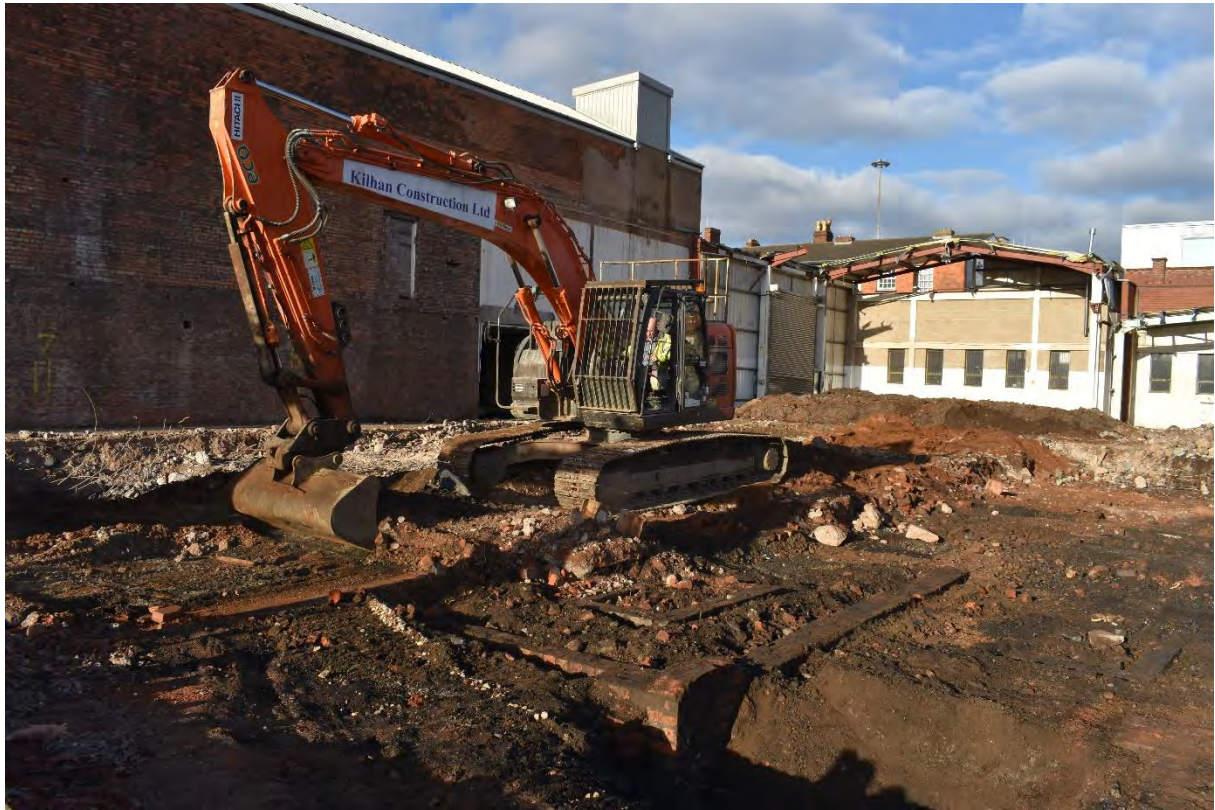
13: The upper parts of brick walls associated with early factory

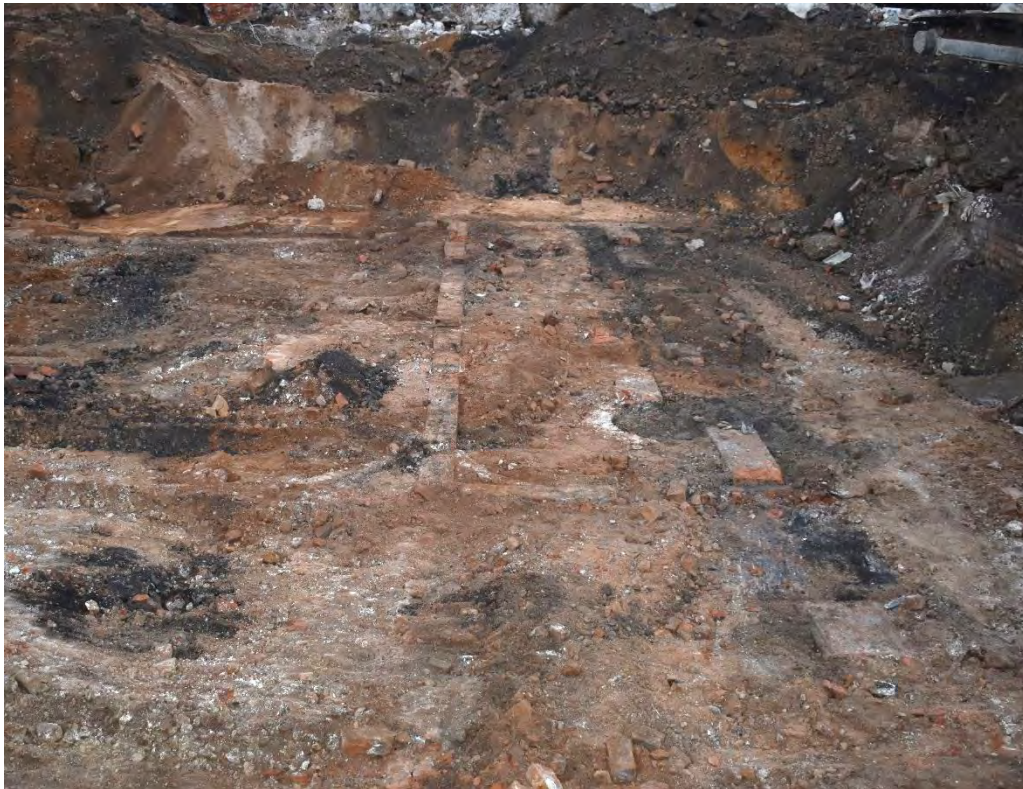
14: The dark fill of foundation trench for pier bases of the early factory can be seen on the right of the picture

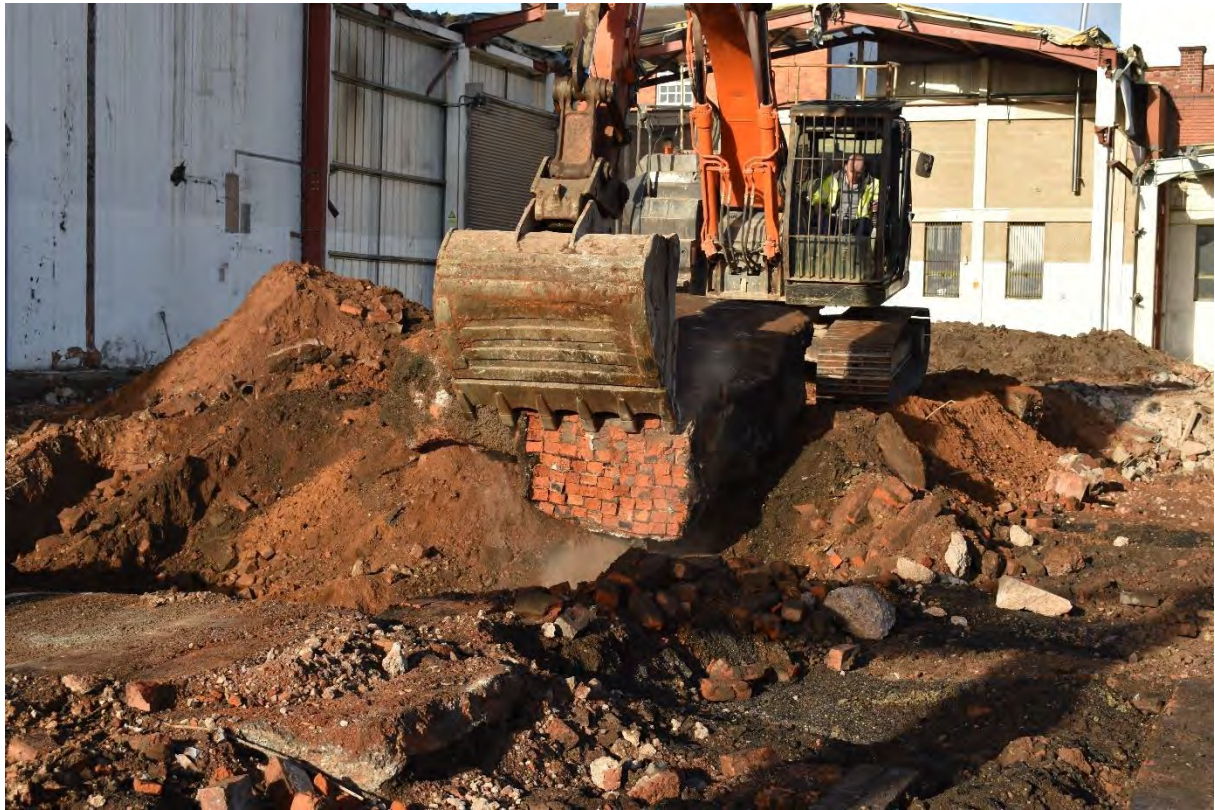
15: Modern brick footing being removed on western part of area

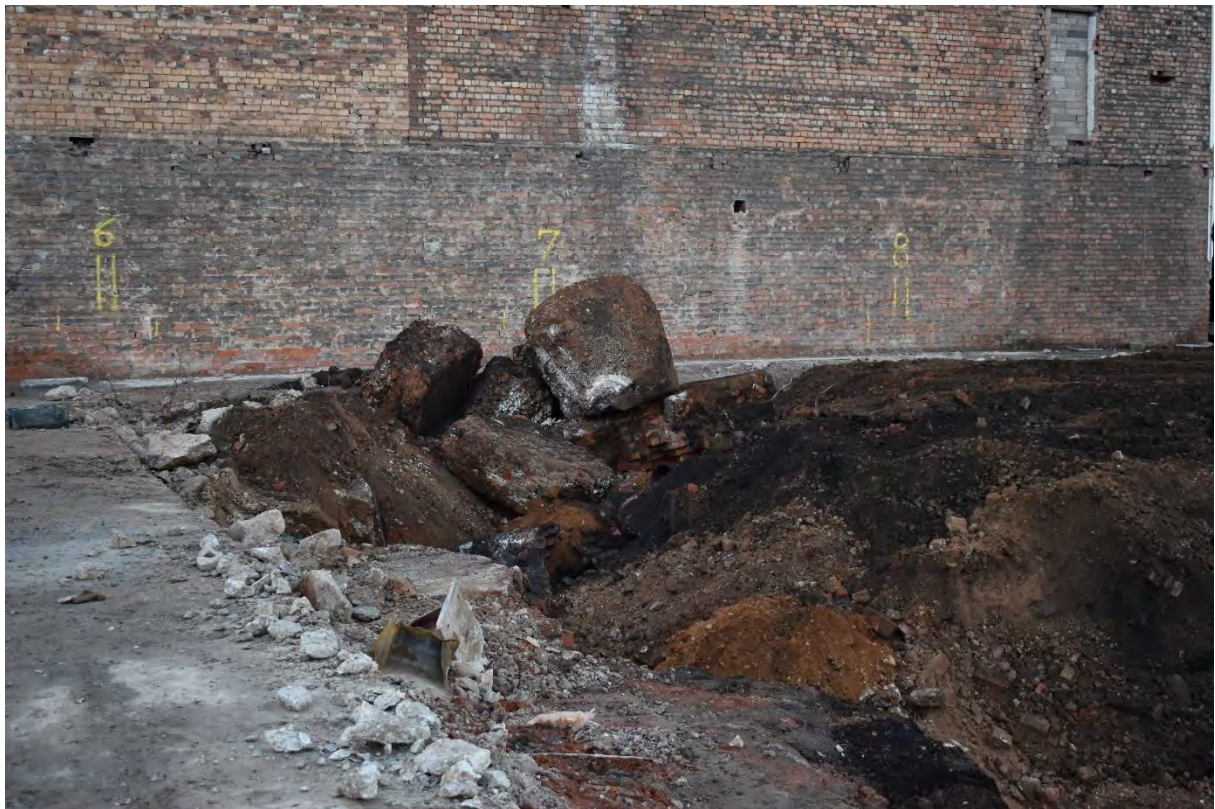
16: Massive concrete footings of modern factory

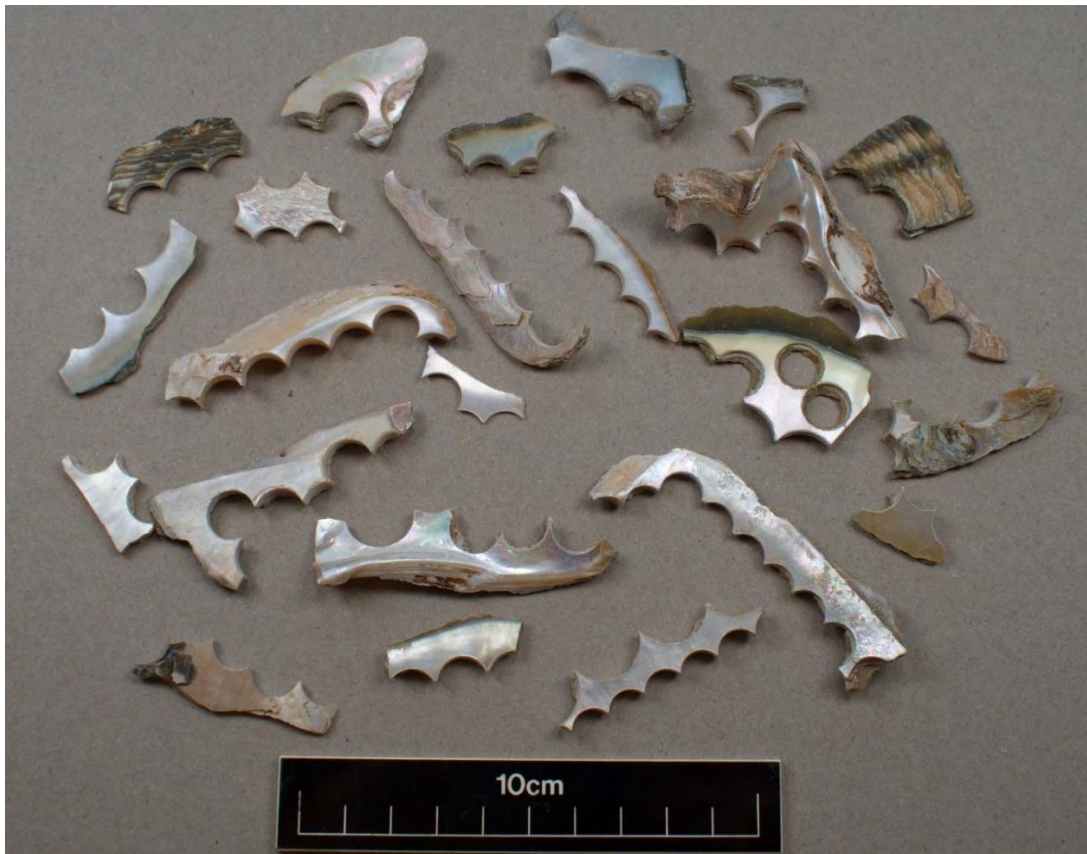
17: Albalone shell button-blank waste

- 6.3 Some physical evidence was recovered for the occupants use of the house. The albalone shell button waste suggests one of the occupants was involved in mother-of-pearl button manufacturing. Birmingham was probably most famous for making shell buttons from mother-of-pearl, with the shells being imported from Australia, the South Pacific, Malaysia and the Americas. The shells were fragile, and it was delicate work to turn them into buttons, with circular button blanks drilled through the shells and subsequently divided into individual thin buttons. Pearl button making tended to be found in small workshops rather than large factories. The small amounts of slag, copper-alloy wire and the shell button-making waste in the layers associated with the demolition of the house suggest that some small-scale industrial activity or jewellery making may have been taking place in the house during the later 19th century.

* A sample of button blank waste was collected, from a large collection from this context, which included button blanks as well as waste, suggesting button manufacturing at the house

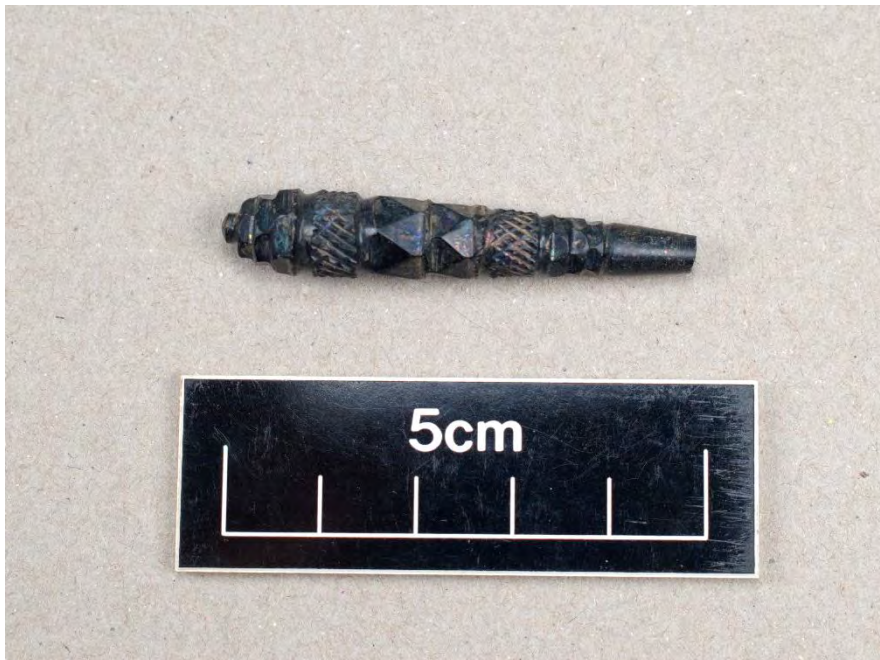
18: Faceted black glass terminal
