# 41 High Street, Bidford-on-Avon Warwickshire

## ARCHAEOLOGICAL WATCHING BRIEF

Archaeology Warwickshire Report No 2158  
JULY 2021

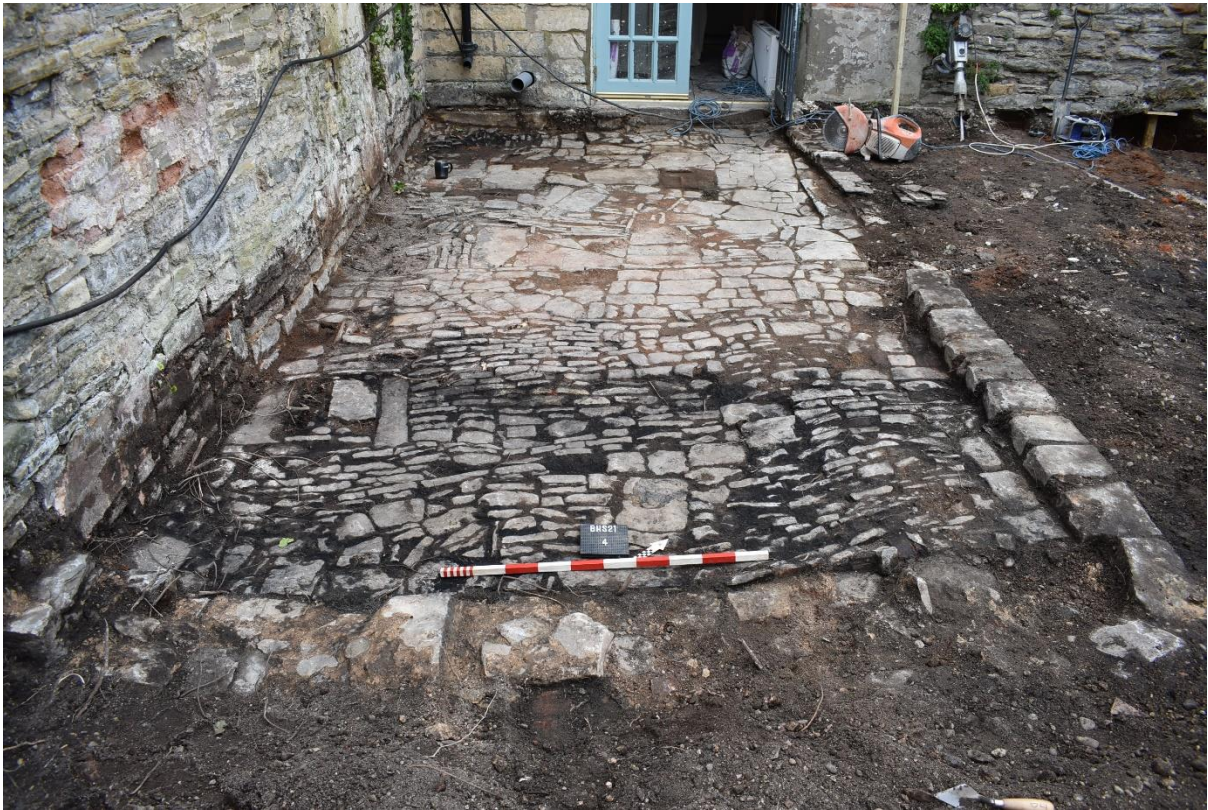
- 5.3 Two external side wall foundations, in blue lias ashlar with dressed faces (5 aligned NE/SW, 3.22m x 0.35m; and 6 aligned NW/SE, 5.90m x 0.22m; Photo 1) were overlain by 0.10-0.15m of modern concrete (3).

1: Floor 4, wall foundations 5 and 6 facing NW

- 5.2 Due to the formation levels, geological natural was not reached beneath the 0.20m+ thick layer of gravel (8) which contained pottery, clay pipe and glass dating from the 16th century to the early 19th century. This was overlaid by partially flagged floor (4)(3.00m x 5.60m), comprised of irregular blue lias stones (from as small as 0.10m x 0.08m to flagstones at the northern end of the floor). In some areas the floor had been patched with red brick.

- 6.3 The floor of the former south-west wing shown on the 19th-century mapping was uncovered along with the eastern and southern walls. This floor was probably laid during the early 19th century as pottery of probable early 19th-century date was recovered from below it. It may be contemporary with the walls but could be a later insertion. Running the width of the floor, a line of blue lias suggests a form of partition within this building. This partition runs from the blocked doorway in boundary wall 7.

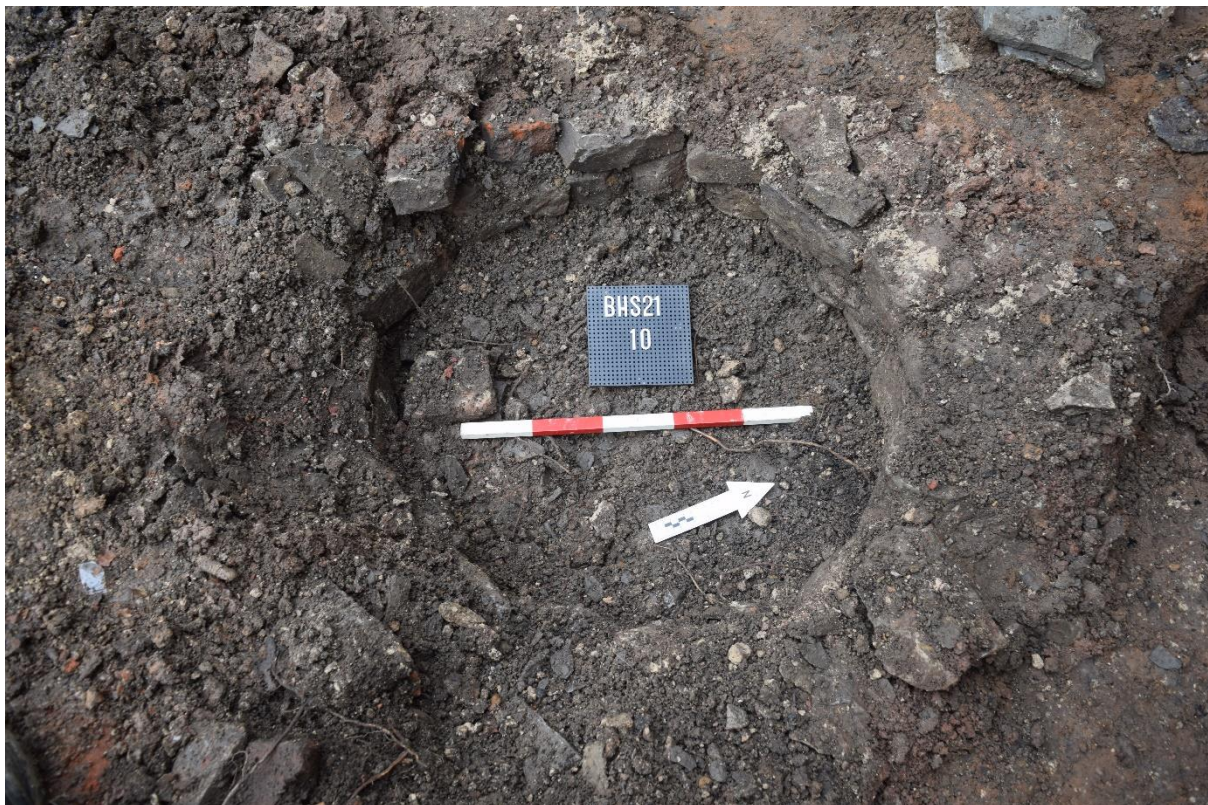
- 5.4 The cut for a well (10) contained a 1.15m diameter drystone blue lias well wall (11), in stone blocks 0.30m x 0.40m (Photo 2) of unknown depth. Its uppermost backfill was dark grey silty sand (12) which contained modern ring pulls and wrappers. Above this lay a disturbed layer of topsoil mixed with rubble between 0.05-0.10 m deep.

2: Cut for well 10 facing NW

- 6.5 The well appears on the 1887 and 1905 mapping and can be associated with the pump so recorded. The ring pulls and food wrappers within its upper fill suggest a very late infilling.

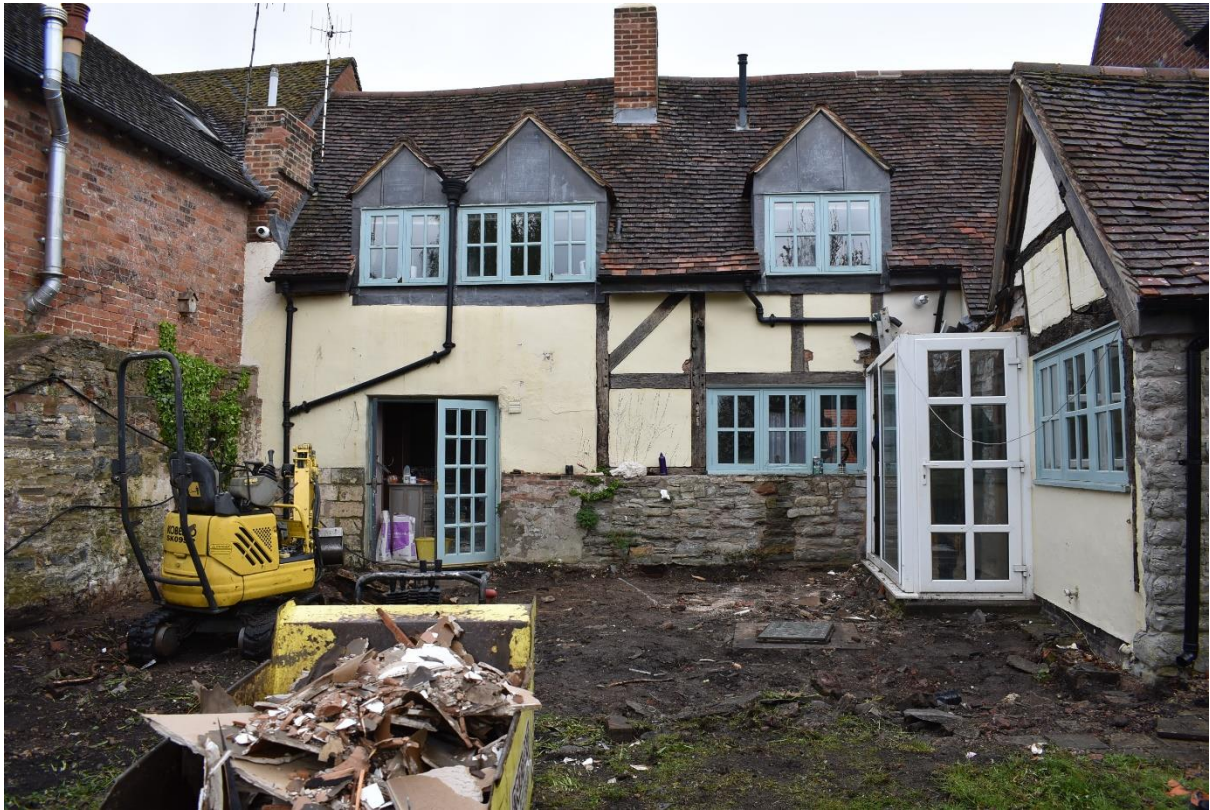
- 6.4 The southernmost end of the floor was quite heavily sooted (but unburnt), which suggests this part was used to store coal (Photo 3). The western wall (7) of this extension has been retained as part of the boundary wall and it contains a blocked doorway and lintel (Photo 4) which would have offered a through passage before the adjacent brick wall was constructed. The wing was still shown on the 1966 Ordnance Survey mapping.

3: Southern elevation

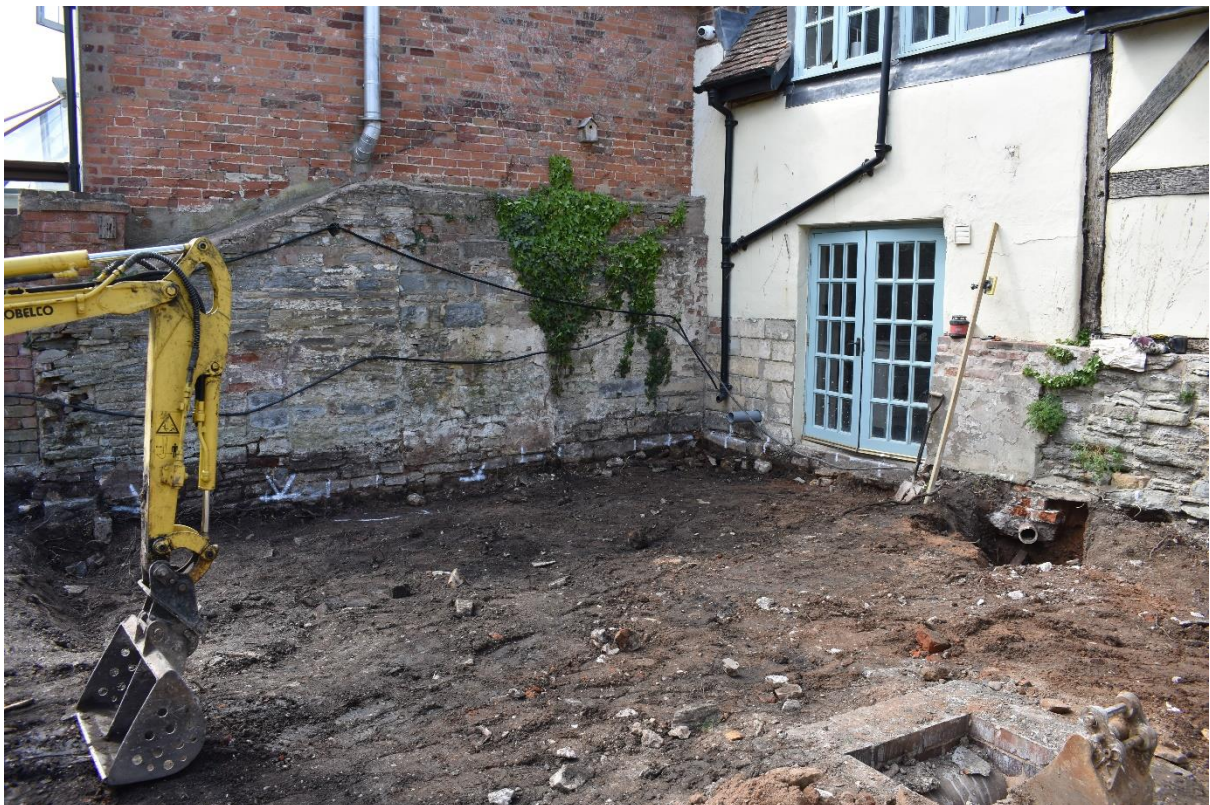
4: Wall 7 facing WNW
