Former TA centre New Broad Street Stratford-Upon-Avon

ARCHAEOLOGICAL EVALUATION AND HISTORIC BUILDING RECORDING

Archaeology Warwickshire Report No 20115

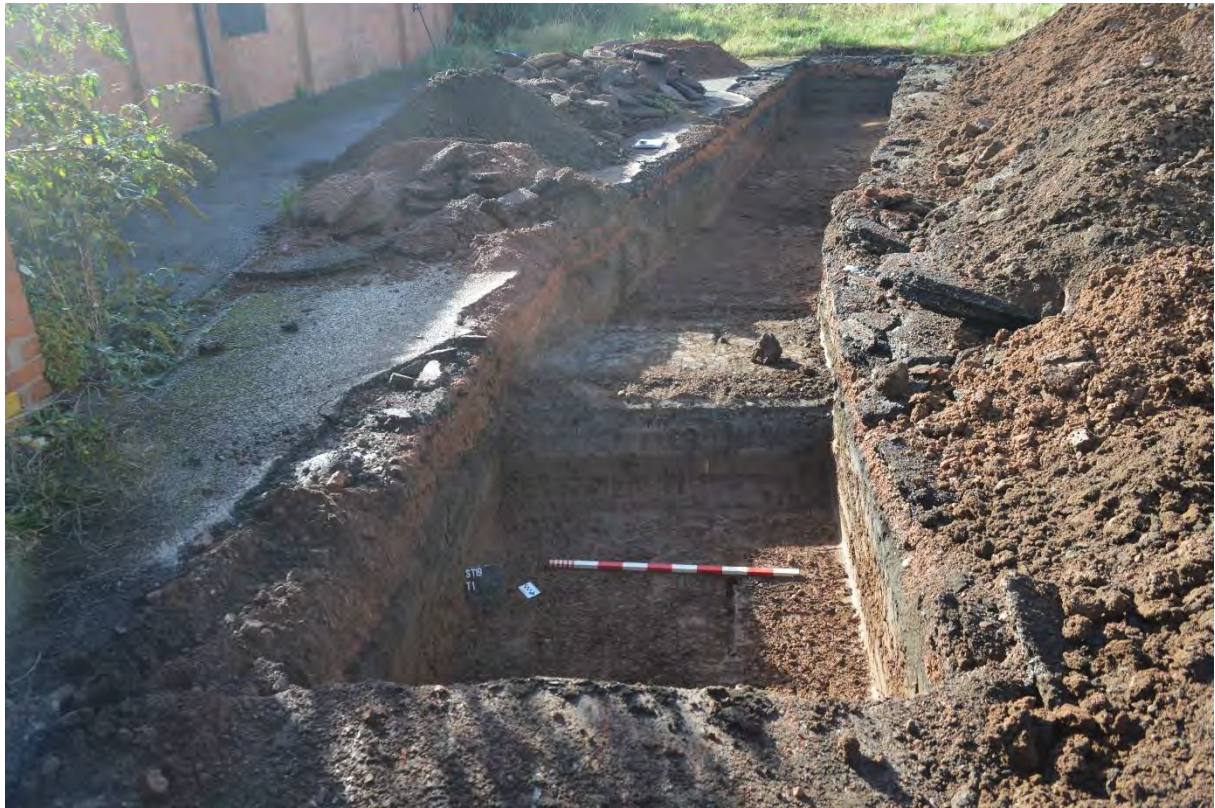
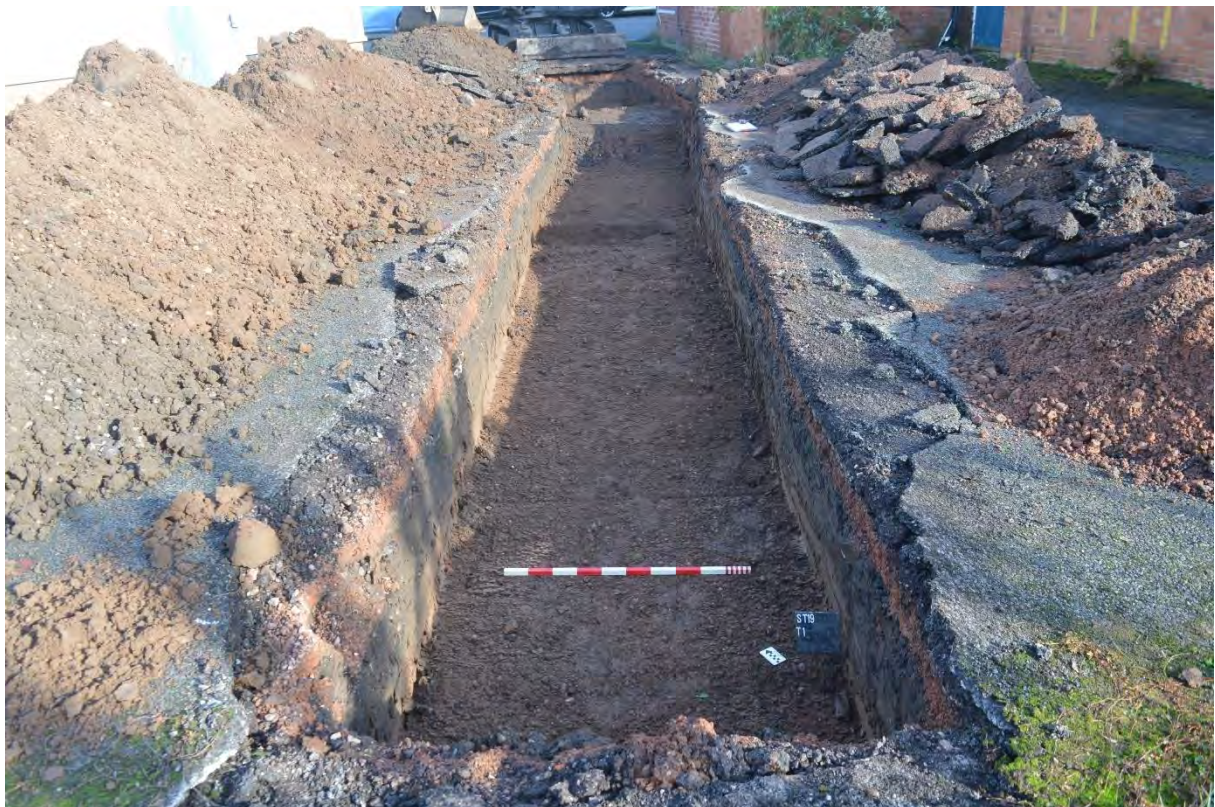
- 5.4 Archaeological features were encountered in Trenches 1 and 3. Evidence for a pre-20th century orchard is shown in Trench 1 (Photos 1-2) in the form of a treethrow pit and across the site a former cultivation layer is suggestive of such a use. A large modern linear feature was located in Trench 3 (Photo 3), this was probably a sewer or large drain.

- 5.6 In Trench 1, a treethrow pit was located which had a maximum diameter of 1.22m and a maximum depth of 0.28m. It was filled by a singular deposit of dark reddish-brown silty sand. No finds or datable material was recovered.

1: Trench 1, looking south-west

2: Trench 1, looking north-east

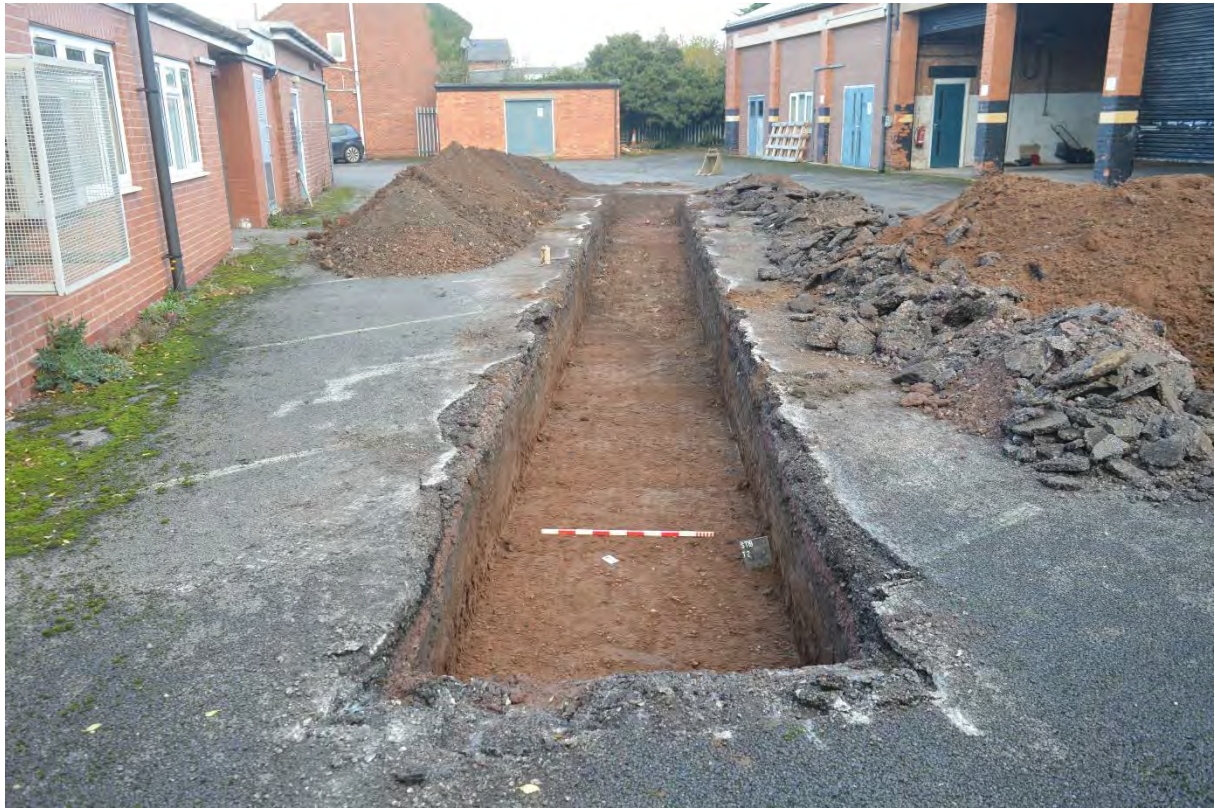
3: Trench 3, looking north-east

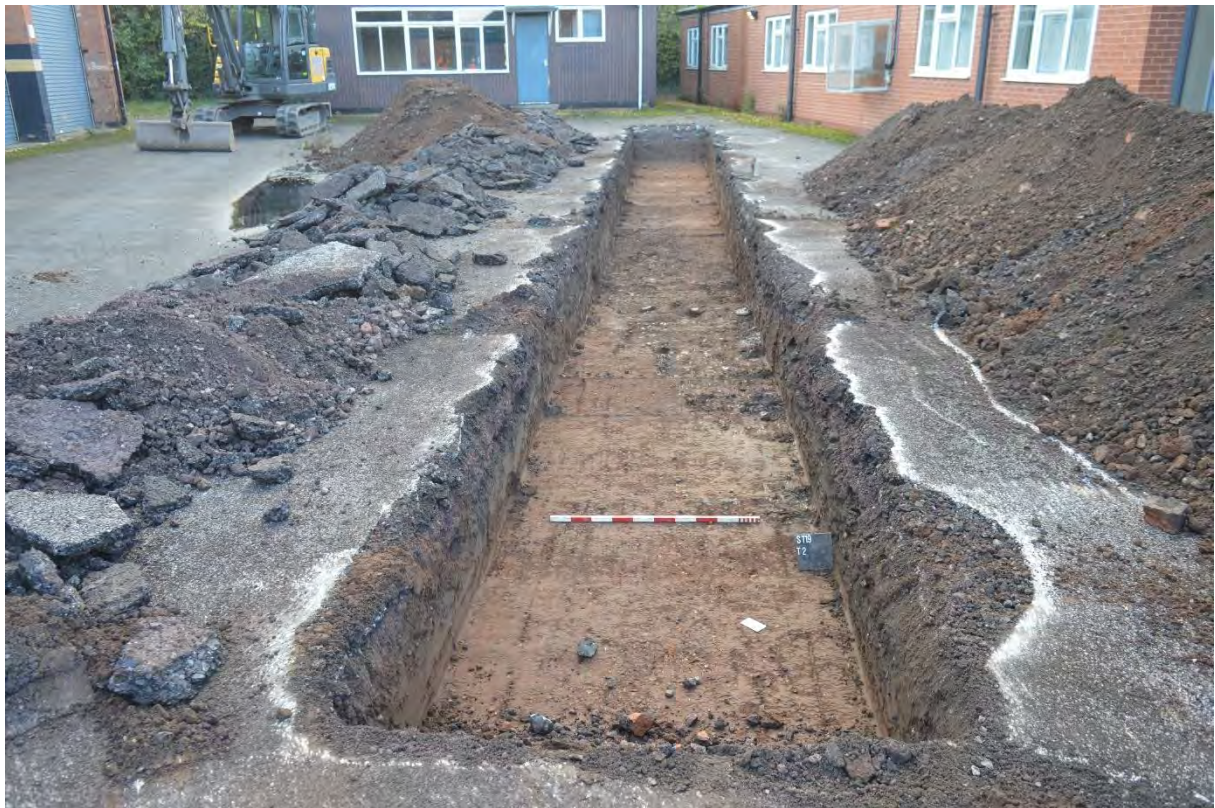
- 5.5 In Trench 3, north-south aligned ditch 306 (Photo 4) measured between 5.95 and 6.53m wide. It was not investigated as it is the cut for a sewer or large drain. The infill deposit which formed the top and only fill encountered (305) contained pottery which indicated an earliest possible date of the early 20th century.

4: Trench 3, looking south-west

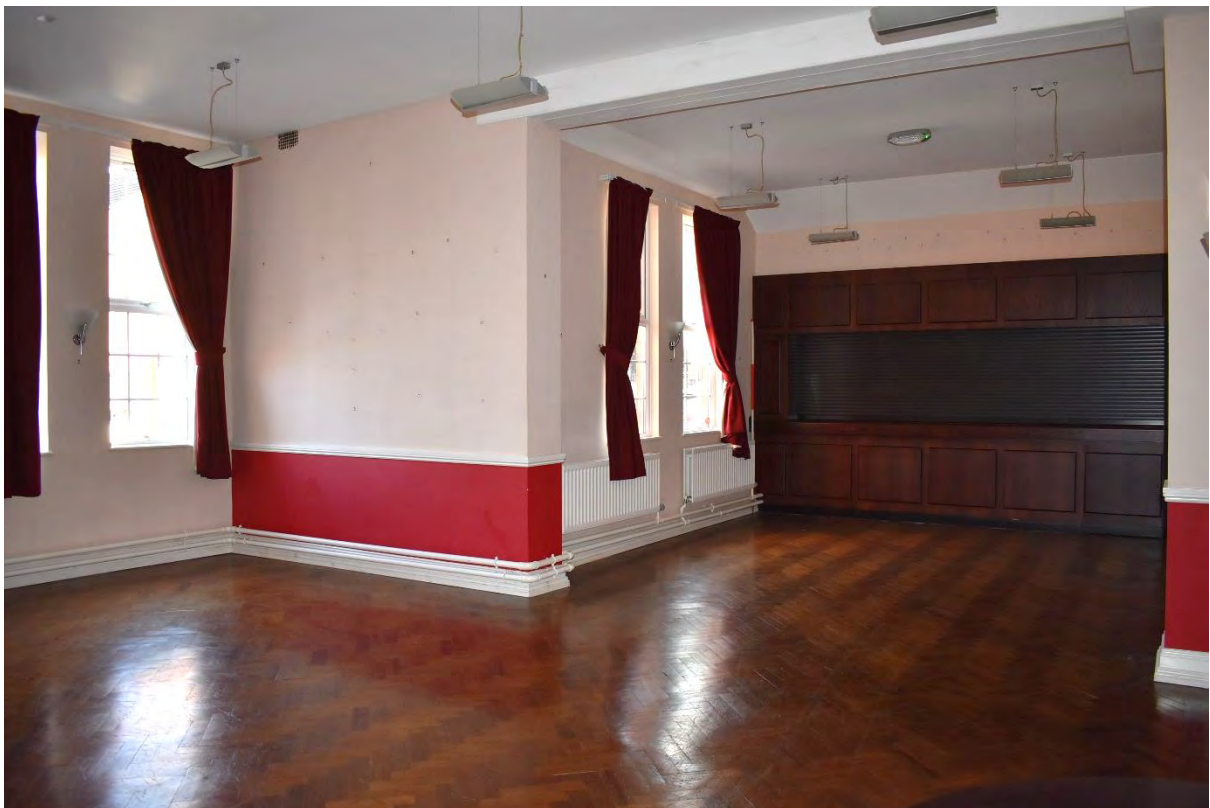
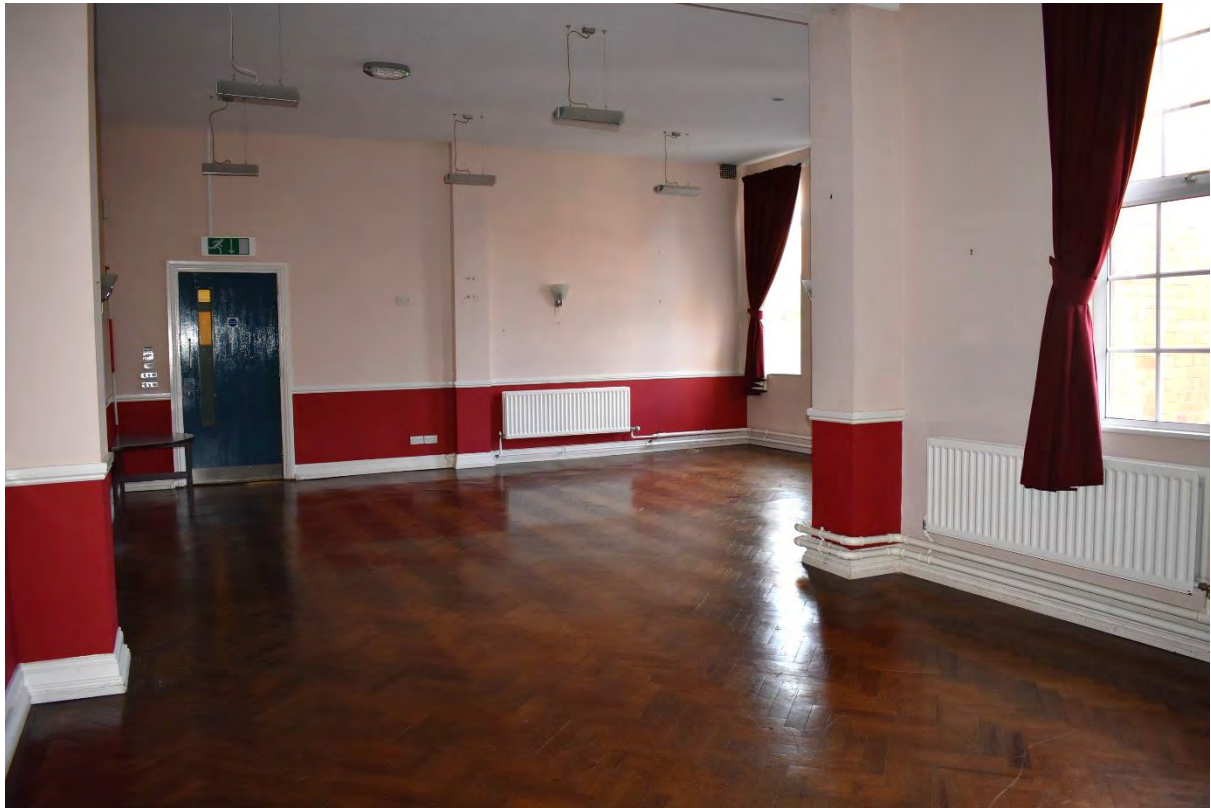
- 5.9 The drill hall building appears to contain ten rooms on the ground floor and six rooms on the first floor. The contemporary doorways have double-brick segmental arches and bullnosed brick edging. Room 1 (now a bar) has been largely altered with two former walls being removed to create a larger space. The floor is laid with wooden parquet tiles (Photos 8-9).

8: Bar room looking east

9: Bar room looking north

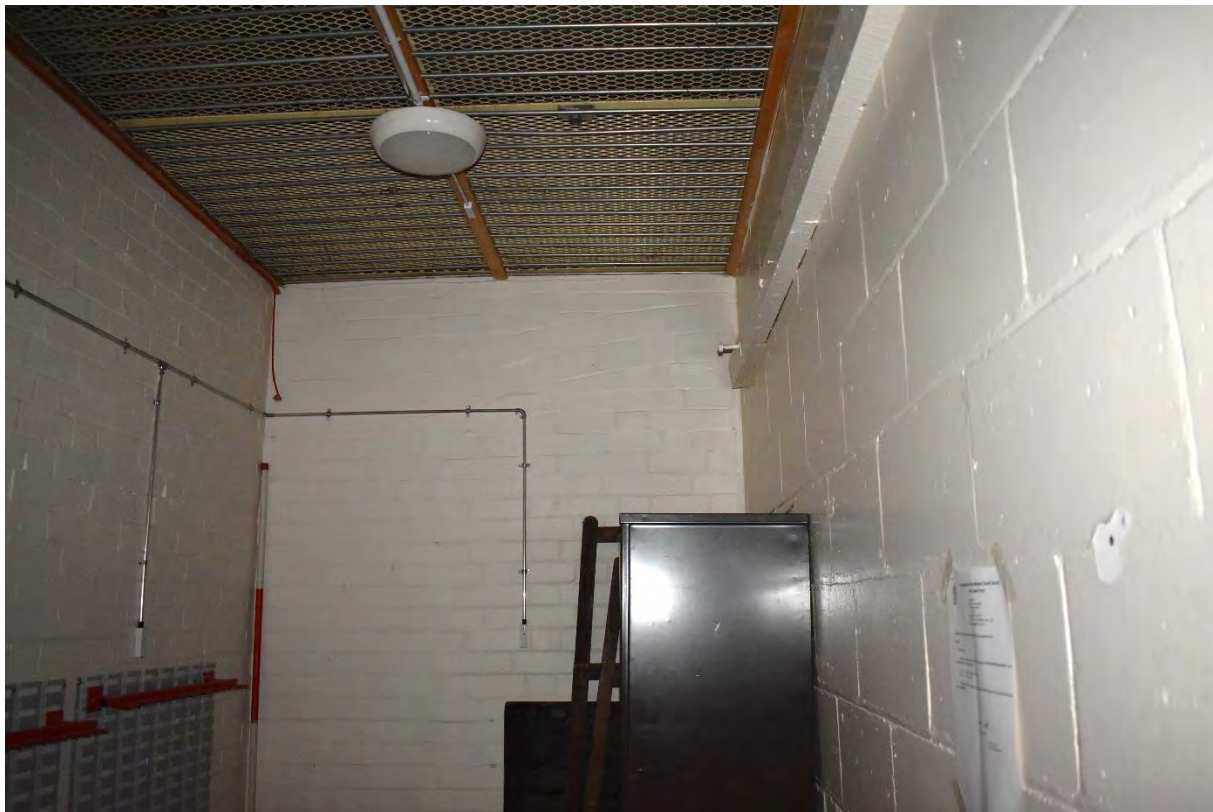
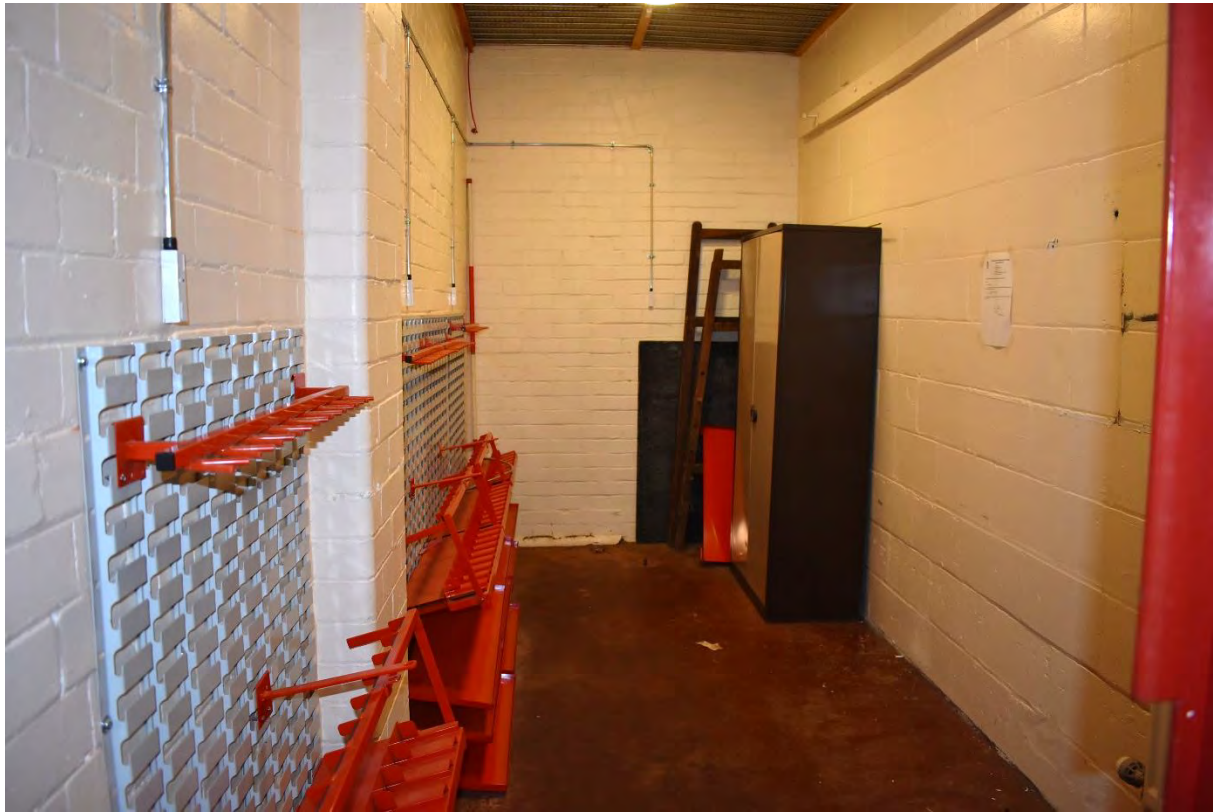
- 5.10 The drill hall has also been altered, with new doorways and small rooms being created at the entrance on either side. The high ceiling is fitted with four roof lights and is suspended on iron trusses (Photos 10-11). The floor is also laid with wooden parquet tiles and white painted wooden skirting boards. Along the eastern wall doorways have been created to access rooms in the modern extension. The SW end of the room has two contemporary doorways, with the armoury's armoured door being widened. These doorways lead onto two separate rooms. To the rear of the current armoury a blocked brick segmental arch can be seen, high on the wall, indicating a wide doorway in the rear wall before the modern breezeblock walling was erected to subdivide the area (Photos 12-13).

- 5.15 The small room at the southern end of the drill hall has been converted into an armoury. This is most likely from when the building was in use by the TA as specially produced door have been fitted to accommodate weapon distribution.

12: Rear of the armoury looking south-west, note high-level segmental brick arch in rear wall

13: Building A, armoury with gun safe

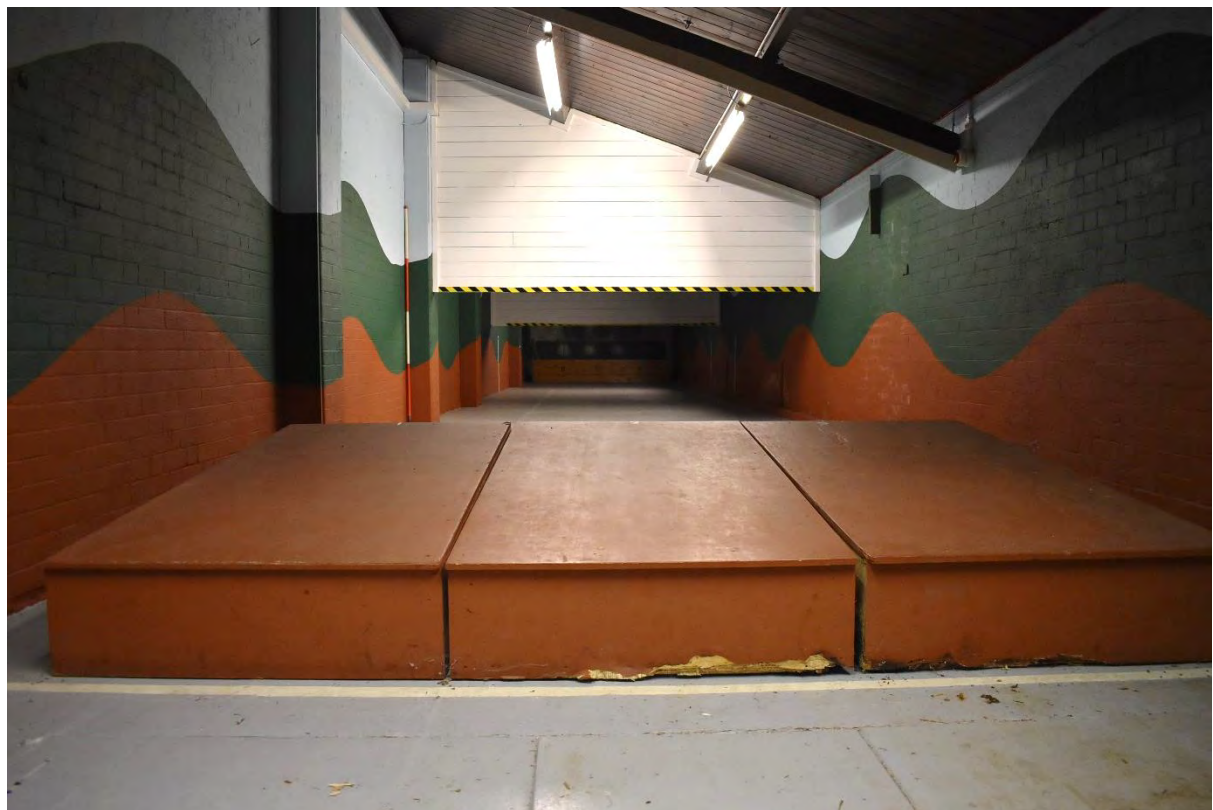
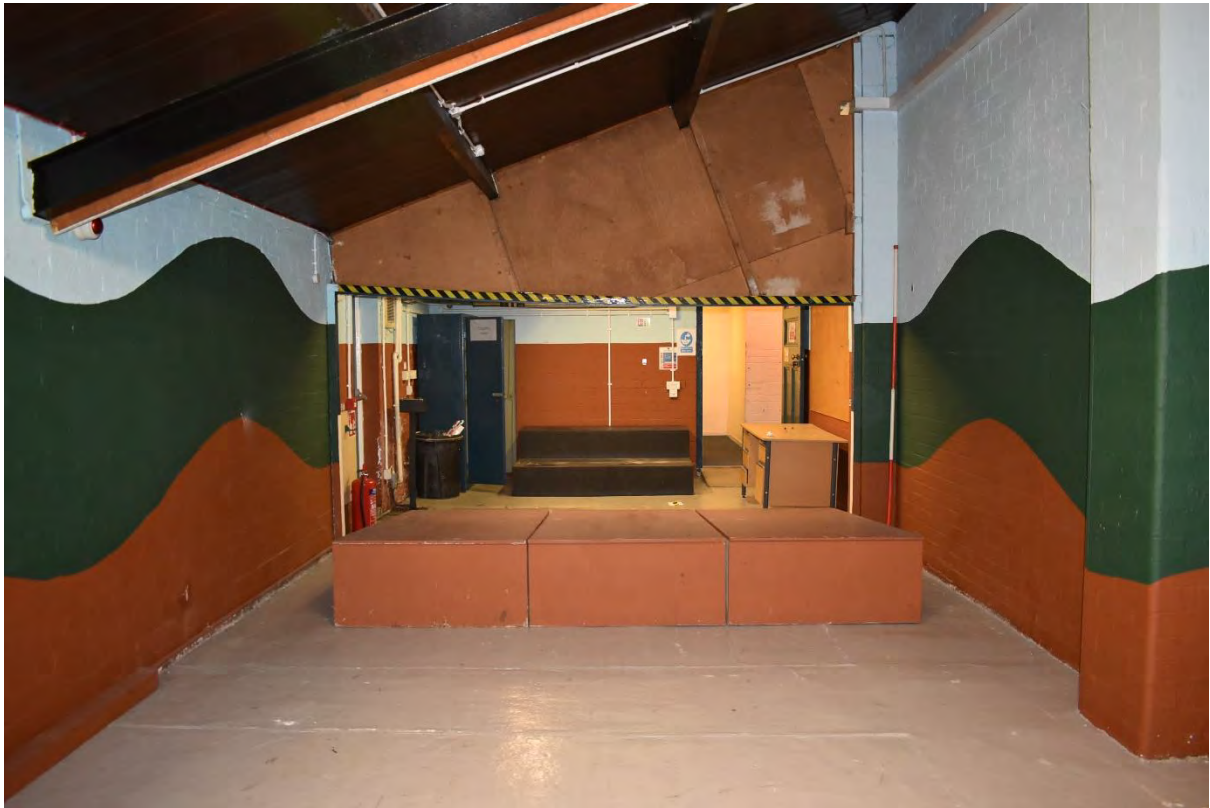
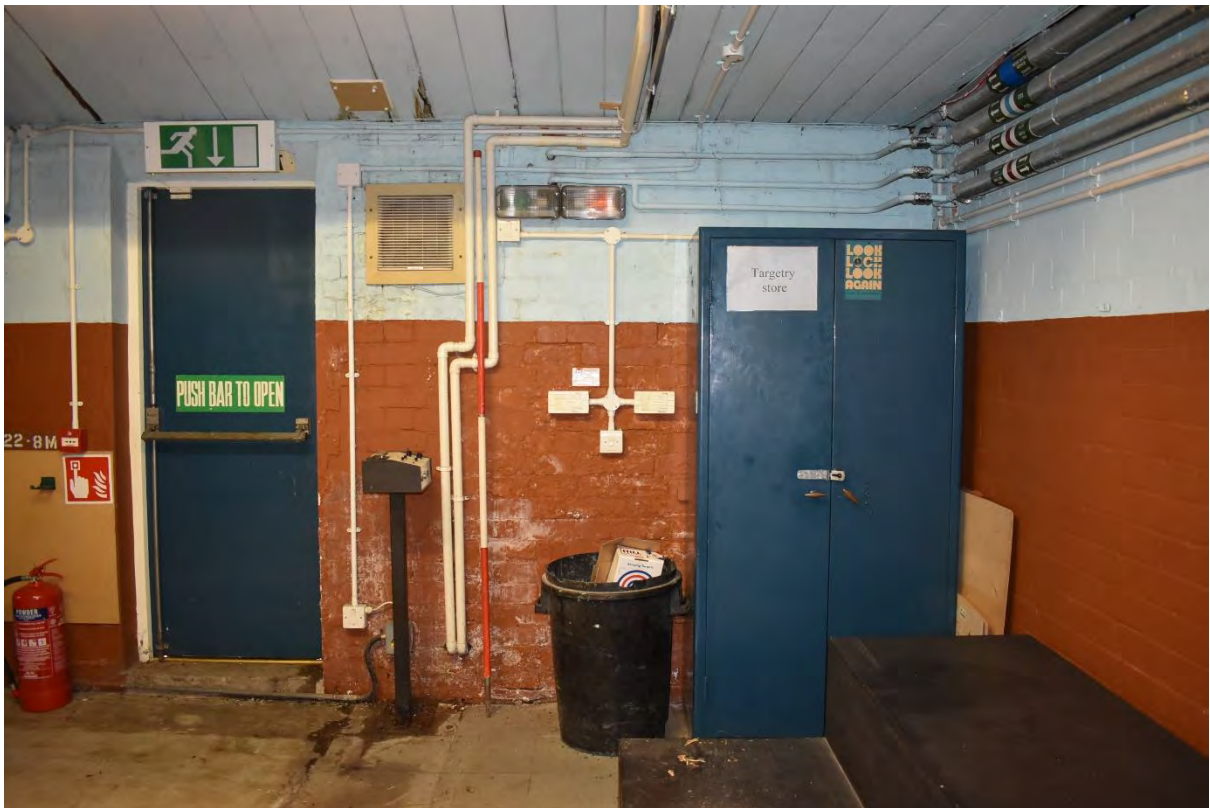
- 5.11 The rifle range is a 27.8m long 4.03m wide, single room with no divisions. The western wall has a single doorway with a preformed concrete threshold and wooden jambs. The door itself is painted blue and used as a fire door. Features included the control panel for the rifle targets and shooting platforms (Photos 14-16).

14: Shooting range looking south-west towards targets

15: Shooting range looking north-east towards platforms

16: Control panel, exit and storage in shooting range, looking north-west

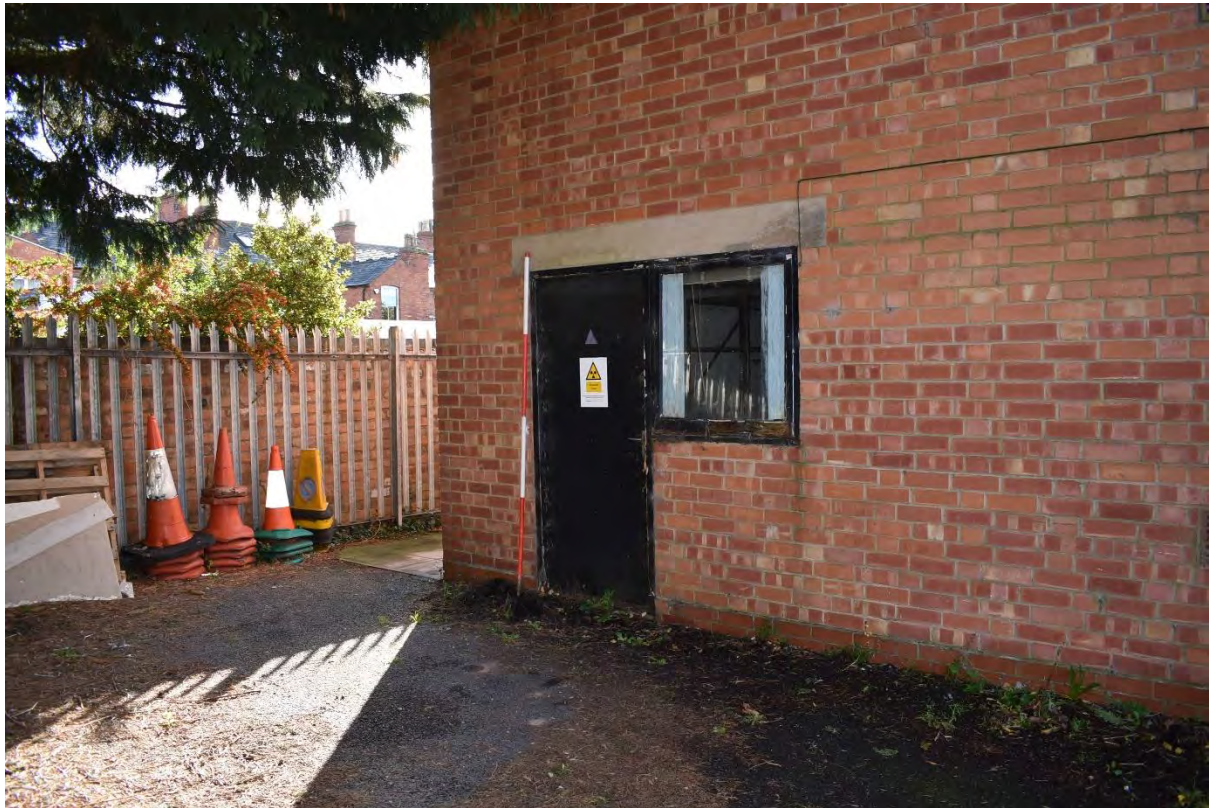
- 5.16 A large rectangular building, built of red brick, laid in a Flemish bond and Portland cement. The garage has nine vehicle entrances with metal roller doors, red brick columns as dividers with preformed cement lintels (Photos 21-22). The pitched roof is formed of corrugated metal with plastic guttering on the eaves. The north-eastern end of this building has been heavily altered. The three-vehicle entrances have been filled in with reddish purple bricks, laid in a stretcher bond and Portland cement with a single row of header on edge bond under the preformed concrete lintels. The ground floor offices to the NE end have signage showing a radiation symbol and 'Restricted Area' (Photo 23).

23: Building B, ground-floor offices, restricted area, looking south

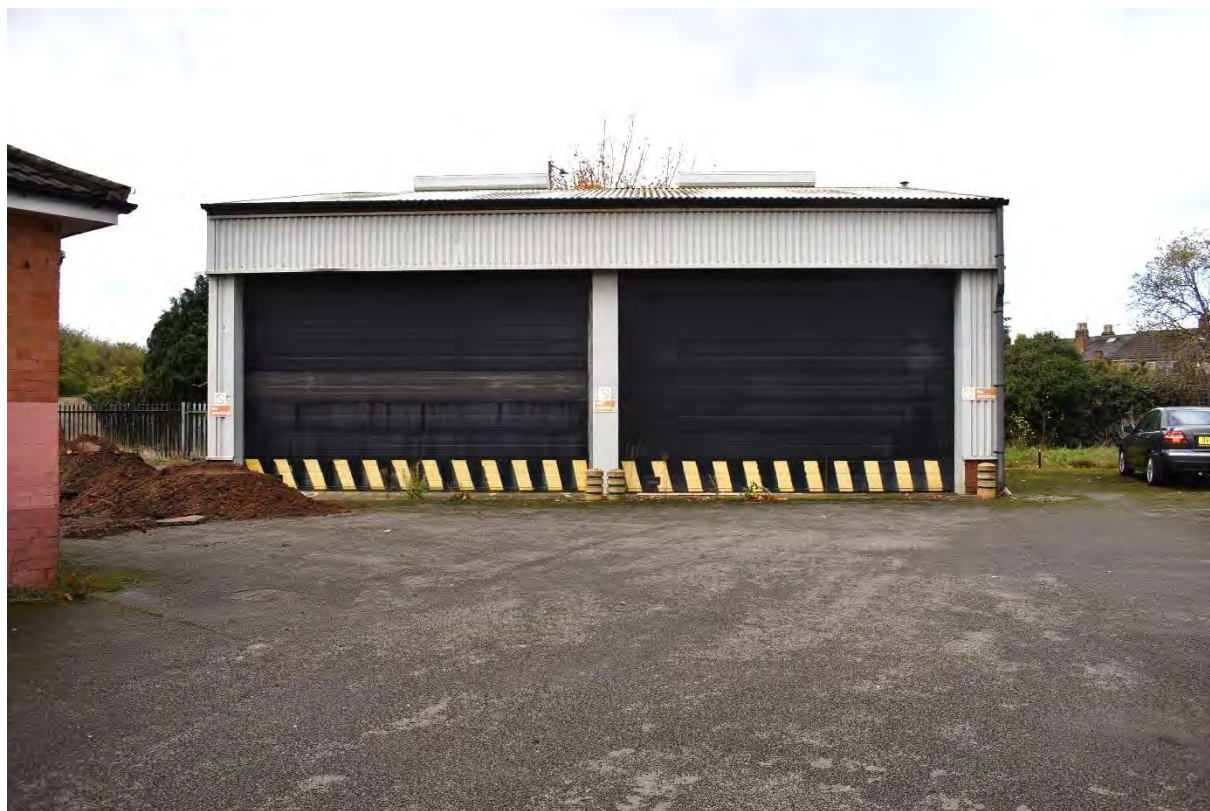
- 5.17 A large rectangular building with two large garage roller doors and central division (Photo 24). It is a corrugated painted metal structure, constructed on a red brick foundation. The pitched roof is also corrugated metal with plastic gutting on the eaves.

24: Building C garage looking west

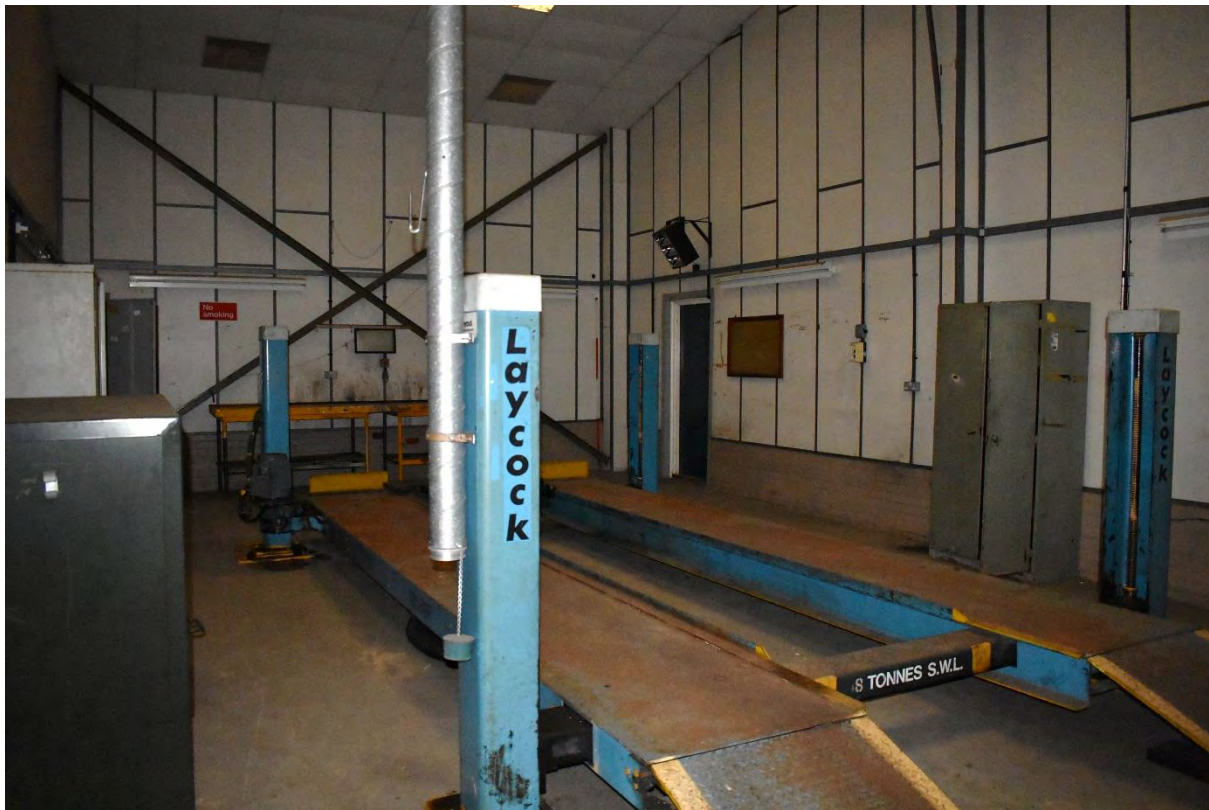
- 5.18 The two rectangular internal rooms both have concrete floors. Room 1 has no equipment left whilst room 2 contains four-post ramps for vehicle maintenance (Photo 25).

25: Room 2 of the garage with maintenance ramp, looking north-west

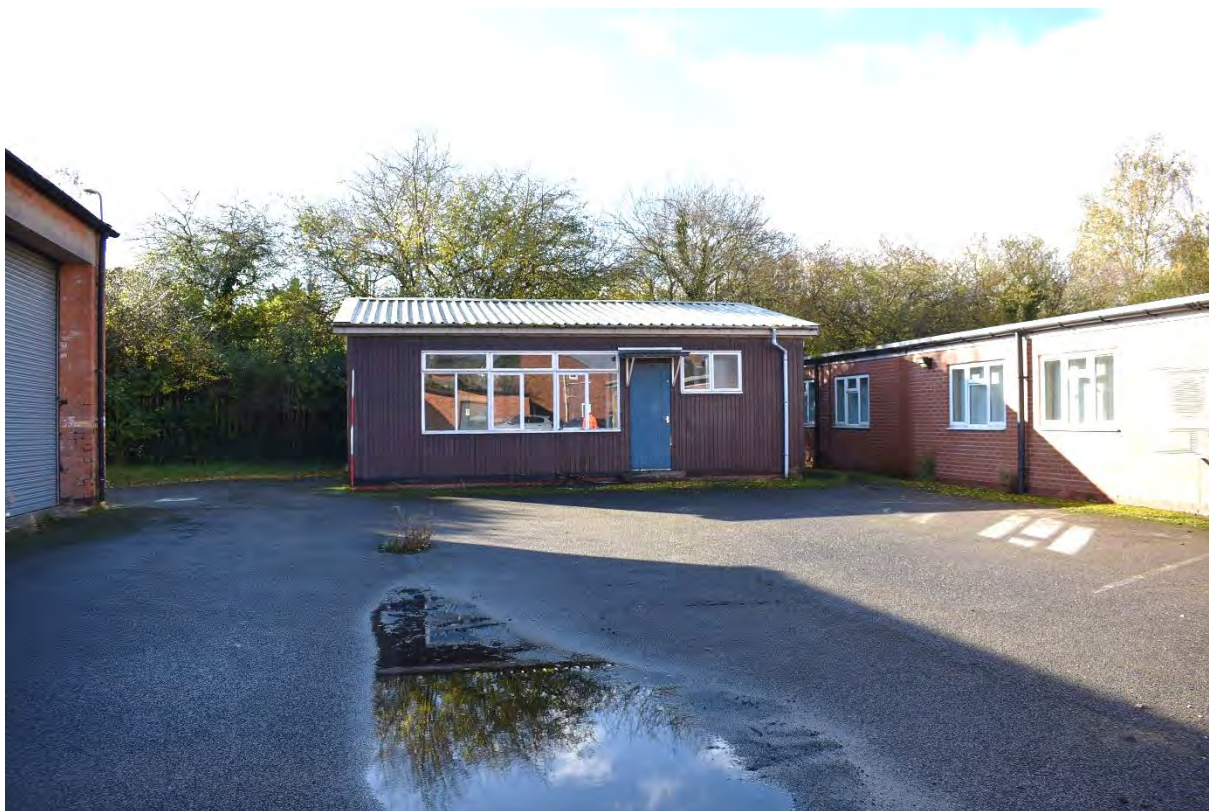
- 5.19 A small rectangular building with wooden slats built on a red brick foundation (Photo 26). The pitched roof is lined with corrugated metal with plastic guttering on the wooden eaves. The doorway threshold is wooden with an exterior double concrete slab step, laid on a brick foundation with a blue painted door. A small, flat porch is suspended on two metal brackets. The windows are single glazed, in white painted frames and

mullions. The sills and lintels are wooden. The top light is rectangular, full length and opens.

26: Building D, wooden outbuilding, looking south-west

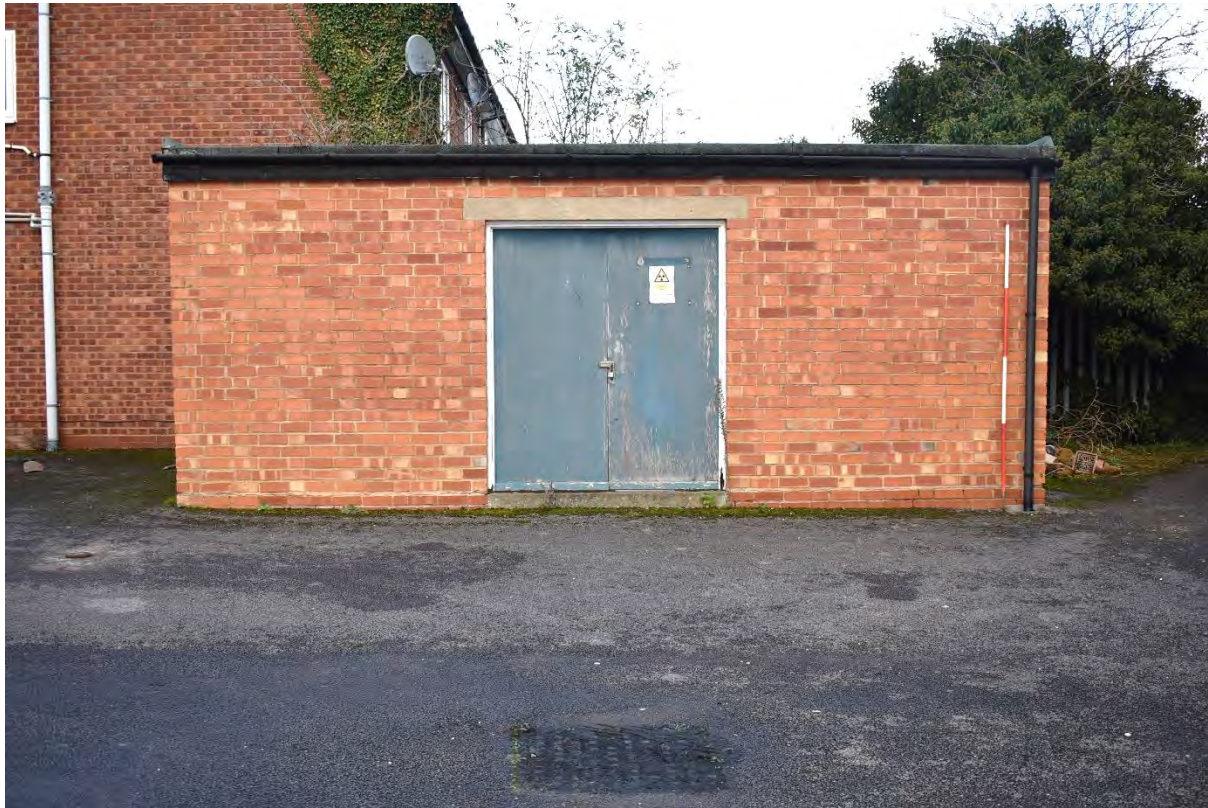
- 5.20 A small rectangular red brick building, constructed in Flemish bond with Portland cement mortar. The roof is flat with plastic guttering on the painted wooden eaves. The threshold and lintel are both preformed cement with wooden door jambs and head painted white. The double doors are plain and painted blue, with signage showing a radiation symbol and 'Restricted Area' (Photo 27).

27: Building E, stores outbuilding, looking north-east

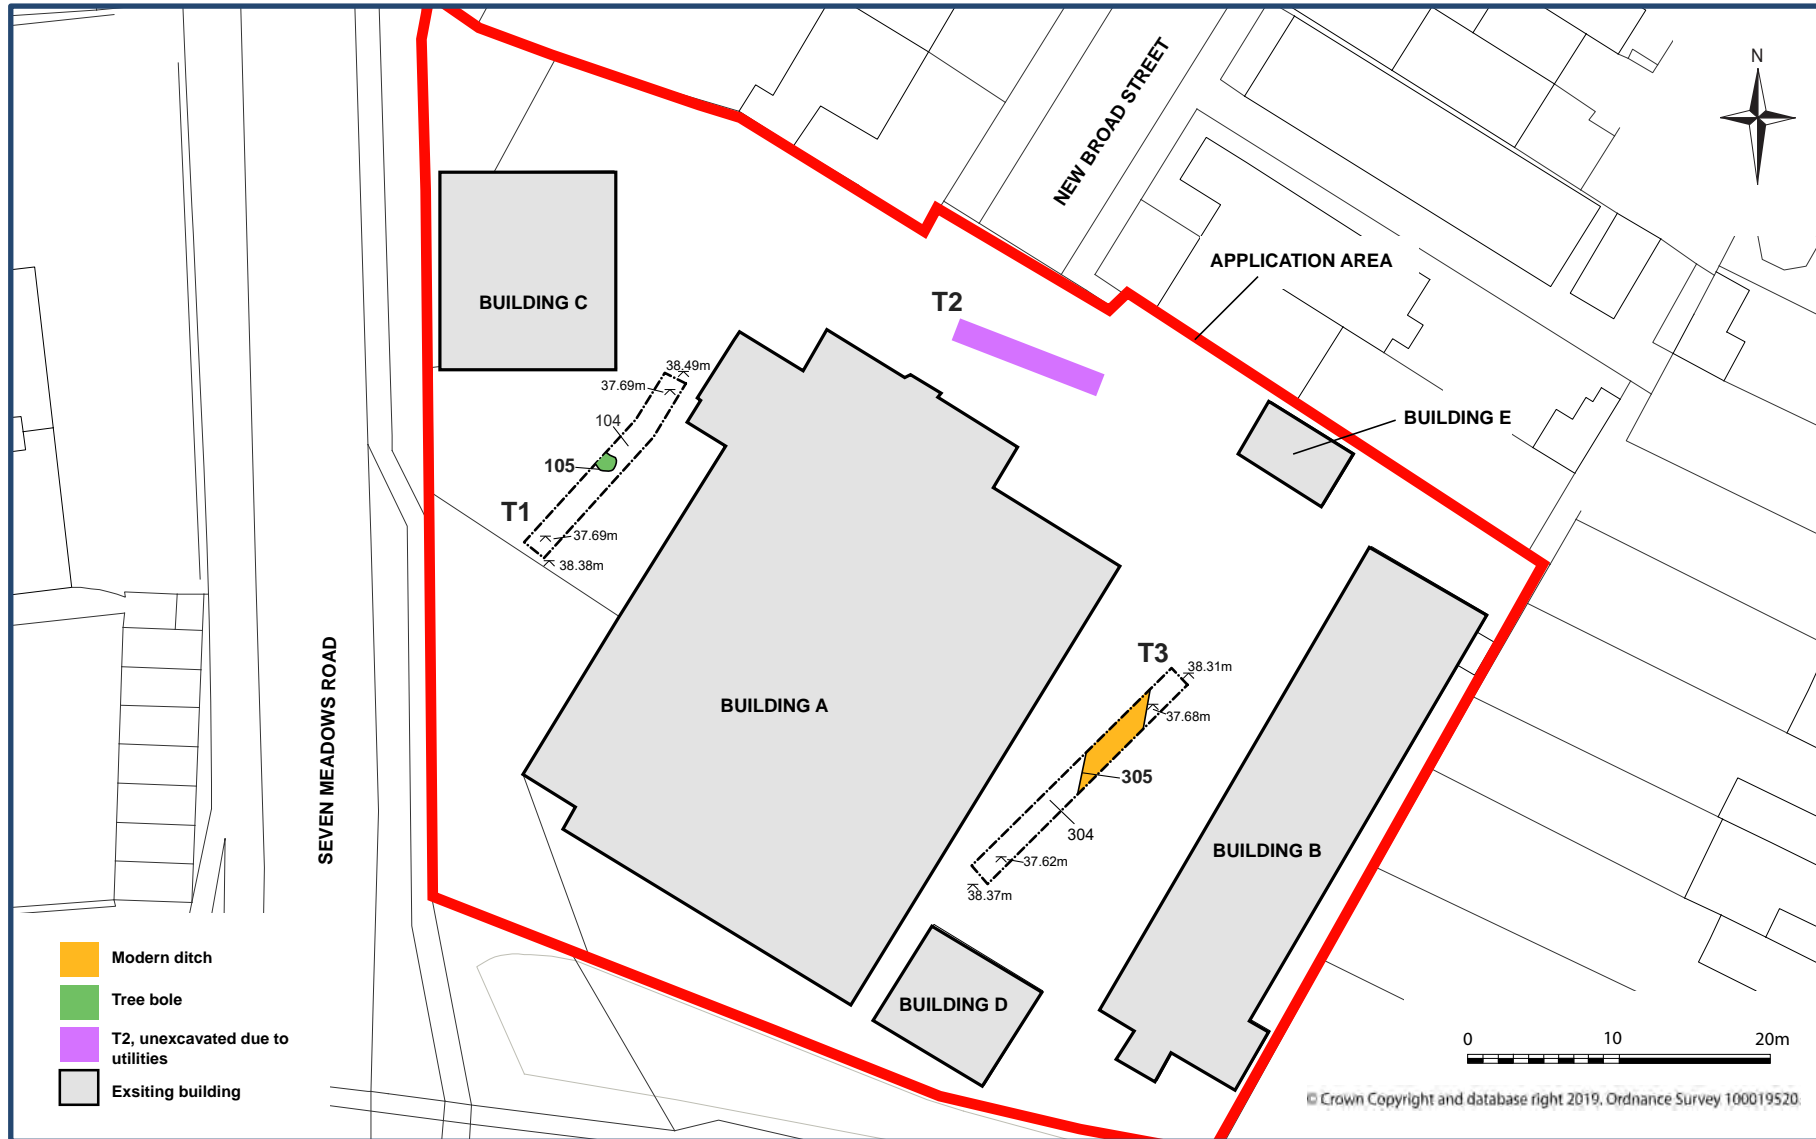
Fig 9: Location of excavated trenches

- 4.5 It was proposed to evaluate the area by means of three trial trenches (2 x 10m; 1 x 20m; total 40m), with a contingency for an additional 5m length or equivalent area (Fig 9). Due to a substantial amount of utilities the 2 x 10m trenches, Trenches 1 and 2, were joined.
- 4.6 The modern overburden was removed by a 14-tonne machine using a toothless bucket under direct archaeological supervision. Ground reduction was in shallow spits until the uppermost *archaeological* horizon, or the geological natural was. Excavation then continued by hand.
