Redvale House Tredington Warwickshire

ARCHAEOLOGICAL EVALUATION

Archaeology Warwickshire Report No 1771

SEPTEMBER 2017

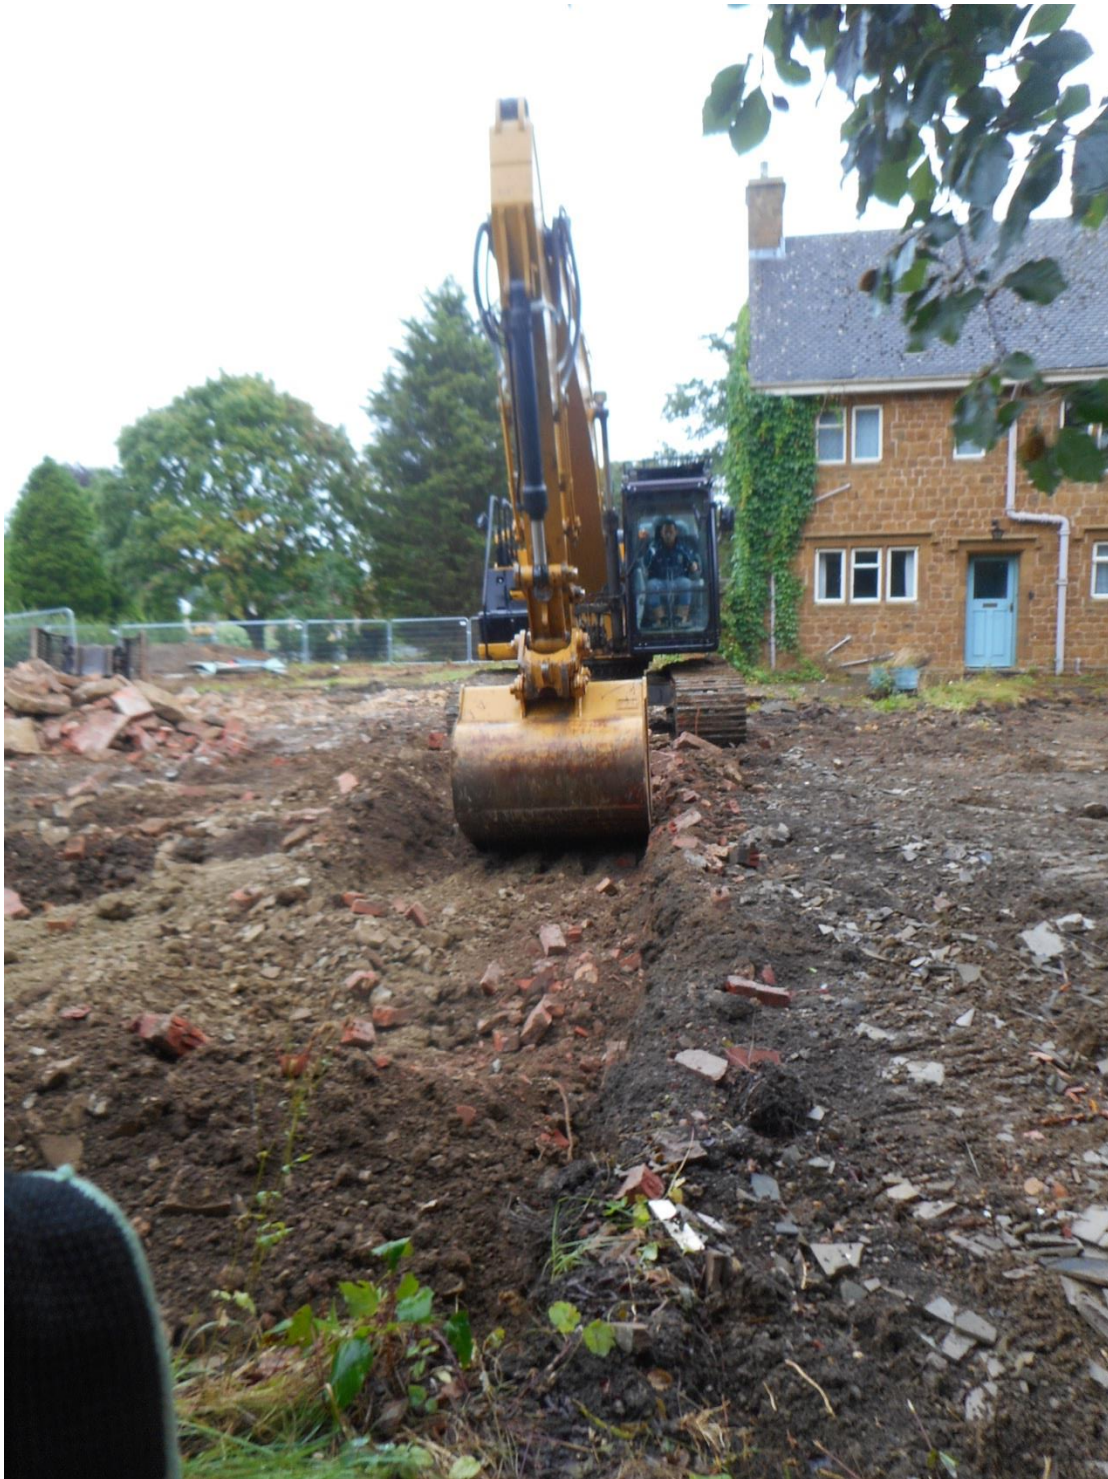
1. Removal of footings of garage and outbuilding

- 5.1 Prior to the evaluation trenching taking place the garage and adjacent outbuilding were demolished. A watching brief was carried out during the grubbing out of the foundations of these buildings, with the concrete and brick of the footings being removed from site. At the eastern end of the area grubbed out, where the modern concrete footings of the garage were particularly substantial, the geological natural could be seen as a series of bands of clay and limestone (3, 10 and 12), with the upper clay layer being reached at a depth of 0.40m below present ground level and overlaid by 0.20m-0.30m of light yellow brown clay with fragments of limestone and pebbles (2) itself overlain by up to 0.20m of dark grey brown clay loam topsoil. No features were recorded and no finds were recovered during the watching brief.

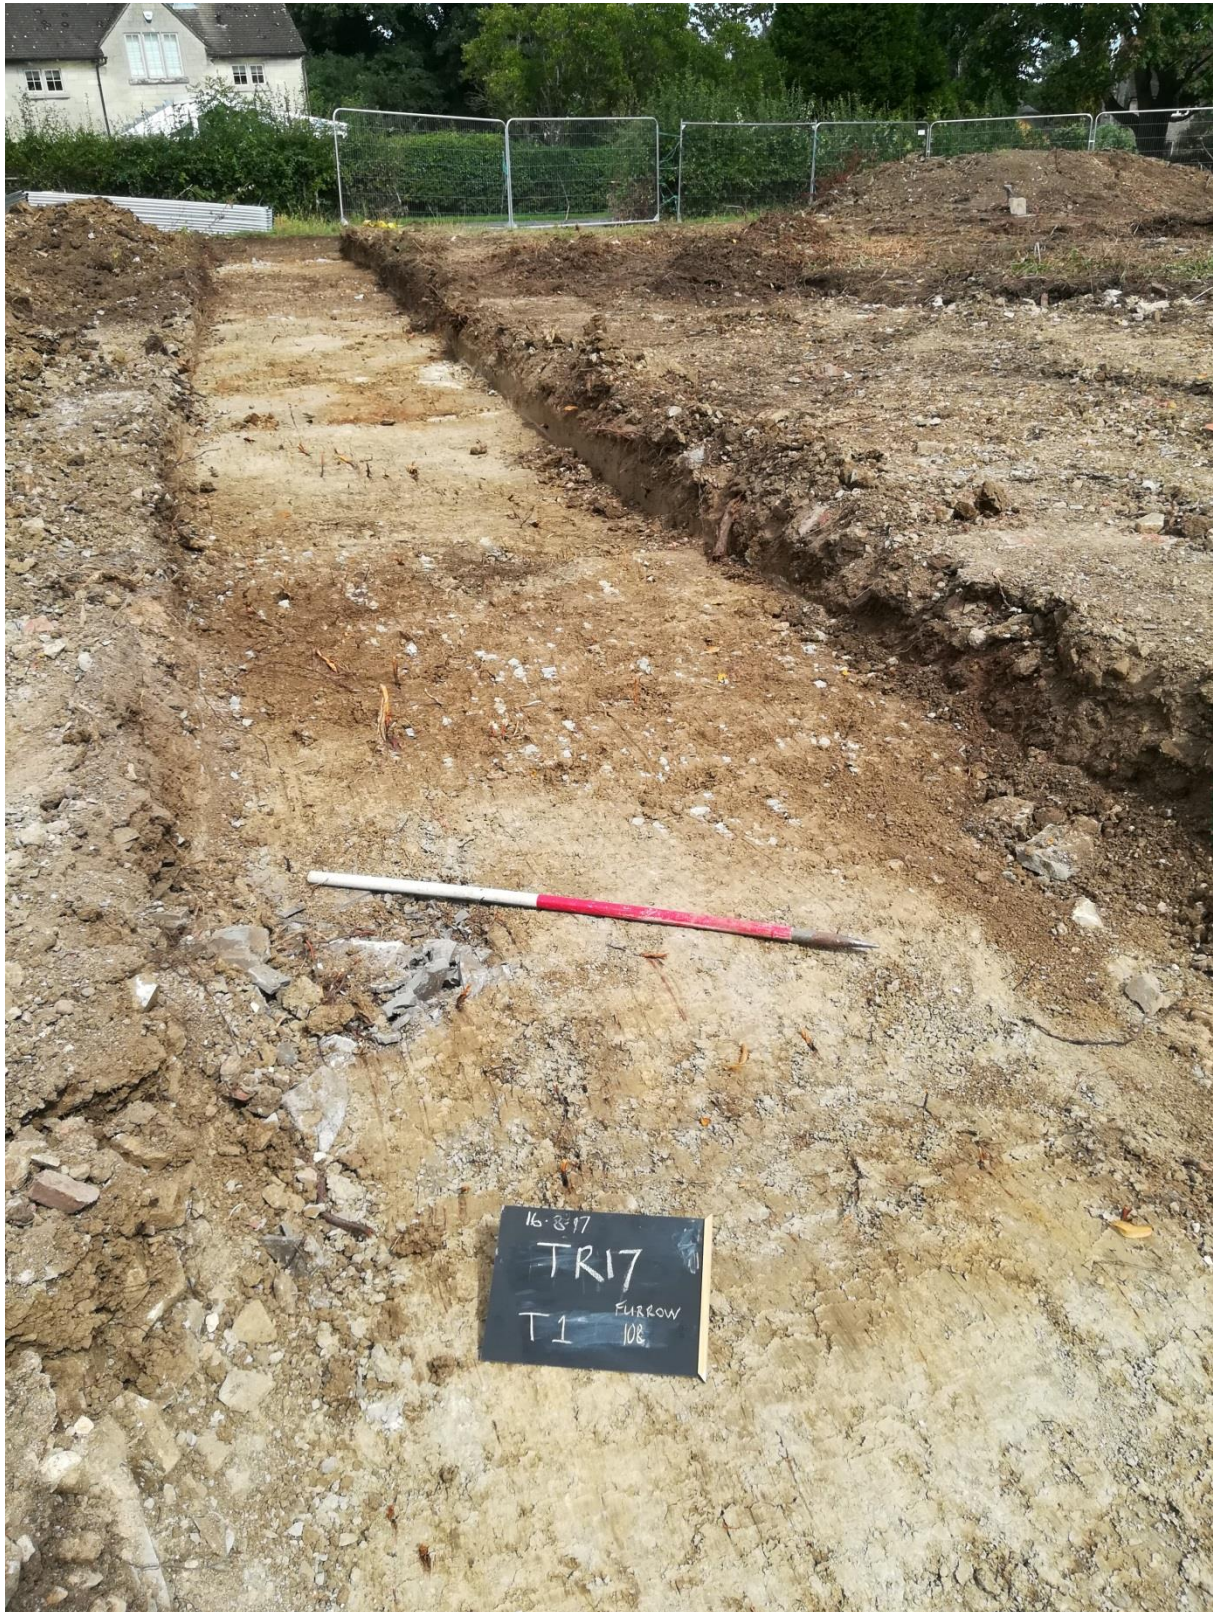
2. Trench 1 with furrow 106

- 5.4 A series of medieval or post-medieval furrows were recorded (106, 108, 204, 302 and 402) cutting into the geological natural. No medieval artefacts were recovered from the furrow fills.
- 5.5 A layer of light grey silty clay (101, 202) overlay the natural and the furrows in Trenches 1 and 2. No finds were recovered from it. This layer is likely to represent a former plough zone.
- 5.6 The topsoil in all four trenches (100, 200, 300 and 400) was greyish brown silty clay loam. The topsoil had largely been stripped where Trench 3 was excavated but survived below the area of patio slabs.

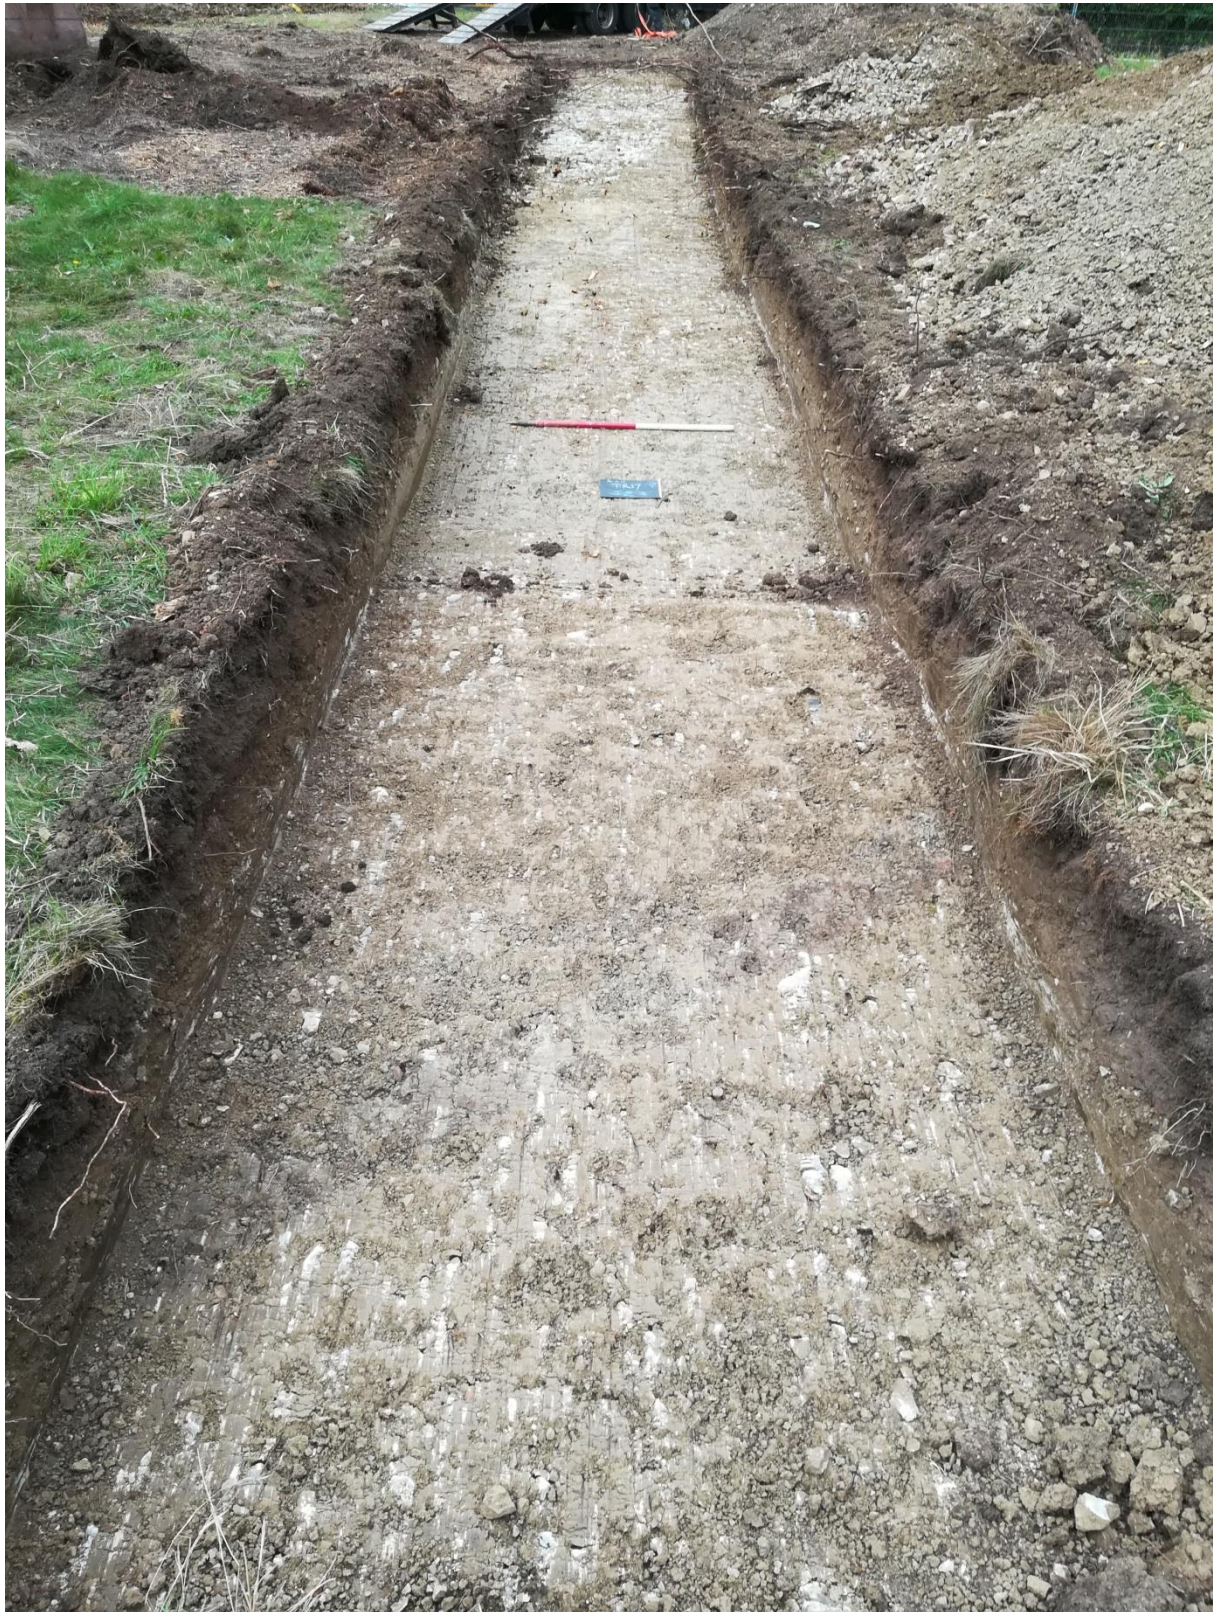
3. Trench 2

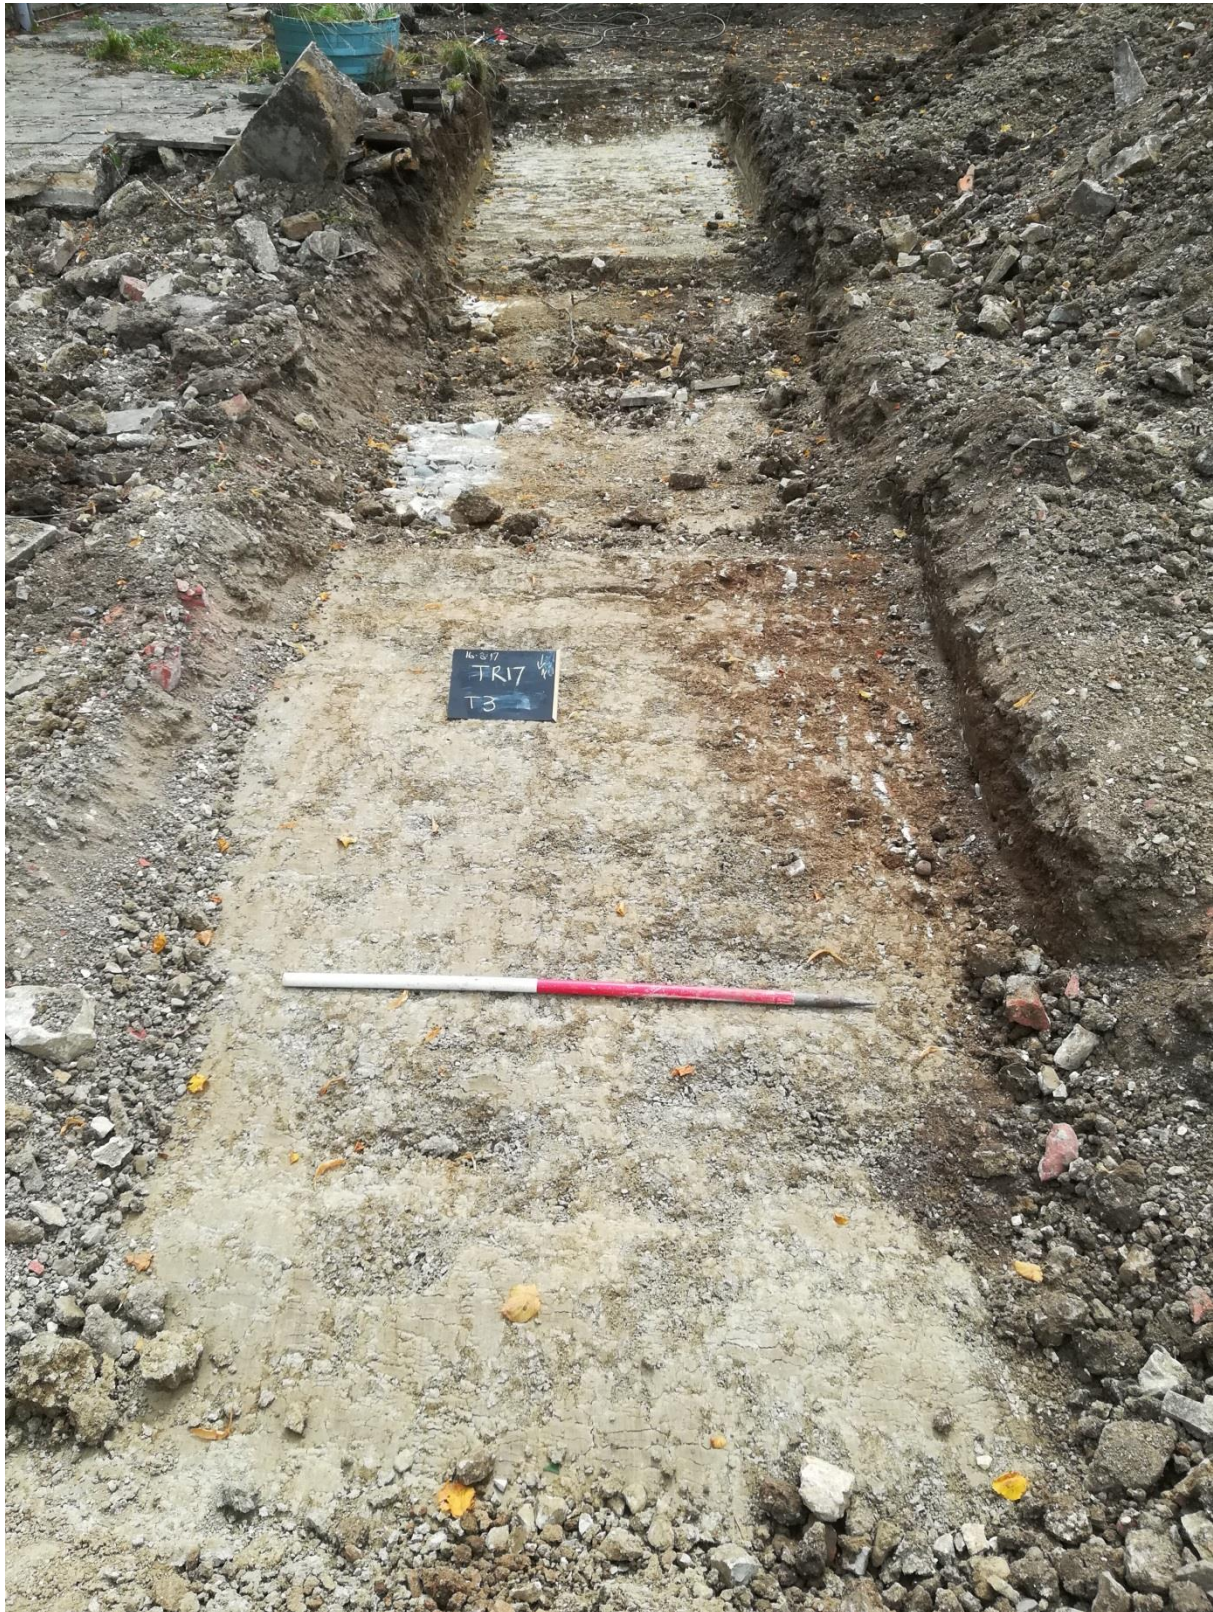
4. Trench 3, with area of grubbed-out footings in centre of trench

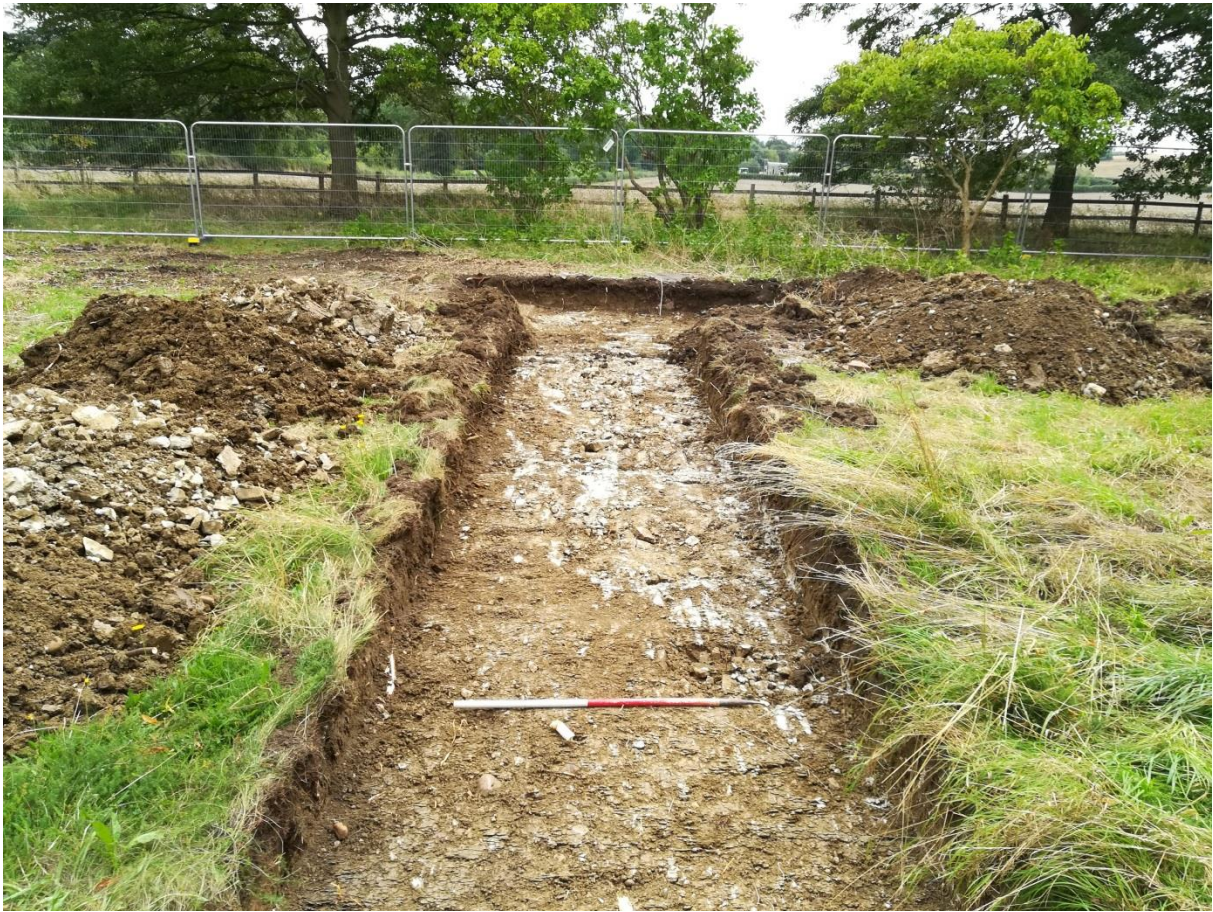
5. Trench 4
