Greenacres Lower Tysoe Warwickshire

ARCHAEOLOGICAL EVALUATION

Archaeology Warwickshire Report No 1929

MARCH 2019

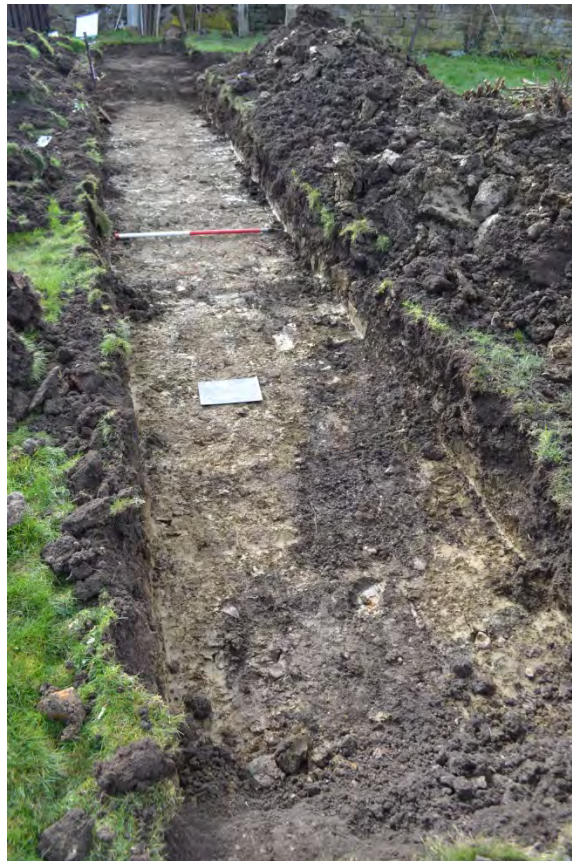
- 5.4 At the north end of the trench, gully 10 was 0.4m wide and approximately 0.1m deep, filled with grey silty clay (9) which contained ceramic drain and stone slate fragments. It was overlain by greyish brown silty clay (2) and topsoil (1).

1: Trench looking west, with gully 10 in foreground

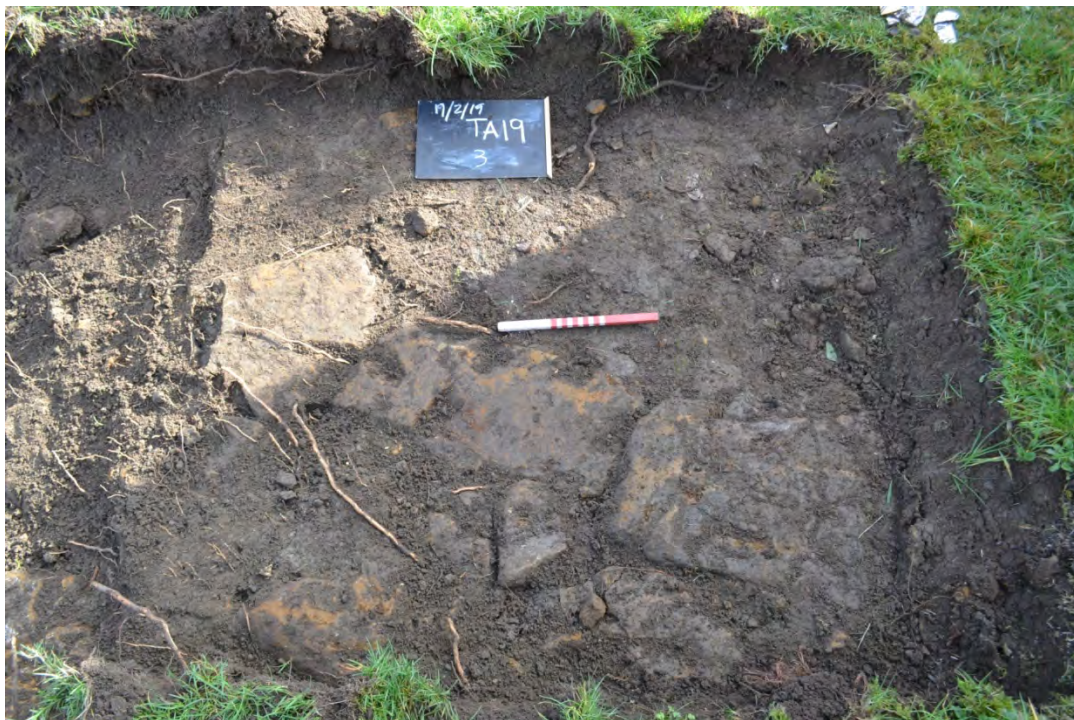
- 5.2 At the south end of the trench was an undated rubble layer (4) 0.2m thick. It was overlaid by several large stone blocks which formed a flattish surface (3). This may have been a surface, but could be the foundation for a wall and is likely to be associated with a structure that extends to the south.
- 5.3 To the north, a small concentration of small fragments of stone and pebbles may be the remnants of a posthole or postpad (6).

2: Hornton stone construction (3) at the south end of the trench

- 6.1 The stonework at the southern end of the trench seems most likely to belong to a structure that extended to the south. It was not possible to determine the date of the stonework although the absence of any medieval pottery on the site may suggest it was not particularly early; however this is not a reliable facet of analysis.

- 6.5 Following the identification of potentially significant remains during the evaluation, which could relate to the development of the farmstead, a further phase of work is considered appropriate in order to better understand and characterise these remains. This work will comprise the excavation of further trenches. The work will form part of the agreed mitigation strategy (below) to be implemented by way of a planning condition and is to be undertaken in accordance with a revised Written Scheme of Investigation (WSI).

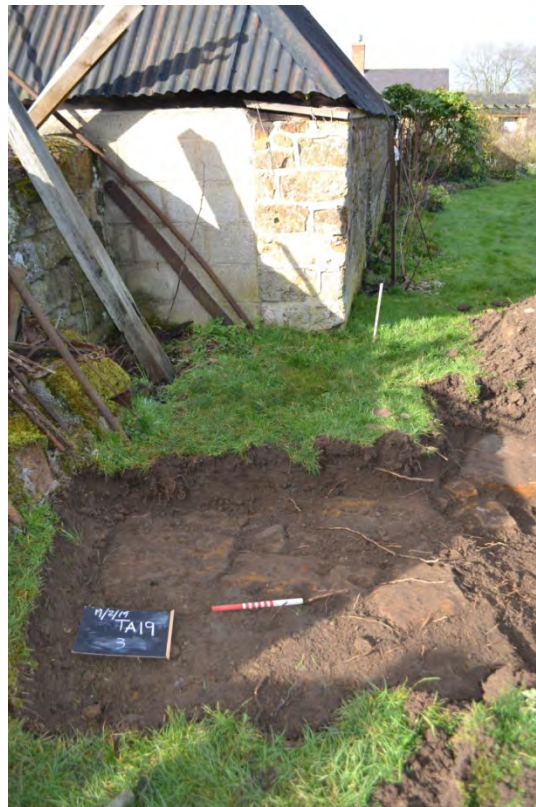
3: Trench looking north, with former shelter shed

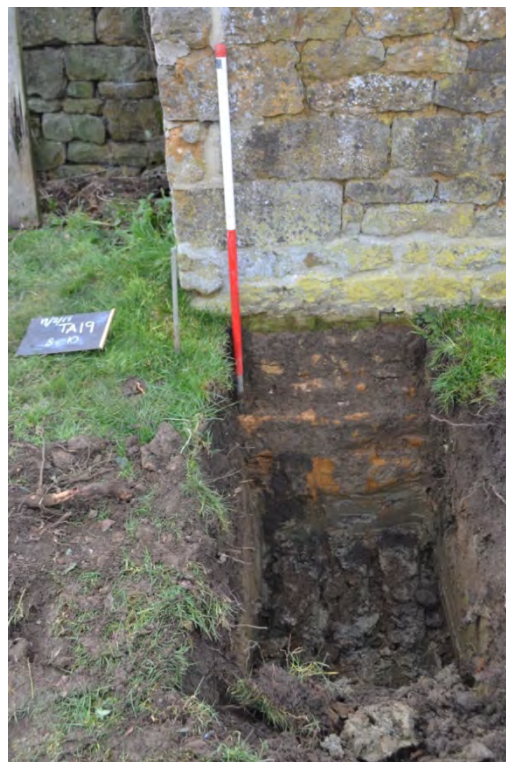
- 5.6 A pit (GP1) dug against the north wall of the former shelter shed revealed the offset foundation of the building footings (11) to be 0.6m deep, 0.3m below that of the stonework 3.
- 5.7 Two further pits dug at the north end of the evaluation trench (GP2) and the western end of the former shelter shed (GP3) revealed no significant archaeological remains.

4: Geotechnical pit 1 looking south, showing wall foundation 11

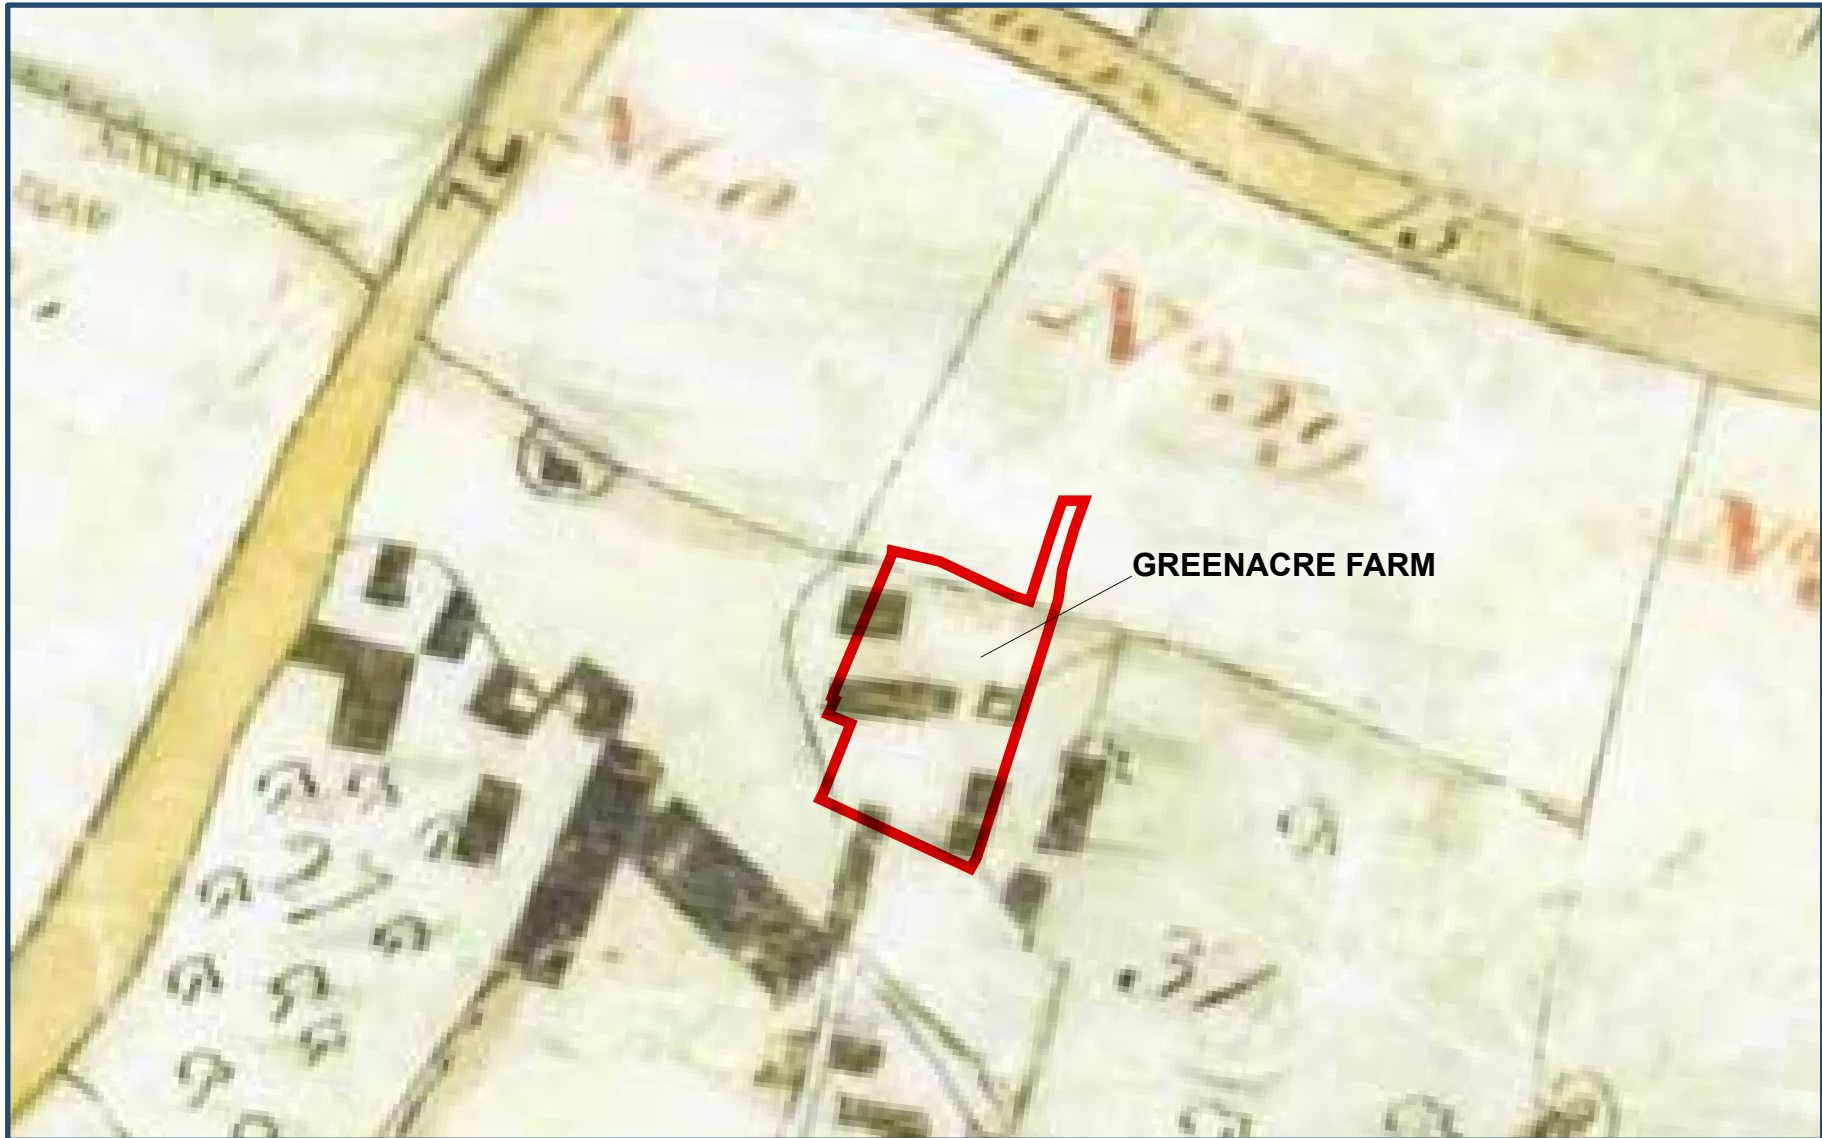
- 3.3 The farm is shown on an enclosure map of 1798 (Fig 2) alongside other nearby farm buildings including Badgers Farm (MWA 12959), adjacent to the south-west, and the Orchard, to the east. The map is a schematic representation and although a long building is shown on the same general alignment and roughly in the same position as the shelter shed it is not clear if this is the same as the subject building. A small square building, marked in outline, is depicted to the east of this building.

Fig 2: Detail from Inclosure map, 1798, showing Greenacre Farm upper left of plot 31

- 6.2 Very similar evidence has previously been excavated in the village and has been equally difficult to characterise (Hillman 2018).
- 6.3 The early cartographic evidence is ambiguous: it is not clear from the 1798 Inclosure map (Fig 2 (a schematic representation)) whether a long east-west aligned building in a similar location and alignment to the shelter shed is in fact the subject building itself. Nevertheless, the findings from the southern end of the evaluation trench seem to alter the balance of evidence here to suggest that the masonry may relate to the square building marked in outline on the Inclosure map. The square building is shown adjacent to the above mentioned long east-west building and further characterisation of the stonework could add to the understanding of the origins of the shelter shed itself, potentially taking it back by around 100 years.
