# St John the Baptist Church, Wasperton, Warwickshire

## Archaeological Watching Brief

Archaeology Warwickshire Report No 1472  
September 2014

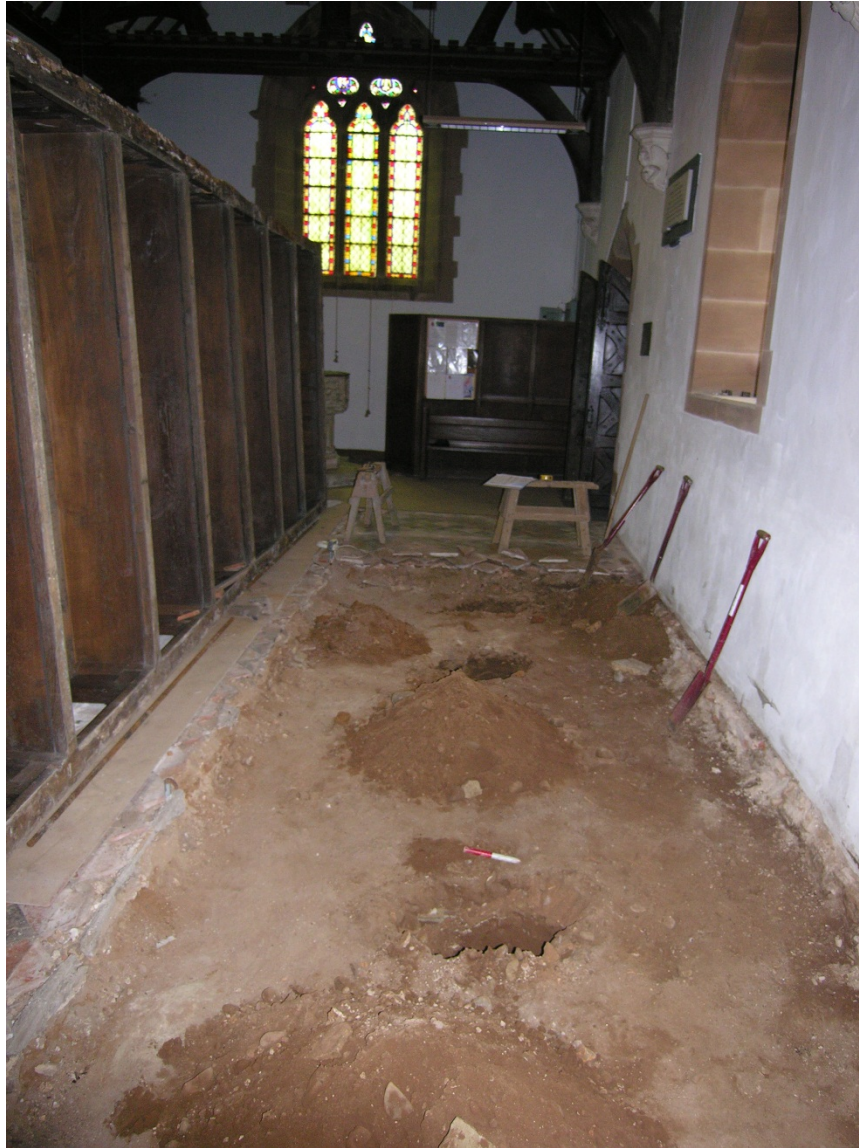
Fig 2: View of area of investigation with excavation of pits

5.2 In total eight small pits (1-8) were observed and these were all hand dug to a depth of approximately 0.3m. The pits were slightly irregular in size, but averaged 0.4m long and 0.3m wide, and were excavated to a depth of between 0.28m and 0.38m. The pits were located in two rows parallel with the nave wall.

5.5 Pits close to the wall contained a close-packed stone foundation (6). The pits did not provide sufficient area to reveal the character of the masonry, which extended along most of the length of the area of investigation. No masonry was revealed within pit 5, which contained a sequence similar to pits (1-4).

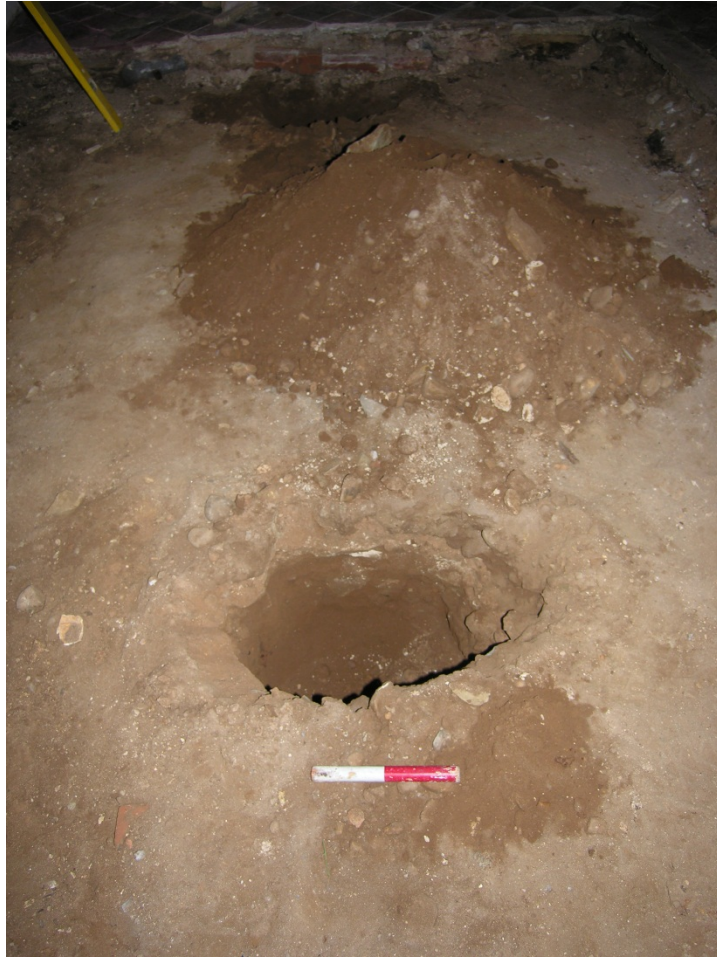
Fig 3: Pit 2

5.3 Geological natural was not clearly observed in the base of all the pits, but a deposit of loose sandy gravel (5) was reached at a depth of approximately 0.34m in most cases. This is most likely to be part of the geological sequence.

5.4 The gravel deposit was overlaid by a layer of light grey brown sandy loam containing fragments of tile, brick and stone. These included several tile fragments, one possible green glazed medieval tile, a fragment similar to those forming the existing floor and one tile of a smaller size. The layer was an average of 0.25m thick and appeared to extend over the majority of the area of investigation.
