8 Church Street Warwick Warwickshire

ARCHAEOLOGICAL MONITORING AND RECORDING

Archaeology Warwickshire Report No 18102
DECEMBER 2018

Project: Watching Brief at 8 Church Street, Warwick
Commissioned by: Nick James (Robothams) on behalf of Mr and Mrs Hawking
Site Code: WC18
Planning Reference: W/17/2034
Planning Authority: Warwick District Council
National Grid Reference: SP 2822 6490
Project Manager: Caroline Rann MCIfA
Fieldwork: Rob Jones PCIfA and Pete Thompson BA
Author: Eri Kleisoura ACIfA and Dr Cathy Coutts
Illustrations: Candy Stevens
Checked by: Dr Cathy Coutts
Approved by: Stuart Palmer MCIfA
Date: December 2018
Report reference: Kleisoura, E. and Coutts, C. M. 2018 *8 Church Street, Warwick, Warwickshire: Archaeological Watching Brief*, Archaeology Warwickshire Report 18102.

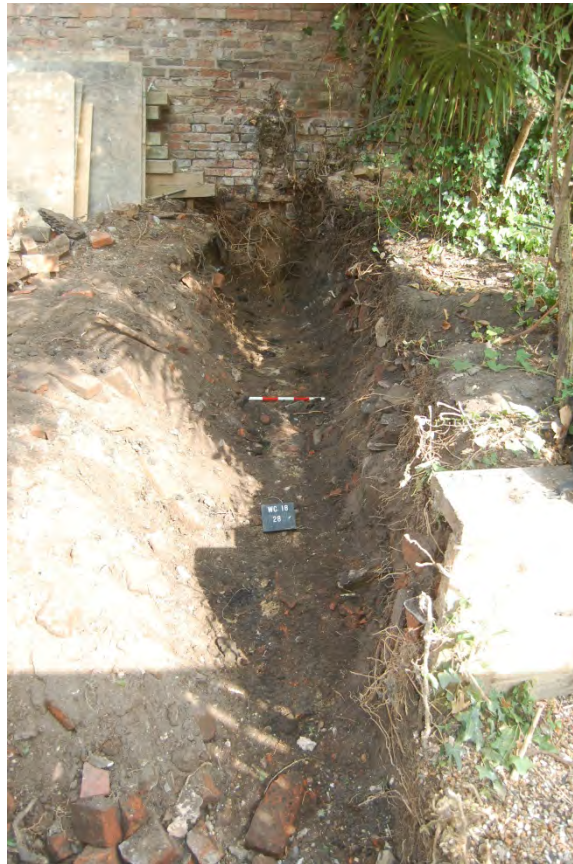
- 5.3 The lowest context recorded was a layer of mixed brown sandy loam (28), briefly exposed by the contractor in a defined area, but almost immediately infilled, containing broken bricks, roof tiles and fragments of 18th/19th-century glass bottles (Photo 1). The top of this layer was occasionally visible at the deepest point of the perimeter foundation. Layer 28 was overlain across the central area by a c.0.30m thick dark greyish brown loam (7), containing clinker, stones and fragments of bricks which almost certainly represented a post-medieval garden soil (Photo 2).

1: Layer 28 exposed along the north-east foundation trench

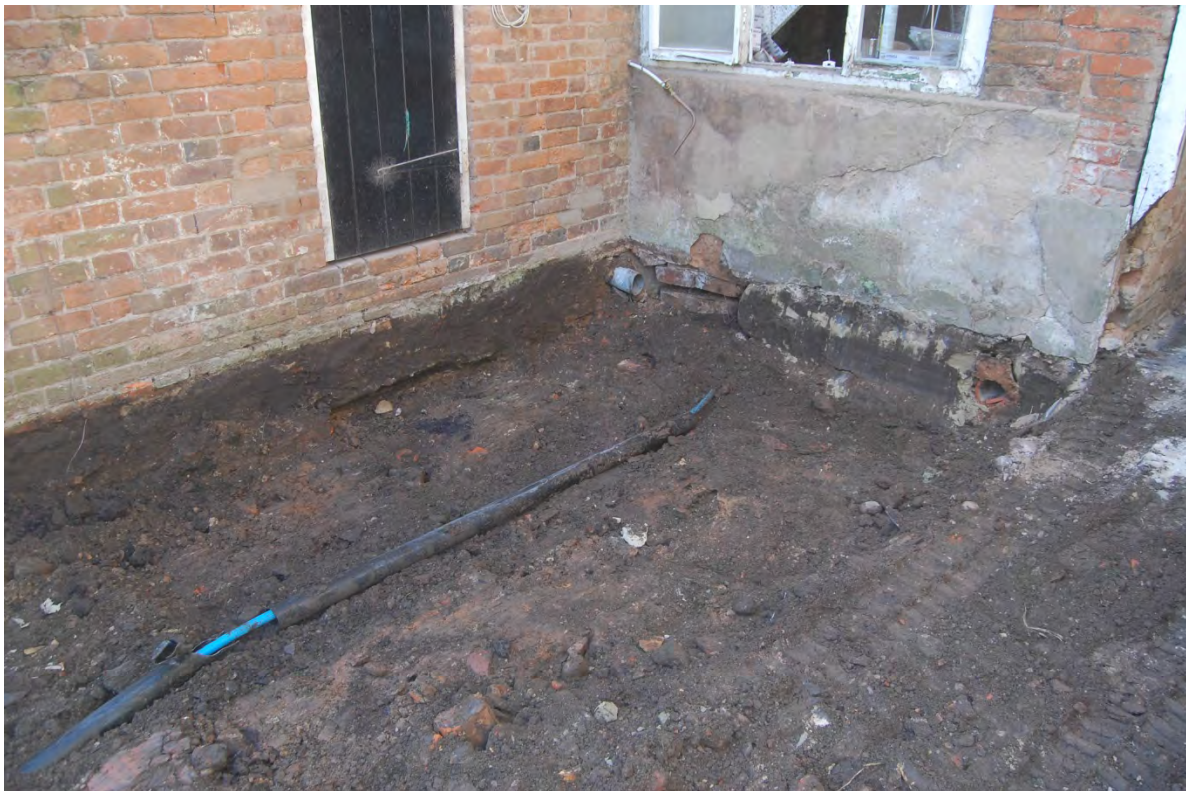
2: Rear of the property, looking south-west

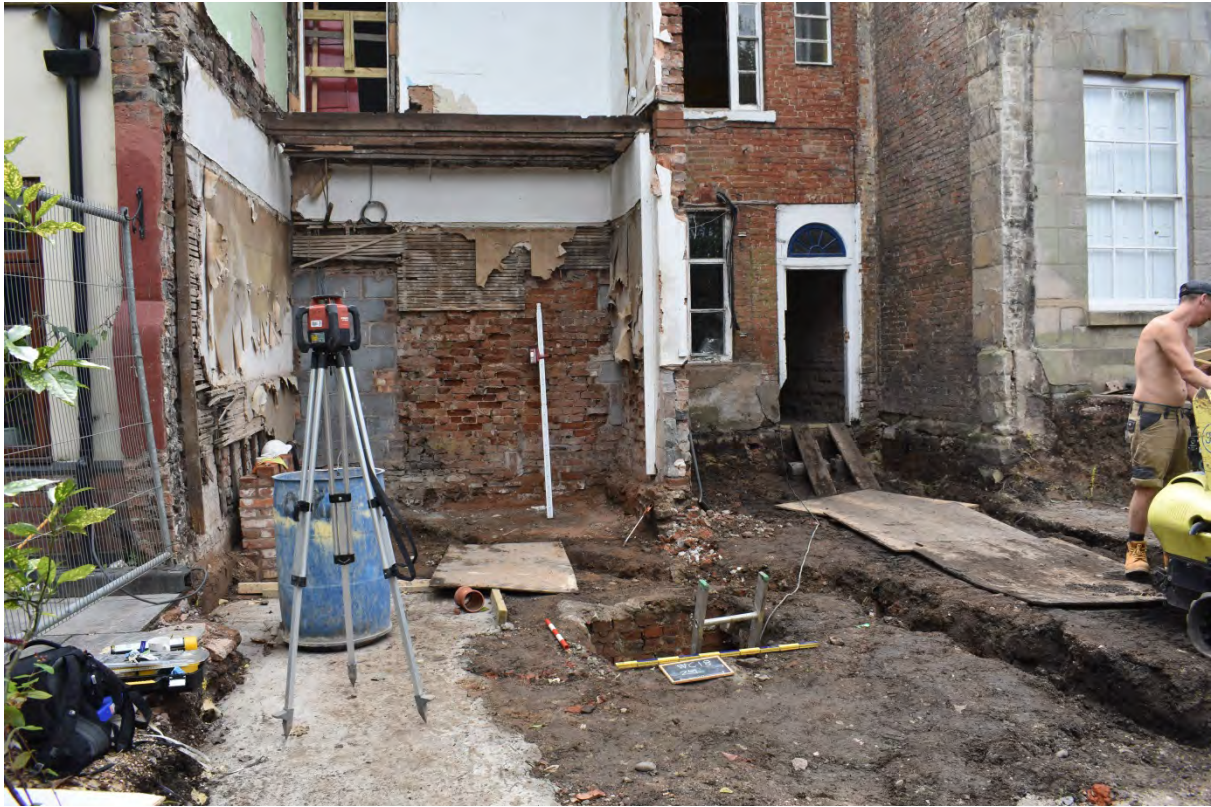
- 5.4 Along the north-west and south-east sides of the site, two brick boundary walls with stone foundations were recorded. The north-west wall (4) was demolished prior to the site being visited (Photo 3). It was formerly 3.80m high and 0.35m wide. The sandstone foundation (5) for the wall was constructed using ashlar blocks bonded with a lime mortar. Wall 6 and foundation 27 to the south-east of the site were of similar size and construction.

3: Rear of the property and demolished wall 4, looking south-west

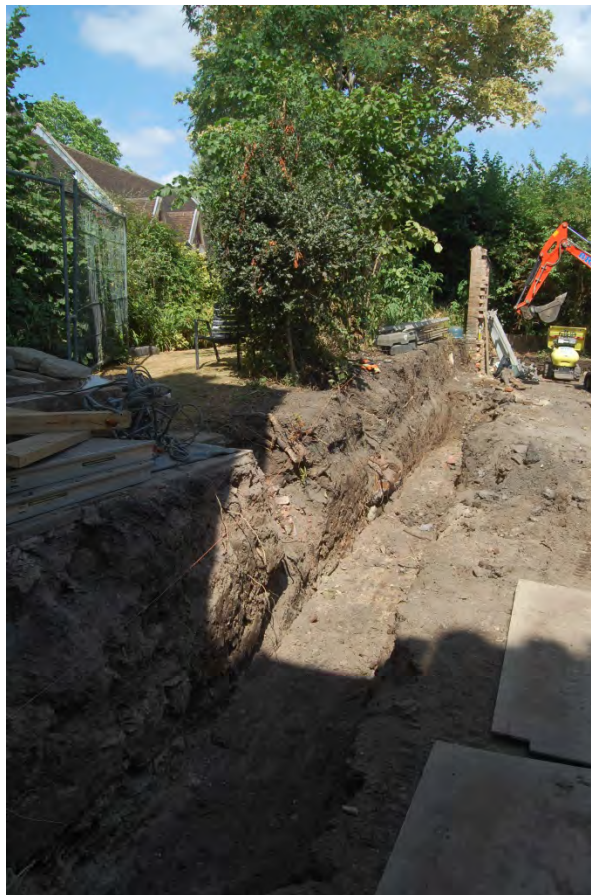
- 5.5 Wall 4 abutted the rear external stone wall of the property to the north-west of the development. Demolition of the brick wall and deepening of the footings revealed a sequence of early modern garden soils from the adjacent property; topsoil (1) overlying subsoil (2) both ranging in various hues of brownish grey silty loam, measuring up to 0.70m in depth. Below was a grey silty clay deposit with occasional mortar flecks and small pebbles (8), measuring c.0.75m deep, which perhaps represented an earlier garden horizon (Photo 4).

4: East footing, looking north-east

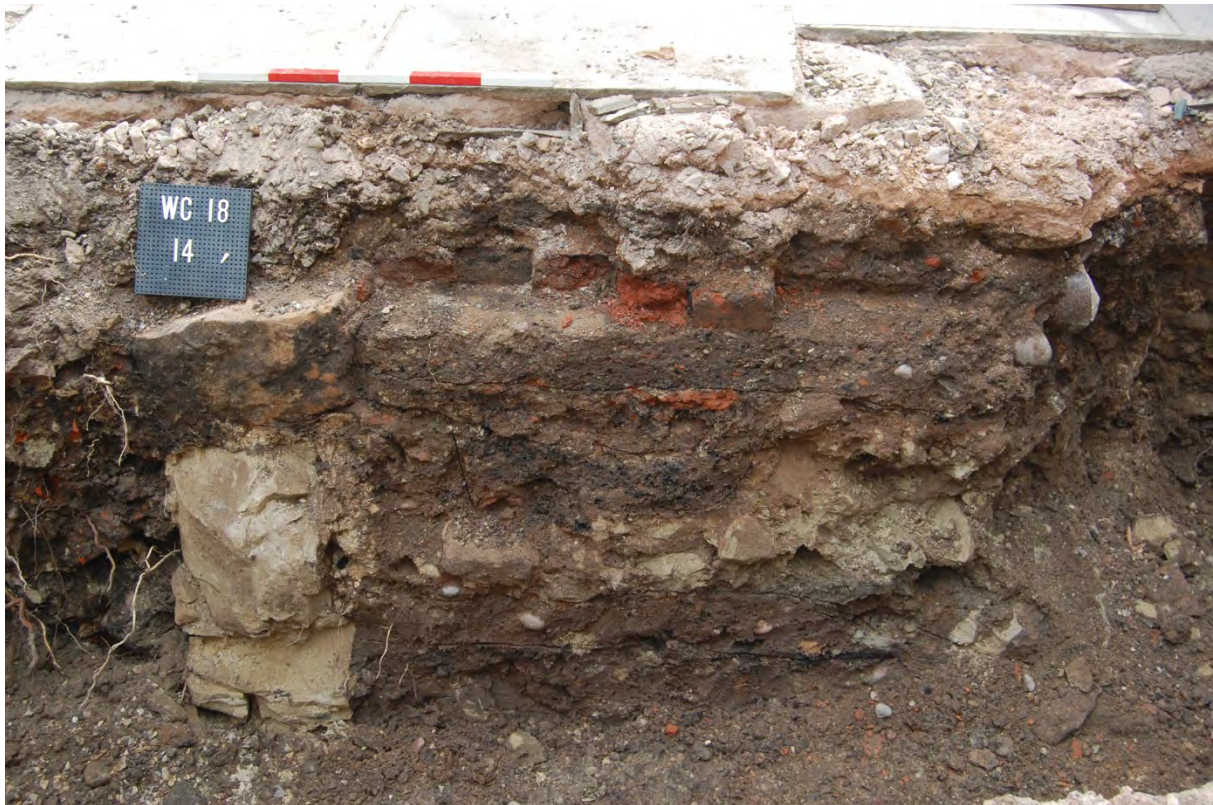
- 5.6 An area of approximately 3.10m from the rear wall of the house to the south-east (Number 6) was paved with Portland stone slabs (9) bedded on a mortar base, some 0.04m thick and 0.10-0.20m thick hardcore (10). The paving overlaid the remains of wall 14 which was butted by a section of brick flooring (15) to the south-east, made of a single thickness of 19th century bricks (c.0.07m thick). Only the foundations of wall 14 survived, comprising three courses of olive sandstone blocks roughly hewn and squared. The foundation cut for wall 14 (19) had a vertical stepped side to the south-west and vertical side to the north-east and was filled by brown sandy loam (20) (Photo 5).

5: Wall 14 and brick floor 15 below 1960s extension, looking north-west

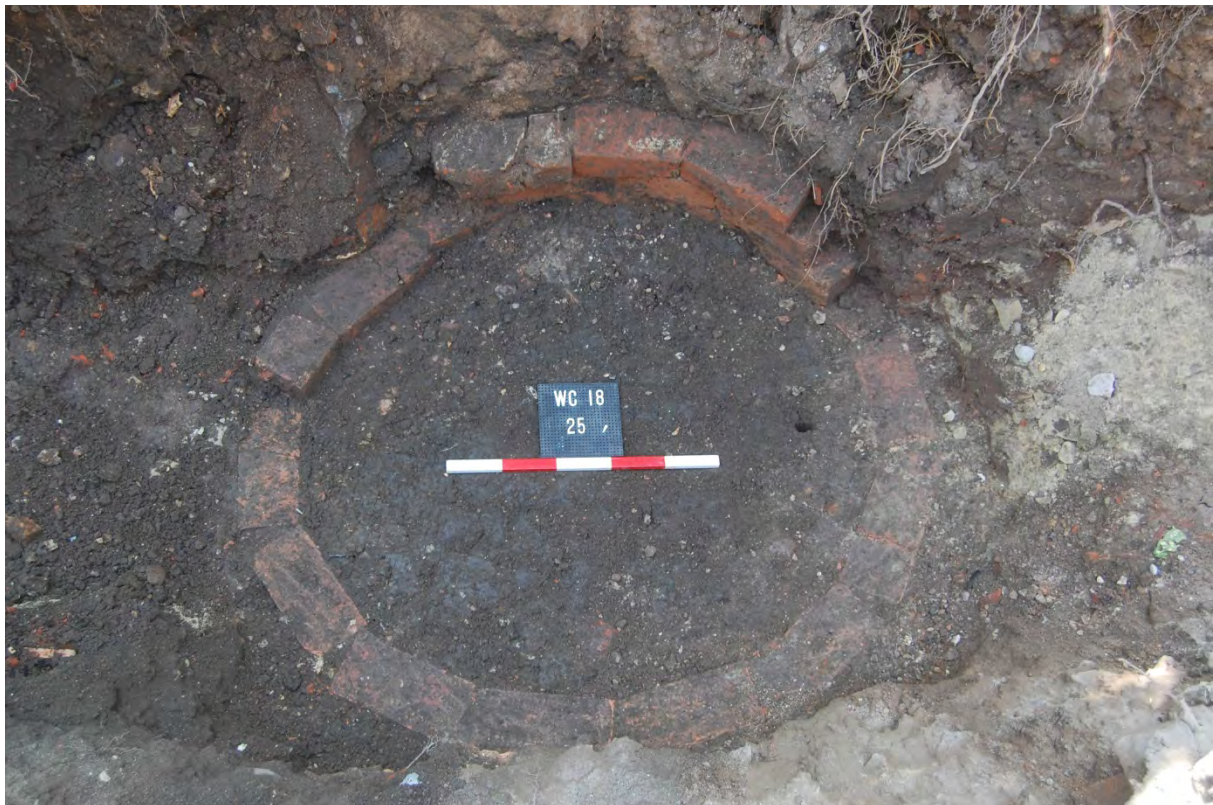
6: Well 25, looking south-east

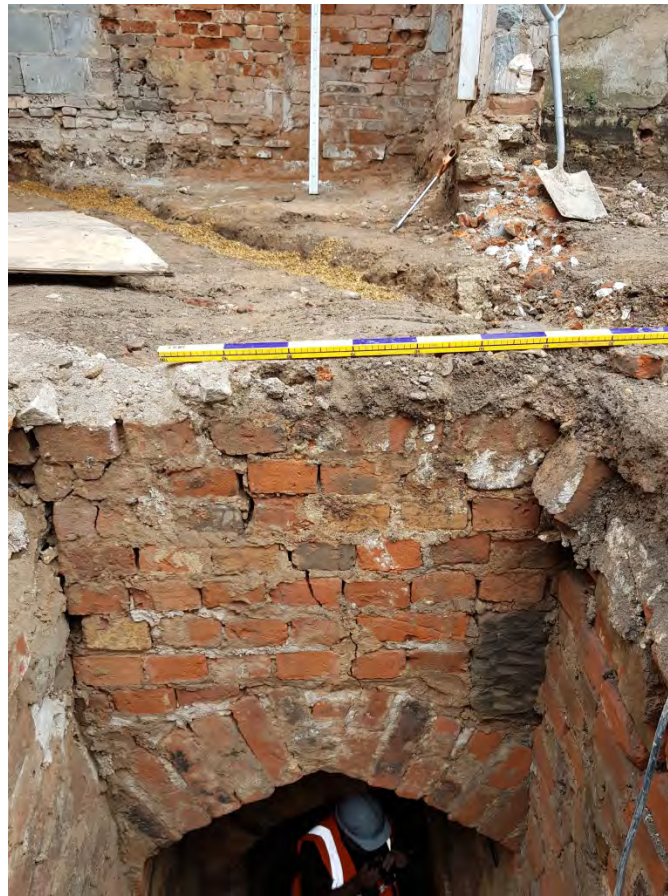
- 5.11 To the immediate rear of the former original rear wing, a square access shaft (29) was recorded, measuring 0.90m x 1.0m x 1.0m, built of seven courses of 18th-century bricks, one side set on a 0.6m wide arch (36), which provided access to a below-ground structure (32), hewn partly out of the natural bedrock, measuring c.2m in diameter and at least 3.20m in depth (Photo 7). Within the structure another arch (37) ran below the line of the former NW wall of the rear wing of the house, providing structural support. The cylindrical structure had vertical sides with segmental brick-lined barrel vault (39) and a side 'chute' cut into the bedrock on its south-western side measuring 0.70m x 0.70m x 1.0m (Photos 7-8). The base of the 'chute' sloped steeply onto the structure possibly providing some form of access to the structure from the cellar that lies below the house, but it was blocked with brickwork. The cellar floor within the house is at a higher level than the base of the structure. The lower part of the structure was partly cut (33) directly into the sandstone bedrock (34_ overlain by six to nine courses of sandstone blocks with no discerning bonding material (31). Along the base of the structure was an unknown depth of rubble and brick fill (30) which was not excavated (Photo 9).

7: Brickwork of access shaft 29

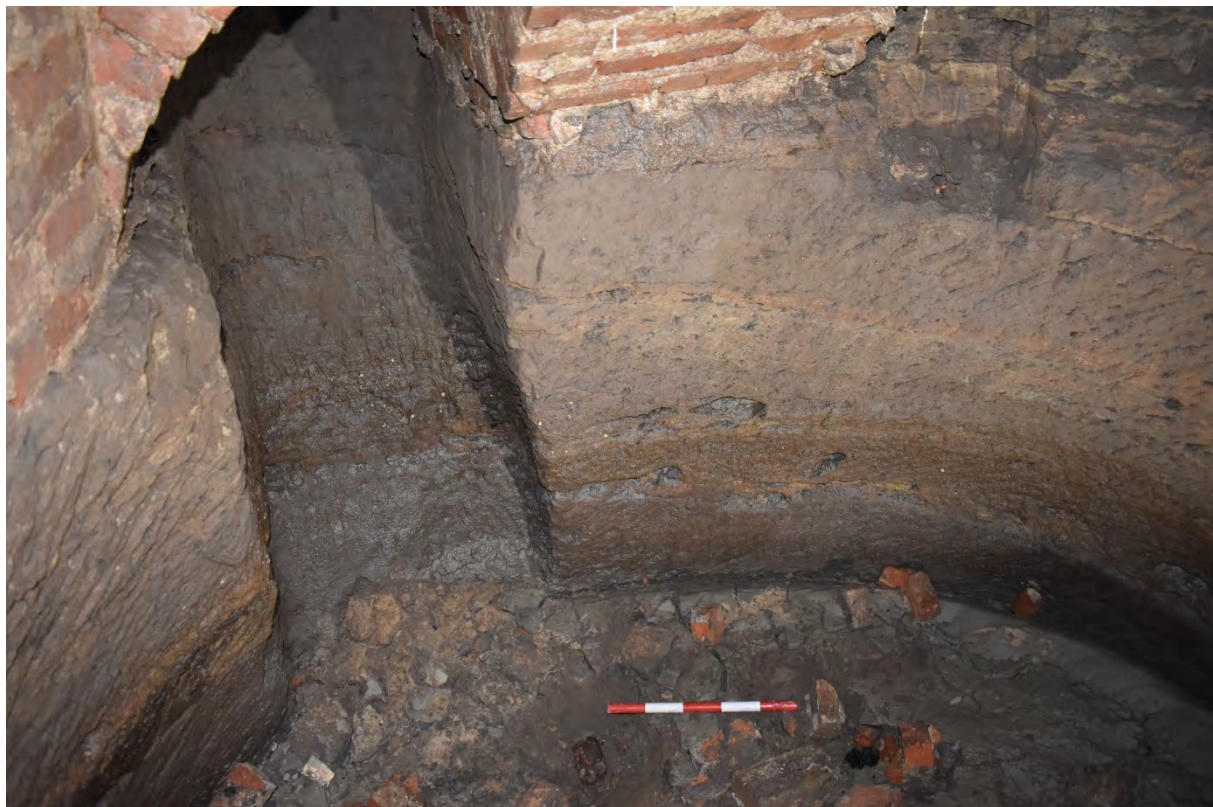
8: Interior of below-ground structure 32, with chute, looking west

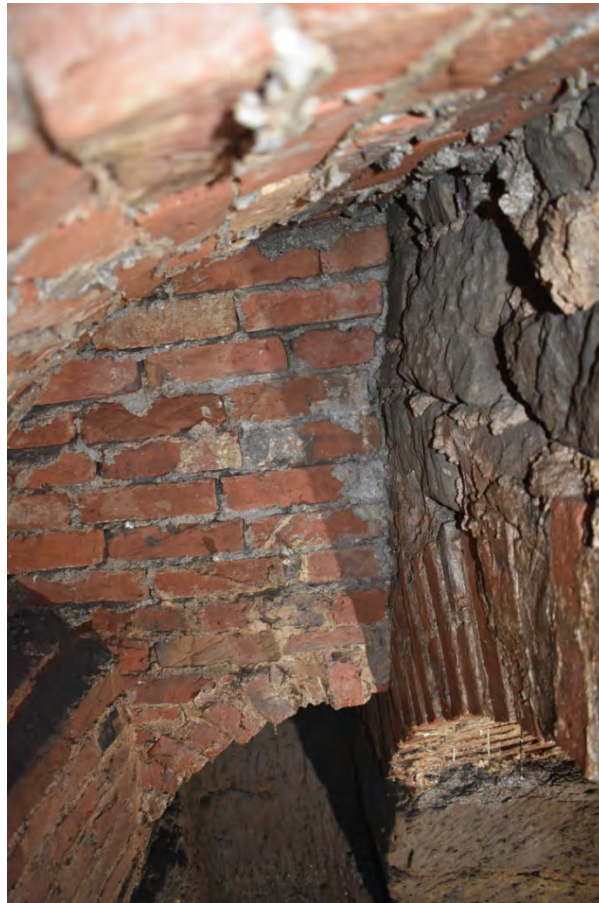
9: Brickwork inside structure 32

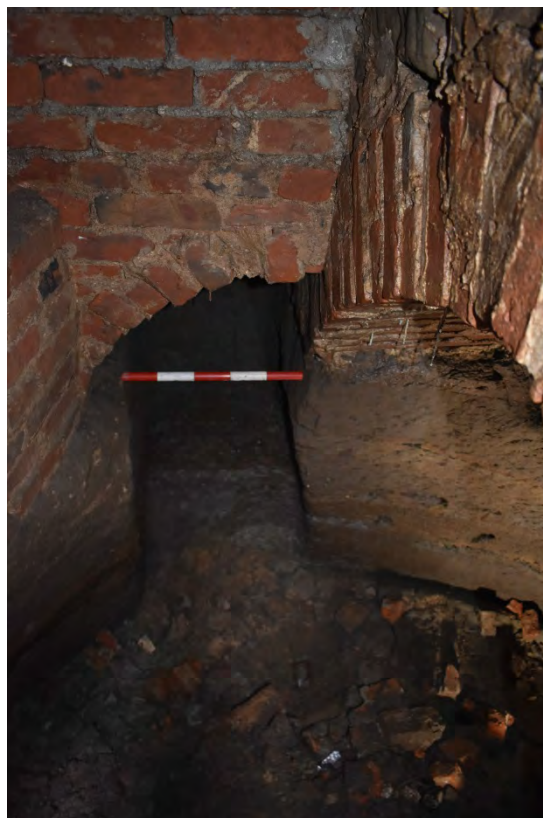
10: Fill inside structure 32 with brick arches

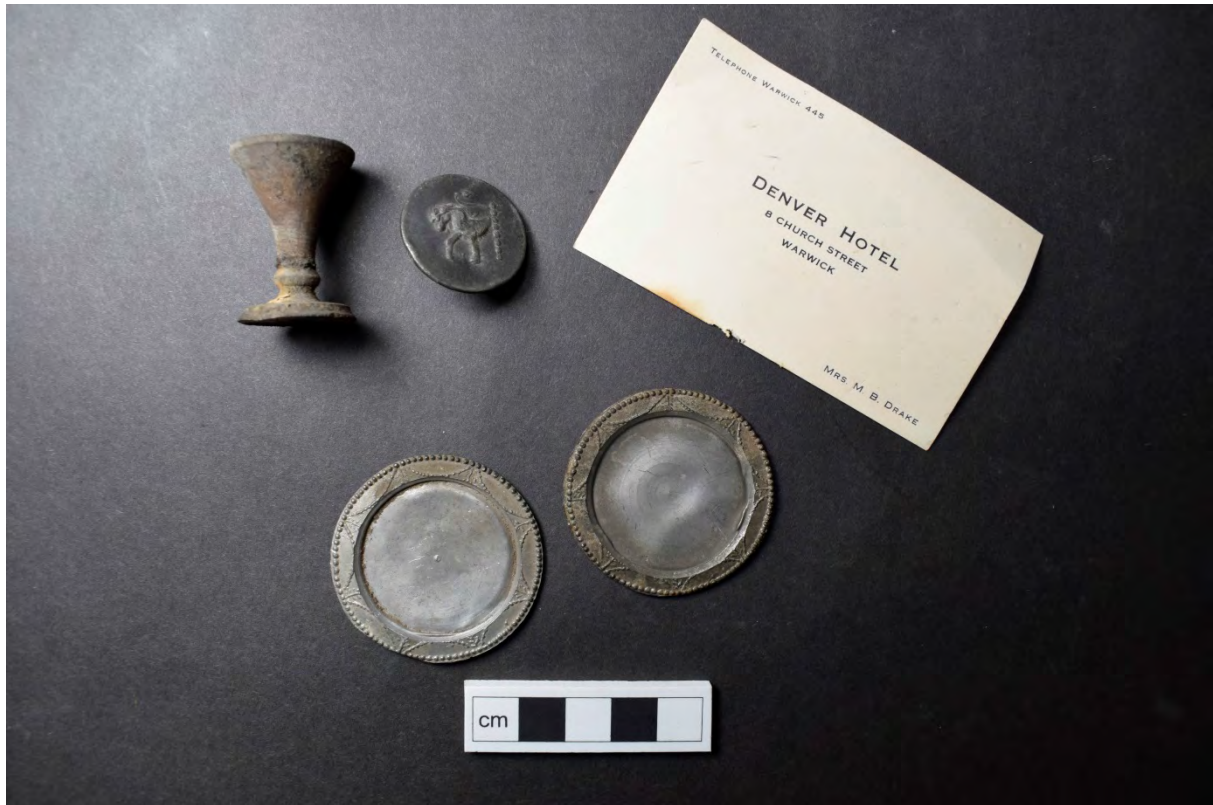
- 6.2 Late 18th- or 19th-century doll's house accessories, including miniature pewter plates and a miniature wooden goblet, were found under the wooden boards of the first floor of the main property. Along with the doll's house accessories were a number of paper finds, this included the front page of the 'Telegraph and Morning Post' newspaper, dated Wednesday, Dec 1st, 1943, a receipt from the Crown Hotel, Clayton Street West, Newcastle-on-Tyne, for a Mr Drake, and a posted receipt from the former clothing shop 'Rowans Ltd', at 71 New Street, Birmingham, with the name of Capt, H.J. Mansfield, Royal Warwicks. Regt. Denver Hotel, Warwick, dated January 15th 1943. There were also three business cards for the 'Denver Hotel, 8 Church Street, Warwick', for a Mrs M.B Drake, indicating former use of the property as a 'hotel' or boarding house up to at least the 1940s (Photo 10). A copper-alloy livery button with a loop shank on the back and a lion (rampant) on the front was also recovered. The fashion for livery buttons started in the mid 18th century and was common in the 19th century in upper class houses where household servants were maintained.

11: Finds from under the wooden floor of the house

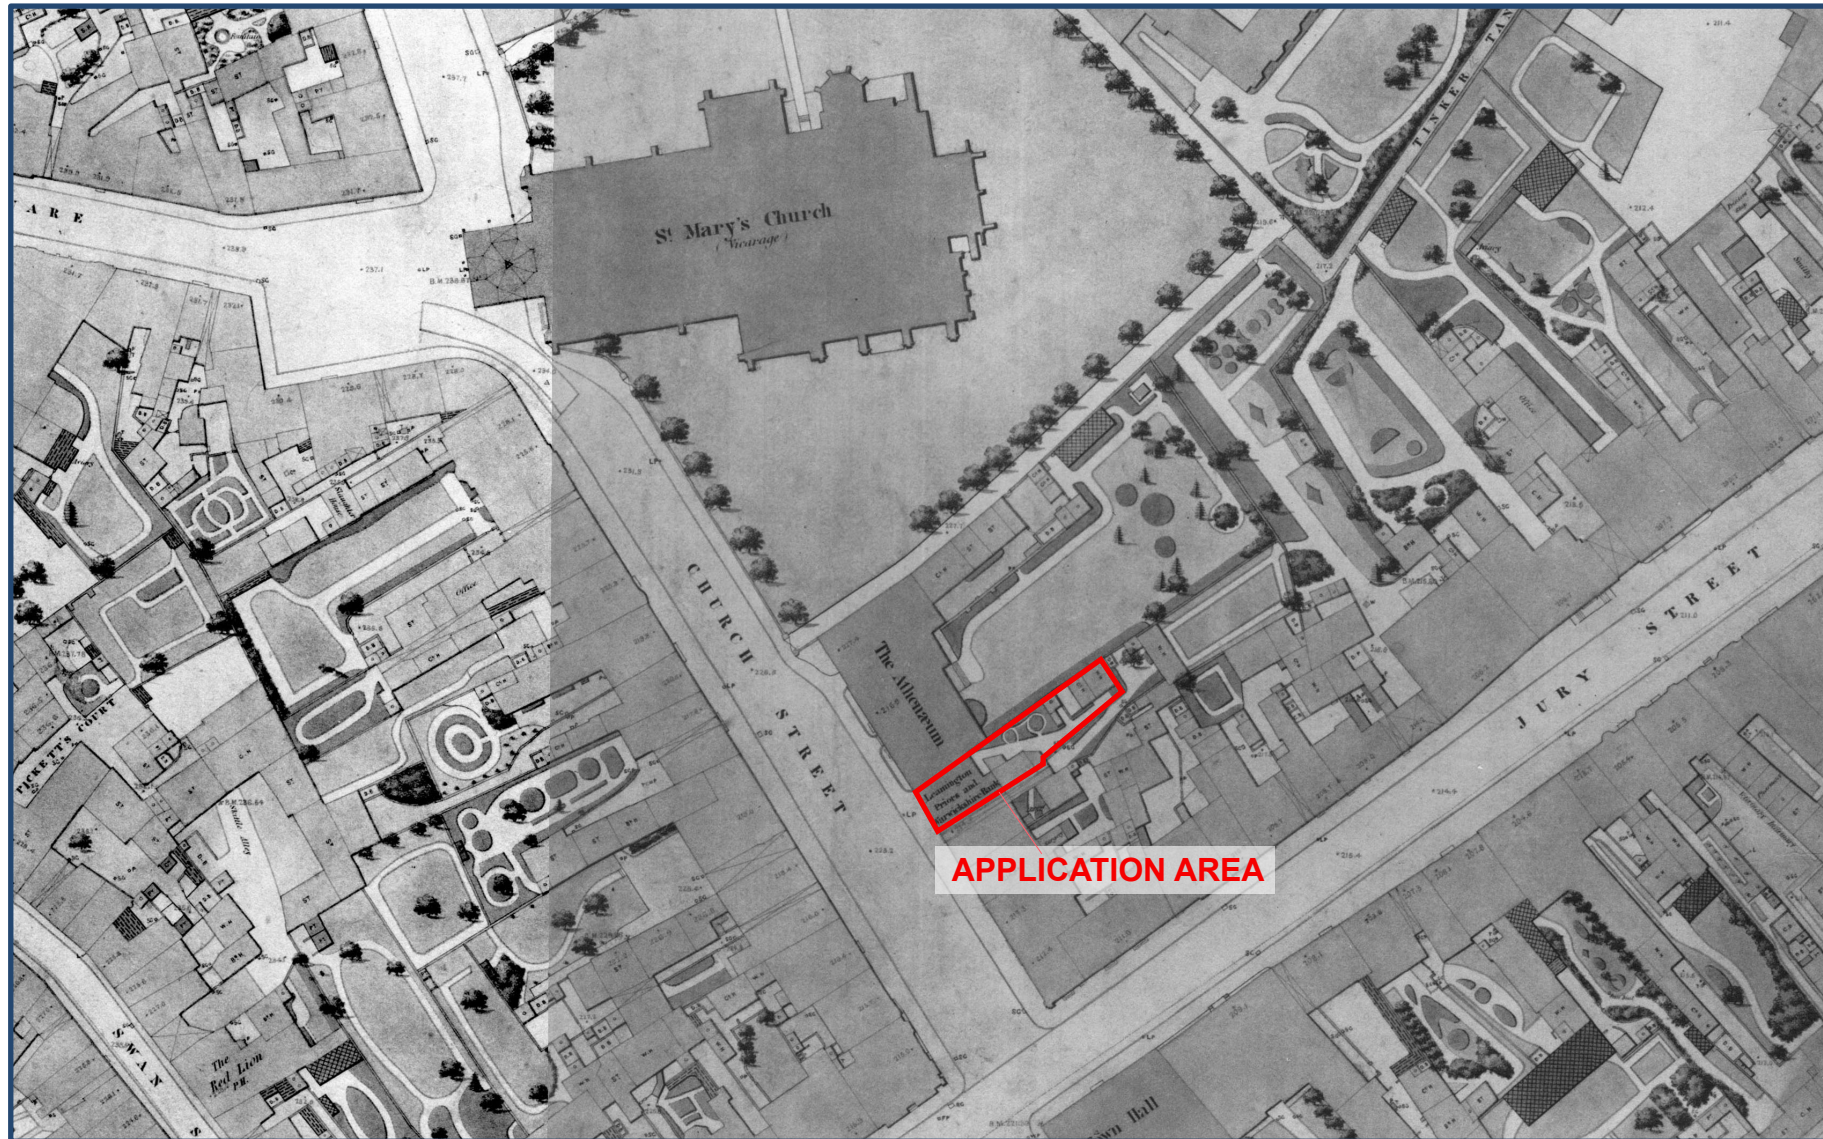
- 3.12 A Board of Heath map of 1851 records the building fronting onto Church Street as comprising the 'Leamington Priors and Warwickshire Bank' (Fig 3). The building immediately to the north is recorded as The Athenaeum (NHLE 1364798) and is also Grade II Listed. The First Edition 1:500 map of Warwick of 1889 also records the building as a bank but it is no longer marked as such on the 1905 Ordnance Survey map of 1905.

Fig 3: Detail from Board of Health map of Warwick 1851
