WELLS CATHEDRAL

Excavations and structural studies, 1978–93

*Excavations and Structural Studies,
1978–93*

ARCHAEOLOGICAL REPORT 21

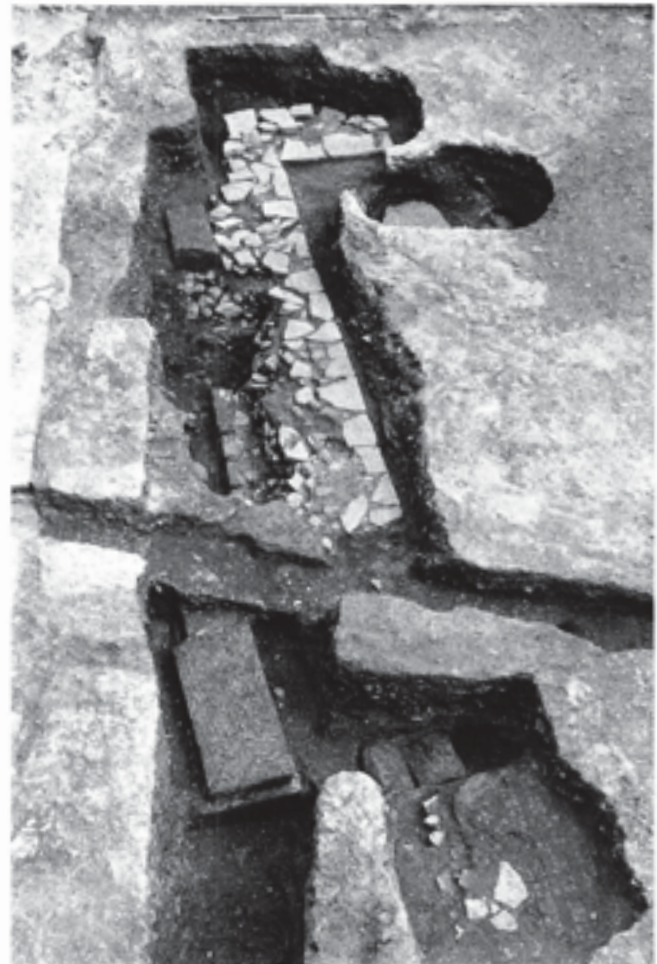
Fig. 14 Detail of re-excavated Victorian trenches which exposed the north wall of the nave of the Lady Chapel-by-the-Cloister (Structure 11), and a fragment of medieval tile paving (bottom right). View east, 1979. Scale of 2 m

slit trenches are certainly assignable to the activities of 1851 and 1873: amongst these are F139, F348, F397, F990 and F991, which picked up skewed wall alignments associated with the pre-Stillington Lady Chapel (Fig. 14). Inaccurate plotting and liberal interpretation of these scant remains gave rise to the conjectured plan of an octagonal building, which the larger scale excavations of 1894 demonstrated to be wholly spurious. For the most part, the early trenches that located portions of Stillington's nave must have been engulfed by the extensive works of 1894, but F137, F347 and F1193 are separately identifiable.

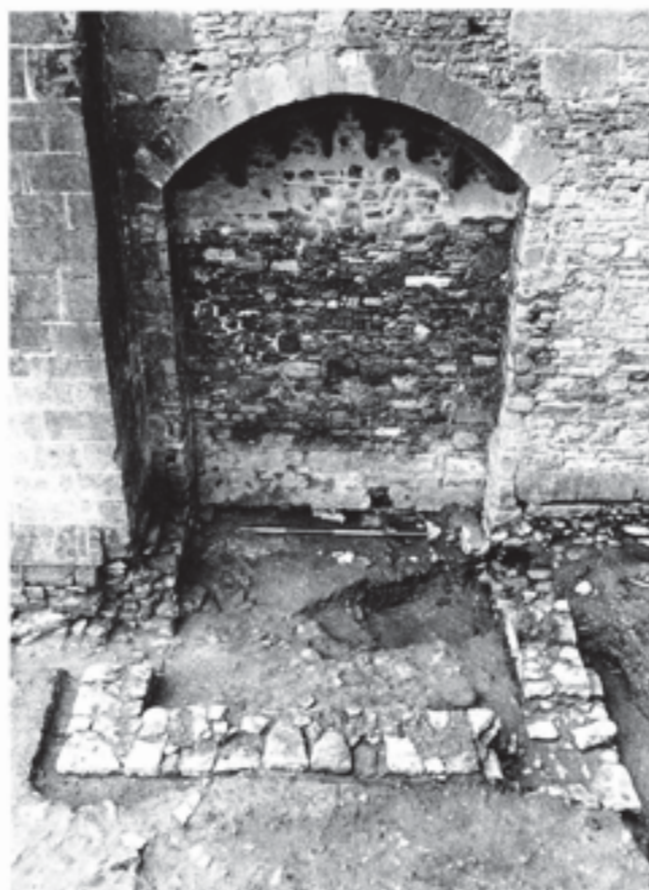
Fig. 15 Re-excavation of foundations exposed by trenching in 1894 of a small building (Structure 18) adjoining the east cloister; this was identified at the time as an 'office', but is probably the chapel of the Holy Cross-by-the-Cloister. Scale of 2 m

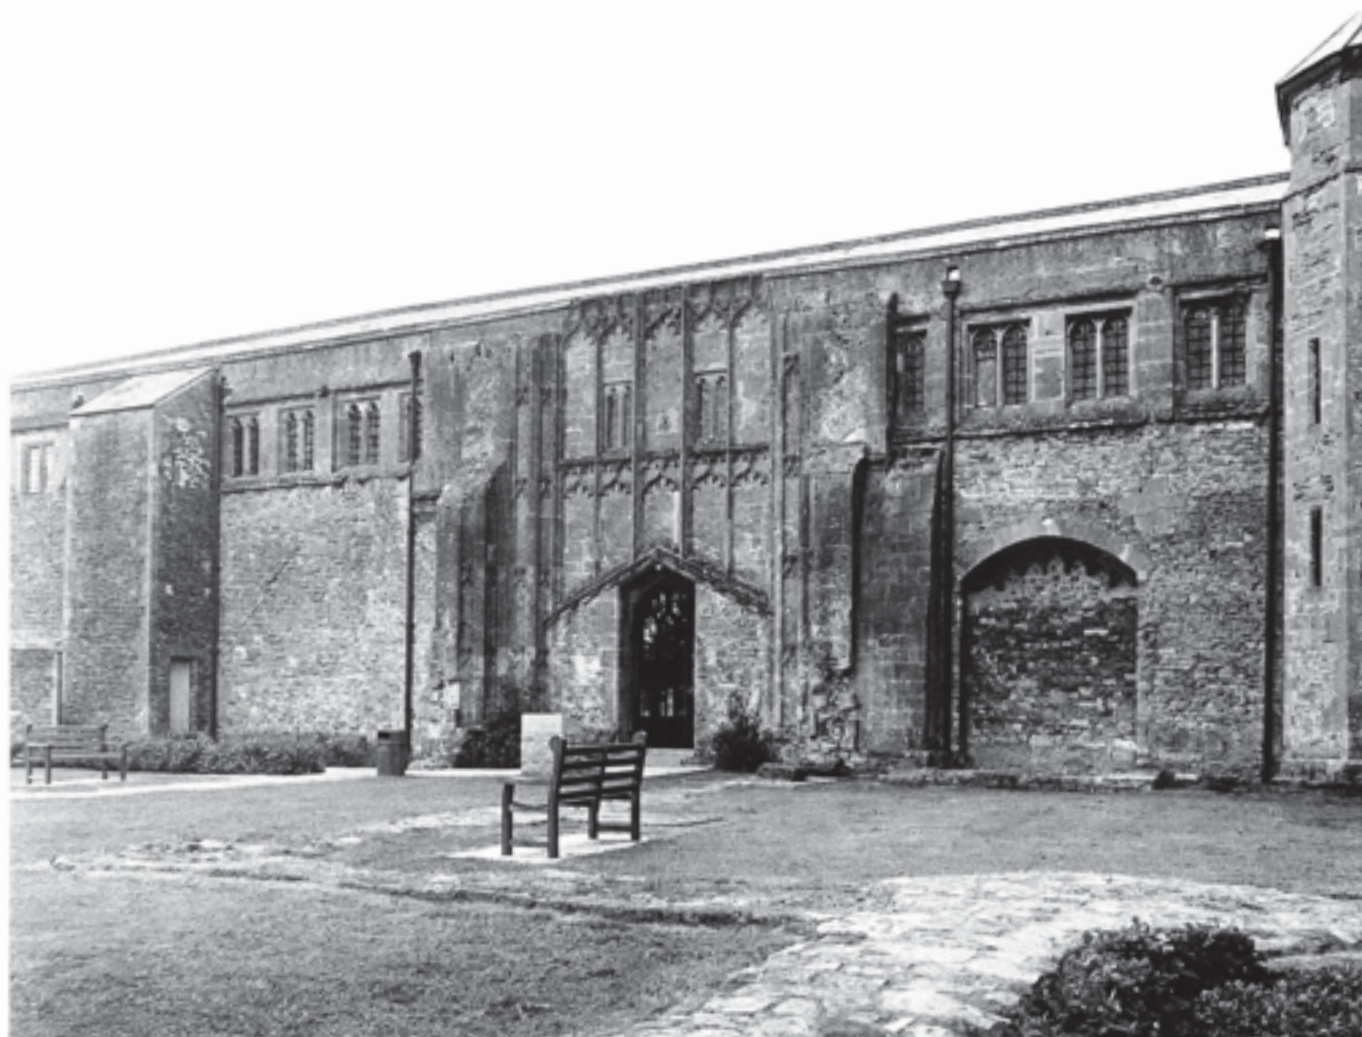
Fig. 20 The east cloister wall in 1982. The landscaped foundations of Bishop Stillington's Lady Chapel are seen in the foreground; and of the Holy Cross chapel in front of the segmental arch (right) (George H. Hall)

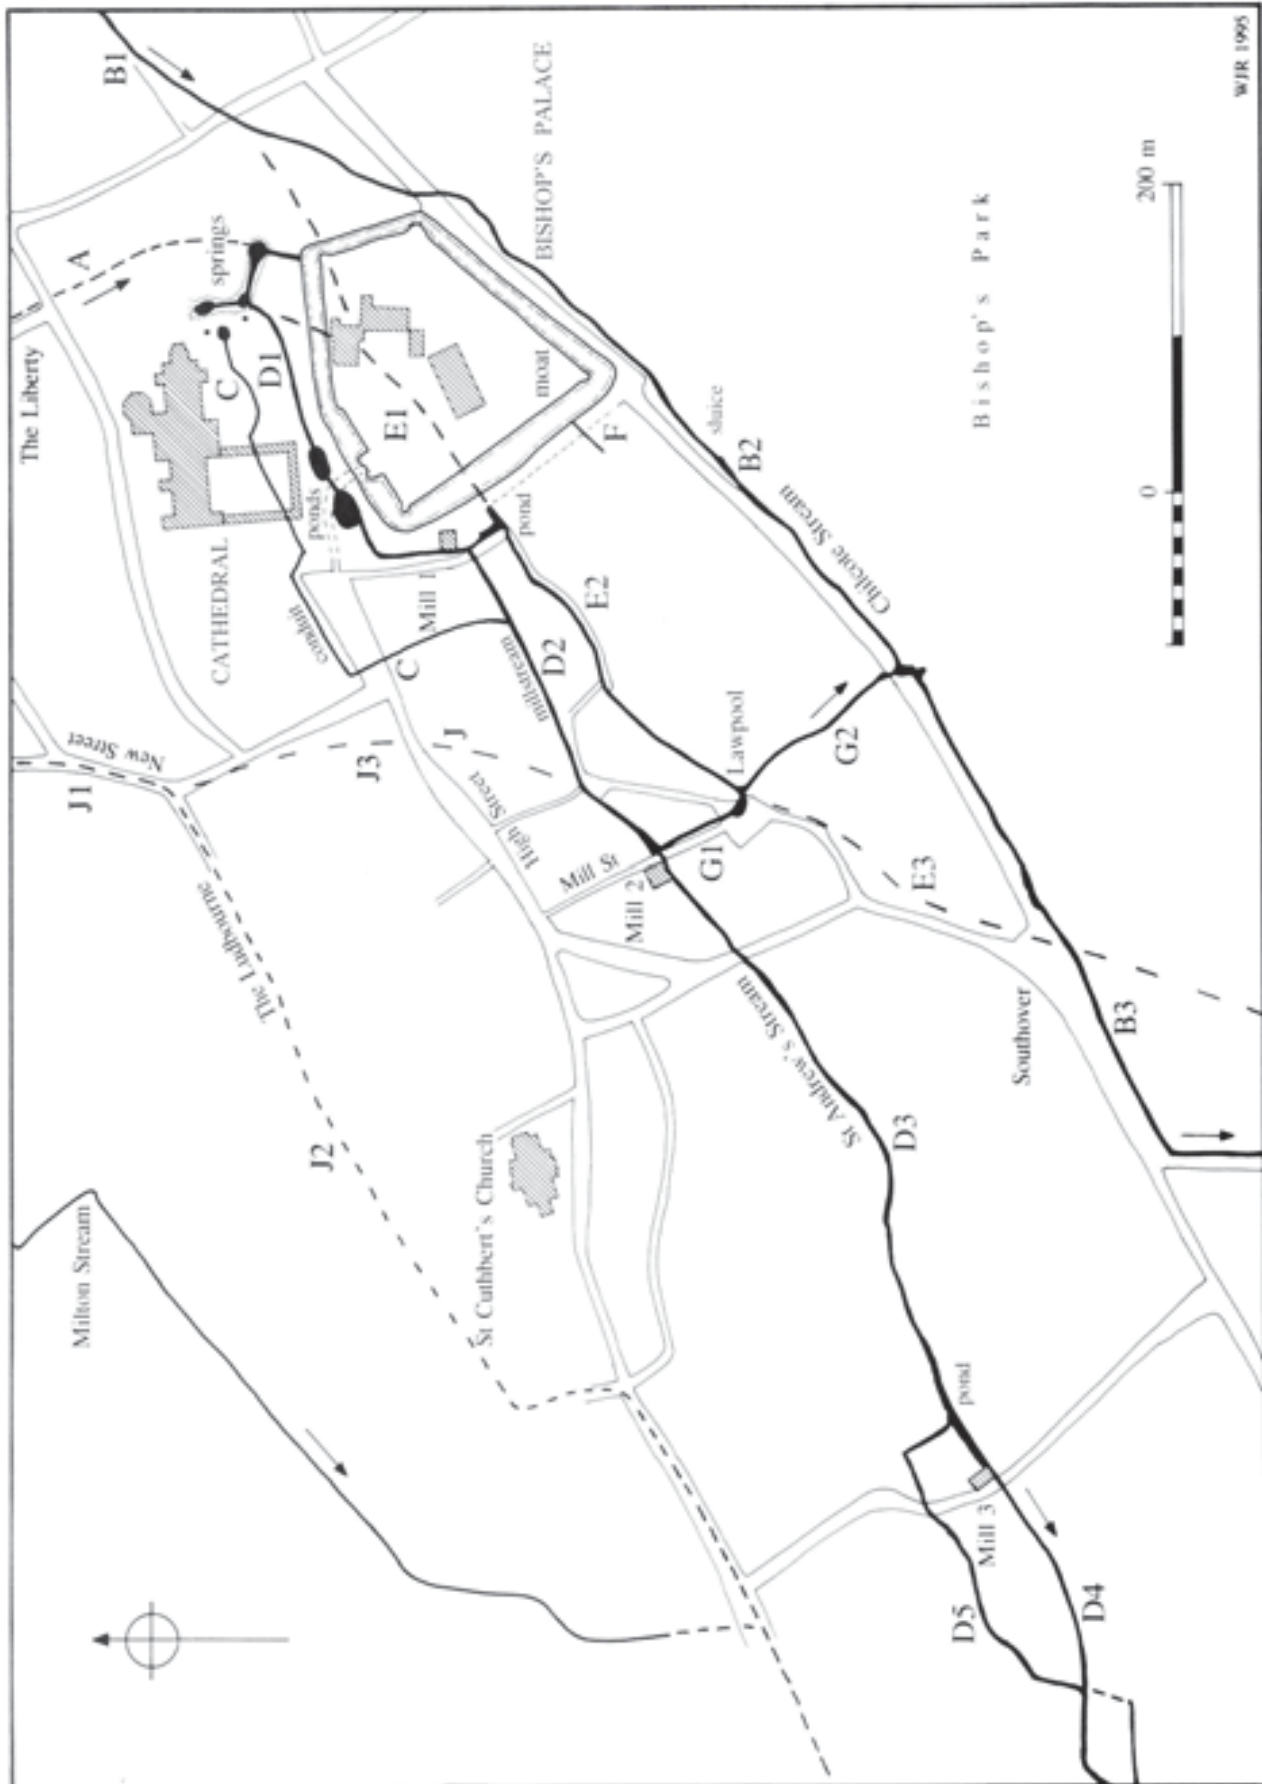
Fig. 23 Plan showing the principal watercourses flowing through Wells. Scale 1:5000

The principal watercourses entering and leaving the cathedral precinct are illustrated in Figure 23 where, for ease of description, they are lettered. Suffix numbers have been added, to distinguish the various sections of each watercourse.

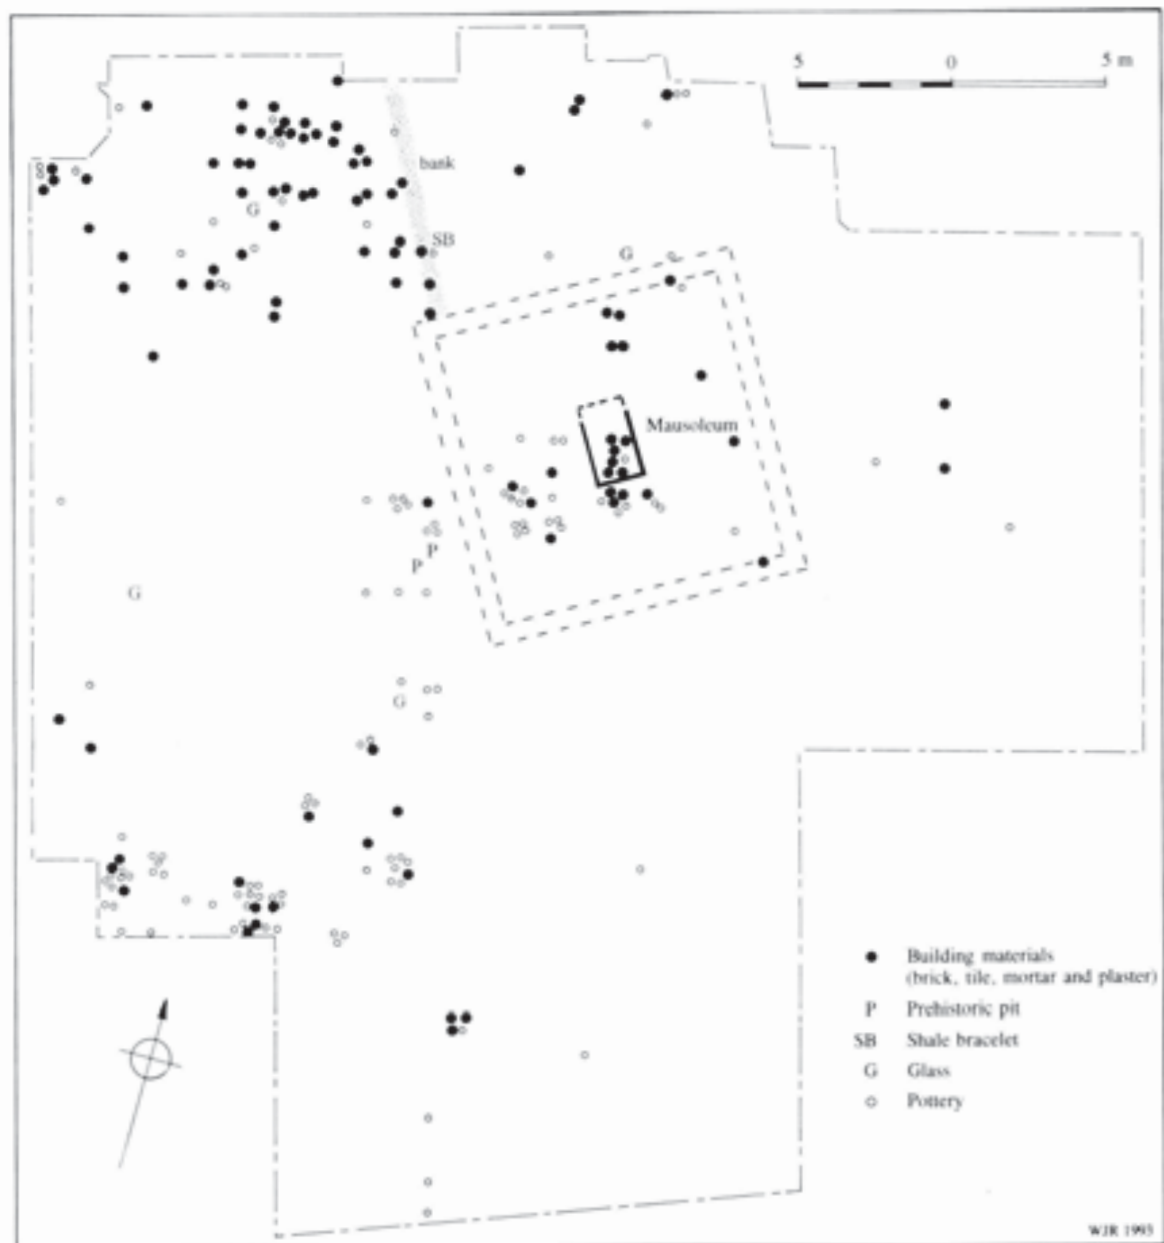
Fig. 28 Distribution of Romano-British artefacts throughout the excavated site. Solid circles represent building materials (brick, tile, mortar and plaster); open circles represent pottery. Scale 1:250

It may also be noted that a few sherds of Roman pottery were recovered from the small excavation close to St Andrew's Well (Area 8, which is not included in Figure 28).

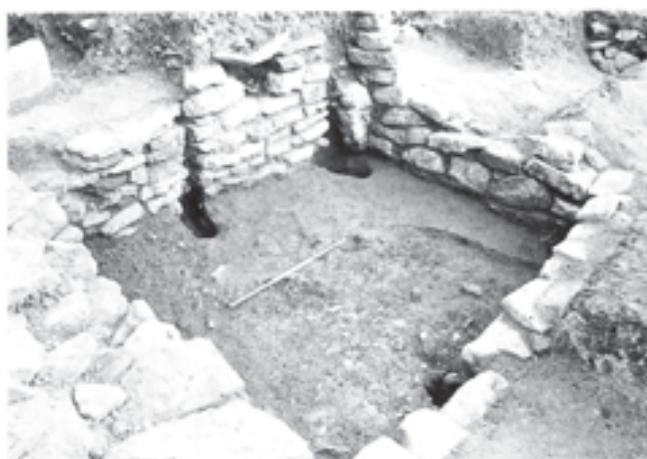
Fig. 30 General view of the mausoleum burial chamber (F1480) from the north-west after excavation. The material differences in the floor are geological. Scale of 75 cm

The structure comprised the remains of a rectangular stone-lined chamber, sunk into the natural gravel (Figs. 30 and 31). The chamber measured *c.* 1.6 m wide internally and was of uncertain length, but it exceeded 2.1 m. It was incomplete owing to the destruction of the northern end by the foundations of the thirteenth-century chancel of the Lady Chapel-by-the-Cloister (Structure 11; F1327).

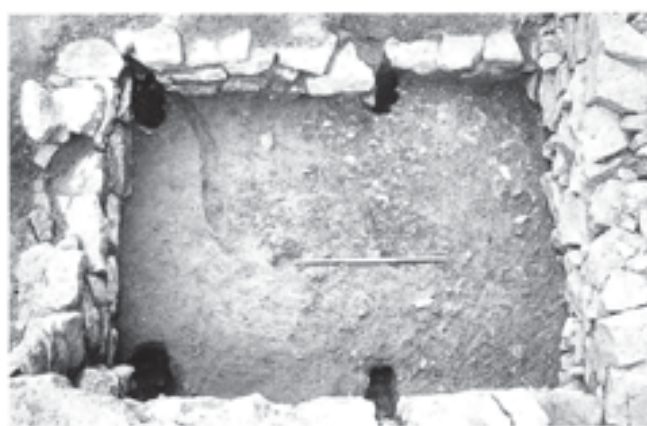
Fig. 31 Overhead view of the fully excavated burial chamber of the mausoleum. North is to the right; the masonry at that end belongs to the medieval Lady Chapel-by-the-Cloister. Scale of 75 cm

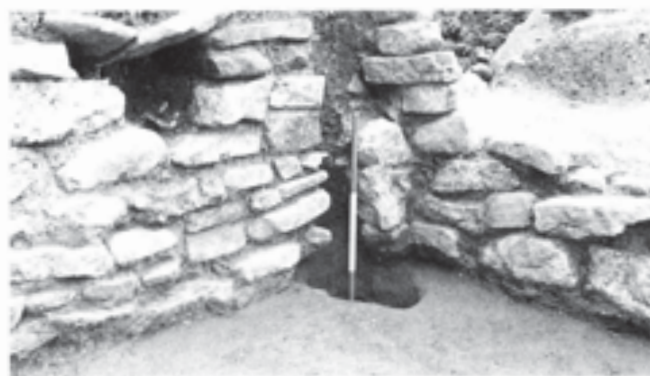
Fig. 33 The south-east corner of the burial chamber, showing the elongated post-pit (F1500) which extends beneath the wall. Scale of 75 cm

pit was flat and lay *c.* 65 cm below the surface of the bedrock, and at least 95 cm below the contemporary ground level. Postholes F1501 and F1500 were dug in the south-west and south-east corners of the pit to a depth of 15 cm and 20 cm, respectively, below the floor. A more-or-less opposed pair of postholes was also dug part-way along the east and west sides, both penetrating the floor to a depth of 18 cm (F1499 and F1502). It is likely that two further postholes, at the north-east and north-west corners of the pit, have been lost. The interval between the extant postholes on the long sides was 1.2 m and, if regular spacing was adopted, the internal length of the structure would have been *c.* 2.4–2.5 m. That is on the assumption that it was two bays in length: it is unlikely to have been of three bays or more, since the masonry would have re-emerged — and thereby been discovered — beyond the north side of the medieval wall.

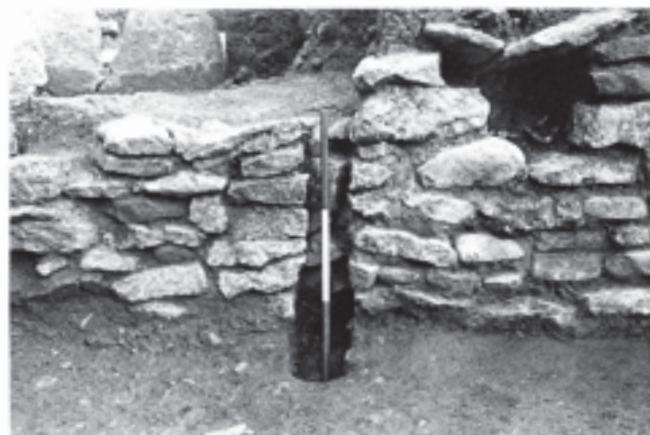
Fig. 34 The east side of the burial chamber, showing post-hole F1499 and the channel in the masonry above it. The slabbed void to the upper right is a medieval cist-burial

The east wall survived to a maximum height of 80 cm above the floor of the pit, the south wall stood to 50 cm, and the west wall averaged 30 cm. The walls were all truncated by later Saxon and medieval features. The posts appear to have rotted *in situ*, and traces of the post-pipes remained, filled with dark sandy soil. The pit itself was backfilled in the later Saxon period with clay and gravel, interleaved with charnel deposits, all overlying the thin layer of brown sandy soil, F1498. Layers above F1498 belonged to a period after the timber posts had decayed; they are discussed on pp. 75–8.

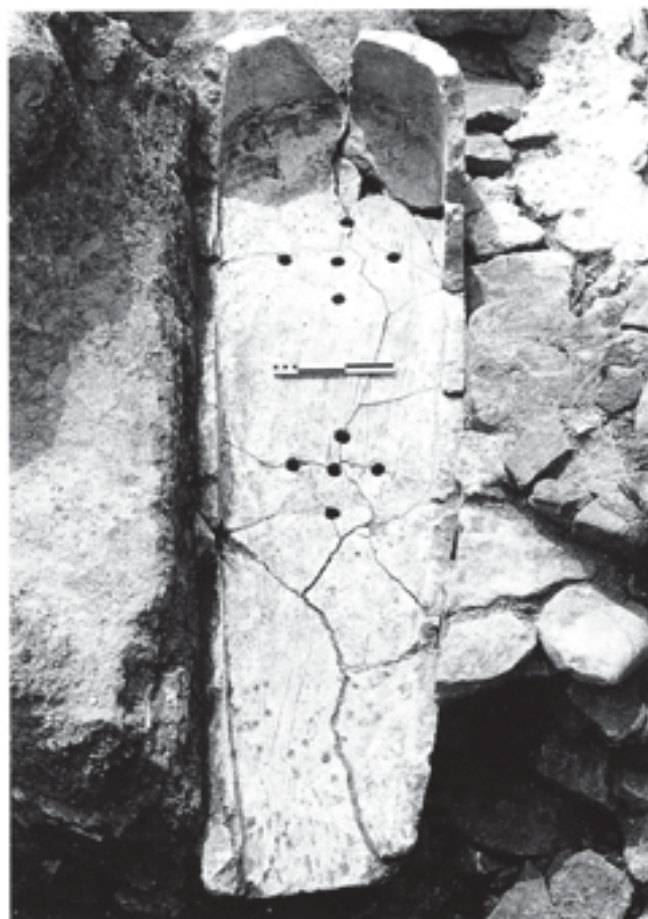
Fig. 37 Roman stone coffin (F1294), modified in the Middle Ages, and reused in the Lady Chapel-by-the-Cloister (cf. Fig. 69). Scale of 25 cm

The broken remains of a coffin cut from a single block of oolitic limestone — apparently Bath stone — were found in the chancel of the Lady Chapel-by-the-Cloister (Fig. 145). The coffin contained a collection of disarticulated skeletal remains, and had evidently been disturbed and put to use as an ossuary when the foundations were dug for Stillington's chapel, in 1477. Prior to that, it must be presumed that the coffin,

which was set hard against the north wall of the Lady Chapel, had previously contained a burial of the thirteenth century, or slightly later. However, the form of the coffin is unlike any of the undoubted medieval examples from Wells.

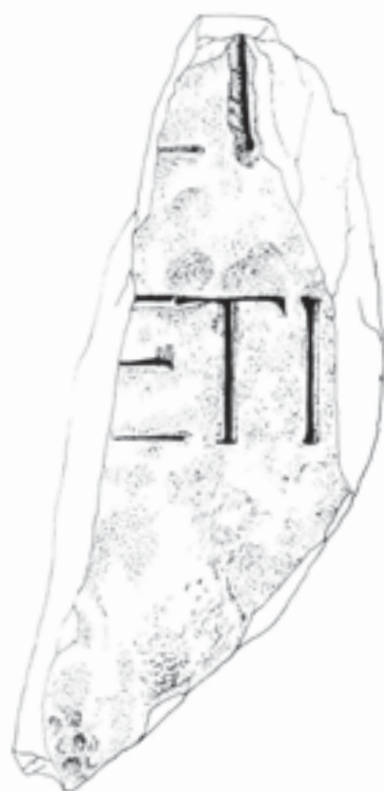
Fig. 39 Fragment of late Roman or Anglo-Saxon inscription cut on Douling Stone. Scale 1:2

Parts of two letters remain in the upper line, but the identification of neither can be absolutely certain: **LI** seems most likely, although Dr Elisabeth Okasha suggests that 'the first lost letter could be L or E or C,²³ followed by I or P or R' (Okasha 1993, 58–9). The lower line contains three letters, the reading of which seems to be **JETI**.²⁴

The letters are 38 mm high and the cut is V-shaped in section. The style is basically Roman, the lower-line 'I' having slight serifs, while the 'T' has one clearly defined serif. It would appear that the top bars of the 'E' and 'T' have been run together. The quality of the lettering is too poor for this to be considered a classical Roman inscription, and it is more immediately

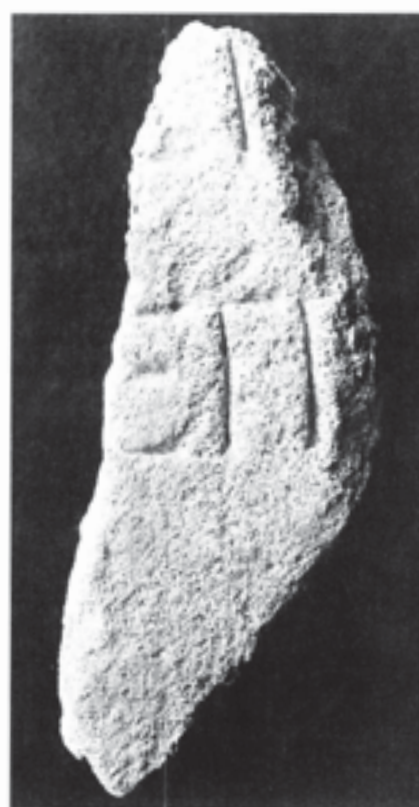
Fig. 40 Inscribed Douling stone fragment. Scale 1:2

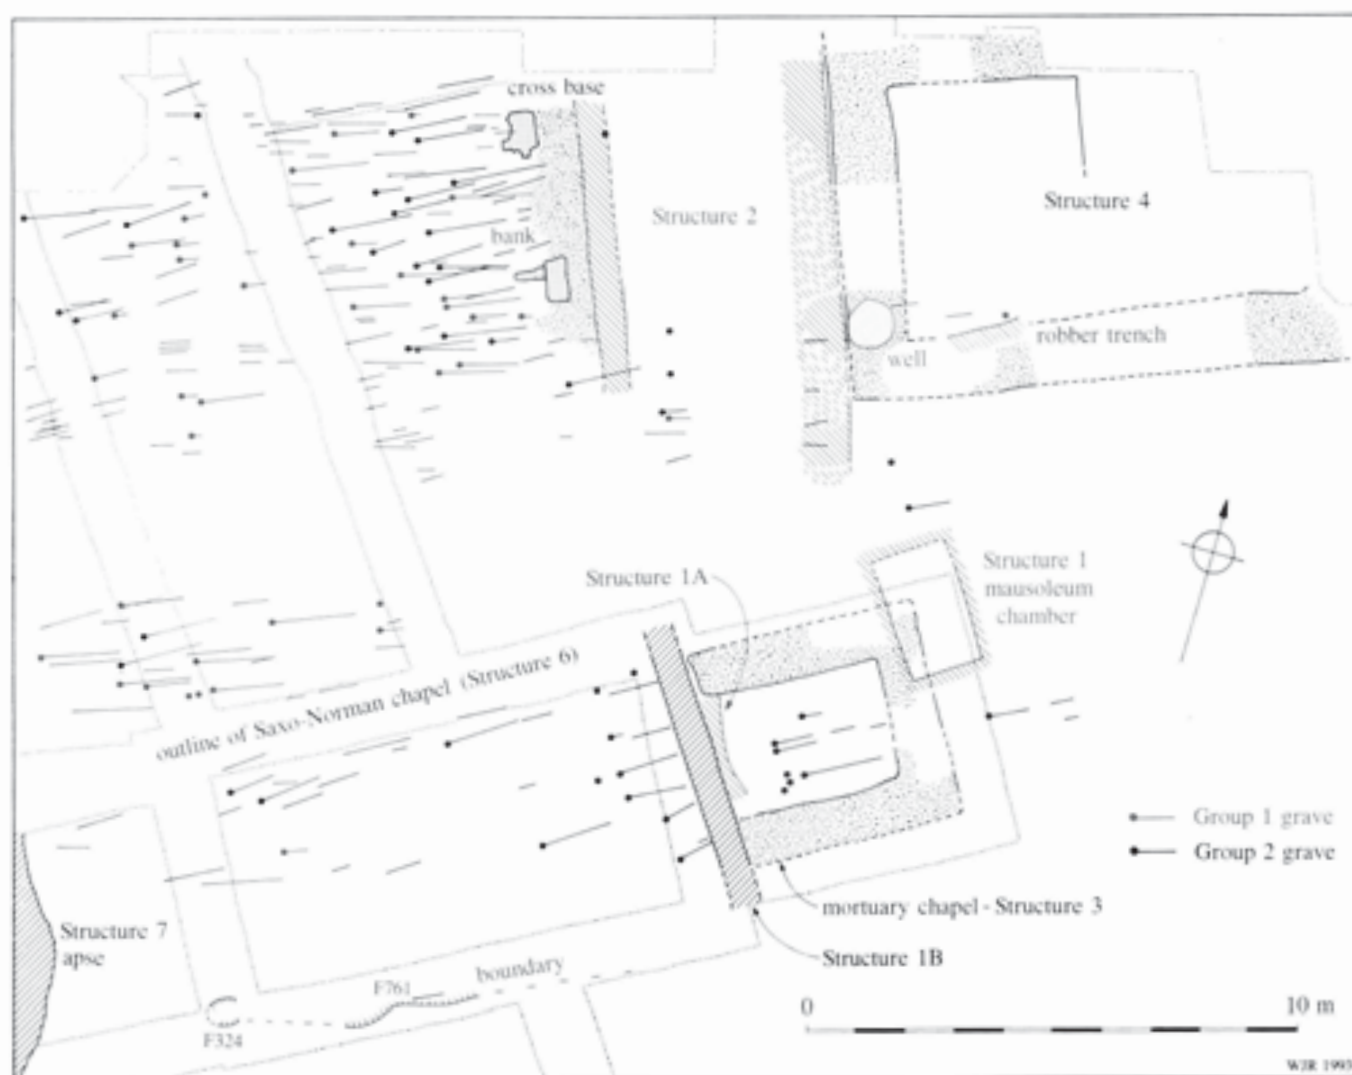
Fig. 42 Composite plan of all Anglo-Saxon and earlier structures and graves in Areas 5–10, differentiating the two major alignments. Early structures and group 1 graves are shown in red; later Saxon structures and group 2 graves are in black. Foundation trenches of the Saxo-Norman buildings are indicated by a dotted outline

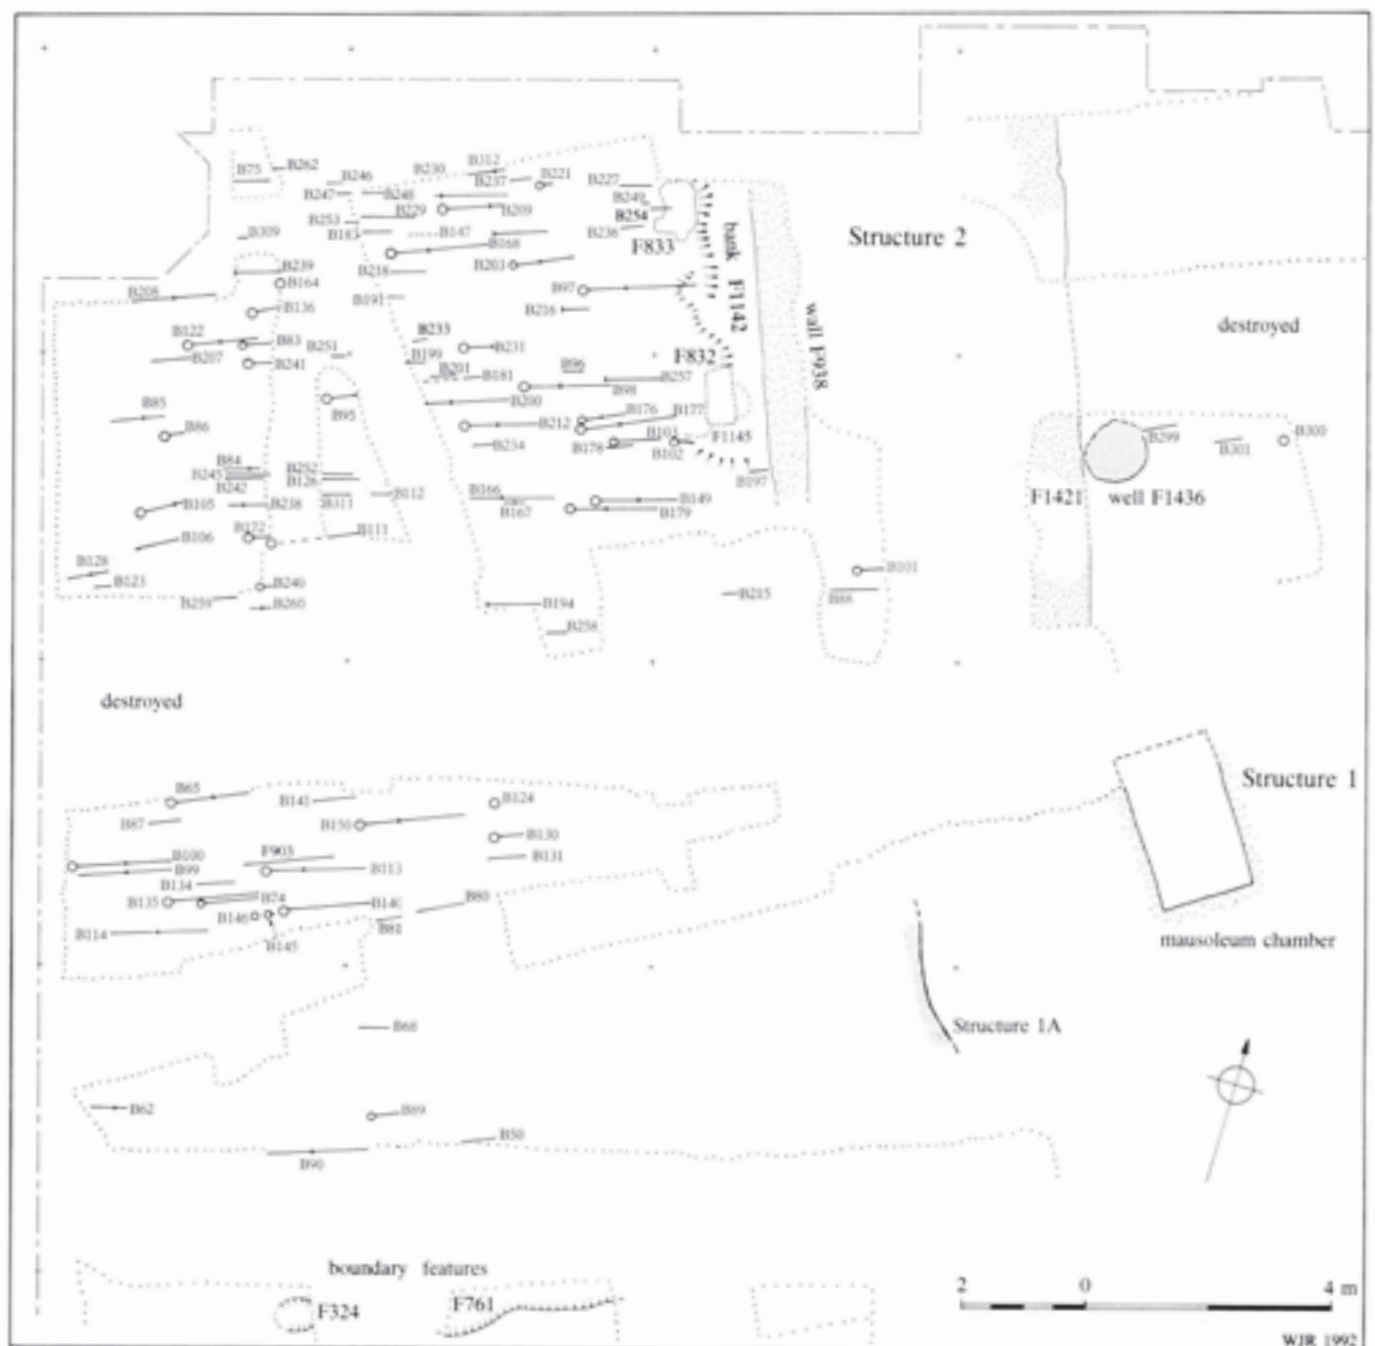
Fig. 44 Simplified plan of the Anglo-Saxon cemetery, showing burials of group 1, together with structures on related alignments. Their spatial relationship to the mausoleum is also shown. Dotted lines indicate the extent of relevant surviving stratigraphy. Scale 1:125

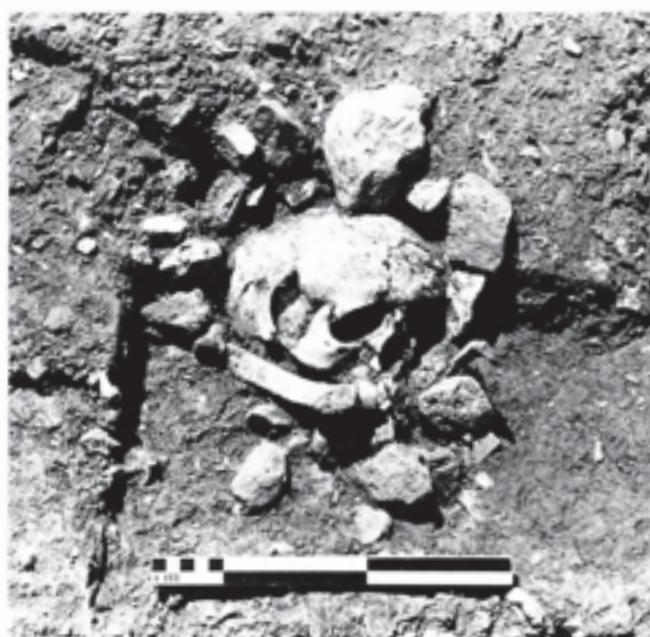
Fig. 50 Skull and femur in pit F1029, packed around with stones. Scale of 25 cm

Although *disiecta membra* were widely scattered, no significant assemblages of charnel occurred in the cemetery, and only one small deposit deserves mention. This was an adult skull and femur which had apparently been buried together in a small pit (F1029) cut into the natural subsoil. The deliberation attached to this act was emphasized by the way that small stones and a piece of Roman brick had been carefully packed round the skull (Figs. 48 and 50).

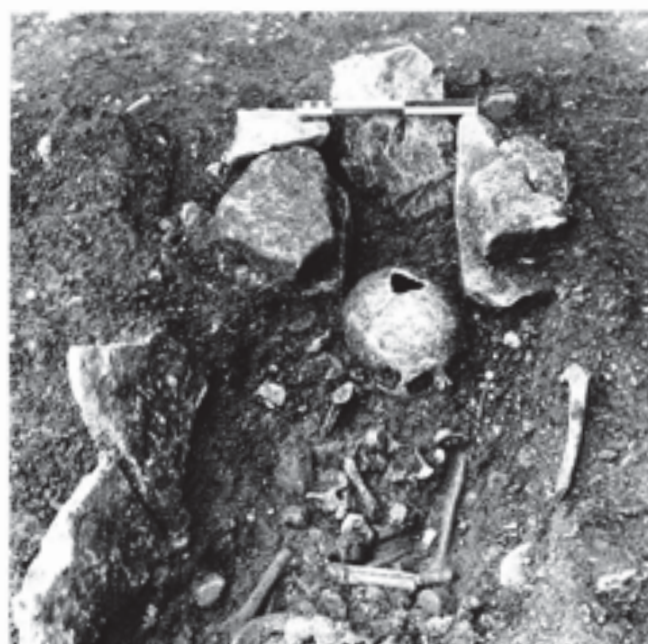
Fig. 51 Rough stone lining of the cist containing burial 212. Note the jumbled bones in the thoracic region. Scale of 25 cm

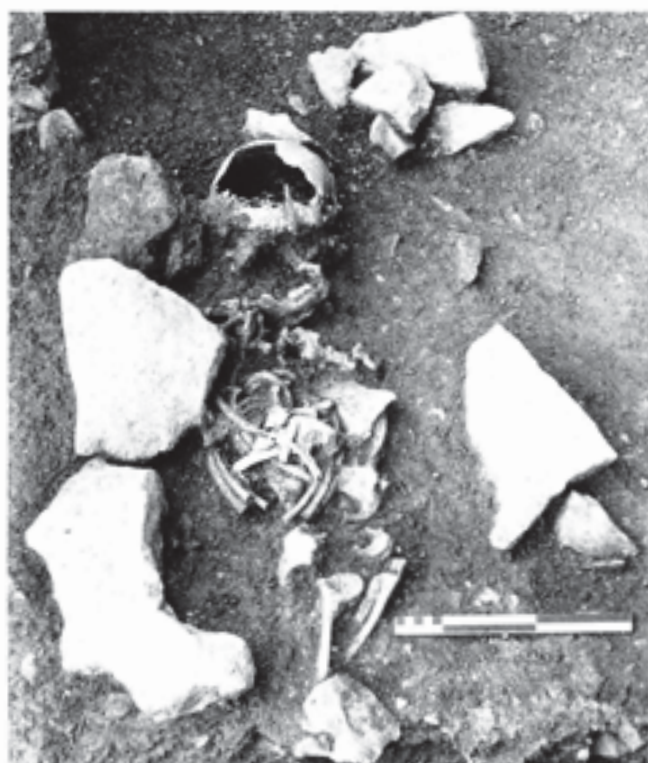
Fig. 52 Child burial 83, with a crude rubble edging to the grave. Scale of 25 cm

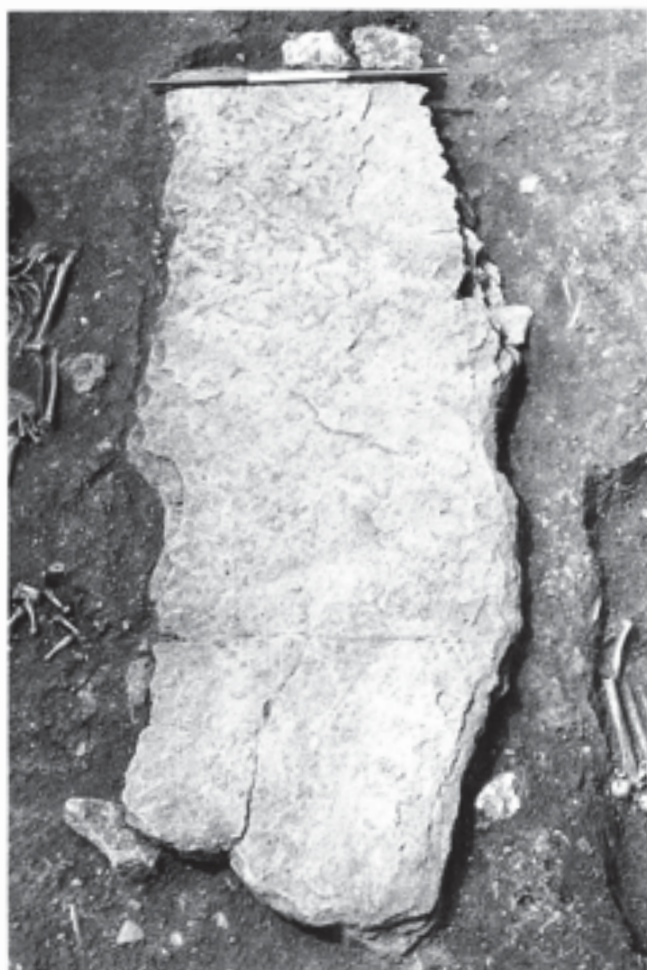
Fig. 54 Burial 152, with the cover-slab in place. Vieto test. Scale of 75 cm

Burial 152 (Figs. 53–57)

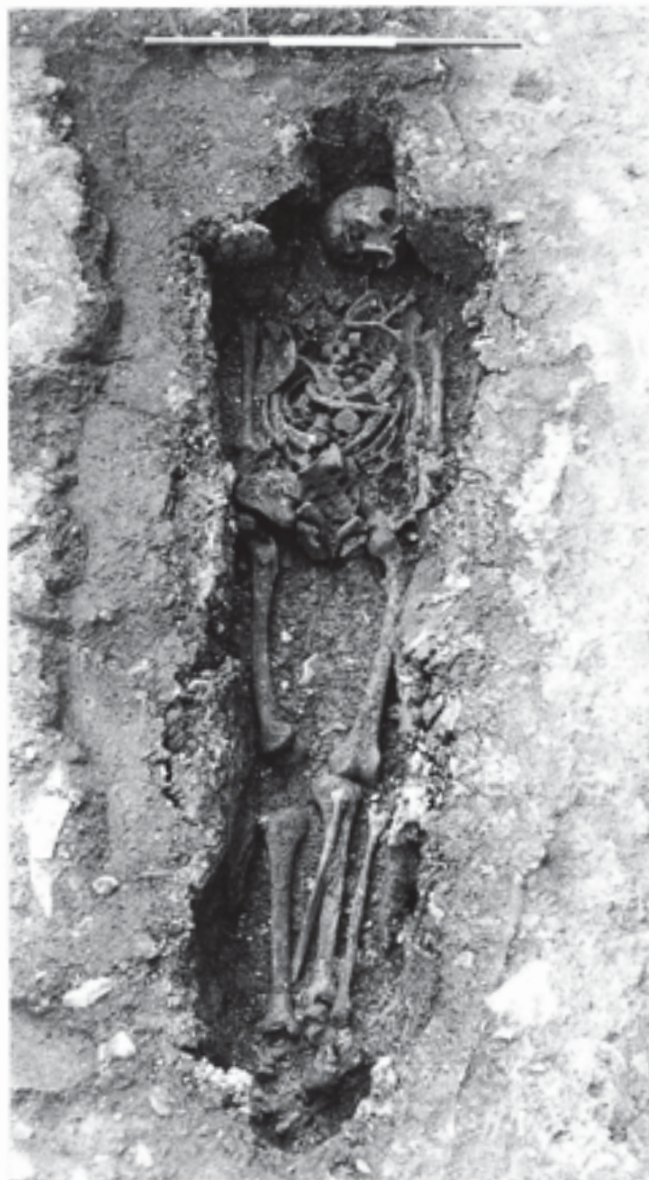
Fig. 55 Burial 152, after the removal of the cover-slab, revealing an earth-cut cist with a plaster lining. Scale of 75 cm

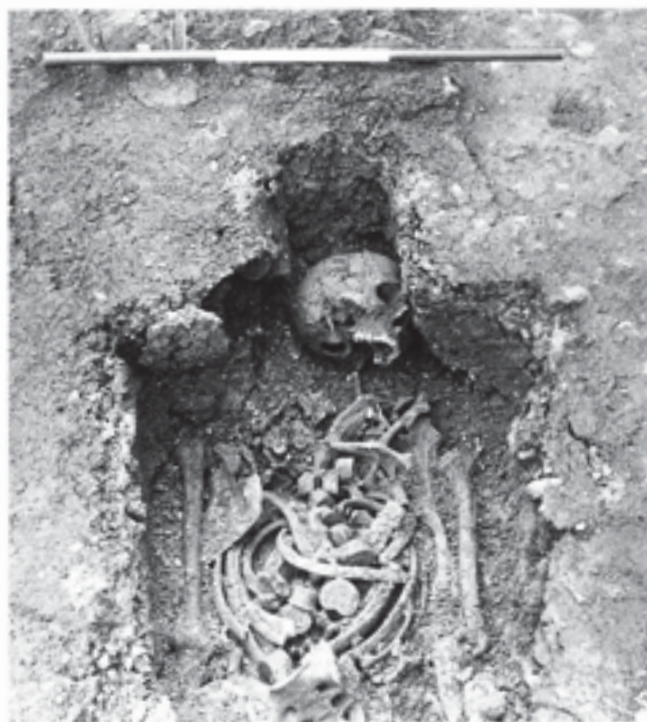
Fig. 56 Burial 152. Detail of the plaster-lined head-recess and jumbled vertebrae. Scale of 75 cm

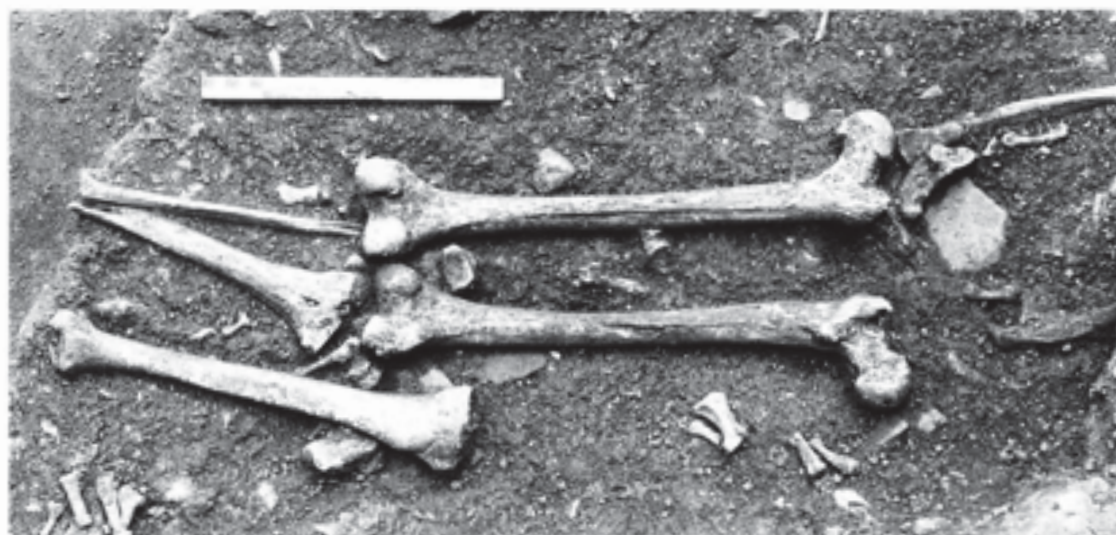
Fig. 61 Burial 169, showing rotation of the femora through 180°, and substantial displacement and partial rotation of the tibiae. Scale of 25 cm

movement of bones, most commonly seen in the form of disarrayed ribs and vertebrae. The other notable type of movement was seen in leg bones, particularly femora. Instances where one, or both, had rotated axially through 180° (so that the femoral head pointed away from the pelvis, instead of towards it) were not uncommon. Less frequently, tibiae were found to have rotated axially.

Bone movements of this type are only possible when a corpse decays in a void, and are hence good indicators of coffins, covered cists and other chambers. Thus all the graves previously mentioned for their tell-tale evidences of coffins exhibited characteristic bone disarray. Many other occurrences were noted. Femoral rotation and tibial displacement were nowhere better demonstrated than in burial 169 (Fig. 61).⁵ This was also a fine example of differential preservation within one grave: bone survival in the limbs was excellent, while the torso had virtually dissolved. The pelvis, sacrum and lumbar vertebrae were represented only by crumbs of bone.⁶

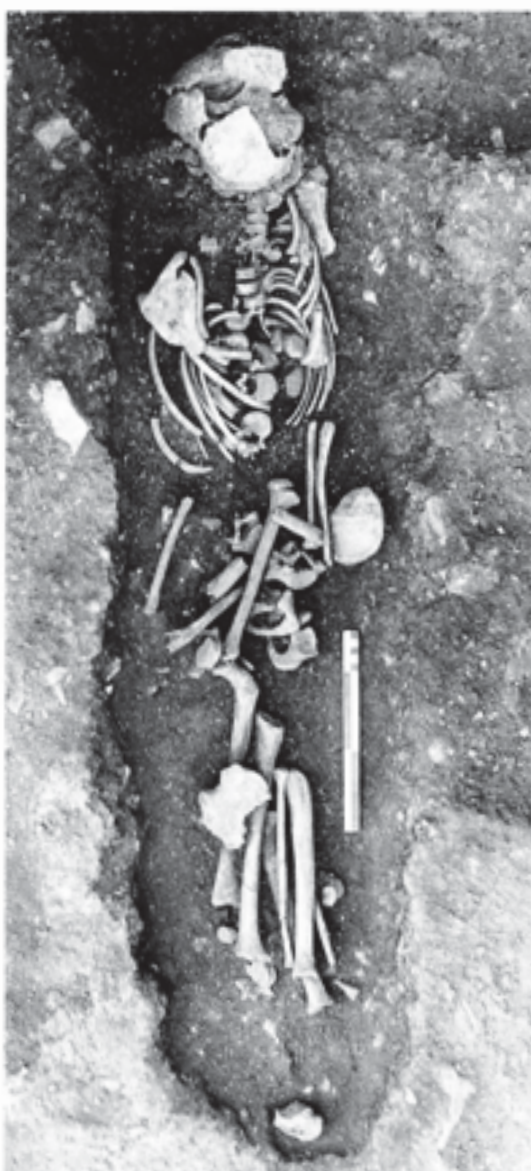
Fig. 62 Child burial 122, showing displacement of the long-bones. Scale of 25 cm

Bone movement in burial 122 largely affected the femora. The lower legs and feet were in a natural position, but both femora had moved longitudinally down the grave by a distance not far short of their own length. One of the humeri had also travelled eastwards (Fig. 62).

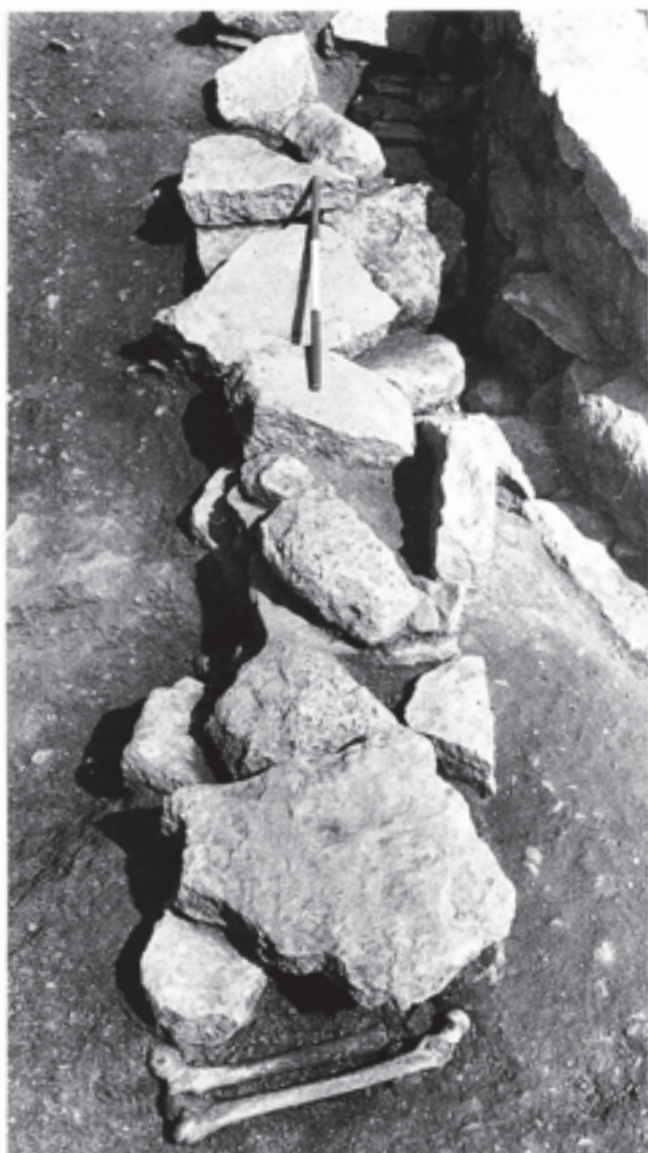
Fig. 63 Cemetery wall F938, looking north. Scale of 75 cm

The foundation trench was *c.* 1.0 m wide, and four courses of masonry survived, the first two being offset on the west face. Most of the east face had been destroyed, so that it was difficult to ascertain the true thickness of the wall, but the footing seems to have been *c.* 70 cm at the lowest level, reducing to 50 cm before reaching ground level. The wall construction was mainly of white lias blocks, but also incorporated Doultling and Chilcote limestones, and Pennant sandstone pebbles (Fig. 63). A late Saxon date for the wall seems likely.

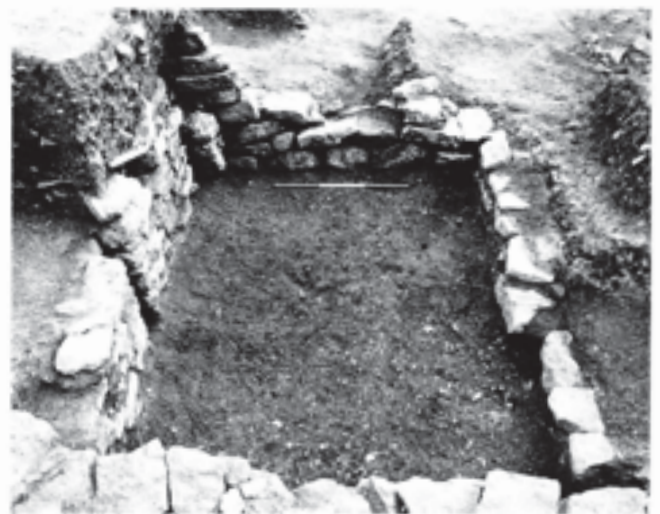
Fig. 66 View south across the interior of the mausoleum, showing the 'floor' F1498, exposed after the charnel deposits had been removed. Scale of 75 cm

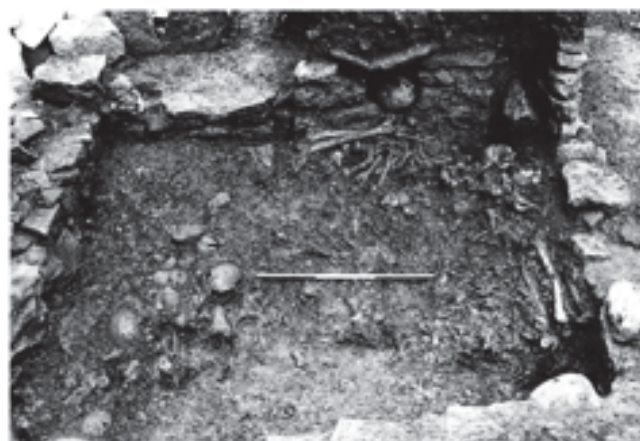
Fig. 67 View east inside the mausoleum, showing the uppermost levels of the charnel deposits. The skull beneath a slab in the far section belongs to a medieval cist-grave. Scale of 75 cm

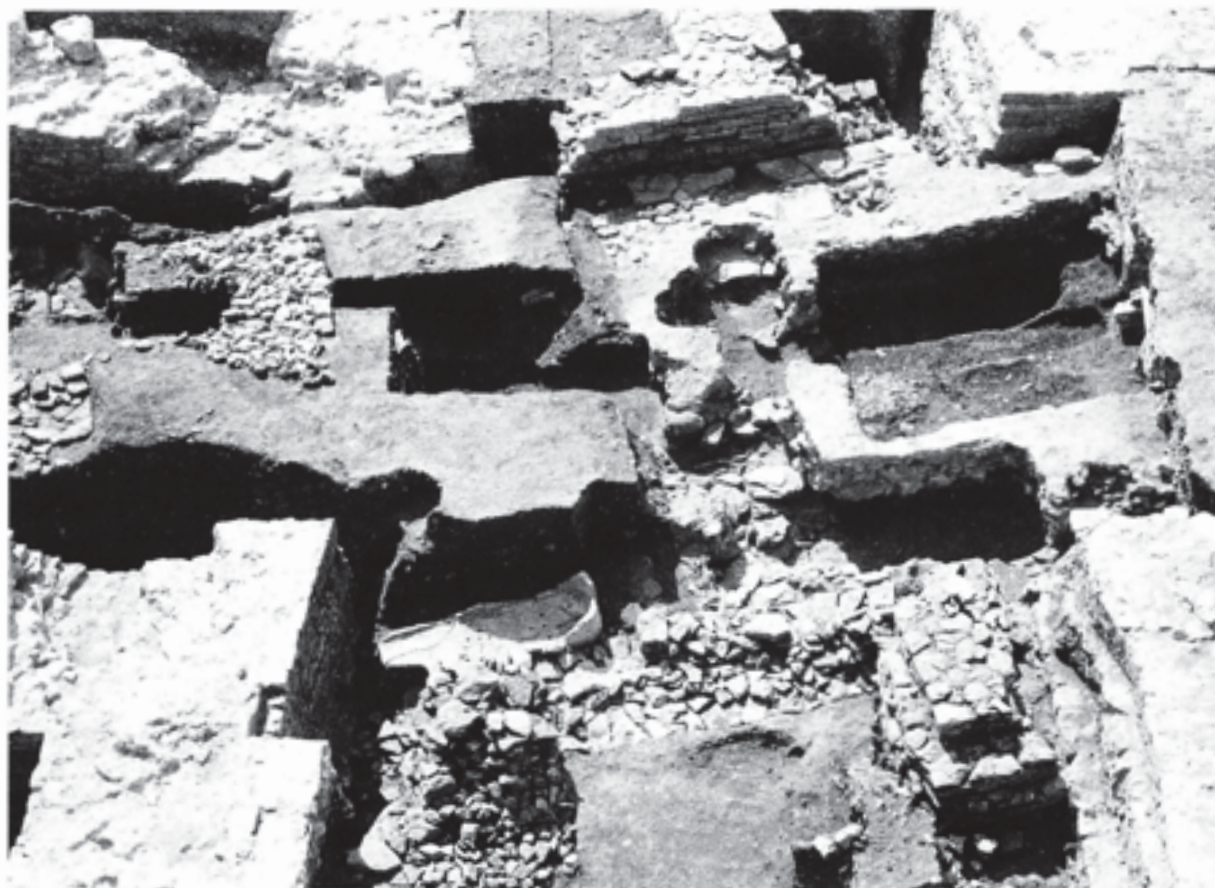
Fig. 69 General view looking south in Area 10, showing the crossing of Stillington's chapel (masonry at the four corners); the north wall of the thirteenth-century Lady Chapel and recycled Roman stone coffin (foreground); and the mortuary chapel (centre right)

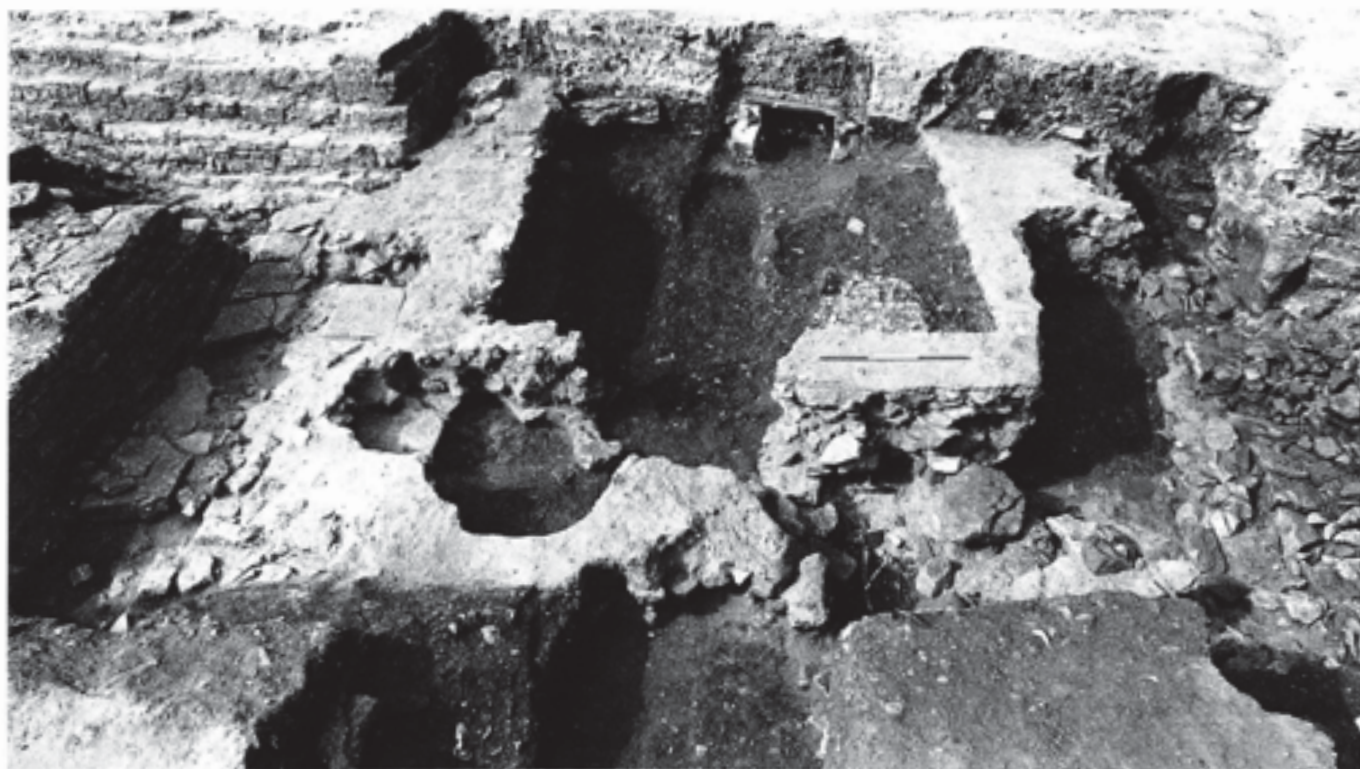
Fig. 70 Structure 3, the mortuary chapel, viewed from the east; the west wall is beyond the section. The other walls all have external thickening of Saxo-Norman date, associated with Structure 6. Scale of 75 cm
