WELLS CATHEDRAL

Excavations and structural studies, 1978–93

*Excavations and Structural Studies,
1978–93*

ARCHAEOLOGICAL REPORT 21

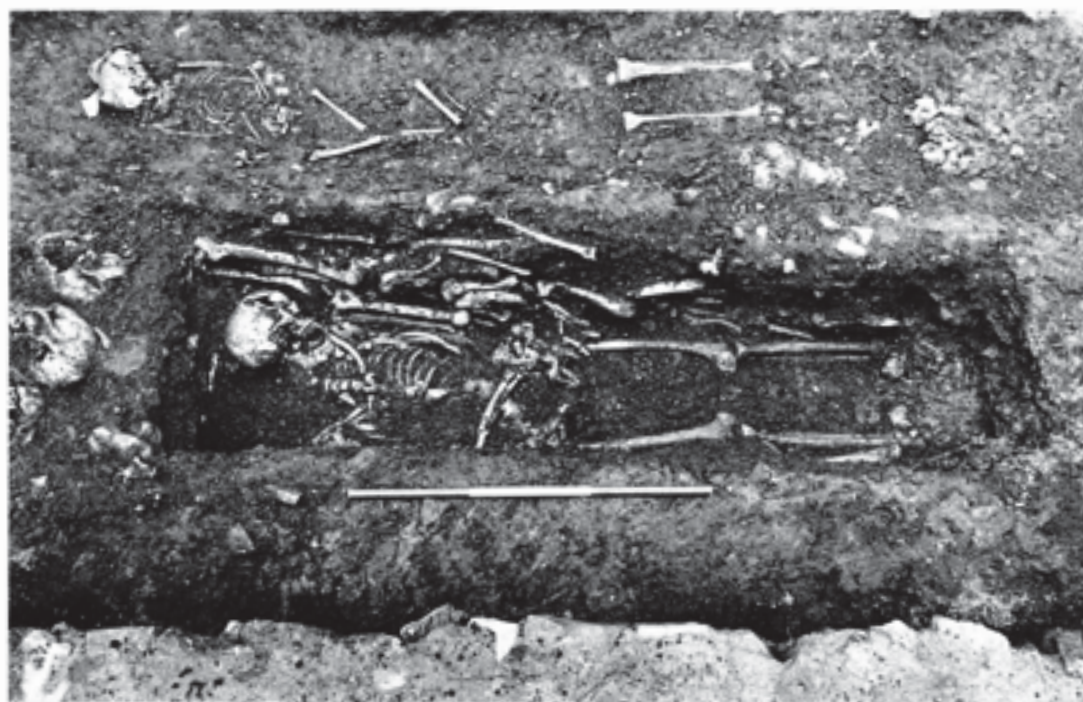
Fig. 71 Fragmentary interments inside the mortuary chapel. In the foreground is burial 293, showing also numerous disarticulated bones packed between the coffin and the side of the grave. Scale of 75 cm

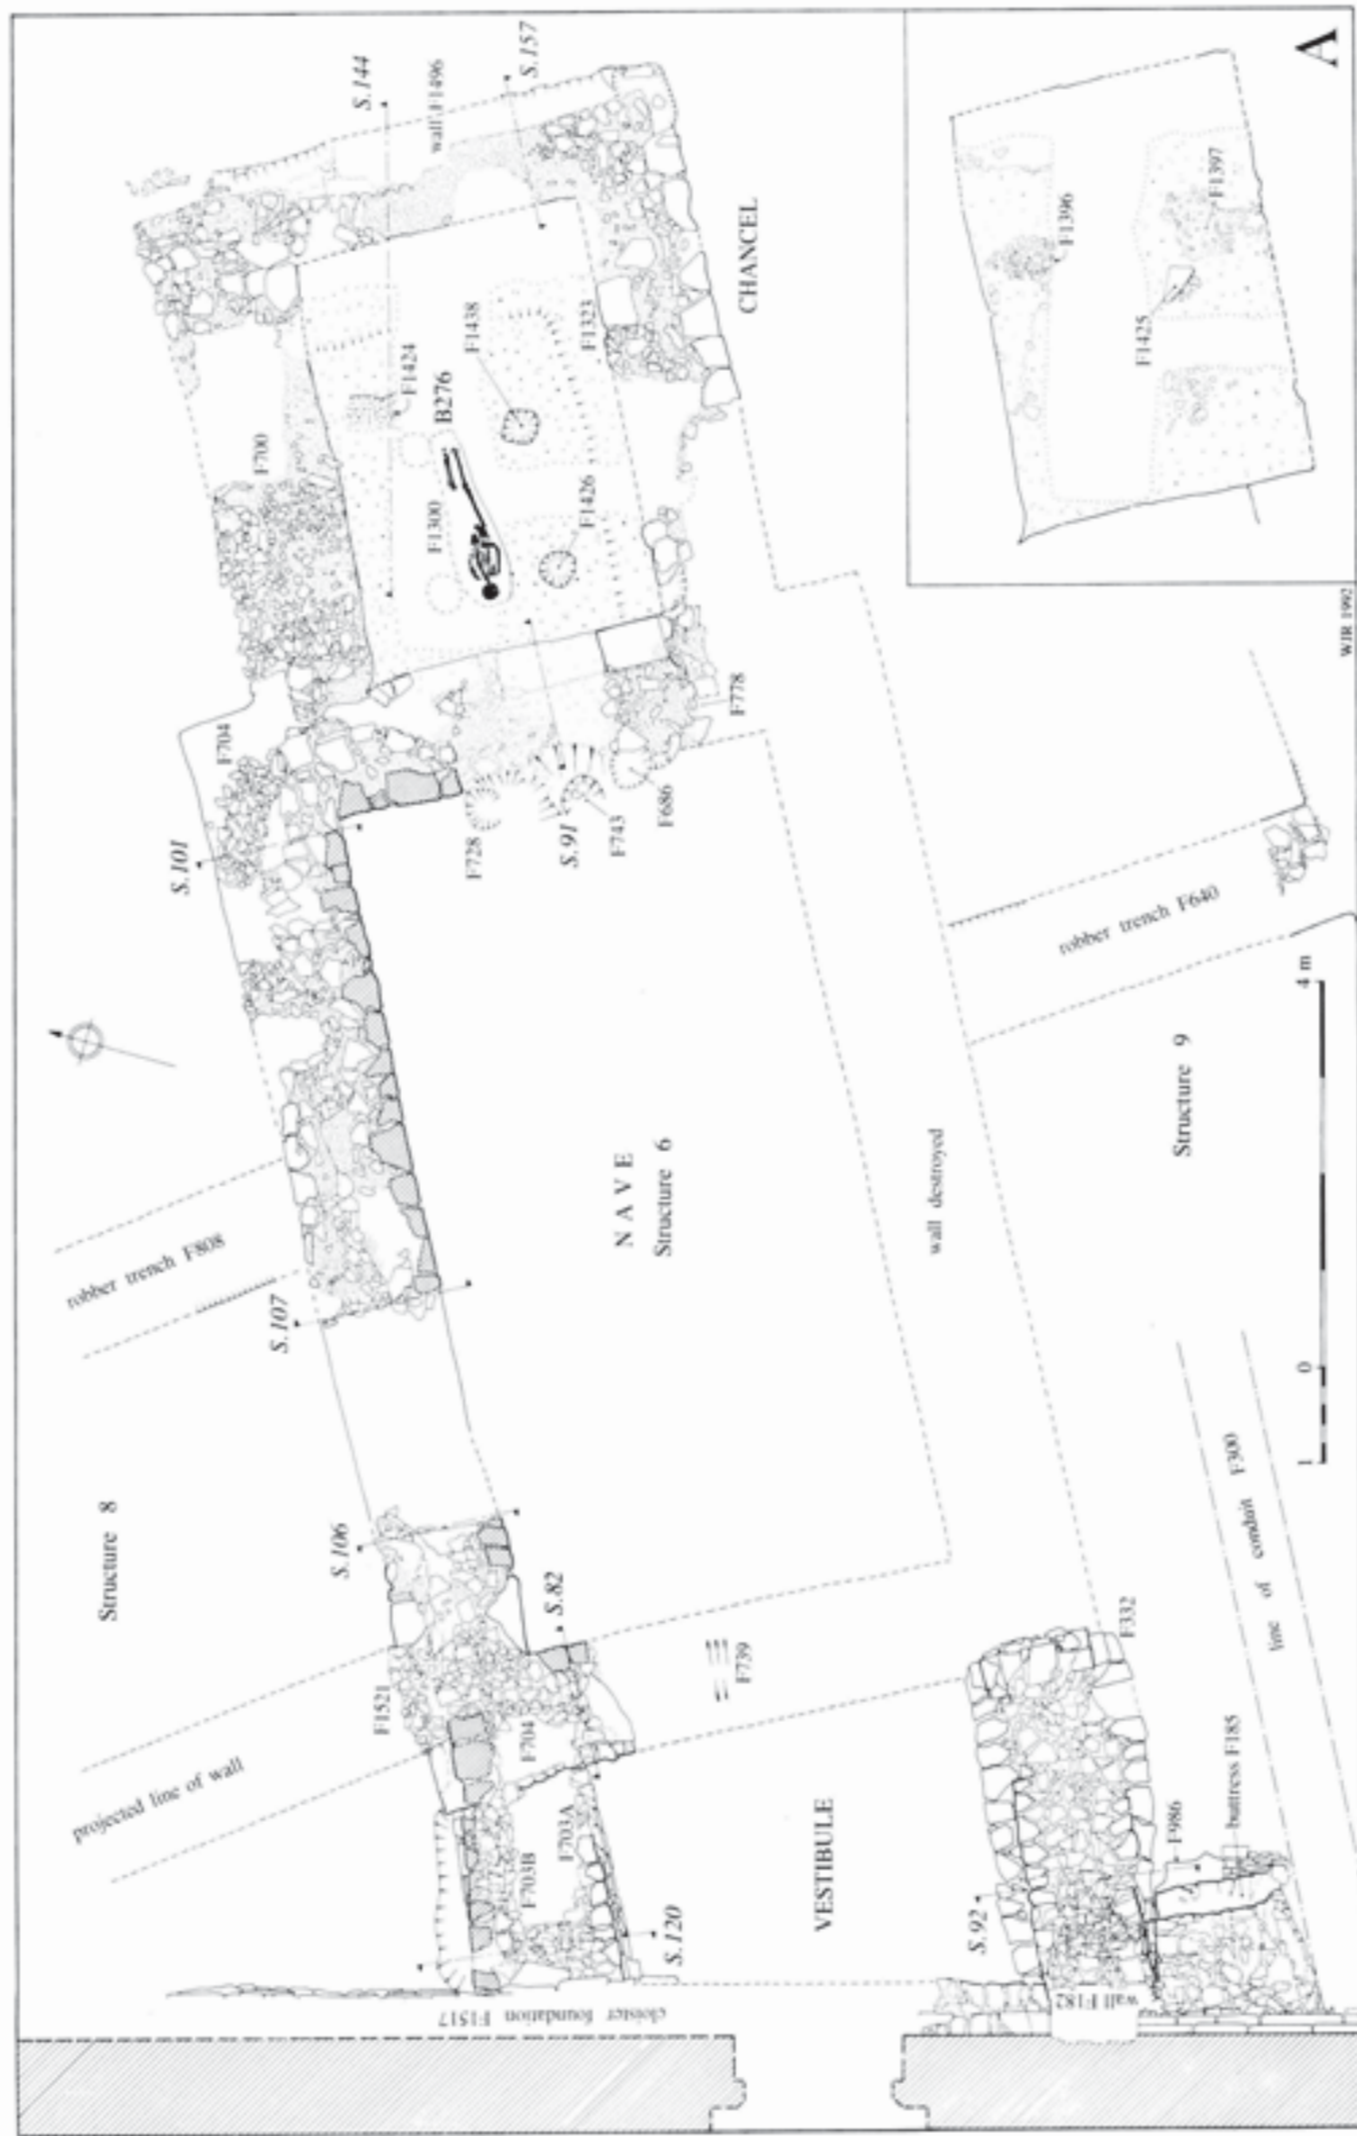
Fig. 74 Foundation plan of St Mary's chapel (Structure 6), showing eleventh- and twelfth-century phases. Inset A shows secondary features in the chancel. For sections see Fig. 76. Scale 1:80

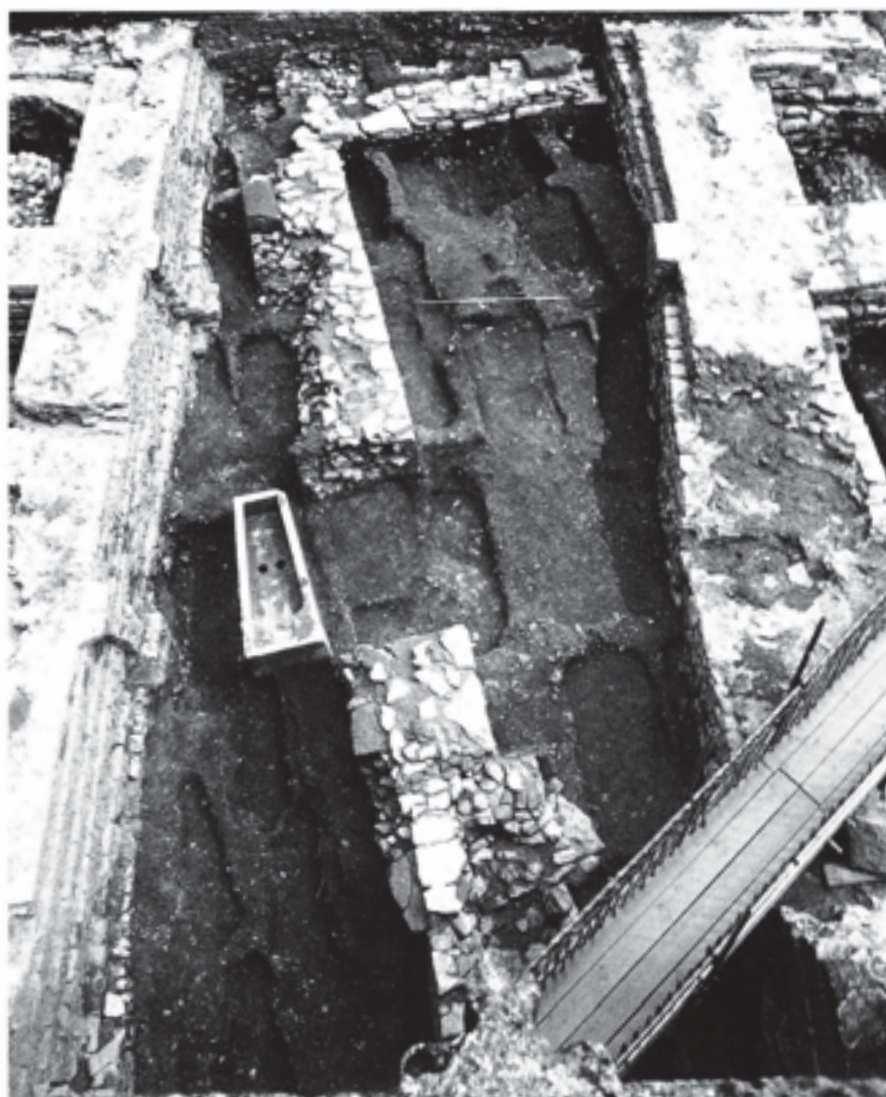
Fig. 75 The north and east walls of the nave of St Mary's chapel, looking east, after full excavation. The stump of the west wall (north-west corner) can be seen alongside the scaffold bridge. The two massive walls framing the picture are the nave of Stillington's Lady Chapel, and the stone coffin is fifteenth century. Scale of 2 m

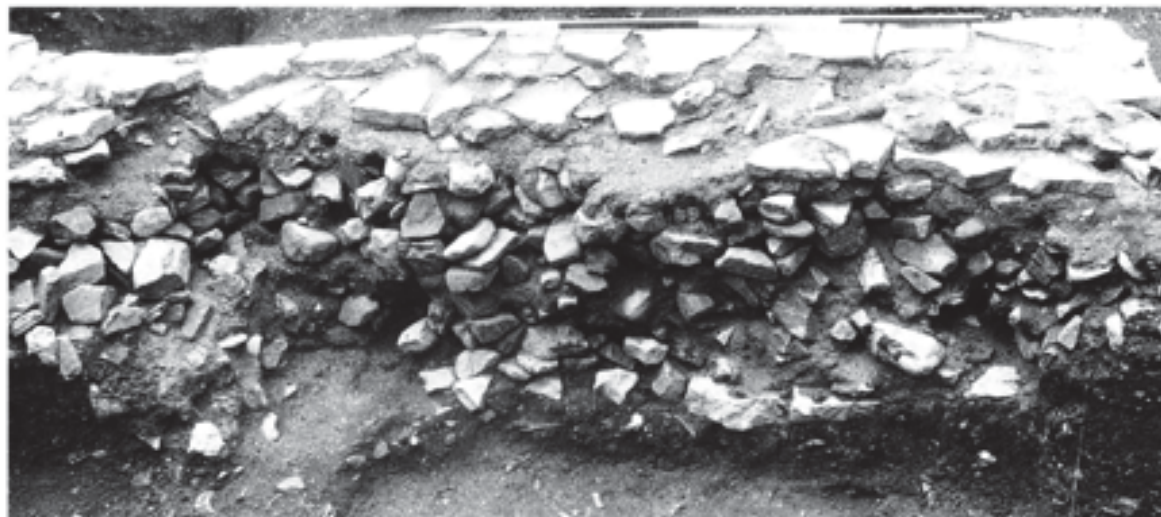
Fig. 77 Part of the north wall of St Mary's chapel, showing the pebble-rubble core exposed by a later grave-cut. On top of the foundation is the lias walling of the second phase of the chapel. Scale of 2 m

Most of the north wall foundation (F704) survived, together with returns at both the east and west ends; it was sectioned in three places and shown to be of two constructional phases (Fig. 76, S.101, S.106 and S.107). The width of the primary foundation was 1.20–1.35 m, and the profile was markedly irregular. It was trench-built, with a sagging base and splayed sides. The materials used were similar to those in the chancel. About fifty percent of the rubble comprised water-worn boulders and pebbles of Pennant sandstone; there were also nodules of lias, lumps of conglomerate, and a few masons' offcuts of Douling stone (Fig. 77). There were obvious idiosyncrasies in the work.

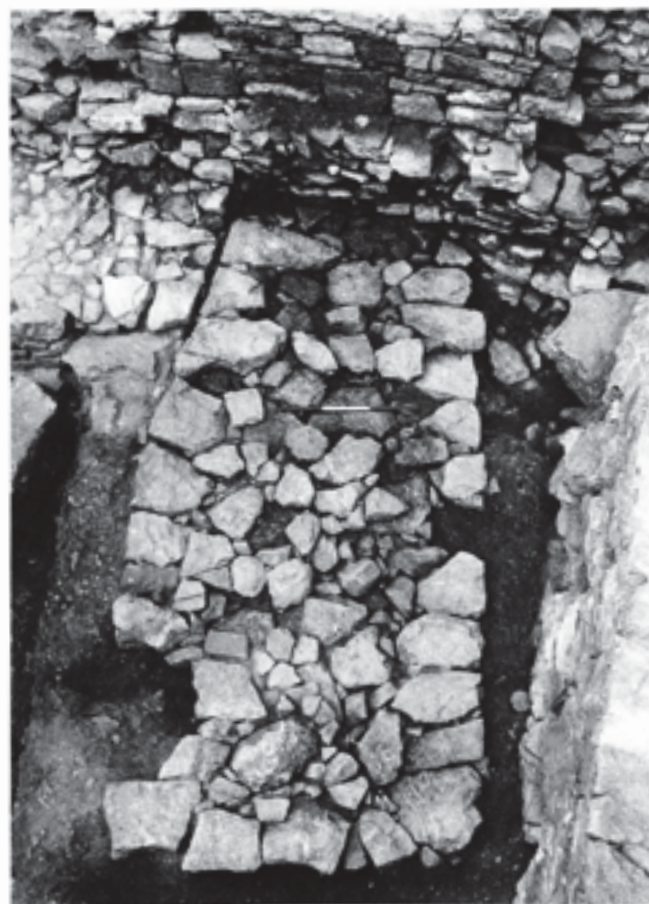
Fig. 79 The lowest foundation course of the south link-wall (F332) of the vestibule (or west nave) of St Mary's chapel, looking west towards the cloister. Scale of 75 cm

The south wall (F332) was free-built from the lowest level, and comprised large, flattish pieces of lias, conglomerate, red sandstone and a single dressed block of Douling stone, set in pink-brown earthy mortar in a broad, flat-bottomed foundation trench (Fig. 79). The foundation was exceptionally wide at 1.8 m, and was made to fit around an earlier wall, F986 (Figs. 80E and 81). Five courses of this foundation survived, with offsets on both faces above the first course. Here, the thickness of masonry reduced to 1.2 m.

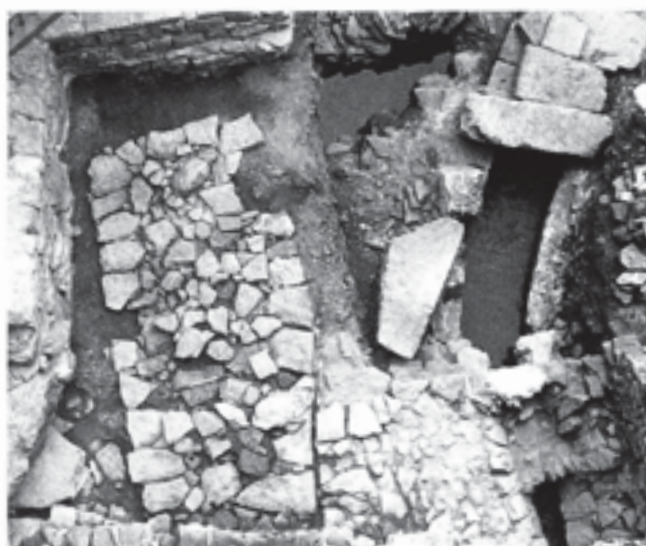
Fig. 81 South link-wall (F332) projecting from the cloister. Note how the masonry was shaped to fit around the earlier foundation (F986) immediately to the right. To the right again is the medieval conduit. Scale of 75 cm

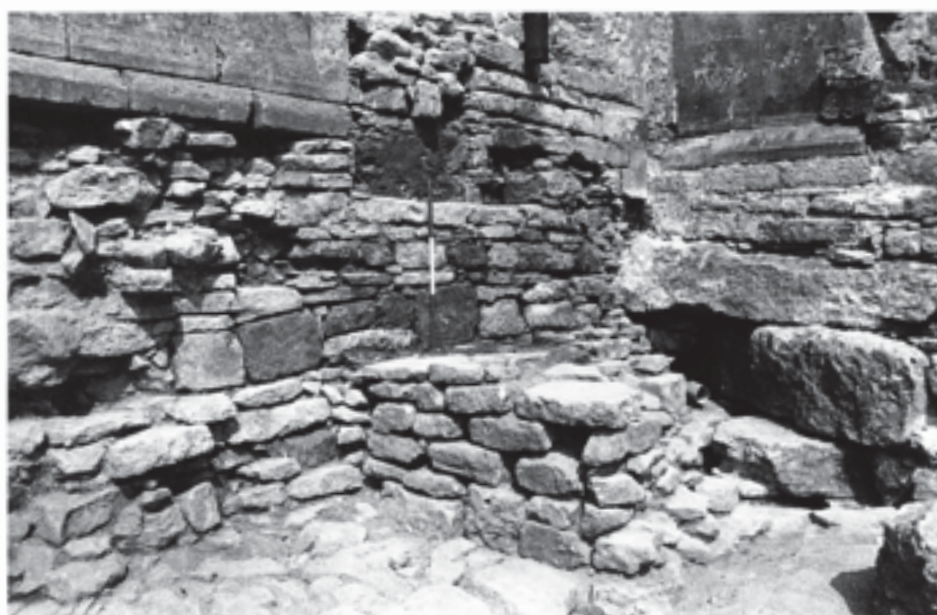
Fig. 82 The east cloister foundation (left), clasp and over-riding the lowest five courses of the south link-wall (F332) of St Mary's chapel, upon which the scale (75 cm) stands

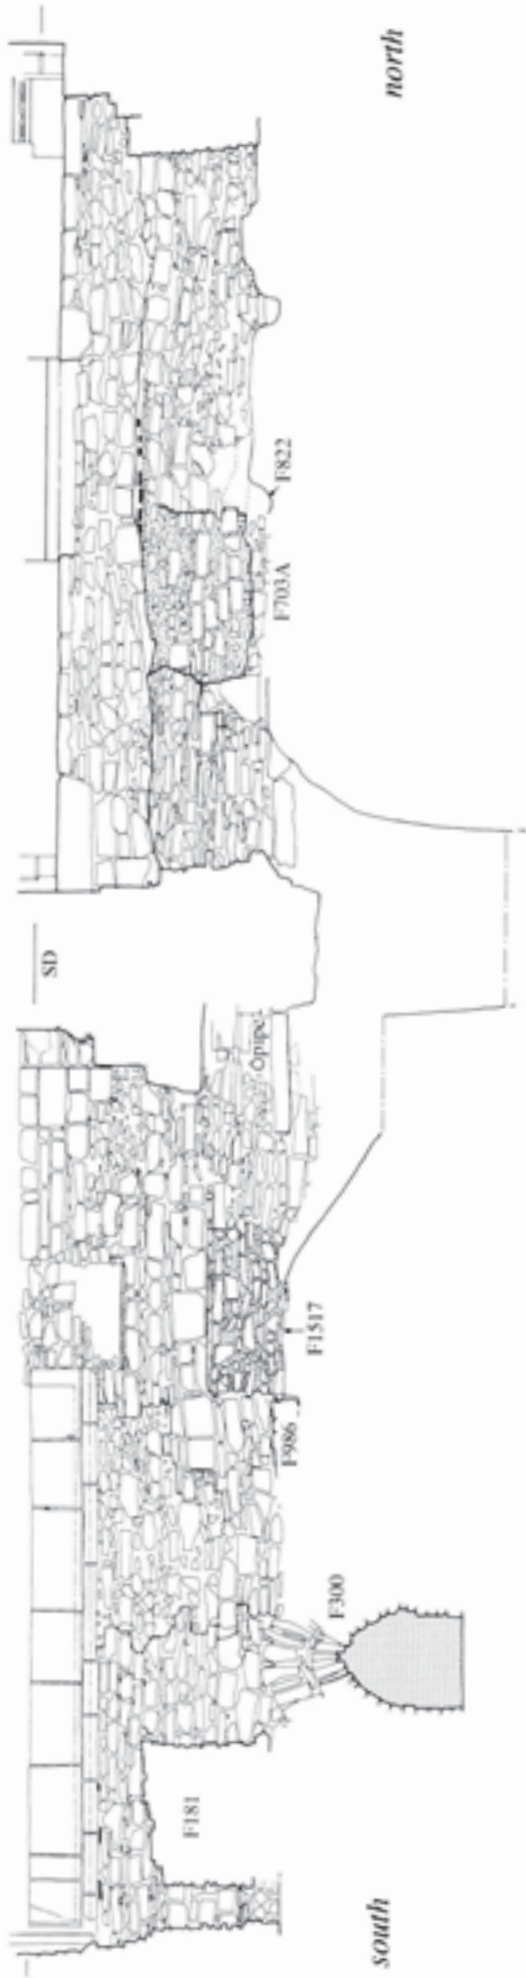
SECTION 105

Fig. 83 Elevation drawing and key diagram to the foundations of the east cloister wall and features directly beneath it. The Anglo-Saxon apse (F1522) is concealed by Stillington's wall (F352) and the masonry facing (F1517) which squared-off the apse. Scale 1:60

primary construction was similar; comparative plans of the lowest foundation course of each are given in Figure 80. The evidence is also consistent in showing that the link-walls were built between St Mary's chapel and the minster apse before the latter was squared off. The squaring-off wall (F1517) was trench-built and of roughly coursed red sandstone, set in an earthy matrix of pink lime mortar; it is shown in elevation in Figure 83 (see also Fig. 85).

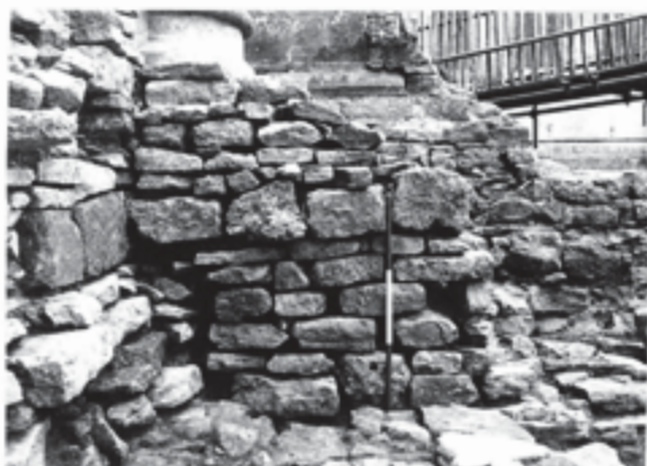
Fig. 84 South link-wall of St Mary's chapel, showing the superimposition of the two phases of masonry (F182 and F332), with a slight overhang between them. Scale of 75 cm

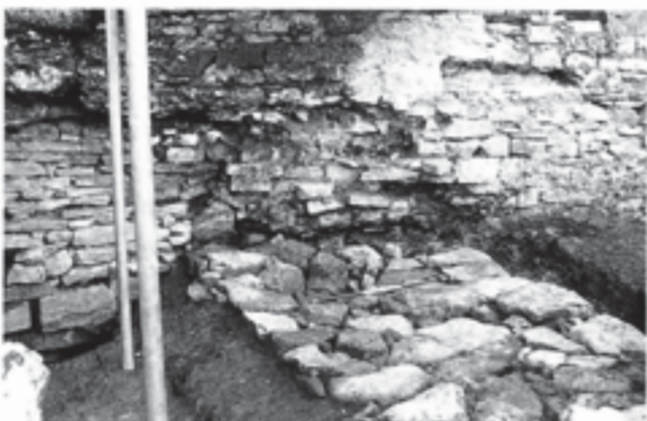
Fig. 85 North link-wall of St Mary's chapel (first phase, F703A), passing under the foundation of the east cloister. The attachment scar of the second phase (F703B) can be seen, together with the contemporary cloister foundation to the right. Left of the scar is the masonry of the squared-off apse (F1517) of St Andrew's church. Scale of 75 cm

The link-foundation was dismantled archaeologically, and the true sequence of construction then became apparent. The foundation masked the junction between the squaring-off wall of the apse (F1517) and the cloister foundation proper, F1524 (Fig. 85). The lower courses of the link-foundation seem, like their southern counterpart, to have clasped the apse, and the squaring-off wall came later. That had a construction trench (F784) which cut into the south face of the link-wall (Fig. 80C). The link had thereafter been reconstructed. Its lowest foundation course and most or all of the south face were primary, but the north face and its separate construction trench were secondary. It was noted that the primary work followed the general alignment of the chapel, whereas the later northern face lay at right-angles to the cloister. Unfortunately, much of the wall core had been removed by a grave, and thus the conjunction of the two builds could not be determined with certainty. A Romanesque base for an engaged shaft, dating from *c.* 1100, was incorporated into the south face (Figs. 432–3), demonstrating that the rebuild was no earlier than the late eleventh century.

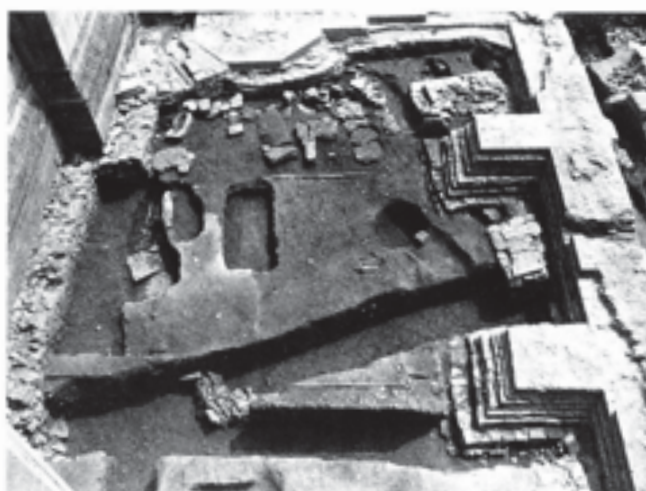
Fig. 88 View east across Area 7, from the cloister roof. The twelfth-century wall trench (F680) runs askew in the foreground. Norman cist-graves and earlier cross-bases are seen in the background, framed by the cathedral foundation on the left and Stillington's chapel to the top and on the right. Scales of 2 m

The easternmost wall (F680) had a foundation 90 cm wide, constructed in a flat-bottomed trench, 90 cm deep (Figs. 87-9 and 90, S.45 and S.83). Two small patches of masonry survived *in situ* towards the northern end of the trench (F839), one of which had been encapsulated by the foundations of the medieval cathedral (Fig. 91). The construction was of rough slabs of pitched stone in an earth matrix (Fig. 90, S.85). The majority of the stone was white lias, but a single fragment of a tenth-century grave-cover of Bath stone had also been incorporated (Figs. 486-7).

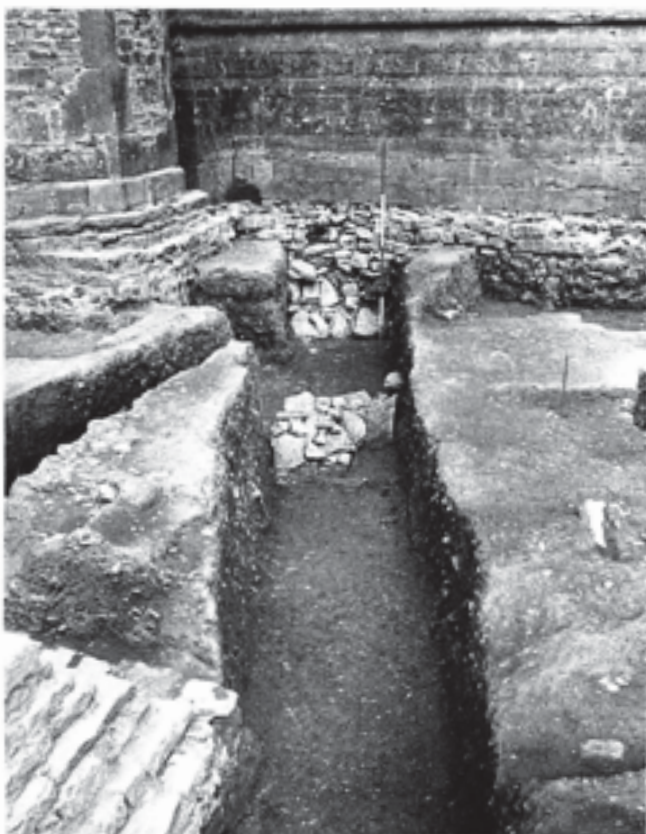
Fig. 89 Foundation trench F680 for the east wall of Structure 8, looking north. Scale of 2 m

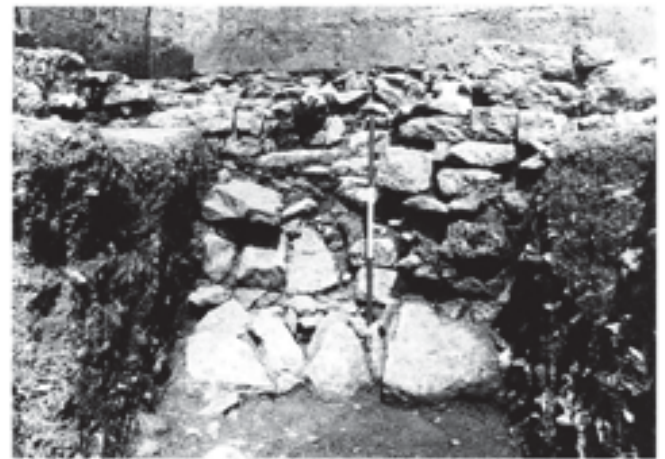
Fig. 91 Structure 8: foundation trench of the east wall, showing pitched stone F839. This is embedded in the masonry of the south transept of the cathedral, under which it continues. View looking north. Scale of 75 cm

Just before it ran under the cathedral transept, the northern end of the east wall (F839) intersected approximately at right-angles with two other, distinctly separate, foundations: one ran east, the other west. The eastward-pointing wall (F1005) had been wholly robbed in the late twelfth century when the transept foundation was constructed. Indeed, the robber trench doubled as a construction trench at this point. The width of F1005 is unknown; it was flat-bottomed and slightly shallower than F839. A 4.8 m length of the trench was preserved; it did not cross wall F839, but seemed to abut it.

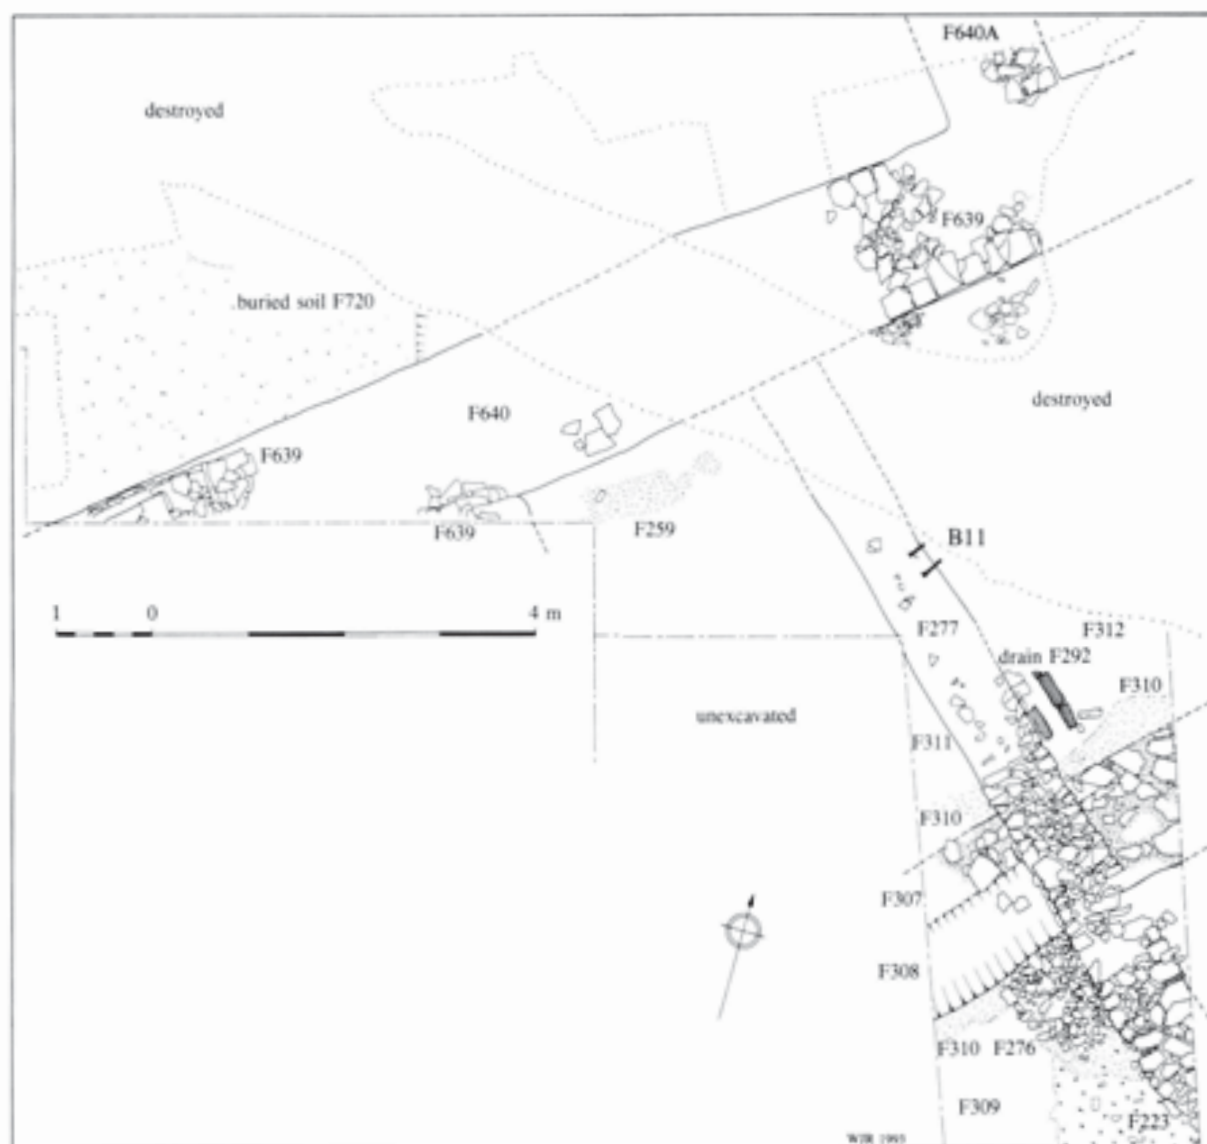
Fig. 92 Plan of late Saxon and Norman walls and adjacent layers relating to Structure 9 (western part). The earlier burial B11 is also shown. For the wider setting, see Fig. 87. Scale 1:80

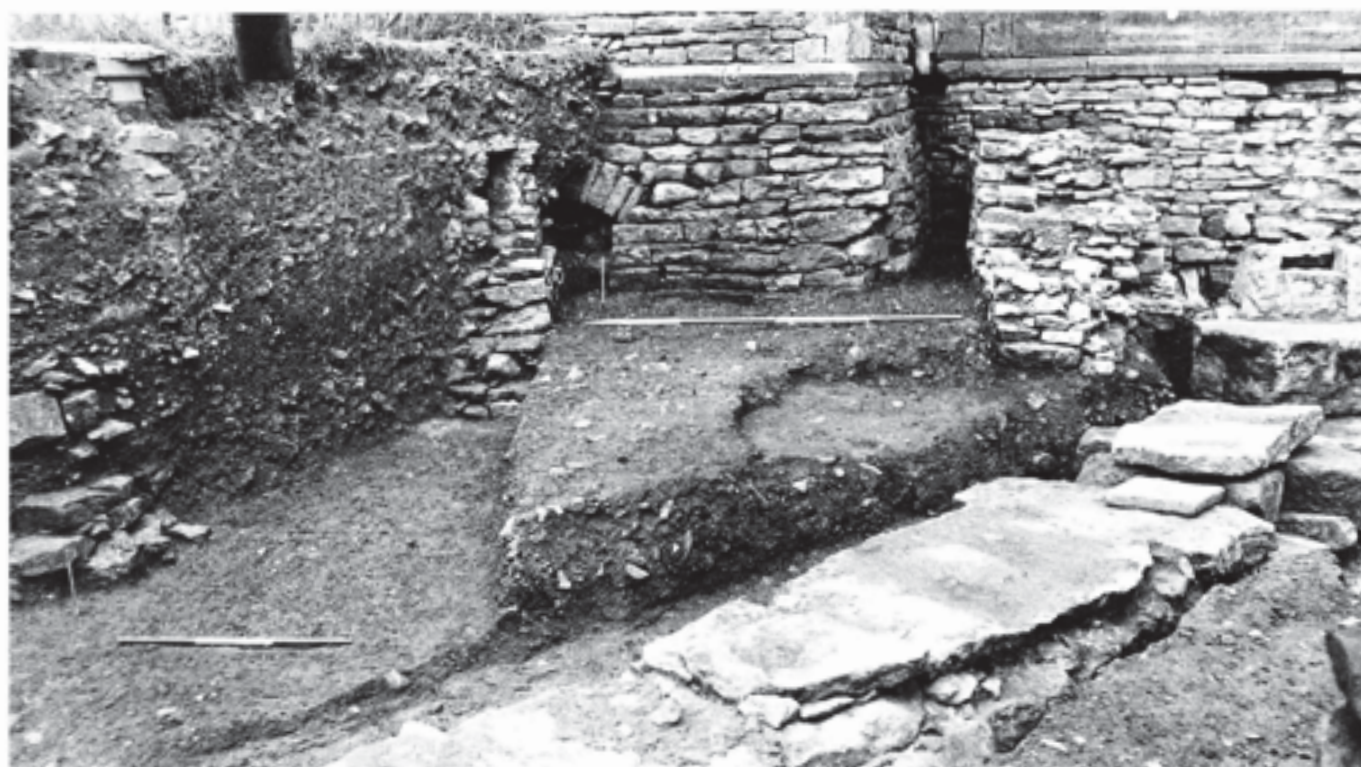
Fig. 93 Saxo-Norman ground surface (centre, with 2 m scale), and foundation trench (F640) for the north wall of Structure 9 (left, with scale of 75 cm). A portion of standing masonry (F639) projects from the section. The medieval conduit crosses the foreground, and east cloister structures are seen in the background, including the latrine tower (Structure 14)

Structure 9 comprised two parallel walls, aligned north-east to south-west (Fig. 92). They were of markedly dissimilar construction, and probably not contemporary in origin. The more northerly, represented mostly by the robbed foundation trench F640, had a width of 1.55 m, clearly indicating that it supported a substantial wall. A section of the masonry, F639, remained standing to a maximum height of eight courses (85 cm), with an offset at the sixth course (Fig. 93). The facing construction was of roughly dressed limestone blocks, incorporating some red sandstone and lias. The core was of small rubble, and the matrix was essentially clay, tinged with slight traces of pinkish-yellow mortar.

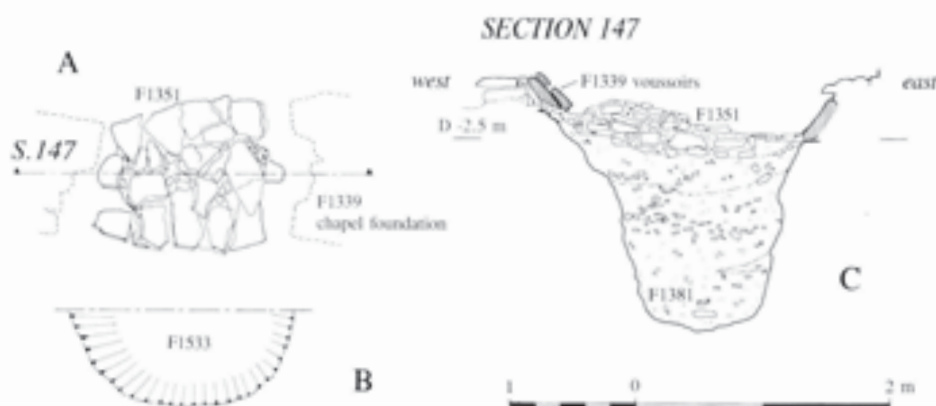
Fig. 94 Anglo-Saxon well, F1533. A Plan of the well mouth, showing masonry blocking; B Plan of the excavated southern half of the well-shaft; C Section, S.147. Scale 1:60

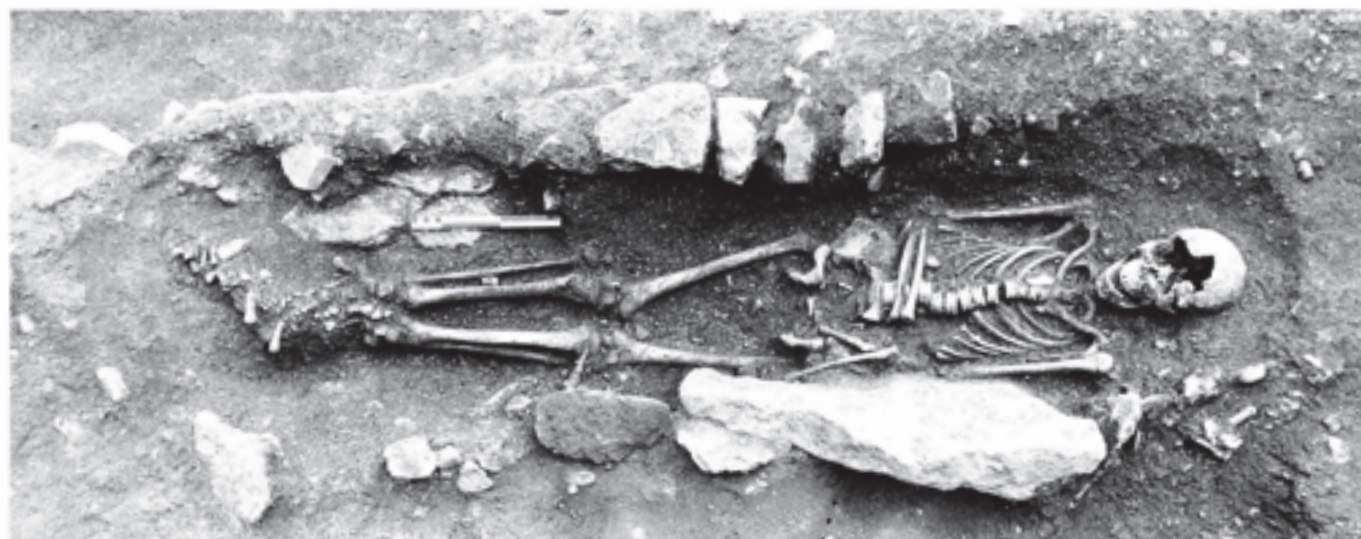
Fig. 97 Burial 48 with the cover-slabs removed, showing the crude stone lining to the grave. Scale of 25 cm

This final grave series began with burial 48, which was demonstrably earlier than the formal rows of adults: it partly underlay B60, and straddled the rows. Burial 48 was stratigraphically later than several graves in both groups 1 and 2, but was distinguished from them by being in a stone cist. Unlike the two earlier burials with monolithic stone covers (B100 and B152), B48 was capped by a number of small slabs, in the medieval fashion. These rested on a series of rough pieces of stone placed along the sides of the grave (Fig. 96, F695; Fig. 97). Similarly crude arrangements of edging stones were noted in several of the Anglo-Saxon graves, but were not present in those with monolithic cover-slabs. It has been suggested that such edgings may have supported wooden covers (p. 68).

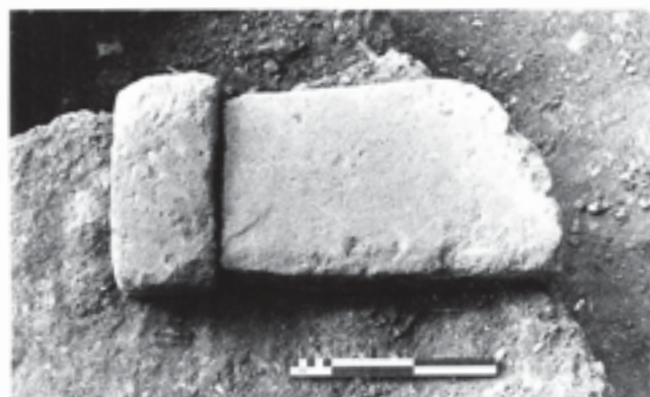
Fig. 98 Worn stone grave-marker (F1018), over burial 315, viewed from above. Scale of 25 cm

poorly preserved infant, possibly a neonate, burial 315. This was unique in the cemetery in that it was covered by a grave-marker of dressed limestone blocks (F1018). The original arrangement probably consisted of a setting of three stones (Figs. 98 and 99). A recumbent stone overlay the body, with a short upright one at the 'foot' end, and there had presumably been a similar upright at the 'head' end, which might perhaps have been ornamented. Unfortunately, that piece had been removed by the robber trench. Weathering on the upper surfaces and edges of the two surviving stones demonstrated that they were flush with the original ground level, and consequently that the burial was very shallow. No evidence for coffins was seen in these graves.

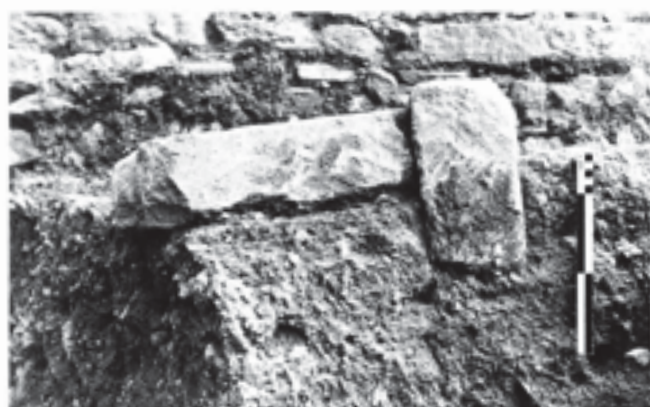
Fig. 99 Stone grave-marker over burial 315, seen in section, from the south. Note the axed finish. Scale of 25 cm

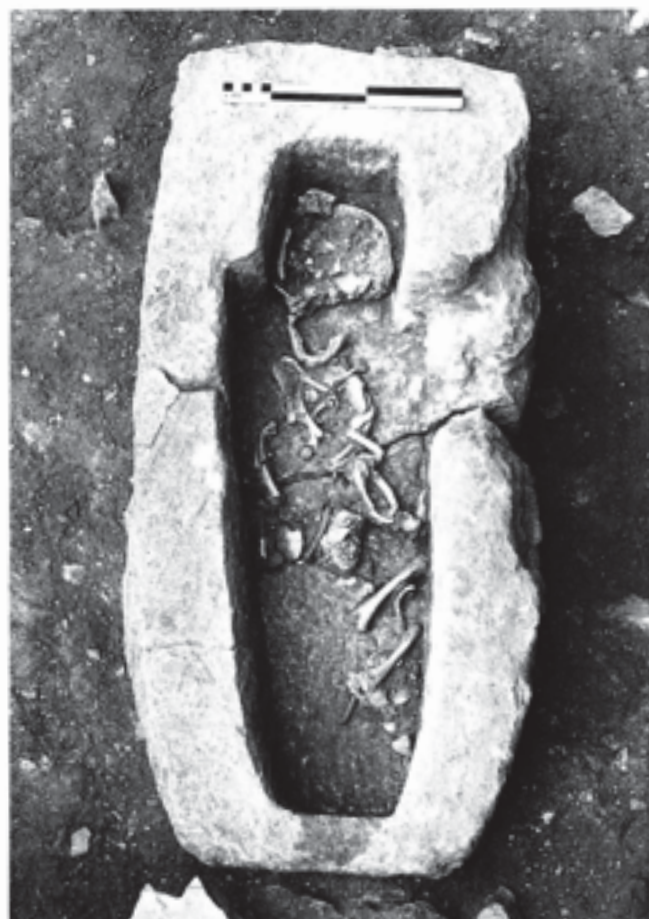
Fig. 100 Infant burial 43, in a stone coffin (F793). Scale of 25 cm

rectangular block measuring 88 cm by 38 cm (F793); a head-recess was provided (Figs. 100 and 497). The coffin had been covered with flat pieces of stone, some of which were missing. One metre to the south lay another infant, burial 63, in an earth-cut grave (F771) covered by three pieces of stone (F768). The latter included a well-cut Doulling ashlar.

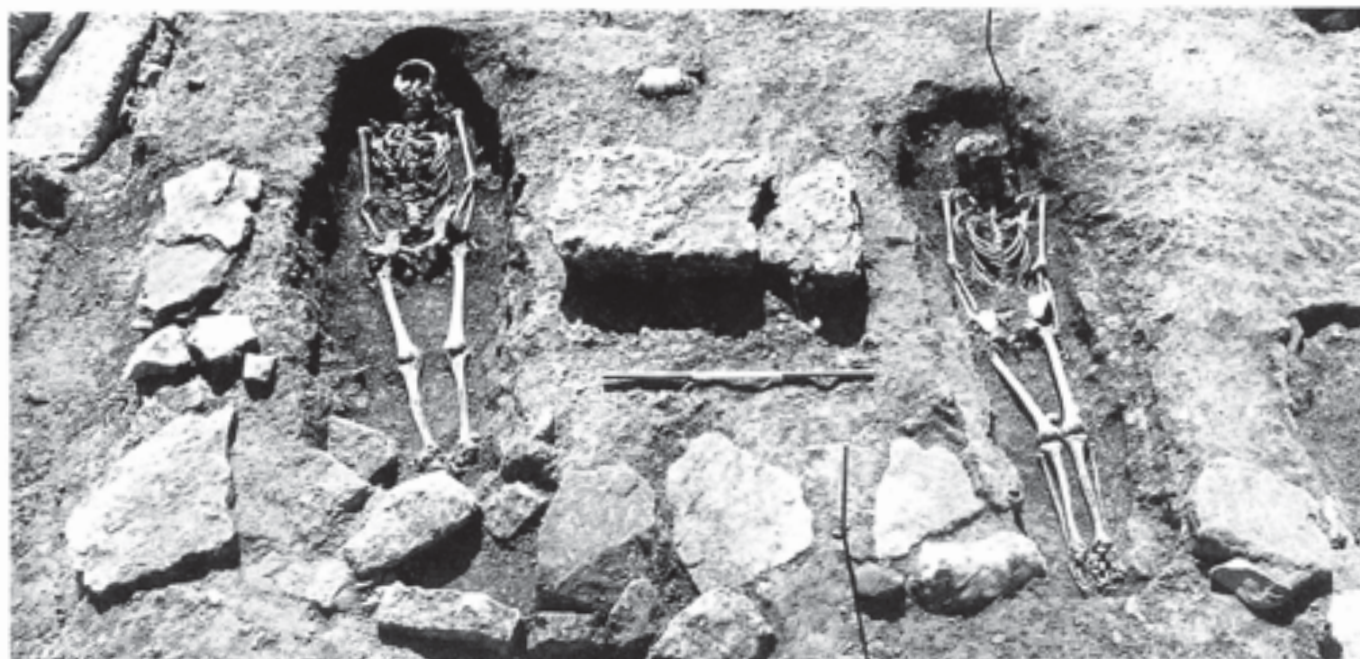
Fig. 101 Burials 60 (left) and 71, flanking a probable stone cross-base (F832). The uppermost stones of wall F938 traverse the picture in the foreground. Scale of 75 cm

Burials 60 and 71 flanked the southern stone cross base, F832 (Fig. 101). Both were supine, with the hands beside the hips. By contrast, B24 had the arms folded across the stomach. The disposition of the bones in these three graves was orderly, and no significant displacement had occurred after deposition. This might be taken to indicate that the corpses were enveloped with soil before the cover-stones were positioned. However, that can be shown not to have occurred in the case of burial 71. This interment was covered by two thick slabs of Douling limestone (F796), under which a void still remained. One slab was very large and preserved tool-marks on its underside; the upper face was weathered, suggesting that it was set at ground level. There were no traces of decoration.

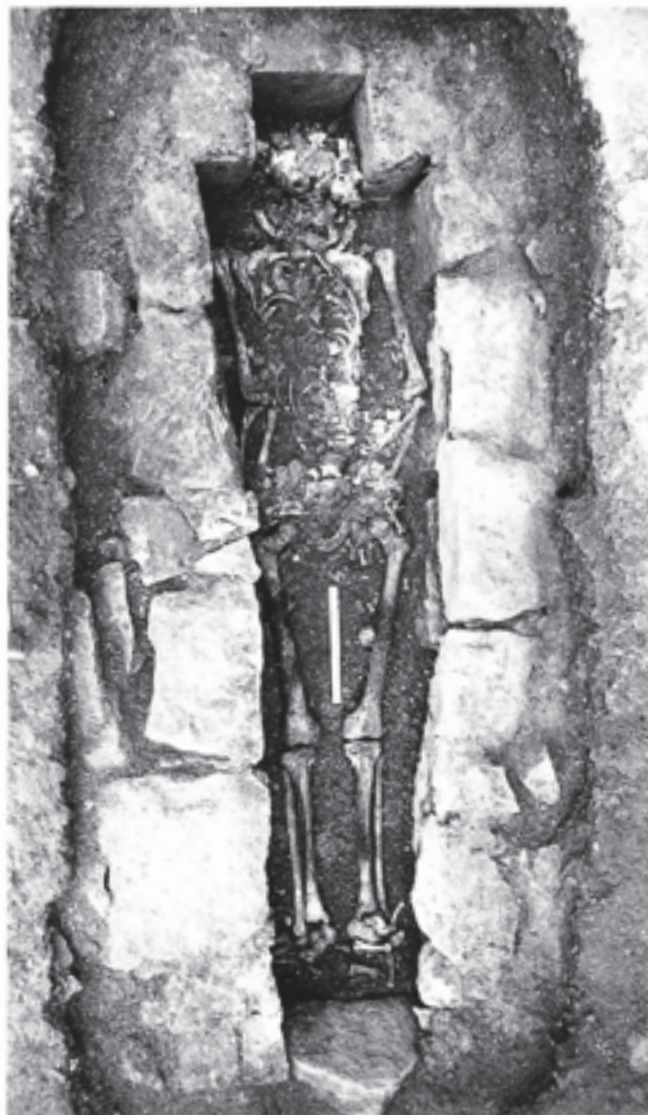
Fig. 105 Cist burial 44. Scale of 25 cm

Burial 72 was in a well-built cist (F798), the sides of which were constructed from a single course of blocks of Chilcote ashlar with diagonal dressing marks (Fig. 104). The joints were mortared. The cist containing burial 44 was slightly less well executed and in the main consisted of two courses of roughly dressed slabs of sandstone conglomerate set in yellow mortar (F676). The head-recess was, however, formed of dressed Chilcote stone (Fig. 105).

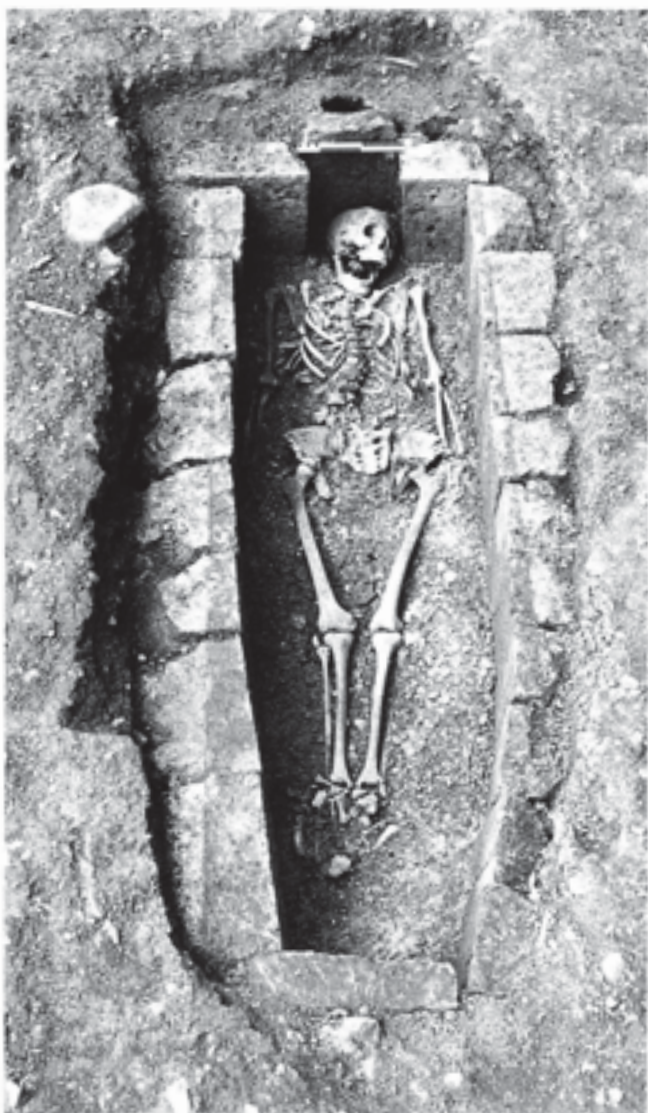
Fig. 104 Cist burial 72. Scale of 25 cm

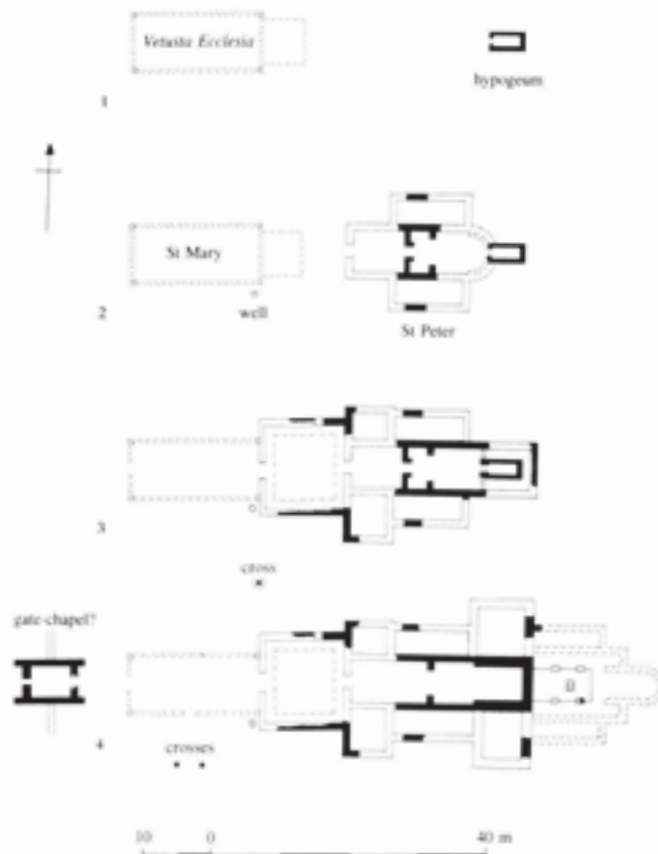
Fig. 108 Reconstructed plans to illustrate the development of Glastonbury Abbey church before the twelfth century. After Rodwell 1984

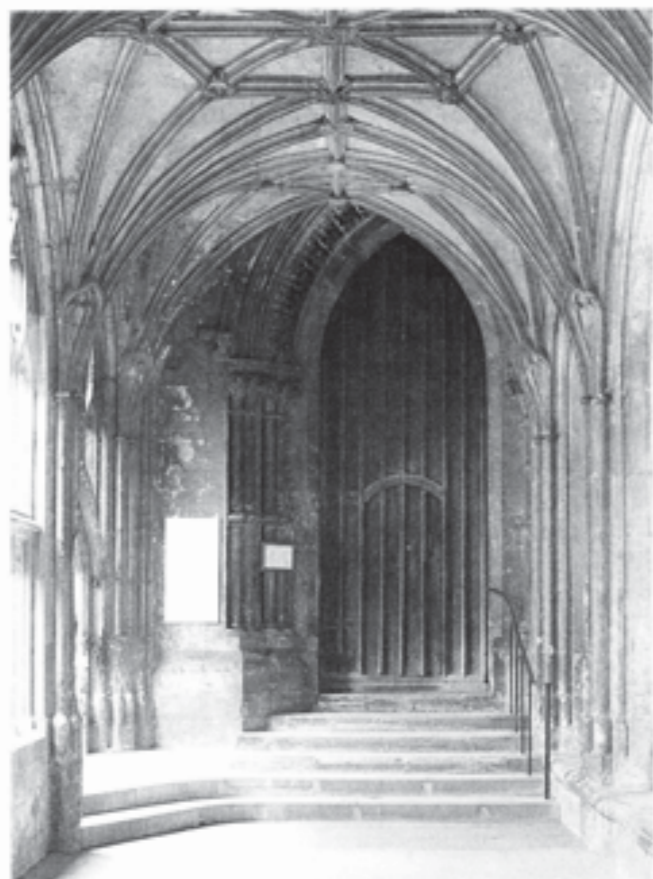
Fig. 119 The south transept portal of the late 1180s, asymmetrically abutted by the east cloister and partly obscured by the vaulting of c. 1420 (Jerry Sampson)

Decorated portals are found in the transepts of a number of other great churches in the Early English style, and are usually axial. Such is the situation at Lichfield, for example, where the two doorways are unrelated to contemporary claustral abutments. Wells differs not only in the asymmetrical siting of the portal, but also in having western aisles to its transepts, a notable rarity. The aisle in the south transept is, in a sense, a processional extension of the cloister walk, and it may have been conceived as such. Additionally, the door must have served as the main entry to the church from the 1190s, while the nave was under construction, and before the north porch assumed precedence. A precisely comparable situation obtains at Oxford Cathedral, where there is a major door in the west transept aisle, directly into which the east cloister leads (Halsey 1988, fig. 60).

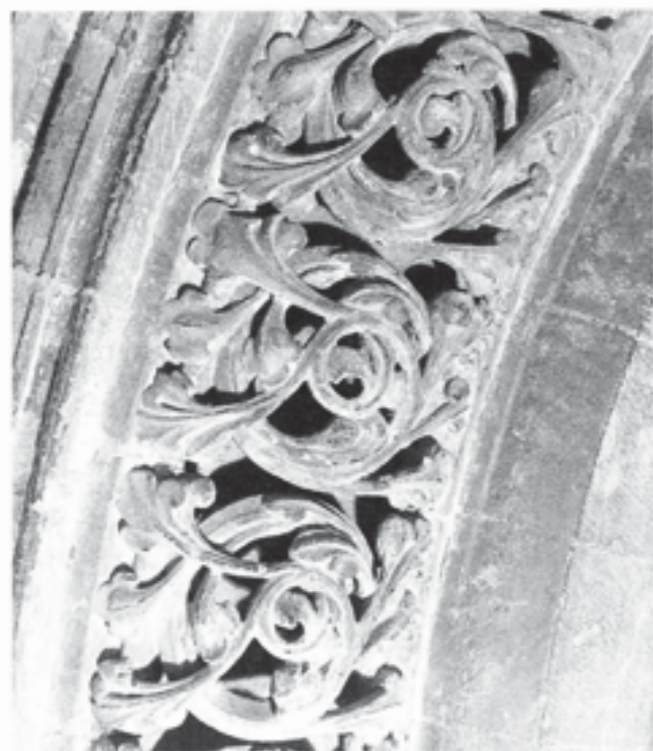
Fig. 120 Detail of fretted, stiff-leaf carving in Chilcote stone on the head of the south transept doorway. Late 1180s. For the moulding profile of the arch, see Fig. 121 (George H. Hall)

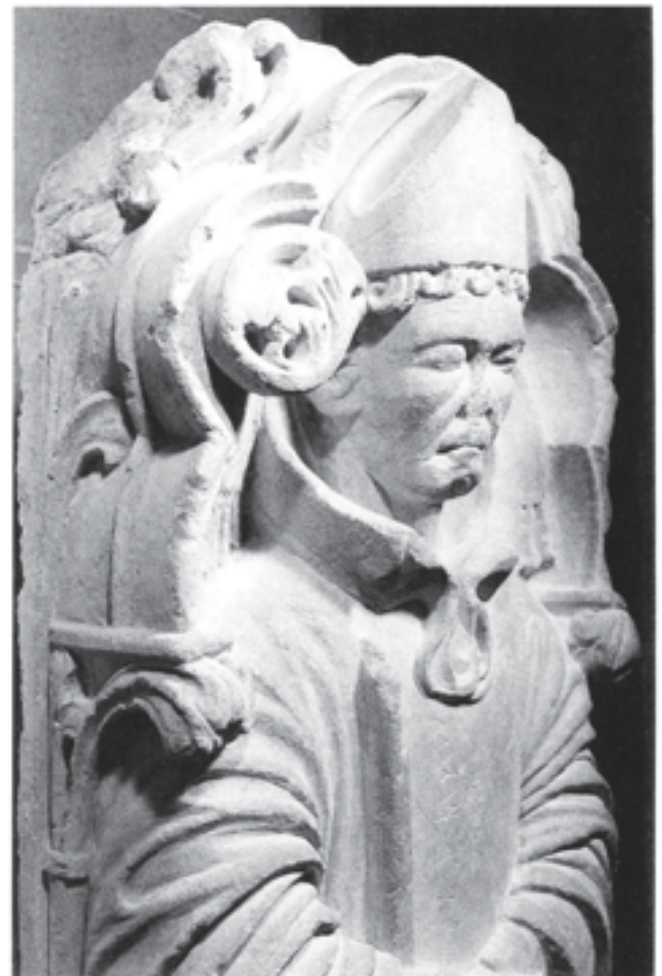
Fig. 122 Upper part of the retrospective effigy of c. 1200 of an Anglo-Saxon bishop, reputedly Levericus. The figure is carved in 'standing' pose, and the architectural detail bears comparison with the north porch

The effigies fall into two distinct groups. Five of them are plainly Early English in style and date from c. 1200 (Fig. 122). The remaining two display a mixture of stylistic features: on the one hand the bishops are shown wearing low mitres appropriate to the Anglo-Saxon period, and their heads rest upon plain pillows, yet on the other hand it is obvious from the edge mouldings of the slabs, and other details, that these monuments were not carved before c. 1230 (Fig. 123; Fryer 1915). In short, they are deliberately archaic, a point which confused Robinson and other early commentators, who thought the effigies had been salvaged from the old cathedral. Robinson eventually set the record right, concluding that the two effigies of ‘early’ appearance were loosely copied from, and replaced, genuine Anglo-Saxon sepulchral sculptures (Robinson 1914, 108–9). If so, these must have been relict from the earlier building.
