WELLS CATHEDRAL

Excavations and structural studies, 1978–93

*Excavations and Structural Studies,
1978–93*

ARCHAEOLOGICAL REPORT 21

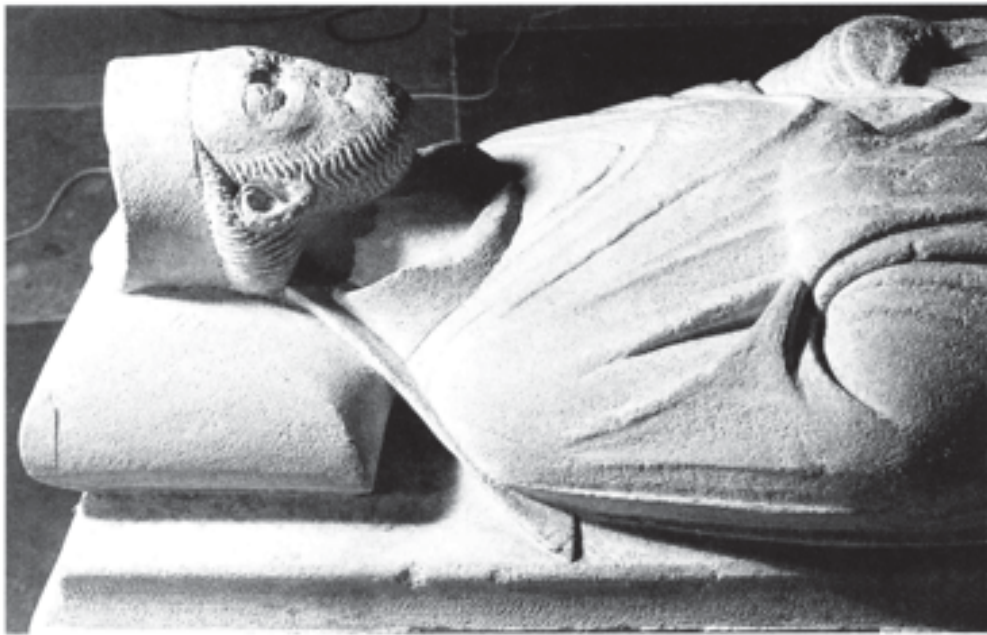
Fig. 123 Upper part of the retrospective effigy of c. 1220–30 of an Anglo-Saxon bishop, reputedly Giso. The figure is carved in recumbent pose

Robinson also demonstrated that the two replacement effigies almost certainly represented Dudoc and Giso, the last two Anglo-Saxon bishops, who had been interred in the *hemicyclia* in the old cathedral (p. 111). The identities of the figures in the other sculptural group are far less certain, although names have been put to four out of the five. The stylistic date of these, c. 1200, almost certainly indicates that they were specially commissioned to adorn the quire of the new church, and that they were probably not replacements for existing effigies.

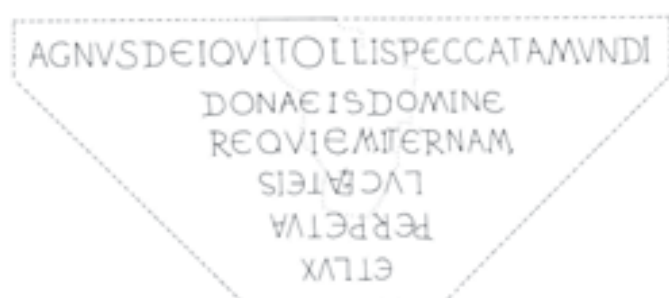
Fig. 125 Hypothetical reconstruction of the triangular lead depositum plate and inscription from Bishop Giso's coffin. Scale 1:1

Superficially, it would appear improbable that part of a funerary inscription would have been inverted, but a possible explanation for such an action might be found in the need to fit the words into a constrained space on the plaque. If the proposed rendering of the inscription is drawn out, with the additions made to scale, it at once becomes clear that the wording fills a triangular area (Fig. 125). It is therefore tentatively suggested that the lead foil is part of a triangular plaque that was affixed to Giso's coffin, and that it carried an appropriate funerary inscription in the form of two excerpts from the Mass for the Dead.

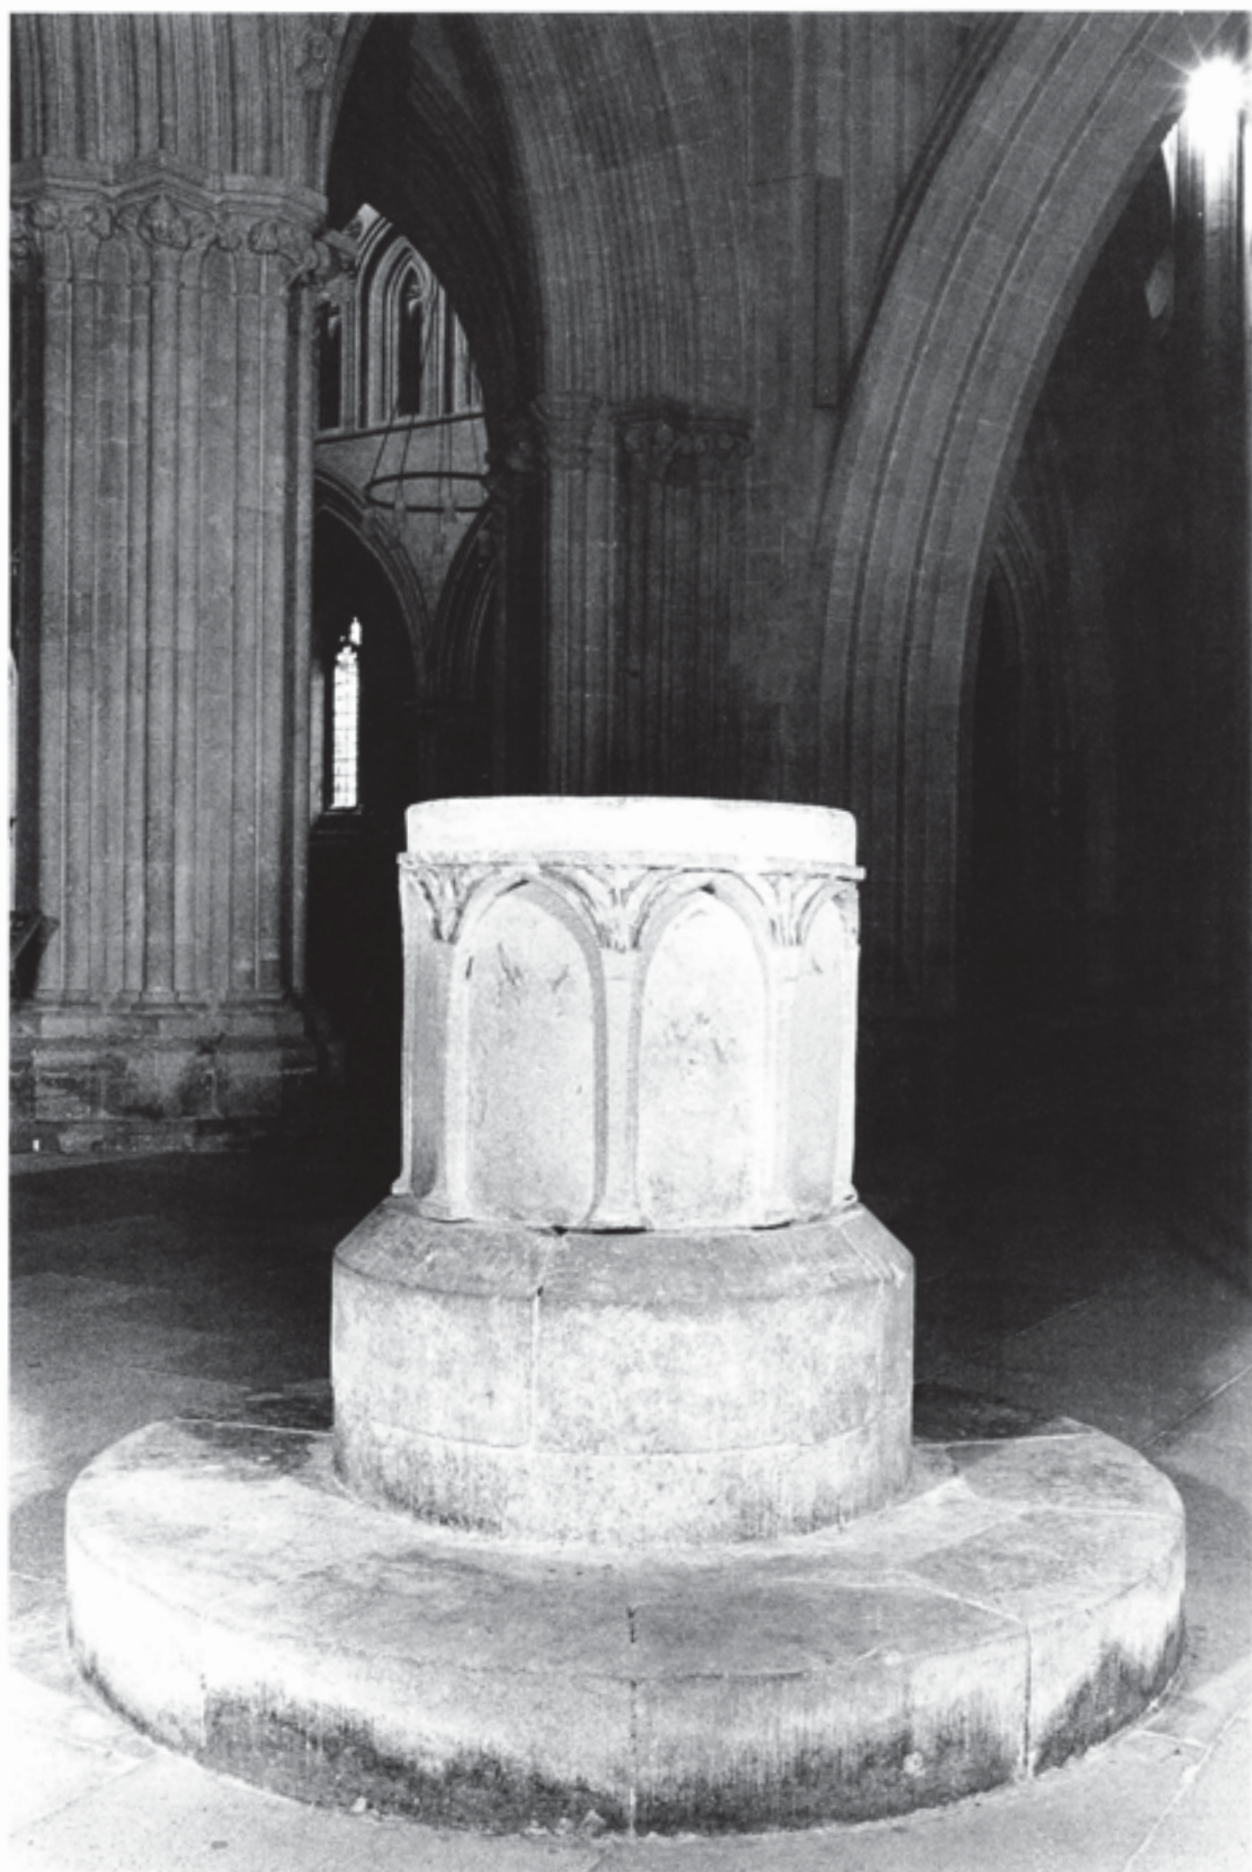
Fig. 126 Wells Cathedral font, without the Jacobean cover, viewed from the south-east

As far as available records allow us to judge, Wells Cathedral has only ever had one font. It stands in the centre on the south transept on the north-south axis

The font is circular and comprises three distinct components: a tub-shaped bowl, a plinth and a step (Figs. 126–8). There is a lead lining to the bowl, and a Jacobean oak

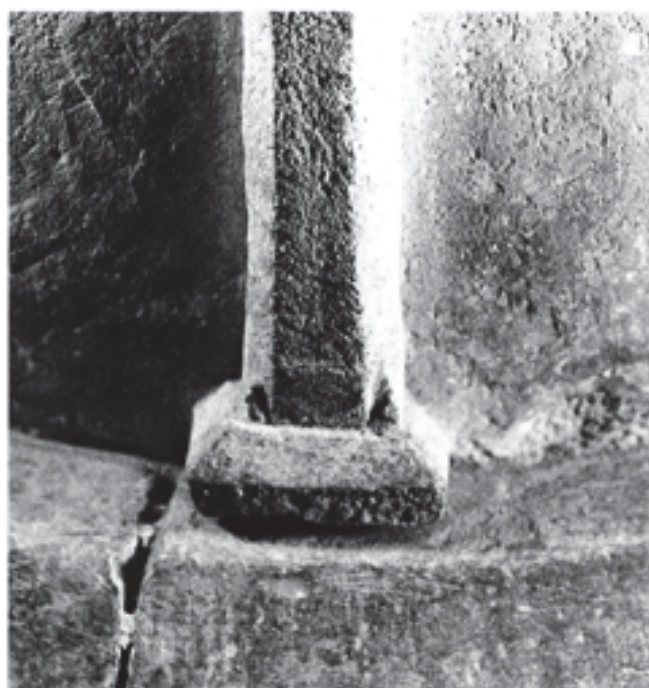
Fig. 131 Font: detail of pilaster-base no. 2/3. The chamfers and broach-stops are secondary (Jerry Sampson)

The arcade, which occupies the main part of the bowl, consists of eight arches of varying widths, supported on pilasters and surmounted by seven spandrels decorated with foliate ornament of different design, set against a recessed background (Fig. 130). While both the arches and the pilasters are crudely chamfered, there is considerable variation in the width of the arches at their springing points, apices, and interstitial sections. At its outer edge, the face of each arch has a lightly incised line which runs parallel to the extrados. In bay 7 there is clear evidence of a second incised line, set in from the intrados. Although there are no clearly defined capitals at the springing of the arches, the base of each spandrel is marked by a common horizontal and, on five of the seven pilasters, there are the remains of a second horizontal — in the form of a faintly incised line — at the point where the pilasters widen into the arches. Again colour, surface texture and patination suggest secondary tooling, of which there is further evidence not only in the front surfaces of the pilasters, but also in the irregularities of the chamfers, arches and their springing points.

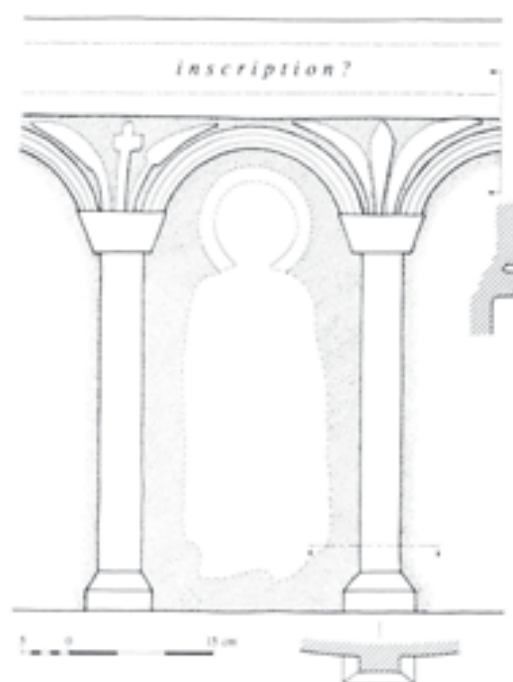
Fig. 132A Suggested reconstruction of the original form of the arcading of the font bowl (based on bay 8), including the profile of the arch moulding and section through a pilaster. Scale 1:8

The evidence of substantial recutting to form a 'Gothic' arcade is incontrovertible, and there is a firm basis for the suggestion that, in their original form, the arches were round-headed and decorated with two, lightly incised, parallel lines. For a possible reconstruction of the arcade, see Figure 132A. There, it is apparent that the arches were not semicircular, rather than pointed, but were segmental, a feature commonly seen in both Anglo-Saxon architecture and sculpture.⁴⁰ The evidence for the original form of the capitals, or imposts, is less clear, but it is certainly possible that they were of the trapezoid form seen at Bibury, Bradford-on-Avon and Milborne Port (Taylor and Taylor 1965, 1, figs. 30, 38 and 202). Re-tooling has removed all evidence of the original form of the arcade supports, but as there is no indication of secondary tooling on the bases, these may be accepted as primary. The pilasters were originally rectangular in cross-section, the chamfers and broach-stops being part of the recutting.

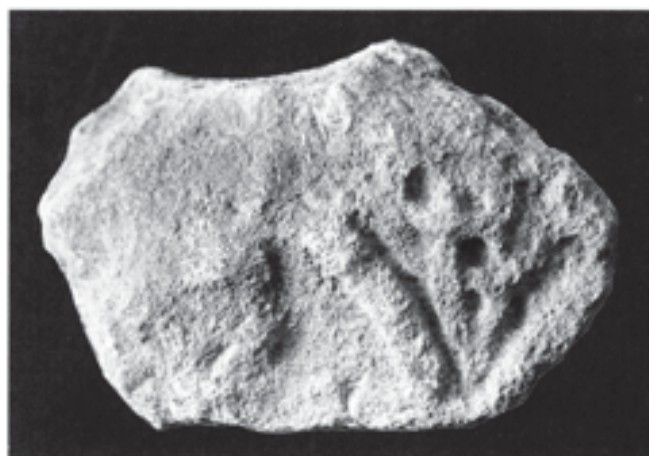
Fig. 132B Heavily abraded fragment of an arcaded panel from Glastonbury Abbey. The spandrel is filled with interlance, and the outline of a head can just be discerned under the left-hand arch. The scale of the decoration is similar to that on the Wells Cathedral font

A potentially comparable sculpture has been found at Glastonbury Abbey, although the circumstances of its discovery are unrecorded (Fig. 132B).⁵⁴ The heavily battered fragment includes parts of two round-headed arches forming an arcade, the moulding profile being of simple rectangular section (*c.* 18 mm by 10 mm). The stone is probably from a flat panel, the back of which bears traces of chisel marks. The arches

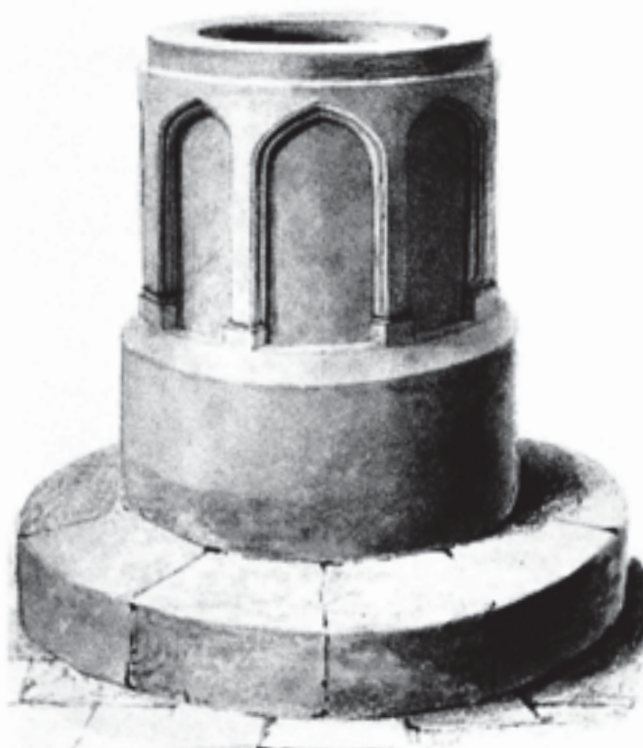
Fig. 134 Wells Cathedral font, drawn by John Buckler in 1827 (Somerset Archaeological and Natural History Society)

It is also noteworthy that no decoration is indicated in the spandrels, either by Carlos or by Buckler: they are shown blank. Nor is the flat-band moulding apparent. The same applies to Dollman's drawing.⁴⁸ Given the high quality and uniformity of agreement between these illustrations, there can be little doubt that the rough tooling of the font bowl, and the crude spandrel carvings, were masked from view in the nineteenth century. Further, it is perhaps worth noting that Buckler's drawing shows the arcading as four-centred, with simple, continuous mouldings around each arch

and its responds: there are neat moulded bases, but no imposts. This could support a Tudor or Stuart date for the plaster remodelling, but it is just as likely to be Georgian Gothick.

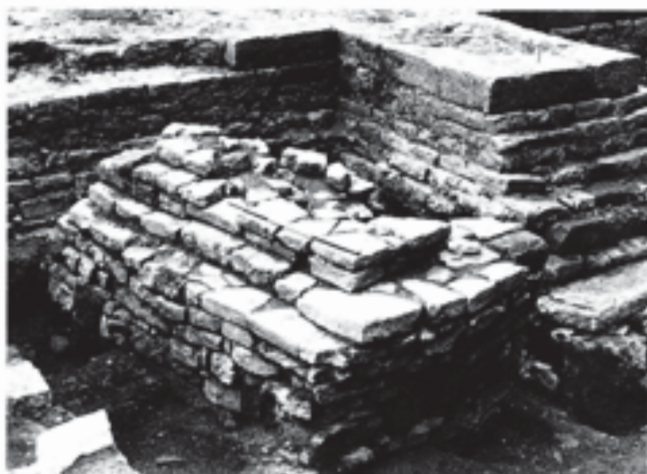
Fig. 138 Stepped foundation of the north-east buttress of the north aisle of the Lady Chapel (F1007c). Behind it is the buttressed north nave foundation of Stillington's chapel. View south-west. Scale of 75 cm

The site of the presumed first buttress (F1007a) was wholly lost, part of the middle one survived (F1007b), as did virtually all of the footing for the third (F1007c; Fig. 138). The east-facing corner buttress (F1007d) was represented only by a fragment of core rubble.

The buttresses were robbed to below medieval ground level, but sufficient survived of F1007c to show that it had been constructed with at least three offsets on its east side. The shallow projection of footing F1007b shows that the aisle had pilaster-buttresses. White lias was mainly used, bonded with soft pinkish-brown mortar with unburnt lime inclusions. The construction of the middle buttress was visibly different, and there were no surviving offsets; red sandstone rubble was employed here, as in the foundation fragment abutting the north-east corner of the nave. The mortar, however, was the same throughout.

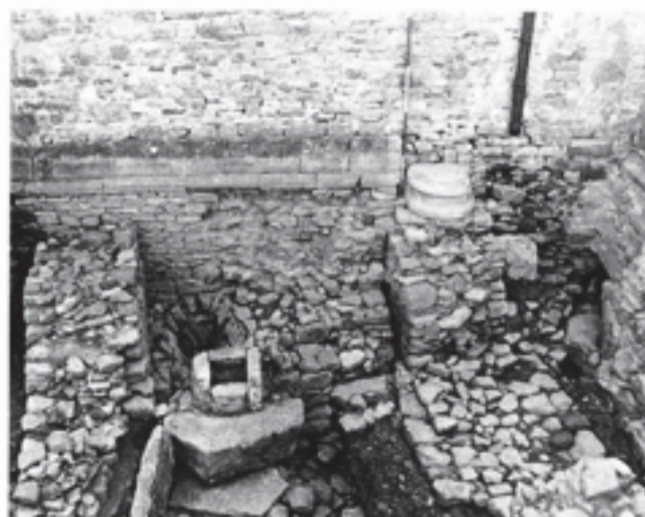
Fig. 139 Lady Chapel. General view of the abutment of the foundations of the south-west chapel to the cloister. The masonry in the centre foreground is the top of the great conduit. Scale of 2 m

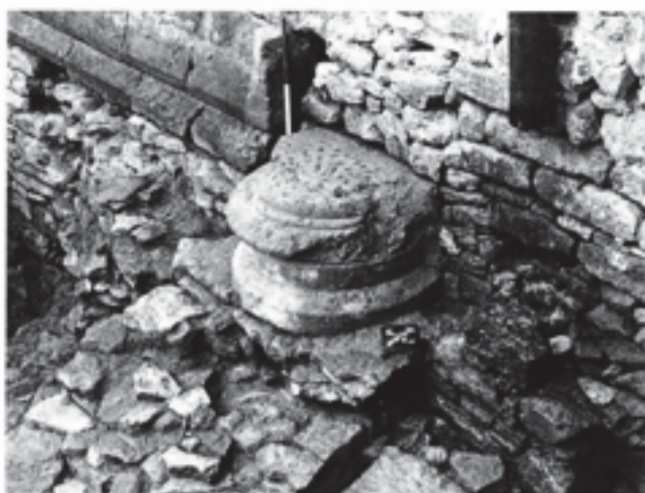
Fig. 140 Lady Chapel. The west respond-base of the arch between the nave and south-west chapel, looking south-west. A single piece of lias paving can be seen on the chapel-side (left of the base), and a fragment of medieval tile paving (*fleur-de-lys*) on the nave-side (Fig. 137, area H). Scale with 25 cm divisions

broad arch. Remarkably, the western respond-base, set hard against the cloister wall, has remained *in situ* (Figs. 80 and 139, F183); it was probably first exposed in 1873, when it was recorded by Irvine (1873, plan). The base was re-examined in 1894, when its association with the south aisle of the Lady Chapel was postulated (Buckle 1894, 37, pl. 2, F). The Douling stone base-block was specially made to accommodate a skewed respond (Figs. 140 and 141A). The site of the eastern respond, and the corner of the original nave which it must have abutted, were destroyed by one of the buttress foundations of Stillington's chapel (Structure 15).

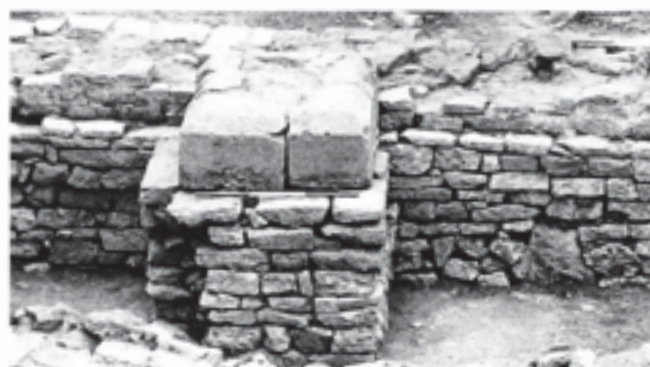
Fig. 142 Lady Chapel. South aisle foundation and mid-wall buttress (F186a), showing the surviving plain-chamfered plinth. Scale of 75 cm

In the reconstructed plan of the south aisle, shown on Fig. 137, the wall thickness is 70 cm, and the buttress measures 84 cm by 90 cm. The aisle's internal width can only be estimated, but must have been *c.* 2.75 m (9 ft). The length is unknown and is more problematical: it is merely an assumption that the aisle terminated flush with the south-east corner of the nave, and that there were clasping buttresses here (Fig. 135; *cf.* the north aisle, below). If that was indeed so, the aisle was of two unequal bays, for which no obvious reason can be suggested. It may therefore be that the south aisle was shorter than the nave, stopping *c.* 1.0 m short of the south-east corner, which would have imparted symmetry to the plan and south elevation. Effecting a junction at a later date with the new chancel would not have been as easy, but that was not a relevant consideration at the time.

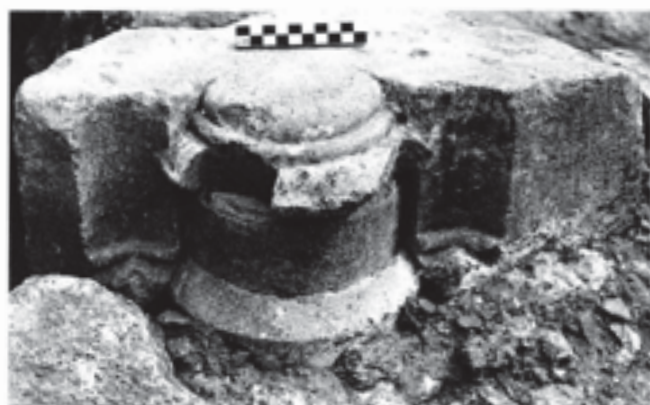
Fig. 143 Mid-thirteenth-century moulded base of a door jamb(?), reused in the foundation of Stillington's chapel. For the moulding profile, see Fig. 141F. Scale of centimetres

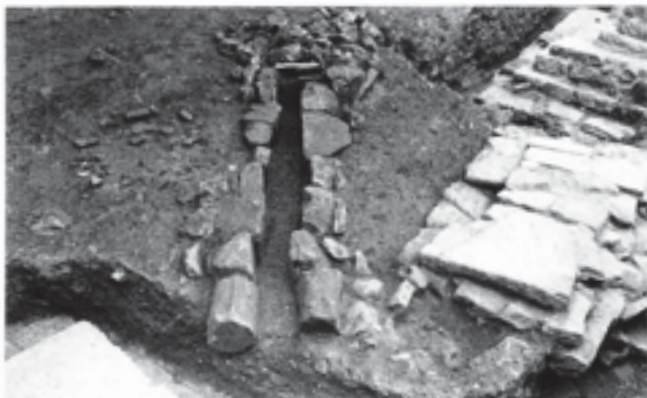
Fig. 147 Stone-lined drain (F646) running north-east from the north aisle of the Lady Chapel, to a soakaway pit (F667). Scale of 25 cm

Four lengths of stone-built drain associated with the disposal of rainwater from the roofs of the chapel were encountered. All were severed, so that their full runs could not be established. One flowed north-east (F646), away from the centre of the north aisle: it must have collected water from a spout between the north doorway and the western buttress, and discharged it into a soakaway (F667) in the former cemetery (Fig. 147).

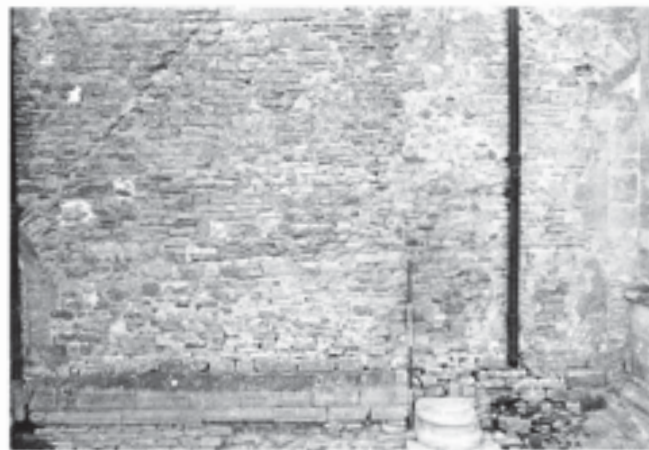
Fig. 150 Outer face of the east cloister wall, showing the abutment scars of the south aisle of the Lady Chapel. Far left is one jamb of the small, infilled doorway that led from the cloister into the Camery; far right is one jamb of the infilled doorway into the nave of the Lady Chapel. Scale of 2 m

The addition of the chapel — and subsequently the aisle — to the south side of the nave caused only slight disruption to the masonry of the cloister: no attempt was made to bond the two structures. The principal effect on the cloister was the cutting of a chase into its masonry, to receive a lead flashing for the abutment of the roof. The chase indicates that the chapel had

remarkably low eaves — only *c.* 2.9 m (9³/₄ ft) above ground level — and that the angle of pitch of the roof was 48° (Figs. 149 and 150).

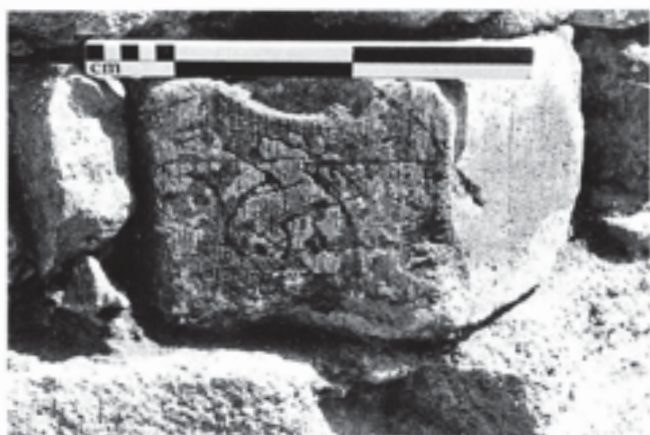
Fig. 151 Section of an octagonal column, perhaps from the north arcade of the Lady Chapel, reused in the foundations of Stillington's chapel. Note the limewashing and graffiti (cf. Fig. 141E)

The architectural fragments observed included: the respond base of a doorway (noted above), plain chamfered plinth stones, sections of string-course, roll mouldings from door or window arches, a semi-circular respond for a major arch, and several portions of octagonal respond and column-shaft (Fig. 141E). The diameter of the semi-circular respond is slightly too small for the extant base associated with the south-west chapel, but it could have belonged to another part of the south arcade. The octagonal fragments may have been derived from the arcade between the nave and the north aisle, where the semi-octagonal western respond base, although long gone, was still ghosted by surviving floor tiling (p. 179). Many of the moulded stones, together with plain ashlar, bore traces of limewash on their principal faces, and in some cases false-jointing was indicated by red painted lines. On one of the column sections was a deeply incised, geometrical graffiti, partly hidden by plaster (Fig. 151).

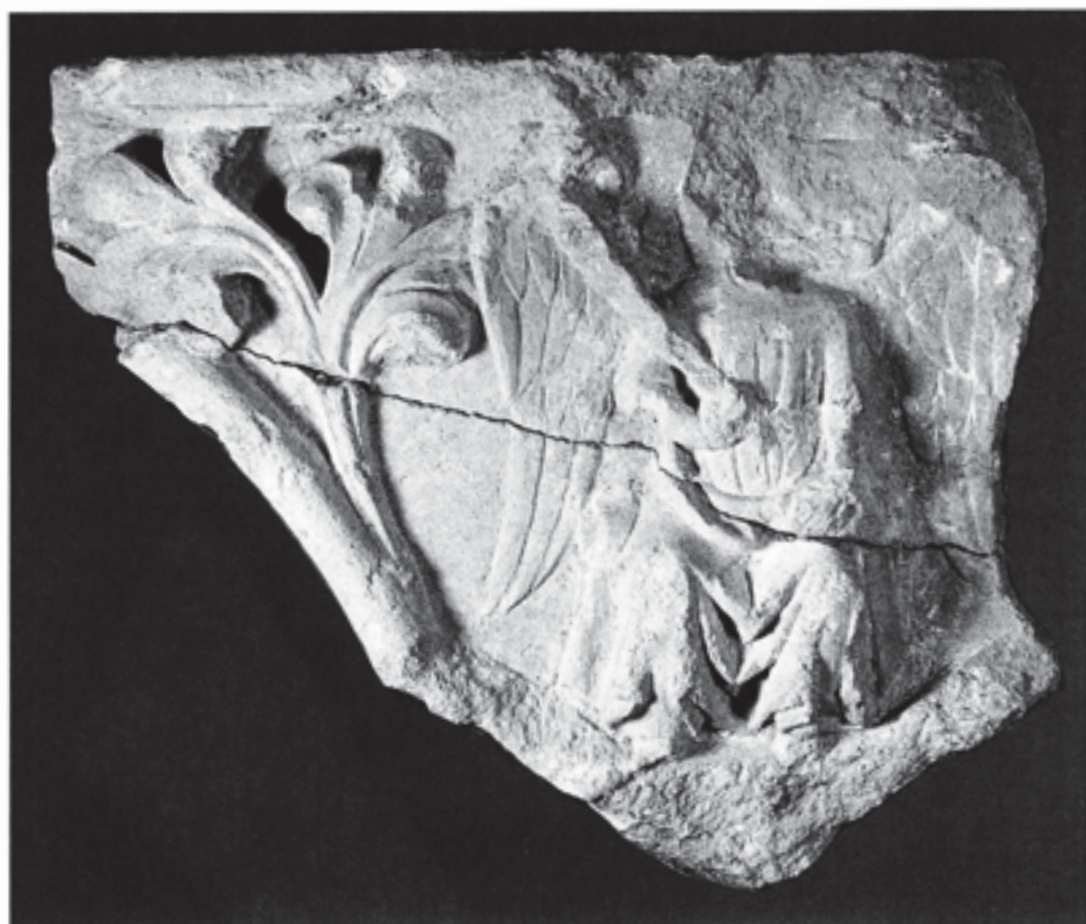
Fig. 152 Mid-thirteenth-century spandrel (no. 6) showing a seated angel, as recovered from the foundations of Stillington's chapel. Note the angel is headless, and compare with Fig. 444

Two rectangular blocks of dressed Douling stone with a small, rounded moulding on one edge were noticed in the foundations of the south nave wall of Stillington's chapel. Cleaning around the joints revealed these to be the top edges of panels of architectural sculpture, with their decorated faces horizontally embedded in the foundations. The decision was taken to extricate the two panels, and to retain them for display. Other, possibly similar, stones were not investigated and remain *in situ*. Upon removal, the two panels were found to be spandrels, derived from a trefoil-headed arcade of small scale and high quality workmanship. One spandrel depicts a hunting scene

involving St Eustace, or St Hubert (Fig. 448), and the other a seated angel holding a palm branch (Figs. 152 and 446). Both were battered and fractured, and the angel's head was lost but, remarkably, this was later found during excavation in Area 7 (Fig. 153).

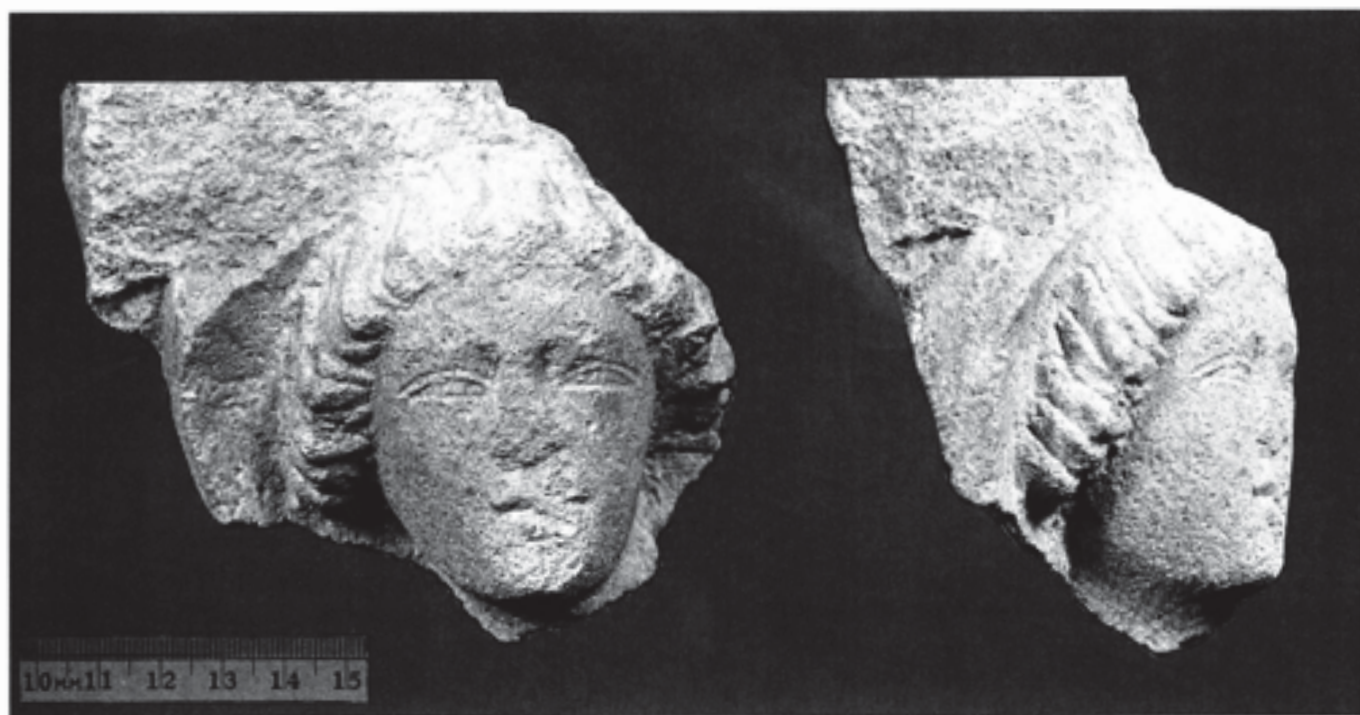
Fig. 153 Head of the angel belonging to the spandrel (no. 6) shown in Fig. 152, found separately. Left: full-face view; right: dexter profile

Spandrel 6: 'The Seated Angel' (Figs. 152, 153, 444 and 446)

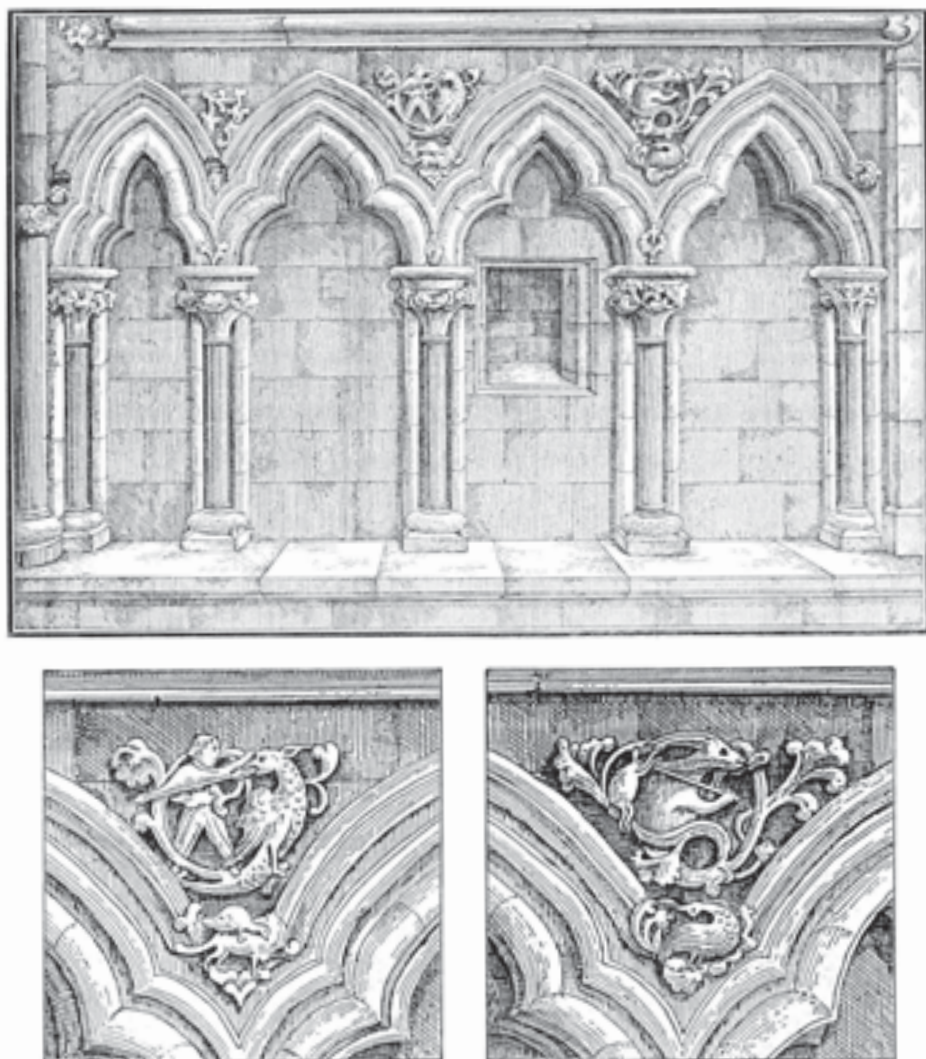
Fig. 155 Bristol Cathedral, Elder Lady Chapel. Wall arcading with sculptured spandrels, c. 1220. Enlarged views of beasts also shown. After Lysons 1803

A closer parallel in style for the Lady Chapel spandrels is found in the trefoil wall-arcading of the Elder Lady Chapel at Bristol Cathedral, dated to c. 1220 (Fig. 155; Lysons 1803, pl. 88). Here, both foliate and figural compositions occur in the spandrels, in an architectural setting to which the Wells Lady Chapel must have borne a distinct resemblance. Indeed, Wells' masons were involved in the construction of the Elder Lady Chapel (Thurlby 1997). Its stiff-leaf capitals, waterholding bases, mouldings and detached shafts of blue lias are all in the characteristic Early English style of Wells.

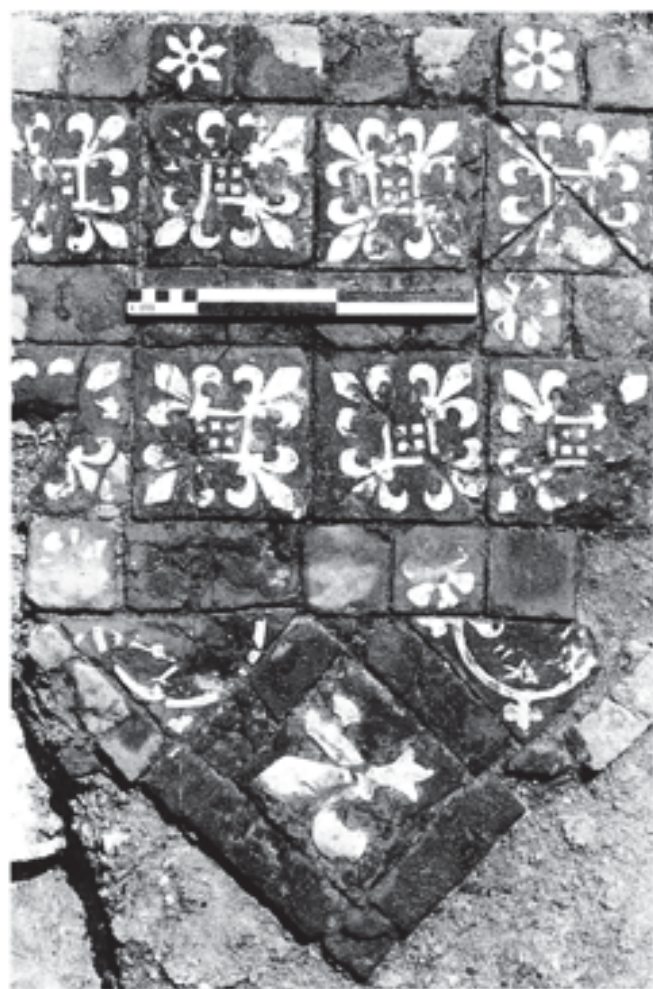
Fig. 158 Detail of the eastern part of the tile paving in area A, showing its worn and shattered condition

The surface of the pavement was well worn, to the extent that the inlaid decoration was wholly lost in some places. The tiles were also badly shattered, doubtless caused by falling masonry during the demolition of both this chapel and its successor. The distortion in plan of the east-west lines of the carpet was caused by slight slumping into an adjoining grave on the south.

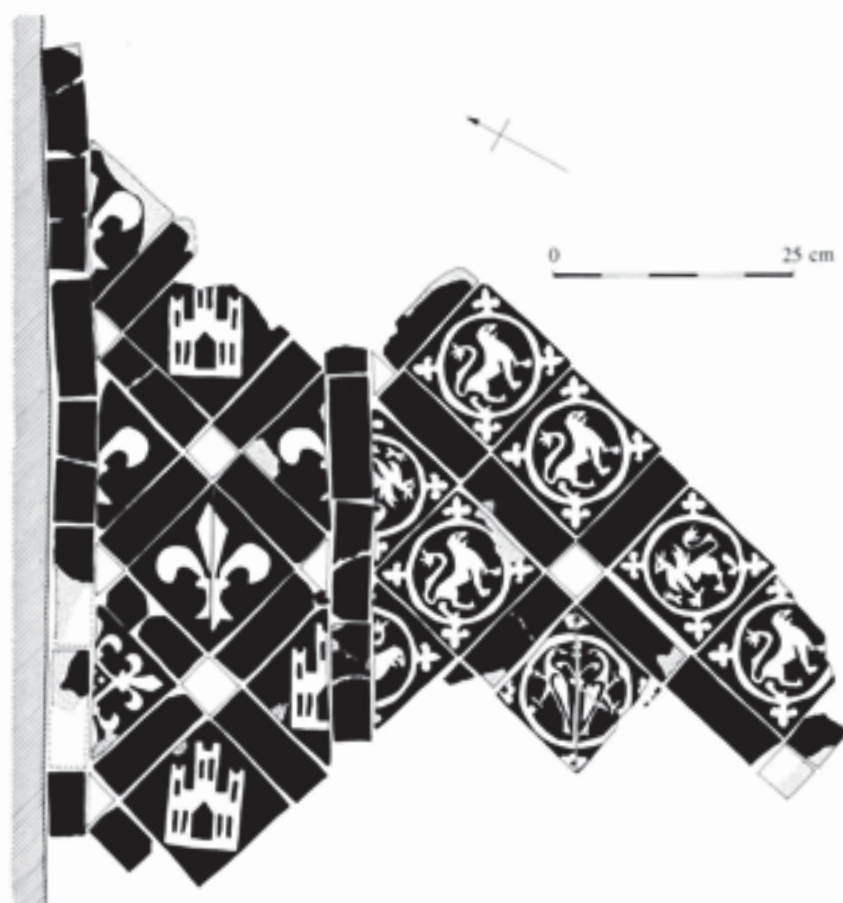
Fig. 159 Lady Chapel. Plan of medieval tile paving F1155, area B, in the north aisle. Scale 1:8

North aisle: Area B (Figs. 159–61)

The second largest area of tiling (F1155) lay in the north-west corner of the aisle, where it was sealed beneath a later mortar spread. The tiles, which were neatly laid, had been subjected to only a modest amount of wear underfoot, and in this respect were in a very much better state of preservation than those in area A: many retained not only their inlaid decoration, but also their glaze. The tiles had, however, been mostly shattered by falling masonry, and their surface was partially obscured by mortar adhesion.

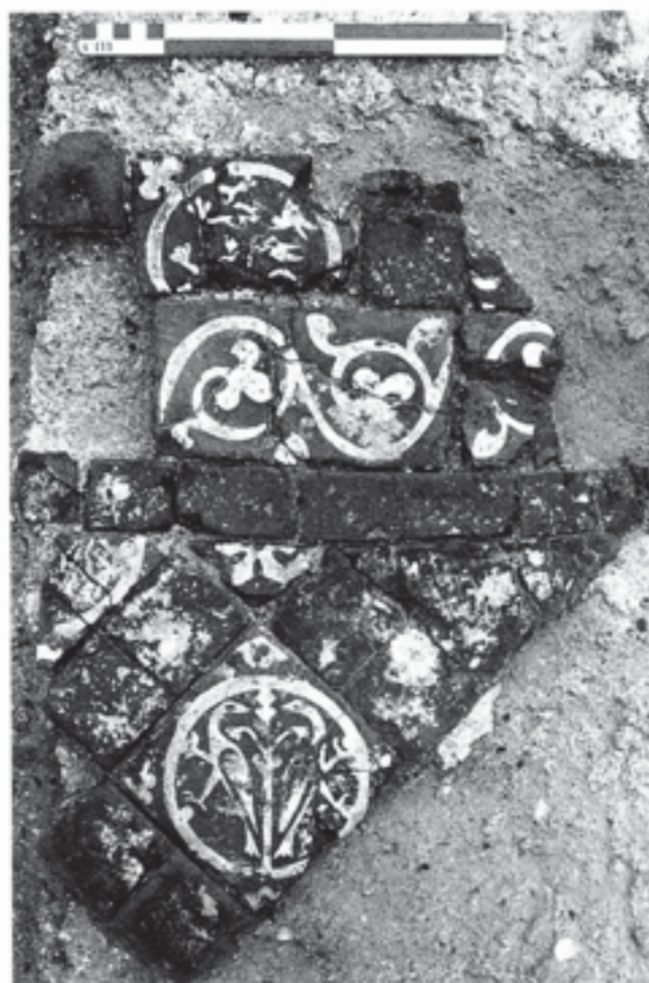
Fig. 163 Lady Chapel. Tile paving in area D. East is at the top. Scale of 25 cm

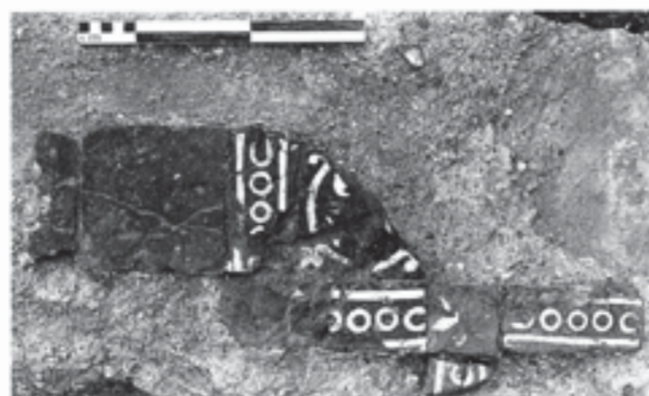
Fig. 164 Lady Chapel. Tile paving in area E. South is at the top. Scale of 25 cm

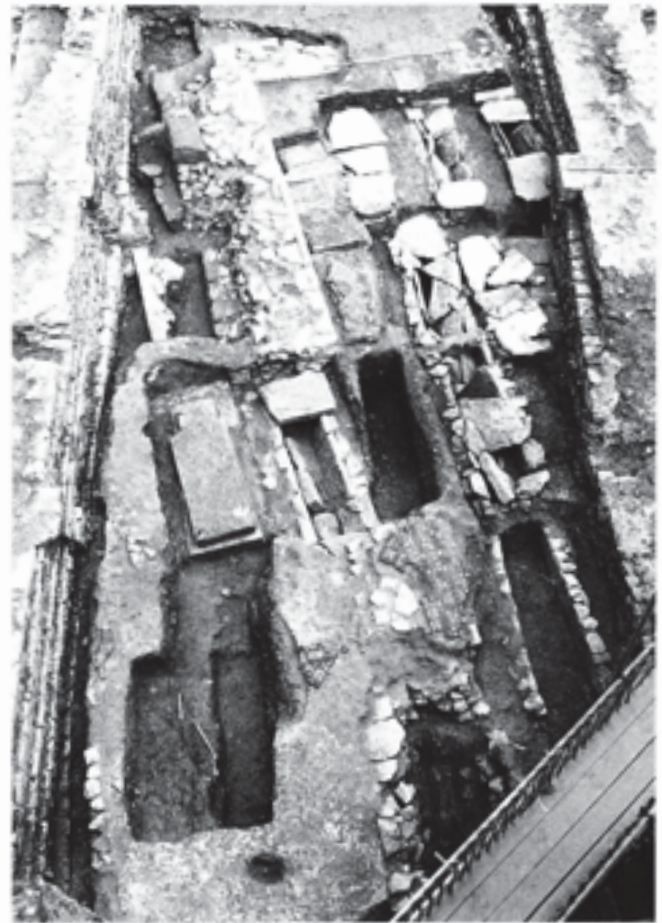
Fig. 166 General view (east) of the nave and north aisle of the early medieval Lady Chapel, showing associated cist-graves with their covers in place. The dominant walls flanking the photograph belong to the nave of Stillington's later chapel. Scales of 2 m

Altogether, twenty-five graves (one with two interments in it) were recorded in the chapel. Twenty-two of these lay in the nave and aisles: four of the graves were earth-cut, two contained stone coffins, and the remainder were stone-built cists (Figs. 166 and 167). The graves all lay within about half of the gross floor area of the nave and aisles, the other half having been totally destroyed by later foundations (Fig. 168). Within the surviving floor area there was space for only one more grave, against the north wall of the

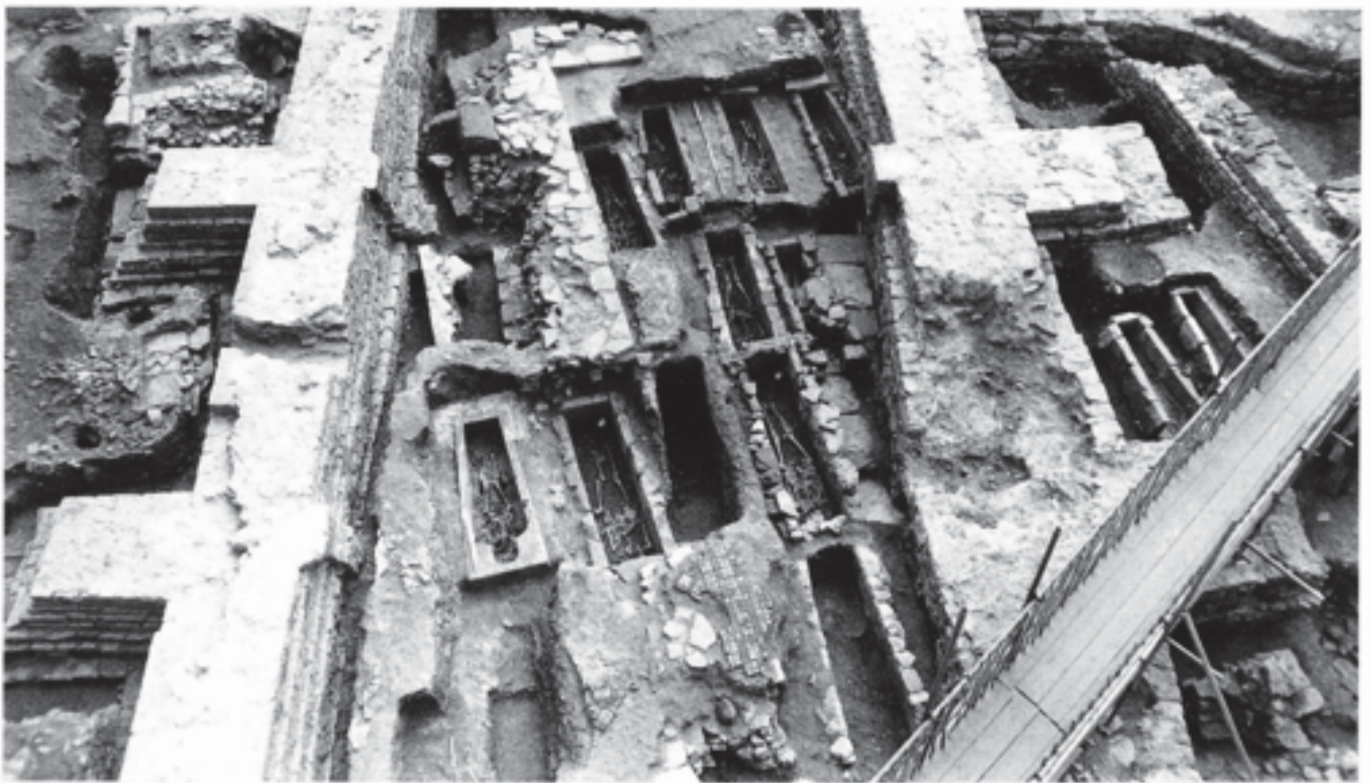
Fig. 167 General view (east) of the nave and aisles of the early medieval Lady Chapel, showing associated cist-graves following the removal of their covers. Scale of 2 m

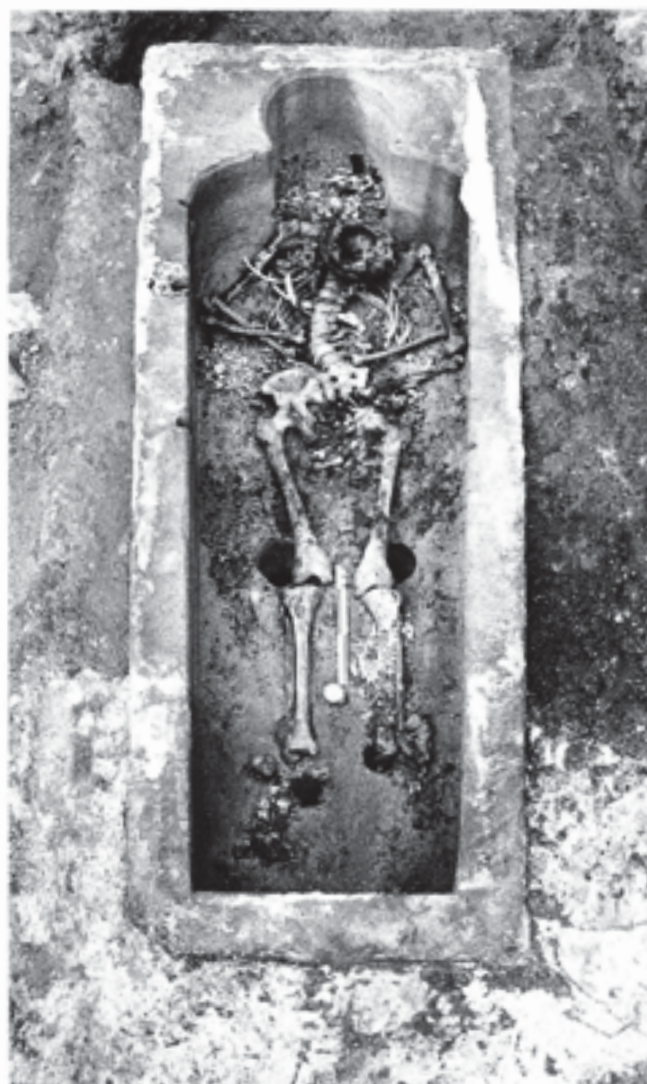
Fig. 170 Coffin F586, containing a priest's burial (B30). The grave fill around the coffin was capped with a thin layer of lime mortar, which survived only at the lower end. Scale of 25 cm

presumably a free-standing monument over the grave. The grave fill around the coffin was topped with a thin layer of white mortar, level with the rim of the coffin. This must have been done to enhance the setting of the open grave during the funeral. The mortar layer survived only at the east end of the coffin; elsewhere the surrounding fill had been removed by nineteenth-century excavations (Fig. 170). The existence of the coffin had previously been noted, but it had not been opened (p. 17; Buckle 1894, 38, pl. 2).

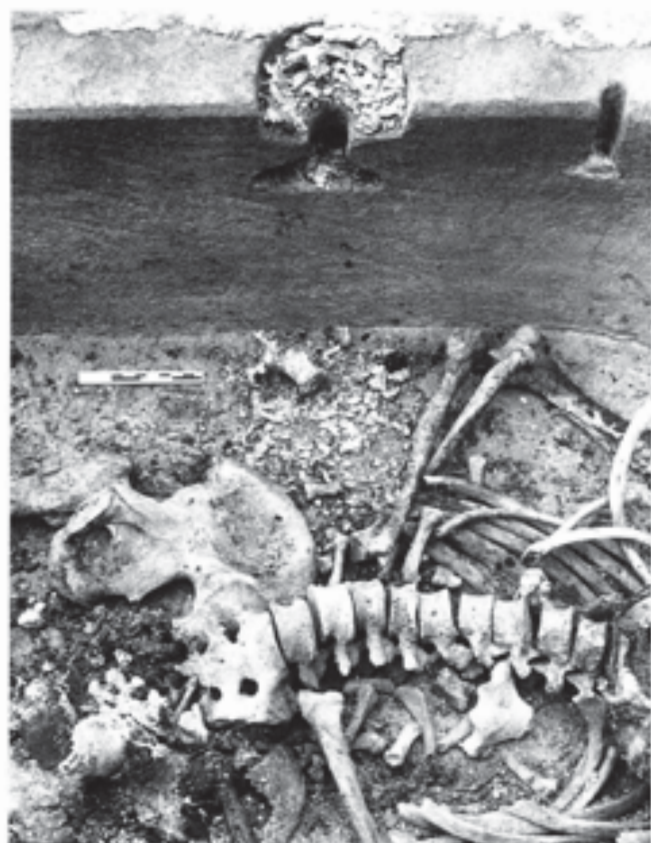
Fig. 172 Burial 30, showing the positions of the arms and hands, the partially disintegrated pelvis, and the chalice-recess in the wall of the coffin. Scale of centimetres and inches

The coffin is described in chapter 13 (p. 500; Fig. 496, no. 4). The burial (B30) was evidently of a priest, who was accompanied by a mortuary chalice housed in a purpose-made niche in the south wall of the coffin (Figs. 171 and 172). The pewter chalice, and the paten that lay upon it, had decayed to a pile of crumbs: only a portion of the stem was recognizable, and that had fallen to the floor of the coffin (see also p. 528 and Fig. 520). Despite being well sealed in a limestone environment, with no possibility of disturbance or animal intrusion, the condition of the skeleton was far from good. Some bones had crumbled, particularly the pelvis and the extremities of the limbs. The skull, which had rolled out of the head-recess and onto the chest, had also decayed quite severely (Fig. 173), but had left its teeth behind as a scatter in the dexter side of the head-recess. The positions of the arms and hands, and the outward obtrusion of the elbows, indicates that the hands were placed together on the stomach, probably pointing upwards in an attitude of prayer.

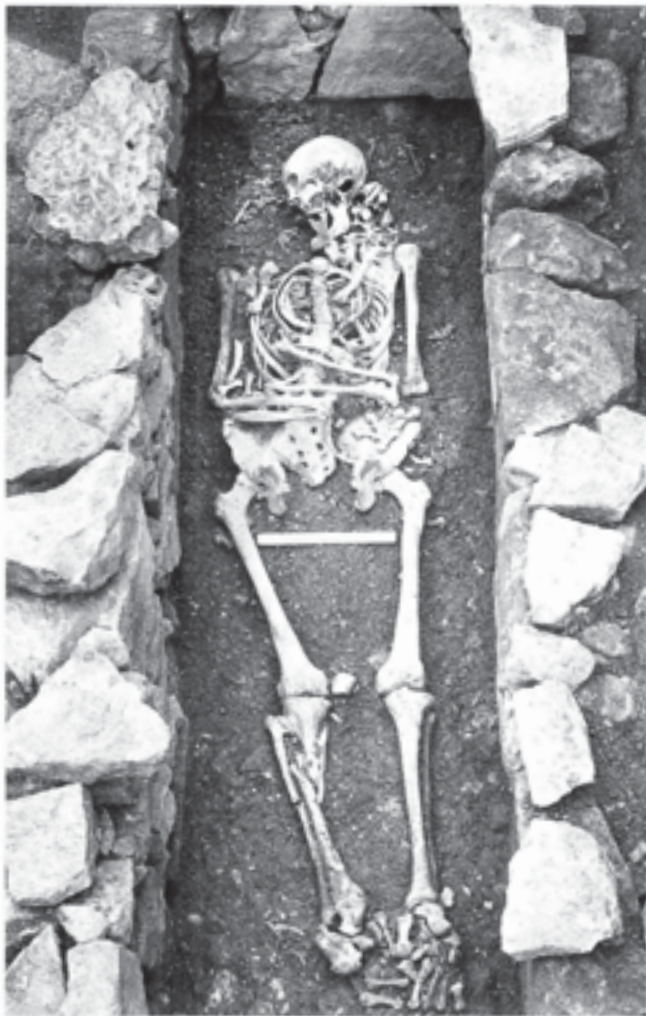
Fig. 176 Burial 32, in a timber coffin within a rubble-built cist. This is an example of near-perfect bone articulation which survived the decay process. Scale of 25 cm

built from a collection of old materials. It housed a nailed wooden coffin containing burial 32, which was in a near-perfect state of articulation (Fig. 176). The construction of the coffin was curious: there were variously angled nails at the west end, a row along the north side, and a group with their points downwards at the east end. The last included a line of nails running across the coffin, over the knees.

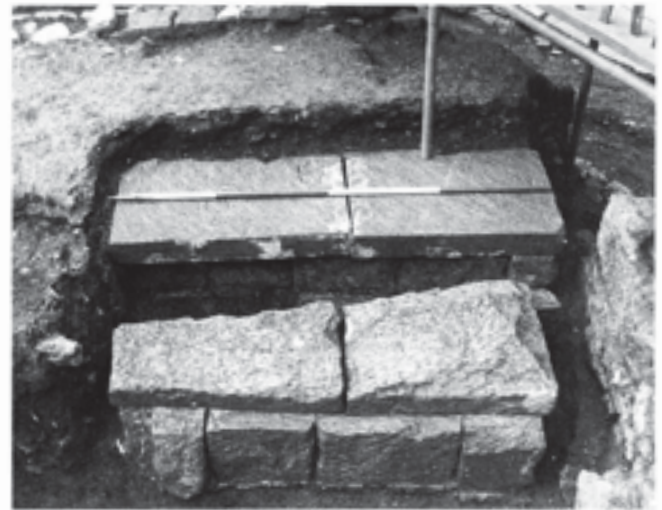
Fig. 177 Cists F560 (foreground) and F559 in the south aisle of the Lady Chapel, before opening. View south. Scale of 2 m

Immediately to the south, and seemingly sharing a contiguous construction pit, was another stone cist built entirely of dressed Doulling blocks (F559; Figs. 177 and 523). These were freshly cut for the purpose:

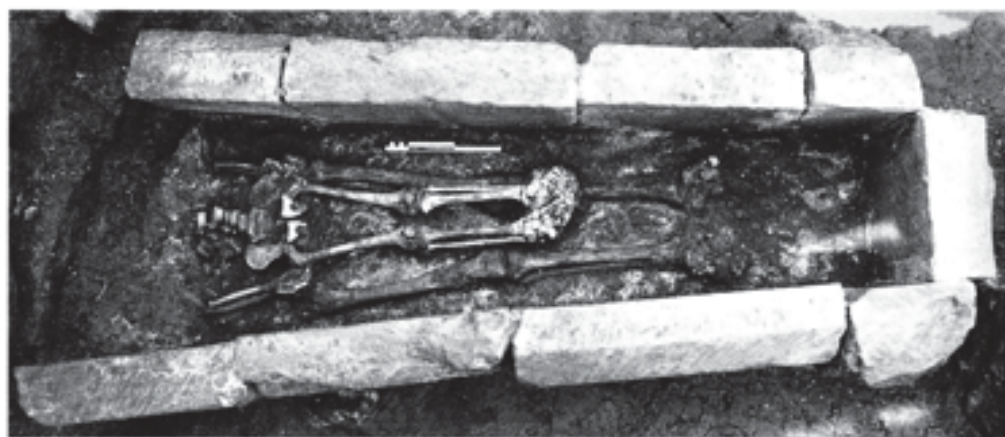
Fig. 178 A double burial in cist F560. Sections of chamfered limestone plinth have been used to form the sides of the cist. The child (B28) overlies an adult male (B27). The west end of the grave has been lost. Scale of 25 cm

8–9 years. Bone preservation was poor. There is little doubt that the two were interred contemporaneously (Fig. 178), and no wooden coffins were included.

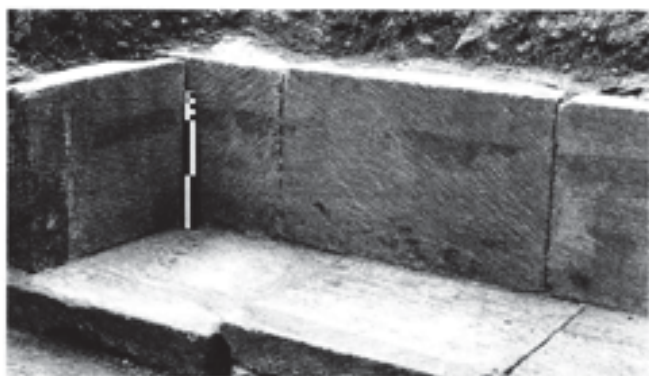
Fig. 180 Detail of the construction of the east end of cist F559, when partly dismantled. Note the brown staining and 'tide mark' on the walls. Scale of 25 cm

the exposed faces and edges were finely tooled, while the back faces were left rough. There were four stones on each side and one at the east end; at the west end a head-recess was carefully formed using four blocks (one was subsequently displaced). Three blocks defined the recess, while the fourth was a pillow-stone, slightly hollowed and rounded on the leading edge. The grave floor was paved with five slabs of Doulling stone, laid before the walls of the cist were built; the lid, made of two slabs, was mortared in place (Figs. 179 and 180).
