WELLS CATHEDRAL

Excavations and structural studies, 1978–93

*Excavations and Structural Studies,
1978–93*

ARCHAEOLOGICAL REPORT 21

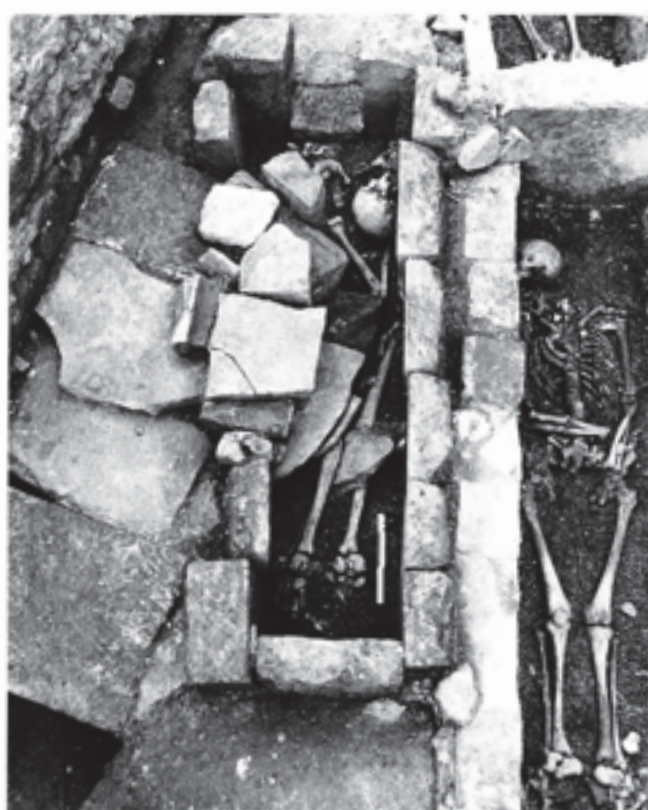
Fig. 182 Cist-graves F593 (centre) and F587 (right), in row 5 in the nave of the early medieval Lady Chapel. Intruding on the left are the cover-stones of the later and differently aligned grave F594 (associated with Stillington's chapel). Scale of 25 cm

Towards the middle of the nave lay two more cist-graves (Fig. 182). The northern one (F587) was the earlier and it also antedated the neighbouring cists in row 3 (F585) and row 5 (F589 and F590). The sides of the cist were constructed of small pieces of mortared Douling stone, many of which were reused and had been cut down from large ashlars with joint-keying grooves; there was also a piece of chamfered plinth with diagonal tooling. The east end was formed from a single, roughly dressed block, and the west end from a

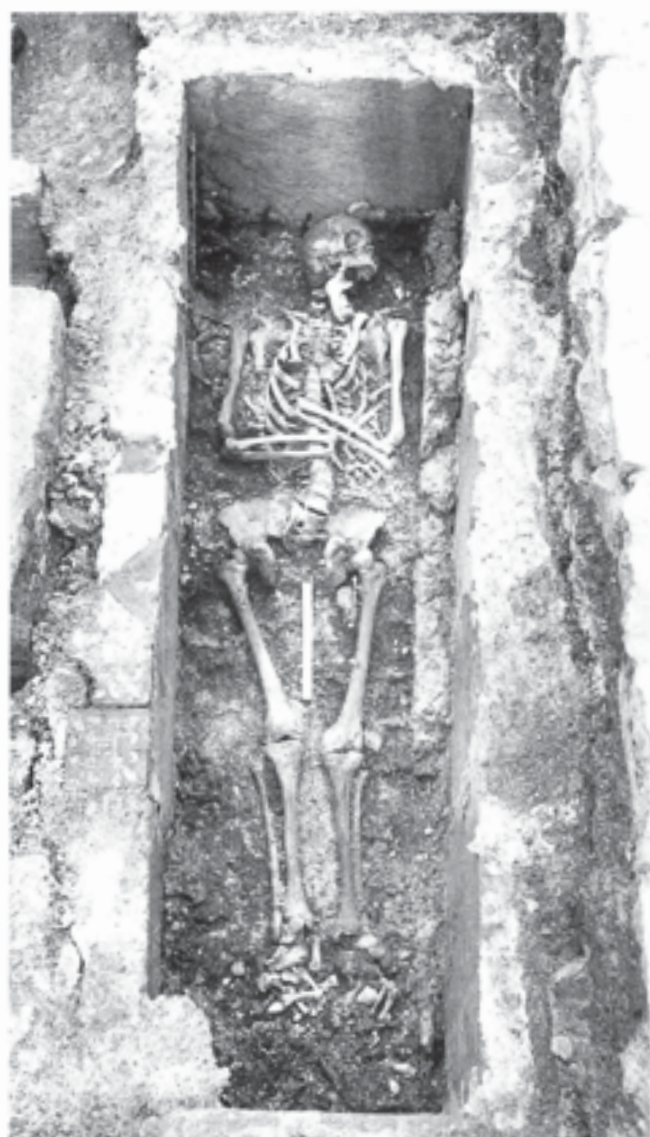
Fig. 183 Stone cist F588, in the nave of the Lady Chapel, containing burial 37 within a wooden coffin. Medieval floor tiles were used in the construction, as seen on the south side (left). Scale of 25 cm

Within the nave, and hard against its north wall, lay cist-burial F588 (Fig. 183). The two sides were each made of four large blocks of Douling stone with pronounced diagonal tooling; there were single blocks at either end. The grave had a clay floor, with a thin skim of lime mortar over it. The cover comprised five slabs of squared Douling stone, which were thoroughly mortared to the structure below; worn floor tiles of the

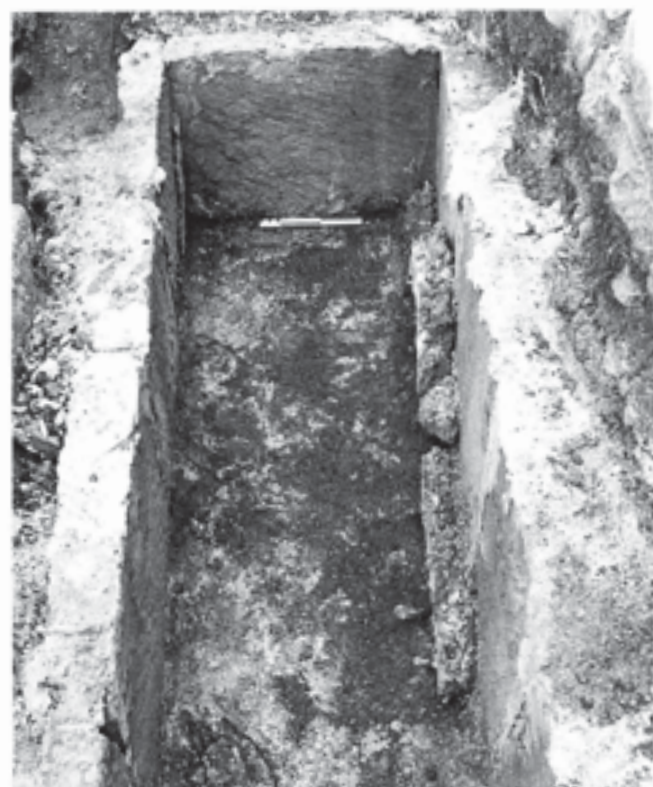
Fig. 184 Cist F588, after the removal of burial 37. On the right can be seen a wedge of mortar which fell into the gap between the coffin and the north side of the cist, preserving an impression of the wood grain, and trapping coffin nails. Scale of 25 cm

The skeleton (B37) was well preserved and had been contained in a heavily nailed wooden coffin (F618; Fig. 524). Owing to the liberal use of mortar in the construction of the cist, squeezes of surplus material had fallen into the void between the coffin and the masonry walls, forming a negative 'cast' of the base of the coffin (Fig. 184). In part, this cast stood 7 cm high, preserving marks of the wood grain. Oak was evidently the timber used. The grain of the end-board on the west stood vertically, as did a series of nails on the floor of the cist; this showed that the end-board was placed on top of the base-board, rather than clasping it as was commonly the case in the Middle Ages. Wood-grain impressions from the lid of the coffin were preserved in

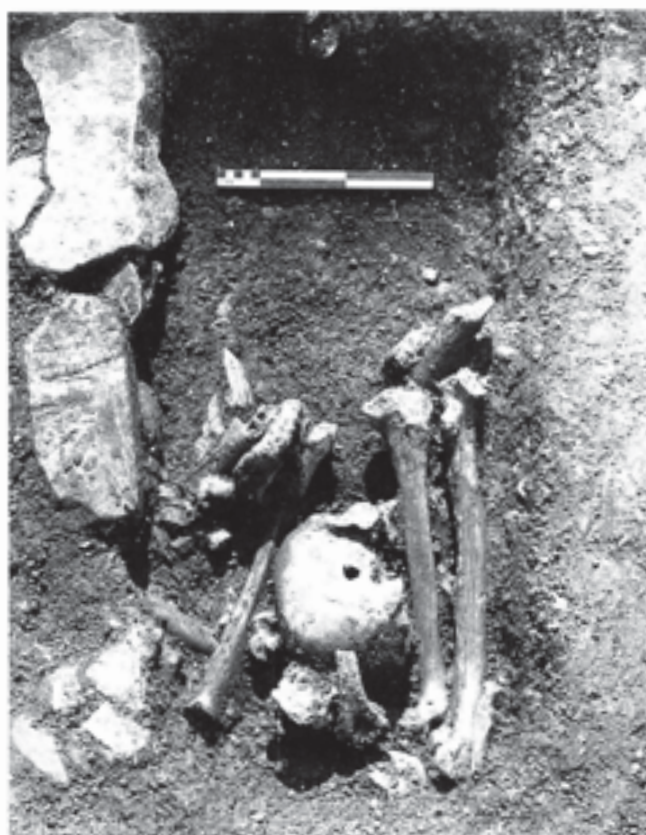
Fig. 186 Rectangular pit containing a skull and long-bones, evidently a medieval reburial of a disturbed skeleton. View west. The deposit lay axially at the east end of the nave, perhaps in front of an altar: see Fig. 185. Scale of 25 cm

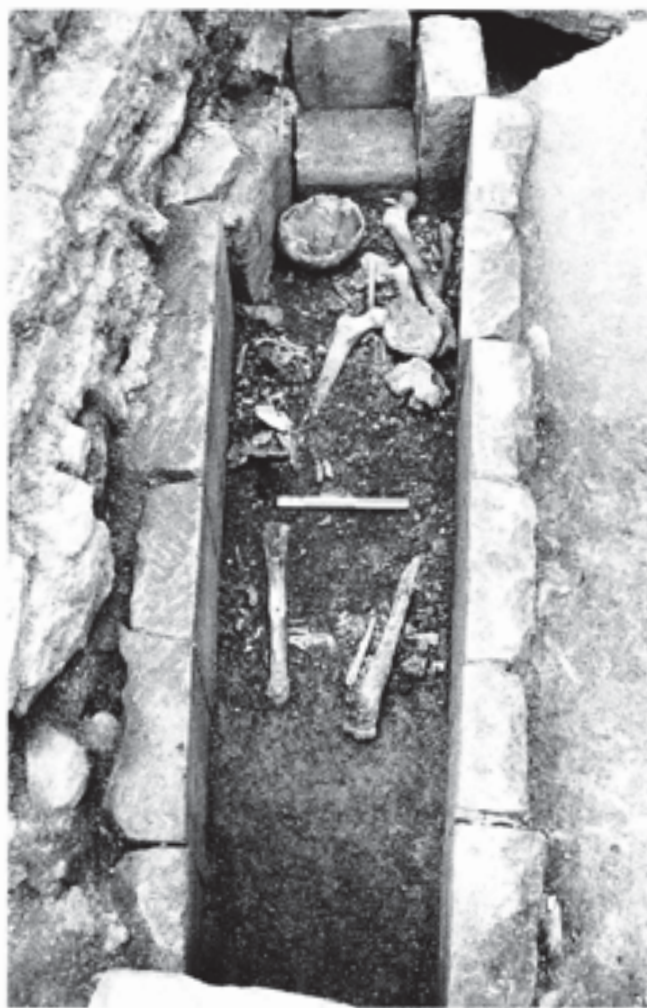
Fig. 187 Cist F591. *cpmtaomomg tje dostirned remains of burial 40. Scale of 25 cm*

The final grave recorded in the nave was another cist, F591, built of finely dressed Douling stone blocks with six per side, bedded on mortar and stonedust. The head-recess at the west end was again formed with three upright blocks (one missing) and a pillow-stone (Fig. 523). The floor of the grave was of clay, and there was no inner coffin. The cist was covered by four rough slabs of yellow sandstone, one fractured and collapsed. Basically, the cist was intact, but the skeleton (B40) was disturbed and very fragmentary, although there is no apparent reason why this should have been so. Many of the bones were missing, and there were supernumerary bones present. The lower legs were found correctly juxtaposed, but were too far west in the grave: they lay approximately where the thighs should have been. The skull was not in the head-recess, but lay in the thoracic region, where the femora and parts of the pelvis also occurred (Fig. 187). In this area, and further down the grave (where the pelvis should have been), were found fragments of cloth and gold-braided ribbon (Figs. 188 and 189; Pl. IV; p. 534). A strip of this ribbon was tied with a knot, as though it had once been wrapped around a parcel of bones.

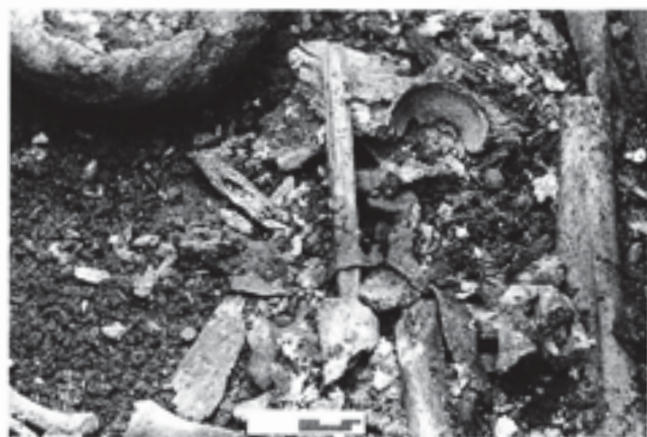
Fig. 188 Detail of burial 40, showing the disintegration and dispersal of bone, and the crossed ribbons that appear to have been used to tie-up a parcel (centre); cf. Fig. 189. Scale of centimetres and inches

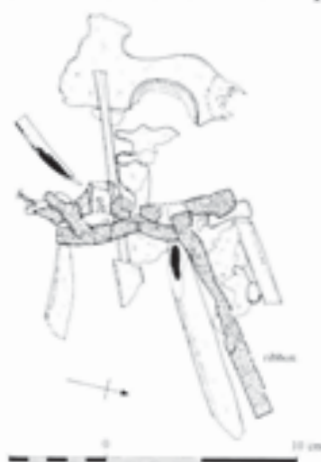
Fig. 189 Plan of gold-braided ribbon overlying decayed bones in the thoracic region of burial 40. The ribbon was evidently knotted, and would appear to have been used to tie a small parcel of bones. Scale 1:4

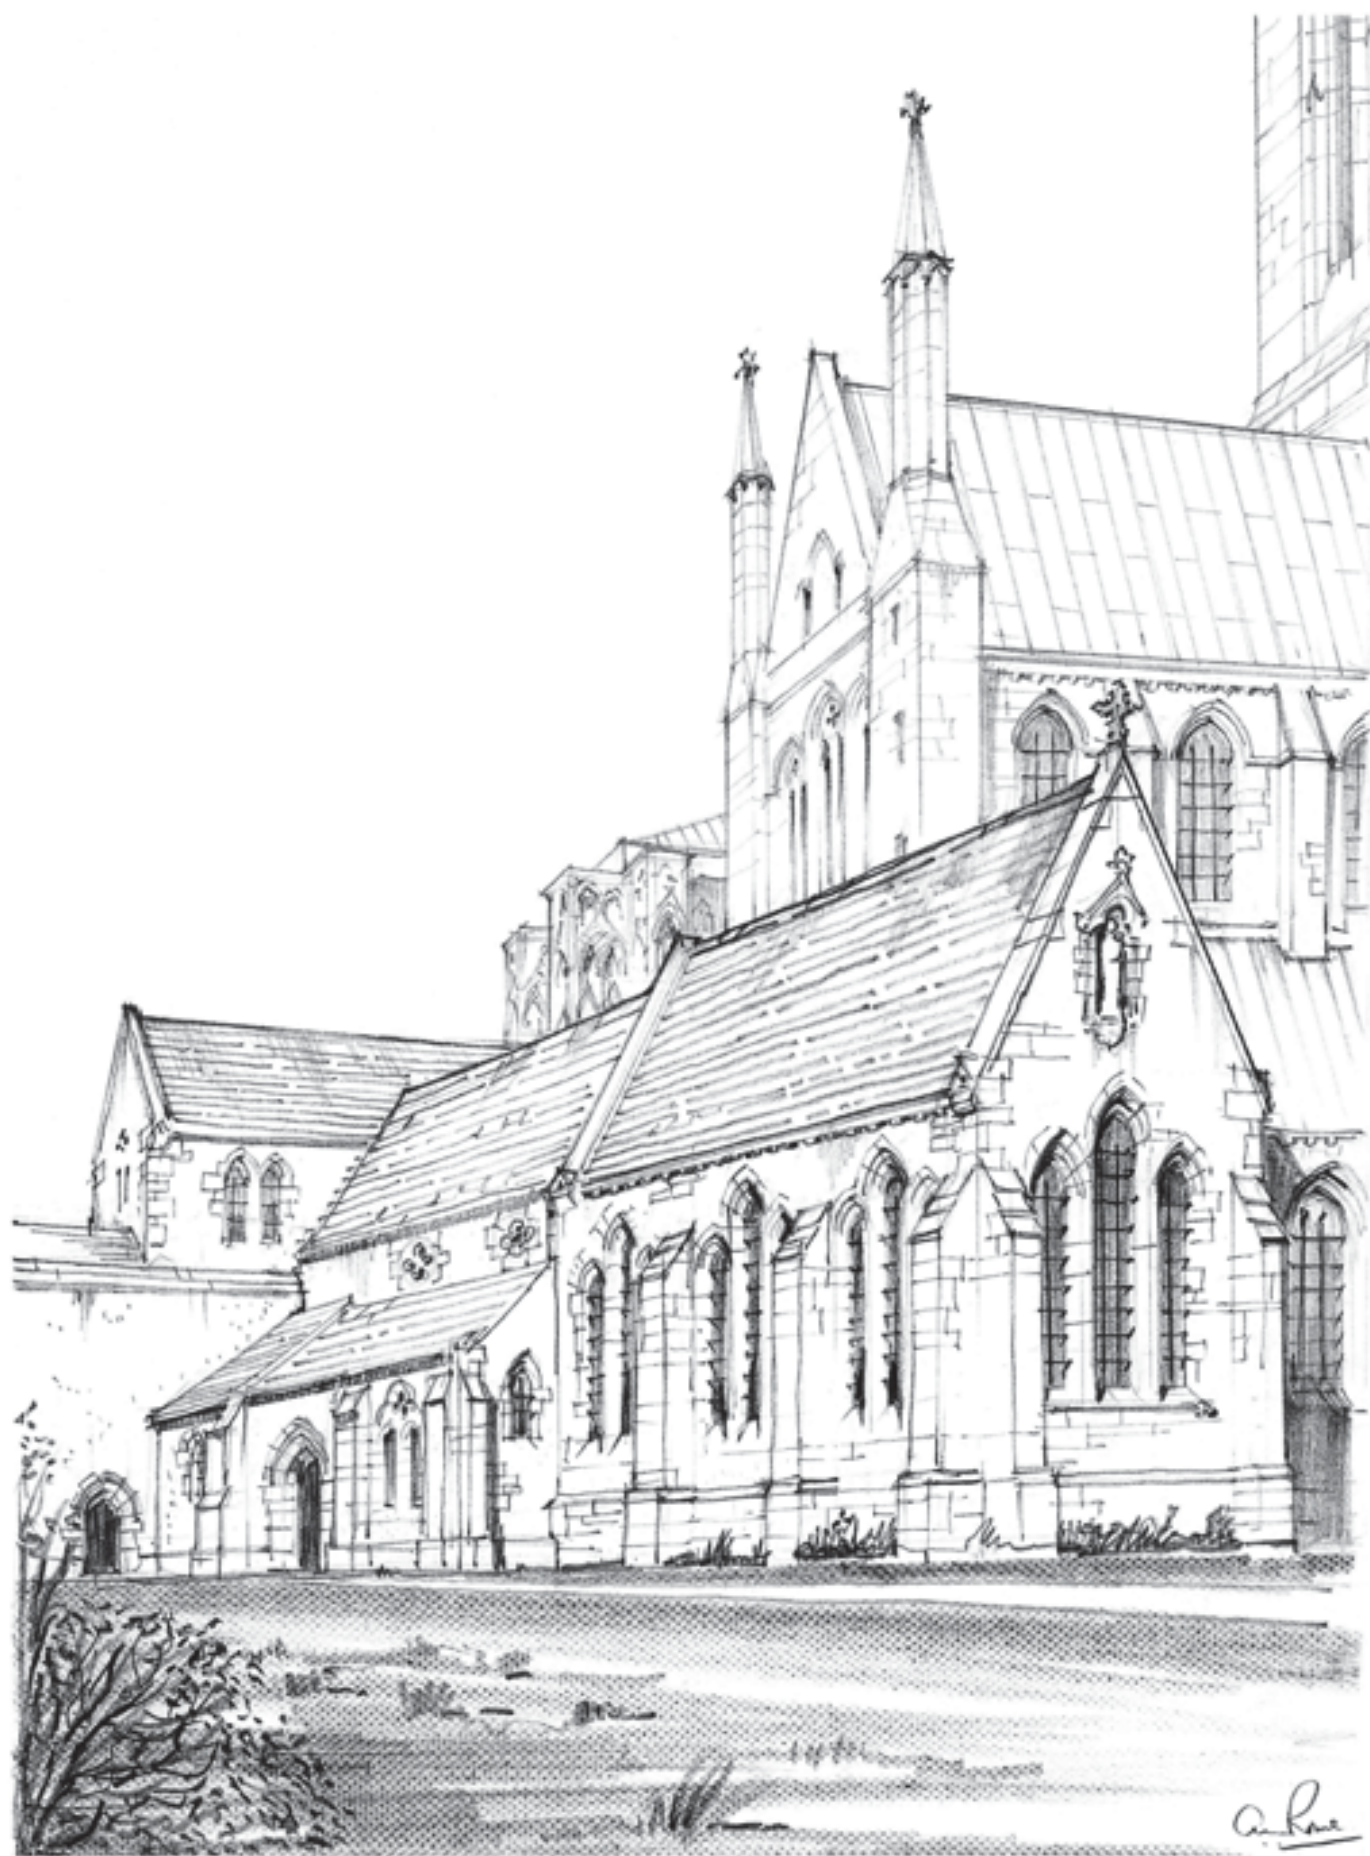
Fig. 194 Artist's reconstruction of the Lady Chapel-by-the-Cloister in the late thirteenth century, seen from the south-east. Drawn by Alan Rome

At close to life-size, the scale would have been appropriate to a gable niche, as already observed by Tudor-Craig (1982, 122). A date of *c.* 1300 has been suggested for the figure, implying that it was an addition.¹⁸ With these observations and deductions in mind, it is possible to attempt a reconstruction of the general appearance of the Lady Chapel in its late thirteenth-century form (Fig. 194).

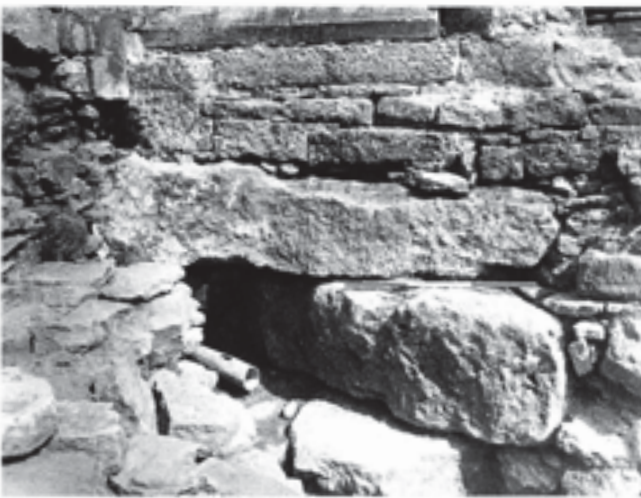
*Fig. 200 The lead water-pipe of *c.* 1451–53 emerging from beneath the junction between the east cloister (left) and the south wall of Stillington's chapel. The large sandstone blocks provided a protective casing. Scale of 75 cm*

The water-pipe entered the Camery from the grounds of the Bishop's Palace, near the south-east corner, taking a diagonal course towards the south aisle of the old Lady Chapel-by-the-Cloister (Fig. 135). The pipe skirted around the mid-wall buttress, before cutting through the threshold of the south door, and taking a swan-necked course under the chapel floor (Fig. 136). The pipe then emerged into the east cloister after passing under the threshold of the main doorway to the chapel (pipe course 1, Figs. 199B and 200). That is where Stillington's builders found it.

At the west end, where the nave wall joined the cloister, the water-pipe and its duct were protected by two huge blocks of sandstone built into the former Lady Chapel door opening. One block flanked the pipe on the north, while the other bridged over it (Figs. 200

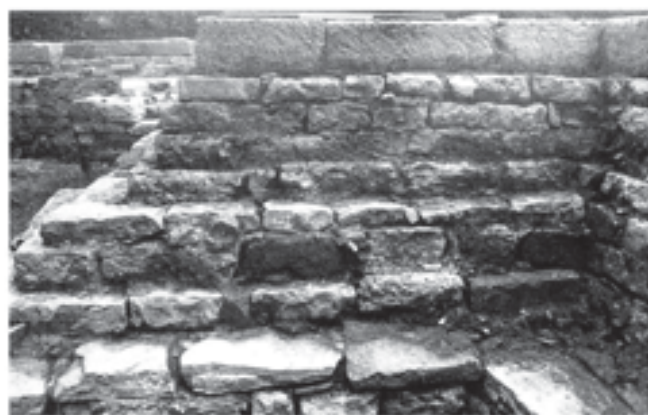
Fig. 201 Stillington's chapel. Stepped buttress foundation (F337b) on the north side of the nave, showing the footing-course of Chilcote stone; west face. Scale of 75 cm

alone being of Chilcote stone. Only about 15% of the wall circuit survives to a height that includes the footing course, the best preserved areas being the north side of the nave (Fig. 201) and the north transept stair-turret (Figs. 213 and 214). On the south side of the chancel, where some of the footing course survives around the buttresses, the Chilcote blocks are of exceptional size, being 40 cm in thickness, and up to one metre in length (Fig. 202). The extent of survival of the footing is indicated by a solid outline on the plan, Figure 196.

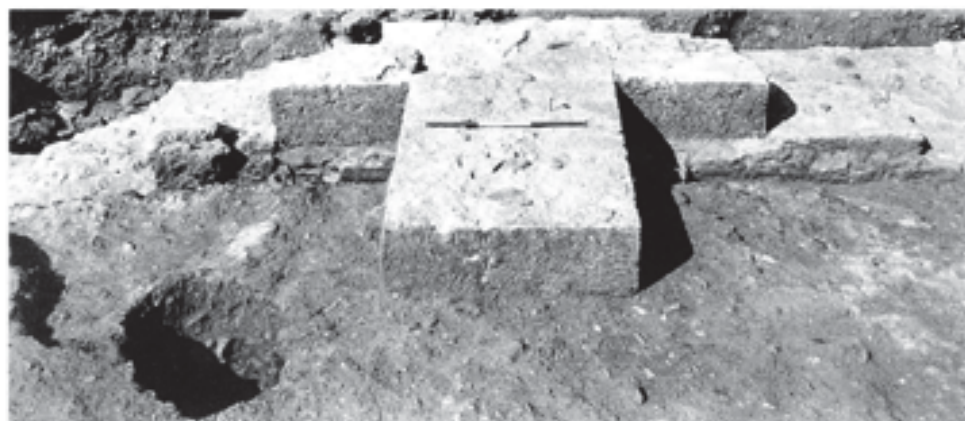
Fig. 202 Stillington's chapel. Footing-course of large Chilcote blocks of buttress F1208f, in relation to contemporary ground level on the south side of the chancel. View north. Scale of 75 cm

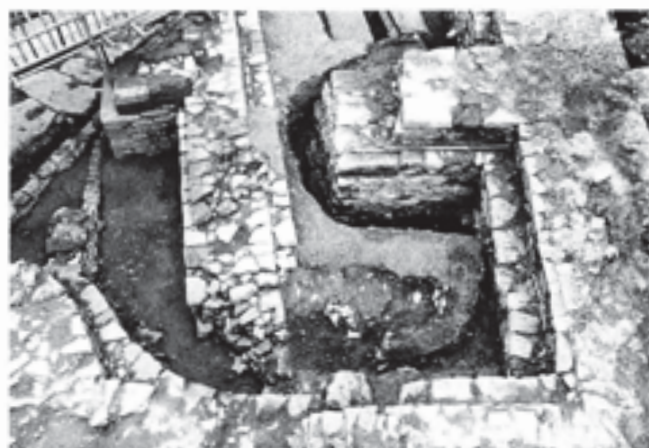
Fig. 205 Junction between the nave (right) and south transept of Stillington's chapel, showing also buttress F352b (note Victorian narrow-trenching around the walls). A section of the buttressed south aisle wall of the thirteenth-century Lady Chapel survives left of centre. Scale of 2 m

The foundations for the south nave wall (F352) and its buttresses were c. 2.2 m wide, and for the most part were only slightly battered; there was a single substantial offset just below ground level, best preserved in buttress F352b (Fig. 205); and there must have been a lesser offset (up to 20 cm wide) carrying the footing-course, but this is not preserved, other than at the extreme west end beneath the surviving wall stub. The toe of the east buttress on the south wall (F352b) was battered, for the better distribution of the outward thrust exerted by the vaulting. The corresponding edge of the west buttress (F352a), however, was more sharply curtailed, and built into it were several pieces of freestone that had formerly defined one flank of a duct (F314) to carry a lead water-pipe (pipe course 2).

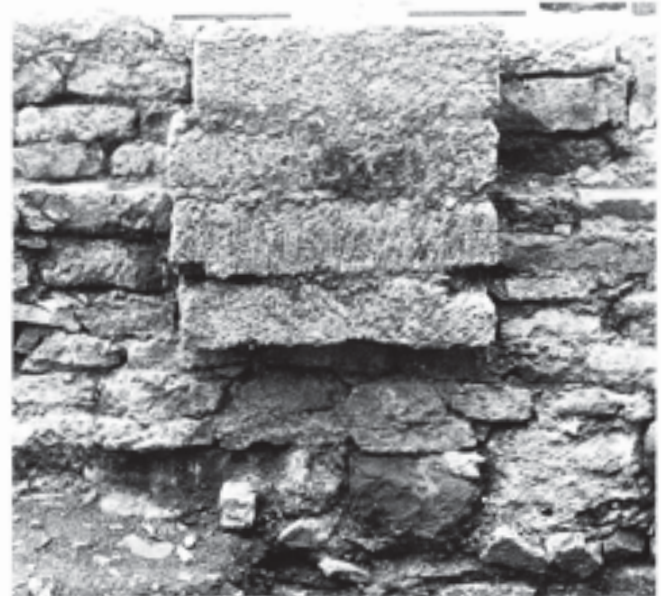
Fig. 207 Stillington's chapel. Corbelled foundation of Chilcote blocks for the support of a wall-shaft between the first and second bays on the south side of the nave. Scale of 75 cm

On the inner face of the south nave wall a pilaster-like projection of masonry, opposite the eastern buttress, marked the position of the vaulting wall-shaft between the first and second bays. The projection, which comprised four courses of Chilcote ashlar, was an integral feature of the foundation, although it did not begin at the lowest level of construction (Fig. 207). Instead, it was corbelled out after several

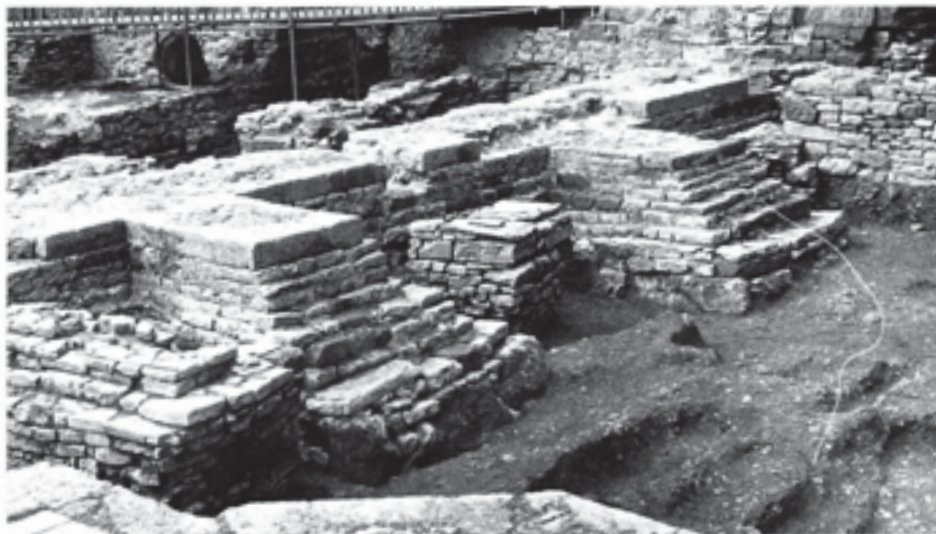
Fig. 208 Stillington's chapel. North wall of the nave, showing the stepped foundations of buttresses F337a and F337b. In between, are the remains of two buttresses belonging to the earlier Lady Chapel. Scale of 75 cm

The north foundation of the nave (F337) was markedly different in construction, with superior coursing: it averaged 1.8 m wide at the base (buttresses 2.0 m wide), and rose in a series of regular steps, up to the footing-course, much of which was well preserved (Figs. 208 and 209). This included the complete outline of buttress F337b, which measured 1.0 m by 1.38 m (3 by 4 N ft). The stepped construction of the foundation was not only regular along both faces of the wall and around the buttresses, but also included one of the projections upon which the vaulting wall-shafts rested (Fig. 210). The other projection (between bays 2 and 3) was a vertical pilaster-like feature, fully bonded to the wall and provided with its own projecting foundation (Fig. 211).

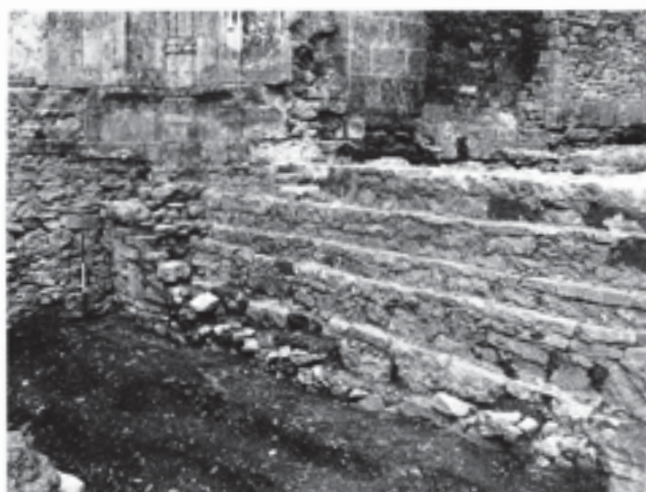
Fig. 209 Interior of the north wall of Stillington's nave, contrasting its neatly stepped foundation (right) and the rough rubble foundation added against the cloister (left) for the support of the wall-bench and screenwork at the west end. Scale of 75 cm

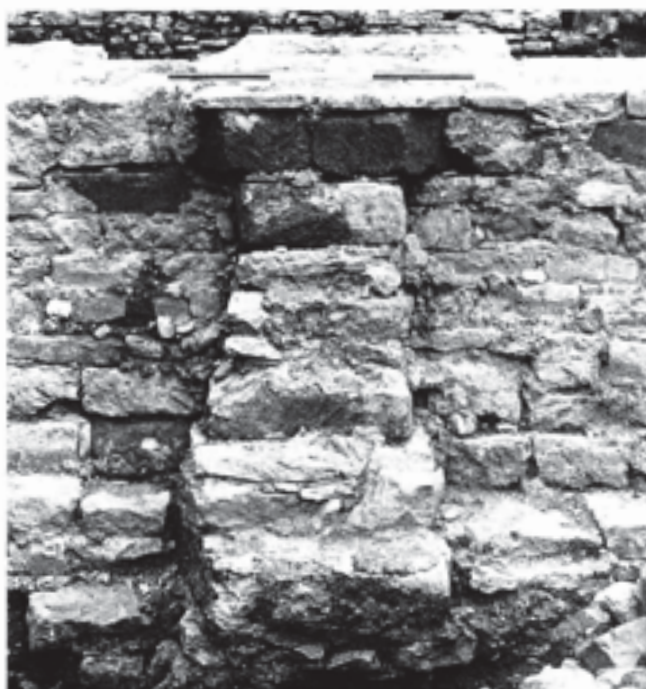
Fig. 210 Stepped projection in the foundation of the north wall of Stillington's nave, intended to receive the base of the wall-shaft between the first and second bays. Note the canted ashlar blocks at the top. Scale of 75 cm

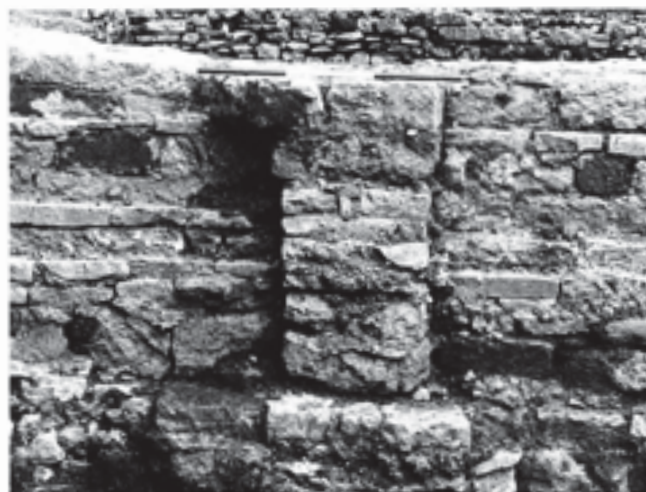
Fig. 211 Pillar-like projection in the foundation of the north wall of Stillington's nave, intended to receive the base of the wall-shaft between the second and third bays. Scale of 75 cm

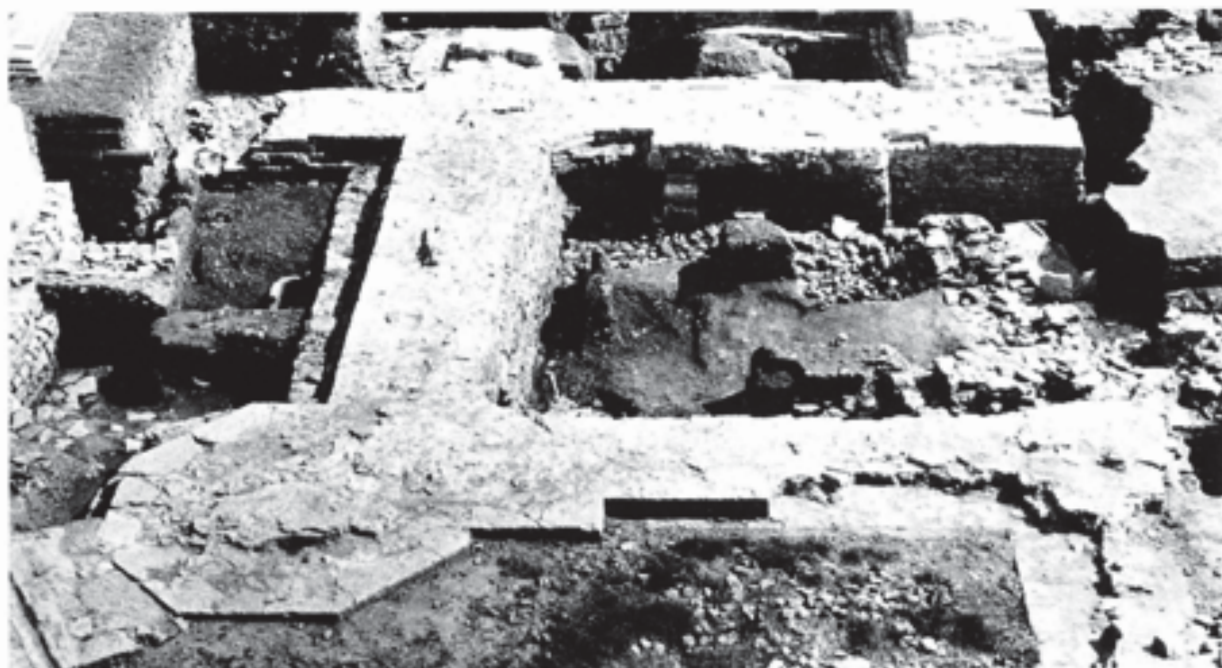
Fig. 213 General view east across Stillington's north transept, after full excavation in 1980

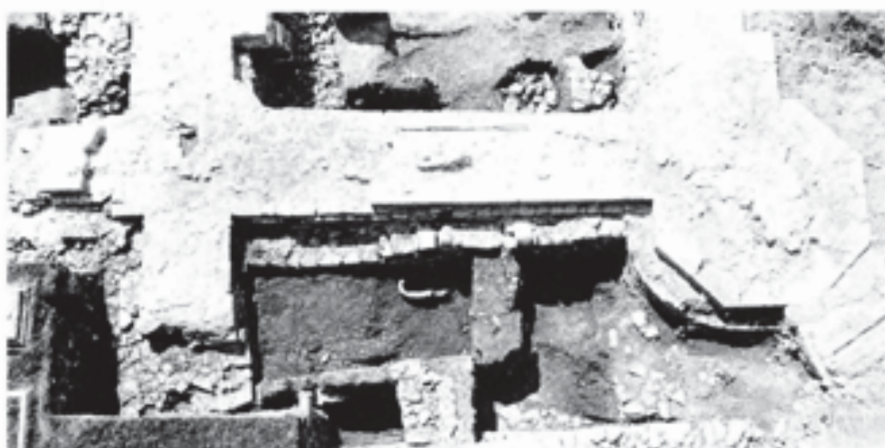
Fig. 214 The north wall, buttresses and stair-turret of Stillington's north transept, showing the close proximity to the cathedral transept and its foundation (which just appear at the bottom of the frame). Scale of 2 m

For the most part, the foundations were stepped and battered, although they were not fully excavated and exposed on the north side. Preservation was good, especially at the north-west angle, where the entire Chilcote stone footing-course of the octagonal stair-turret remained intact, resting upon a solid circular foundation, 4 m in diameter (F1187a). No certain evidence remained for the base of the stair-well, although an irregular, but roughly central tump of rubble core-work may ghost the outline of the well (Fig. 214).

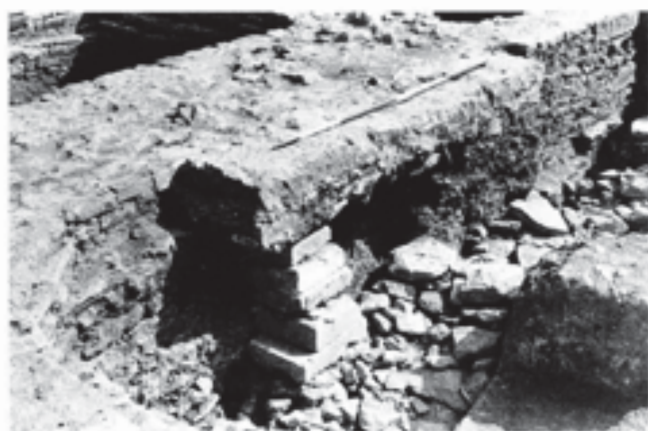
Fig. 215 The east wall of Stillington's north transept, showing the added foundation (F1188) for an elongated altar, or possibly a reredos. Note the pile of ashlar blocks used to support the north end of this structure where it overlay a soft grave filling. Scale of 2 m

The lowest foundation courses of the east wall were slightly skewed, influenced by the alignment of a fragmentary earlier wall. The same applied to the foundation of the north buttress (F1187b) which rested on a mass of masonry (F1392) that appeared to be contemporary with Stillington's works, but was probably filling the robber trench from which an earlier, and differently aligned, wall had been removed.

Inside the east wall of the transept, and directly abutting it, was a shallow foundation 2.7 m long by 0.6 m wide (9 ft by 2 ft), F1188. This was certainly a structural addition, since it overlay the consolidated infill of the foundation trench for the east wall; it was also curiously supported at the northern end alone by a pillar of stone blocks set into the robber trench of an earlier medieval wall (Fig. 215). The foundation is interpreted as the base for a reredos associated with the use of the transept as a chapel (p. 239). The cream mortar employed in the construction of the base was not

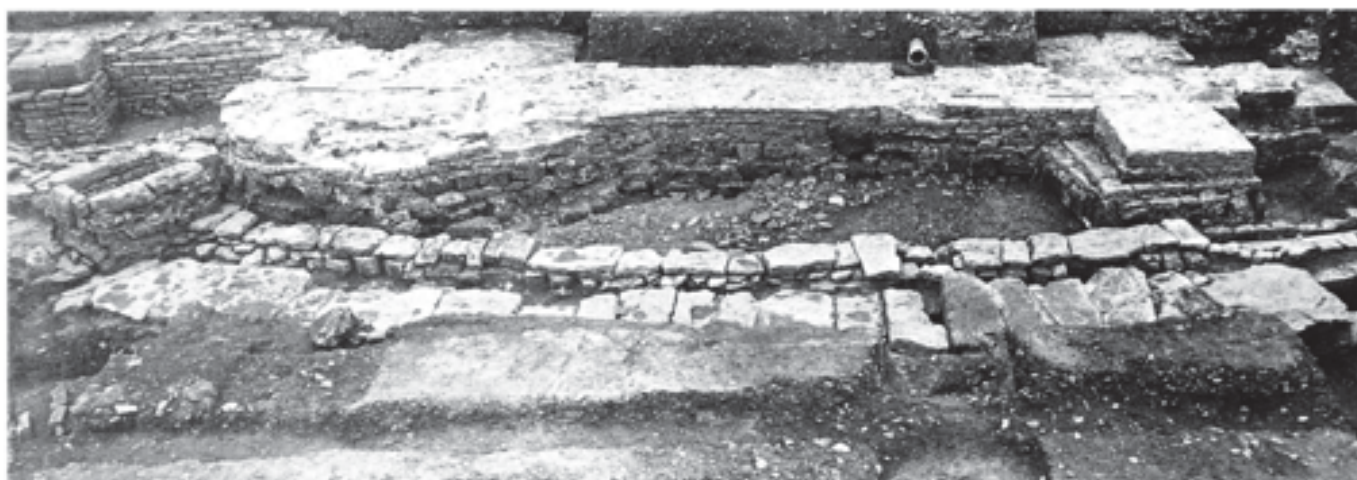
Fig. 217 View of the south transept of Stillington's chapel, from the south, showing robbing to a level below the footing-course of the octagonal stair-turret. The cover-stones of the conduit and pipe-duct can be seen in the foreground. Scales of 2 m

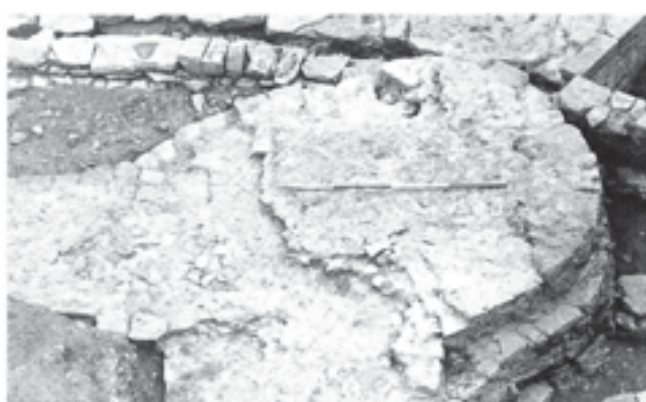
Fig. 218 Stillington's chapel. Stepped circular foundation for the south-west stair-turret. View south, with the pipe-duct and conduit beyond. Scale of 2 m

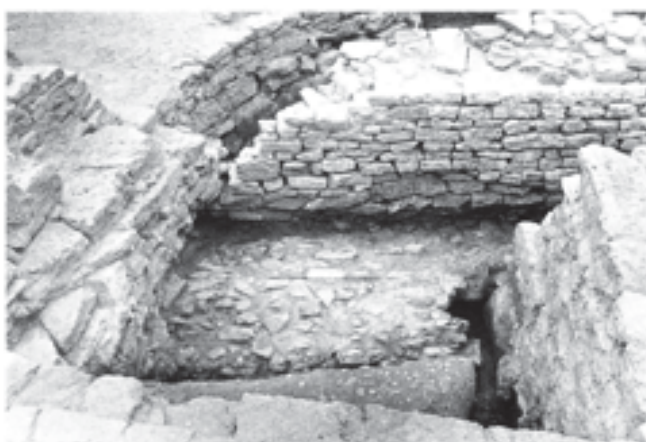
Fig. 219 The junction between Stillington's south transept and the early medieval conduit, looking south. The vaulted roof of the conduit has the 2 m scale lying on it. It is severed by the transept foundation (left) and one of the nave buttresses (right). Note the offset and other changes in the masonry of the transept where its construction was interrupted when the conduit was encountered. Beyond the conduit, and partly overlying it, is the south aisle wall of the earlier Lady Chapel

not the influence of the pipe, but rather that of the old Lady Chapel alignment which had caused the errant work. The misalignment of the buttress was corrected in the second foundation course.

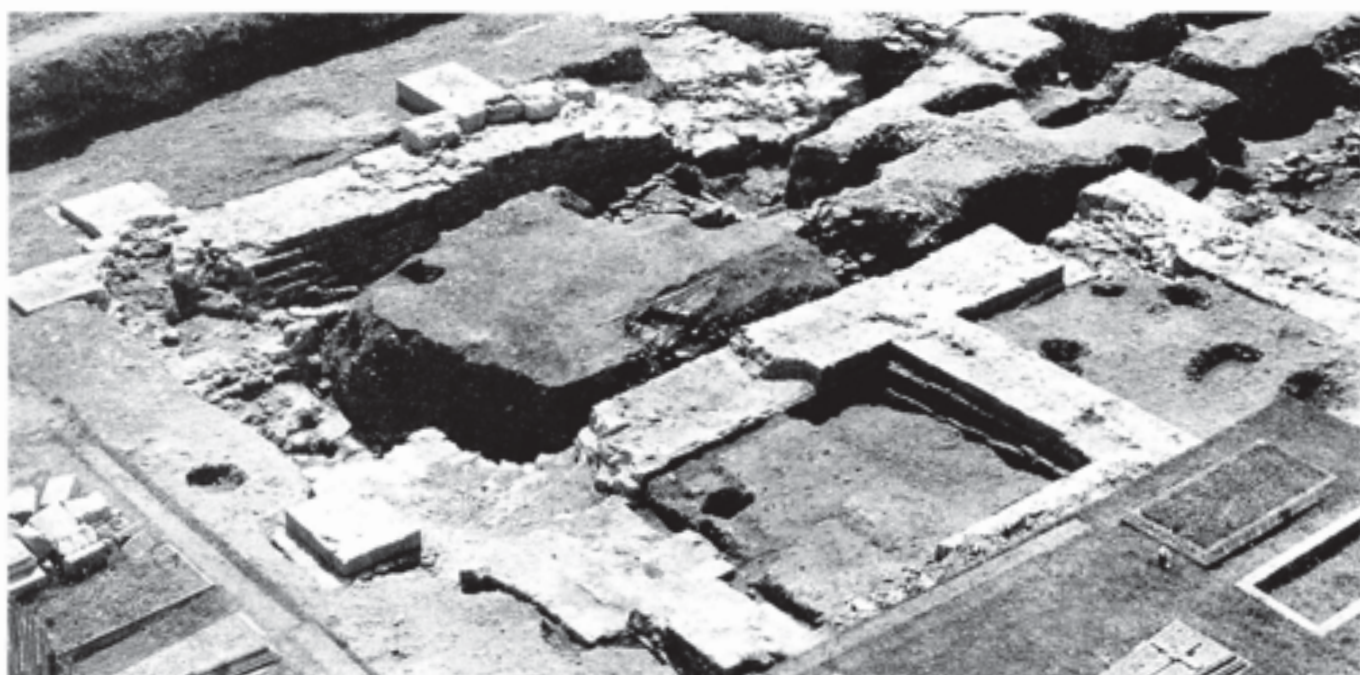
Fig. 221 The chancel and sacristy of Stillington's chapel from the north-east, during the excavation of the construction trenches. Scale of 2 m

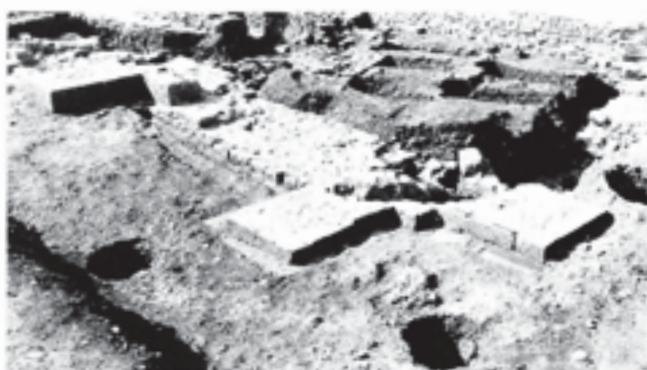
Fig. 222 South-east corner of Stillington's chancel, showing the survival of footing-courses to buttresses, and large postholes association with construction scaffolding. Scale of 75 cm

The buttress outlines on the south and east sides were well preserved, complete with footing-course, but their foundations were not exposed by excavation (Fig. 222). The original extent of the two northern buttresses (F1208a, b) was not clear, since they had been incorporated in the side walls of the later sacristy. The foundations for these buttresses were anomalous, possibly suggesting that they were built to carry stub-walls with the specific intention of adding a sacristy (Fig. 223). The more westerly foundation (F1208a) projected considerably further north than would appear to have been necessary for a buttress, while the eastern one (F1208b) was of a more appropriate length, but was much broader. The broadness was probably only a function of the level to which the structure had been robbed: the masonry here survived to just below the footing-course, as seen on the adjacent east buttress (F1208c; Fig. 224).

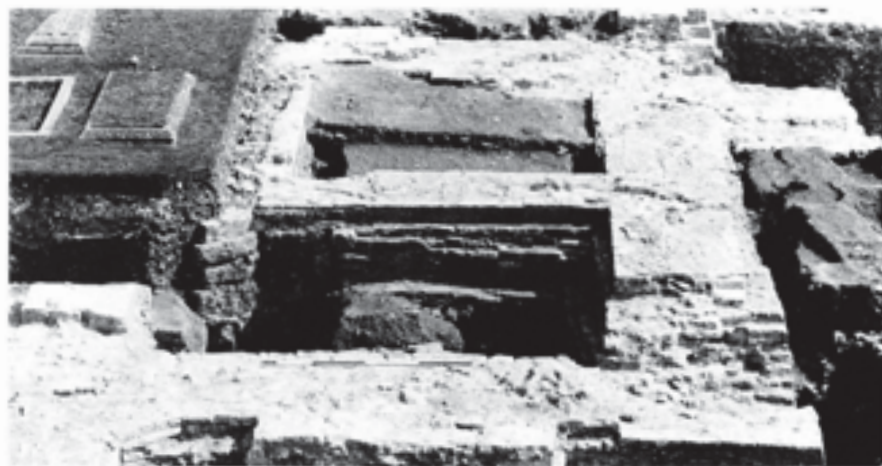
Fig. 223 The sacristy of Stillington's chapel from the west. The east wall of the north transept is seen in the foreground, and upon it rests the 2 m scale

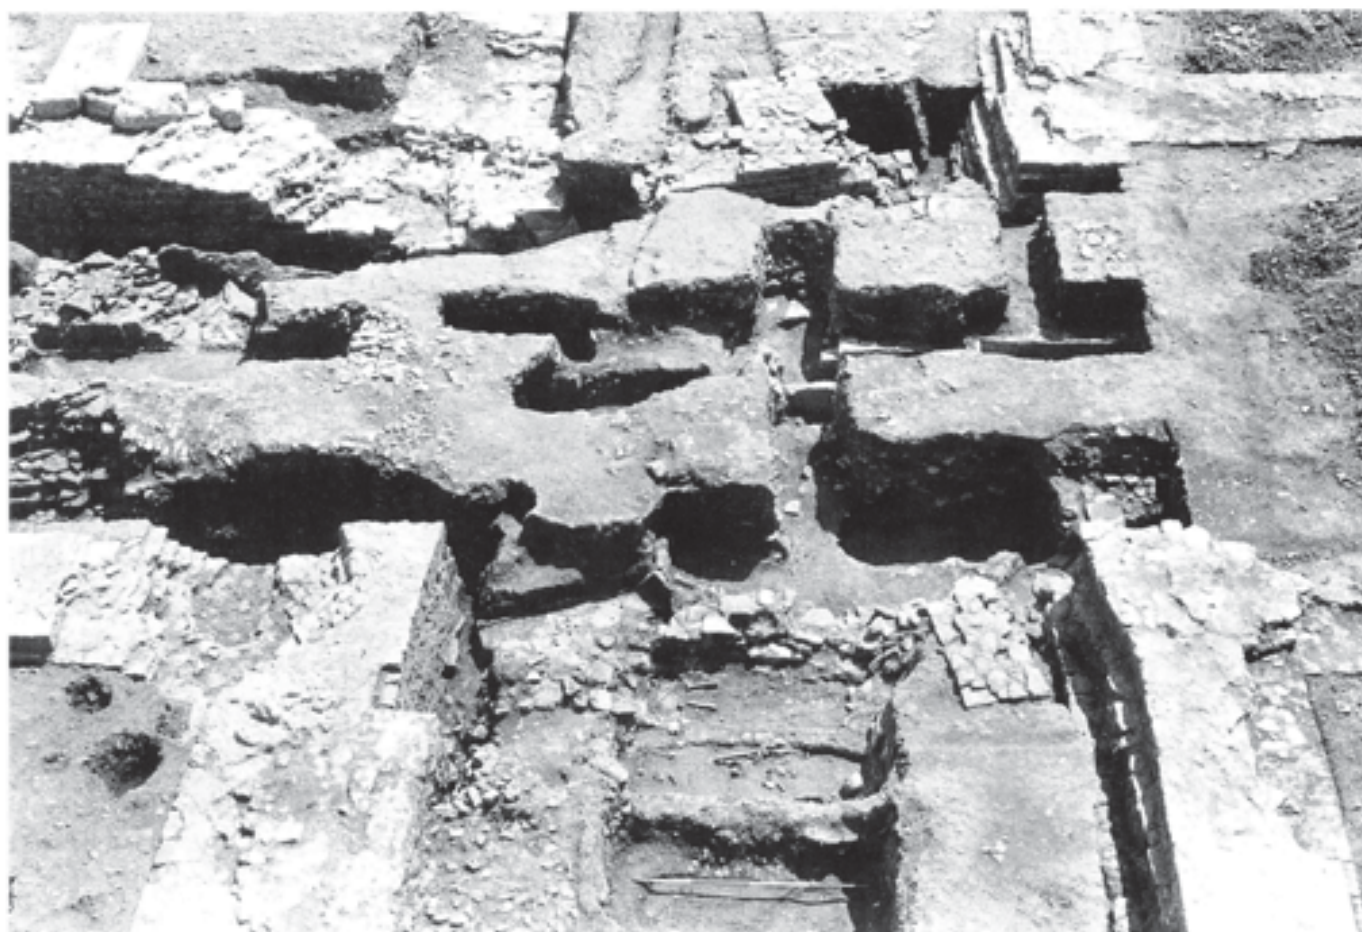
Fig. 226 General view of the crossing of Stillington's chapel, looking south, after the excavation of Victorian trenches and robbing pits. The craters caused by the use of gunpowder to blow up the eastern crossing piers (left) are visible. Scales of 2 m

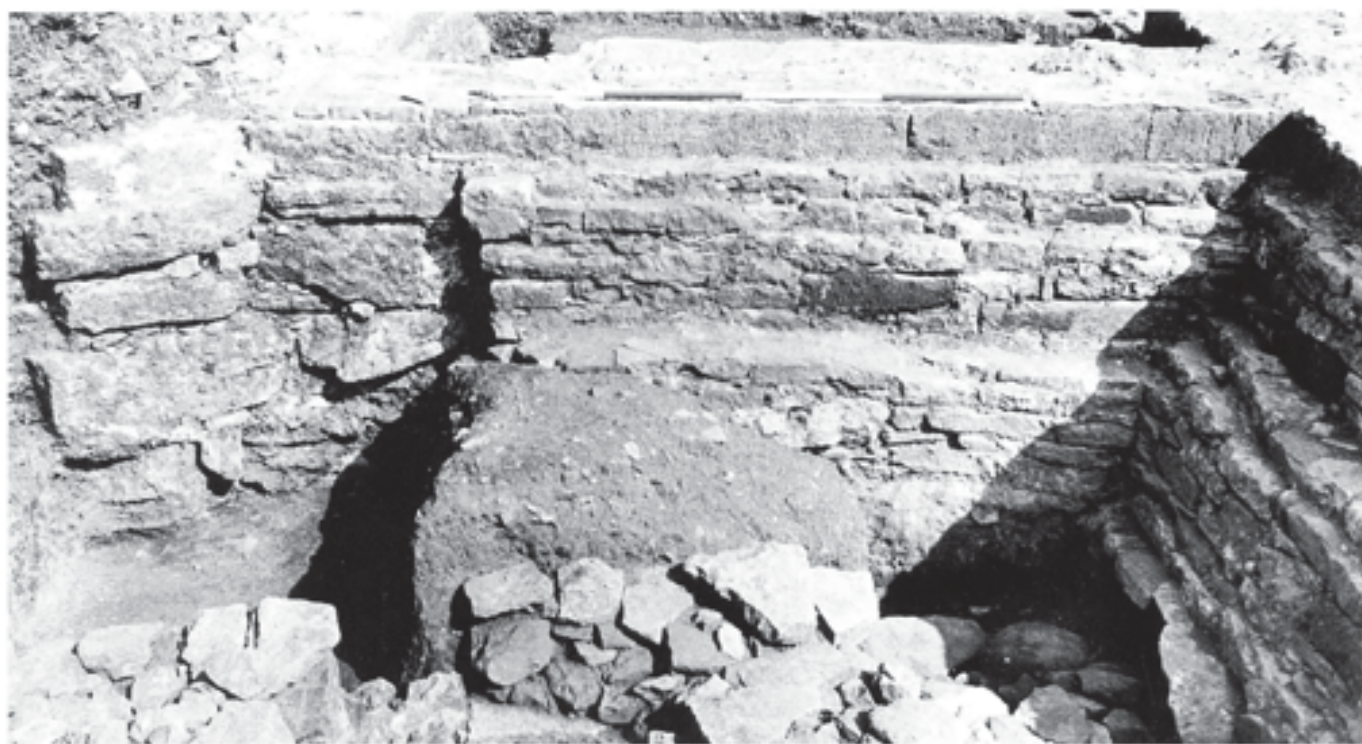
Fig. 227 Foundation of the west wall and diagonal buttress of the sacristy of Stillington's chapel, showing the incorporation of an original chancel buttress. The shadow (left of centre) marks the junction between the two periods of construction. Scale of 2 m

or wall-stubs (Fig. 220, F1208a, b). An additional foundation had to be constructed for the north wall and its southward returns (F1232), and the external angles were supported by diagonal buttresses (F1232a, b), rather than clasping ones (Fig. 227). The sacristy foundation was constructed to the same depth as that of the main chapel, but was ill-coursed and employed large blocks of Chilcote stone with small packing stones between. There was no well-defined footing-course. Doubling ashlar was used both above and just below ground, and there was again a damp-proof course of slate at floor level. On account of the rising ground towards the cathedral, part of the north wall of the sacristy still stands to one course above internal floor level.

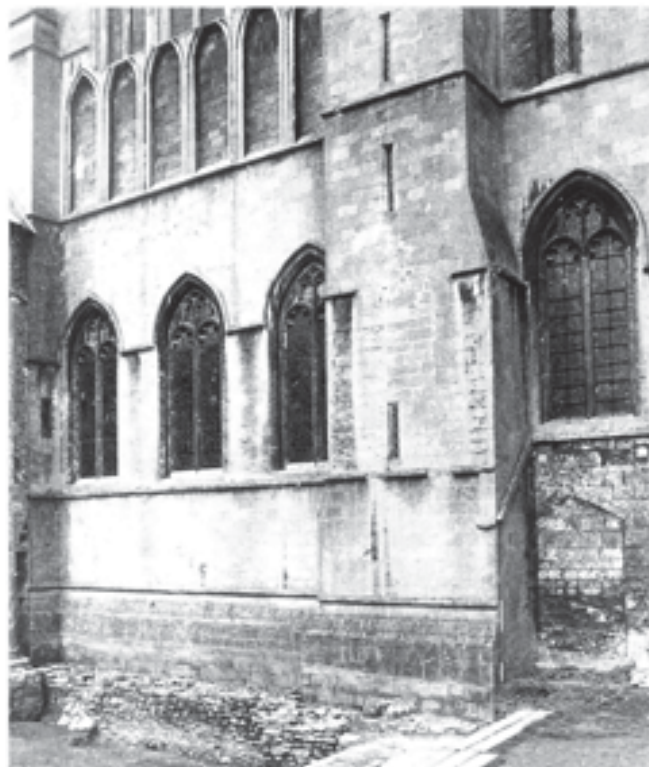
Fig. 228 The south transept of the cathedral, showing the projecting stair-turret to which the bridge from Stillington's chapel connected. For a detail, see Fig. 231. Scale of 2 m

Between the northern stair-turret of Stillington's chapel and the large, stepped buttress containing the newel stair leading to the upper levels of the cathedral transept (Fig. 228) lay a gap of only 1.5 m, at plinth level. This was merely sufficient to gain access to the area of dead ground lying between the chapel and the cathedral. There was clearly no original intention of providing a physical link for access between the two structures, but it must subsequently have seemed desirable to effect one. This was not done at ground level but at a height of c. 5.5 m above the floor of the chapel: the new structure was therefore a bridge.

The attachment of the link-structure to the cathedral is still witnessed by a series of scars on the face of the transept (Fig. 228). First, the chamfered plinth has been notched to house facing stones on the east and west sides of the bridge. Second, there is a rough housing where a moulded string-course on the west face of the bridge was recessed into the buttress. Third, two levels of string-course have been cut back to receive the bridge, and the dripping of rainwater off the broken ends of these mouldings has fortuitously created marks on the transept buttress ghosting the abutment of the bridge. Fourth, the second in a vertical series of narrow, square-headed windows that lit the transept stair

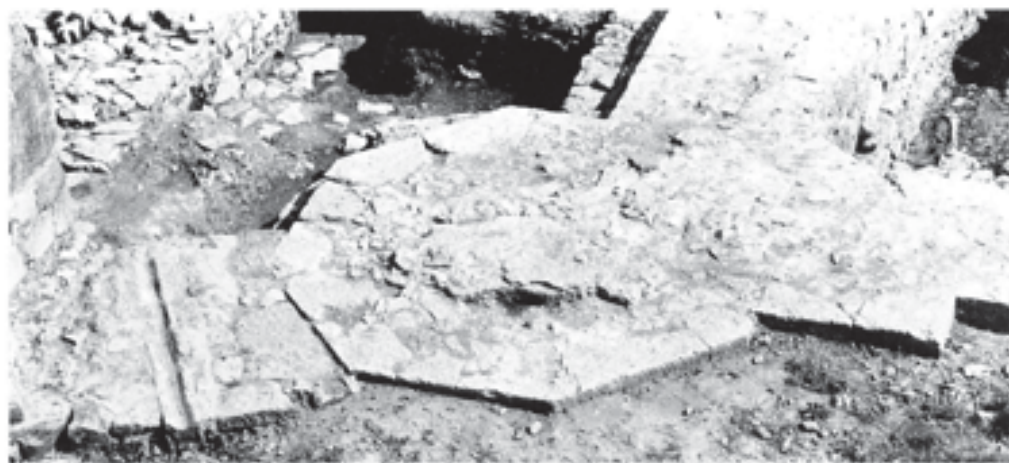
Fig. 229 The base of the north-west stair-turret of Stillington's chapel and foundation for the later bridge linking it to the cathedral. View north-east

A rough foundation (F1536) was constructed on an angled course between the cathedral and the north-west turret of the chapel. Through the top of the foundation ran an open channel (F415) for draining surface water (Figs. 212, 229 and 230). A wall c. 1.6 m in thickness was erected upon the foundation; two of the Doultling ashlar facings survive on the west side (both are reused stones). The wall was pierced by an opening, presumably arched, at ground level, through the centre of which ran the gully. The width of the opening cannot be determined with certainty since the jamb stones are missing, but it was probably only c. 70 cm.

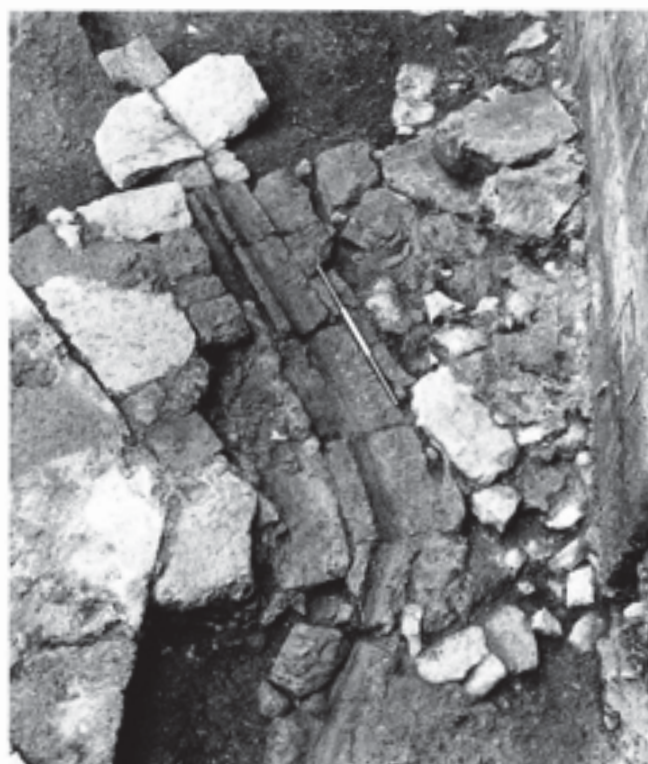
Fig. 230 Detail of the final phase of the open drain passing under the bridge between Stillington's chapel and the cathedral transept. View west. Scale of 75 cm

The open drain beneath the bridge exhibited several phases of use and reconstruction. Initially it was little more than a naturally formed gully in the ground surface; but in its final form the drain comprised a series of gutter blocks (Fig. 230).
