WELLS CATHEDRAL

Excavations and structural studies, 1978–93

*Excavations and Structural Studies,
1978–93*

ARCHAEOLOGICAL REPORT 21

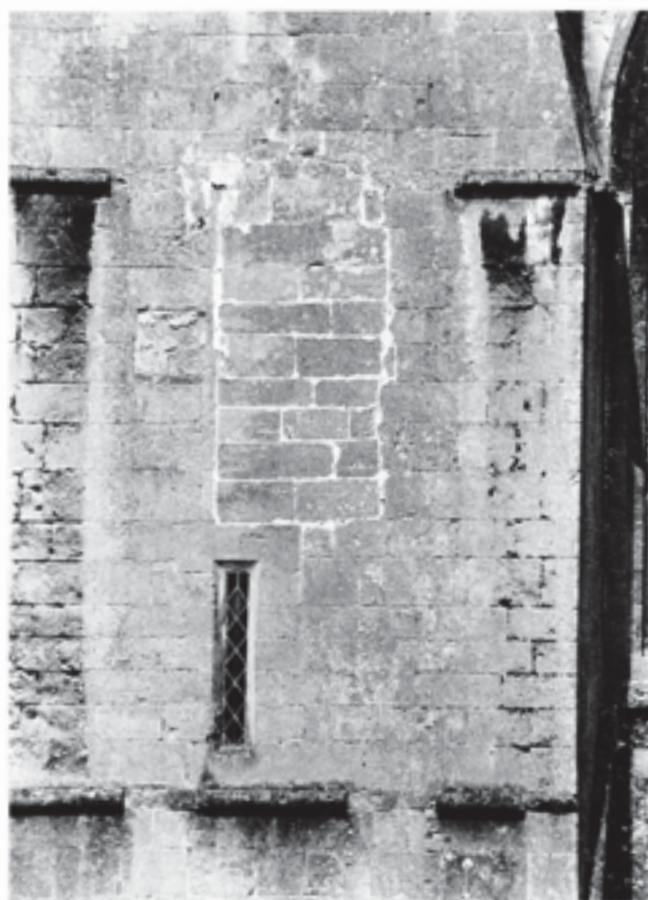
Fig. 231 Blocked high-level doorway and scars left by the removal of the linking bridge between Stillington's chapel and the south transept of the cathedral

was opened out to form a doorway, which appears to have been given a roughly arched head. The chamfered west jamb of the former window may still be glimpsed. The post-Reformation ashlar infilling of the doorway is set in hard white mortar, with ample joints, and remains plainly visible both internally and externally (Fig. 231).

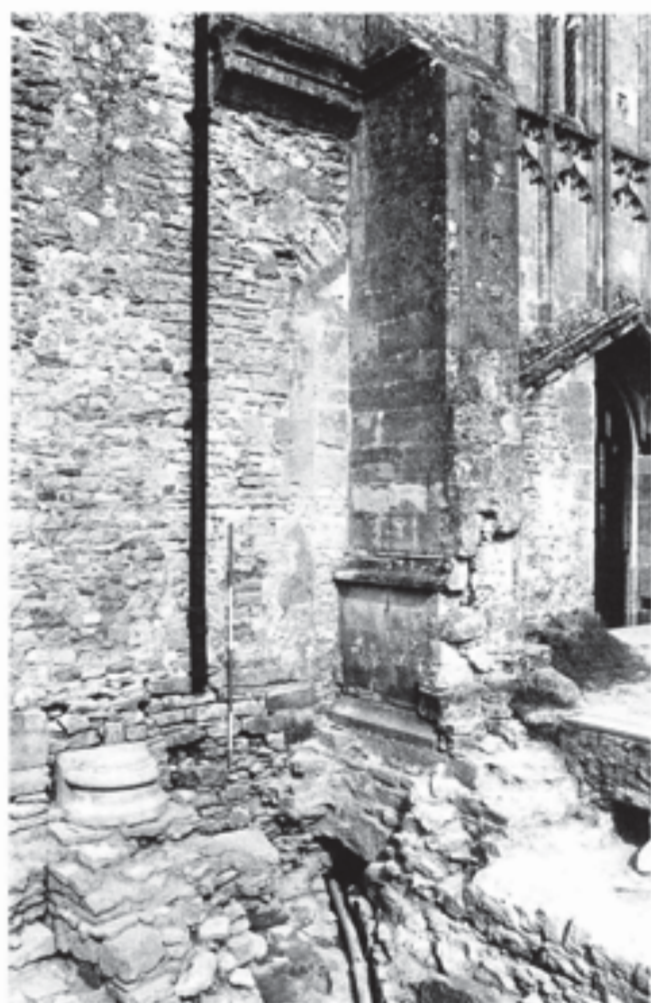
Fig. 233 The remaining stub of the south wall of Stillington's nave abutting the cloister. This fragment includes the west splay of one window, and it blocks the original entrance to the Early English Lady Chapel. The lead water-pipe of c. 1451–53 is seen below, set into a protective duct. Scale of 2 m

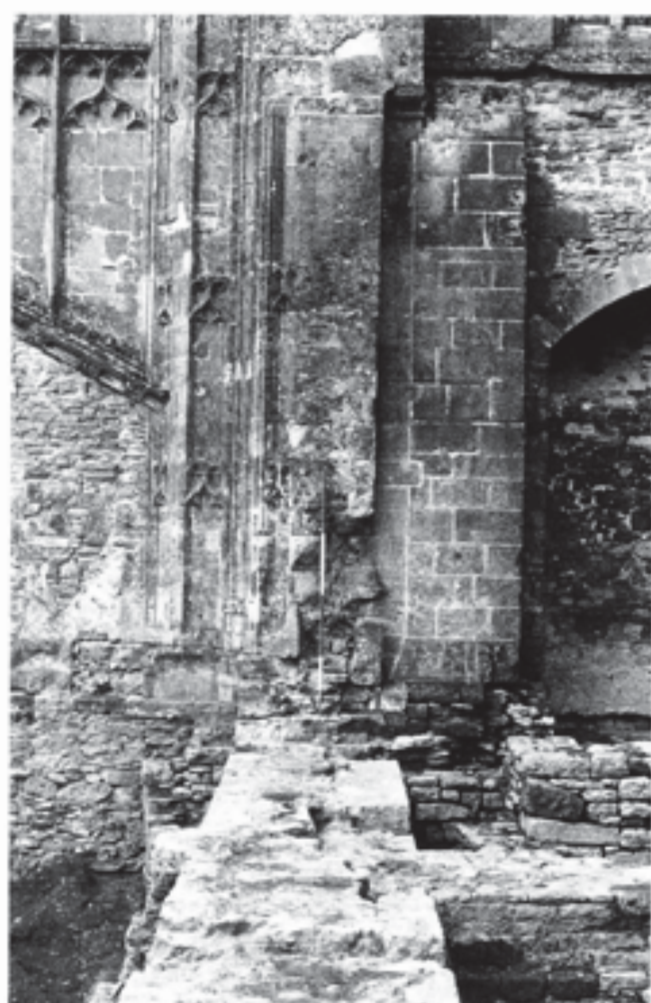
Fig. 234 View west along the north wall of Stillington's chapel where it abuts the cloister. Above the 2 m ranging-pole is the splay of the westernmost window of the chapel. Between the wall and the arched entrance to the Holy Cross chapel (right) is one of the early Gothic cloister buttresses (E67)

The new chapel had to be knitted into the existing fabric of the two-storey cloister. On the south side, the median string-course was returned for a short distance along the cloister elevation, from the face of which it was slightly corbelled out, providing evidence for the buttressing of Stillington's west gable from the cloister parapet (Fig. 233). This arrangement was not, however, mirrored on the north side of the chapel, where there was only a very slight return of the string along the face of the cloister. A buttress on the north-west angle of the chapel would have been virtually invisible from ground level, which doubtless excused its omission. The north wall of Stillington's nave abutted the cloister alongside one of the early Gothic buttresses, and the narrow gap between the two elements was infilled with ashlar (Fig. 234).

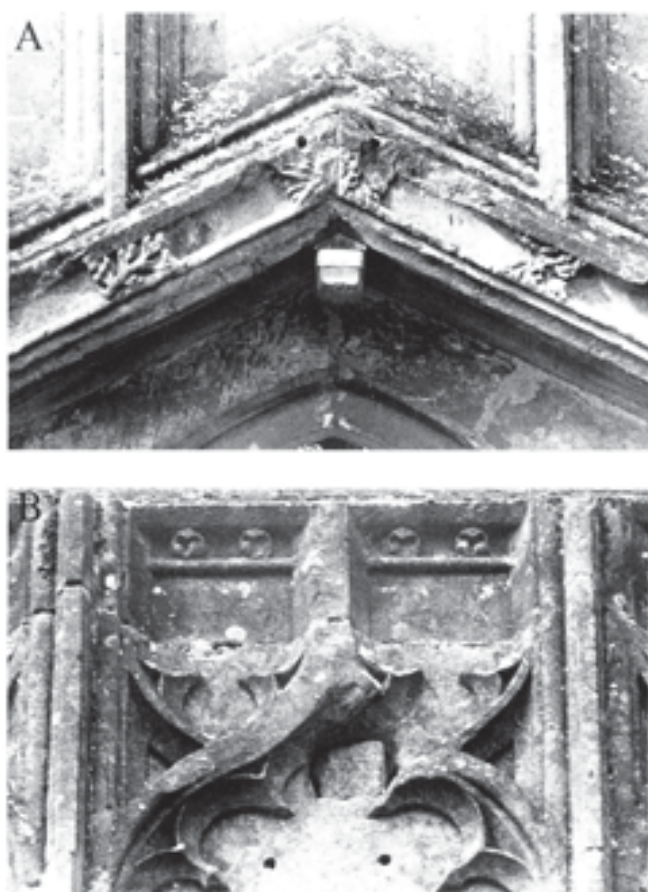
Fig. 235 Stillington's chapel. A Detail of the enriched string-course over the entrance; B One of the sections of ball-flower string-course, inserted between the super-mullions of the truncated arcading in the west wall

plain plastered rubble, framed under a gabled head (Fig. 237). In part, the rubble work represents the outer face of the Early English cloister, but also includes much infilling associated with the creation of Stillington's doorway. Some of the fifteenth-century white wallplaster is still adhering. The gabled head of this panel, which rather resembles a Tudor arch, carries a heavy moulding with spaced-out foliate decoration set in a broad hollow (Figs. 235A and 237).

Above the entrance, the early medieval wall face has been cut back and two tiers of traceried panelling inserted, each divided into five bays (Fig. 197). Two sizes of mullion were employed, defining two paired panels, and a single one in the centre. The lower register of panelling contains a graduated series of cinque-foiled, ogee-headed arches, each crowned by a pair of *mouchettes*. Above these is an interrupted transom supporting the upper register, a regular set of ogee-headed arches, cusped within and above. The two king-mullions, along with five super-mullions, rise a little further before being truncated by the false 'sill' with its strange ball-flower ornament (Fig. 235B). The springing of the ceiling vault survives, and there is sufficient to determine the arcature.

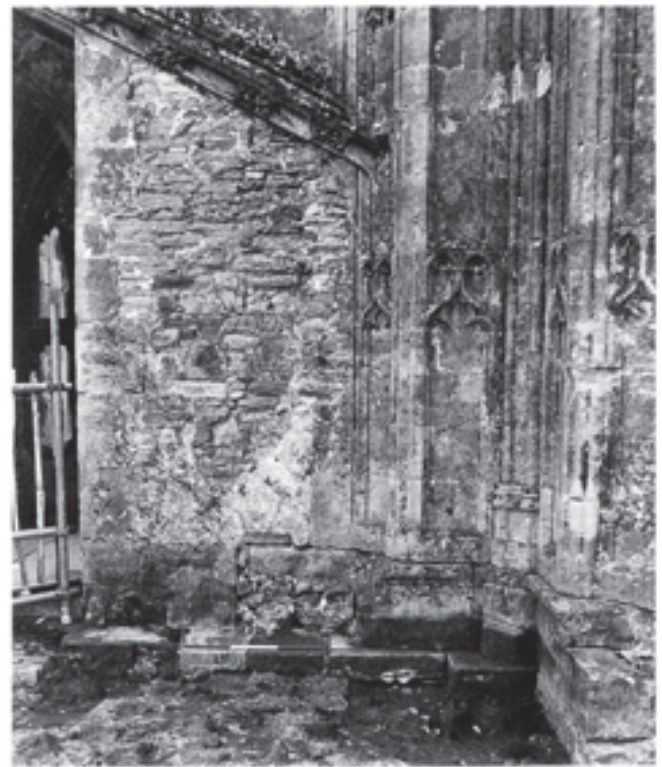
Fig. 239 The north-west corner of Stillington's nave. The 75 cm scale rests on the remaining original Douling stone paving, upon which there was formerly a wall-bench

At the west end of the chapel the floor was laid prior to the construction of the wall-bench, and the first line of paving here was consequently preserved *in situ* when the floor was generally robbed. There are remains of the wall-bench, including the edge-moulded seat, to either side of the door (Fig. 238.8). The bench doubled as a plinth upon which the wall-shafts and blind panelling rested, the arrangement at the two western angles of the nave being fully preserved (Fig. 239). Above the bench on the west, the wall all around the doorway was of

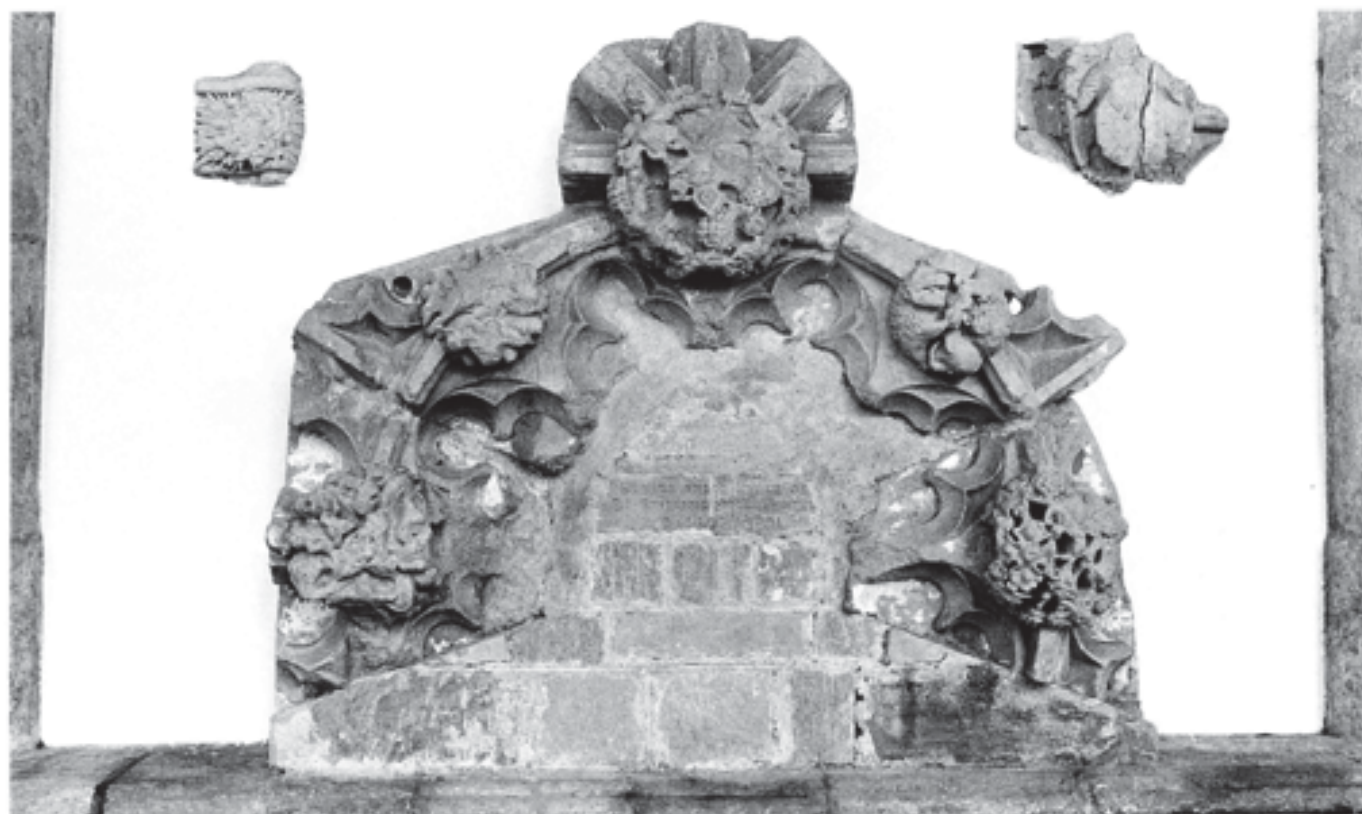
Fig. 241 Reconstructed central vault-ring representing one of the chancel bays in Stillington's chapel; the chain-holes are arrowed. Display constructed in the east cloister in 1894 (boss nos. 3–7). Two other vault fragments from the chapel are affixed to the wall above (nos. 1–2)

The bosses and ribs were of Doulting stone, rebated to receive the webs, which were apparently made from tufa. Much of this lightweight filling material was found in the excavations. The four principal bosses belonging to each central ring have a single rectangular socket cut into the side of the ornament. These were evidently mortices to receive the ends of four small flying-ribs attached to pendentives. Buckle made a reconstruction (Fig. 240). Several stones belonging to the central rings also had holes 3.7 cm (1½ in) in diameter drilled right through them, immediately outside the ring-moulding. The original arrangement seems to have comprised a set of four equally spaced holes which, in the case of the chancel and crossing bays were drilled through the plain webs, but in the transepts the holes passed through the cusps. These holes were not constructional features, and nor were they fixings for metal eyes. Internal wear suggests that something passed vertically through the holes, presumably chains for the attachment of a *corona lucis*, with an arrangement for raising and lowering.

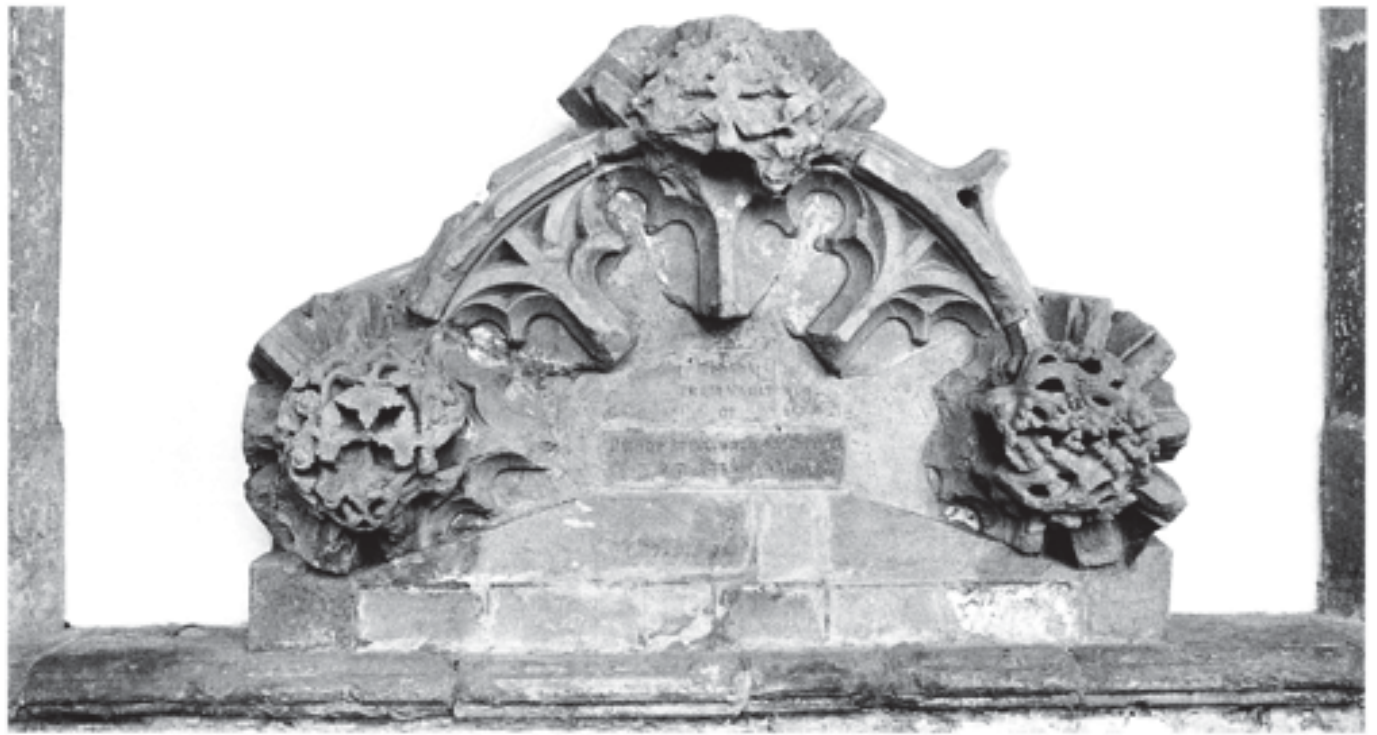
Fig. 242 Reconstructed central vault-ring representing the north transept bay in Stillington's chapel; chain-holes are arrowed. Display constructed in the east cloister in 1894 (boss and segment nos. 8–12)

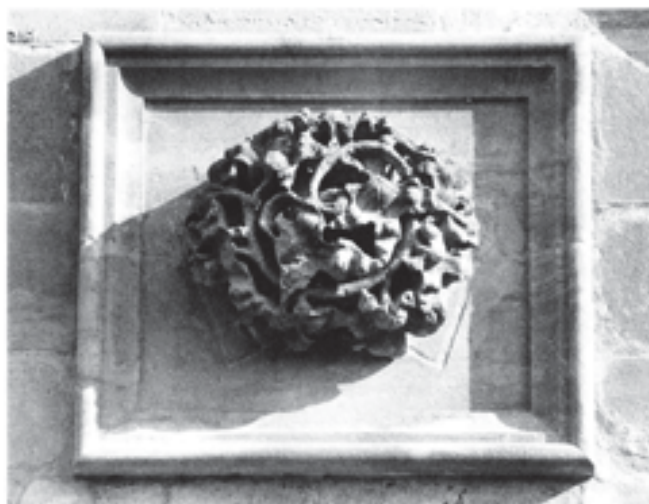
Fig. 245 Vault-boss (no. 19) from Stillington's chapel, reused as a decorative feature and set in a recessed panel over the doorway to the west cloister porch. It was possibly placed there in the sixteenth century. See also Fig. 462

sometime before c. 1790, and was reused as a central ornament in the gable of the west cloister porch (Fig. 245). This reuse may be as early as the Tudor period (p. 336).⁶ Other bosses were found 'when the ground was levelled some years ago' (Buckle 1894, 51), which was c. 1851. Three more were recovered during

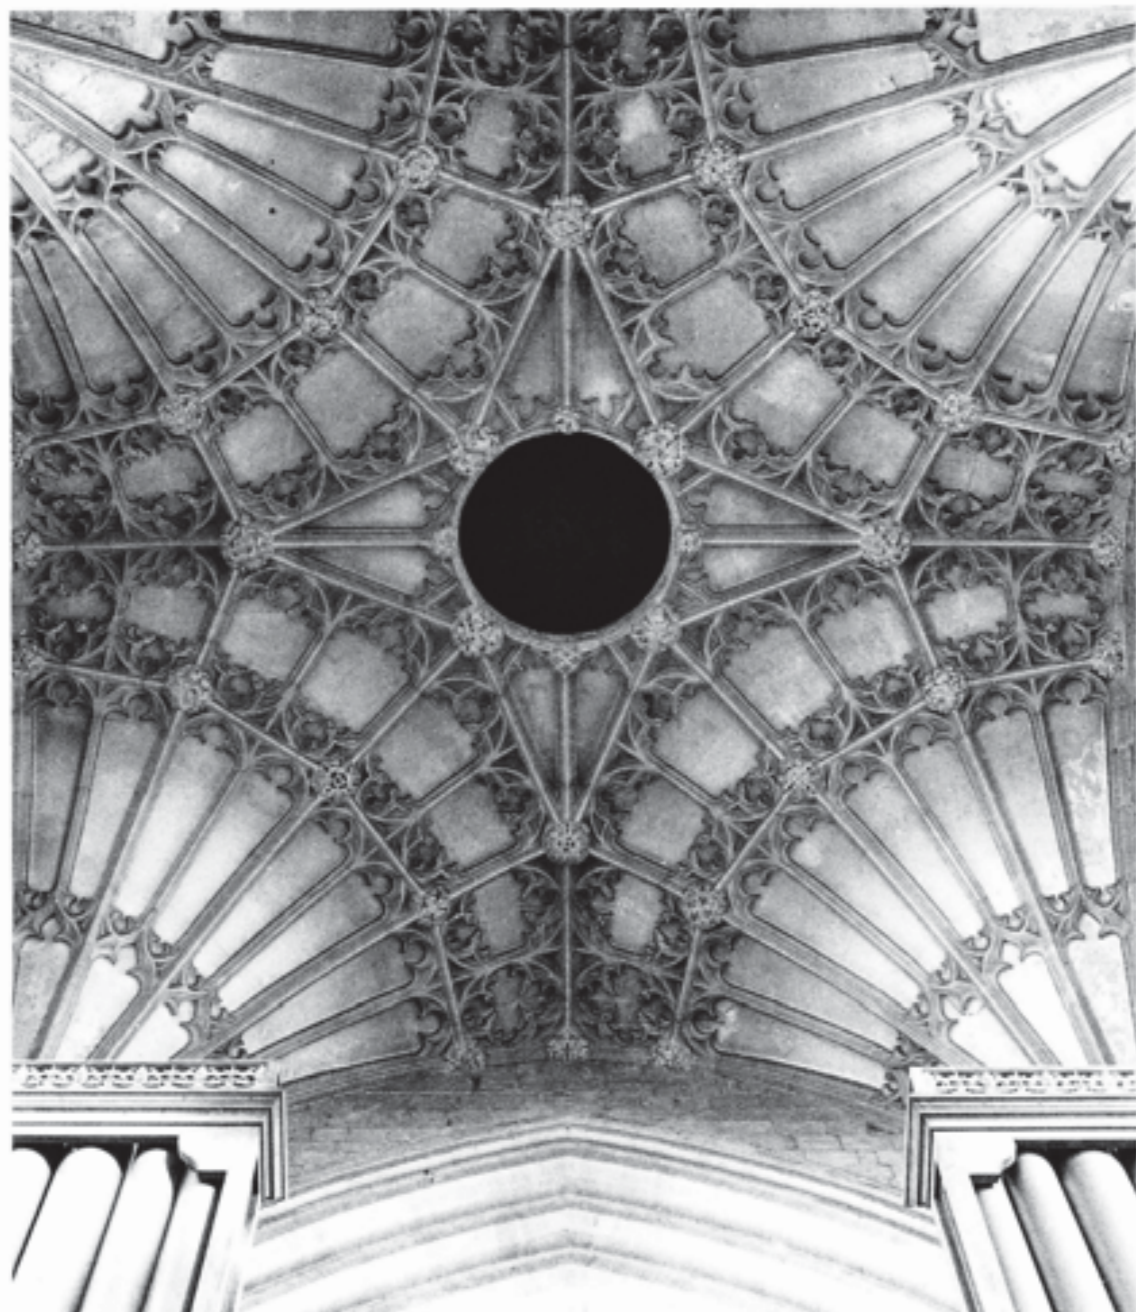
Fig. 250 Fan vault, probably erected by William Smyth in the 1480s, over the crossing in Wells Cathedral. East is at the bottom (Jerry Sampson)

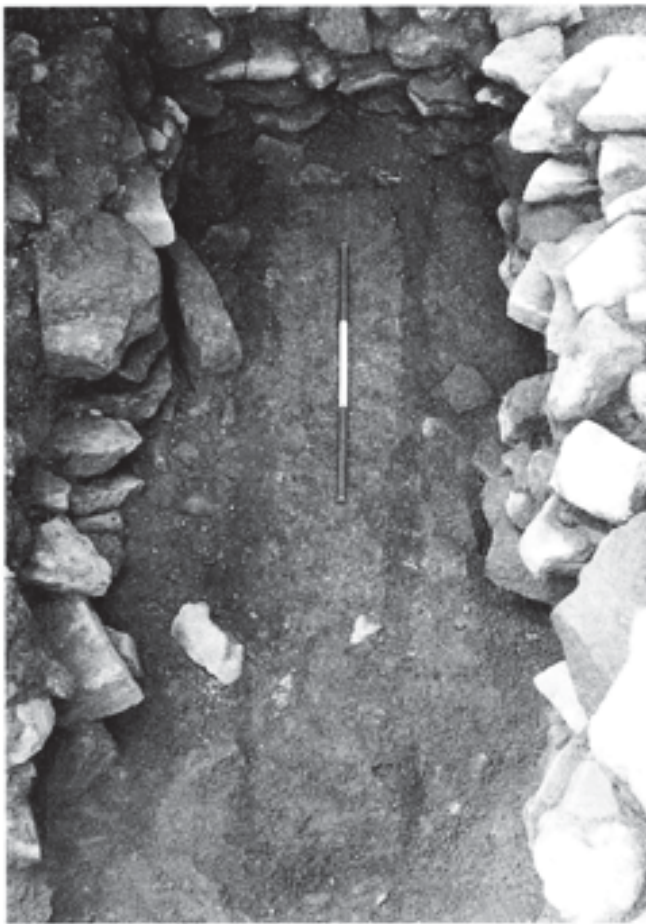
Fig. 252 Coffin silhouette seen above the level of the skeleton (B29), in the south-west corner of Stillington's nave. This grave had been cut into the foundation of the earlier Lady Chapel. Scale of 75 cm

Burial 19 was of a male, aged up to 50 years, and once again a family pair seems likely. A third grave on the south side of the nave may have been associated too, but lay closer to the west door. This burial (B29), a woman up to 45 years old, had been fortuitously cut into the core of an earlier wall foundation, which was not lined to form a cist. The corpse was contained within a nailed timber coffin (F580), the outline of which was exceptionally well preserved as a grey stain in the pale, mortary fill of the grave, F557 (Fig. 252).

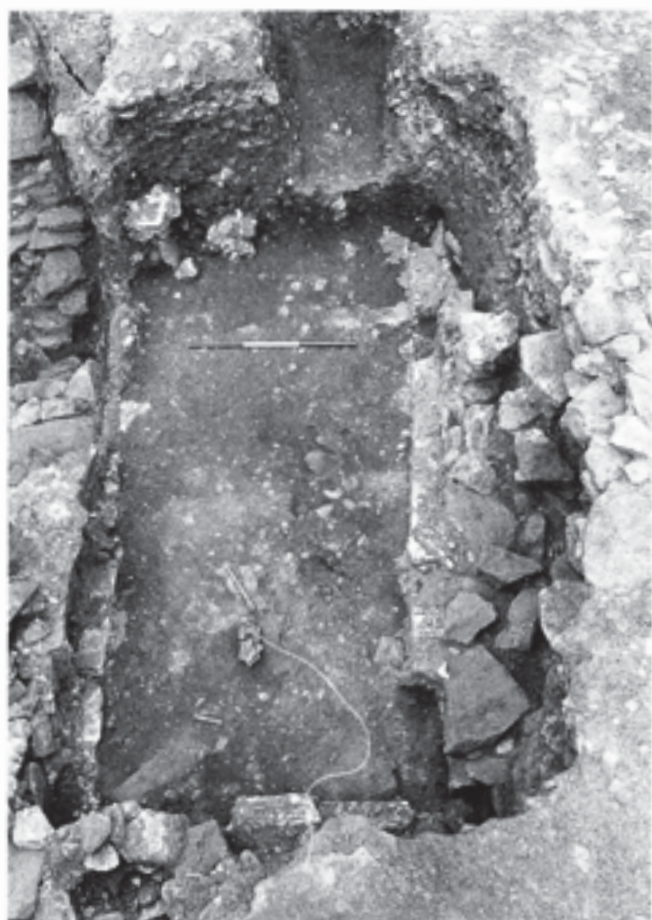
Fig. 254 The robbed remains of Bishop Stillington's cist-grave (F1478) in the centre of the chancel. View west. Scale of 75 cm

for its construction measuring 3.2 m by 2.0 m (F1477). Inside, had been a stone-lined cist (F1478), built with hard, white lime mortar similar to that used in the construction of the chapel itself. The masonry had been largely robbed out, leaving only impressions in the base of the grave of the lowest course, and the loose rubble packing behind the cist structure on the north side (Fig. 254). The robbing pit (Fig. 257, F1262) was almost coterminous with the construction pit. The cist had been built of limestone ashlar, and was plastered internally. It was amply proportioned, being 2.45 m long and tapering from c. 1.25 m to 1.15 m in width: it had contained a burial in a nailed wooden coffin. Destruction had been so severe that only the right foot and fibula, and part of the left foot, were *in situ*, together with a few nails (Fig. 255). The remains were those of an adult, probably aged up to 50 years. The backfill after robbing contained many pieces of a fine, painted and gilded Bath stone monument. Almost inevitably, these must have been the remains of Bishop Stillington's burial and tomb.

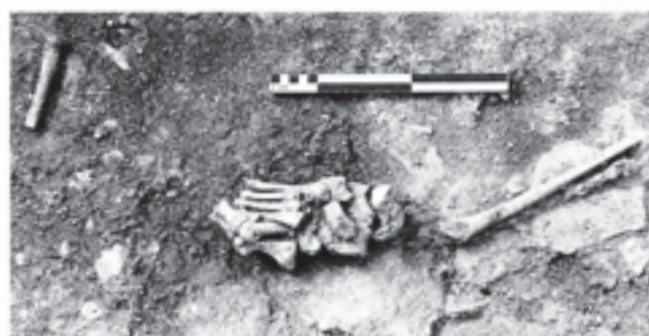
Fig. 255 Cluster of foot bones and a fibula in articulation in Stillington's grave. The separate bone fragment (left) is part of a radius. Scale of 25 cm

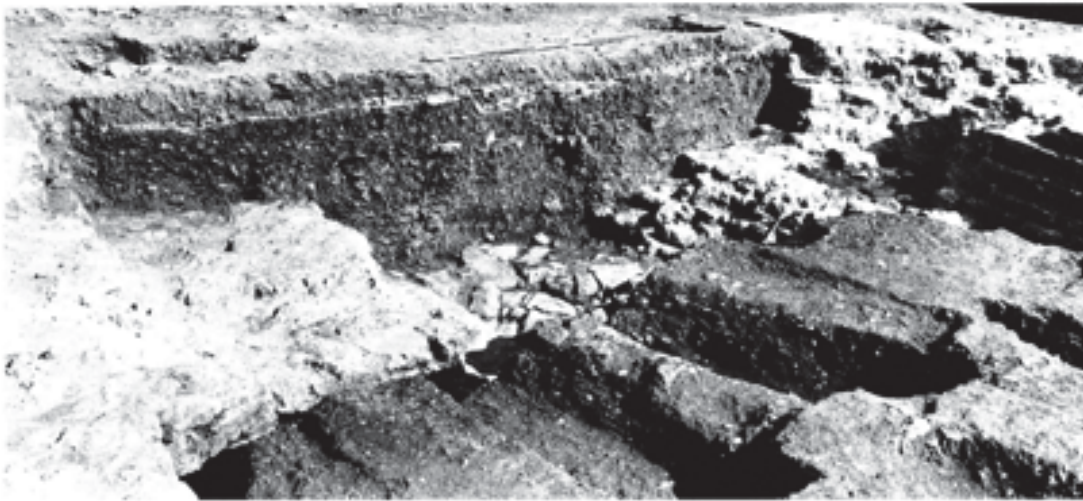
Fig. 258 Crater in the foundation of the east wall of Stillington's chapel caused by the use of an explosive charge during demolition. Scale of 2 m, centred on the east wall

Pits had been excavated against the foundations in three places, and charges laid well below ground level. One was on the site of the principal altar, against the east wall; this explosion blew out the entire central section of the foundation (Fig. 258). The other two charges were laid in the crossing, and were embedded

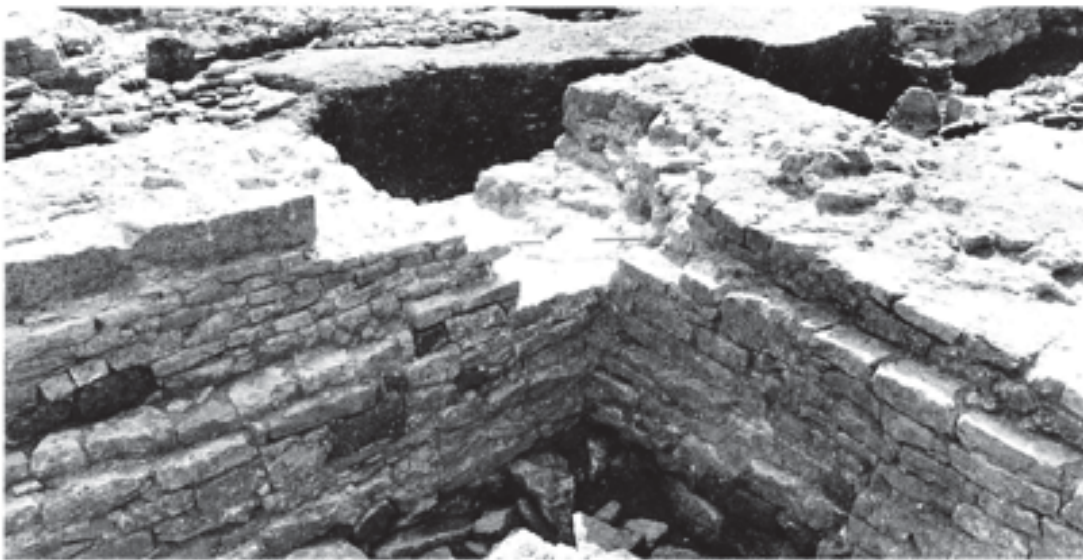
Fig. 259 Crater in the foundation of the north-east crossing pier of Stillington's chapel, caused by the use of an explosive charge during the demolition. Scale of 75 cm

in the foundations of the north-east and south-east piers, where substantial craters were generated (Fig. 259). These charges would certainly have brought down the vaults in the crossing, transepts and chancel, but whether they had any material effect on the nave is unassessable. The craters left in the foundations by these explosions were plainly visible: F1348, F1236 and F1539 (Fig. 257).

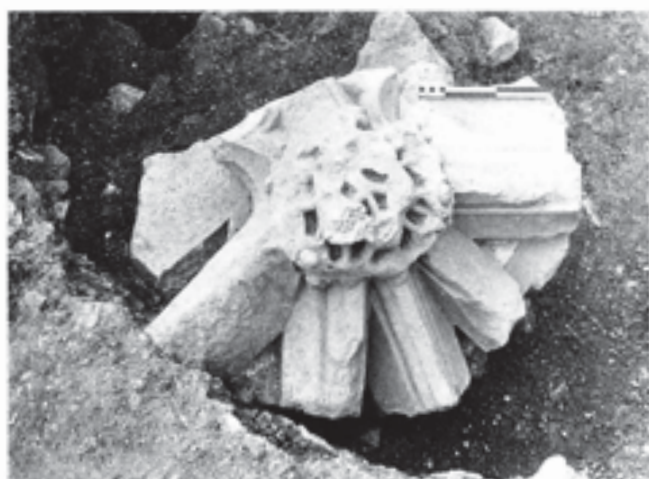
Fig. 260 Vault-boss (no. 13) under excavation in the chancel of Stillington's chapel; it had been buried in a shallow pit (F1219). Scale of 25 cm

When the vaulting fell, the bosses plummeted to the ground and became embedded in the then-exposed soil and stone-dust layers that had supported the paving in the chapel. On account of this relatively soft landing, many of the bosses did not sustain serious damage to their carved decoration. In total, sixteen have been recovered at various times, the last being in 1980. This survived because it had been rolled into a pit, dug specially for the purpose of burying it, in the chancel (Fig. 257, F1219); hence the boss was found face-up. It had incurred damage to its decoration at the time of the original fall (Fig. 260).

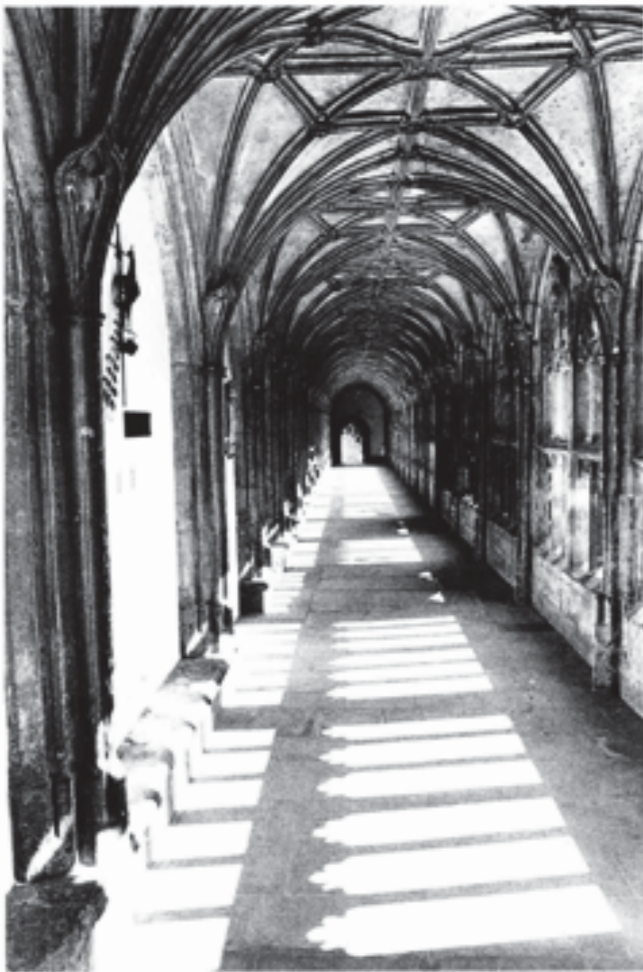
Fig. 263 The east cloister walk, looking south, in 1980, prior to the traceried screen being glazed

The early Gothic cloister was also furnished with a continuous bench around the base of its solid outer wall, and there still is an ashlar-faced bench in this position (Figs. 263 and 273). Much of it is undoubtedly original, although partly rebuilt in the fifteenth century, when the bench had to be modified to accommodate the base-blocks of the wall-shafts supporting the new vaulting. The Doulling stone slabs forming the bench-top are mainly original, and their leading edge is finished with a weak triple-roll which matches the bench moulding in the north porch, datable to

to the plan and elevations of c. 1420 (Figs. 263 and 271). It might therefore be argued that the reconstruction did not diverge greatly from the general form of the thirteenth-century cloister arcade, and in particular that the width of the walk was unchanged. If so, the asymmetrical placing of the doorways at the two ends of the east walk would have to be explained by other circumstances. The construction of the south transept door was, of course, earlier than the cloister, and its position was determined by the design of the cathedral church itself, and in particular the western aisle of the transept. It could be argued that when the cloister was added it was deemed more convenient — for some reason that now eludes us — not to centre it on the transept doorway. By extension, it may be argued that the south doorway leading out of the cloister was sited so as to be in a direct processional line from the transept. But this would be special pleading: one aesthetic misfit hardly justifies another. Moreover, the proposition does nothing to explain the curious relationship between the west walk and the south-west tower doorway, where the asymmetry is opposite-handed.

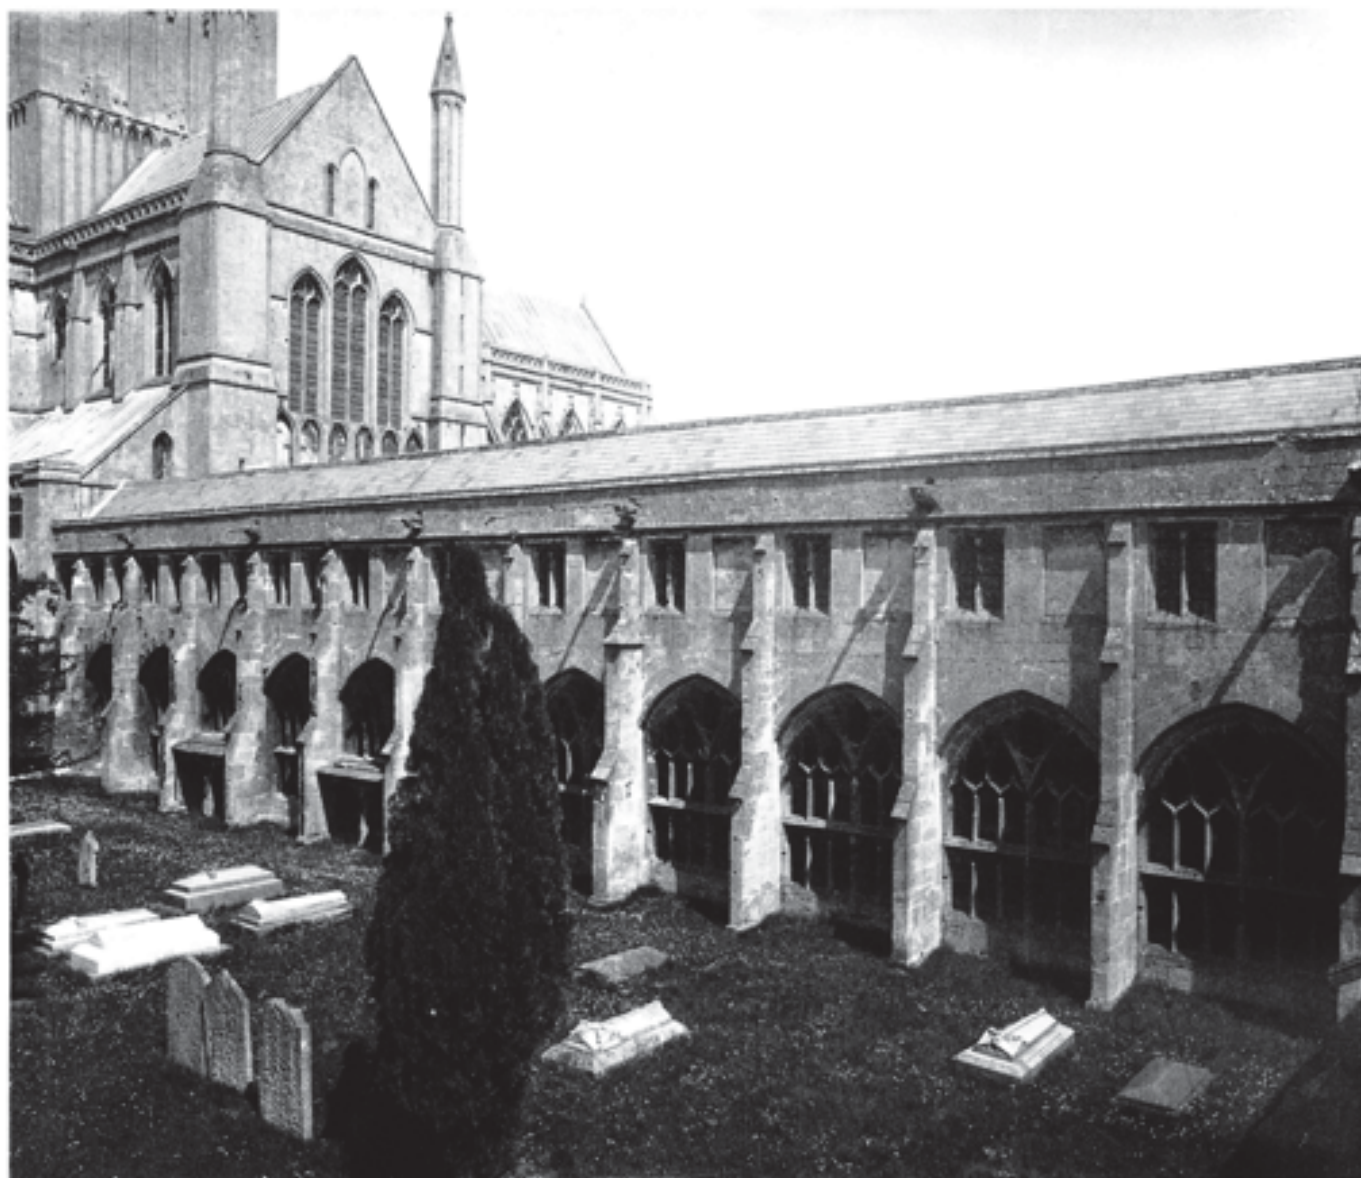
Fig. 266 Bubwith's library over the east cloister, taken from the roof of the south cloister by Thomas Phillips between 1895 and 1900. Note the fresh, recumbent grave-slabs (left of the yew tree), encroaching on the site of the dipping-well (then infilled). The stone-roofed penteries (Structures 19A–B) can be seen between the buttresses of bays 4 and 6 (Wells Cathedral Library)

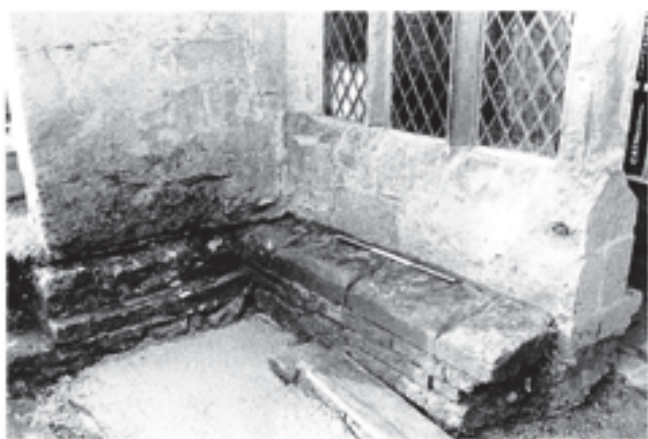
Fig. 269 West cloister, bay 35. Detail of the exterior of the early thirteenth-century bench-top beneath the later screen wall (cf. Fig. 276E). Scale of 75 cm

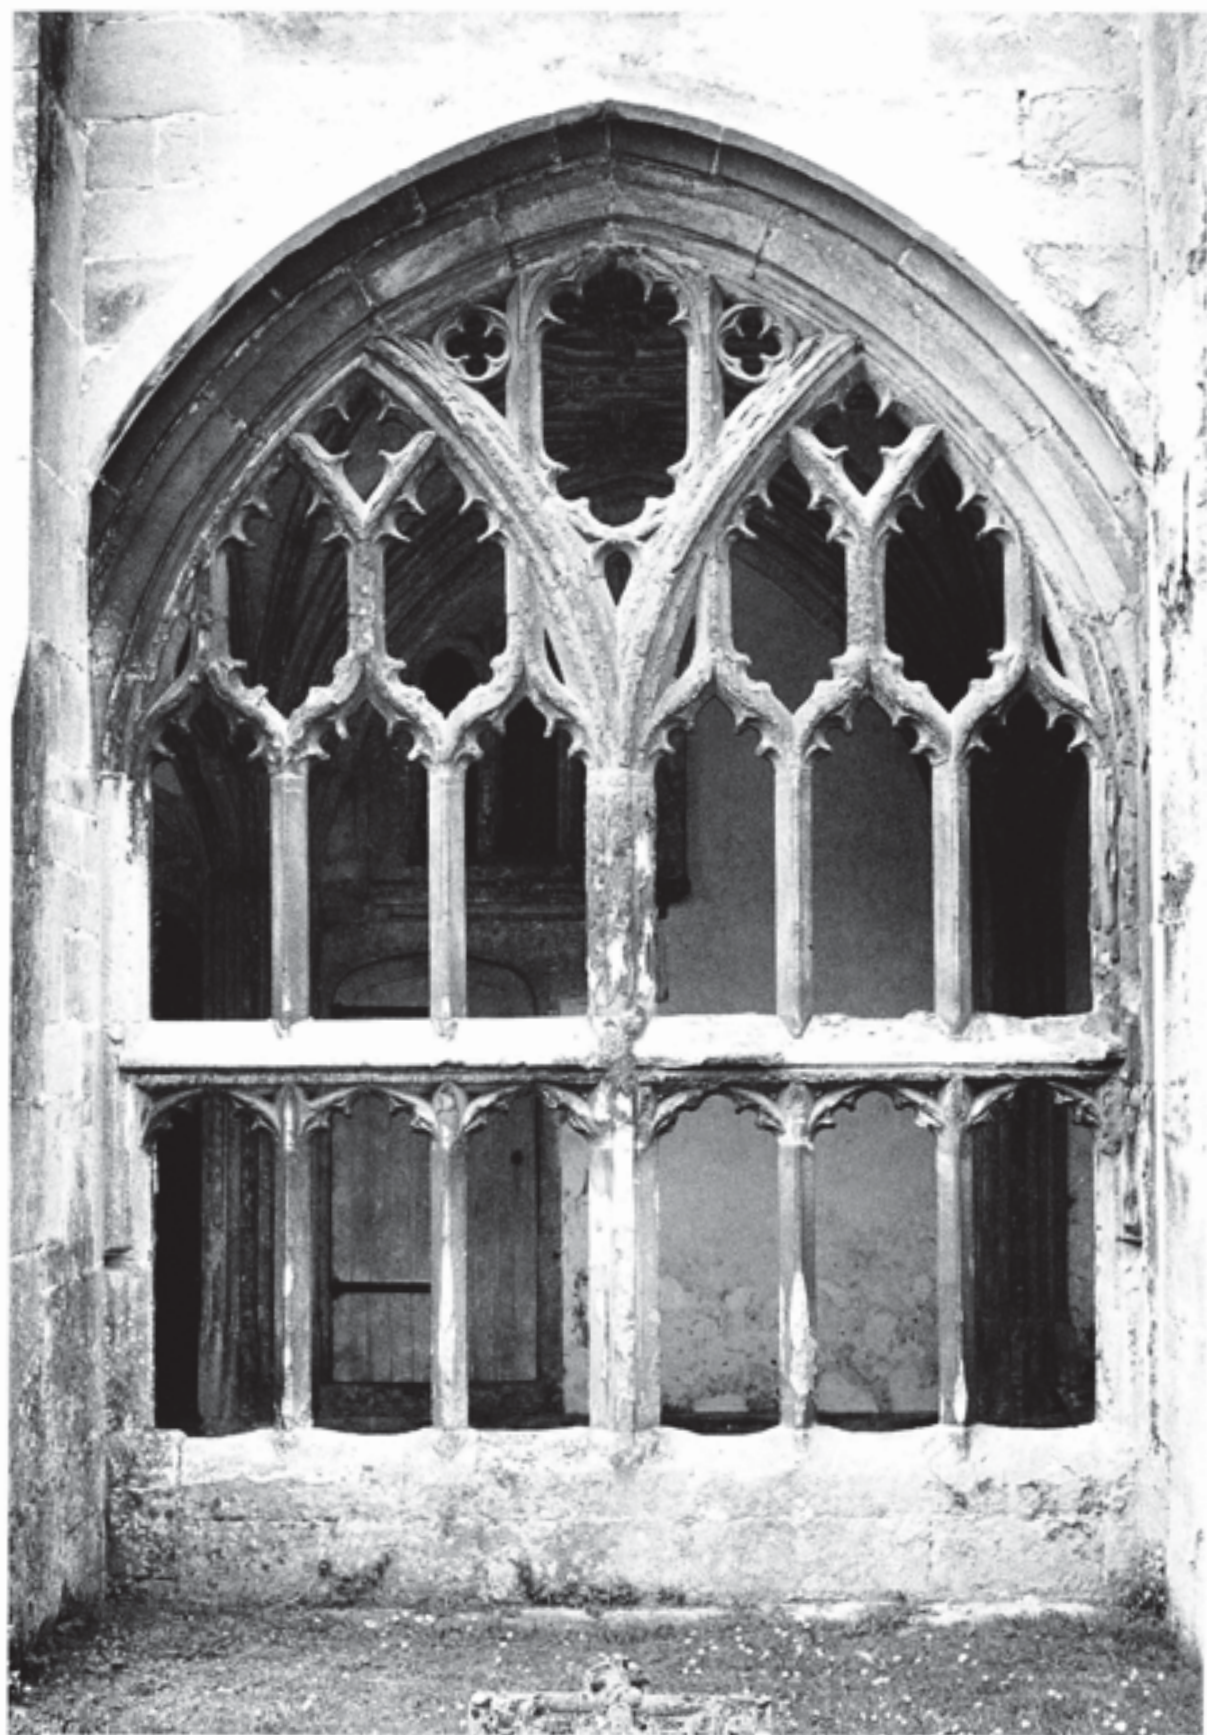
Fig. 271 A typical traceried cloister bay, seen here in 1980 before reglazing. The design dates from c. 1420, but this example, in the west cloister (bay 36), is later in the series (c. 1460–70). Within the walk can be glimpsed the doorway and window of the stair-turret adjoining the cloister porch (Structure 25A). (Jerry Sampson)

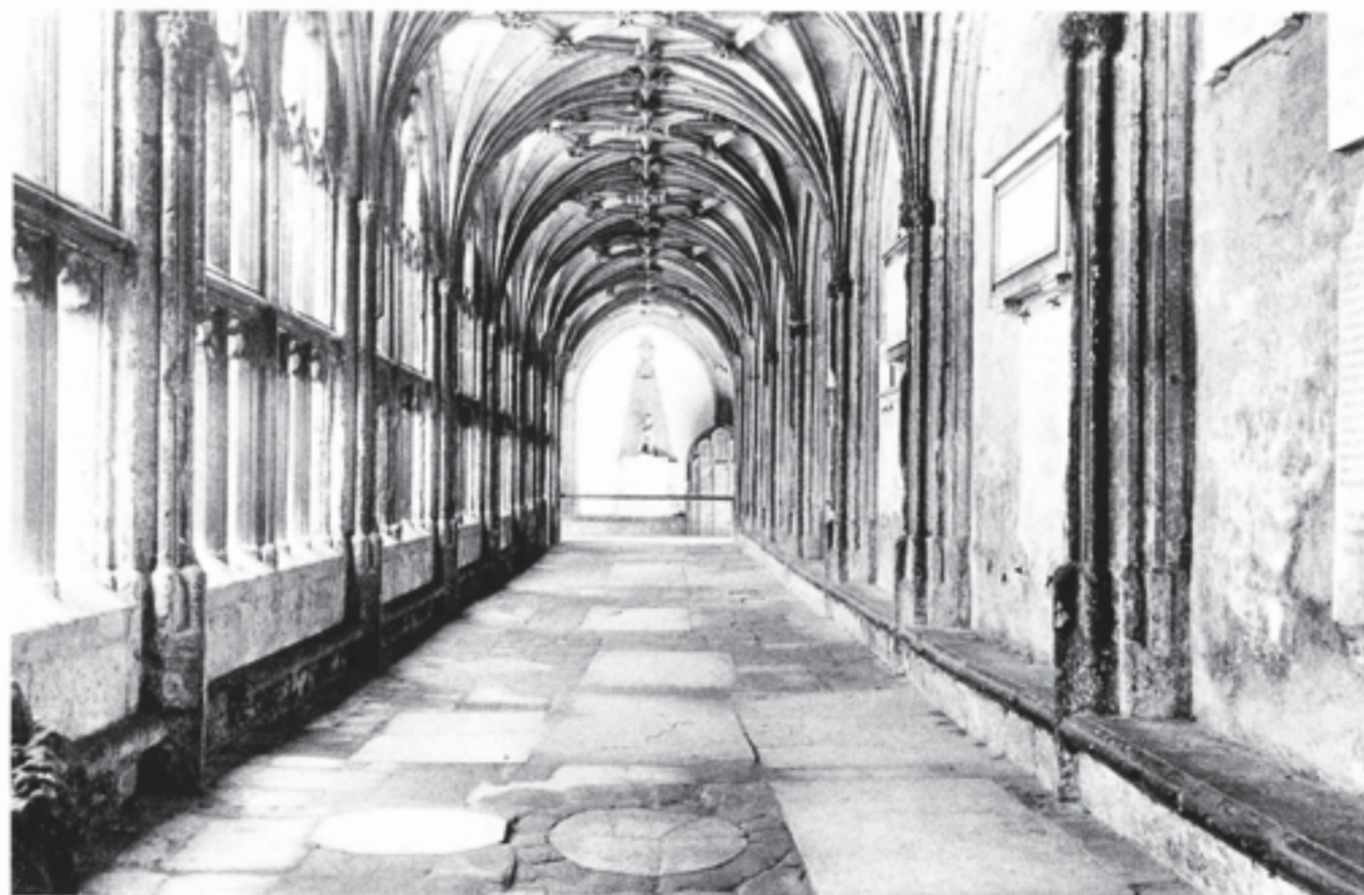
Fig. 273 South cloister walk, looking east, showing the medieval paving and later grave slabs. Note how the late medieval screen wall (left) is built on top of the earlier bench, which has a projecting roll-moulding. Taken by Thomas Phillips, around the turn of the twentieth century (Dean and Chapter of Wells)

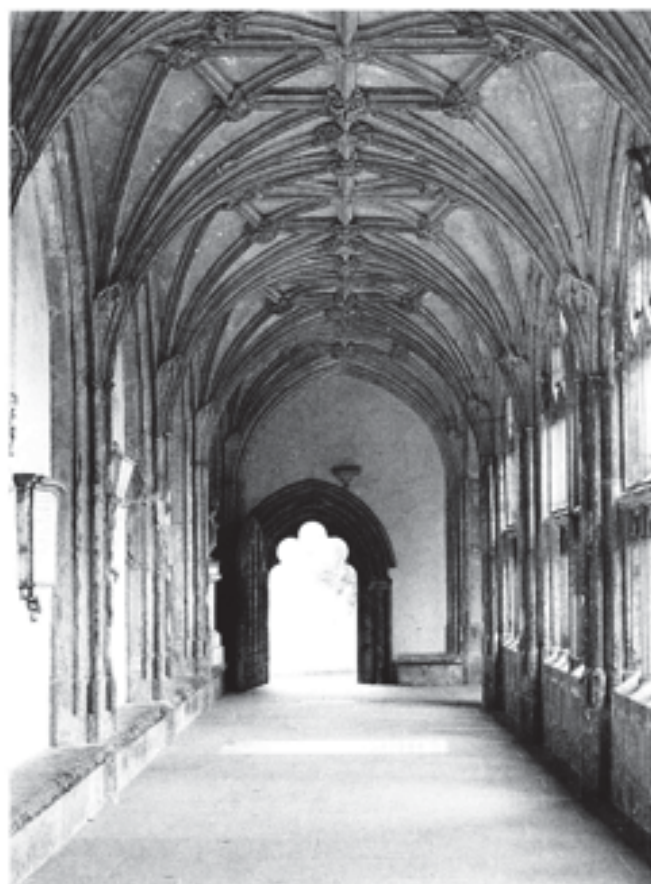
Fig. 275 The southern end of the east cloister walk, showing the asymmetrical siting of the Early English doorway leading to the Bishop's Palace (Jerry Sampson)

The fact that the early thirteenth-century doorway leading south from the cloister to the Bishop's Palace is also asymmetrically placed in relation to the width of the present east walk (Fig. 275) lends further support to the argument for the initial cloister being narrower. The processional doorway leading eastwards into the masons' yard, from the south-east corner-bay (14), is placed slightly asymmetrically in relation to the axis of the south walk, and it could be seen as giving credence to the notion of an original narrow range there too.

structure beyond. The jamb-stones have been recut, and the medieval door itself has been reversed and rehung, so that it now opens into the cloister (Fig. 275). It is thus likely that the buttress spacing on the south wall — particularly at the east end — was influenced by a contemporary adjunct that no longer exists. That adjunct was evidently a porch (Fig. 277, Structure 22).

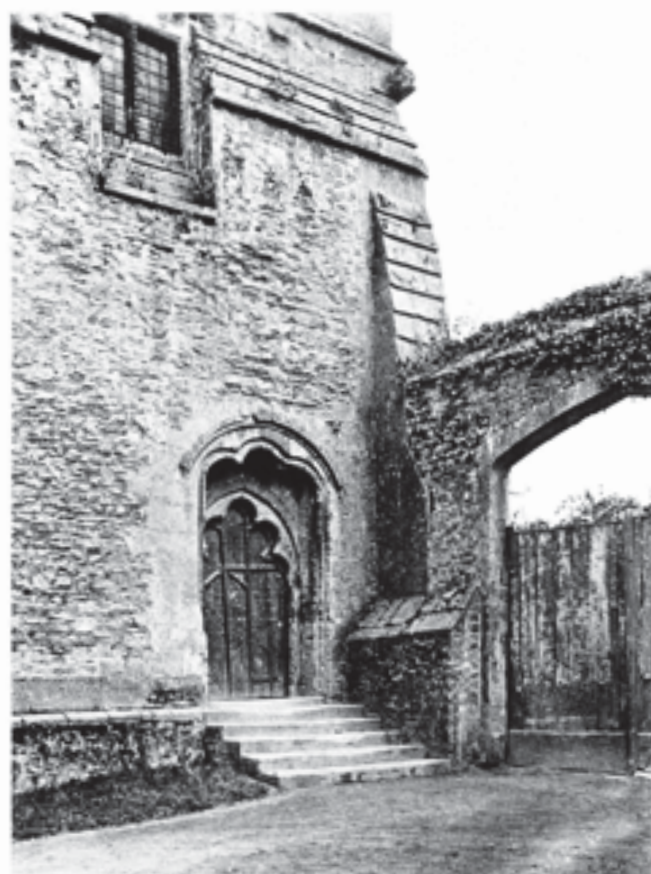
Fig. 278 Early thirteenth-century south doorway (with original door) to the cloister, and the arched entrance of 1433 leading into the masons' yard beyond. Taken c. 1865. After Parker 1866b

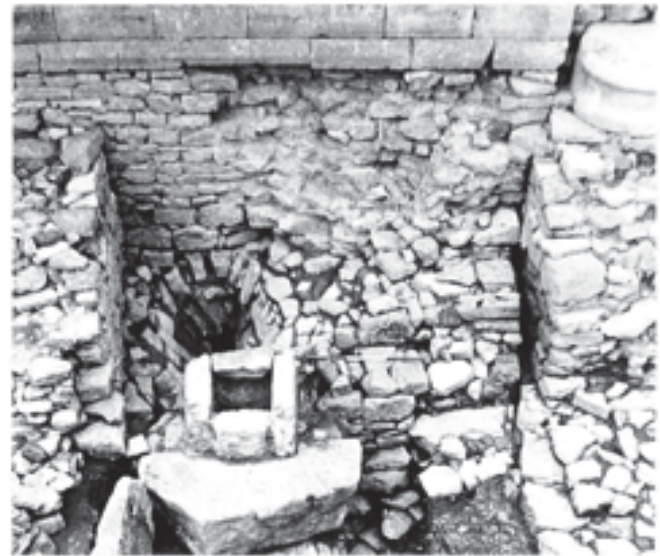
Fig. 281 Robbed foundation for the unbuilt buttress at the junction of bays E₄ and E₅ on the east cloister. Note how the chamfered plinth at the base of the main wall was carried across the intended site of the buttress, and returned along the south wall of the Lady Chapel (right). The 75 cm scale rests on the front edge of the buttress foundation

Turning to the east cloister wall, a wholly different picture emerges (Figs. 262, 264 and 277). Five external buttresses remain here. The stump of a sixth is embedded in the base of the library stair-turret, the foundation of a seventh (unbuilt above ground level) was encountered during excavation (Fig. 281), and the north wall of the Lady Chapel-by-the-Cloister occupied the site where, according to measurement, there should have been an eighth buttress. Indeed, evidence was recovered to suggest that the foundation was laid, but the buttress was not built (p. 265). There were thus theoretically eight bays externally to the east cloister, although the northernmost was so narrow that it constituted little more than a gap between the buttress and the transept (E_8).

Excavation in the Camery has shown additional ways in which the erection of the superstructure did not follow the intentions implied by the foundations. Thus although the foundation for the buttress between bays E₄ and E₅ was constructed (Fig. 277), it was abandoned before the chamfered plinth at the base of the wall was laid (Fig. 281). Almost certainly the same occurred in the case of the buttress between bays E₅ and E₆, although the evidence is less well preserved.

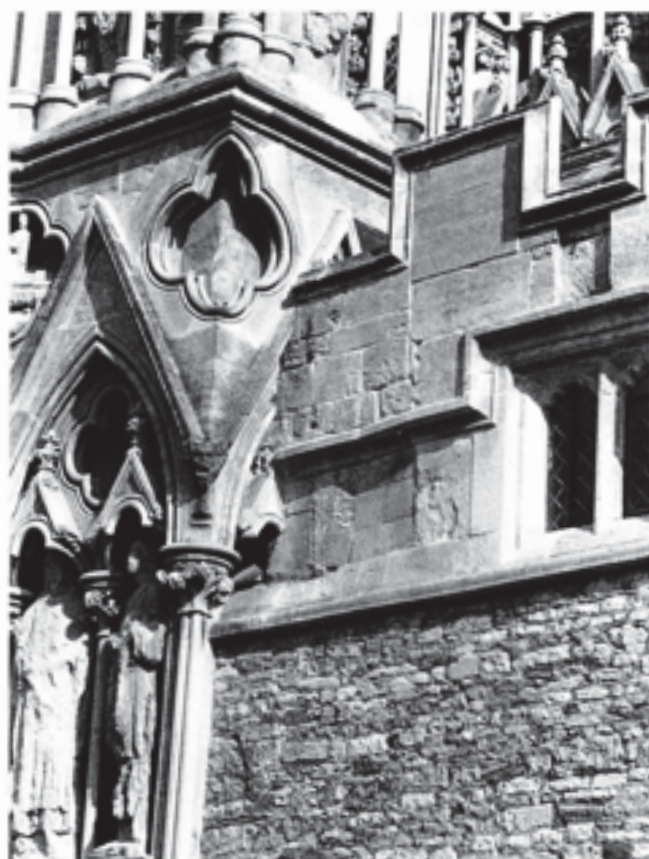
Fig. 282 Union of the outer wall of the west cloister with the buttress of the south-west tower. The remains of the thirteenth-century cloister coping can be seen disappearing under a gablet intended as a statue canopy. The vertical joint and misalignment in the fifteenth-century upper storey of the cloister suggests that it initially stopped just short of the tower

In each range, the builders of the fifteenth-century cloisters retained the solid outer wall of the twelfth/thirteenth-century structure, though only on the south is its full height preserved, complete with the original coping. The outer south wall is of semi-coursed rubble (mostly of local red Triassic sandstone, but including some conglomerate and freestone), and rises to an ashlar coping consisting of four sloping weathering courses (Fig. 274). The last remnants of a similar arrangement are preserved at the northernmost end of the west walk where, at the junction with the west front of the cathedral, two weathering courses survive: they run into the head of a niche on the south-western buttress¹⁰ (Figs. 282 and 283).
