WELLS CATHEDRAL

Excavations and structural studies, 1978–93

*Excavations and Structural Studies,
1978–93*

ARCHAEOLOGICAL REPORT 21

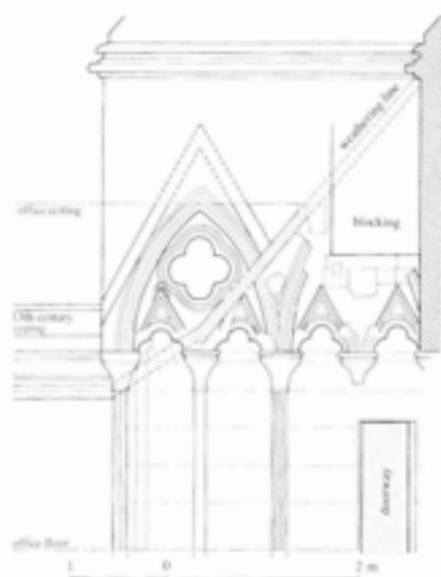
Fig. 286 South-west tower. The east face of the south-west corner buttress, showing the chase of a pentice roof that closed the north end of the west cloister. This is now preserved inside a first-floor office. The thirteenth-century coping to the cloister abutment is shown partly restored; later medieval work is omitted for clarity. Scale 1:80. After Sampson 1998

The outer wall of the west cloister abuts the south-west buttress of the tower, and the inner face of that buttress forms part of the interior of the accounts office. It bears the weathering scar of a pentice roof, spanning the gap between the tower buttresses. The roof sloped down from north to south and had a pitch

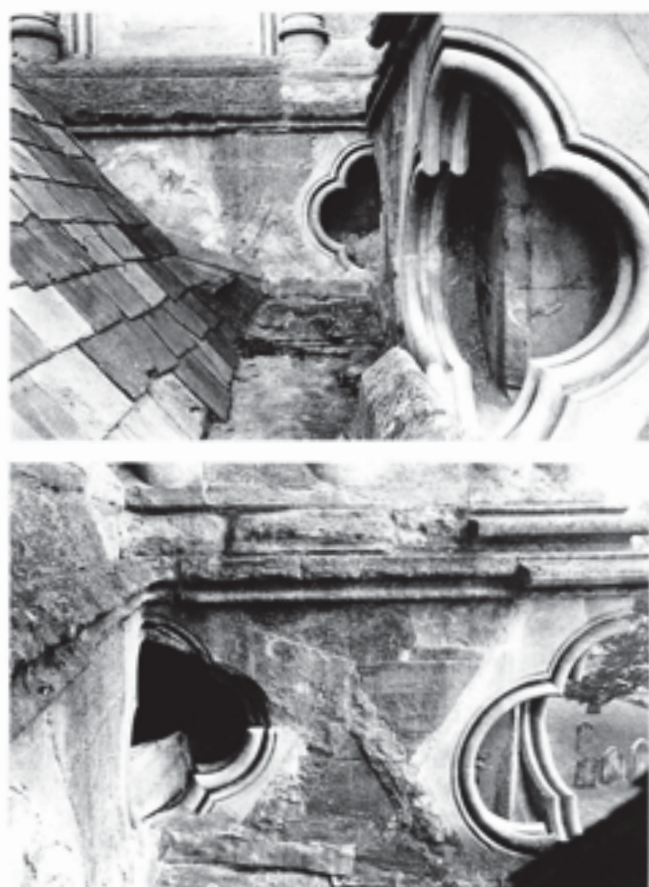
Fig. 287 South-west tower. Quatrefoil niches and hacked-off gablets, above the west cloister roof. A (upper) South face of tower, with south-east buttress on the right; B (lower) West face of the south-east buttress

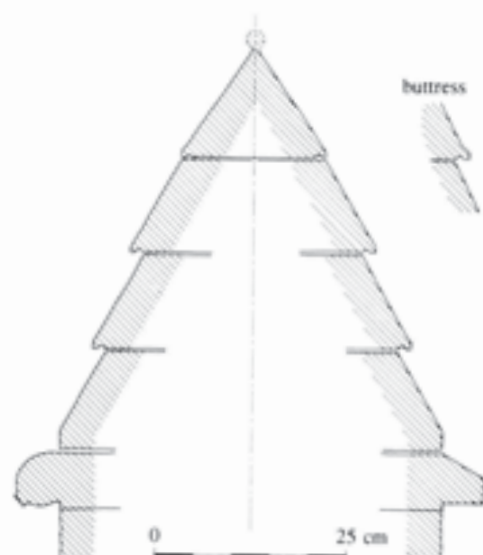
Fig. 290 Section through the early thirteenth-century coping and string-course of the south cloister wall. The inset shows the kicked weathering-groove found on the copings of the south cloister buttresses. Scale 1:10

die into the wall face immediately below the parapet string-course, which comprises a large roll with a downward-angled fillet (Fig. 289.1). The coping consists of four weathering courses (Fig. 290): the lowest is plain, while the other three all have drips. The top stone formerly had a small roll along the crest, but this has entirely gone, leaving, in a few places, only the necking. For the most part, the weathering-groove under one or both edges of the top stone is concealed by the second course, and is therefore ineffective. This arises as a result of the lower courses all being too broadly spread. The several elements of the coping could only be correctly juxtaposed if surmounting a wall 91 cm (3 ft) in thickness, whereas the existing wall is 99 cm (3 $\frac{3}{4}$ ft).

Unambiguous evidence for a thirteenth-century monopitched roof over the south walk has been discussed (p. 269). It had a 16° pitch, and sloped down from an angular weathering-course at the base of the parapet coping (Fig. 290). The covering must have been of lead. Presumably, a plate carrying the rafter ends was affixed to the wall face, at a level now obscured by the nineteenth-century lead gutter (Figs. 284 and 285).

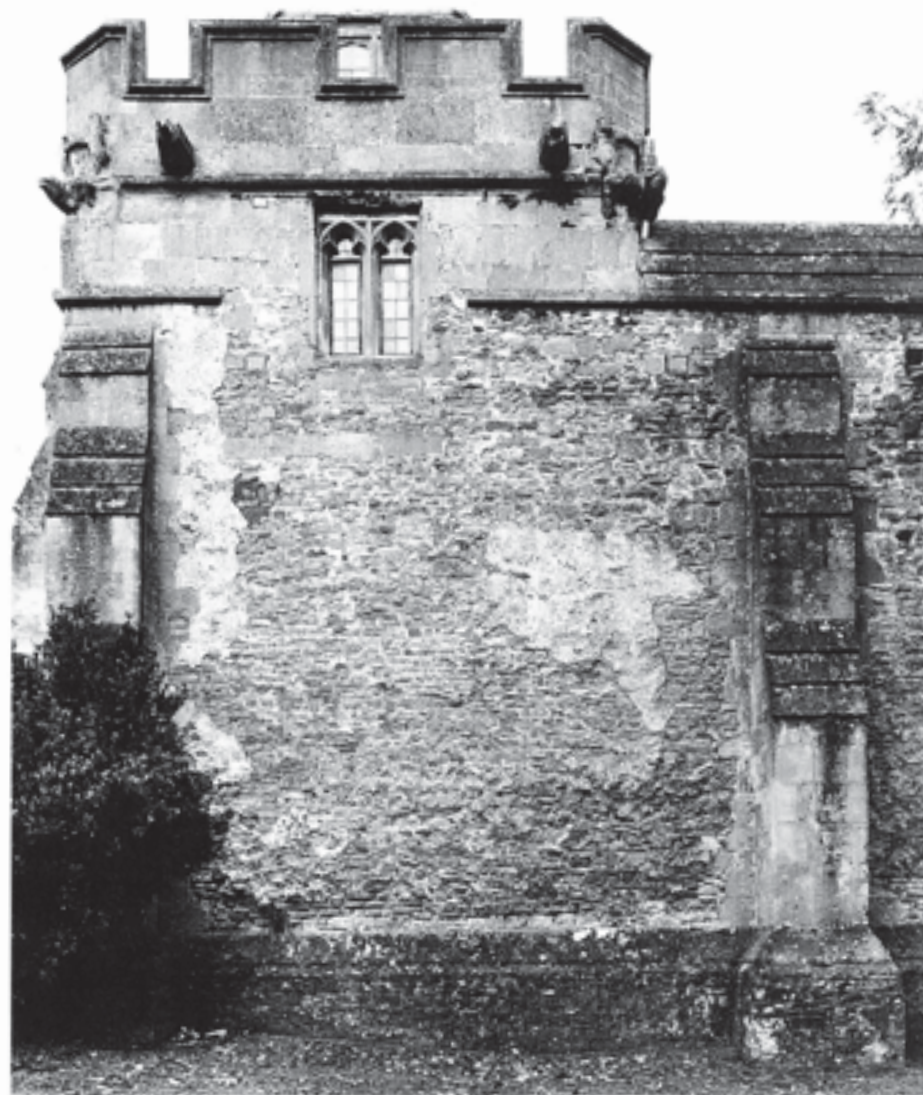
Fig. 292 Cloister bay S₁, with the fifteenth-century crenellated parapet (1992). A glimpse of the recessed gable of the west range can be seen through the central embrasure of the parapet. For a key to structural features, see Fig. 291 (English Heritage)

Bekynton's reconstruction of the west cloister in the late fifteenth century included the erection of a parapet and gable-end on top of the old south wall (Fig. 292). No attempt was made to replicate the southern termination of the east cloister. Instead, the original coping of the south wall was removed, leaving the string-course in place. The Doulling ashlar used to raise the wall were remarkably irregular, and badly laid. A two-light window was provided as a feature of the new work, set flush with the south wall face; its sill was cut into the top of the thirteenth-century wall.³¹

Above the window is a string-course, which returns along the east and west walls of the range, marking the base of the crenellated parapet. The two southern corners are canted, and from these project brackets in the form of human busts, gargoyle-fashion. The figures were never water-spouts, and instead each carried a small pedestal for a statue, together with canopy-work associated with a niche. The niches and any statuary they contained have been destroyed: everything above pedestal level was removed and replaced with a simple canted merlon during a substantial rebuilding of the parapet in the nineteenth century.

Set back behind the crenellated parapet, facing south, is the stone gable of the west cloister roof, complete with a Tudor two-light window. This window is an insertion, and relates to the formation of an attic room over the main chamber in the upper west cloister. It also seems clear, from a number of surviving scars, that a garret was built out from this roof, over the west end of the south cloister. It had a pitched roof running east–west. One of the coping stones of the south wall, in bay S₂, has had its top reduced to form a level seating, presumably as part of the support for the superincumbent structure (Fig. 291). Nothing is recorded of these attic rooms, but they may well have been associated with the schoolmaster's lodging, which is known to have been in the upper part of the west cloister, along with the school itself. Possibly other rooms were built into the roof space above the south cloister, causing its early sixteenth-century roof to be mutilated. That would provide a ready explanation for its complete removal, and replacement with the existing softwood construction in the early nineteenth century.

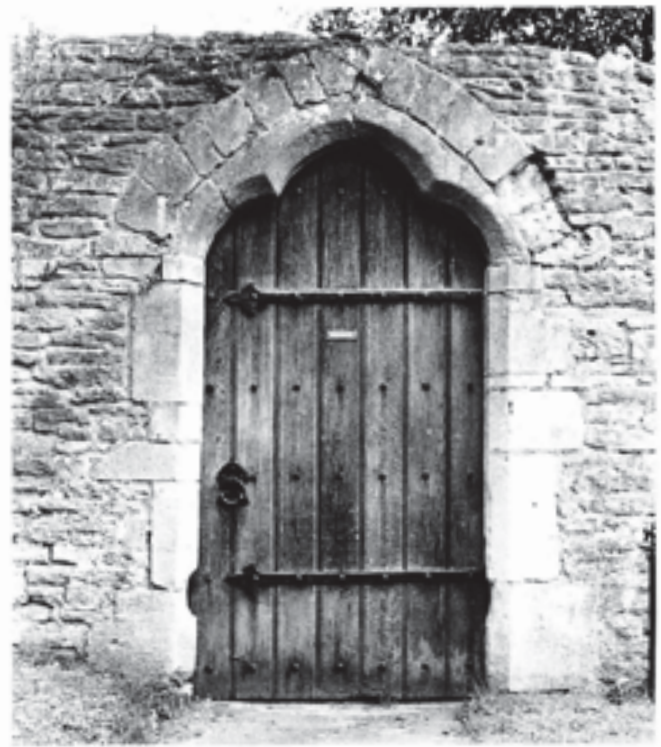
Fig. 295 Possible recycled thirteenth-century doorway from the south cloister porch, now used as a gateway in the late medieval wall separating Palace Green from the bishop's garden

It might be argued that the south porch, although undeniably intended by the early thirteenth-century builders, was never constructed. If that were the case, it would be difficult to explain the initially outward-opening door. Mention should be made of the survival of what was plausibly the outer doorway to the porch. Only a few metres to the south, in the wall dividing the bishop's outer garden from Palace Green, is an early thirteenth-century doorway that is *en suite* with the cloister entrance (Fig. 295). In its present position, functioning only as a garden gate, this elaborate Douling stone doorway is anomalous. Although some of the stone is undoubtedly Victorian, it is not entirely a post-medieval fabrication, and it appears in one of Carter's sketches of *c.* 1795. If this doorway is not derived from the porch it is difficult to suggest another source. The arch has a depressed trefoil head with a plain chamfer on the outer arris; and the foils, once again, are of rounded form. Rebated on the east side, the opening has a late nineteenth-century door hanging in it. Apart from this south entrance, there are no

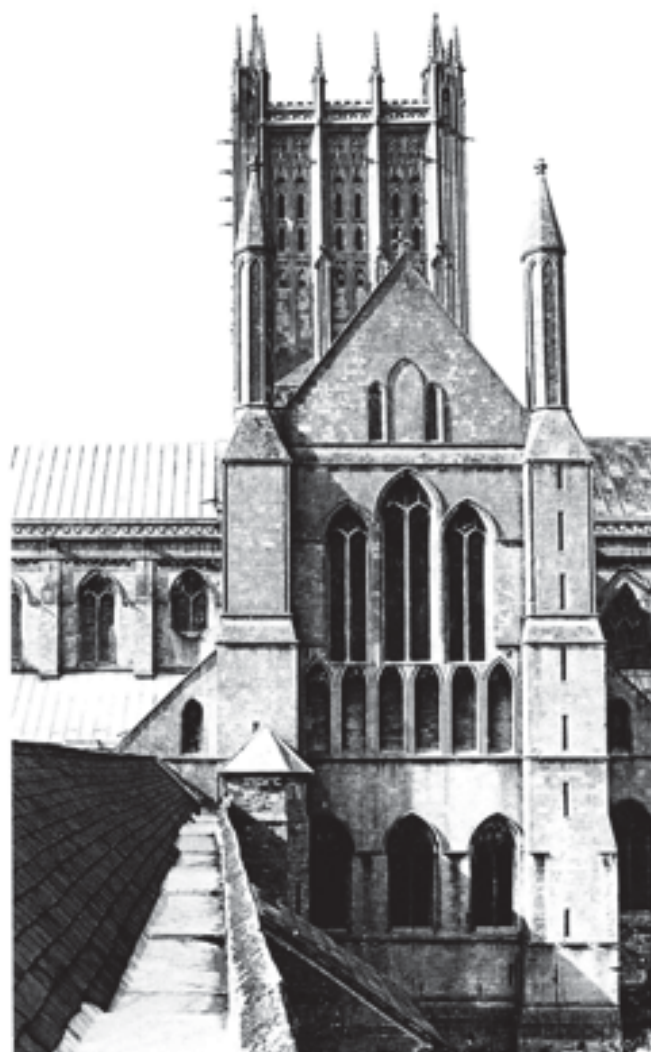
Fig. 296 The south front of the south transept, showing the abutment of the east cloister and stair-turret. The library roof and parapet enter from the bottom of the picture. Note the broad, shallow parapet gutter

south elevation (Fig. 296). These are flanked in turn by a pair of windows lighting the aisles, which are set higher than those in the centre bay. In both aisles the positioning of the windows was conditioned by doors beneath them: in the eastern aisle is the door to the intended 'sacristy' (p. 138), and in the western aisle is the great door to the cloister. The visual integration of the raised windows with the design of the elevation was maintained as far as possible, by stiling the connection between their hood-mouldings and the median string-course to which all windows at this level related (Fig. 116).

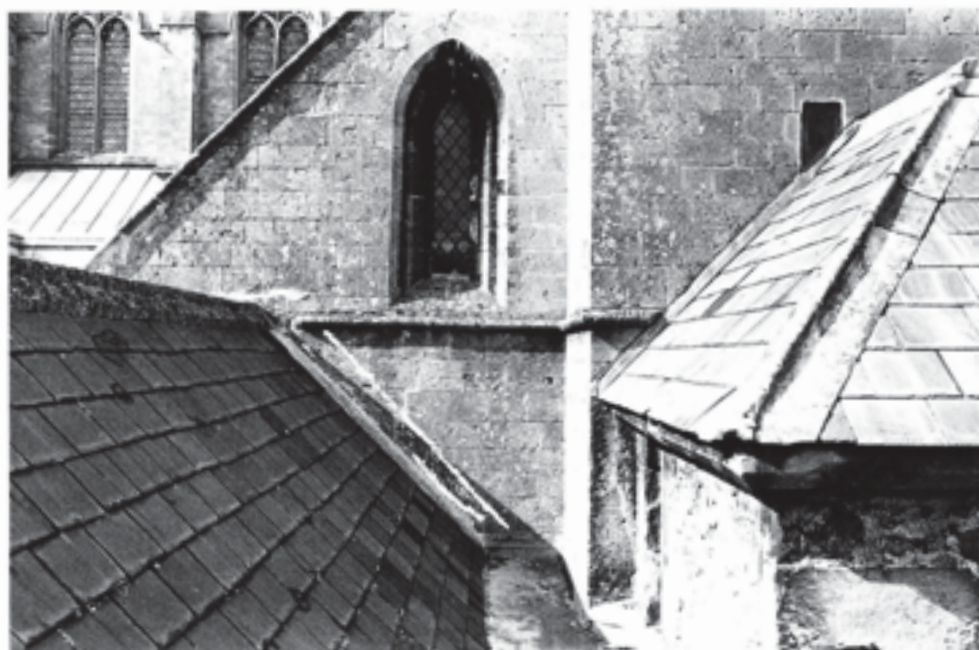
Fig. 298 Detail of the abutment of the present east cloister roof to the west aisle of the south transept. An earlier roof-line is emphasized by the white mortar filling of the flashing chase. The roof of the 1420s stair-turret (Structure 13) is seen on the right, partly blocking an original window to a chamber in the triforium

However, there are traces of another, plainly earlier, roof-line, also cut into the late twelfth-century ashlar of the transept, some 25 cm above the fifteenth-century roof (Fig. 298). The pitch is slightly less (45°). At the bottom of the west side, the chase defining this earlier roof-line becomes horizontal, and evidently marks the position of a former parapet gutter, 40 cm above the present gutter level. The flashing line disappears into the side of the transept's south-west buttress, but does not return around its south face, demonstrating that the inner face of the earlier parapet was aligned on the east side of the buttress (Fig. 299).

There is no corresponding sign of a parapet flashing-groove at the base of the eastern side of the cloister: here the roof-line simply dies out, 42 cm above the present parapet gutter level. The chases of the old roof-line intercept the transept's fourth, or aisle-top, string-course; and then they flatten out, turning into a horizontal chase 90 cm long. There was thus no true apex at the point where the roof met the transept: the flat top was doubtless a lead-covered platform on which to stand while a ladder was passed from one pitch to the other. Such features were not uncommonly incorporated as aids to roof maintenance. The chase relating to this relict roof-line is filled with white lime mortar which could be of fifteenth-century date.

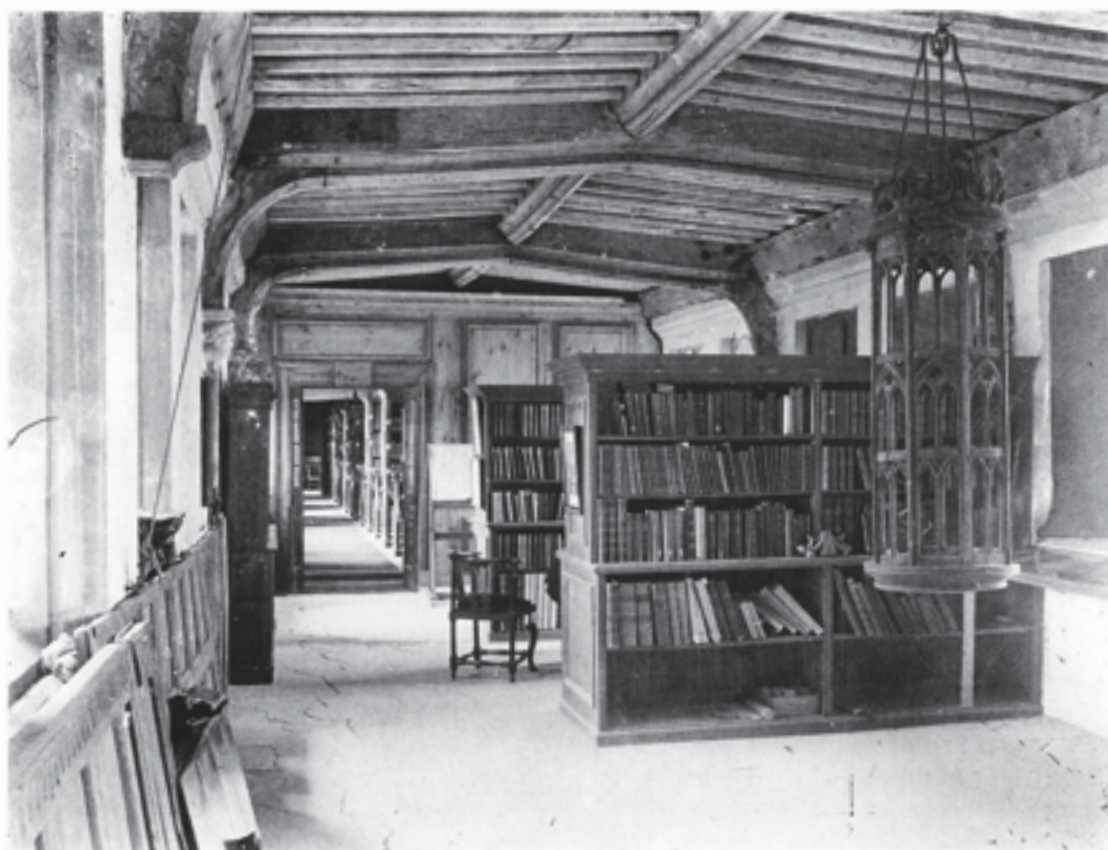
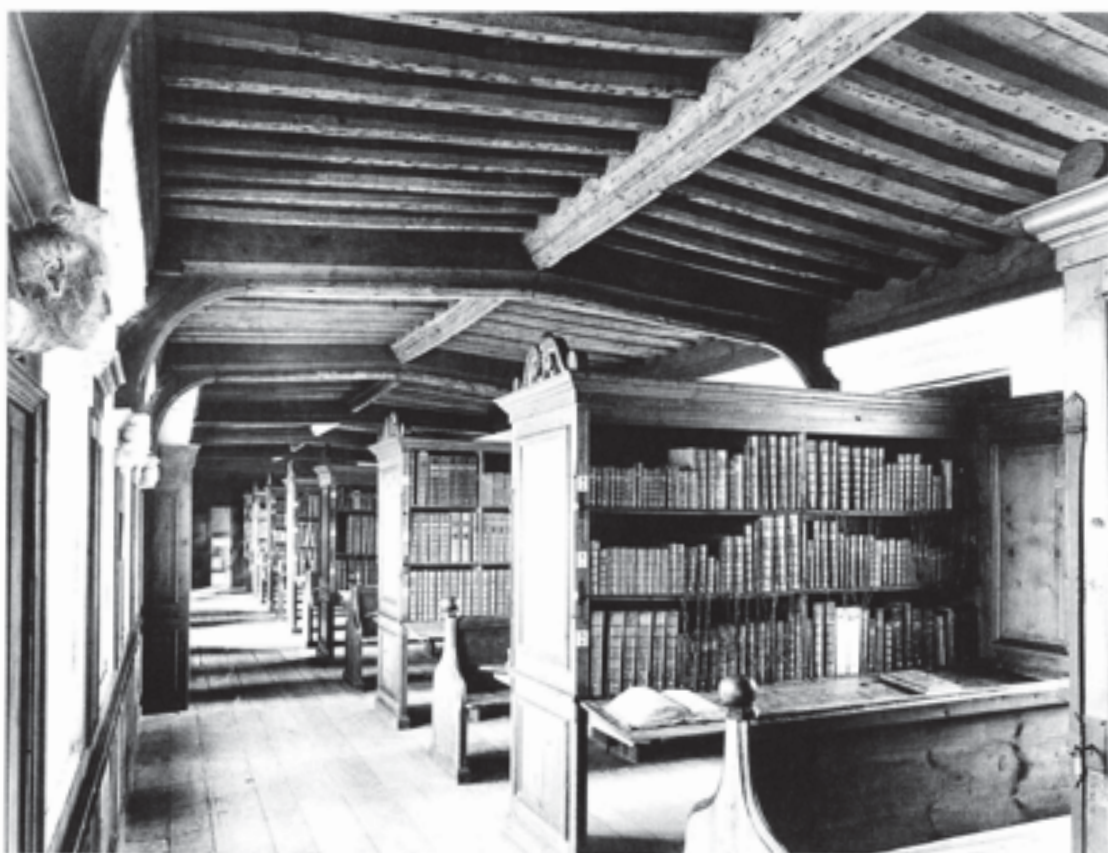
Fig. 300 The interior of Bubwith's library. A (upper) The outer room in c. 1900, looking south from bay 2 towards the panelled screen of 1686, through the open doors of which the chained library can be seen. The cracked floor is of lime-ash or gypsum. Note the medieval hanging pyx-cover, and sections of dismantled screen. B (lower) The chained library in 1982, looking south from bay 6; the muniment room is glimpsed through the open door at the far end. The head-cornice on the left is no. 12, and the pine book-presses date from 1686 (A, Dean and Chapter of Wells. B, George H. Hall)

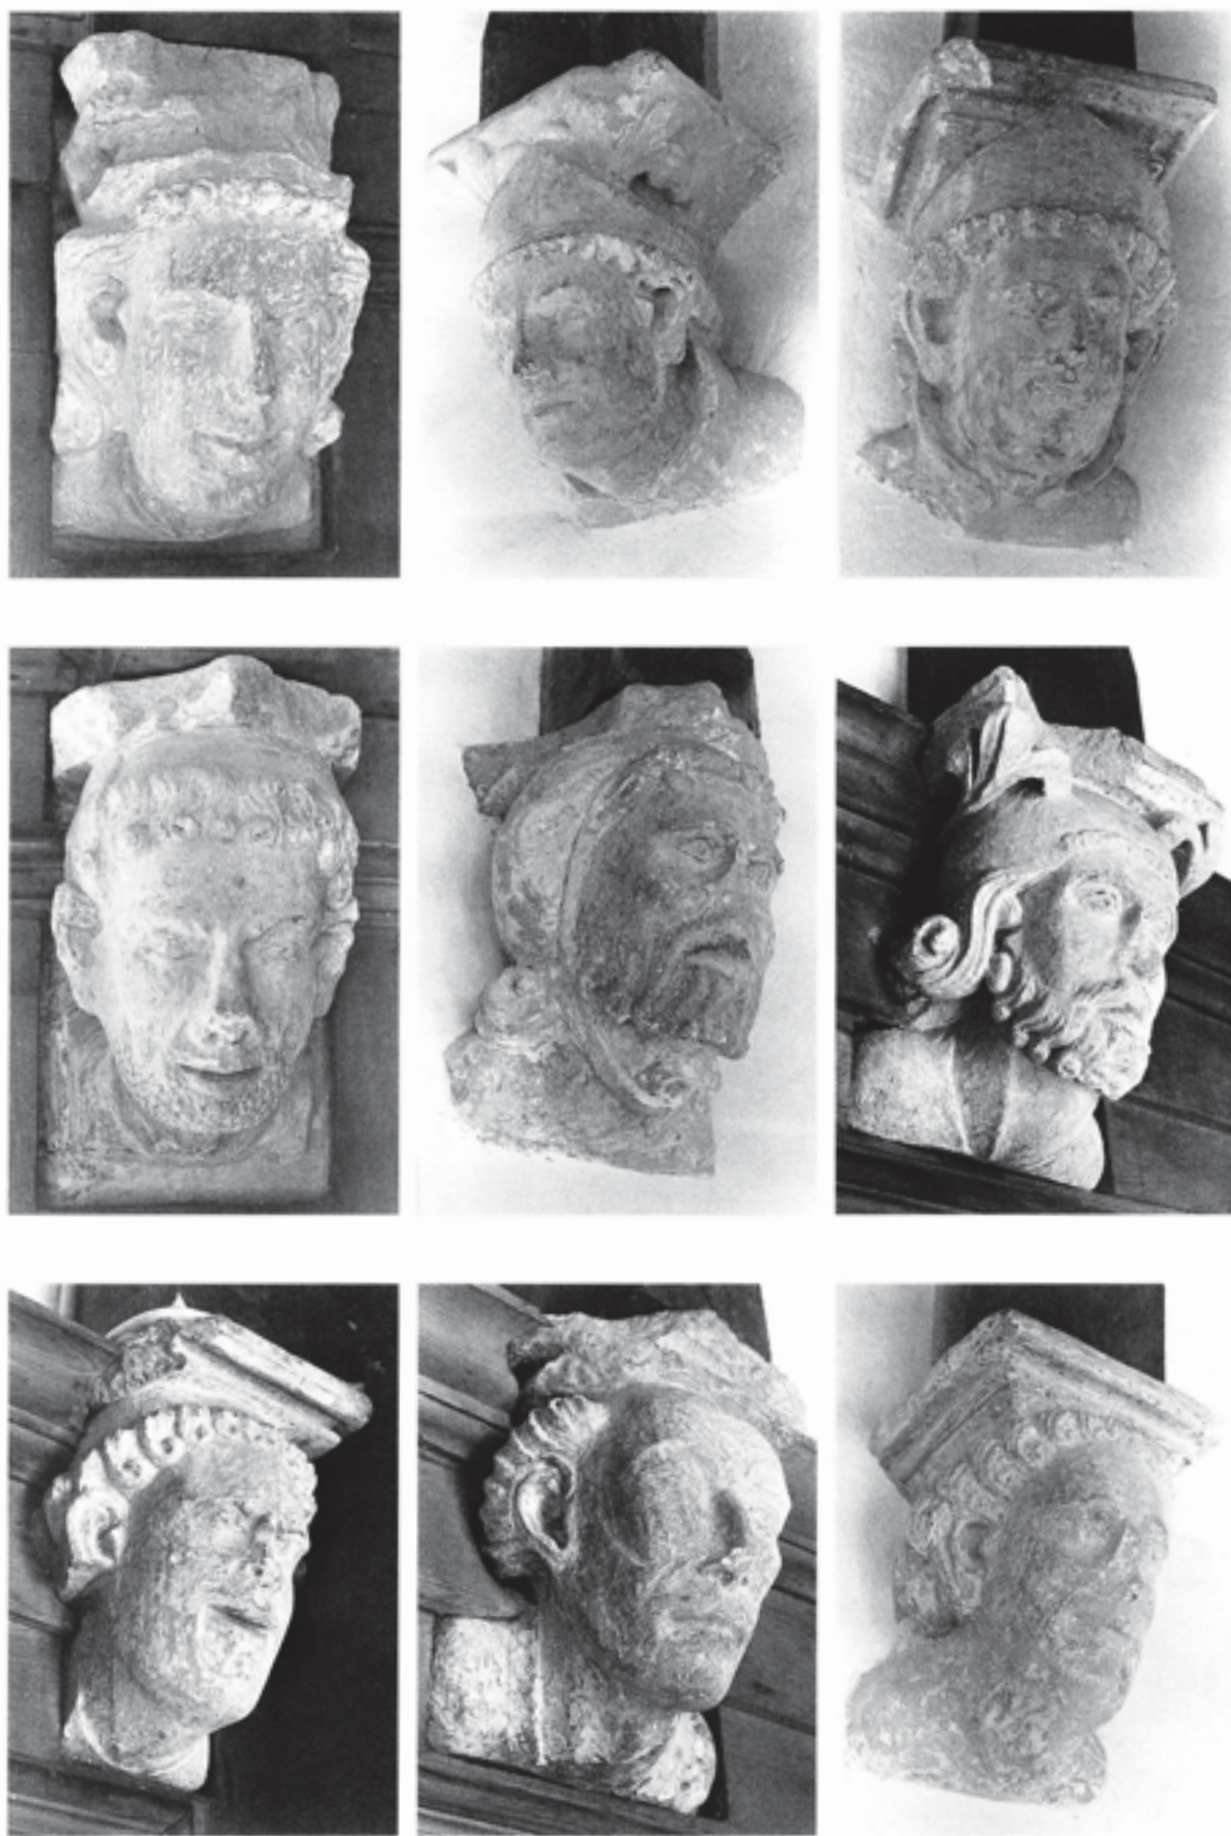
Fig. 301 Thirteenth-century corbels reused as roof supports in Bubwith's library. Top row nos. 13, 5, 1; Middle row nos. 11, 8, 14; Bottom row nos. 16, 12, 6. The average width across the abacus is 20 cm (Jerry Sampson)

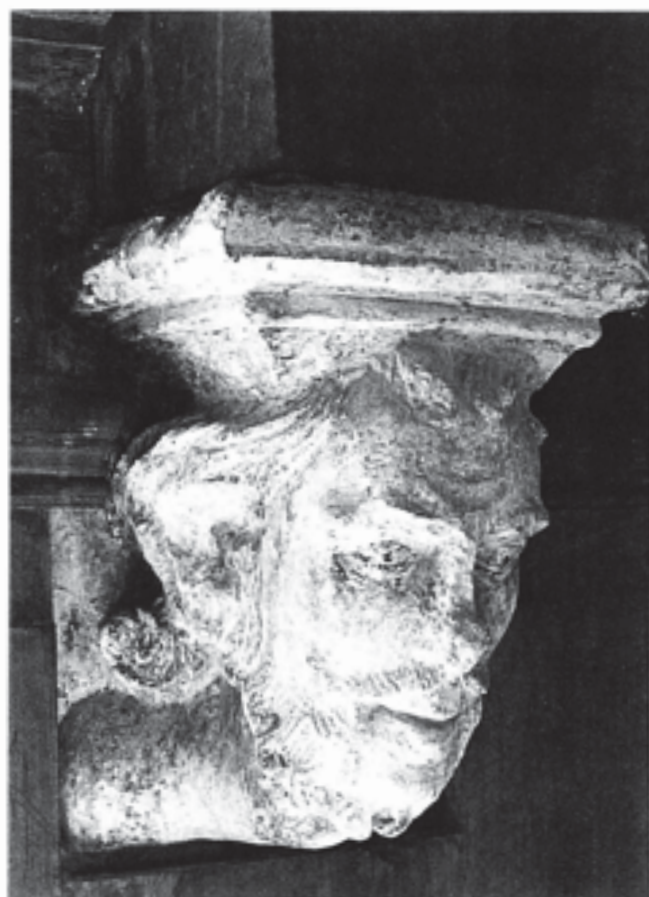
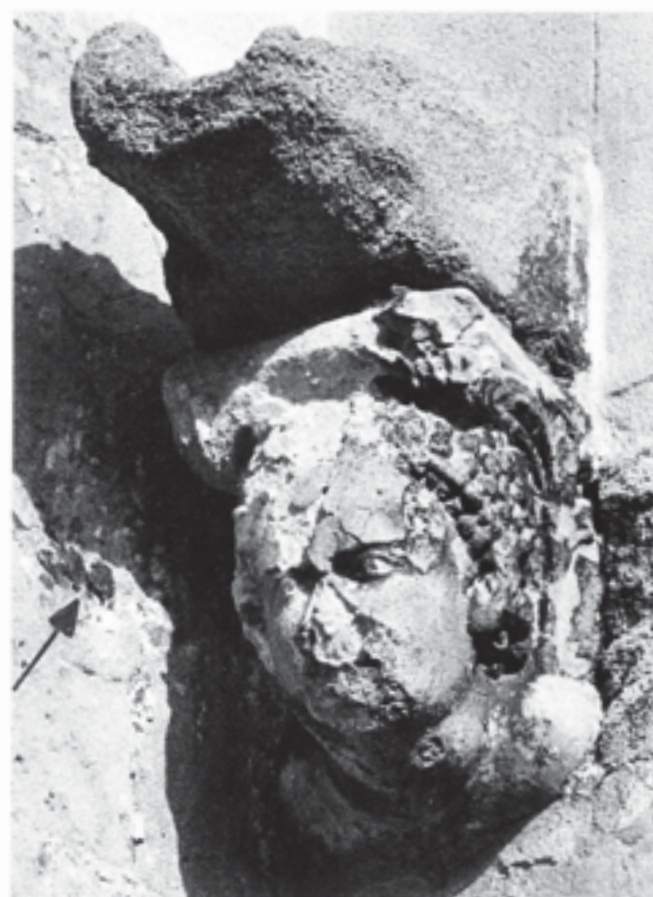
Fig. 302 Thirteenth-century corbels recycled in Bubwith's library. Left: no. 15, used as an internal roof support. Right no. 17, used to support a fifteenth-century water-shute on the west face of the library, at the junction with the transept. The arrow points to two medieval nail heads with a fragment of lead flashing trapped behind them (Left, Jerry Sampson)

colouring, crudely executed. The serious damage all appears to be post-medieval, and in some cases it can clearly be linked to library fixtures. The absence of medieval corbels at position nos. 3 and 4 relates to a former partition here. However, it cannot be determined with certainty whether there ever were stone corbels in these locations: the timber one which is seen in a photograph of *c.* 1900 (Church 1901, pl. 26) may have been medieval and associated with an oak screen across the library at this point.³⁵ Corbel nos. 9 and 10 are now encased within a seventeenth-century panelled division.

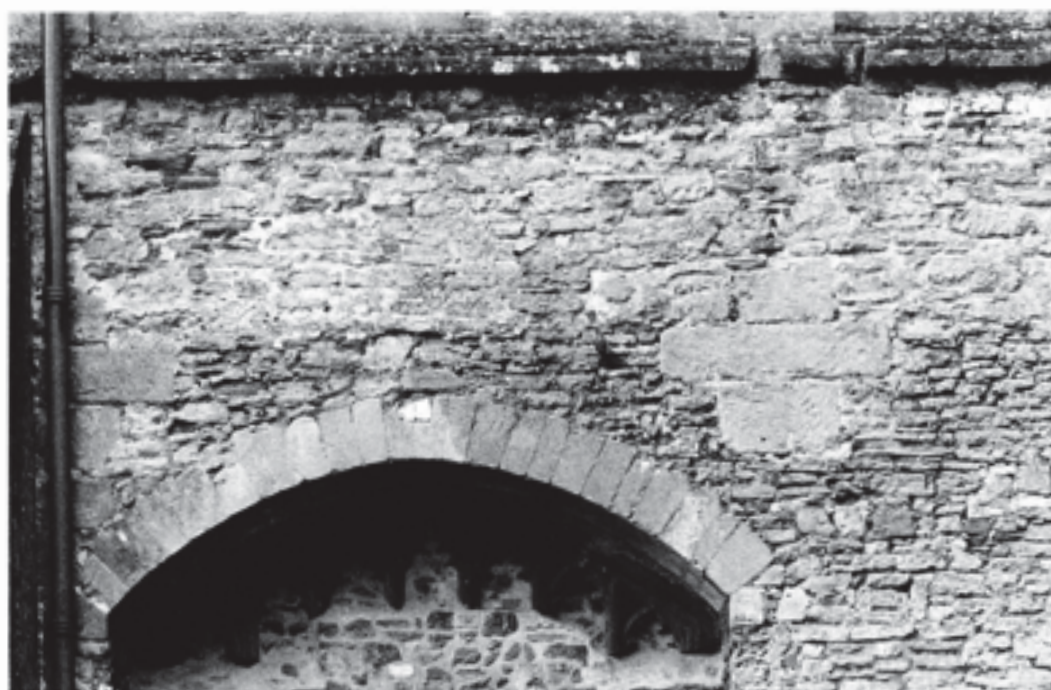
Fig. 303 Two groups of large ashlars in the east wall of the cloister, bay E₇, apparently counterpoise blocks associated with an inserted stone vault of mid-thirteenth-century date. Below is the late fifteenth-century arched entrance to the Holy Cross chapel (English Heritage)

Evidence for the former existence of a pre-fifteenth-century stone vault in the northern half of the east cloister has long been visible, but never fully recognized or explained. On the outer face of the east walk (bays E₄ to E₇), some four metres above ground level, is a series of large, roughly squared blocks of Douling stone, spaced at regular intervals: three blocks, grouped vertically above one another, occur at each position (Figs. 265B and 303). Six such settings survive, and the spacing suggests that another has been lost where the

screenwork of Stillington's chapel now masks the face of the cloister wall. The blocks were demonstrably inserted into the early Gothic cloister wall, after its coping and a few courses of rubble-work had been removed; the wall top was then built up again. Some of the inserted stone triplets form neat compositions (e.g. bay E₇), while others are more casually placed (e.g. bay E₄). The spacing of the blocks is coincident with bays 2 to 8 of the extant vaulting: i.e. it is coterminous with Bubwith's first-period reconstruction.

The inescapable conclusion is that the stone triplets are relict from some earlier vaulting arrangement within the east walk, the bay structure of which presaged that of Bubwith's reconstruction. The simplest explanation is that the blocks were built into the outer face of the wall as counterpoises for the *tas de charges* of a vault. Presumably the lowest stone in each group was a long block which ran through the full thickness of the wall, and either rested directly on the tail of the *tas de charges* or, more likely, was part of the springer-corbel carrying the inserted vault. When studied in section (Fig. 299), it is readily apparent how the arrangement would have worked. The perceived need for careful counterpoising of the vault structure was related to the fact that it was being introduced into an existing wall and hence the masonry bond would be weak. The relevance of this counterpoising provision is seen, *a fortiori*, if there was at first no intended upper storey to provide substantial downward thrust.

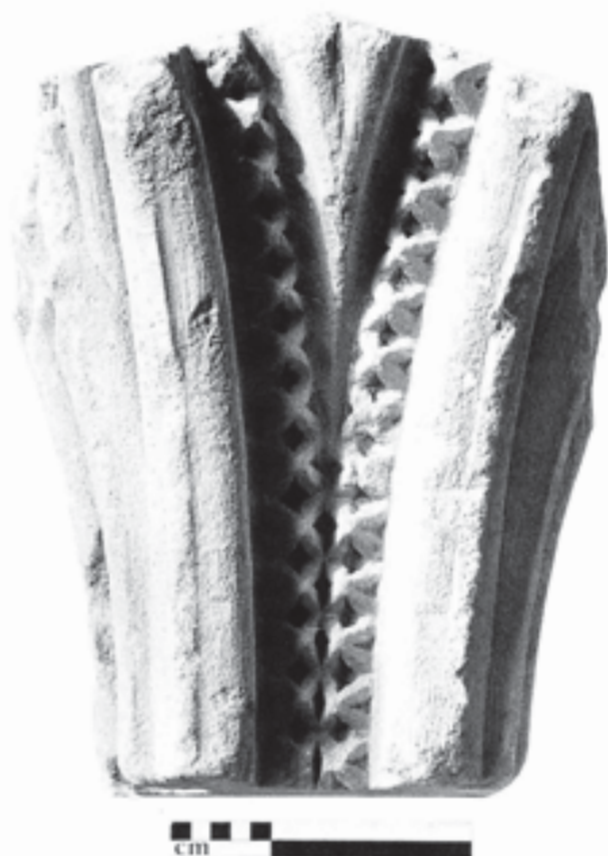
Fig. 304 Vault springer with small ribs and dog-tooth ornament, from a thirteenth-century structure associated with the cloister, possibly the well-house. For the moulding profile, see Fig. 289 (Jerry Sampson)

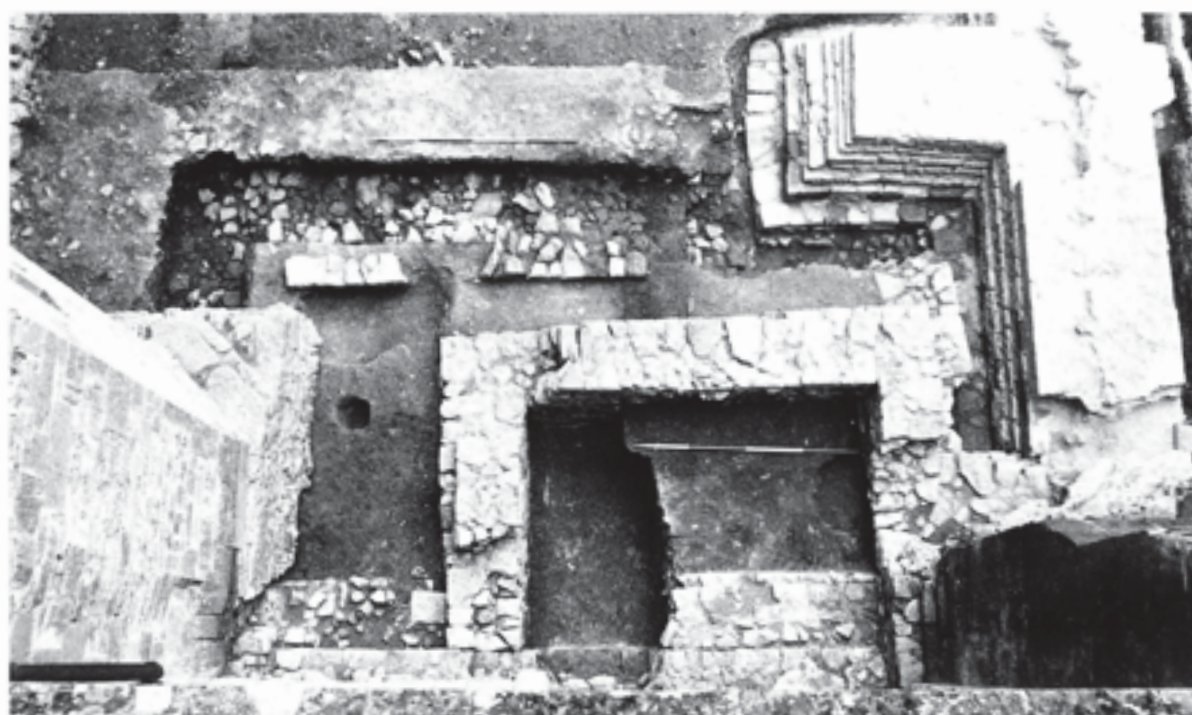
Fig. 306 View from the cloister roof, showing the fragmentary foundations and possible wall-benches of Structure 12, with the later Holy Cross chapel superimposed (the smaller, squarish building). The library stair-turret (Structure 13) rises on the left, and one of the early cloister buttresses is glimpsed on the lower right. East is at the top. Scales of 2 m

No floor levels remained within the building, but along the east and west sides were shallow strip-foundations abutting the respective walls. On the west, the foundation (F668) was 60 cm wide, and constructed against the twelfth-century cloister foundation (F184): the two-stage chamfered plinth at the base of the cloister wall had been cut back. The same had been done to the southern buttress, where this was exposed within the building, but in the case of the northern buttress only the lower plinth section had been cut away. The foundation ledge thus created against the cloister was 80 cm wide. This would have been excessive for a normal wall-bench, and a more substantial construction extending along the west side of the building, from buttress to buttress, is implied. A two-tier wall-bench — as in the chapter house — would have been possible, as would a series of recesses or cupboards built in masonry. The central one-third of the foundation was destroyed by a wall and cist-grave associated with the Holy Cross chapel (p. 311), and therefore continuity of the foundation is not certain; also, there may have been a doorway in this side.

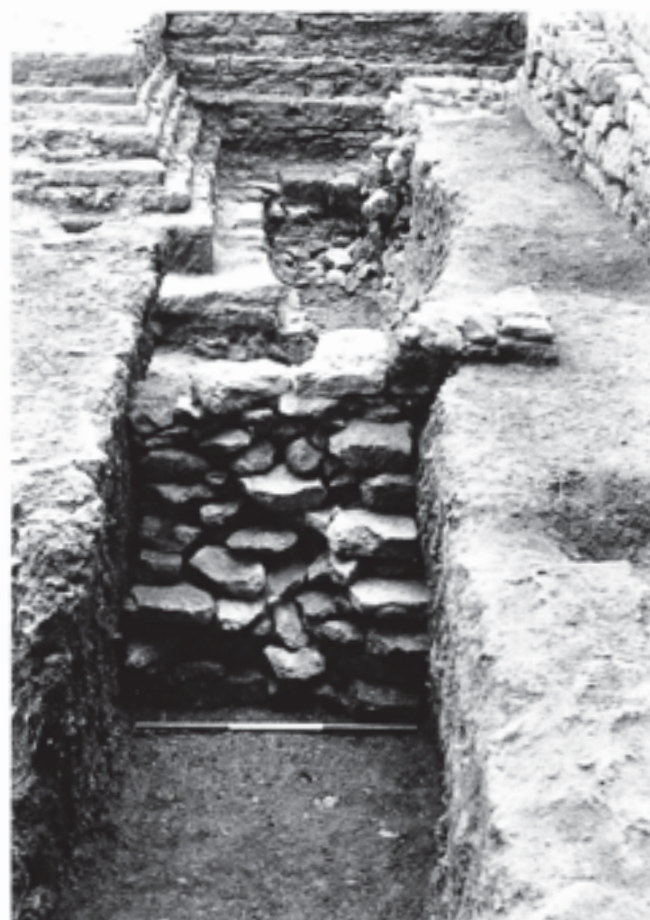
Fig. 307 Structure 12: section through the foundation of the east wall, showing also the shallow setting (right) for a presumed internal bench. Scale of 75 cm

The foundation on the north and east (F644) was of well-laid rubble in a trench 80–90 cm wide (Fig. 307). At one point a trace of the footing-course for the wall survived, indicating that the above-ground thickness of the masonry had been 60 cm. The internal

The added foundation against the east wall (F385), on the other hand, was a much slighter construction: here the width was only 40 cm, a suitable dimension for a wall-bench, or even a sleeper wall for the support of a raised timber floor (Fig. 307). The latter is less likely in a medieval context. The east foundation was badly robbed, but the two surviving sections probably represented a once-continuous feature. No evidence remained to establish whether the internal foundation returned along either the north or the south wall; if it did it must have abutted the salient angles of the buttresses.

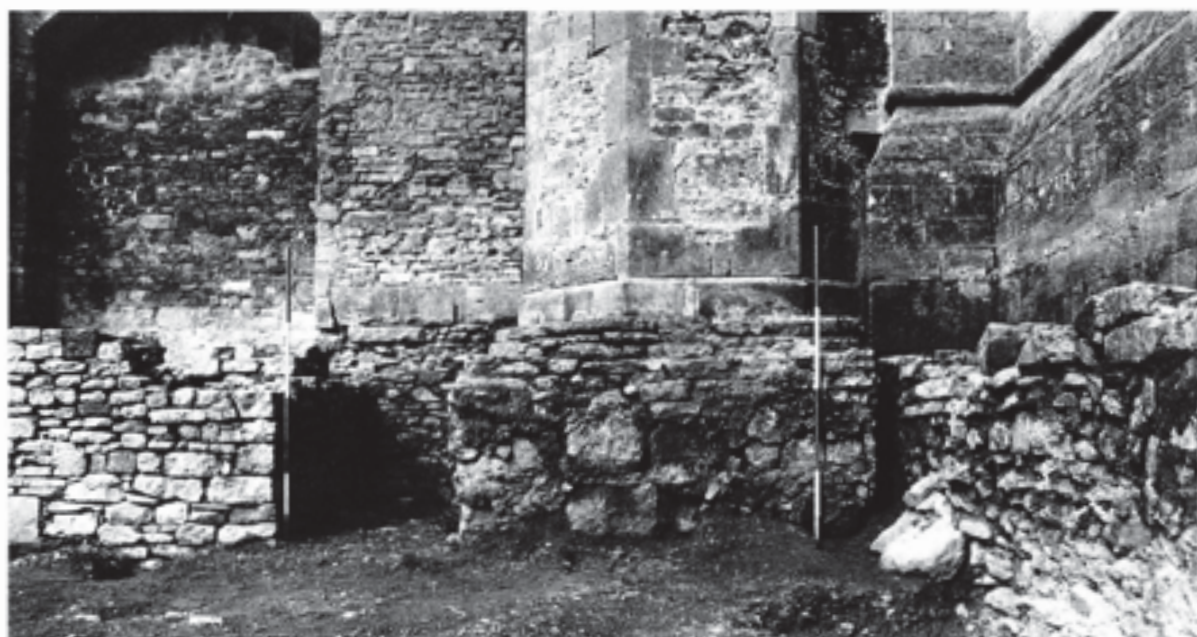
Fig. 313 Different foundation characters revealed in the north-west corner of the Camery. Right small broken rubble and mortar filling the foundation trench of the south transept, c. 1180. Centre large boulders and ample mortar forming the foundation raft of the library stair-turret, c. 1425. Left coursed rubble of the Holy Cross chapel, c. 1495. Scales of 2 m

The foundation for the turret comprised a 2.8 m square raft of mortared rubble (Figs. 313 and 314B, F1535), filling a trench that cut through and removed

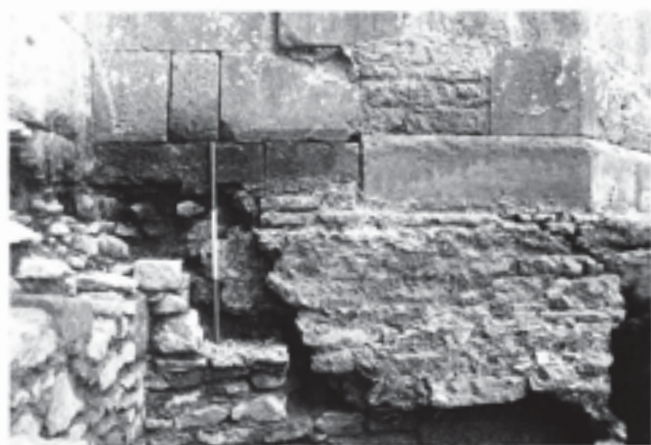
Fig. 315 Detail of the junction between the late twelfth-century east cloister (left) and the base of the library stair-turret (Structure 13). The turret and its foundation can be seen to override, respectively, the earlier buttress (E7a) and its foundation. Scale of 75 cm. For the elevation, see Fig. 312

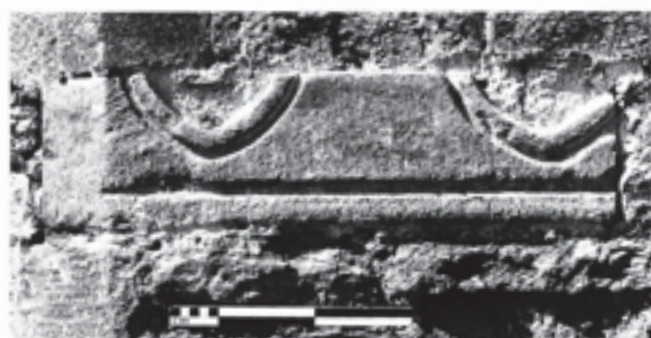
Fig. 316 Lintel embodying the heads of two pointed and moulded arches, thirteenth century. Reused, inverted, in the north-east face of the library stair-turret (Structure 13)

pointed arches side by side (Fig. 316). The first and principal structural stage rises uninterrupted to the wall-plate level of the library roof, a height of 8.3 m. Here, a chamfered weathering-course accompanies a reduction in wall thickness; above, the second stage rises again for a further 1.25 m before reaching a hollow-chamfered eaves-course.

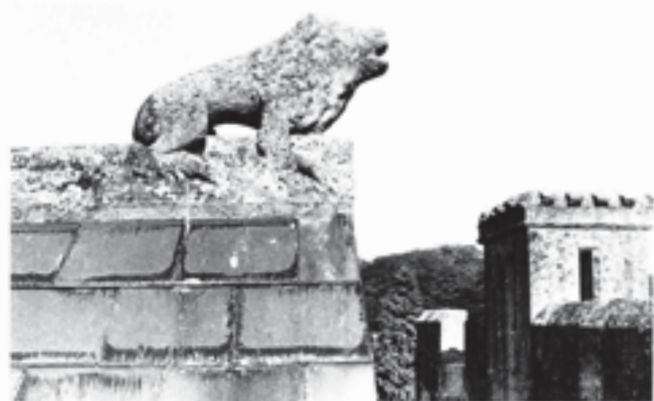
Fig. 317 Mid-fifteenth-century ridge finial, representing a crouching lion, on the south gable of Bubwith's library extension. To the right is the crenellated chimney stack serving the muniment room fireplace

The ridge of the concealed southern gable has a finial in the form of a crouching lion (Fig. 317), similar to one on Bekynton's west range and another on his well-house of 1451 in the palace grounds (Fig. 410). This animal provides an additional indication that the second phase of the library was not built until the 1450s. The system of rainwater outlets incorporated in the parapet string-course, used in the first-phase work, was abandoned and the gutters of bays 1 to 8 were completely relaid at a higher level, along with the new bays 9 to 14. Instead of being deep and narrow, the gutters were now broad and shallow, with their outlets halfway up the parapets (Fig. 296). Six large stone gargoyles carrying lead shuttes were fitted to the garth face (Fig. 266), and plain lead shuttes to the east face. The latter have since been replaced by downpipes.

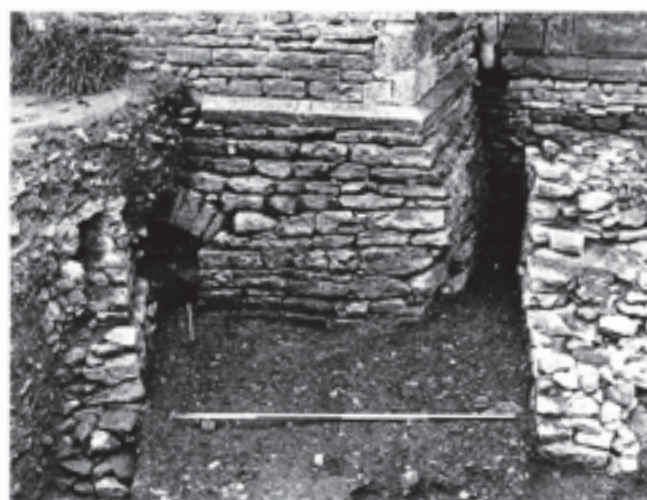
Fig. 319 Plinth and foundation of the north-east corner of the latrine tower revealed by excavation. The segmental arch enabled the contents of the cess pit to seep into the adjacent ground. Scale of 2 m

The foundation effectively defined a cesspit, the below-ground arch on the east allowing the effluent to seep away into the soil of the Camery. The arch was large enough to have admitted a man to what was otherwise a totally inaccessible space, if it became necessary to clear out the residual contents. In order to gain entry it would have been necessary to dig a hole alongside the tower, but that plainly never happened, since medieval stratigraphy and a late Saxon wall foundation remained intact immediately outside the arched opening (Fig. 319).

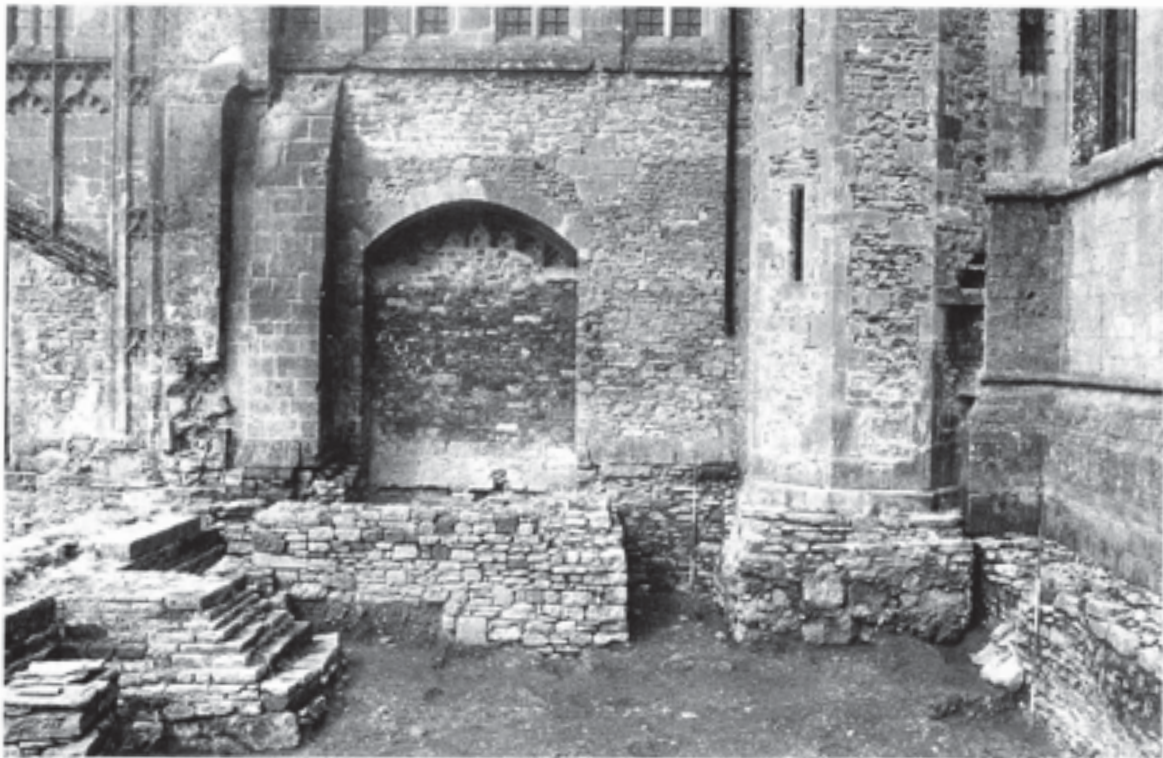
Fig. 320 General view of the excavated foundations of the chapel of the Holy Cross-by-the-Cloister (Structure 18), with the segmental entrance arch and remains of the traceried screen embedded in the east cloister wall. Scales of 2 m

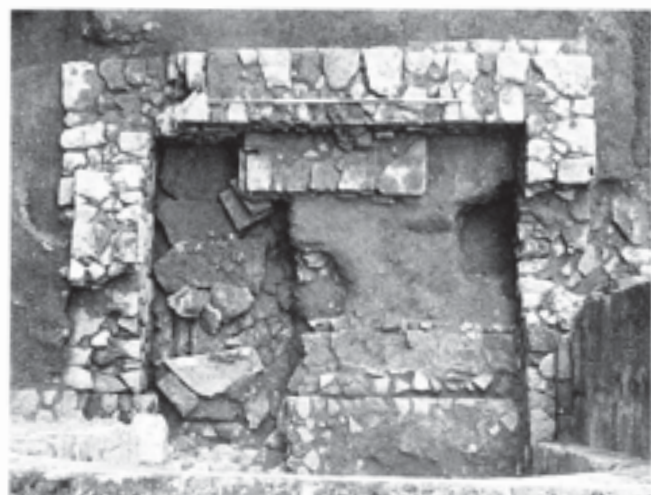
Fig. 322 View of the Holy Cross chapel from above, showing the altar foundation and cover-slabs over burial 21. East is at the top. Scale of 2 m

The foundations of the chapel were of roughly coursed, mortared rubble, and were cut through the debris of an earlier building occupying the same site (Structure 12; Fig. 306). A mixture of stone types was used, and there was a slight offset at ground level, above which the walls were 54 cm thick. The foundations and walls abutted the late twelfth-century cloister, clasping one of its buttresses (Figs. 321 and 322). Internally, the chapel measured exactly 3.0 m (10 ft) square.

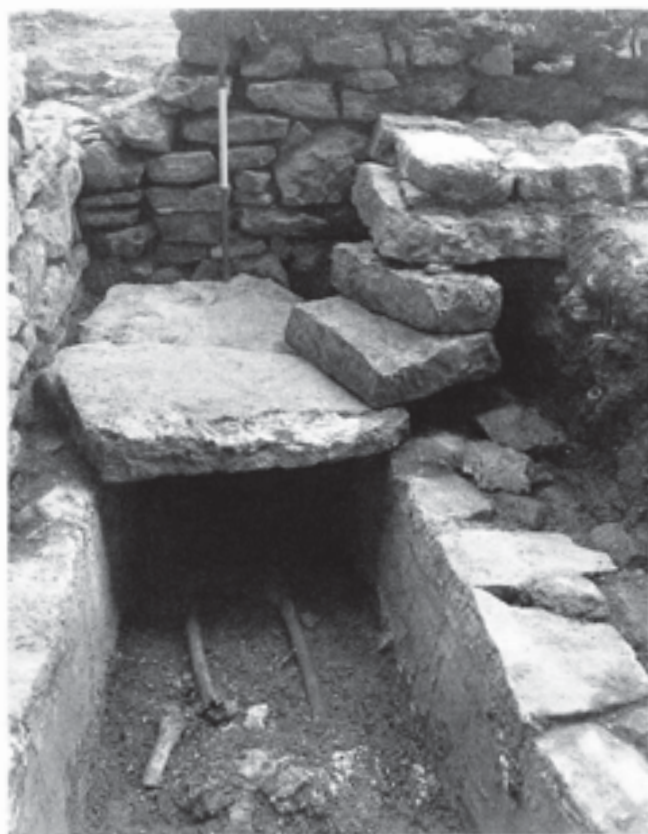
Fig. 325 View towards the east end of the grave containing burial 21, during excavation, showing how the corner of the altar foundation (F533) was propped by stones resting on the cover-slabs of the cist. Scale of 75 cm

Two contemporary features were investigated within the building which confirm its identity as a chapel: the altar foundation and a single cist-grave. A rectangular base, 1.45 m by 55 cm, built of mortared rubble was centred on the east wall and was undoubtedly the setting for the altar (F533). Alongside the north wall lay a rubble-built cist, internally plastered and capped with slabs of conglomerate (F515). Hard white mortar was used in the construction and rendering. When the cist was constructed — or at least when the burial was inserted — it was necessary to undermine the northern end of the altar foundation, so tight was the space available. Stepped underpinning was then built on top of the cover-slabs, to support the altar (Fig. 325).

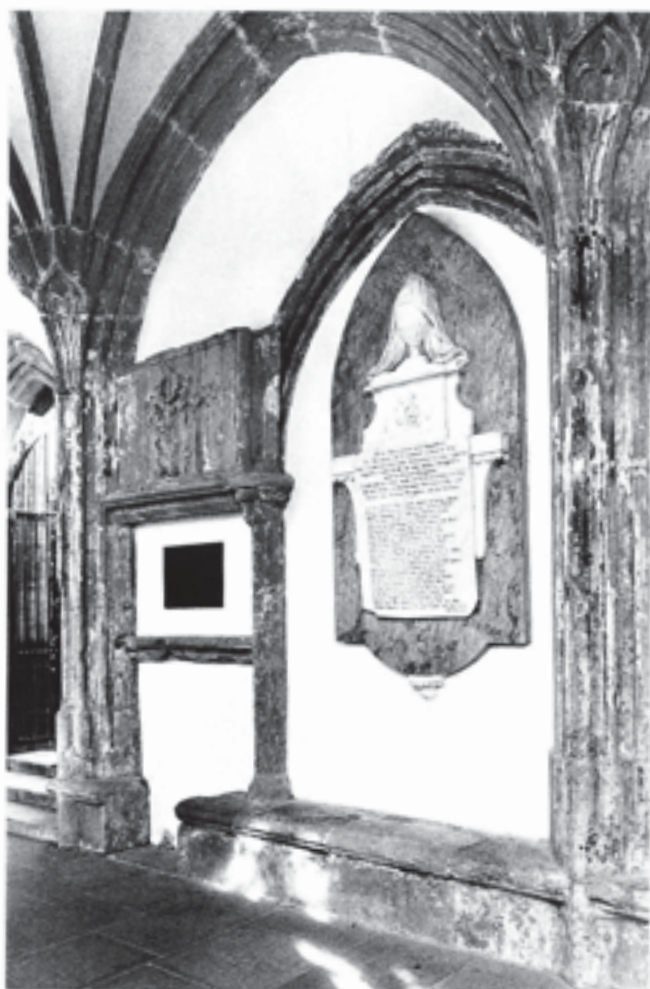
Fig. 326 Cloister bay 6, showing the outline of the original entrance arch to the Lady Chapel (centre right), Stillington's doorway to the new chapel (far left), and the probable setting of the pyx of St Saviour between the two

The doorway leading into the Early English chapel from the east cloister is blocked by the abutment of the nave wall of Stillington's chapel. However, the mouldings of its pointed arch are visible within the cloister (Fig. 326; p. 313), and part of the rear-arch can be glimpsed on what is now the outside face. The segmental rear-arch is entirely plain, and the thin ring of dressed Douling stone is reinforced externally with a soldier-arch of sandstone rubble (Fig. 149). The doorway must be dated to *c.* 1196.

The late twelfth-century doorway leading to the Lady Chapel-by-the-Cloister occupied two-thirds of the outer wall of the sixth cloister bay. Following the construction of the early fifteenth-century vaulting, the doorway assumed a very awkward relationship to its surroundings, on account of its southern jamb being concealed behind one of the new wall-shafts. Some effort to mask this imbalance seems to have been made, by constructing a stone frame, to form a panelled feature, in the remaining one-third of the bay. This construction, apparently contemporaneous with Bubwith's vault, concealed the moulded northern jamb of the old doorway, thus approximately restoring the balance of the entrance, but not significantly enhancing it (Fig. 326).
