WELLS CATHEDRAL

Excavations and structural studies, 1978–93

*Excavations and Structural Studies,
1978–93*

ARCHAEOLOGICAL REPORT 21

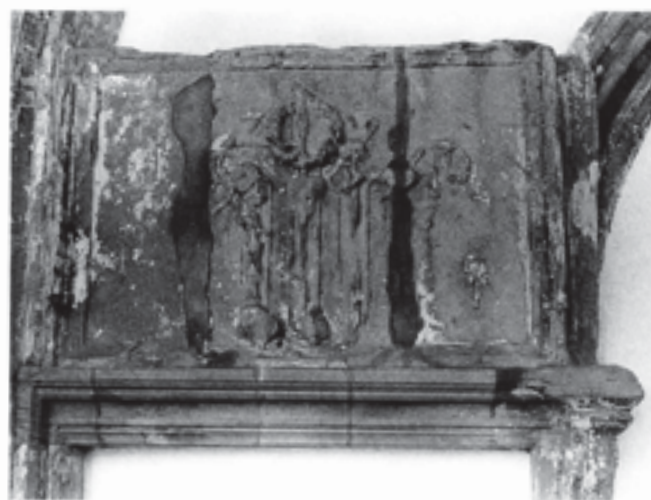
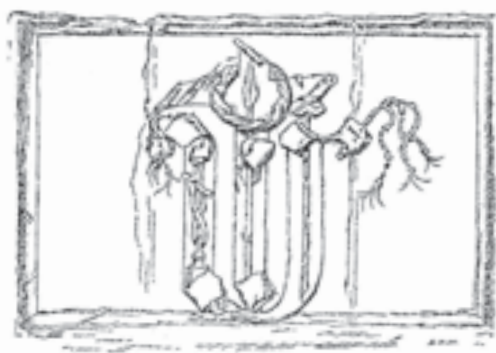
Fig. 327 Upper: The *IHS* monogram panel in cloister bay 6, in 1998. Lower: Drawing by Edmund New, 1908 (after Holmes 1908). The panel probably marks the site of the pyx of St Saviour-in-the-Cloister. For its setting, see Fig. 326

Resting on the upper shelf, and surrounded by its own moulded frame, is a rectangular panel of Douling stone (1.28 m by 0.87 m) sculptured with the sacred monogram, *IHS*, and the letters are adorned by representations of the instruments of the Passion (Figs. 327 and 328). The sculpture is now very eroded and much detail has been lost; it has been limewashed in the past. No trace of colour is visible, but it would undoubtedly have been enlivened with polychromy. The *IHS* monogram, accompanied by the instruments of the Passion, features in many different media including pre-Reformation wallpaintings, not only in ecclesiastical but also in secular contexts, as at Bradley Manor, Devon (Barakan 1986).

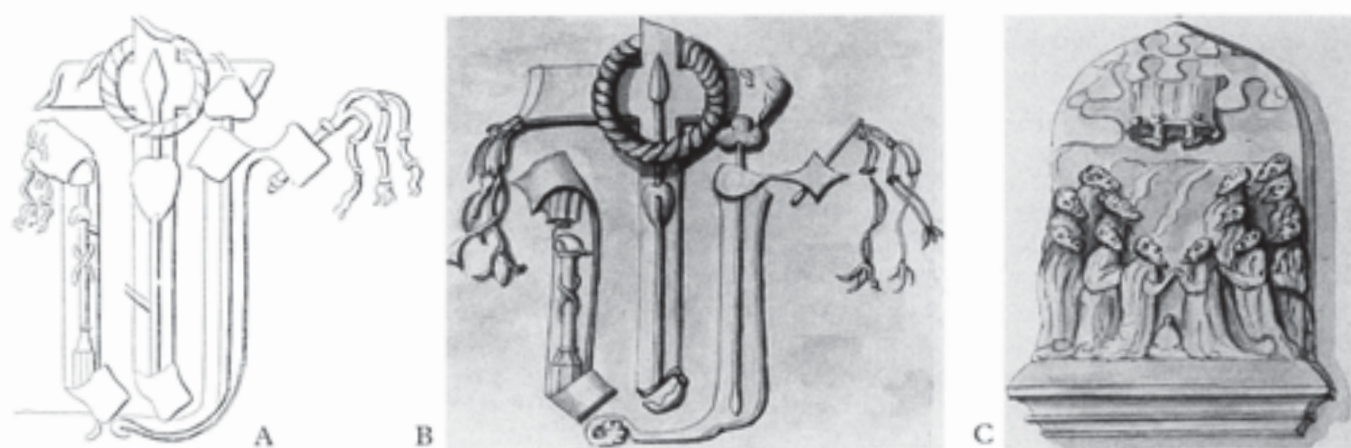
Fig. 328 Devotional artefacts in cloister bay 6. A The IHS monogram, drawn by Carter (after Gough 1786); B The same by Carlos, 1824; C The Ascension panel, illustrated by Carlos, before its removal (B, C, Richard Neale, courtesy of the Dean and Chapter of Wells)

Buckle (1894, 56) records that there was formerly a sculpture of the Ascension fixed to the cloister wall above the gap in the bench, but that it was not *in situ*, and was moved in 1864 into the north-east transept of the cathedral, where it is now set above the Corpus Christi altar (Colchester 1987, 144). Carlos illustrated the panel in 1824, commenting that it was ‘now almost covered with whitewash’.⁴ He showed it supported by a neat bracket with a moulding of late medieval type, being of the same profile as that upon which the IHS panel rests (Fig. 328C). The Ascension was fixed in the apex of the wall-arch of the cloister bay, above the monogram, but that cannot have been its original position.⁵

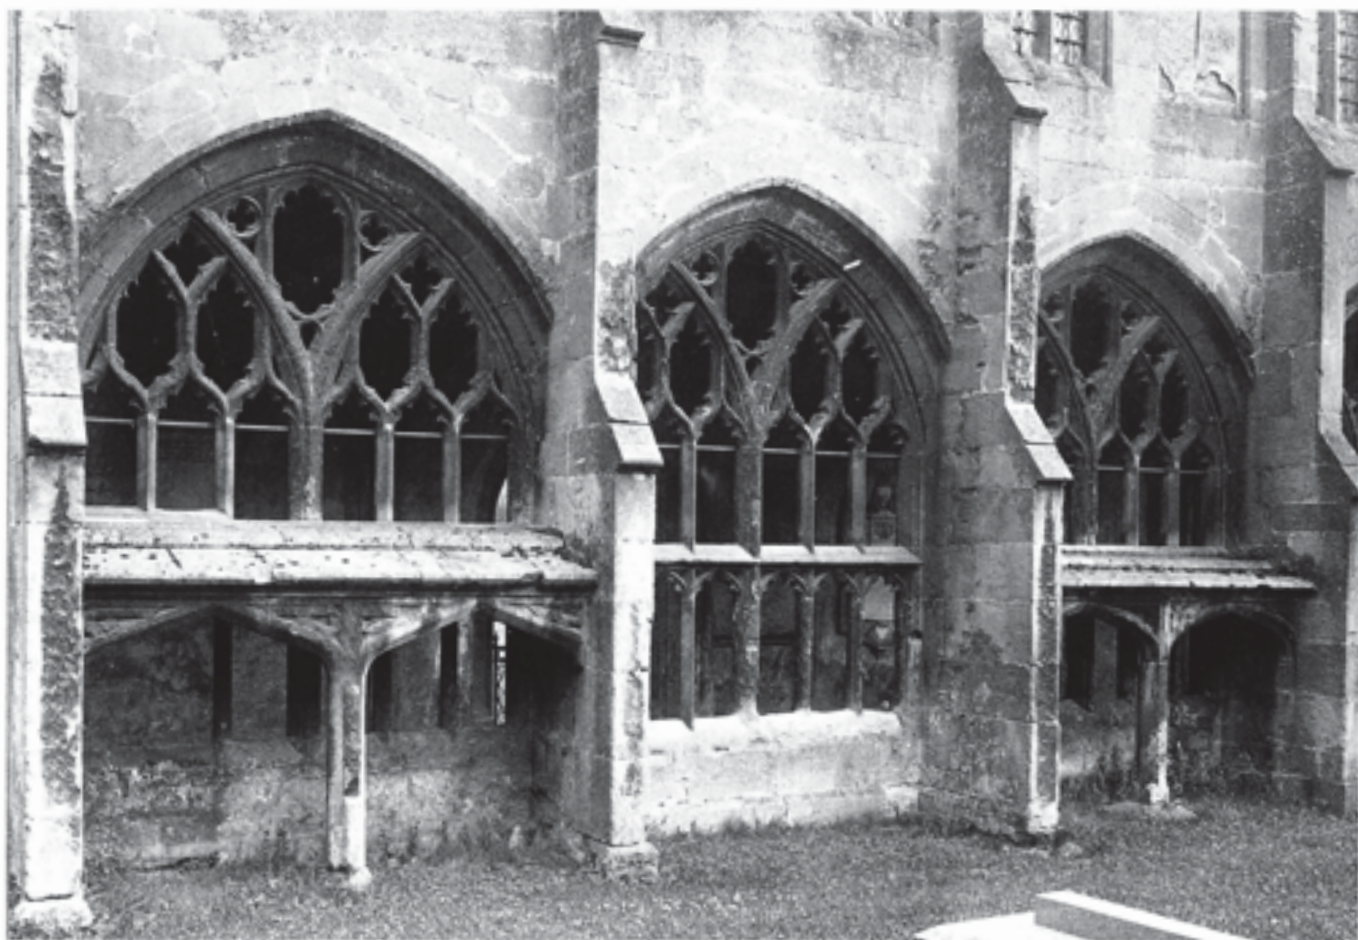
Fig. 330 The two pentices (Structures 19A, right; 19B, left) constructed between the buttresses of bays 4 and 6 of the east cloister. Photographed by T.W. Phillips between 1895 and 1901 (Dean and Chapter of Wells)

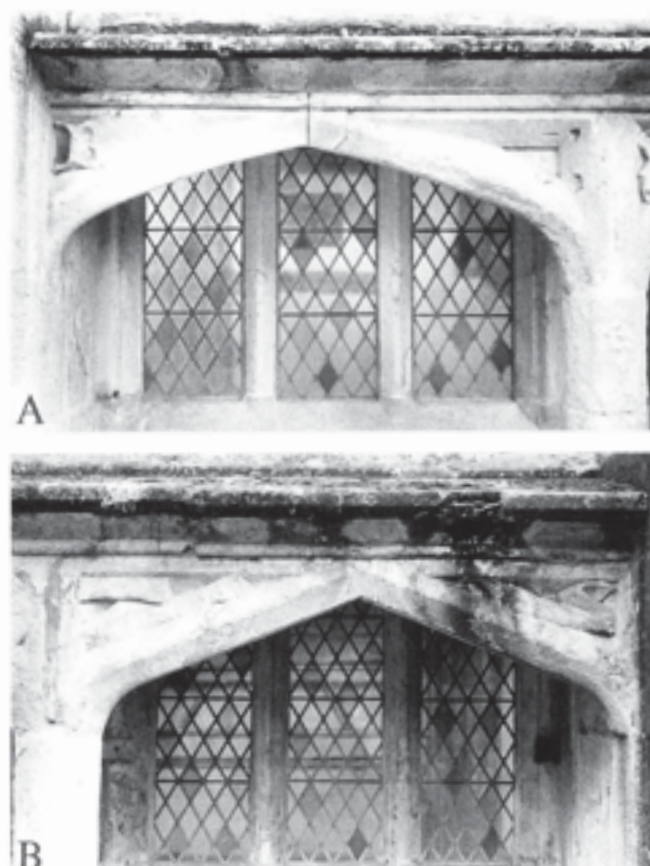
Fig. 332 Details of the arched heads of the pentices. A Left-hand head of the southern pentice (Structure 19A), showing the initial 'B', and the empty socket of a second letter (lost), in the spandrels; B Right-hand head of the northern pentice (Structure 19B), showing ribbon decoration in the spandrels

the central sinking of the spandrel by cutting four small notches as housings, around the edge (Fig. 332A). The letter has fallen out, leaving only the empty housings; while the identity of the initial cannot now be firmly established, the attachment points preclude about half of the alphabet.¹² Presumably the reason for the different treatment of the two letters is the consequence of an error on the part of the medieval letter-cutter, or accidental damage. The spandrels of the southern arch are carved with ribbons, upon which there are likely to have been painted inscriptions. The surfaces are too eroded for any trace to remain.

The pair of arches in bay 4 are of Tudor profile, and are clearly later than those in bay 6, but made with general conformity in mind (Fig. 333). The four spandrels of the arches are all carved in low relief with ribbons; the carving is much flatter than in bay 6 (Fig. 332B).

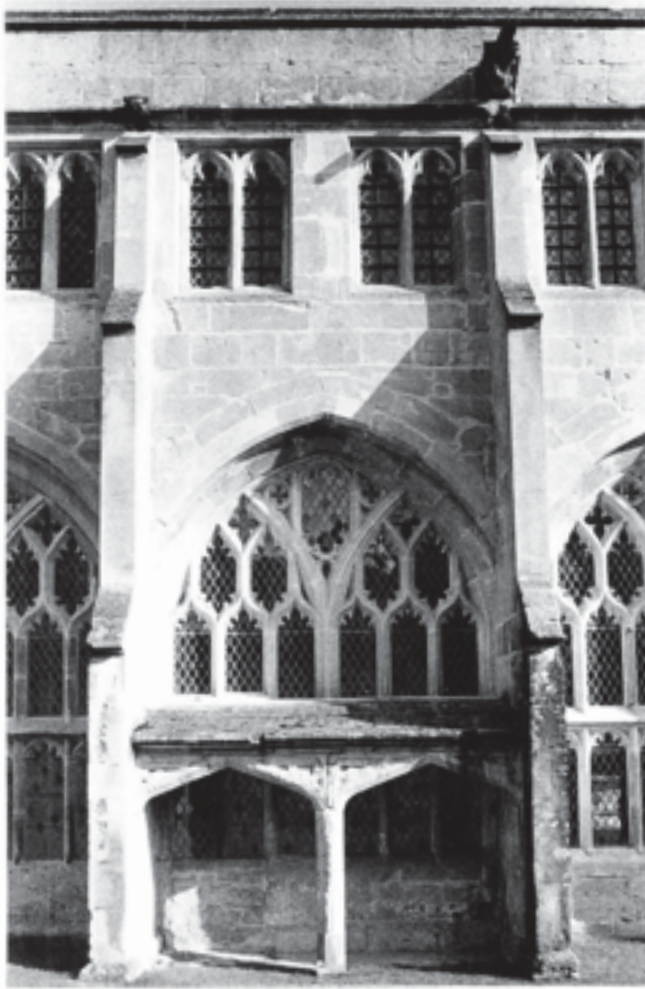
Fig. 333 Cloister bay 4, after restoration and glazing in the late 1980s, showing the northern pentice (Structure 19B)

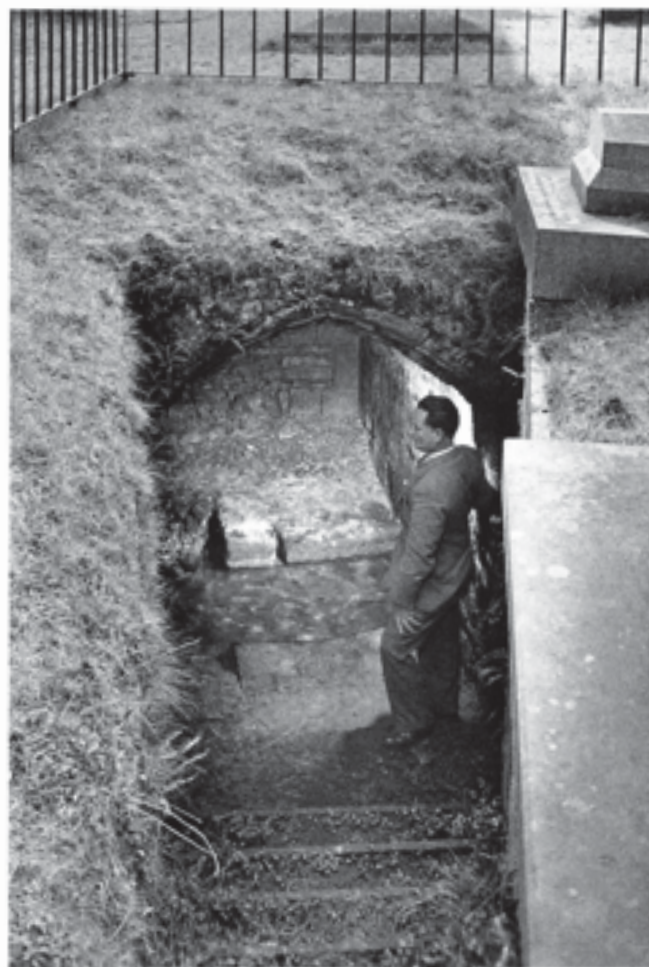
Fig. 336 View into the Dipping-Place, c. 1980. The intrusive tombs on the right are those of Bishop (Baron) Auckland (1870) and Canon Fagan (1875) (S.W. Kenyon)

than a hole in the ground, bounded by an iron railing, but it was formerly surmounted by a building (Fig. 336).

now living at Wells.' However, the site was not opened up permanently to view at the time, and it was not until the early part of the present century that the dean and chapter caused the existing iron railing and steps to be constructed. The awkwardness of the present access results from the need to erect a wall to retain the intrusive Victorian graves on the west, and to support their monuments (Fig. 336).

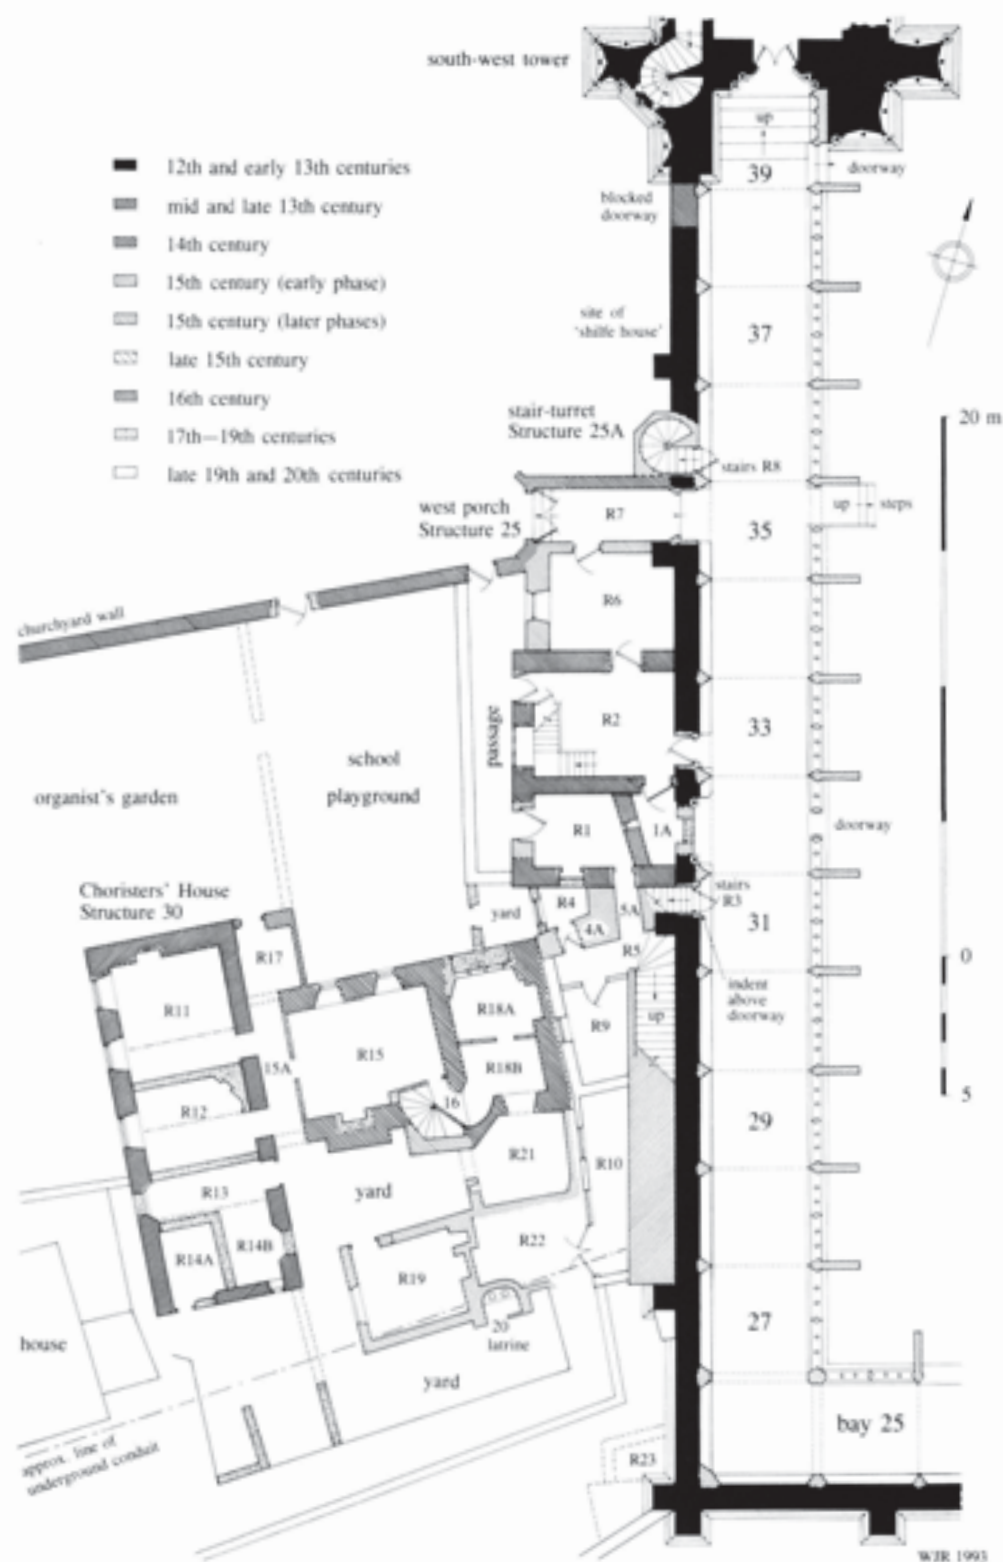
Fig. 338 Ground plan of the west cloister, differentiated according to period. The choristers' house (demolished 1870), which is also appended, has been reconstructed from various sources. Rooms and spaces are numbered to facilitate textual reference

Problems concerning the design and plan of the west cloister, as originally conceived, have already been discussed, with the conclusion that the foundations could have been laid out along with those for the primary west front (p. 264). It has further been argued that some of the cloister superstructure was also erected before the modified west front was built, thus fixing the present position by the opening years of the thirteenth century. A more detailed examination of the salient features of the west walk may now be given, and its structural development traced (Figs. 338 and 339).

For reasons related to the development of the choristers' house and school complex (see below, p. 337), the thirteenth-century porch became an inconvenient point for public access to the cloister, and it was superseded by a new porch adjoining bay 35 (Fig. 338, R7). This porch is almost of the same depth as its predecessor, but somewhat narrower. It has diagonally placed buttresses at the two western angles, flanking a Tudor-arched outer doorway with crudely carved spandrels containing blank shields, and a square label (Fig. 345). Set into a square, recessed and moulded panel in the gable above the door is one of the vault bosses from Stillington's Lady Chapel (Fig. 245; boss 19, p. 448).

All that survives of the choristers' house today is the much diminished shell of the hall, comprising the north gable and short returns on the east and west (Figs. 348–50). The remainder of the complex was thoroughly demolished, and the site landscaped to create a terraced garden (complete with fashionable ruin) for Penniless Porch house. Terracing has probably removed even the foundations of most of the hall. Nevertheless, it is possible to attempt a basic description of the complex, and broadly to assess its physical development. Rooms and spaces are numbered and described with reference to the reconstructed plan, Figure 338.

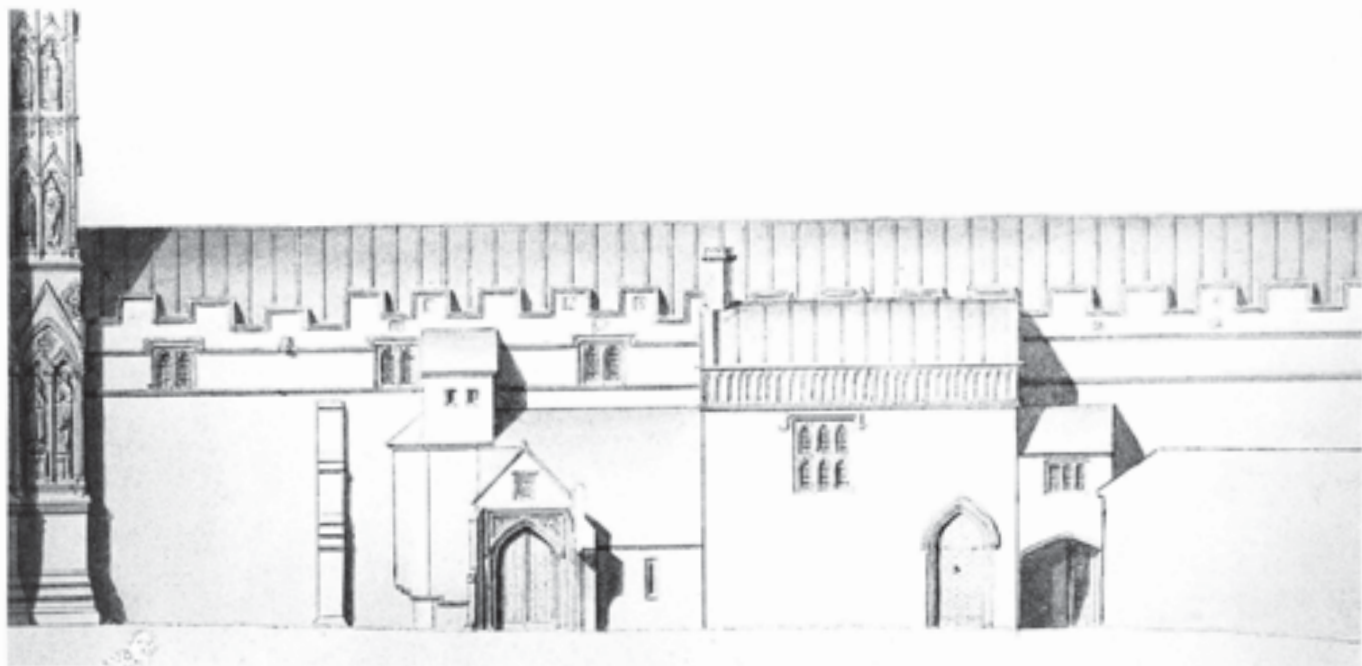
Fig. 341 Garter's elevation of the west cloister, c. 1795, showing the two porches but omitting later additions (Courtesy of the Society of Antiquaries of London)

2. Carter's elevation of the west front, to which the west cloister is attached; some of the detail shown is potentially unreliable (Fig. 341). All structures in front of the cloister are omitted.

The west slope was later cut back from the eaves, and a low stone parapet added, with short returns at both ends. Carter's elevation shows the roof as lead covered. The parapet is decorated with continuous blind arcading, having a narrow pitch and trefoiled heads (Fig. 341). This is unlike any other parapets at Wells, but a fourteenth-century date seems more likely than a fifteenth (the narrowness and continuous rhythm of the arcading recalls that around the top of the chapter house, just below the parapet). A six-light mullioned and transomed window was provided in the first-floor chamber (R25). The upper register of three lights has cinquefoiled heads, while those below the transom are plain. Internally, shutter rebates and some iron crooks remain. The window form suggests a fifteenth-century date, although one might have expected the lower register of lights to have had foiled heads

The small trapezoidal space (R4), where the under-stair latrine lay, was not always enclosed. The area was once open-sided on the west, where it was spanned by a depressed four-centred arch (Fig. 341).³⁶ While it has the appearance of being a porch, entered from the yard to the west, it evidently led nowhere. A tall, narrow doorway formerly opened off the south side, apparently leading into a chamber contained within the exceptionally thick wall here.³⁷ This is beneath the upstairs latrine (R3A), and it seems likely that there was a ground-level latrine too (R4A), replacing the one that had formerly been under the stone stair. This may provide a clue to the purpose of the open-sided, trapezoidal space (R4). Surely, it housed a late medieval urinal for the use of the boys at the school, and that R4A was an adjoining closet. The cathedral accounts for 1726–27 contain an entry for 'repairing the bog-house' at the grammar school (HMC 1914, 517).

The porch is meanly and shoddily built, reusing much old stone, and in its present form appears to be sixteenth century, but appearances are deceptive. It has also been claimed that the porch was rebuilt in 1822, with salvaged materials from the Camery (Colchester 1987, 70). The presence of the vault boss would appear superficially to support this suggestion, but that is unfortunately untenable since the boss was already here in the late eighteenth century, when Carter illustrated it (Fig. 341).

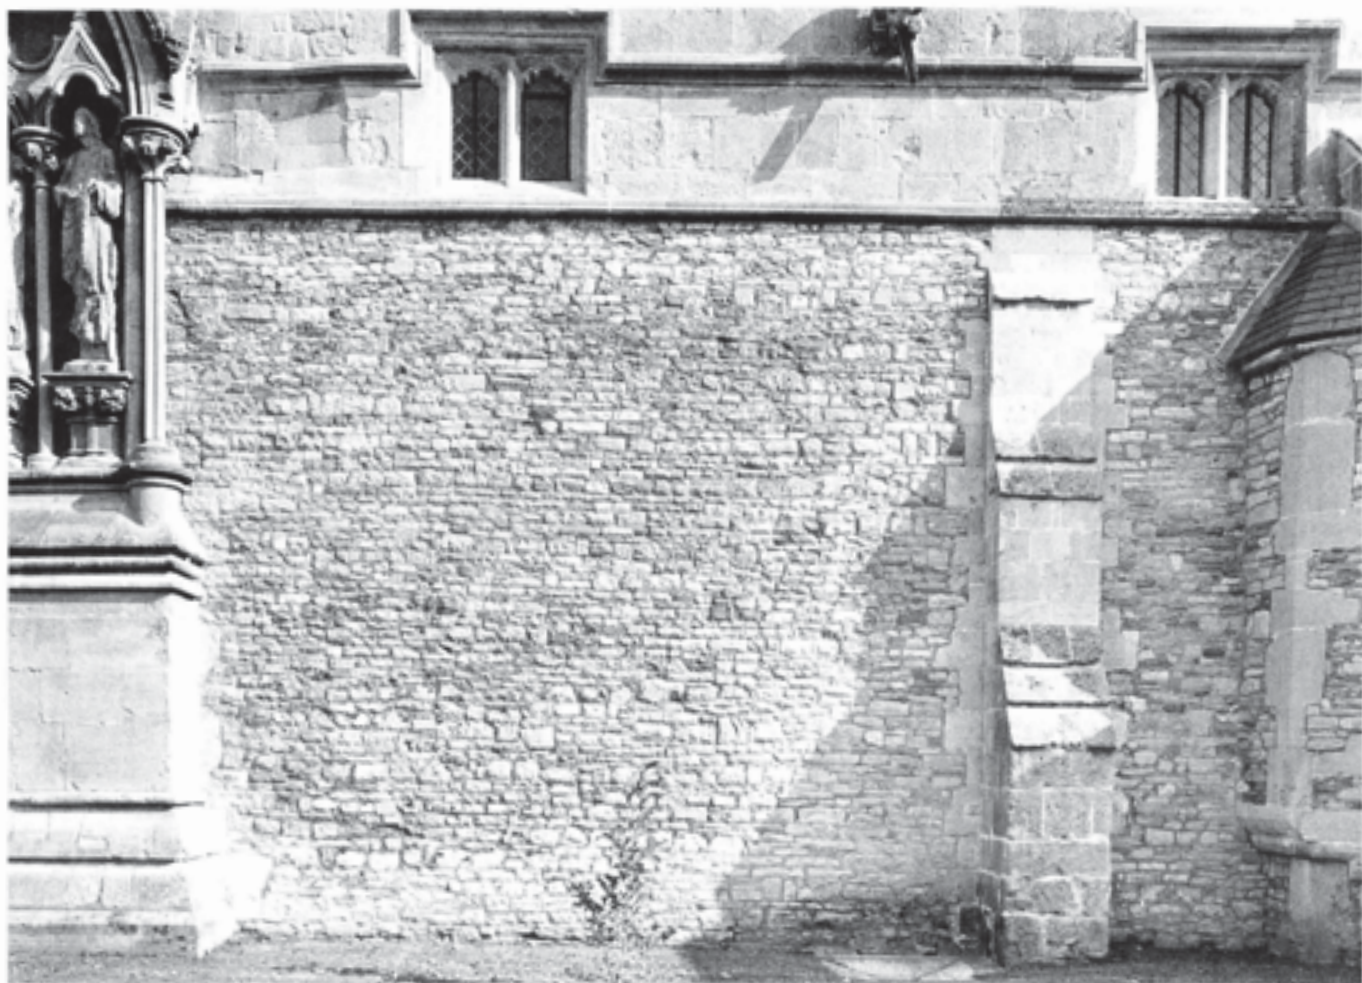
Fig. 342 The northernmost bay (*W₁*) of the west cloister and the first buttress, showing the relationship to the west front of the cathedral. Note that the cloister plinths are now below ground level. The porch stair-turret (Structure 25A) is seen on the far right

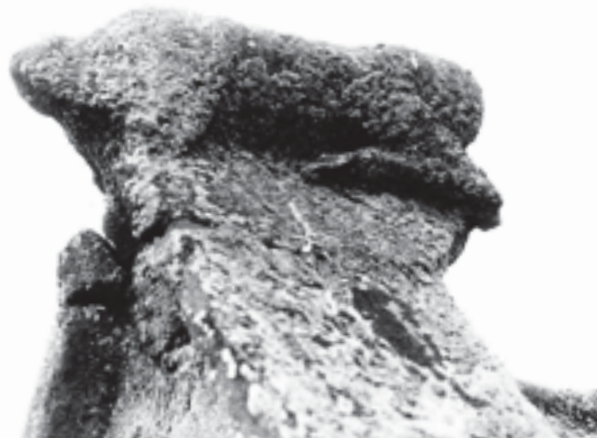
Fig. 344 Fifteenth-century gable finial at the south end of the west cloister range

Outwardly, to the west, the range presented a simpler elevation than its eastern counterpart. The thirteenth-century parapet coping was removed throughout the length of the cloister, leaving only its basal string-course and a few coping blocks that were tucked into one of the statue niches of the south-west tower (Fig. 282). Above the string, the wall was raised in Doulling ashlar, and crowned with a heavy crenellated parapet. The roof is currently slated, but Carter's elevation shows it as lead covered (Fig. 341). At the southern end is a stone gable-finial in the form of a crouching beast, probably a lion; the head has weathered away (Fig. 344; cf. p. 398).

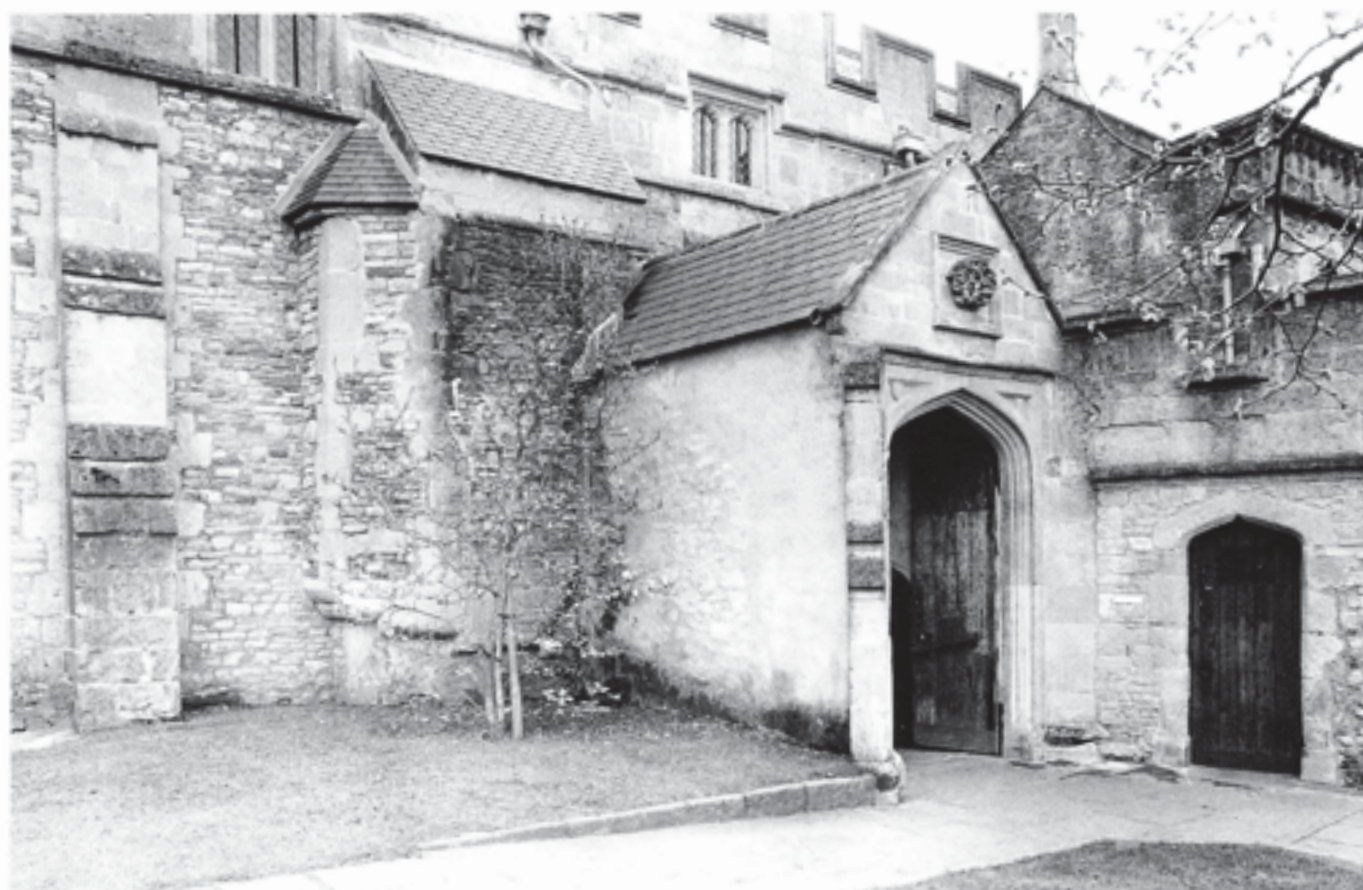
Fig. 345 West cloister porch (Structure 25) and adjoining stair-turret, from the north-west, in 1998. The small Tudor door in the crenellated garden wall to the right was the entry to the Grammar School

Restoration carried out in 1990 revealed that no less than two periods of construction — and a further two of minor alteration and restoration — are involved. Masonry that is clearly earlier than the present porch is incorporated in the north wall (Fig. 346). Built of rubble laid in red mortar, this wall was evidently part of a structure abutting the cloister: it has the remains of a jamb of rough ashlar at its west end, onto which the late medieval porch façade has been abutted. The structure is undated, but must be between the thirteenth and fifteenth centuries. The semi-octagonal stair-turret (Structure 25A) associated with the late fifteenth-century upper cloister range abuts the pre-porch wall (Fig. 345). Also observed in the north wall, at a low level, was the base of an infilled opening,

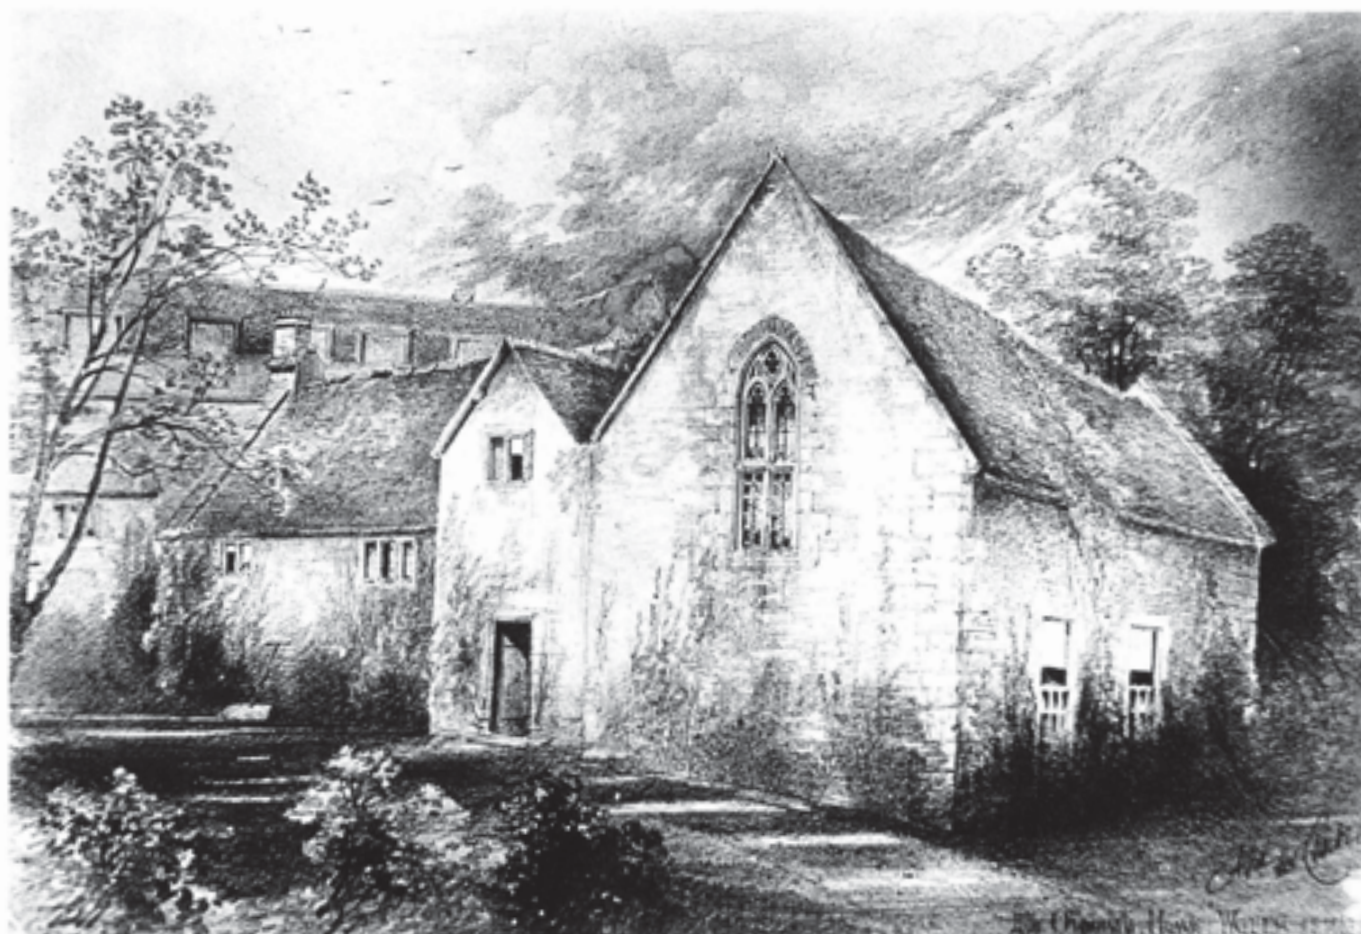
Fig. 347 The choristers' house from the north-west in 1863. From a watercolour by Alfred A. Clarke, in Wells Museum. After Parker 1866b

The basic arrangements within the house can be evinced by studying the surviving plans and water-colour (Fig. 347), albeit that they constitute a very inadequate record (pp. 339–41). There are some clear disagreements in detail between the plans given by Carter (c. 1795; here Fig. 340) and Parker (1866a; here Fig. 343), but broadly speaking the structural development is likely to have been as follows.

Alfred Clarke's view of the house in 1863 shows the north gable of the hall with its early Perpendicular window of two transomed lights; next to this was a tall porch, evidently sixteenth century; and, running from that to the cloister, the lower chamber block (Fig. 347). This appears to be a minutely accurate depiction, and even the window mouldings are recognizable. The porch and chamber wing still had

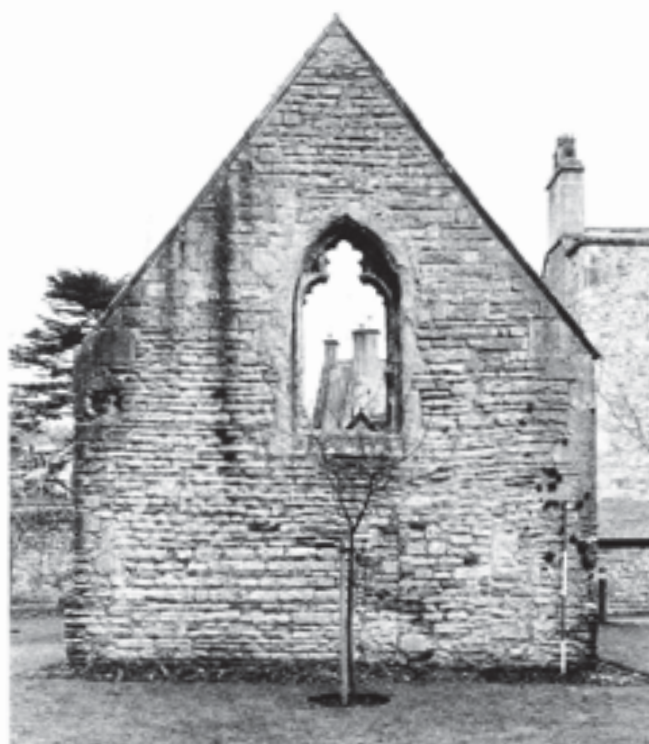
Fig. 349 North gable of the choristers' house, in 1987. The house was built by Bishop Ralph of Shrewsbury in 1354. Scale of 2 m

The north gable contained a two-light, transomed window of very early Perpendicular style. It is related to, but slightly more developed than, the side windows in the Vicars' Hall (Pugin and Pugin 1895, 3, pl. 20), which is also attributable to Bishop Ralph and is dated c. 1349. The architect was William Joy, who probably fell casualty to the Black Death. His successor, Richard Farleigh, presumably designed the choristers' house, and the tracery bears close comparison with that which was being introduced at Windsor in the mid-1350s (Harvey 1978, figs. 16 and 17; 1982, 100).

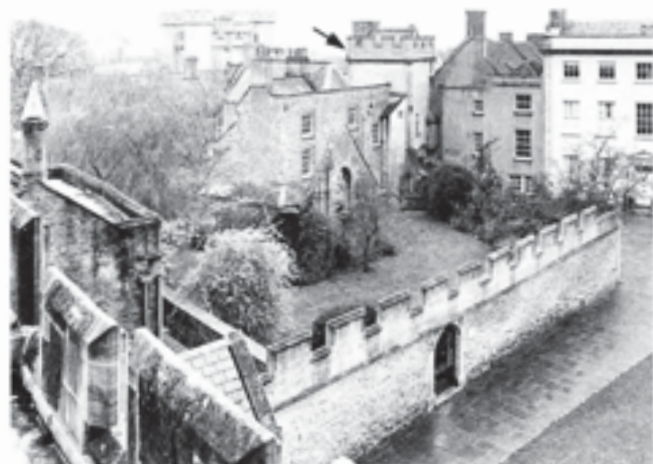
Fig. 348 The choristers' house garden (now Mary Mitchell Garden) viewed from the roof of the west cloister (1993). The crenellated wall was the northern boundary of the garden, and the arched gate marked the entrance from Cathedral Green. The ruined north gable of the choristers' house can be seen in the middle of the garden. Penniless Porch gatehouse is indicated by an arrow (centre top), and to the left of that are seen the now-restored turrets of the Palace Gate

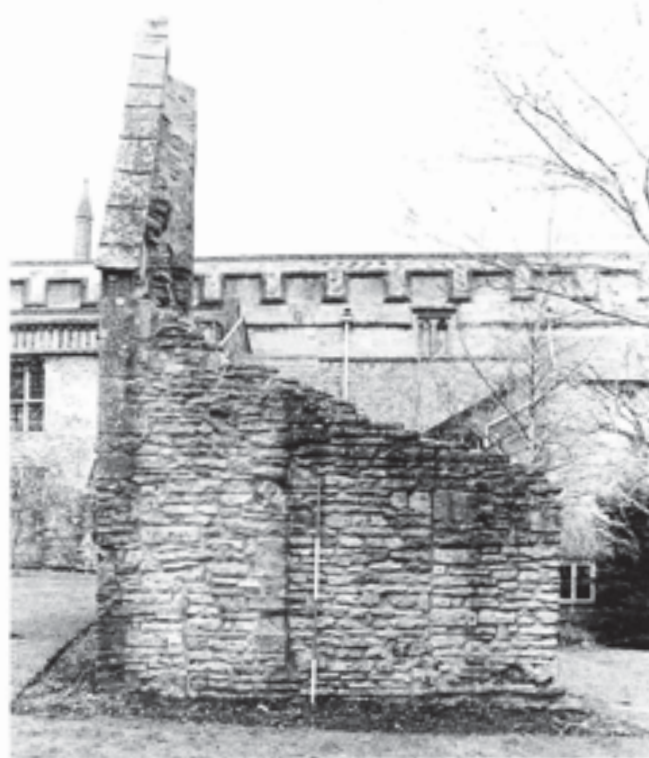
Fig. 350 Fragment of the west wall of the choristers' house

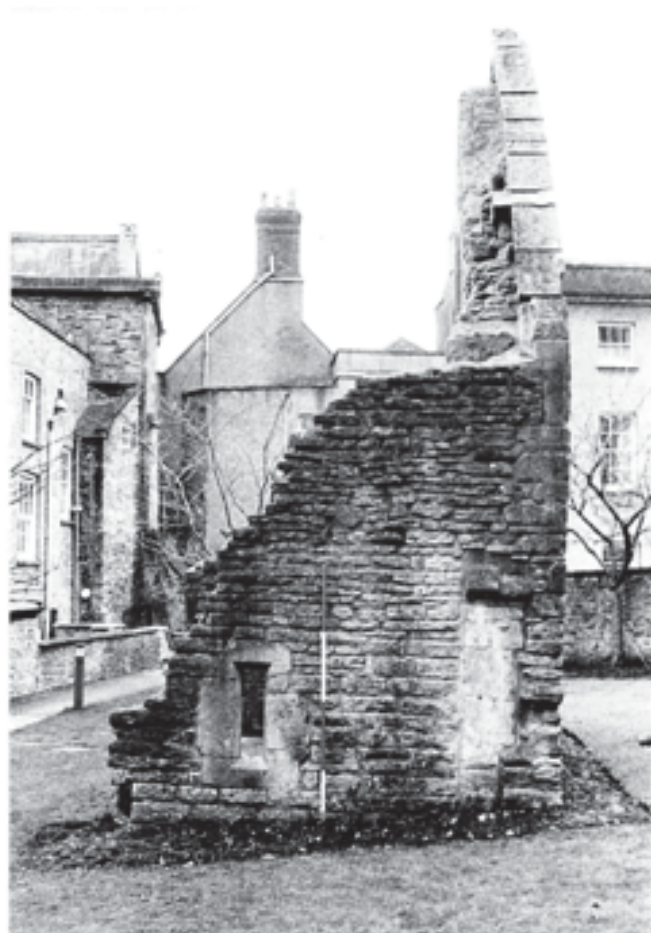
Fig. 351 Fragment of the east wall of the choristers' house

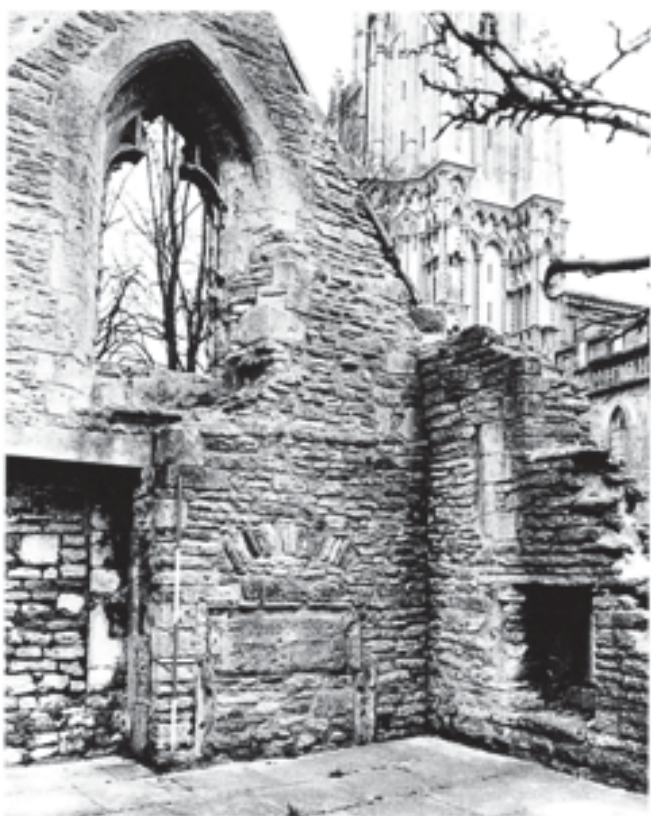
Fig. 352 Interior of the choristers' house, looking north-east

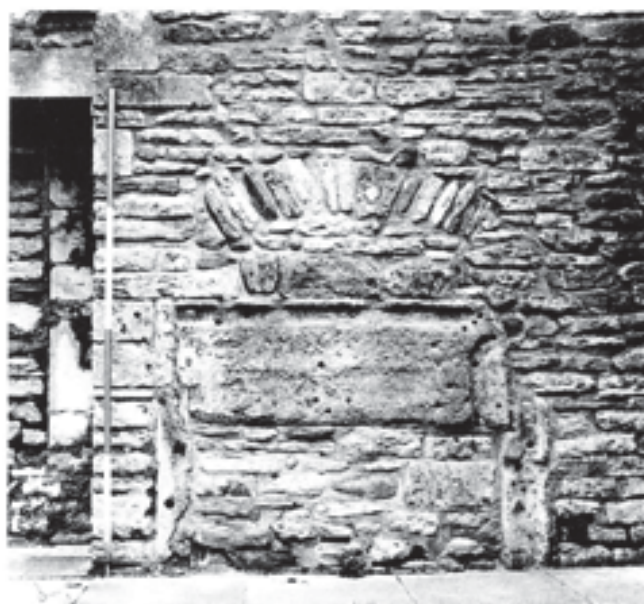
Fig. 353 Detail of the two infilled fireplaces(?) in the north wall of the choristers' house. Scale of 2 m

There is no reason to doubt that the surviving ruin is a fragment of the hall built by Bishop Ralph in 1354. The house was an unbuttressed, rectangular building of four bays, measuring c. 13.8 m by 5.3 m overall. The open hall occupied the northern two bays (R11–12), the screens passage (R13) lay in the third bay, and the fourth was probably divided into buttery and pantry (R14A and R14B). The location of the original fireplace is problematic: we would expect it to have lain at the mid-point of the east wall, where a later sub-division and corner fireplace were inserted (R12). However, two asymmetrically sited recesses occur in the north wall at ground level (Fig. 353). One is almost certainly original, and has a large stone lintel, now cut back, under a segmental relieving arch. This has the appearance of being a fireplace, although the position of the flue is unclear, as is its relationship to the gable window above. The recess is now infilled, and the floor level has been considerably raised.

Alongside is a taller, lintelled recess of post-medieval date which also appears to have been a fireplace, although once again the flue poses problems; nor is a stack shown at this end of the building, in nineteenth-century illustrations.

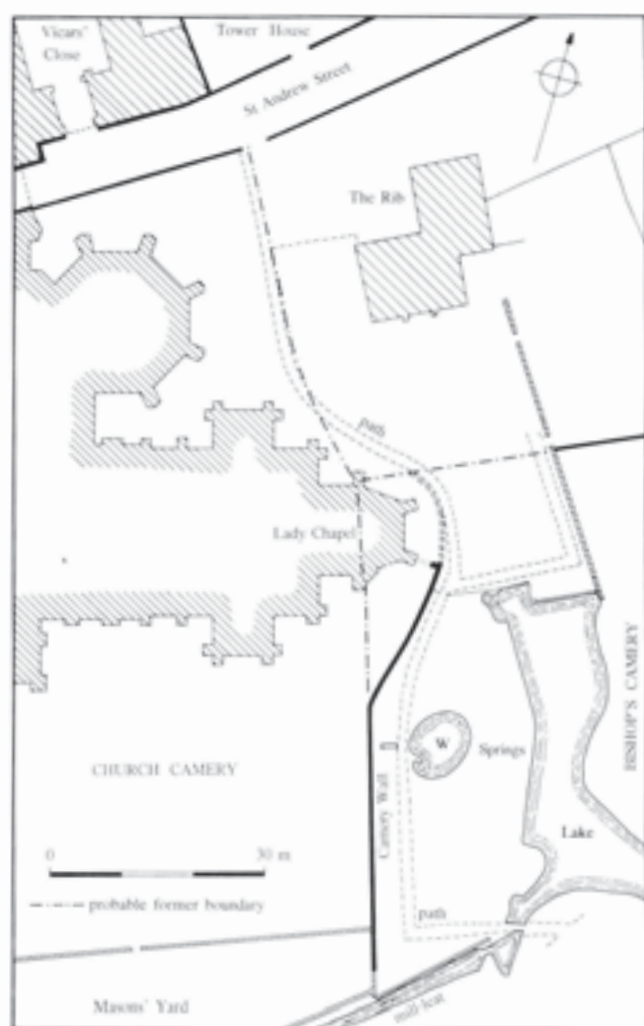
Fig. 356 Plan of lands abutting the east end of the cathedral, based on the 1:500 scale Ordnance Survey map, 1886. Boundary walls of medieval date are shown in solid black; those of later or uncertain date are obliquely hatched. The suggested courses of lost medieval boundary walls are indicated with chain lines. St Andrew's Well is marked 'W'

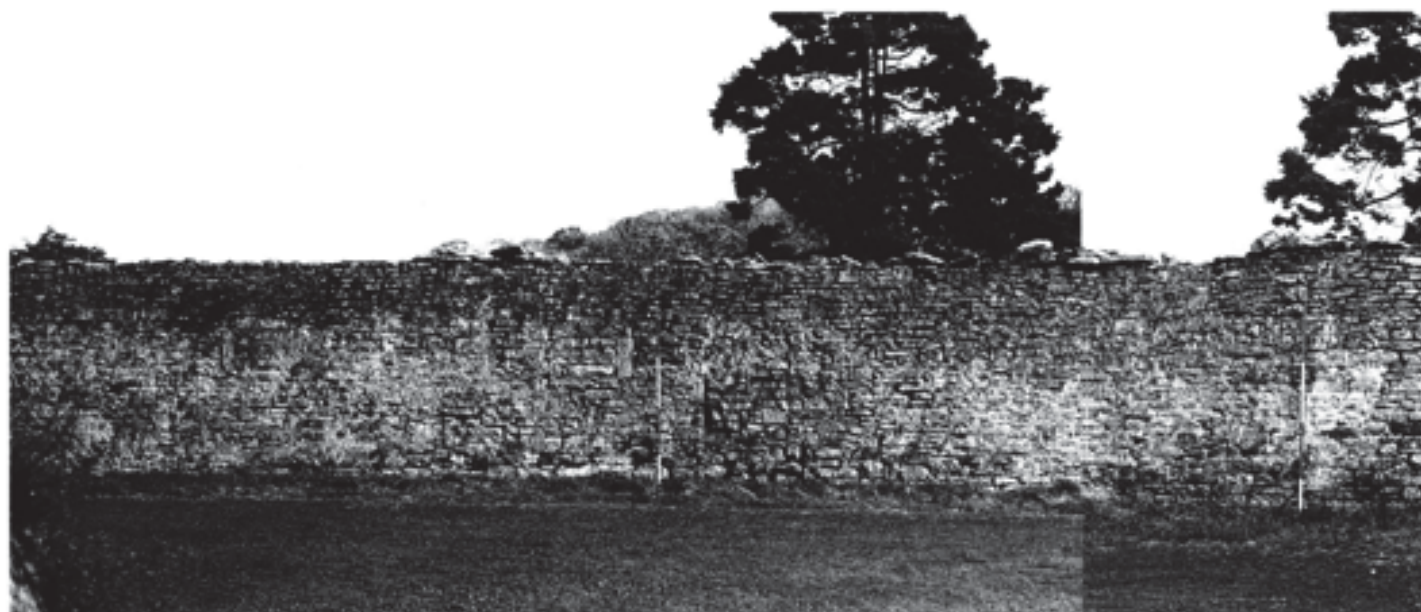
Fig. 357 General view of the east Camery wall, from the west in 1979, after being stripped of vegetation. The right-hand ranging-pole stands at the bend in the wall, from which point northwards (left) it was realigned in the early fourteenth century. Scales of 2 m

The greater part of the east wall, however, remains intact, and is essentially of two medieval builds (Fig. 357). Running north from the stream, a length of *c.* 35 m of what is presumed to be original masonry still

The unsuspected antiquity and importance of the wall were at once recognized, and its dilapidation was registered as a matter of concern. Consequently, in 1980 the dean and chapter caused the remainder of the west face of the wall to be stripped, and a trial area was conservatively repaired (Fig. 357). Full-scale repair and repointing took place in 1984, when the east face was also necessarily stripped of vegetation. Both elevations of the wall were studied and recorded photographically; unfortunately, resources were not available to allow the preparation of stone-by-stone drawings, which would have been merited. Many archaeological features were observed in the construction of the wall: these have to a large extent been masked by the repointing, but not destroyed.³

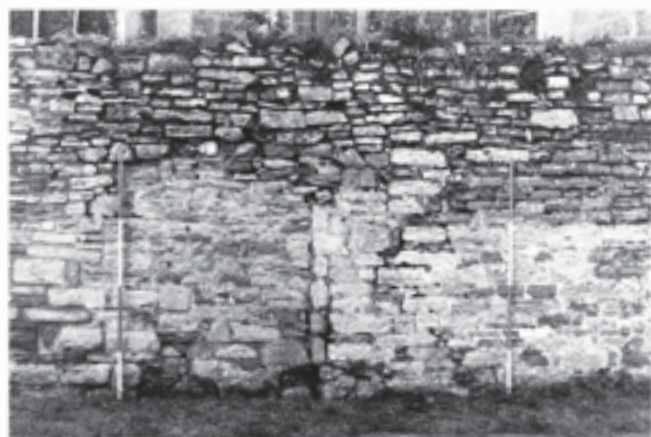
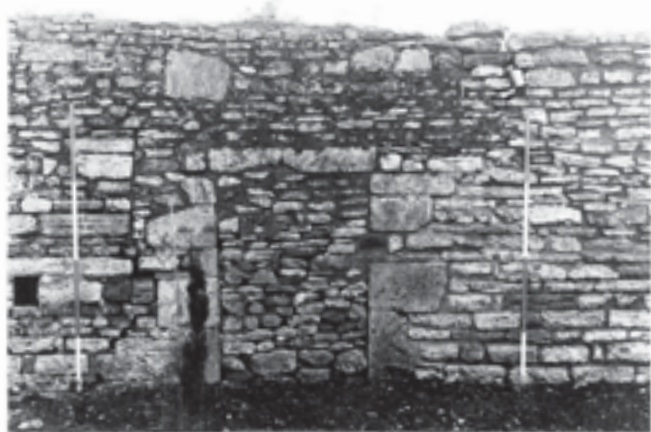
Fig. 359 Features in the Camery wall. A (upper) East face of blocked doorway 'A', before repointing; B (lower) West face of the same feature, during repointing. Note also the open putlog hole on the left. Scales of 2 m (Jerry Sampson)

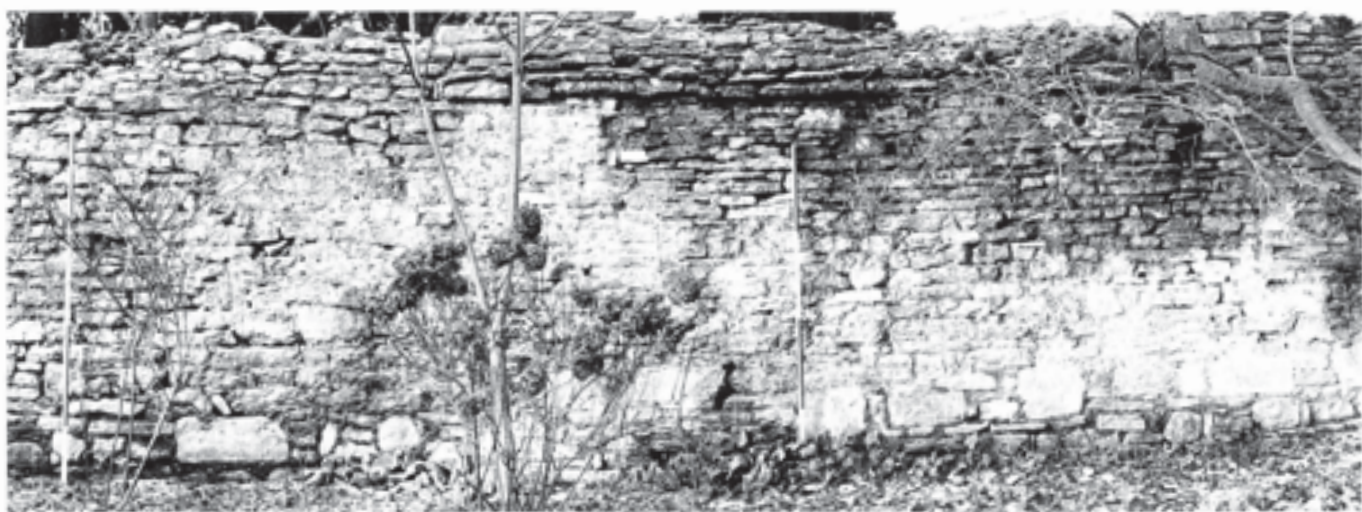
Fig. 362 Camery wall. Remains of the thirteenth-century weathering-course and rubble coping. Viewed from the east, before repair. Scales of 2 m

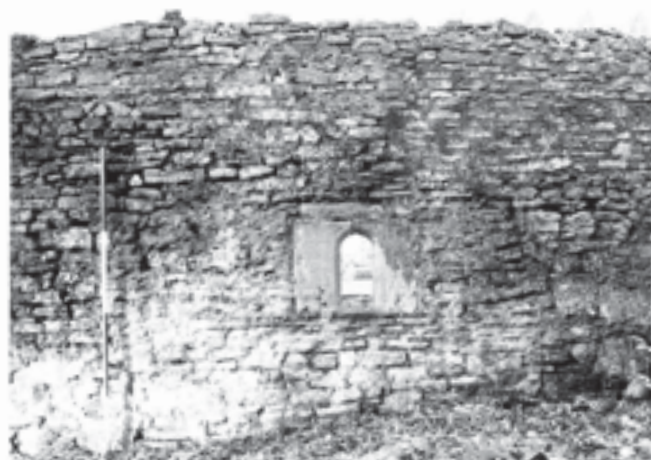
Fig. 360 Fifteenth-century window ('C') in the Camery wall, viewed from the east during clearance. Scale of 2 m

At *c.* 22 m the curvature of the wall begins, and from 22.5 m to 25 m there are marked differences in the character of the masonry, and the whole west face has possibly undergone a localized reconstruction here. Next comes the rear opening of the small fifteenth-century window (C). The window is here contained within a square recess, measuring 60 cm wide, 56 cm deep and 1.2 m high. The lower half of this has subsequently been infilled with a blocking of rubble (Figs. 366 and 396). As on the east face, the structural break resulting from the insertion of this window and its surrounding masonry into an older wall can be seen clearly on the north and less distinctly on the south. The aperture cut through the Camery wall was far larger than was necessary simply to insert the window and accompanying recess, and excavation here showed that

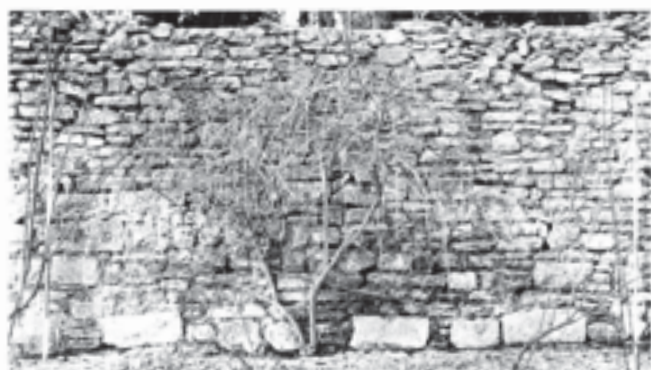
Fig. 361 Detail of the construction of the early thirteenth-century Camery wall, showing reused ashlar blocks in the lowest visible courses. Scales of 2 m

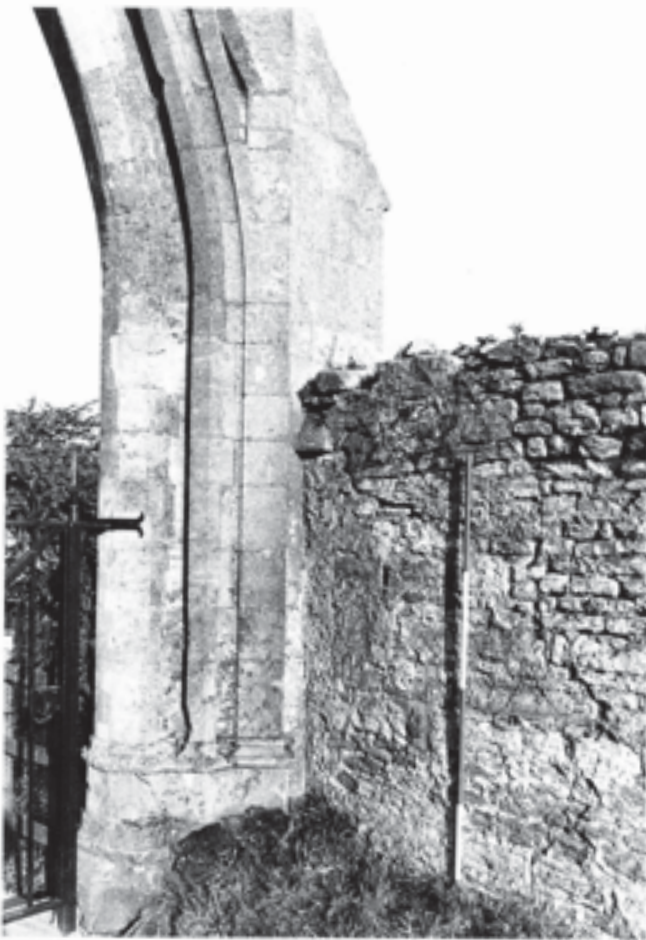
Fig. 363 Detail of the mouldings of the buttress-arch and abutment of the Camery wall on the south. Note the beginning of a steeply profiled ashlar coping embedded in the wall-top. Scale of 2 m

A freestone coping at a height of 2.0 m above ground level was intended, as evidenced by the abutments provided to the buttress-arch mouldings, to both north and south. There is no evidence to confirm that such a coping was ever fixed on the south side (Fig. 363).
