WELLS CATHEDRAL

Excavations and structural studies, 1978–93

*Excavations and Structural Studies,
1978–93*

ARCHAEOLOGICAL REPORT 21

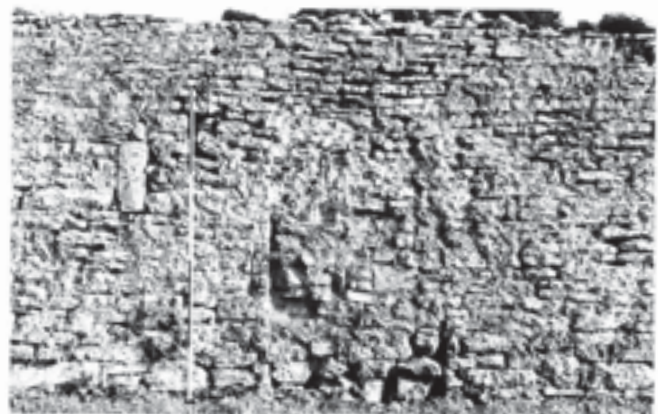
Fig. 364 Camery wall. West face of blocked doorway 'B', and jamb of window 'F' to the left. Scale of 2 m

The second blocked doorway, B, is encountered at 15.5 m. Its width is 1.0 m and the jambs can be discerned for a height of *c.* 1.5 m, before being lost in the rebuilt upper courses of the wall; as on the east face, there is no sign of a lintel, and the opening is not dressed with freestone (Fig. 364). Set between the two doorways, at 10.3 m, is a pair of blocks of Doulling stone standing vertically in the wall, their tops being approximately level with the posited lintel of doorway A. These were found to be the jambs of a small rectangular opening, further elements of which were

revealed during repairs. The opening measured 50 cm by 60 cm (Fig. 365), and was evidently a window (E). The less well preserved remains of a second example (F) lay at 14.5 m, close to doorway B. Only the southern jamb of this window remained (Fig. 364), but was supplemented on the east side of the wall by the corresponding jamb of its rear opening. The window was splayed, and the building to which it admitted light must have stood on the bishop's land, east of the Camery wall. The windows, like the doorways, were evidently original to the build at this point.

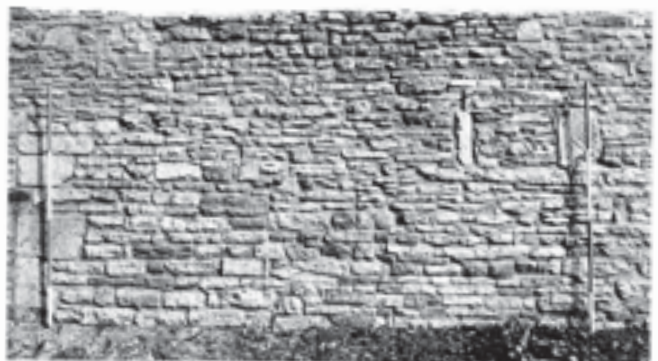
Fig. 365 Camery wall. West face of window 'E', after repointing. The jamb of doorway 'A' is visible on the far left. Scales of 2 m (Jerry Sampson)

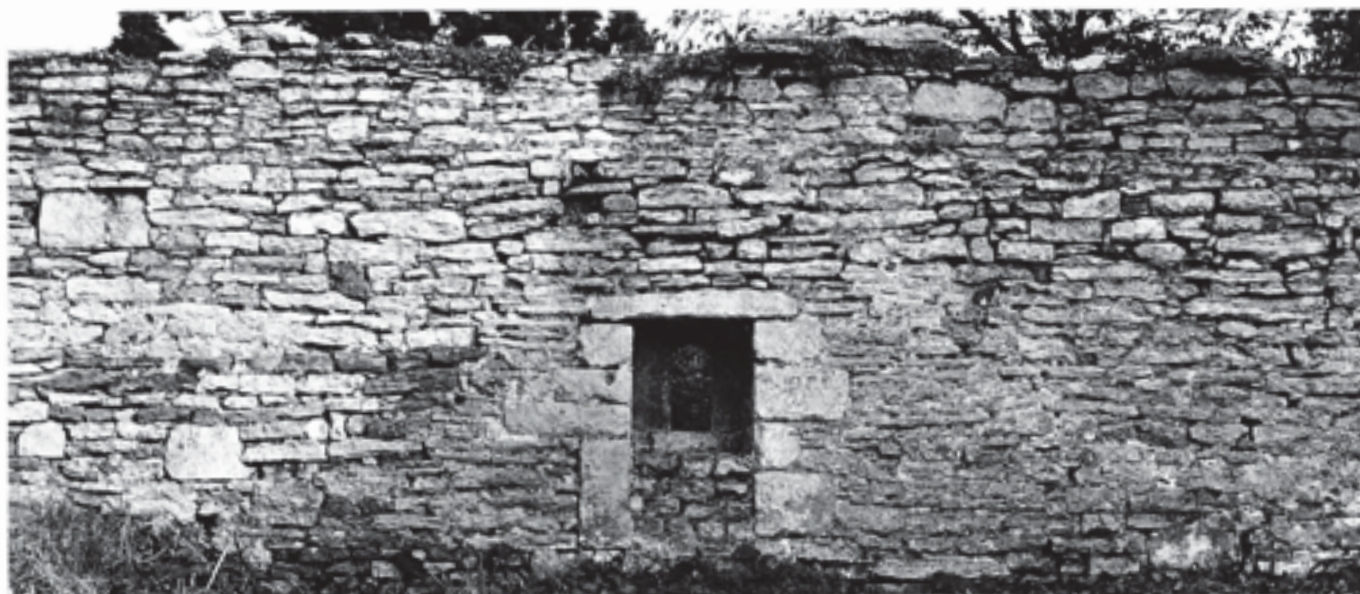
Fig. 366 Camery wall. West face, after clearance, showing the fifteenth-century window-recess 'C', with masonry blocking in the lower part (cf. Fig. 396)

At *c.* 22 m the curvature of the wall begins, and from 22.5 m to 25 m there are marked differences in the character of the masonry, and the whole west face has possibly undergone a localized reconstruction here. Next comes the rear opening of the small fifteenth-century window (C). The window is here contained within a square recess, measuring 60 cm wide, 56 cm deep and 1.2 m high. The lower half of this has subsequently been infilled with a blocking of rubble (Figs. 366 and 396). As on the east face, the structural break resulting from the insertion of this window and its surrounding masonry into an older wall can be seen clearly on the north and less distinctly on the south. The aperture cut through the Camery wall was far larger than was necessary simply to insert the window and accompanying recess, and excavation here showed that

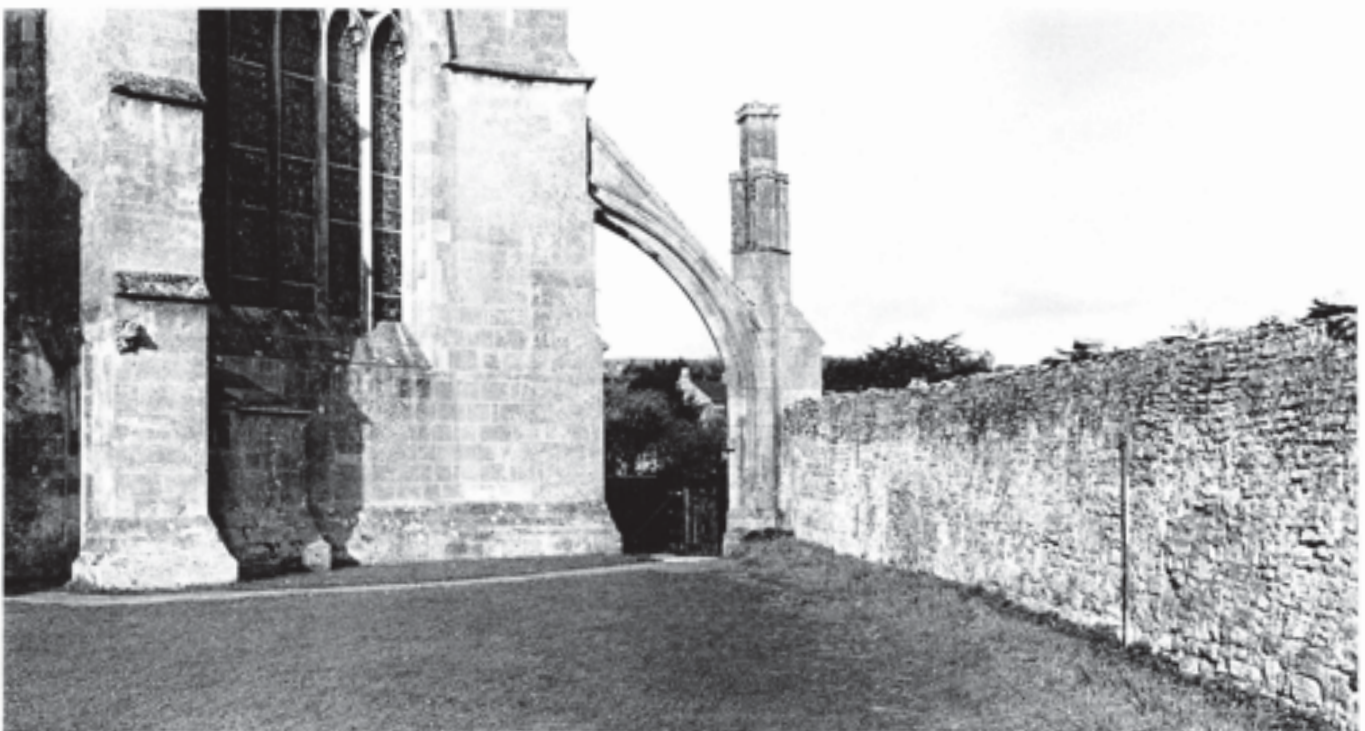
Fig. 367 The north-eastern corner of the Camery, and the buttress-arch adjoining the eastern Lady Chapel. Scales of 2 m

The construction is that of a ground-based flying buttress that appears to give support to the south-east corner of the Lady Chapel, which is itself conventionally buttressed (Figs. 367 and 369). The flier between the buttresses has three hollow-moulded and chamfered orders which are carried down to a moulded plinth (Fig. 363). The counterpoise is of square section, diagonally set on top of the outer buttress, and rises like a chimney. It is stepped and clasped by a quartet of lesser shafts, also square. All five have castellated caps.

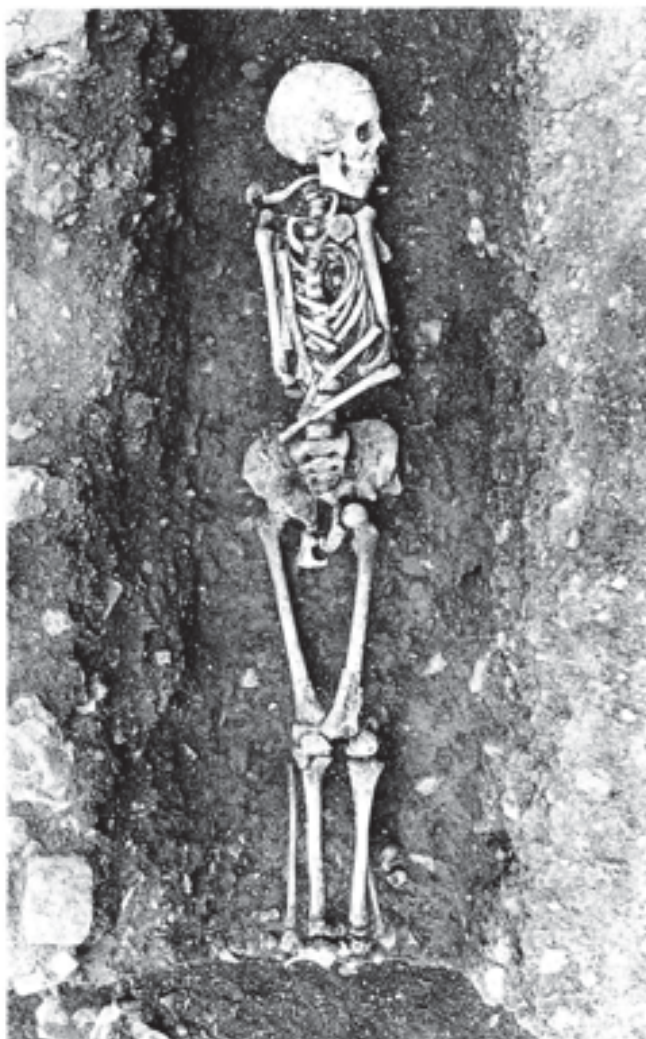
Fig. 371 Burial 283: the posture suggests that the corpse was tightly bound in a shroud

Graves F1370 and F1386 were both fairly spacious, and with adequate capacity for coffins, yet the burials themselves testify to a different form of treatment. In both cases the bones were very tightly juxtaposed and had not been allowed to spread laterally as the corpse decomposed. In burial 283 the upper arms were virtually on top of the ribs, and the left leg was crossed over the right one (Fig. 371). There can be no doubt from the posture of burial 283, and probably burial 281 also, that the corpses were bound in winding-sheets. Both were young adults in their late teens.

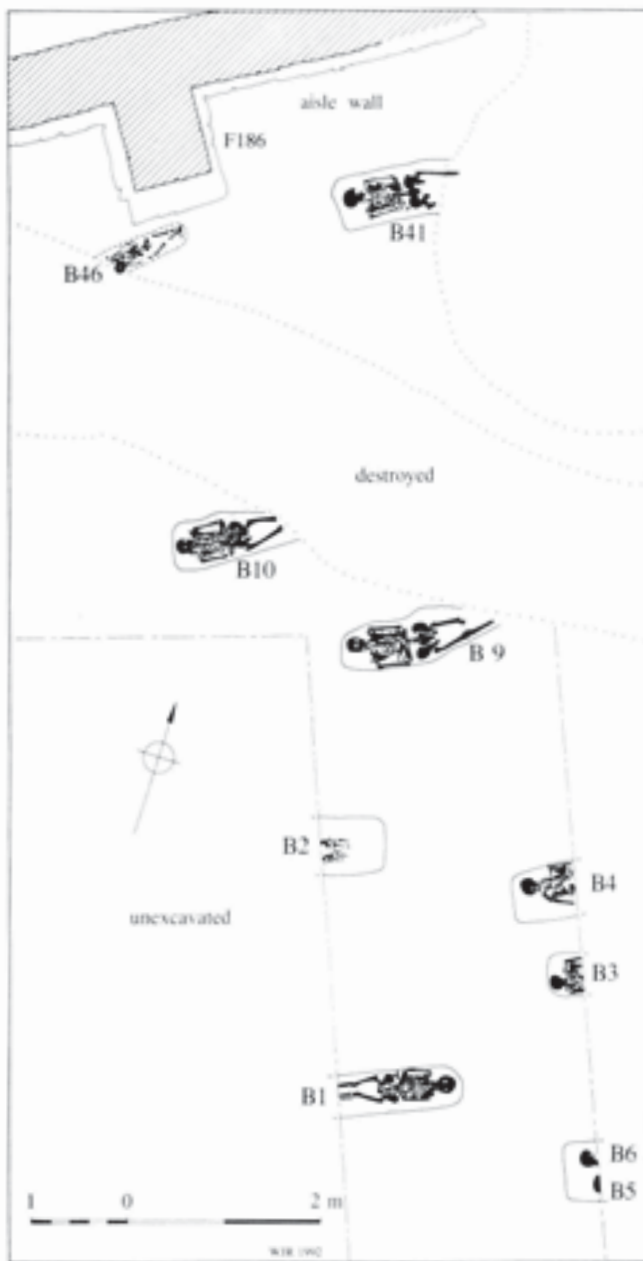
Fig. 372 Plan of burials in Areas 3 and 10, to the south of the Lady Chapel-by-the-Cloister. Scale 1:80

A thinly distributed series of interments occurred outside the south aisle of the Lady Chapel, and extended into the ill-defined area occupied by the medieval masons' yard (Fig. 372). Two early graves, potentially Anglo-Saxon, have already been discussed (p. 60), and the remaining twelve were all medieval. They were found to extend up to 6 m south of the Lady Chapel, their arrangement was orderly, with a hint of rows, and there was no intercutting or superimposition of graves. The fifteenth-century realigned conduit cut a swathe through the area, essentially divorcing the cemetery from the chapel. The masons' yard and workshops which were built at the same time effectively sealed the bulk of the cemetery, which has been archaeologically examined only where it was necessary in 1978 to cut two foundation trenches through the yard surfaces.

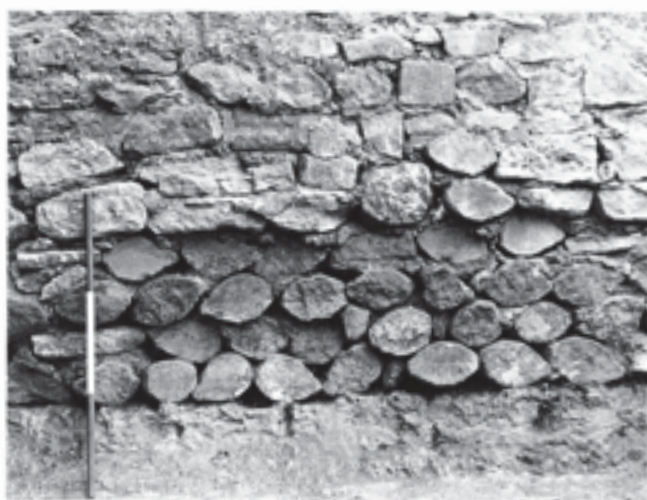
Fig. 373 Sections of discarded medieval screen mullions used in the foundations of the Victorian masons' yard wall. Scale of 75 cm

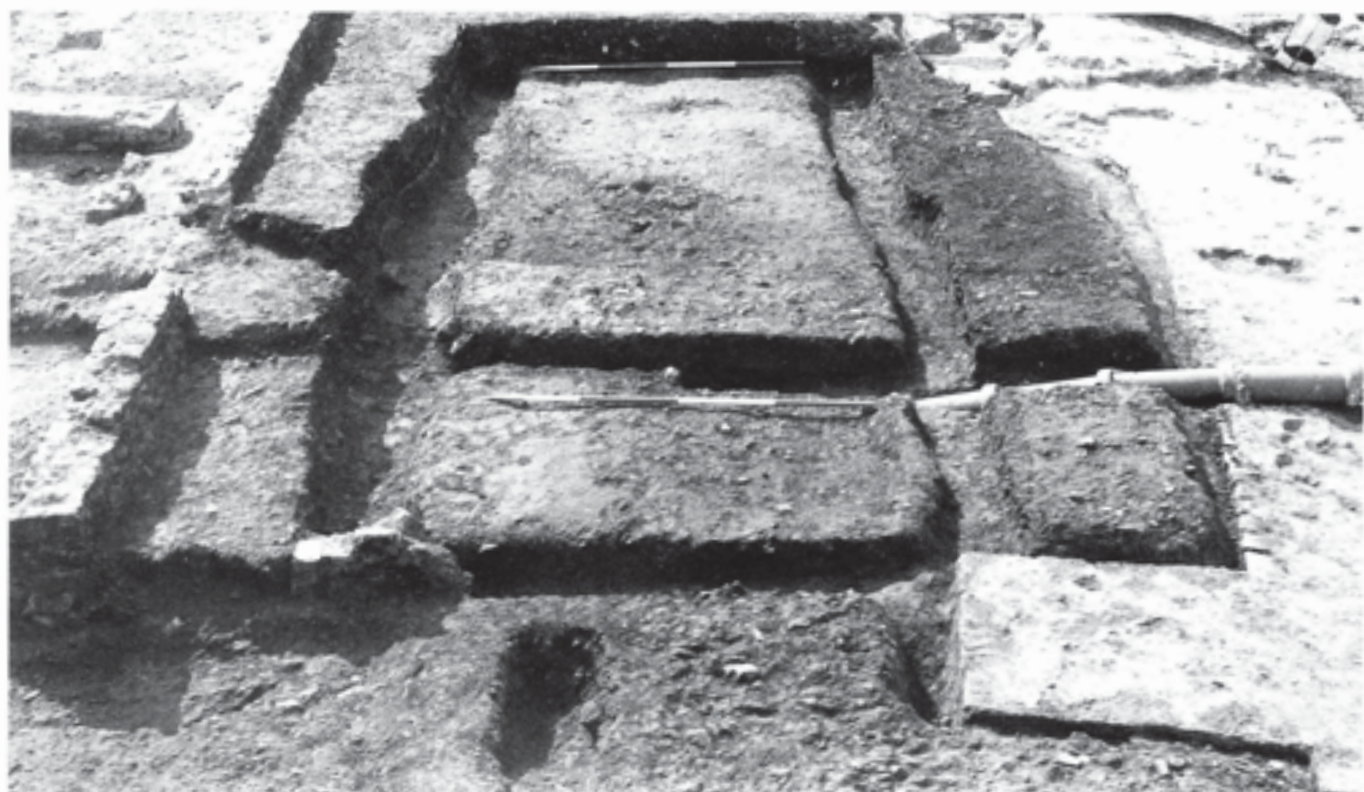
Fig. 376 Foundation trench (robbed) of Structure 16, in phase 2. View west. Scales of 2 m

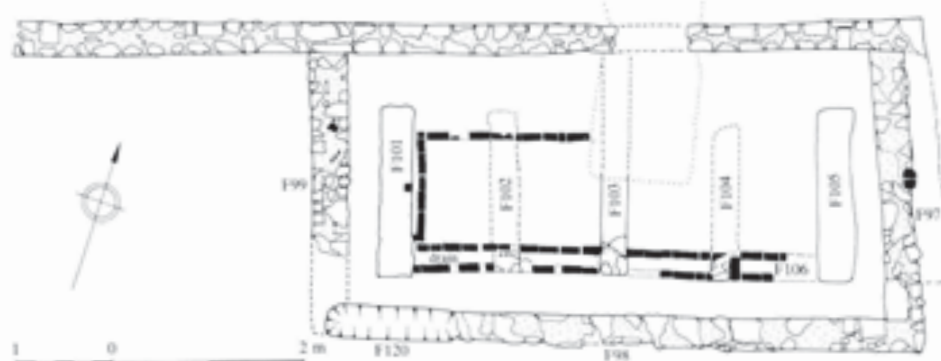
Fig. 378 Plan of the eastern part of Structure 17, after conversion into a stable (phase 5). Scale 1:80

Three of the cross-walls defining the stalls of the previous phase were retained (F101, 103, 105), while the others were probably removed (F102, 104), so that the accommodation of the stable now comprised two double stalls. These were edged around the walls with brickwork, and a drainage slot (F106), also lined with brick, was formed along the south side. The bricks were red, frog-less, and of eighteenth-century type (Figs. 378 and 379).

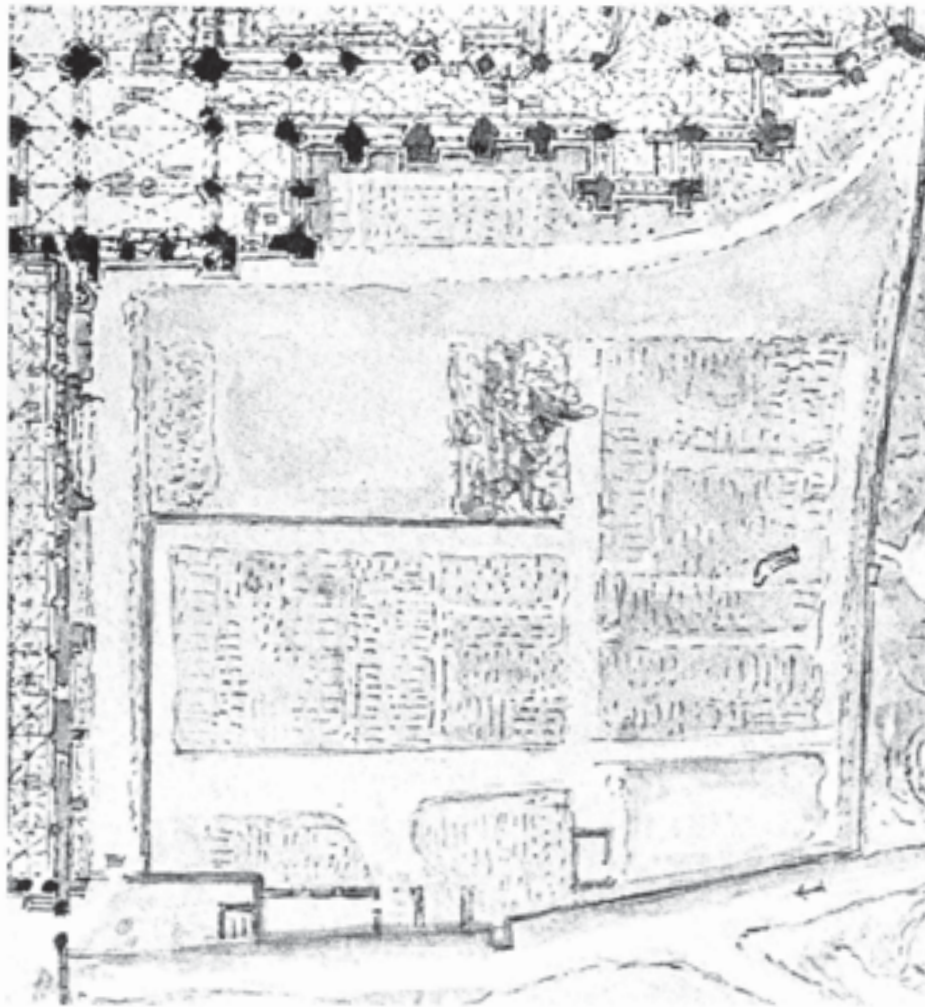
Fig. 381B Extract from Carter's plan of the cathedral environs in c. 1795, showing the layout of the Camery (Courtesy of the Society of Antiquaries of London)

Clearly, the privy must have been built on or close to the line of the great conduit. Neither it nor its replacement have been found, but a possible candidate for the latter is shown on Carter's plan (Fig. 381B). Midway along the south wall of the Camery, a small square feature is shown, which has the appearance of a projecting tower. This was undoubtedly a latrine chamber, discharging into the bishop's millstream, but its date is unknown. It may have been post-medieval.

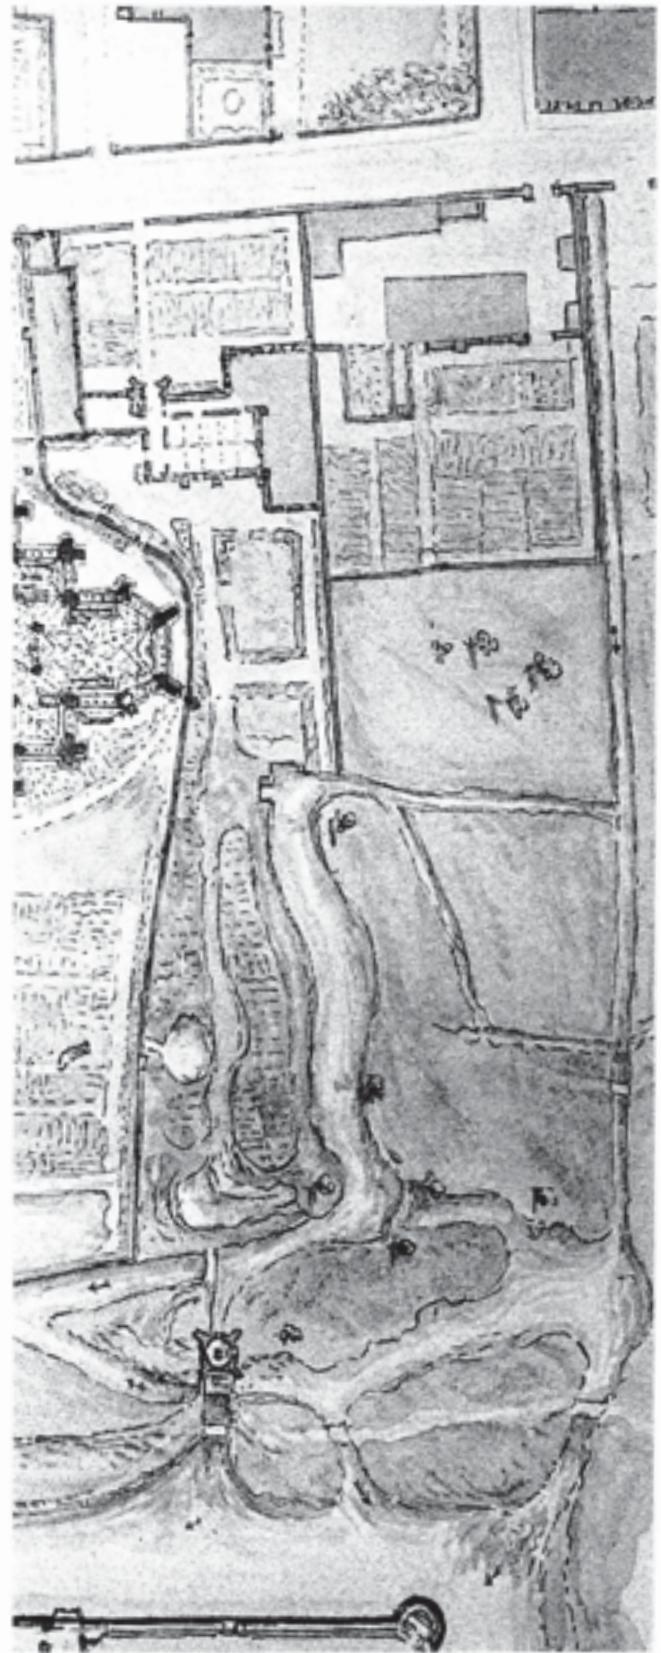
Fig. 384 Detail from Carter's plan of c. 1795, showing waterworks in the grounds of the Bishop's Palace (Courtesy of the Society of Antiquaries of London)

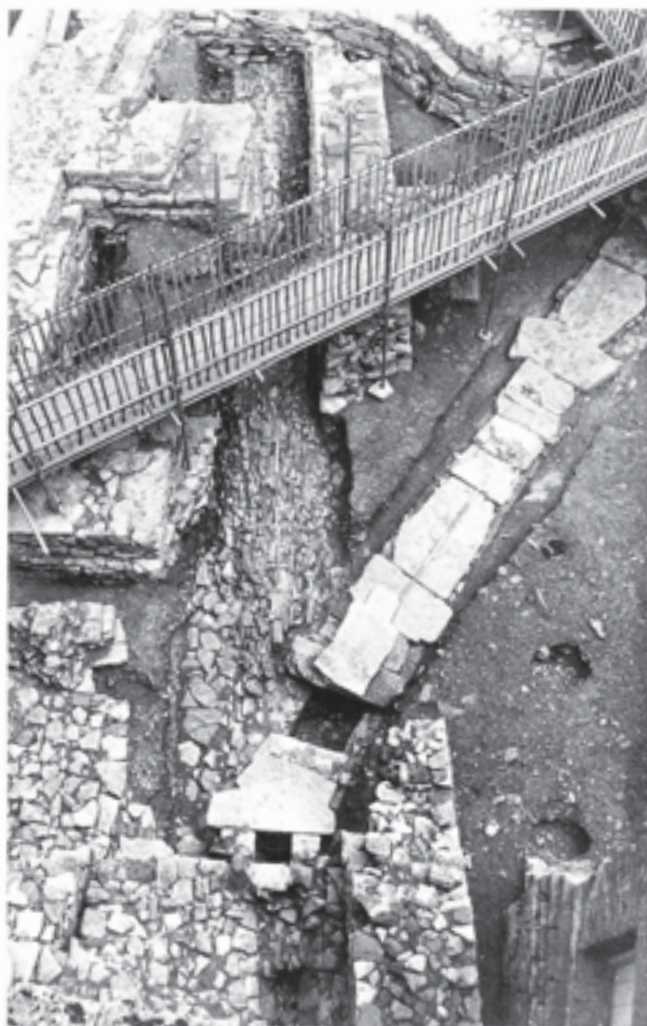
Fig. 390 The converging routes of medieval conduits in Areas 4 and 5, approaching the cloister from the east (top). The vaulted conduit of c. 1190–1200 runs through the centre of the picture, with the south aisle wall of the early Lady Chapel alongside (right); the diversion of 1477, with its slabbed top, enters from the upper right. Part of the transept turret of Stillington's chapel is visible at the top. Scales of 2 m

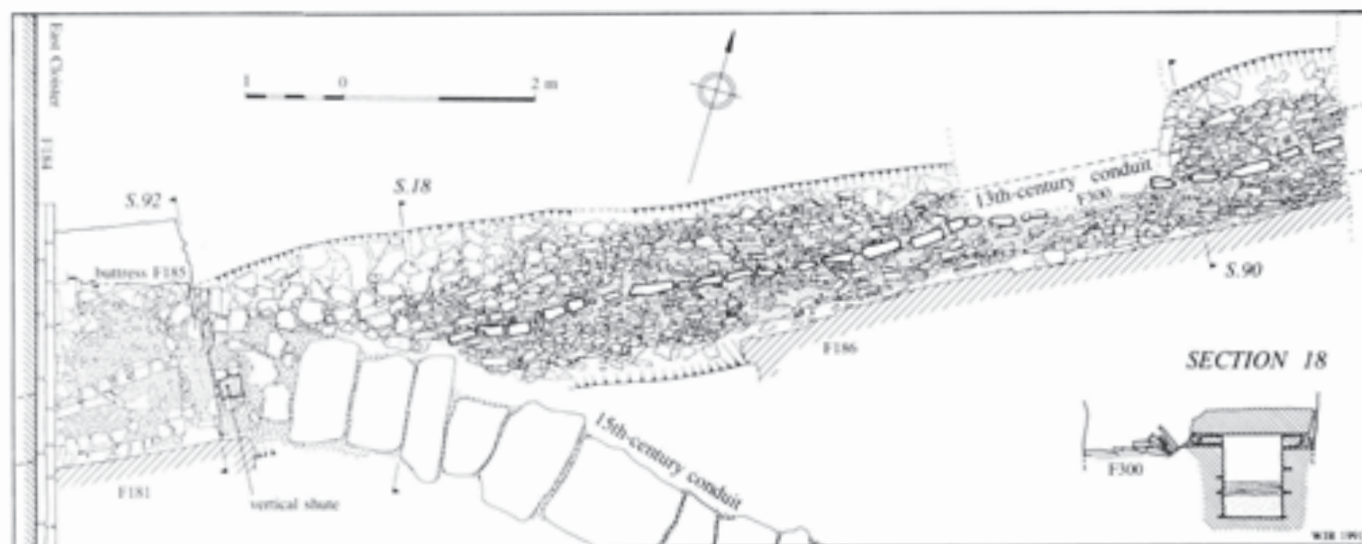
Fig. 391 Plan of the early thirteenth-century conduit (F300) as excavated in Areas 4-5. The junction with Stillington's conduit, entering from the south, is also shown. For sections, see Fig. 392. Scale 1:80

The only part of the original conduit still in use today is the section under the cloister garth and walks. To east and west, later diversions have veered away from the old line. A 10 m length of original conduit, cut off and disused since the late fifteenth century, was found during excavation in Area 5, where its construction was examined (Fig. 390). The north side of the conduit was also encountered in Area 8, and the junction between the original conduit and its fifteenth-century diversion was investigated against the east cloister wall, in Area 4 (Fig. 391).

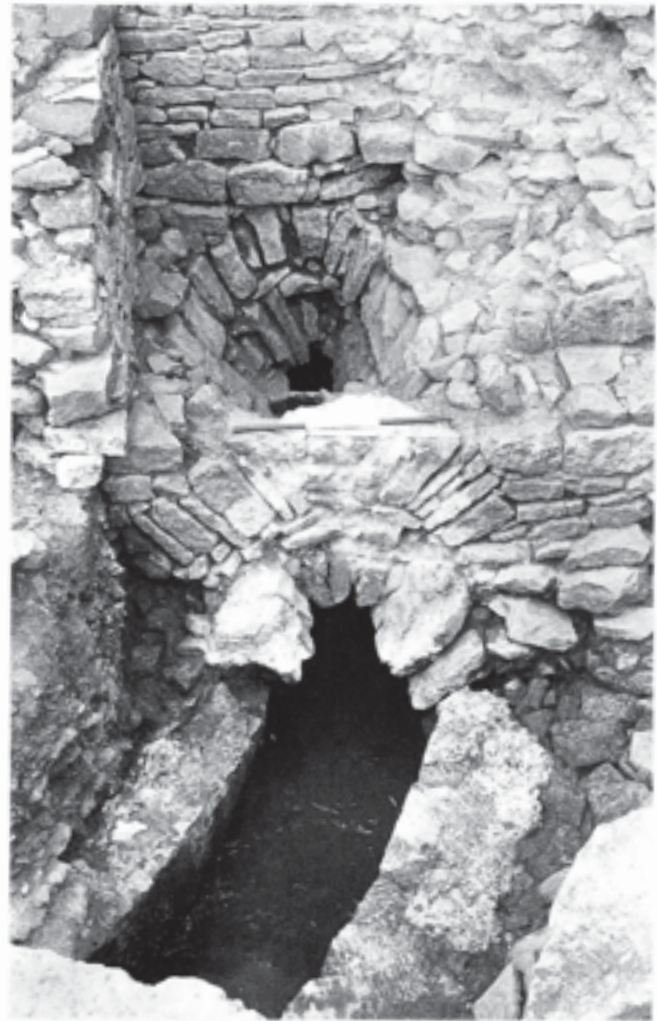
Fig. 393 Junction of Stillington's conduit (seen here with the cover-stones removed) with the earlier medieval vaulted conduit, where it passes under the east cloister. Note the double ring of voussoirs, and the post-medieval hole broken through the vault (behind the 75 cm scale)

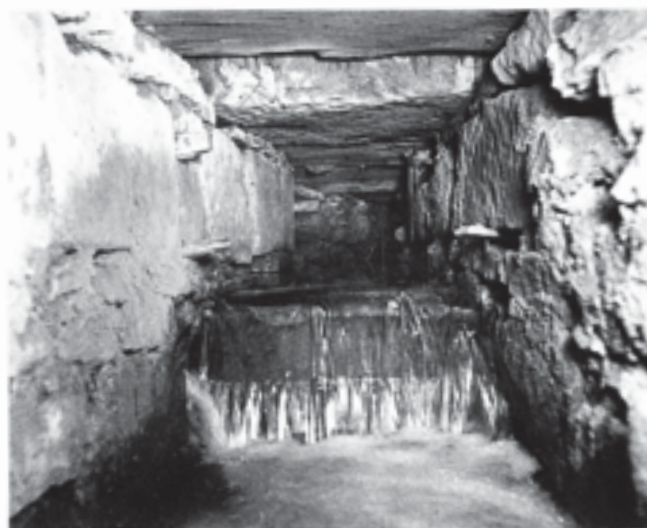
Fig. 394 View east inside Bekynton's conduit of c. 1451, adjacent to the Camery wall. The weir was created when the water level was raised in St Andrew's Well, probably in the early nineteenth century. The floor of the conduit was also raised

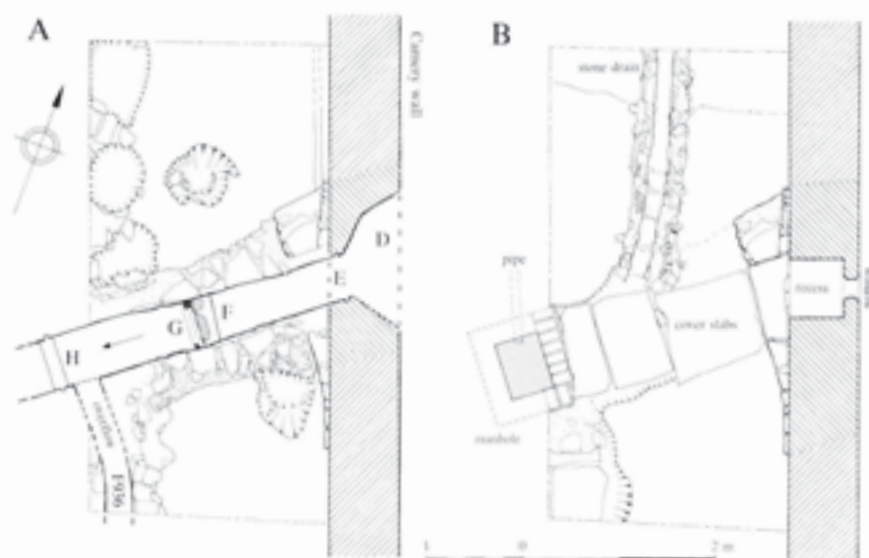
Fig. 398 Plans of excavation Area 8 and the adjoining Camery wall. A Late medieval features. The conduit is shown without its cover-stones. B Post-medieval features. Scale 1:80

Bekynton's conduit did not pass directly through the wall, but started from a funnel-shaped opening on the east face (*D* on Fig. 398A). This suggests that St Andrew's Well, or an open channel leading from it,

No vertical channels were cut in the walls of the conduit; instead, four iron pins were driven into them to act as guides, two on each side (Figs. 398A and 399). One of the pins on the south side had fallen out, but was recovered from the silt. Again, this feature was associated with a post-medieval raising of the water level.

At 2.9 m west of the Camery wall lay another sluice, this time certainly an original feature (*H* on Fig. 398A and 399). The walls of the conduit are vertically channelled from top to bottom, and the sluice-board seated on a Doultling stone bar which was built into the floor. This bar formed another step in the conduit floor, again acting against the flow (Fig. 402). There is a late nineteenth-century brick-built inspection chamber over the conduit at this point, into which a modern pipe-drain feeds rainwater from the roof of the eastern Lady Chapel. The first two cover-slabs east of this chamber are both post-medieval, and are either additions or replacements.

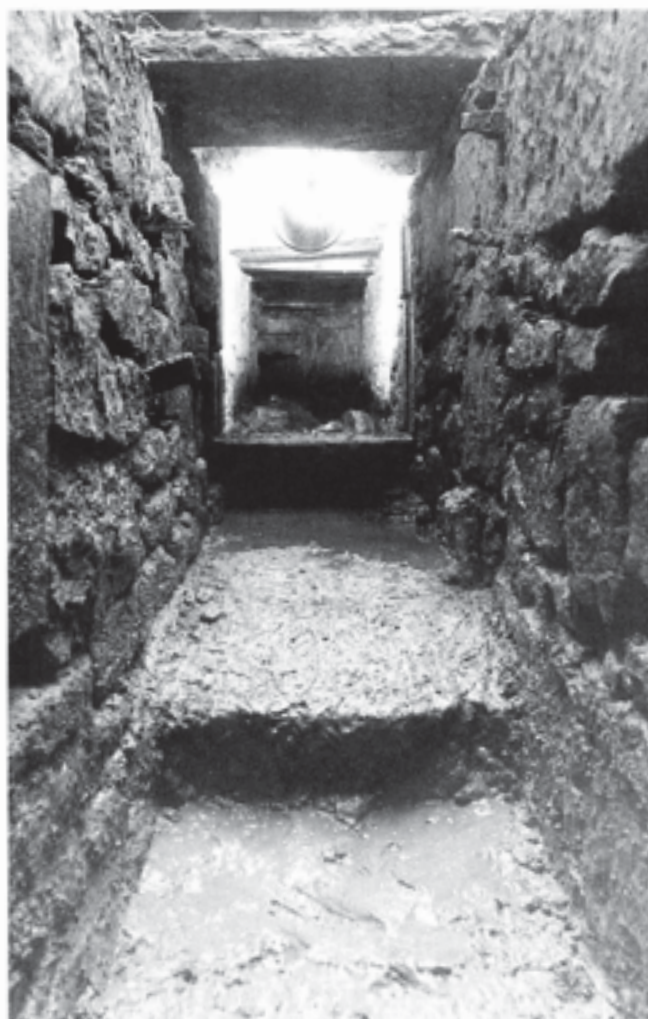
Fig. 400 View west inside Bekynton's conduit, after draining and removal of post-medieval fills. The two steps in the floor are original

The two contra-flow steps in the conduit floor are original and their purpose was undoubtedly to act as silt-traps. They were later infilled and sluices constructed. These features have all long been disused and a considerable mass of rubble and silt had piled up on the floor. Although the excavation was not extensive enough to provide the necessary evidence, it seems likely that there was formerly a small building against the Camery wall at this point, enclosing the sluices, the wall-recess and the window overlooking the holy well. No trace of a sluice-house survived long enough into modern times to appear on any map.

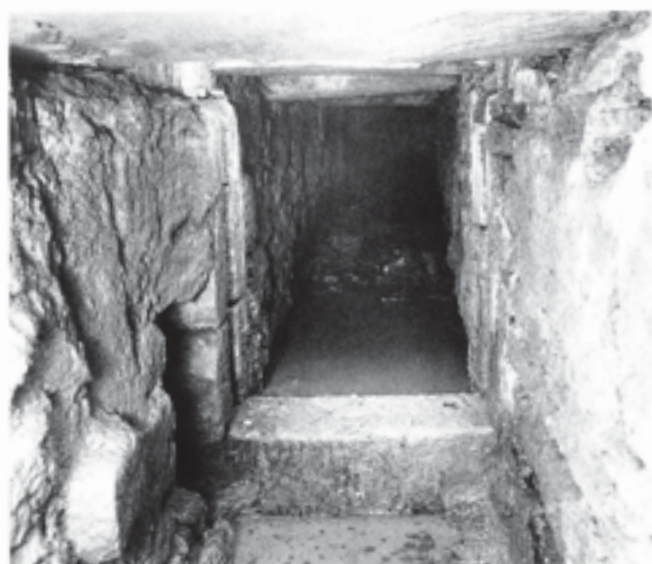
Fig. 402 View west inside Bekynton's conduit, showing the original sluice ('H') and bar forming a step in the floor. The opening to a small culvert (F936), heading south towards the millstream, can be seen on the left

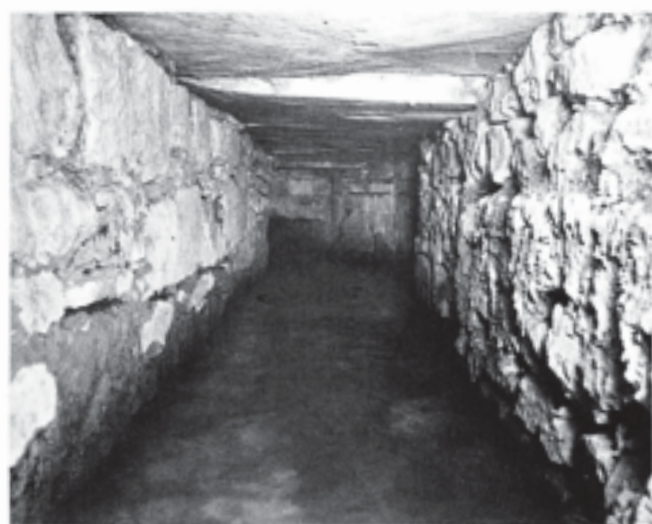
Fig. 403 View west inside Bekynton's conduit (water filled), towards the junction ('K') with Stillington's diversion. Note the reduced aperture to the latter

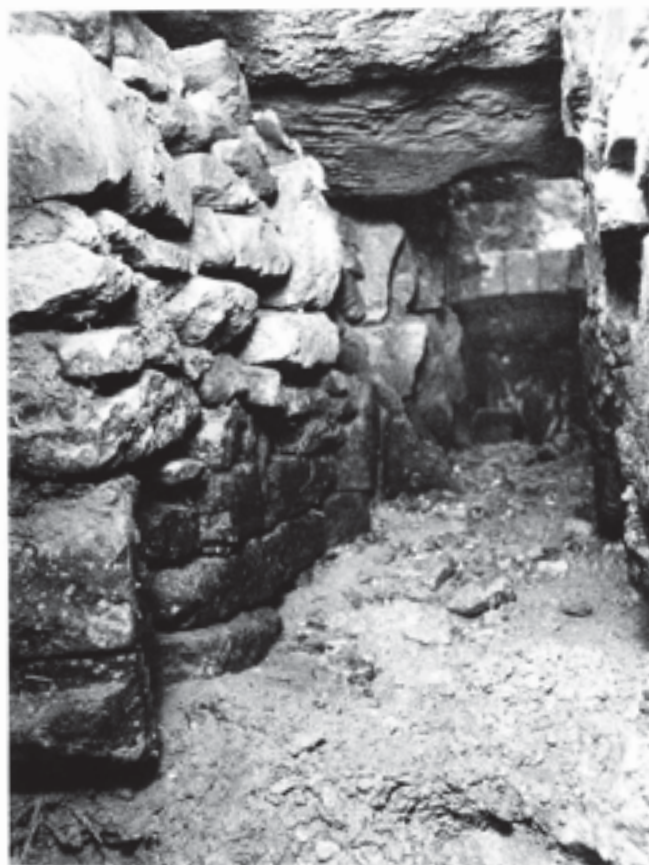
Fig. 405 View east inside the post-medieval conduit running between the Camery wall and St Andrew's Well (plan, Fig. 395, 'D' to 'B'). The furthest part of the channel is open topped, and the voussoirs of the bridge beside the well can be glimpsed in the distance

well constructed channel, although whether *in situ* is unclear. The upper parts of the walls are made of uncoursed and unmortared rubble (Fig. 405). There are reused stones, including Douling blocks bearing evidence of sluice-channels (Fig. 406). The roof is slabbed, and the floor consists of a deposit of rubble and clay, at least 50 cm in depth.

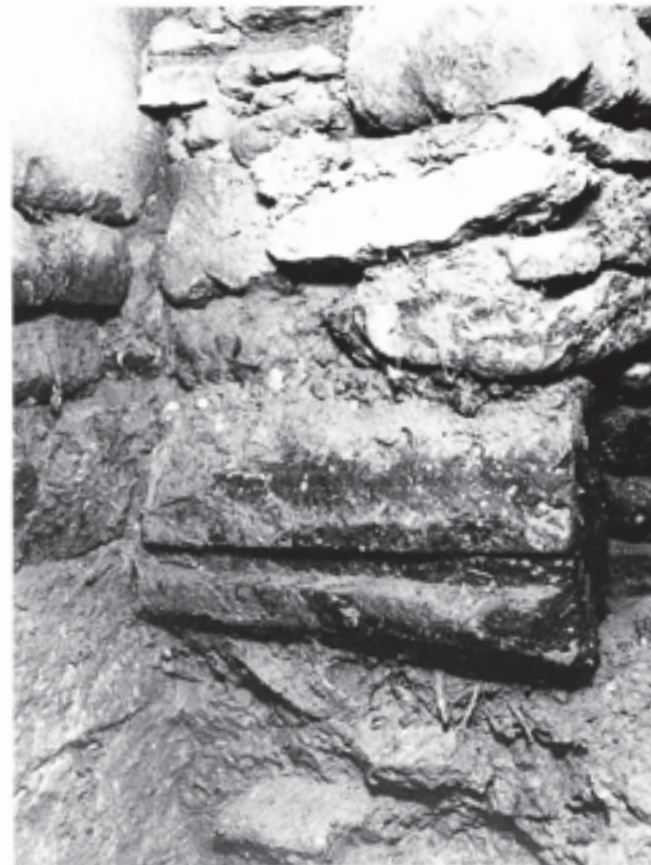
Fig. 406 Rubble construction of the post-medieval conduit east of the Camery wall ('D'), showing the base-course made from a block of channelled masonry salvaged from an earlier sluice (cf. Fig. 405). The conduit here is built on a bed of mud and rubble

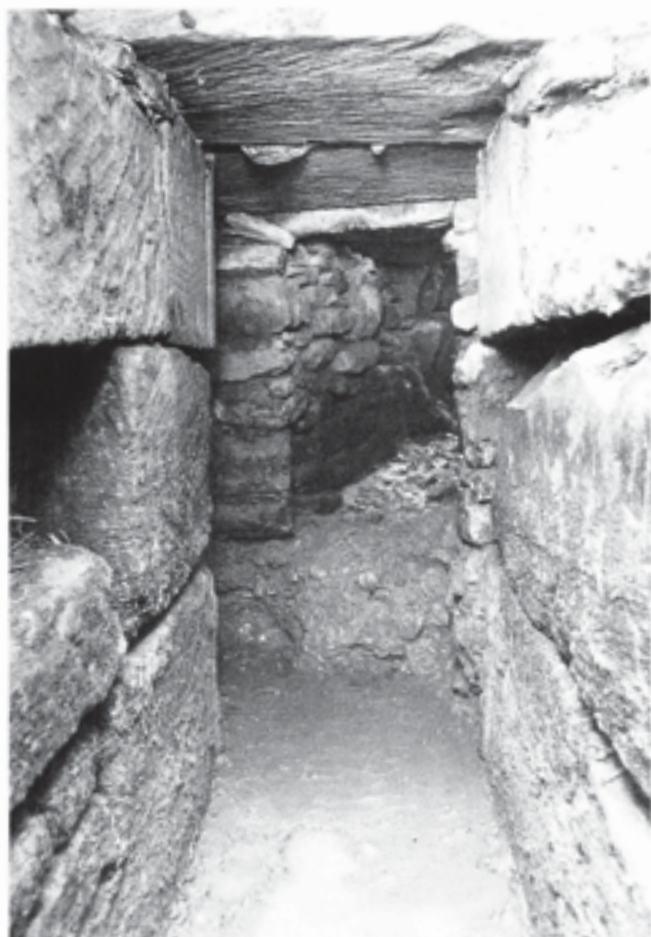
Fig. 407 View east inside Bekynton's conduit, beneath the Camery wall at sluice 'E'. In the middle distance is the junction ('D') with the post-medieval extension beyond. Its clay and rubble floor is at a higher level, and relates to the raising of the lake in the early nineteenth century

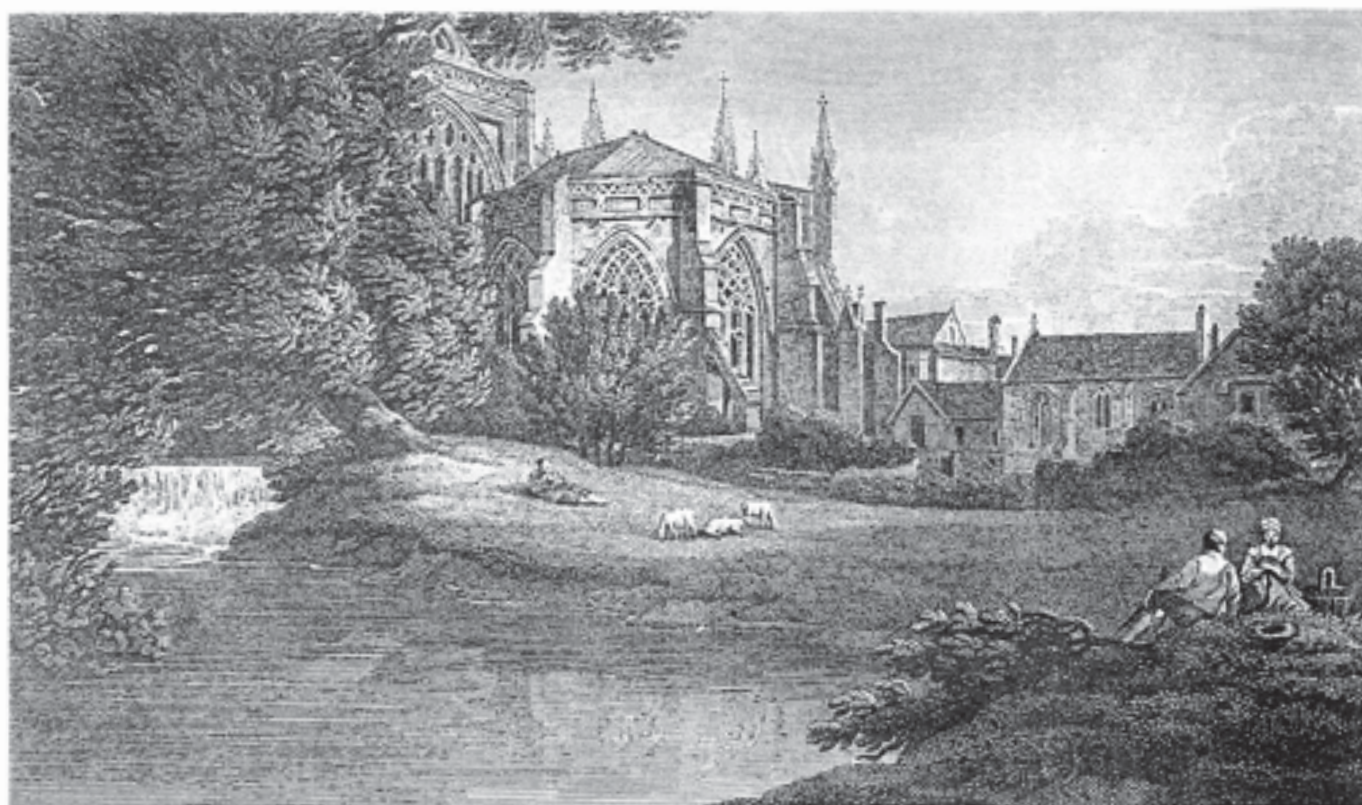
Fig. 408 The east end of Wells Cathedral from the Bishop's Palace garden, by Thomas Hearne, 1802. The east pot is in the foreground, being fed by a cascade (exaggerated) over the fifteenth-century weir. The buttress-arch adjoining the Lady Chapel can be seen in the mid-ground, and the house on the right is The Rib

One of the most instructive views is that drawn by Thomas Hearne, and published in 1802: it shows the east pot in the foreground, and beyond is the weir (a stone bar) over which water is cascading from the central pot (Fig. 408).⁸

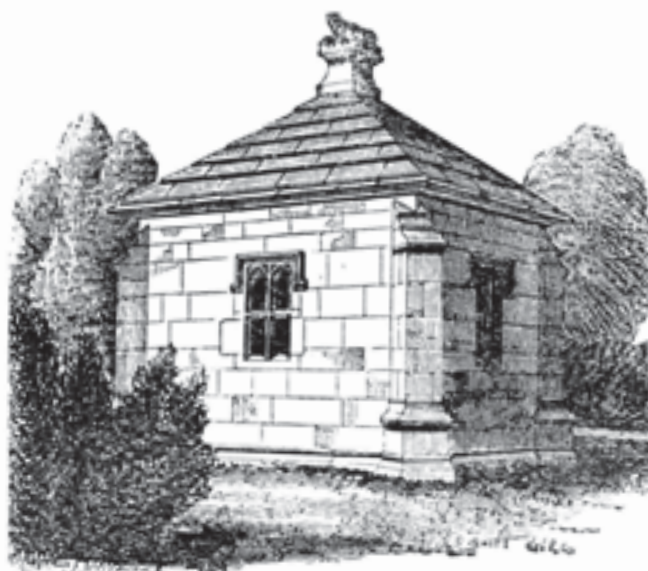
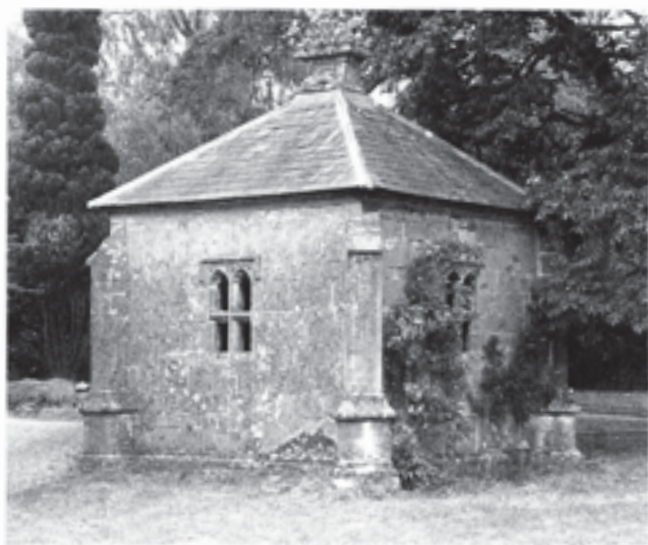
Fig. 410 Views of Bekynton's well-house of 1451 in the grounds of the Bishop's Palace from the south-west. A (upper) From a drawing (reversed) by Orlando Jewitt, c. 1860. B (lower) As existing in 1979

The charming little well-house standing in the northern part of the palace grounds remains and is in good condition, although the original plumbing fittings have long since been removed (Figs. 386 and 410). Measured drawings were made in the 1830s by A.W.N. Pugin, and are reproduced here as Figs. 411 and 412. The original cistern was evidently then intact (Pugin and Pugin 1895, 2, 47). The well-house features prominently in John Buckler's view of the palace from the north, in 1837.¹⁷

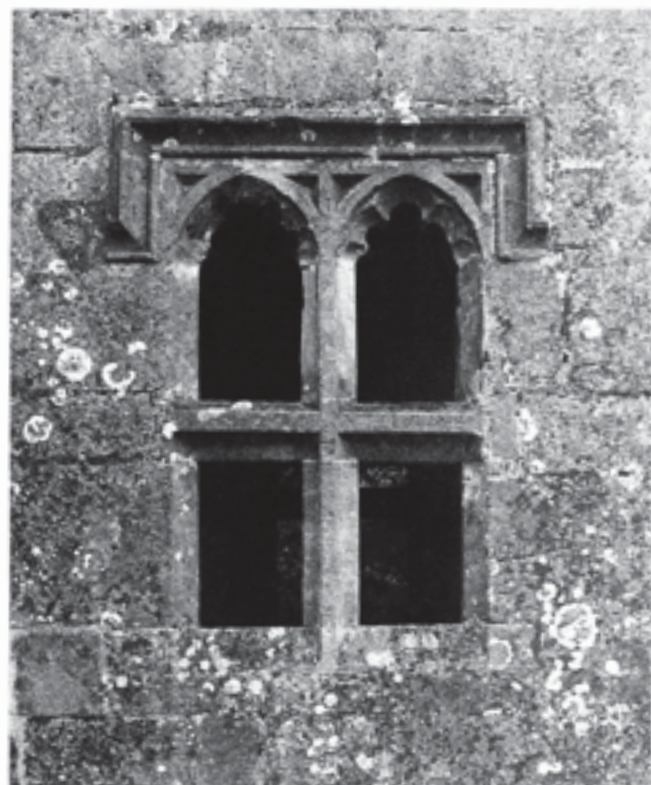
Fig. 414 West window of the well-house

(Fig. 414). The vaulted stone roof is pyramidal and was finished with stone slates externally; these were replaced with Welsh slates in the late nineteenth century. The roof is crowned by a castellated finial which bears the figure of a crouching lion. The latter may be compared with the somewhat similar creature surmounting the ridge of Bekynton's school over the west cloister (Fig. 344).

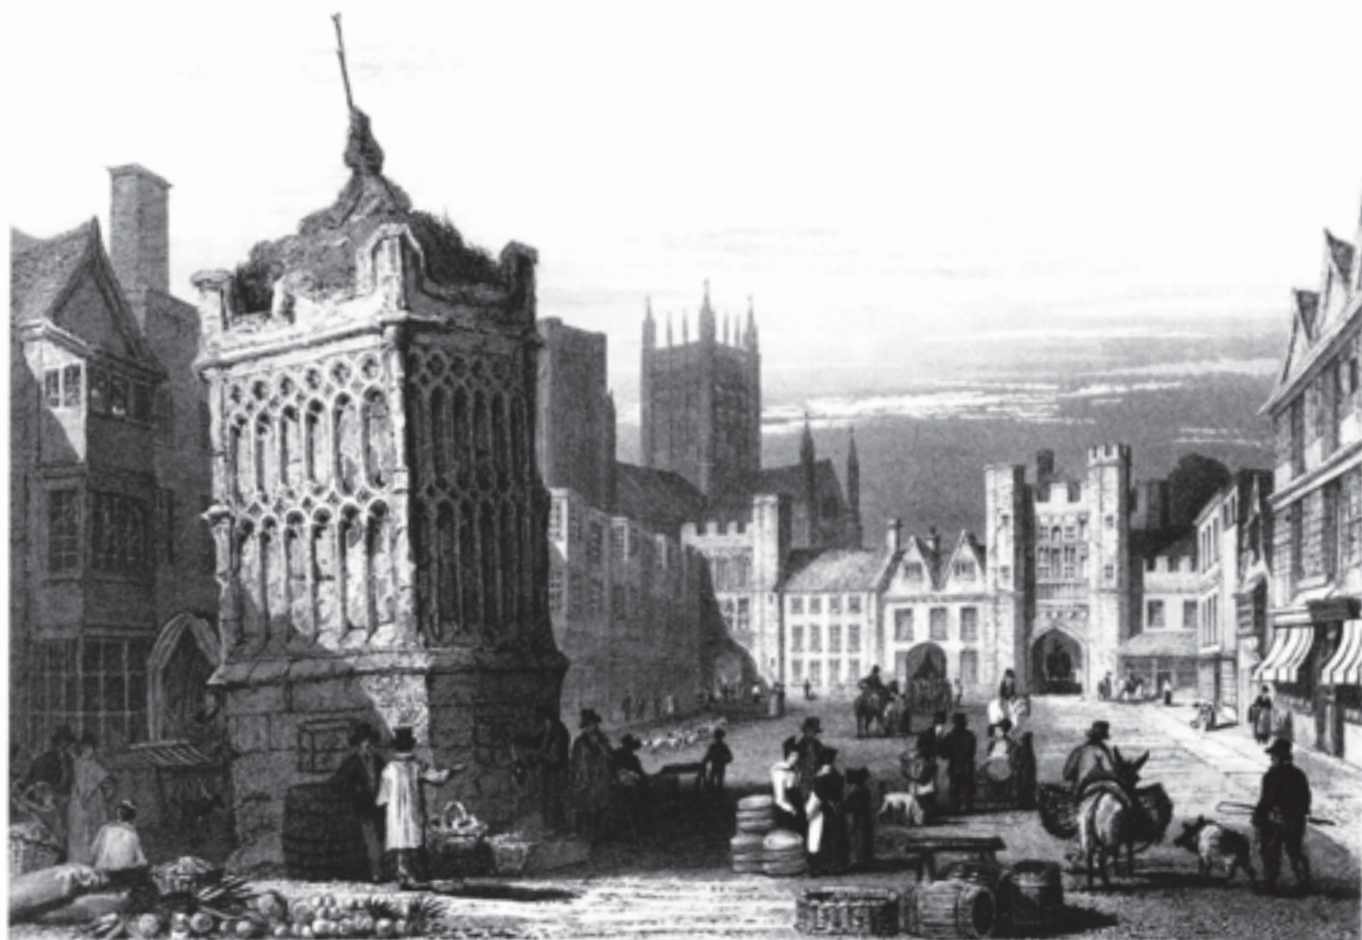
Fig. 415 Bekynton's conduit-head of 1451 in the market place, from the south-west in c. 1800. The architectural detail is meticulously represented. After Britton 1830

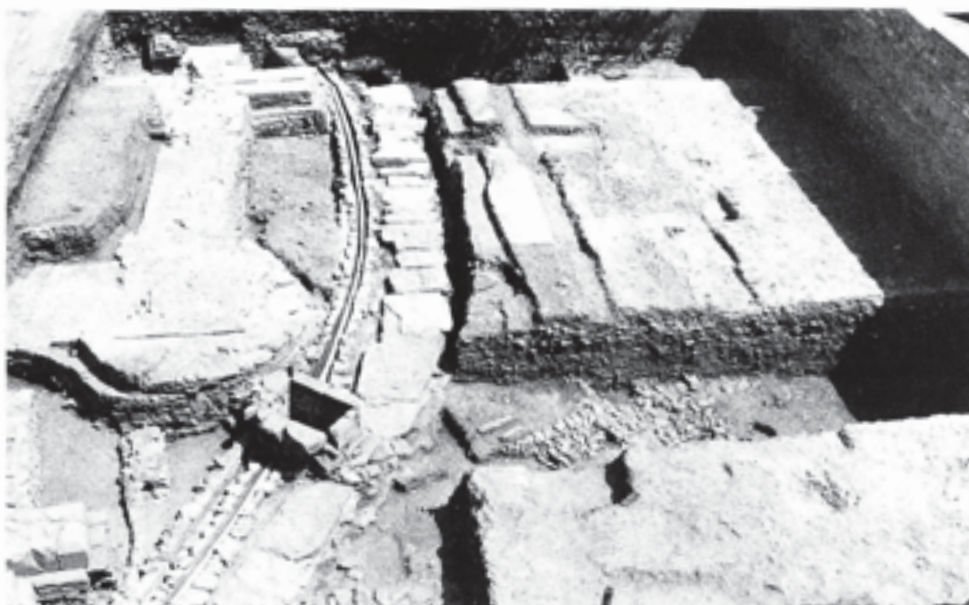
Fig. 418 General view looking east, showing the conduit and lead water-pipe of 1477, curving around the south transept of Stillington's chapel. An inspection chamber can also be seen, adjacent to the turret base. The capstones have been removed from the pipe-duct, but are still in place over the conduit. The surface of the late medieval masons' yard is seen on the right. Scales of 2 m

c. 58 m in length, follows a curving course through the southern part of the Camery (Fig. 16). Twenty-five metres of the conduit were exposed and studied in 1978 (Figs. 199, 217 and 418). Its sides are built of dressed Douling stone, exhibiting strongly pronounced tool marks from a bolster. The roof of the conduit is mainly capped with slabs of roughly dressed white lias, mortared in place; the floor seems to be of similar stone. The rectangular internal section averages 50 cm wide by 48 cm high, and is thus only half the size of Bekynton's conduit (Figs. 393 and 401.5). A small step was created, contra-flow, at the junction between the two (K on Fig. 395). The floor level at the beginning (east end) of Stillington's diversion is estimated as lying at c. 45.15 m O.D.

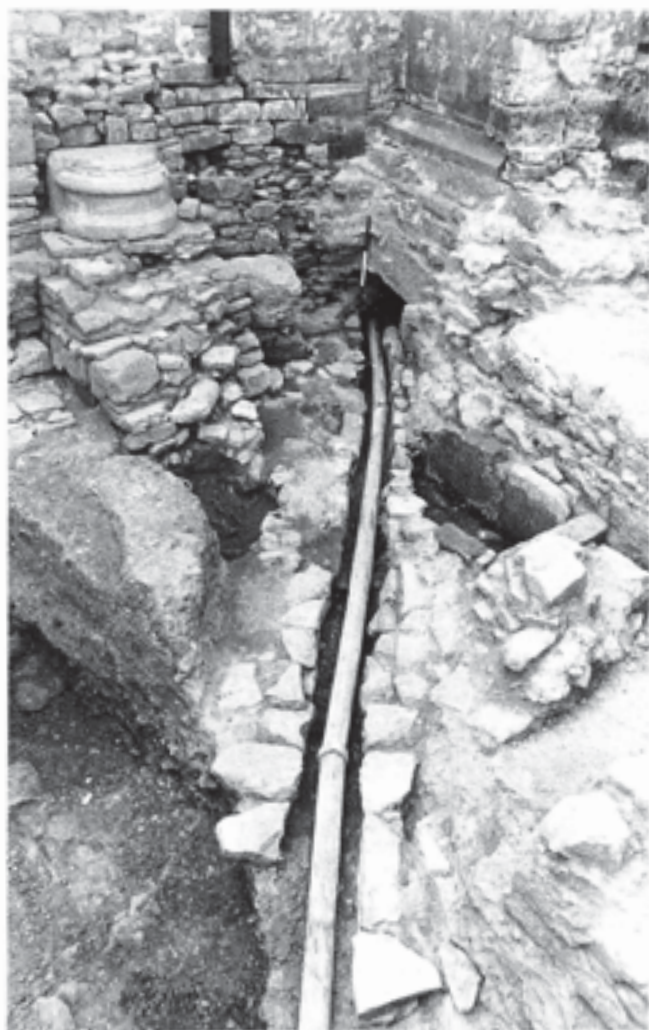
Fig. 419 View north-west along the lead water-pipe to the point where it disappears under the junction between the cloister (left) and Stillington's chapel nave. Pipe collar 2/3 is seen in the foreground. Scale of 75 cm

arrangement obtained when the pipe was relaid: it was placed in the open duct and propped at intervals on small pieces of stone. The surrounding void was then entirely filled with liquid clay, before the capstones were set in place. This treatment was accorded to the pipe, right up to the cloister wall, albeit that the original duct was retained for the last few metres here.
