WELLS CATHEDRAL

Excavations and structural studies, 1978–93

*Excavations and Structural Studies,
1978–93*

ARCHAEOLOGICAL REPORT 21

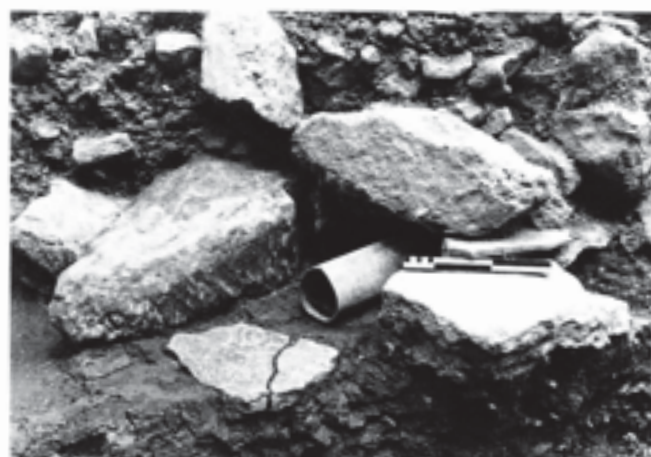
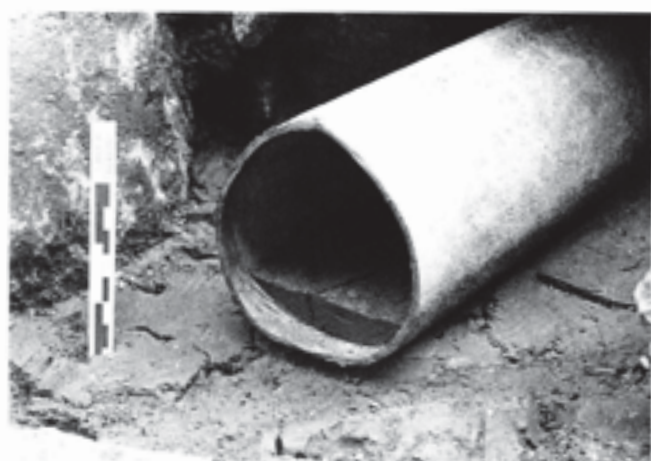
Fig. 421 Section through the pipe-duct (F132) and the lead water-pipe (F133, length 3). A (upper) The realigned duct of 1477; in the centre foreground is one of the pad-stones that supported the pipe before the duct was filled with liquid clay (removed in this view). B (lower) Close-up of the sectioned pipe, showing the final internal silting. The clay packing (F134) can be seen here beneath the pipe. Scales: (A) 25 cm; (B) centimetres and inches

As specified in Bekynton's grant (p. 397), the pipe was made with a circumference of 12 inches (30 cm). Sheets of cast lead, one foot wide and ten (or twelve) feet long, were rolled longitudinally, to produce a pipe with a diameter of approximately four inches (10 cm). The sheets varied from 3.0 mm to 5.5 mm in thickness. In practice, the pipe was not quite circular in cross-section, but tended to be pear-shaped (Figs. 420 and 421). The edges of the sheet were simply butted, and seamed with solder. This is an inherently weak method of jointing. While a pipe manufactured in this way might last for several centuries if undisturbed, a soldered seam that has been buried for 25 years, or so, is liable to crack if subjected to any stress. The failure of a soldered joint does not always manifest itself immediately or dramatically: a distressed seam may take a little while to develop a hairline crack, and then to leak. For this reason it is likely that Stillington's architect felt it advisable to renew the section of piping which had to be disturbed.

Individual lengths were butt-jointed and held in place with cast lead collars, into which the pipe-ends were a push-fit. The collars were not soldered, but some form of sealant must have been used in the joint: resin is a possibility.²⁷ The collars were rectangular in cross-section, and each had a square boss on it, upon which a St Andrew's cross was stamped by the plumber at the time of fixing (Fig. 422). The bosses were aligned with the pipe seams, which pointed upwards. Most of the bosses exhibited a dimple or concavity on the top surface, resulting from metal contraction during the casting process (Fig. 420). The section of pipe which fell within excavation Area 4 was removed (F133/1-3), but the remainder has been left *in situ*.

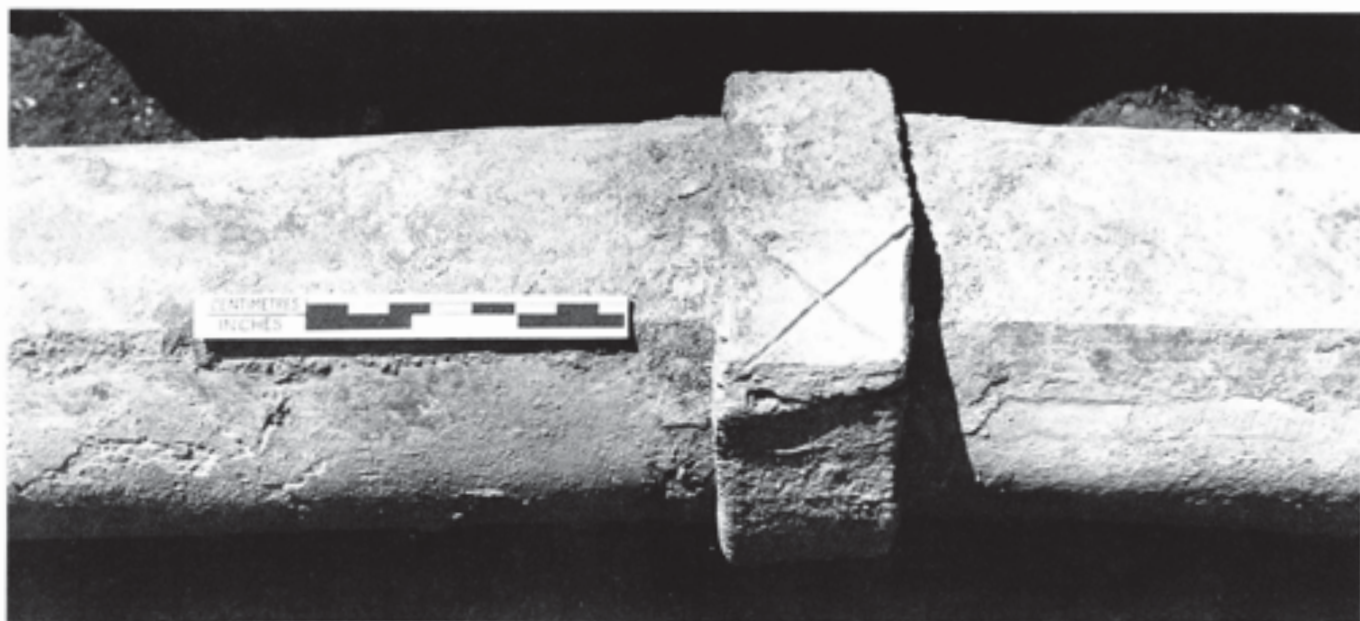
Fig. 422 Detail of the lead collar joining pipe lengths 2 and 3. The cross is the plumber's stamp, and the scale rests on the seamed top edge of the pipe. Scale of centimetres and inches

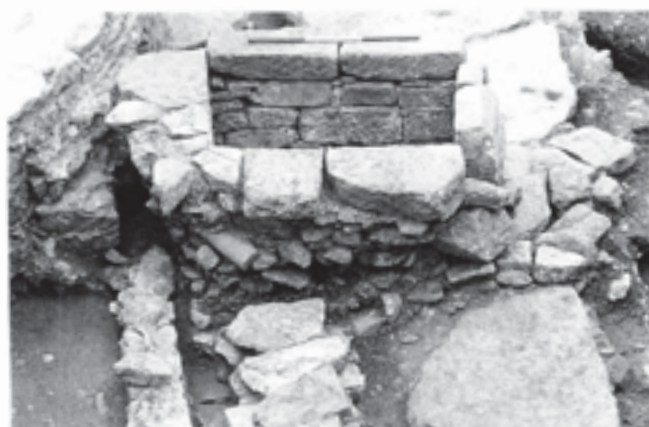
Fig. 424 Manhole F95, from the west, with Stillington's transept turret on the left. In the foreground, from left to right, are: the remains of pipe-duct 2 (F216); duct 2A with cover-stones in place (F132); a capstone of the conduit (F131). Scale of 75 cm

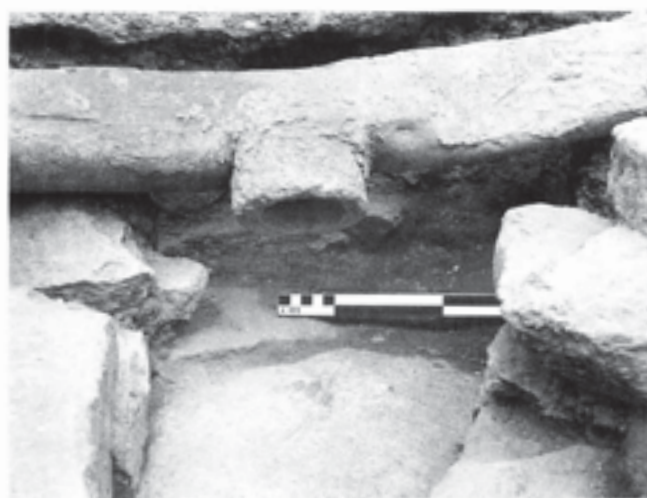
Fig. 426 Close-up view of the washout point on pipe length 5, as seen inside manhole F95. Scale of 25 cm

The boss has a tapering aperture which would have been closed by driving in a wooden bung 5.2 cm (2 ins) in diameter. The boss pointed south, towards a short length of stone-lined channel that discharged into the conduit (Figs. 423, 426 and 427).

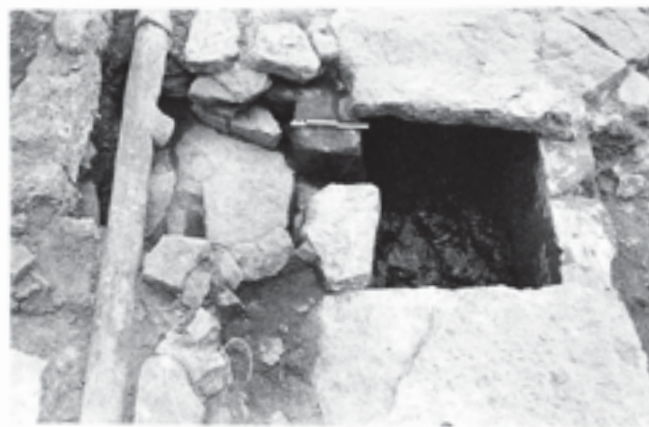
Fig. 427 Lead water-pipe and the channel leading from the washout point to the conduit, after dismantling the sides of the manhole (F95). View east. Scale of 25 cm

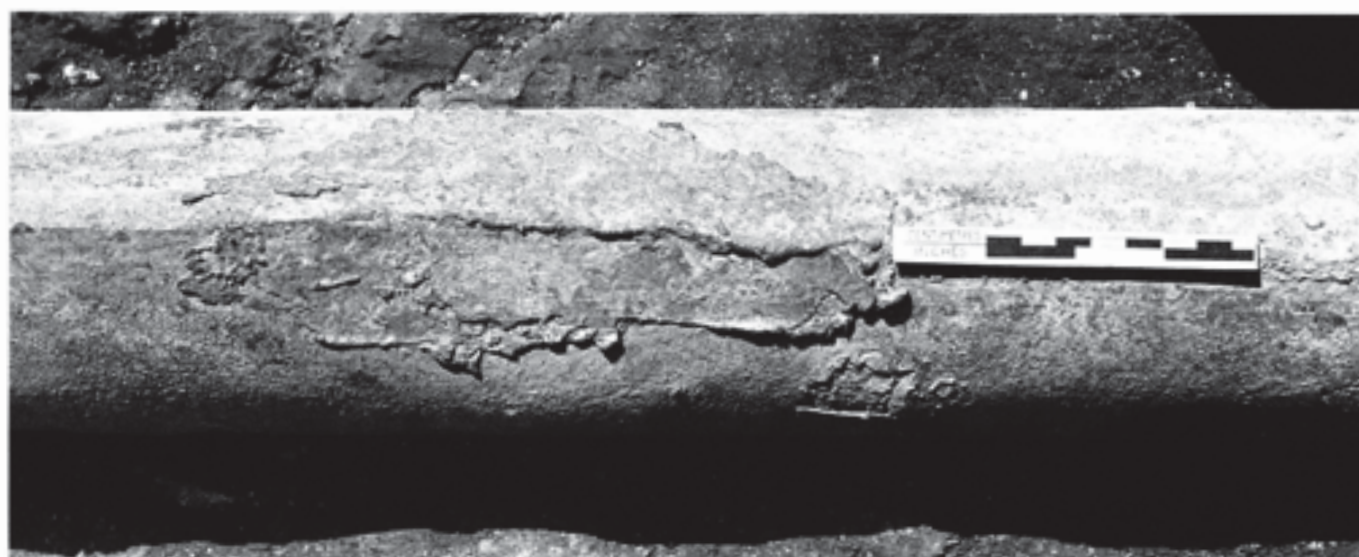
Fig. 428 Example of a soldered repair to the seamed top edge of the lead water-pipe (pipe length 2). Scale of centimetres and inches

From time to time, leaks in the system occurred and holes were dug in the Camery to locate and repair the pipe. Several such holes were recorded (p. 368; Fig. 380). An example of a soldered repair, carried out on the seam of F133/2, is shown in Figure 428. In four places along the length exposed during excavation, the cover-stones were found to be missing from the duct, as a consequence of repairs or intrusions. Where the pipe was crossed by the surface-water drain of 1893, adjacent to collar 7/8, not only was the cover missing, but the pipe was pierced with a pick-hole. Buckle did not explore the water-pipe in 1894, and curiously no mention of it is made in his report.

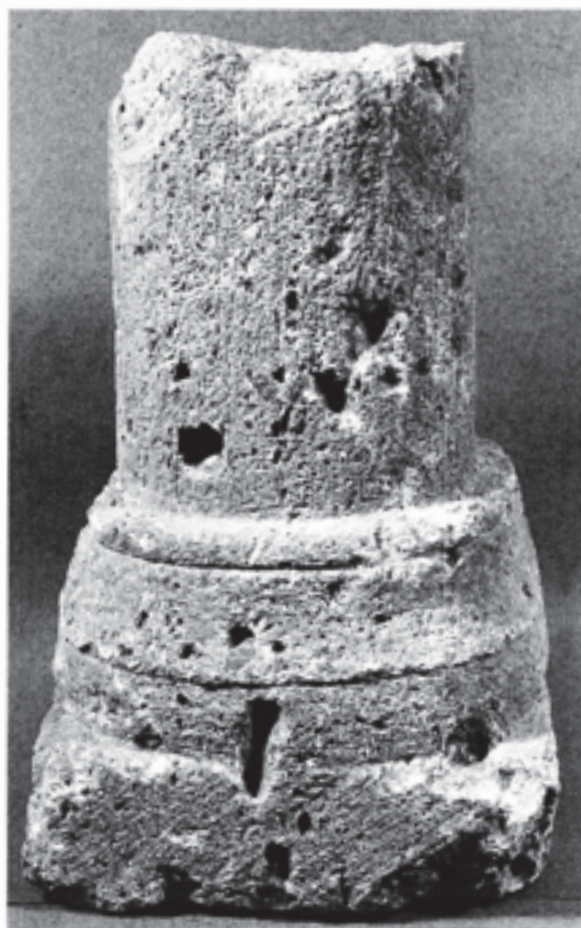
Fig. 432 Romanesque engaged shaft and base (no. 2) in coarse Chilcote stone

2. Fragment of a composite engaged shaft, base and plinth. The mouldings of the base are of sub-attic form; the shaft is 14 cm in diameter, slightly flattened. Cut from remarkably coarse Chilcote stone, with many pebbles, fossils and pits. Although much of the reverse face has been broken away, on the sinister side are the remains of a right-angled rebate which may originally have formed the shoulder of a keying piece. Alternatively, this feature may have formed the rebate for a door or shutter; a proposal which is supported by the backward extension of the base moulding towards the rebate, on a line parallel with the plinth. There is a hint on the dexter side of a return, presumably for keying. Late eleventh to early twelfth century. (JKW)

Pale pink lime mortar on the underside of the diagonally tooled plinth is probably the original bedding material. Dark pink mortar adhering to the fractured surfaces relates to the reuse of the fragment in the foundations of

the late twelfth-century reconstruction of the Lady Chapel; it was recovered from the vestibule to the nave (north side, F703A). For position, see Figs. 74 and 80C.

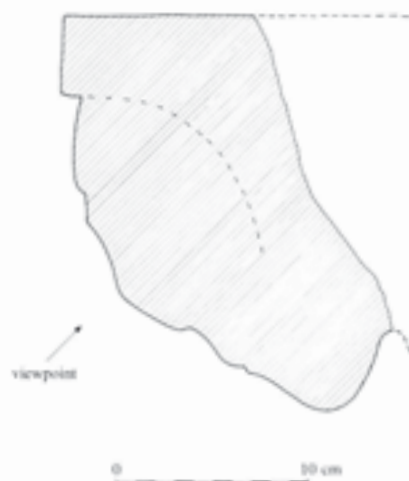
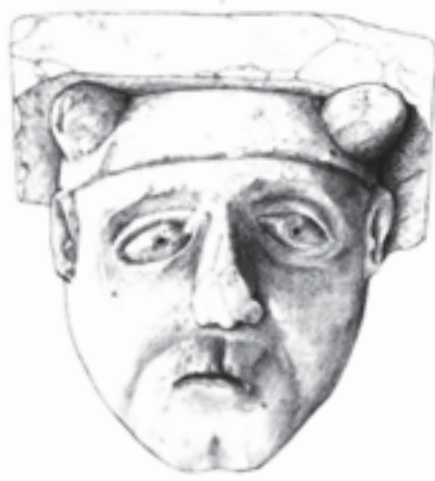
Fig. 436 Romanesque corbel-head (no. 13). The arrow on the section indicates the viewing angle for the elevation. Scale 1:4. Drawn by Richard Bryant

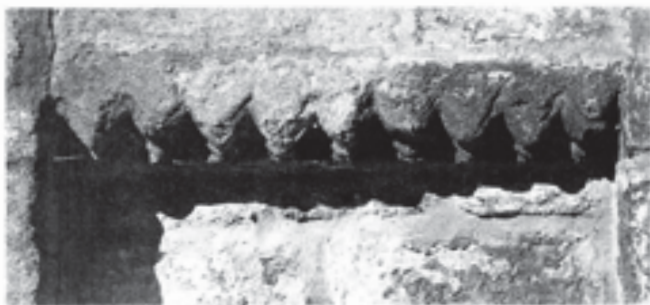
Fig. 438 Romanesque chevron-moulded string-course (no. 14), now used as a false-lintel in the south-west corner of the Vicars' Hall. Length 75 cm (Jerry Sampson)

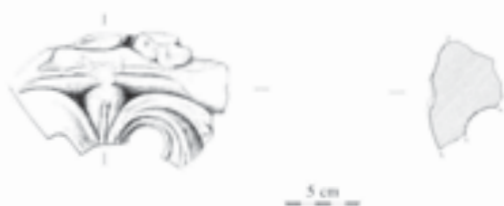
Fig. 453 Fragment of thirteenth-century carving, probably from a pierced spandrel. Scale 1:5. Drawn by Richard Bryant

A slightly curved roll-moulding with a damaged keel or narrow fillet, flanked by stiff-leaf foliage. The leaf on the outer face of the curved moulding is a mere stub, but that on the inner face has three lobes of foliage.

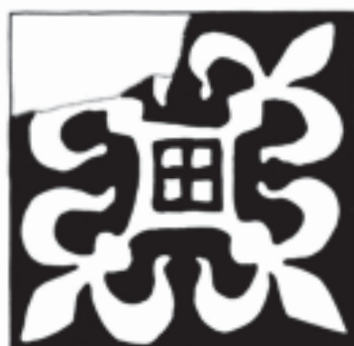
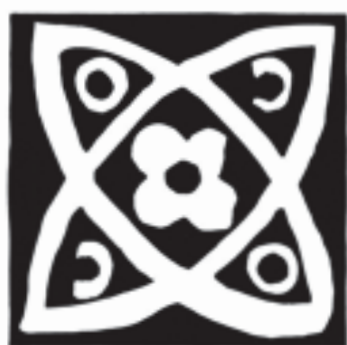
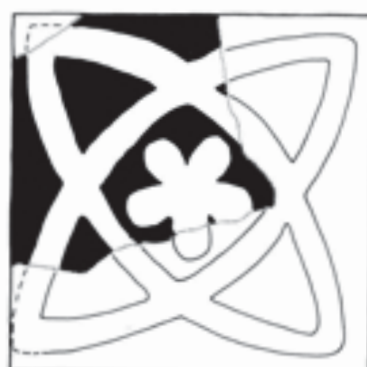
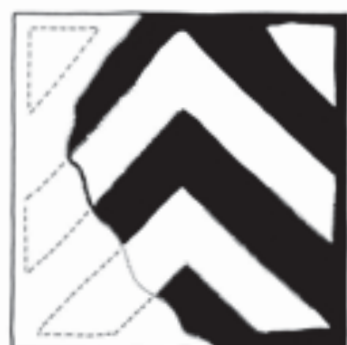
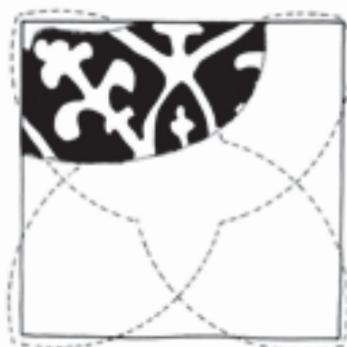
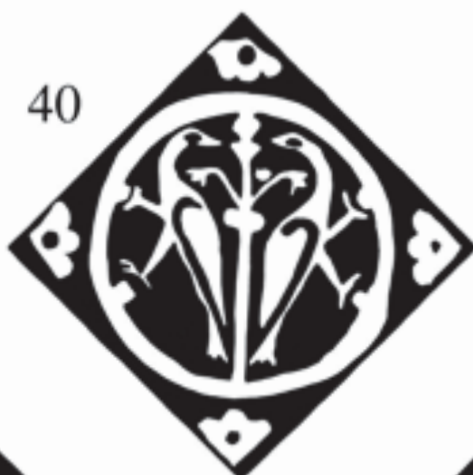
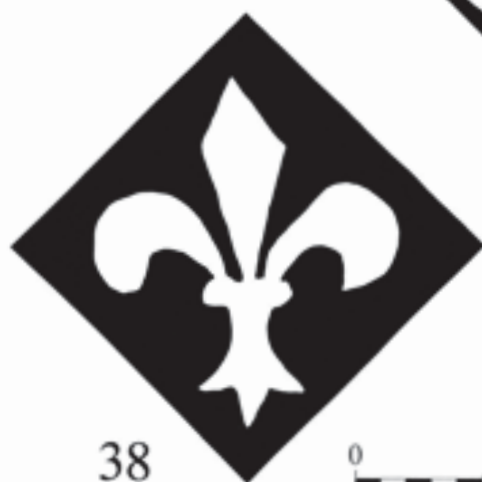
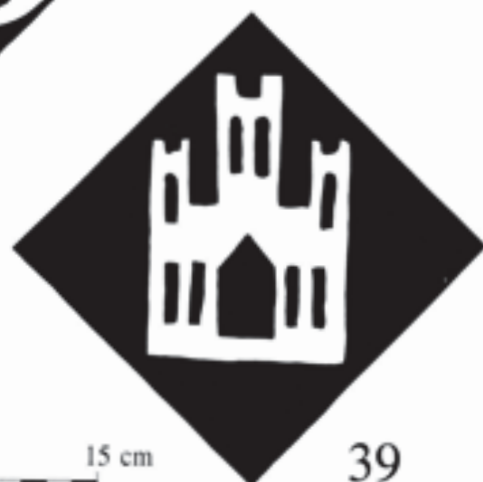
Fig. 472 Medieval floor tiles, group 1. Designs 31–40: formal designs. Scale 1:3

Formal designs (Fig. 472)

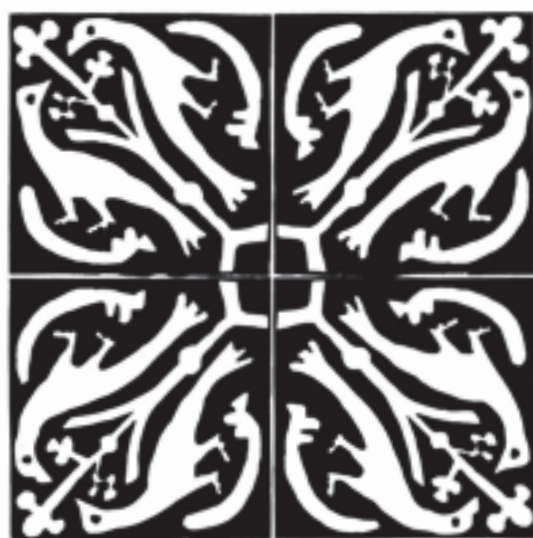
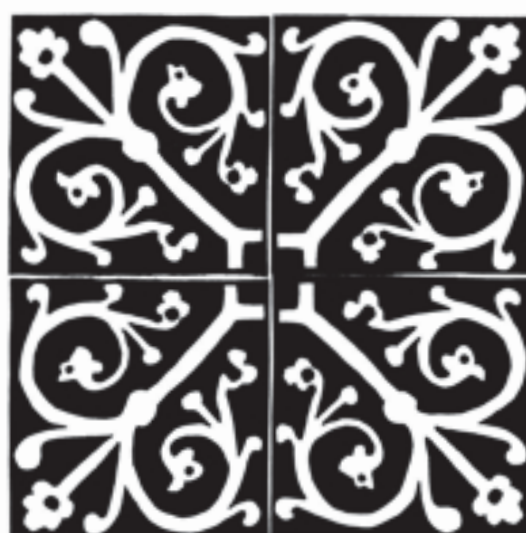
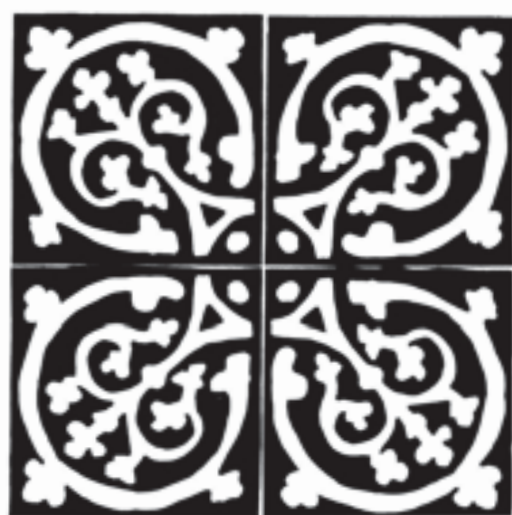
Fig. 473 Medieval floor tiles, group 1. Designs 41–47: four-tile patterns. Scale 1:3

- Formal designs composed of four similar tiles**
(Fig. 473)
- Although intended for use in four-tile patterns, designs 41–43 could have been used singly, in a diagonal setting. For reconstructions of the four-tile units, see Figs. 474 and 475.

42. Stem with stiff-leaf foliage, encircled. Tile 130 mm².
Die-link: Glaston. A (Museum). Close copy of Clarendon 74, Nash Hill 23 and Keynsham 10.
Provenance: Camery, 83 exx., including 19 overfired.
Wells Cat., type 30, illustrated (now lost).

43. Stem with stiff-leaf foliage. Tile 135 mm²; single keying scoop.
Die-links: Nash Hill 25; Bath 20; Hinton Charterhouse; Keynsham 9; Wedmore; Exeter Cathedral; cf. Bristol 3. Note the break in the die in the lower left leaf, present on all examples.
Provenance: Camery, 113 exx.
Wells Cat., type 28, illustrated (now lost).

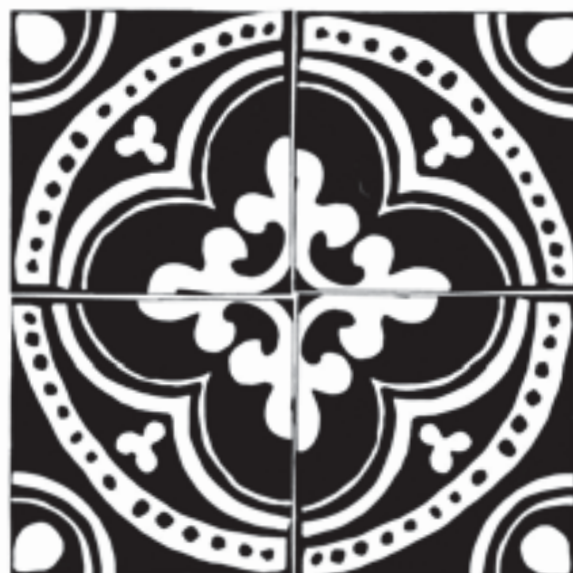
Fig. 475 Reconstructions of four-tile patterns, group 1, designs 44–47. Scale 1:4

44. Quatrefoil containing fleurs-de-lys. Tile 130 mm².
Die-links: Nash Hill 26; probably Bath 18.
Provenance: CCC, 1 ex. (relaid); Camery, 83 exx., including 22 overfired.
Wells Cat., type 13. Unillustrated, but described in detail, and recorded as being in CCC.
45. Encircled quatrefoil. Tile 130 mm².
Die-link: Nash Hill 9. Cf. BM Cat. 2782.
Provenance: Camery, 13 exx., including 3 overfired.
46. Encircled quatrefoil. Tile 130 mm².
Die-link: none found.
Provenance: Camery, 13 exx., including 2 overfired.
47. Encircled quatrefoil. Tile 150 mm², a size that is otherwise unmatched at Wells.
Die-links: Nash Hill 8; Bath 17; Hinton Charterhouse; cf. Keynsham 36.
Provenance: Camery, 39 exx.
Wells Cat., type 17, illustrated (now lost).

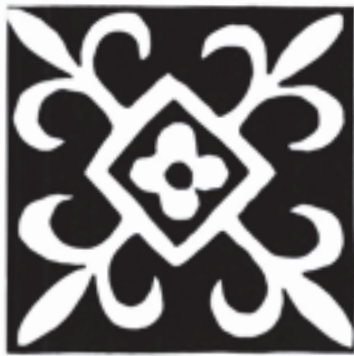
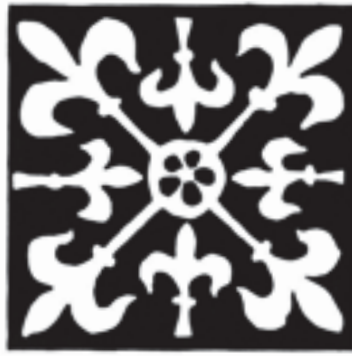
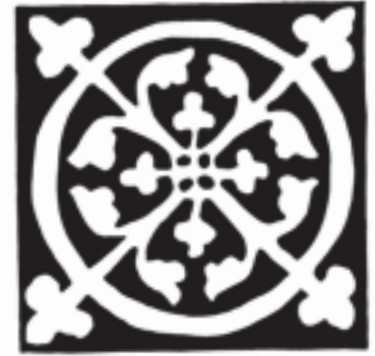
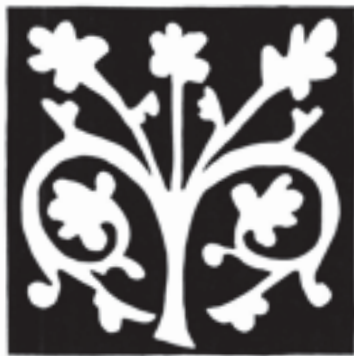
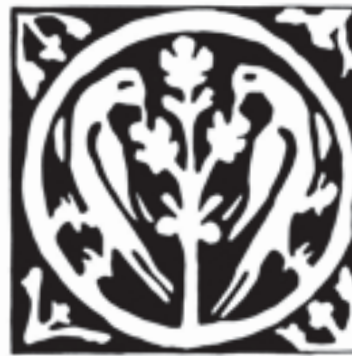
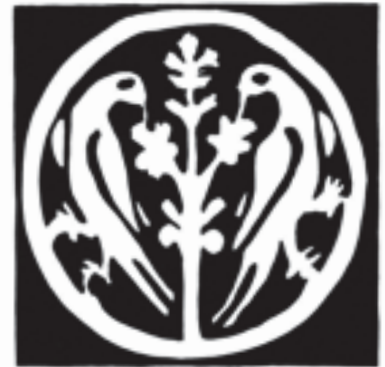
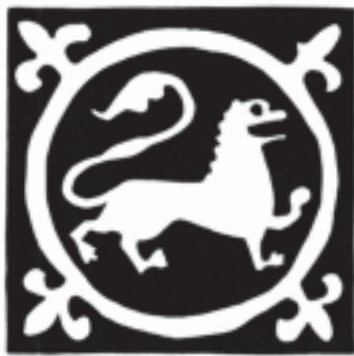
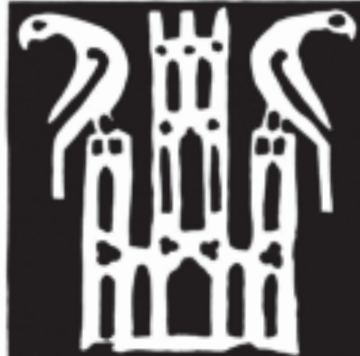
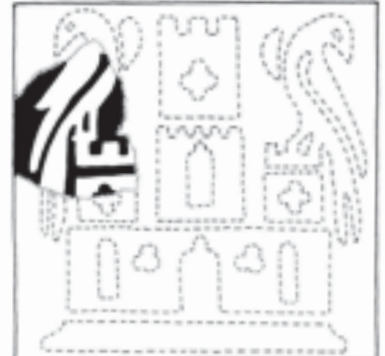
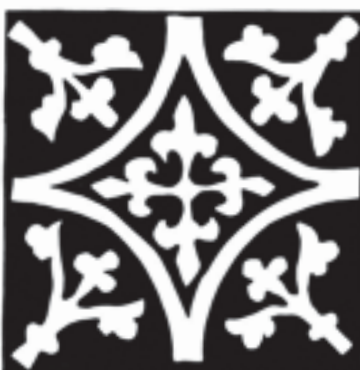
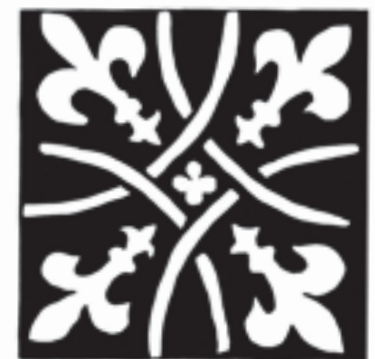
Fig. 476 Medieval floor tiles, group 2. Designs 48–57: formal designs, birds and beasts. Scale 1:3

48. A quartet of fleurs-de-lys. Tile 140 mm².
Die-link: Bruton; Glaston. A 15; Muchelney Abbey; Sherborne Abbey (Emden 1977, no. 85). BM Cat. 2344.
Provenance: CCC, 1 ex. (relaid); Camery, 28 exx.

53. Encircled lion, to sinister. Tile 135 mm². The upper right fleur-de-lys became damaged on the die; both forms are present at Wells.
Die-links: Bleadon; Cleeve 11; Glaston. A 8; Glaston. B 13; Muchelney Abbey; Sherborne Abbey (Emden 1977, no. 2); Tintern Abbey (Lewis 1976, fig. 10); Wedmore. BM Cat. 1793.
Provenance: Palace, 1 ex.; CCC, 4 exx. (relaid); Camery, 23 exx.; Wells Mus., 2 exx.

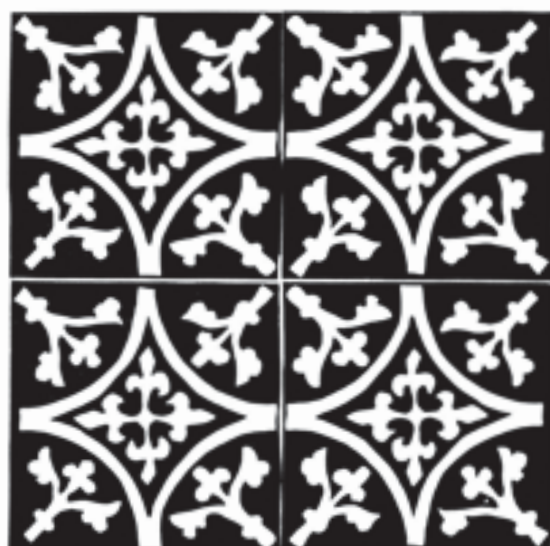
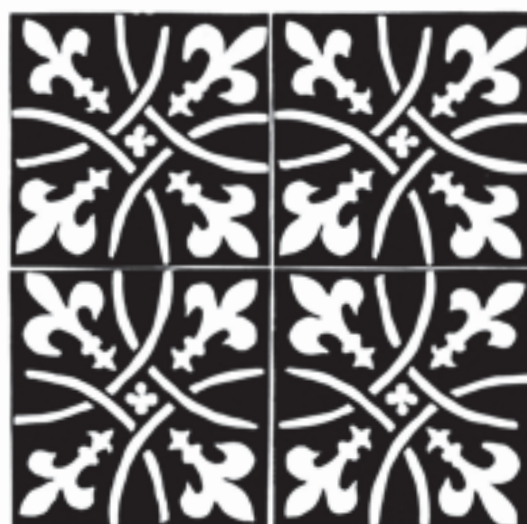
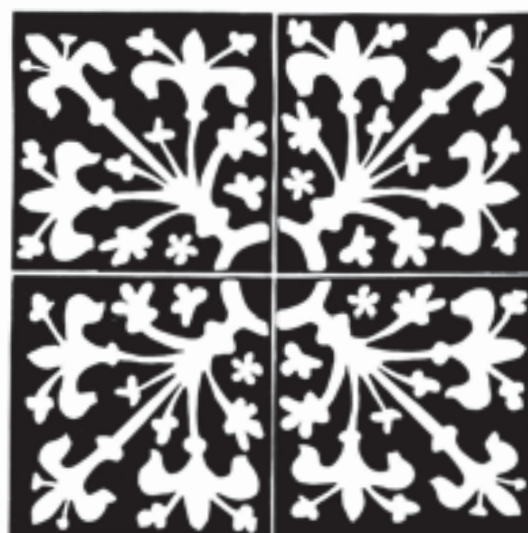
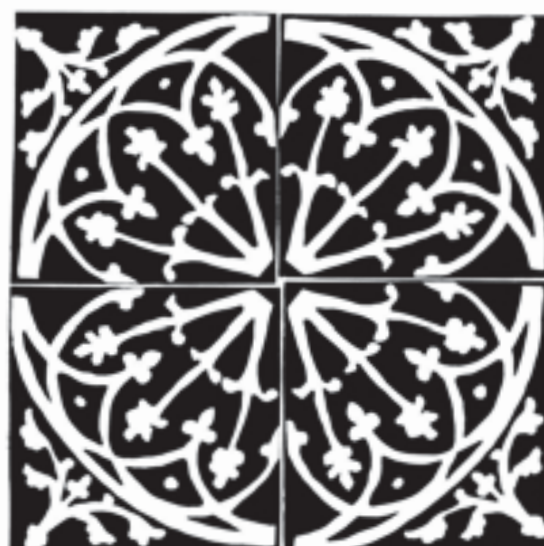
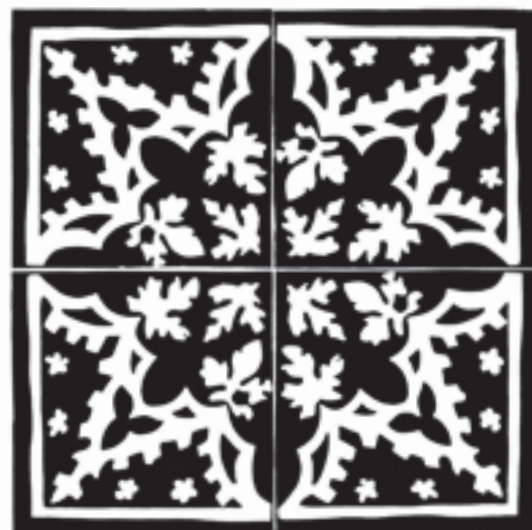
Fig. 479 Reconstructions of four-tile patterns, group 2, designs 56–60. Scale 1:4

- Provenance: Camery, 1 ex., but not in the Nash Hill fabric.
- Four-tile patterns** (Figs. 476–9)
- Although intended for use as components in four-tile patterns, designs 56–58 were capable of being used singly; design 58 needed to be set diagonally. For reconstructions of the four-tile patterns, see Fig. 479.

58. Spray of foliage. Tile 135 mm². Used singly in Corpus Christi chapel. Note how the rosette at the lower right is missing one petal, indicating a damaged die (Fig. 477).
Die-links: Bleadon; Cleeve 6; Congresbury; Glaston. A 23; Tintinhull; Watchet; Wedmore; Witham Friary.
Provenance: CCC, 54 exx. (2 relaid); north quire aisle, 2 exx.; Camery, 19 exx.

Carpet no. 3 is composed solely of the arms of England, diagonally laid for viewing from the west (design 65). Carpet no. 4 again uses only one design (58), a foliate spray laid diagonally. The tiles are in groups of four, surrounded by black borders with yellow corners. Although design 58 was intended for use in four-tile compositions, with the sprays radiating from a common centre (Fig. 479), in this instance the tiles have been laid singly, all pointing towards the east.

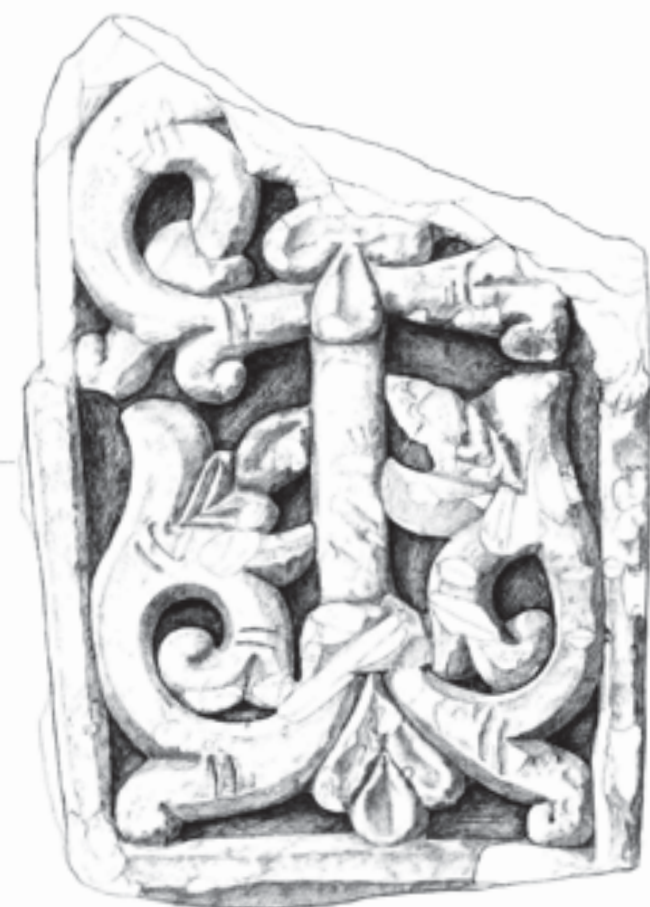
Fig. 486 Anglo-Saxon decorated grave-cover, no. 1. Scale 1:4. Drawn by Richard Bryant

Although the context of this fragment provides no evidence of its original function or date, its form, decoration and general similarity to the slab excavated at St Oswald's Priory, Gloucester (West 1980; 1983; 1984, cat. no. 24) suggests that it too may have been an early tenth-century grave-cover. In both its overall design and in the particular details of its ornament, the Wells panel may be compared to the tree motifs on the back of the Alfred Jewel (found at North Petherton, Somerset), or the early tenth-century Gloucester and

Braunton slabs. While these artefacts also share some points of detail with the Wells panel, geometrically similar ornaments occur in the frontispiece borders of the Cambridge copy of Bede's *Life of St Cuthbert*;¹ a manuscript recently attributed to either Glastonbury or Wells (Keynes 1985, 184–5). If this manuscript was indeed produced at either of these centres, rather than at Winchester, it is important to note that, like the earlier

Alfred Jewel, the Wells tree motif displays none of the acanthine features which characterize its ornament. The same conclusion holds true for a comparison between the Wells panel and either the Gloucester or Braunton slabs, and as the Wells panel displays a high quality of carving, the relative simplicity of its ornament may be explained in terms of an earlier or transitional example of the tree 'scroll' motif.

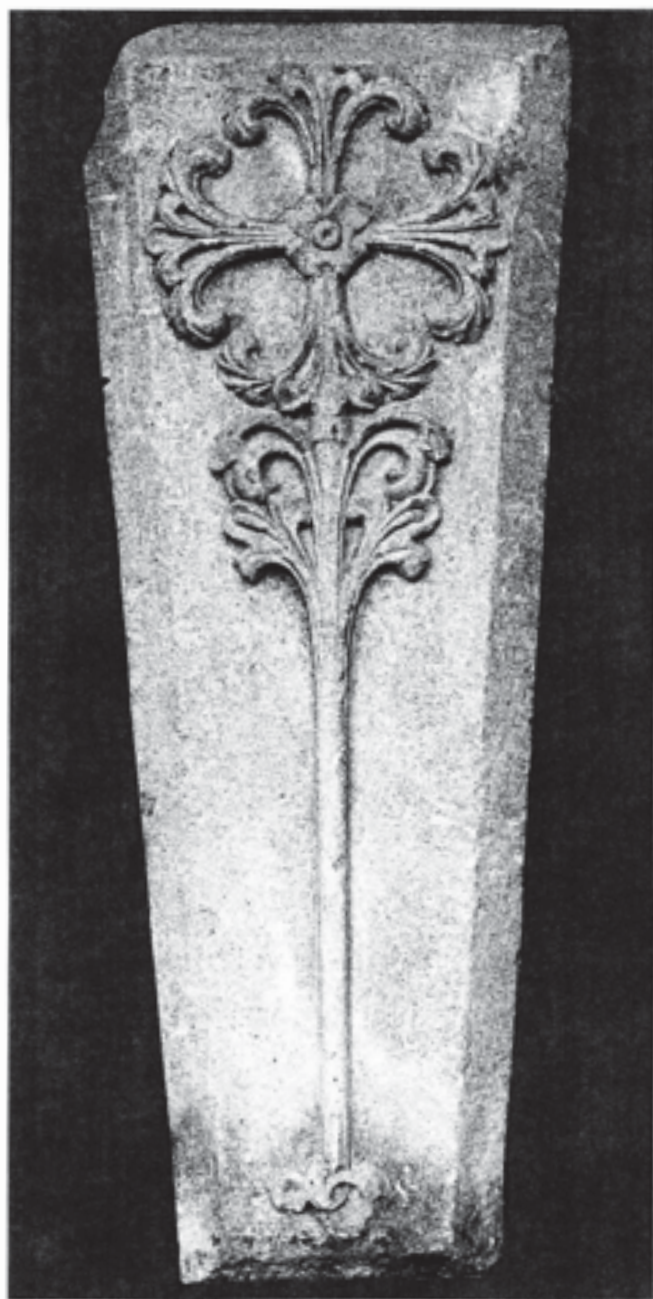
Fig. 491 Medieval grave-slab, no. 2

The sculpture of the slab is in remarkably fresh condition, and the tooling of the edges and chamfers shows no signs of wear. There is modern abrasion to some parts of the decoration in highest relief. The top dexter corner is broken and a large chip is missing from alongside one of the lateral arms of the cross; these damages are ancient. The entire surface of the

stone exhibits a pinkish-orange hue, which includes the two ancient fractures, but not the areas of modern abrasion. The colour is quite strong in some of the deeper recesses between the decorative elements, and at the bottom right-hand corner a tiny patch of limewash overlies this colour. The slab may thus have been limewashed at some stage in its history as an exhibit, presumably to disguise its previous colour. The latter clearly cannot be a medieval ground for painting because it is continuous over the fractures.

In 1826, Skinner sketched the slab and described it as 'a most beautiful foliated cross, the most perfect I have anywhere seen'.⁵ Bishop Law had the slab transferred from the chapter house undercroft, to his private museum at the Bishop's Palace (p. 13; Wicks 1932). A few years later it was returned to the cathedral.

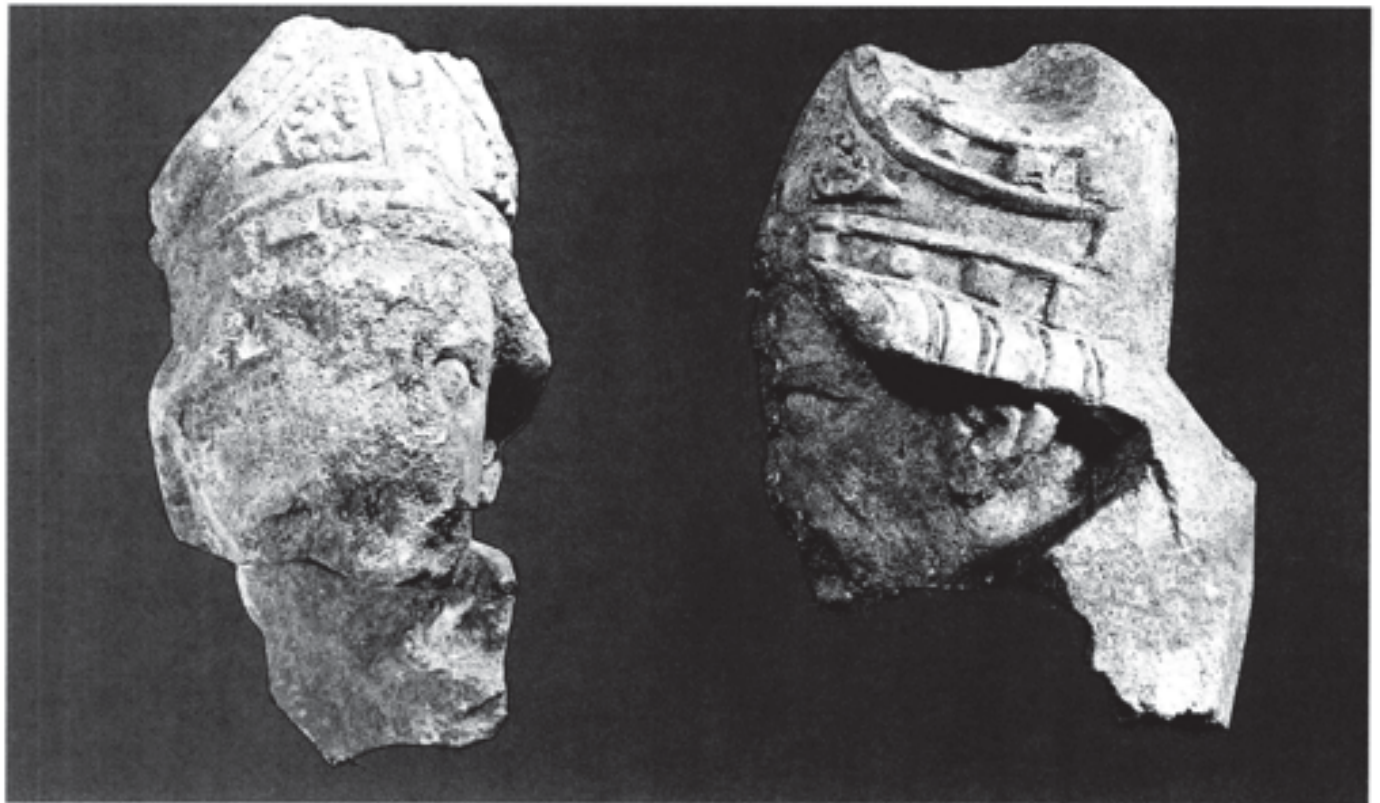
Fig. 499 Frontal and sinister views of the head of a bishop from a statuette (no. 1)

1. Head of a bishop (Figs. 498–9). Mid-fifteenth century. Douling stone. Dimensions: 21.5 cm high × 12 cm wide × 14.5 cm deep. F394/5.

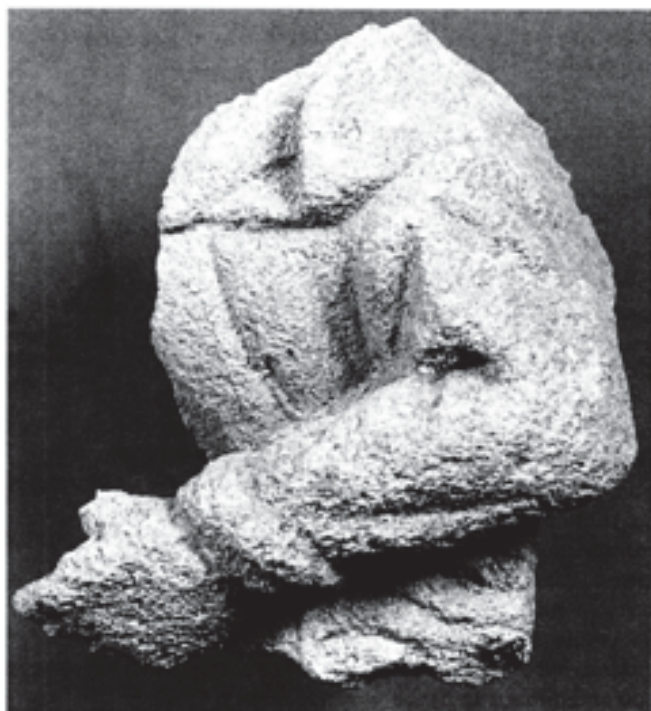
Fig. 501 Sinister arm of a fifteenth-century angel (no. 12)

12. Sinister arm and upper torso of a small figure (Figs. 500–1). Fifteenth century?
Doulting stone. Dimensions: 12.3 cm high × 11 cm wide × 4.3 cm deep. F341.
A thin fragment from the sinister side of a figure wearing a long-sleeved robe and amice, the arm bent at the elbow. The hand is complete but for the ends of the thumb and fingers, and there is little or no sign that it ever held an object.

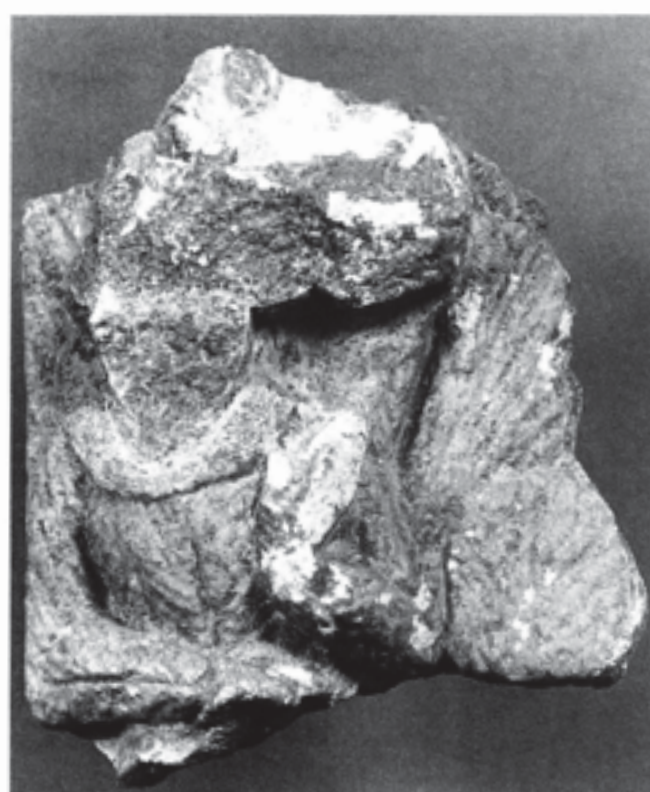
Fig. 503 Panel fragment from a fifteenth-century tomb, showing an angel (no. 15)

(a) Neck and shoulders of an angel. Around the neck is tied, or held with a small trilobe brooch, a kerchief, and the angel is clothed with feathers over the shoulder and chest. There is a knob of amorphous stone in front of the sinister shoulder which, by analogy with the smaller Beer stone angel (no. 15), is probably the remnant of the sinister hand held up in front of the shoulder. The head is broken off at the base of the neck, the

sinister arm at the shoulder (where the feathers run down the line of the arm), and the dexter side of the chest is lost.

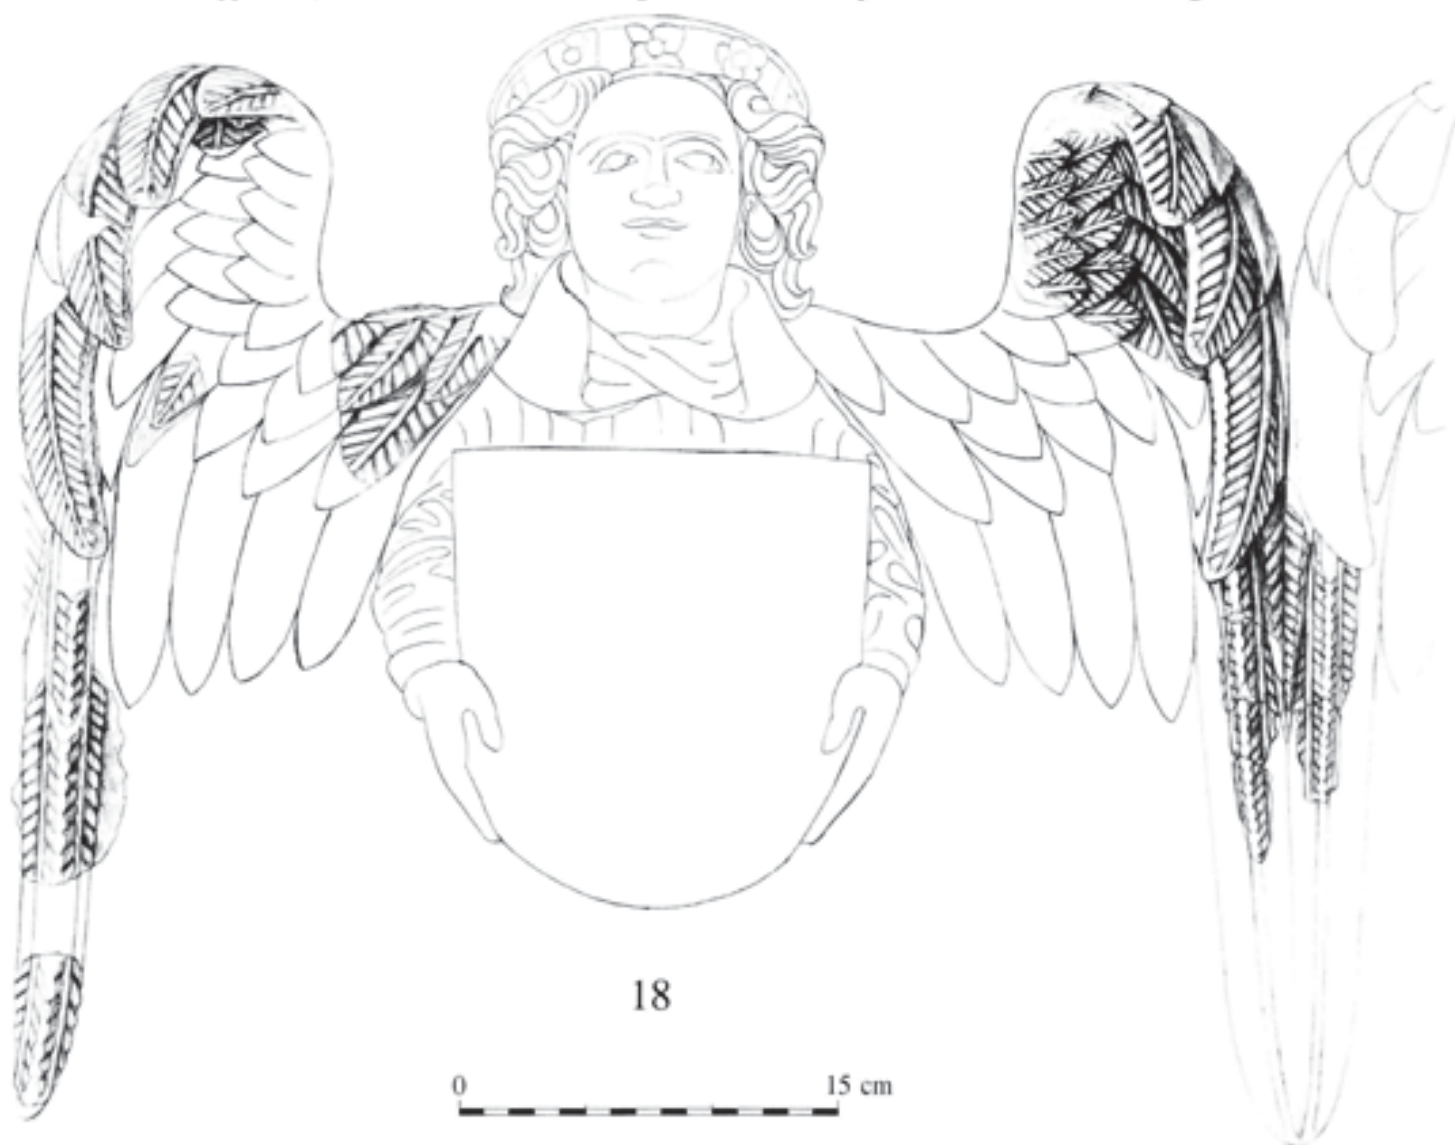
Fig. 504 Fifteenth-century sculpture, 18 Reconstructed figure of an angel bearing a shield, based on fragments recovered and on a similar arrangement preserved in Hugh Sugar's chantry. Scale 1:3. Drawn by Richard Bryant

18. Group of 29 fragments of angels' wings (Fig. 504). Later fifteenth century.

These fragments are all from the wings of angels similar to those on the Sugar Chantry. Being of Douling stone, they probably derive from screen-work or some other architectural context, rather than from Stillington's tomb, which may have been carved in Bath stone. Two further major fragments from the cathedral collection (of the apices of wings) belong to this group and have been incorporated into the composite illustration. All are characterized by the carving of the tines and main ribs of the feathers, the former as a series of parallel grooves.

Among the most significant fragments are a group of five pieces from F1219 which fit together to form what

appears to be the junction between the dexter wing of one angel with the sinister wing of another angel to dexter of it: thus there would appear to have been a series of angels whose wings just touched. The shape of the two wing apices suggests more broadly set wings than those of the Sugar Chantry angels (Fig. 505), a form also indicated by a fragment of feathers from a dexter shoulder top.

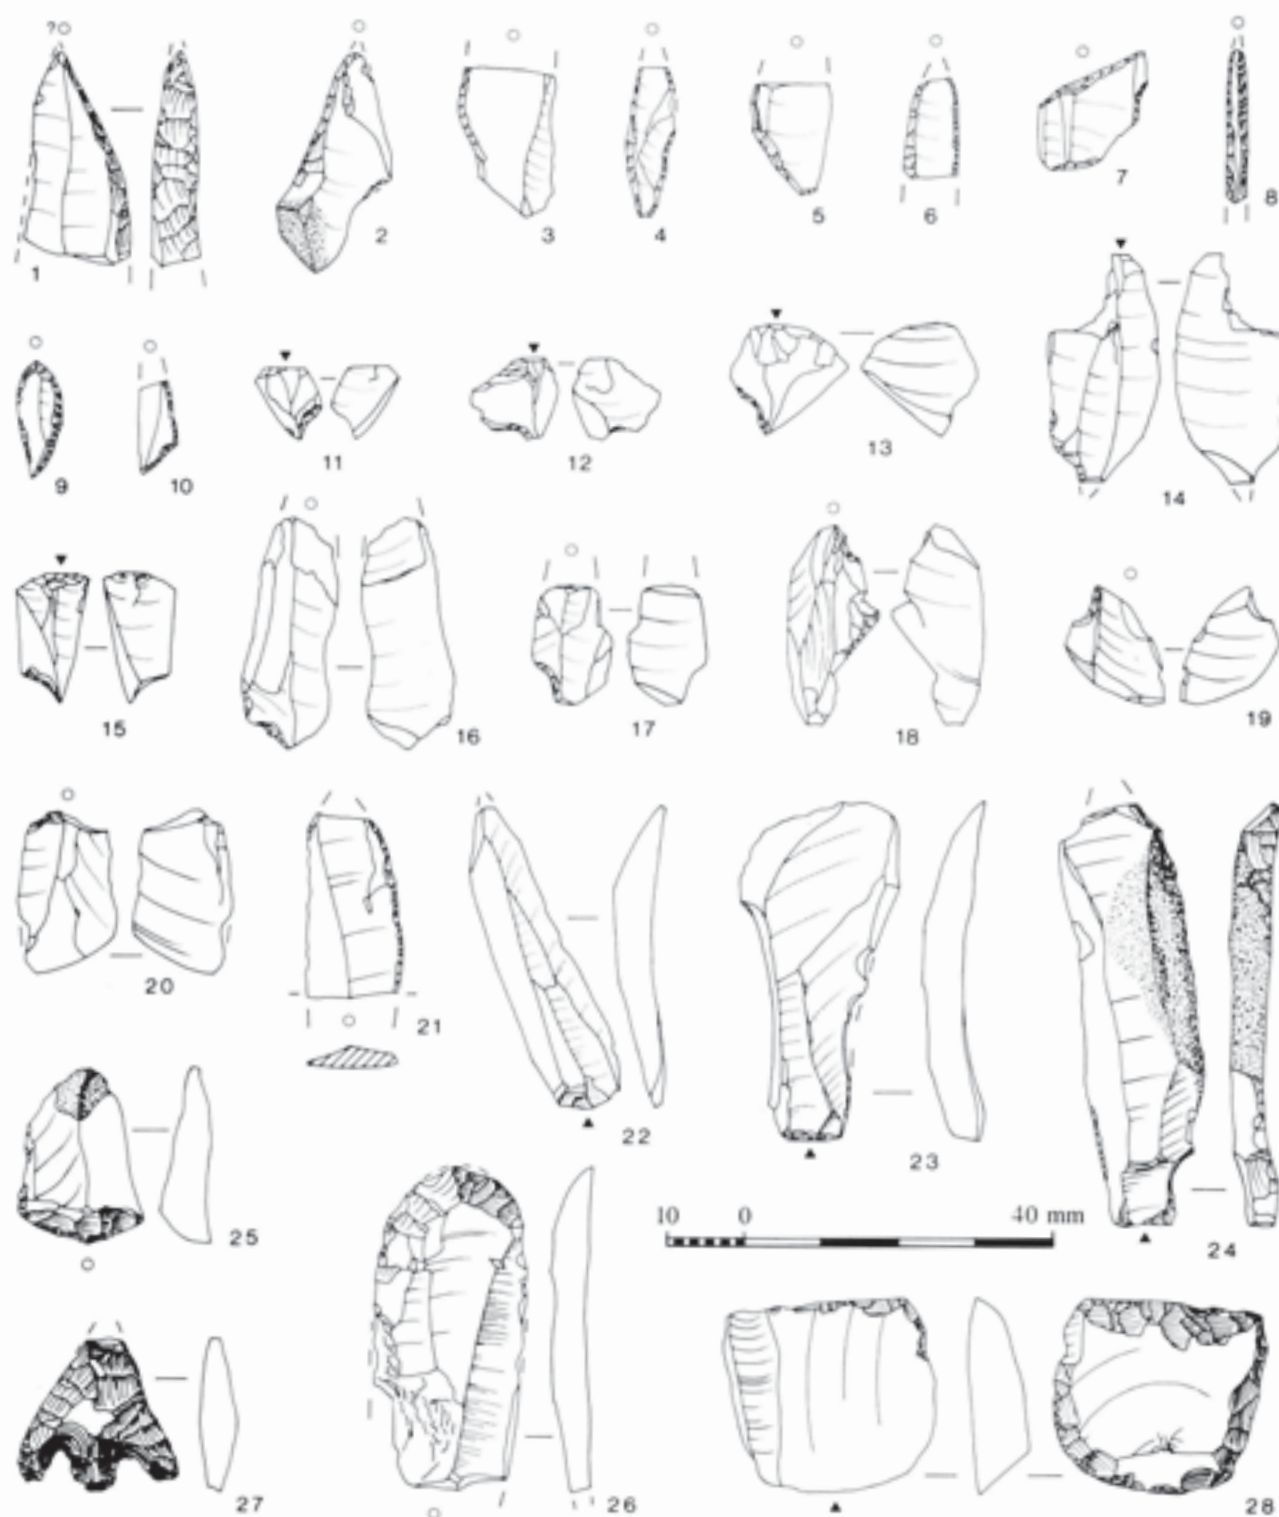
Fig. 509 Flint and chert artefacts. Scale 1:1. Drawn by Alan Saville

This section is limited to discussion of the main implement categories, with particular reference to the pieces illustrated in Fig. 509, and listed in the appendix.

The fragmentary large backed piece (1) raises the possibility of late Upper Palaeolithic activity, but on its own cannot substantiate this. However, it is worth pointing out the general similarity with Upper Palaeolithic backed forms from the Mendip caves

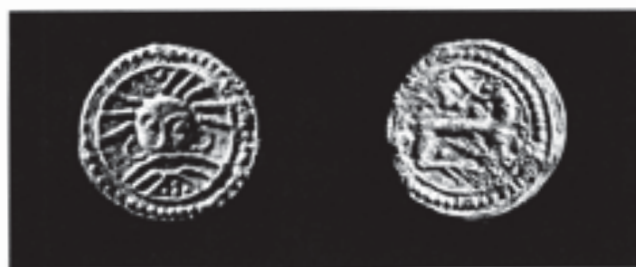
Fig. 510 Anglo-Saxon sceat, obverse and reverse. Scale 2:1 (Gordon Kelsey)

1. *Sceat*, Anglo-Saxon copy of 'Woden/monster' type (Series X, BMC 31), c. 720–30. Fig. 510.

Although this specimen has the basic designs of the Continental 'Woden/monster' coins, it is not in their characteristic and consistent style. It is in lower relief,

drawn in firmer lines, has 'ears' instead of crosses by the head, and has three-pellet detail on the bust. The reverse beast is similarly in a finer style. These characteristics are indicative of an Anglo-Saxon rather than a Continental origin. Although the dies of this piece cannot be matched exactly, there have been recorded quite a number of such insular pieces, sometimes muled with Anglo-Saxon *sceatta* designs. The English origin is supported by the coin's small size, light weight and visibly base metal. Where these copies were made is not known.

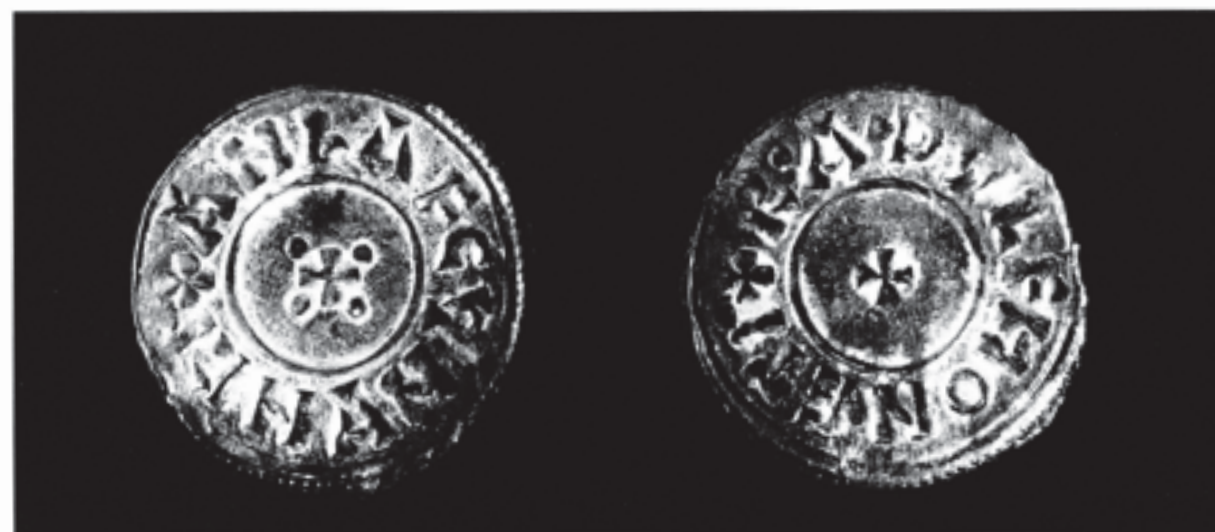
Fig. 511 Penny of Anlaf Sihtricsson, king of the Viking Kingdom of York, struck 941–44, obverse and reverse. Scale 2:1

2. Penny of Anlaf Sihtricsson, King of the Viking Kingdom of York; struck at York, 941–44. Fig. 511.

were probably on a larger scale than the few surviving examples would suggest. There are only two other coins known of the cross *pattée* (type VI) group for Anlaf. The present is closest to the Copenhagen specimen (Galster 1964, 639) which also has the *gamma*-like letter after MONETA, while the Rome, Forum, hoard specimen (Blunt *et al.* 1989, pl. 27, 12) has an R. The type with pellets in the angles of the obverse cross was not previously recorded.
