WELLS CATHEDRAL

Excavations and structural studies, 1978–93

*Excavations and Structural Studies,
1978–93*

ARCHAEOLOGICAL REPORT 21

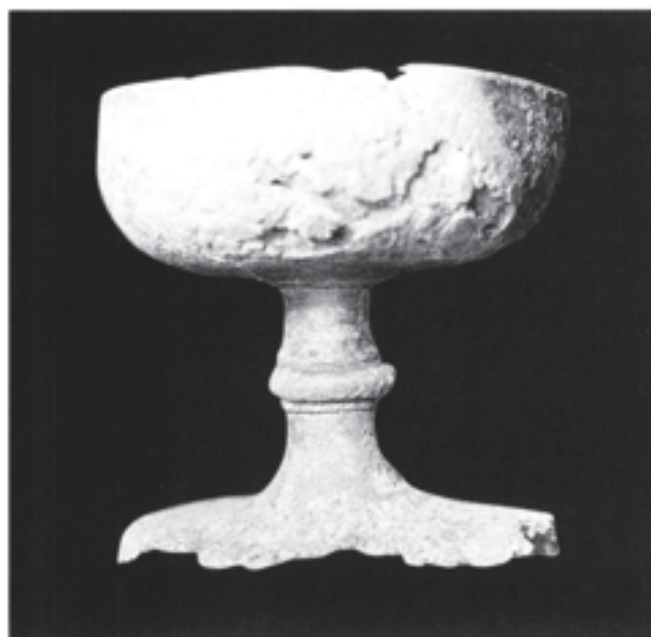
Fig. 519 Chalice 7, showing erosion of the foot and bowl on the side upon which it evidently lay in the coffin

The chalice evidently lay on its side in the coffin: about one-third of the foot has rotted away, and the bowl on the same side is decayed and perforated (Fig. 519). It therefore seems likely that the coffin from which this object was recovered did not have a chalice-recess. There is no surviving paten to accompany this vessel. It may well have disintegrated.

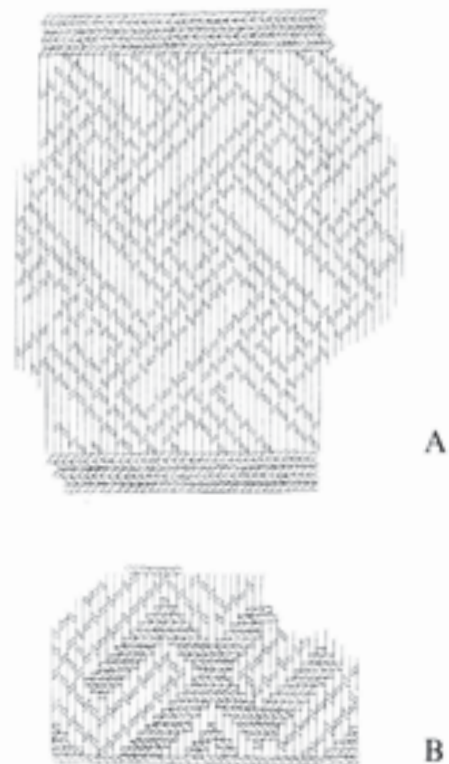
Fig. 522 Reconstructions of brocaded patterns in medieval textiles. Drawn by Elisabeth Crowfoot

- F615, fill of cist-grave (F589) in the Lady Chapel-by-the-Cloister (Fig. 168). Thirteenth century. Four fragments of tablet-woven band with metal brocading (Fig. 522A).

- Fill of cist-grave F591 in the Lady Chapel-by-the-Cloister (Fig. 168). Thirteenth century. Remains of tablet-woven bands, used to tie a bundle of bones, which had probably been removed from an earlier ecclesiastical burial (Figs. 188–9). All the fragments come from four-hole weaves, threaded right and left, wool, Z-spun, with traces of brocading, silver-gilt thread with vegetable core, only traces of metal remain; weave wefts not clear (Fig. 522B).

Two variations are present in the Wells bands. The small areas of pattern clearly seen in fragment no. 3 are very similar to parts of the brocading in no. 4 (Fig. 522A), and though both are badly damaged, they certainly have the single tie-down throughout the brocading. They are strikingly similar in technique and style of pattern to a finer silk band from a thirteenth-century burial at Guisborough Priory, Cleveland,¹⁰ but the design recognizable in some small fragments of deteriorated all-wool braid (5) combines areas with two-thread tie-down, where the metal threads are concealed by intermediate strap patterns with the single tie-down (Fig. 522B). The same combination appears in the ninth-century girdle of Witgarius (Collingwood 1982, fig. 203a), though in that, being a complete vestment with reversible pattern, the gold thread passes through to the back. This perhaps indicates that these fragments are earlier than nos. 2 and 3, and the description of their use, perhaps to tie together relics, such as bones, suggests remains already salvaged from earlier burials, rather than pieces from graves undisturbed prior to excavation.

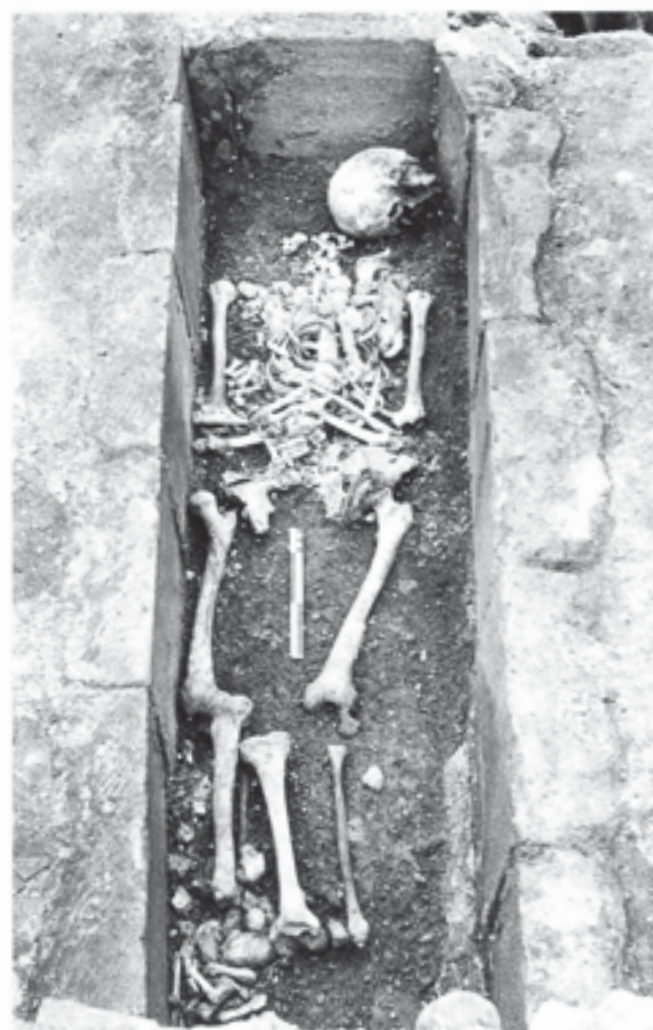
Fig. 525 Burial 39, in cist-grave F590, illustrating an extreme case of the axial rotation of long bones during the process of corporeal decay

in a reasonable state of preservation; it provides one of the more dramatic examples of the axial rotation of limbs during decomposition (Fig. 525).

Burial 39 in the nave of the Lady Chapel was contained in a sealed stone-built cist with an earth floor; the body was uncoffined and no evidence of wrapping or envelopment was found (Fig. 525). The corpse therefore decayed in a void, without constraint. The torso was intact, with the arms crossed on the chest. The skull had rolled to one side, but there was nothing to suggest that any disruptive influence had affected the upper half of the body. The legs presented a different picture. The left femur was perfectly in place, its head still engaging with the acetabulum of the pelvis. The fibula was also more-or-less in place, but had moved slightly eastwards in the grave. The left tibia, however, had not only moved down the grave but had also rotated through 180° in a clockwise direction, and its distal end had somehow managed to come to rest on top of the tarsals. Of the right leg only the fibula remained in place; the tibia had rotated through 90° and the femur through 150°, both in a clockwise direction. Both feet had also fallen towards the right.

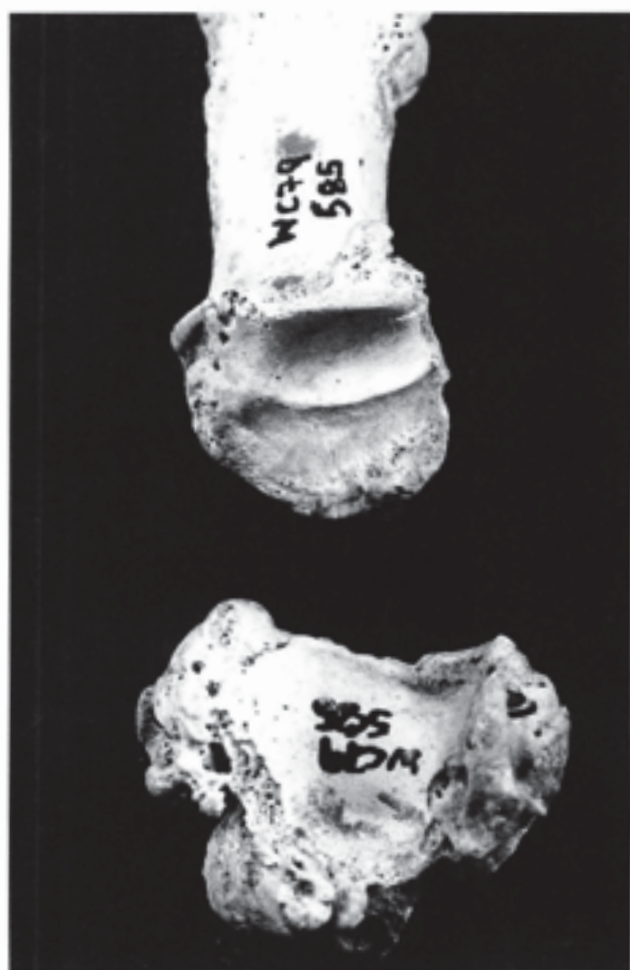
Fig. 529 Thumb base with osteoarthritis in the hand of skeleton 32 (Palaeopathology Study Group)

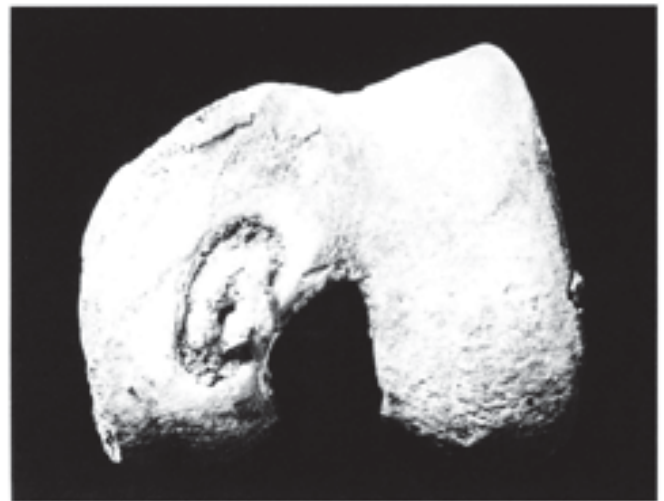
Fig. 533 Osteochondritis dissecans of the medial condyle of a left femur (Palaeopathology Study Group)

Two other skeletons should be mentioned in this section on joint disease. They are skeleton 73 (adult female) and skeleton 97 (20-year old female) both with a lesion on the medial condyle of a femur (Fig. 533). This is known as osteochondritis dissecans and represents an area of dead or dying bone owing to the interruption of the blood supply. The site of the lesion in these two skeletons is typical, but today it is usually found in males. The age, however, is characteristic as symptoms generally start in the second decade. It is

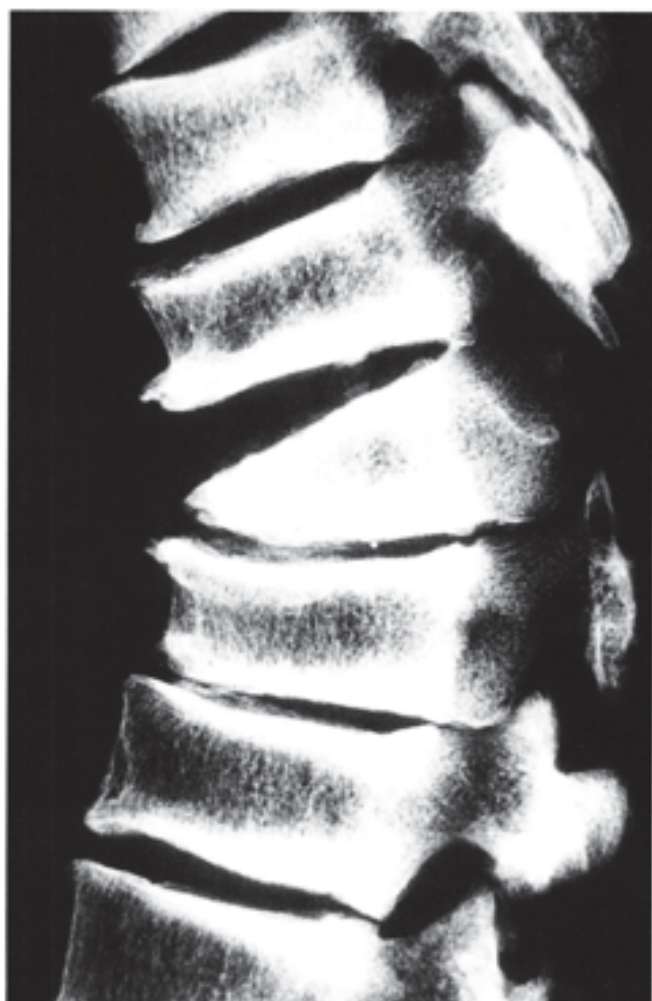
Fig. 537 Skeleton 16. X-ray of spine with wedging of vertebra subsequent to a fracture (Palaeopathology Study Group)

The fractures in twelve skeletons involved nine different bone sites (Table 17), the most frequent being ribs, tibia and ulna (each represented by three individuals). An X-ray of a crush fracture of a vertebra from the thoracic lumbar junction of skeleton 16, an adult male, is shown in Figure 537.

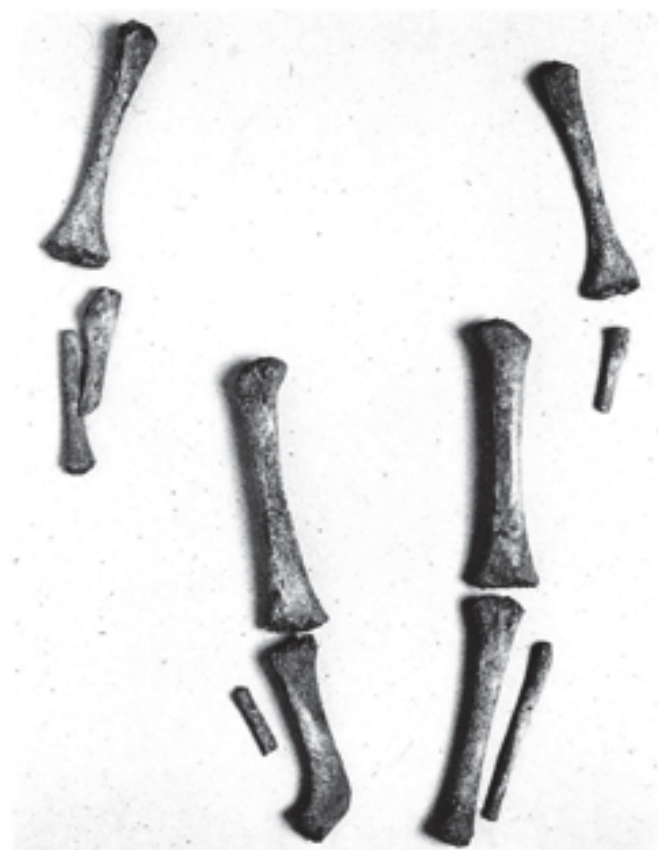
Fig. 539 Baby's skeleton (B217) with malformation of the right tibia (Palaeopathology Study Group)

The last skeleton in this group was that of an infant (B217). The size of the long bones was consistent with a seven- or eight-month foetus, but it might have been a small full-term infant. The right tibia was malformed, the shaft being bent laterally at the junction of the proximal two-thirds with the distal one-third (Fig. 539).
