# **BANFF CASTLE, CASTLE STREET BANFF ABERDEENSHIRE**

## **- Archaeological Watching Brief -**

Carried out 11<sup>th</sup> November 2010  
by  
**Murray Archaeological Services Ltd**

**Report No: MAS 2010-26**  
by  
J C Murray

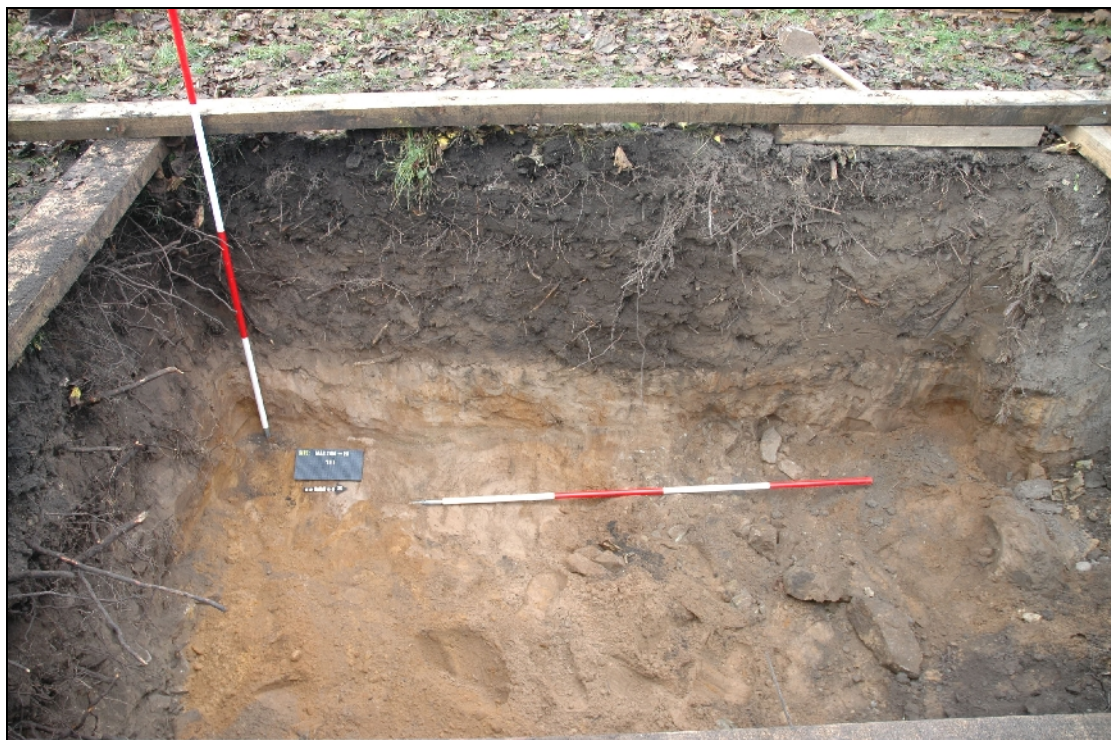
- 3.1 The trench excavated measured 5m long x 1.8m wide x c.1.9m deep. It ran N-S and lay a few metres E of the boundary wall separating the site from Castle Street [NGR: 6885 6425]. It was thought that locating it at this point, it would be possible to pick up the line of a blocked drain running E-W under the road from the N end of 37, Castle Street.
- 3.2 A layer of topsoil and subsoil, much mixed with tree root, extended to c.1.1m below ground level. This overlay c.500mm of clean yellow/beige natural sand, which, in turn, overlay hard, but fairly friable, bedrock.

- 3.3 It was evident that the natural sand and bedrock below the topsoil was completely undisturbed and, therefore, not on the supposed line of the blocked drain.
- 3.4 Having established that this was the case, the trench was backfilled and no further excavation took place.

Illus. 3: Trench 1 looking W at E facing section.

- 4.1 The excavation of a 5m long trench within the scheduled area of Banff Castle, failed to locate the supposed line of an E-W running drain coming from across the road at 37 Castle Street.
- 4.2 No archaeological features or finds were evident in the trench excavated.
- 4.3 Should a further attempt be made to locate the drain within the area of the Scheduled Monument, then another watching brief is recommended.
