**CONTAMINATED GROUND IN  
SERVICE TRENCHES  
CASTLE FRASER STABLES  
ABERDEENSHIRE**

**- Archaeological Watching Brief -**  
Carried out 4<sup>th</sup> and 31<sup>st</sup> August 2011  
by  
**Murray Archaeological Services Ltd**

**Report No: MAS 2011-22**

**CASTLE FRASER STABLES  
ABERDEENSHIRE  
CONTAMINATED GROUND IN SERVICE TRENCHES  
-Archaeological Watching Brief-**

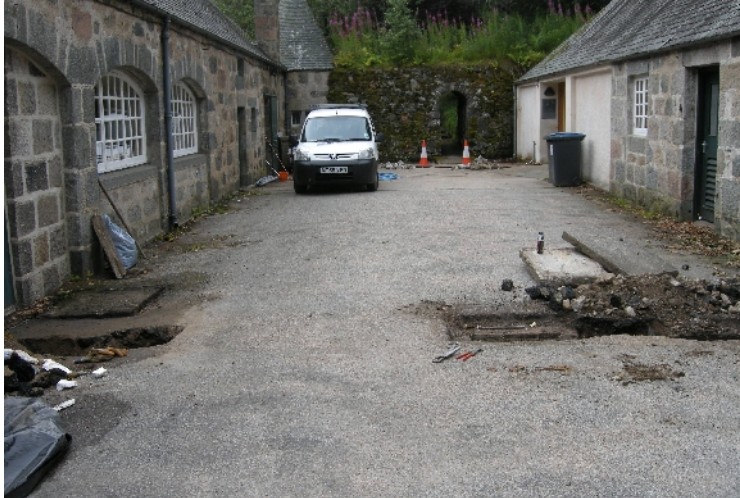
**Illus 2 Location of site, looking S with the W exterior wall of the Stable Range of building to LHS and the freestanding W range to the RHS**

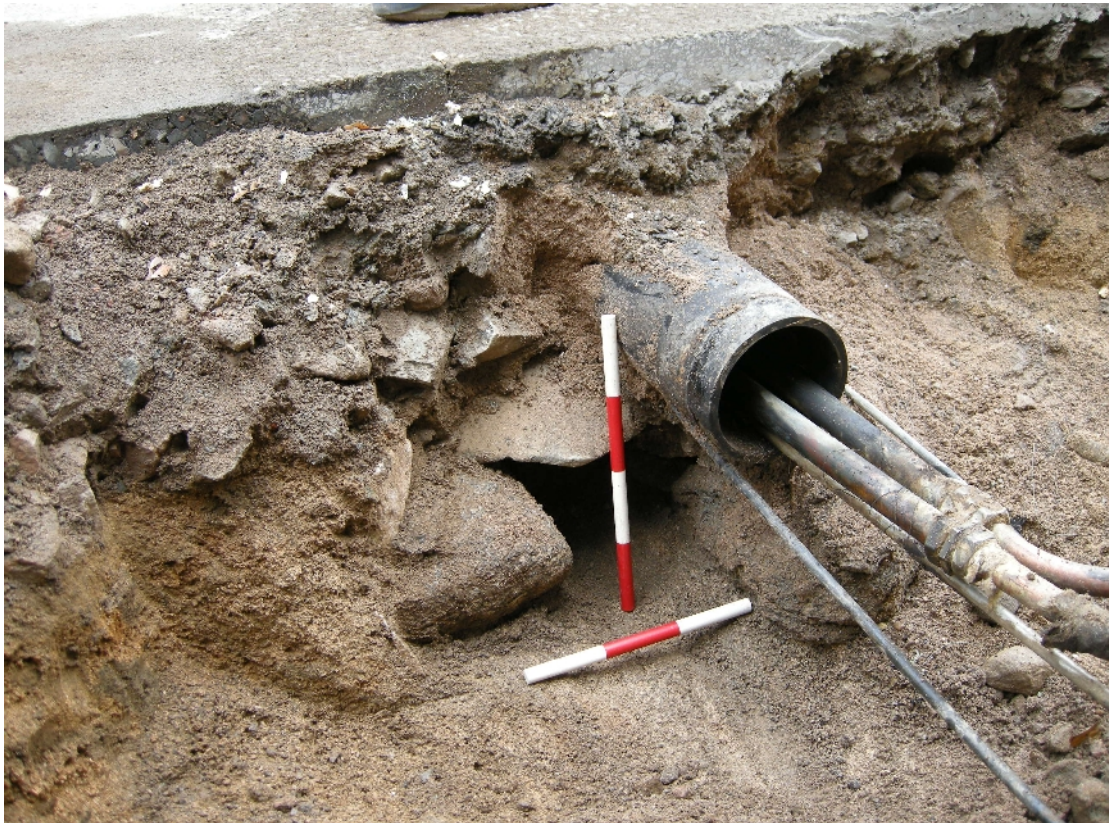
As the service pipes and duct were exposed it became clear that they had been built over and partially destroying an E/W stone drain. The drain was c 200mm wide and 200mm deep internally with stone sides and caps set in a cut dug into the natural compact clean hard natural glacial deposits. The E end of the drain and its relationship with the W range of the main stable block had been cut away by a N/S sewer pipe. The W end of the drain and its relationship with the freestanding W building had been cut by a clay drain and other services at a point c 2.5m from the wall of the building. About 3m of the drain was exposed, mostly in the S section of the trench, it ran E/W, draining down towards the E.

**Illus 3 Trench 1. Section of stone drain shown below duct for service pipes**

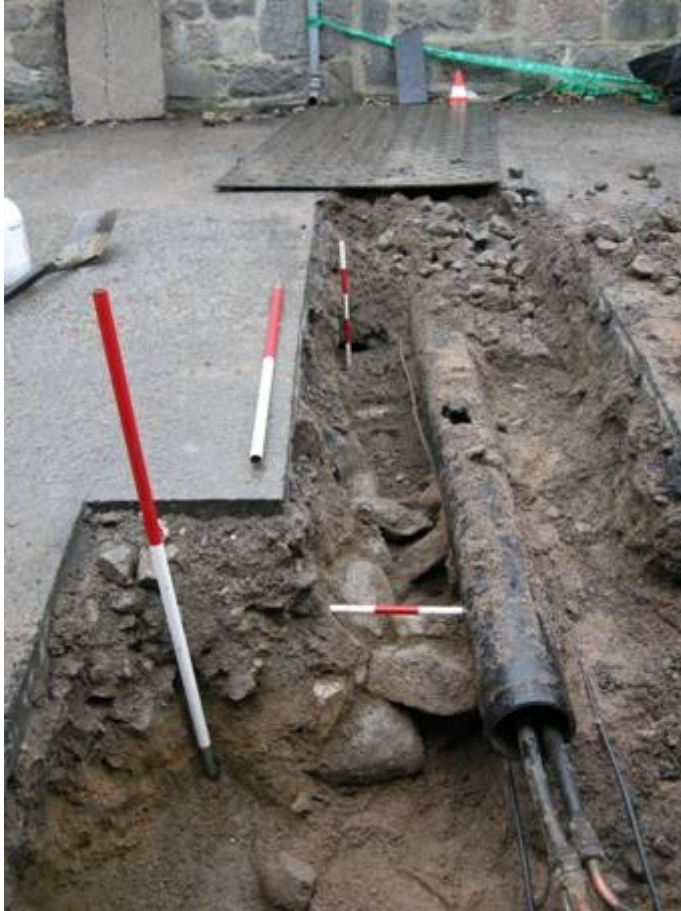
**Illus 4 Looking W along trench 1, showing stone drain on LHS of pipe duct**

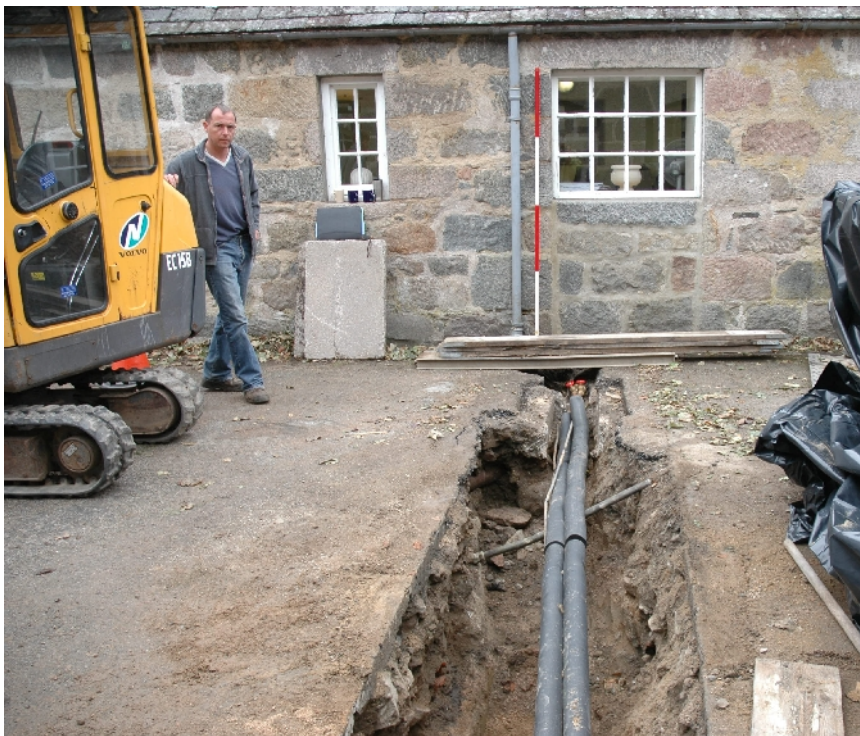
Although no direct relationships survived with the standing buildings, some deduction may be made from its line. If the line of the drain was continued, the W end would have extended to the S side of the blocked doorway in the freestanding W building (illus 5) and the E end would have run through the now blocked central archway in the W elevation of the 1795 Stable Block (illus 1).

**Illus 5 Looking W along trench 1, showing new service pipes and the stone drain (LHS) in relation to doorway (now window) in W building.**

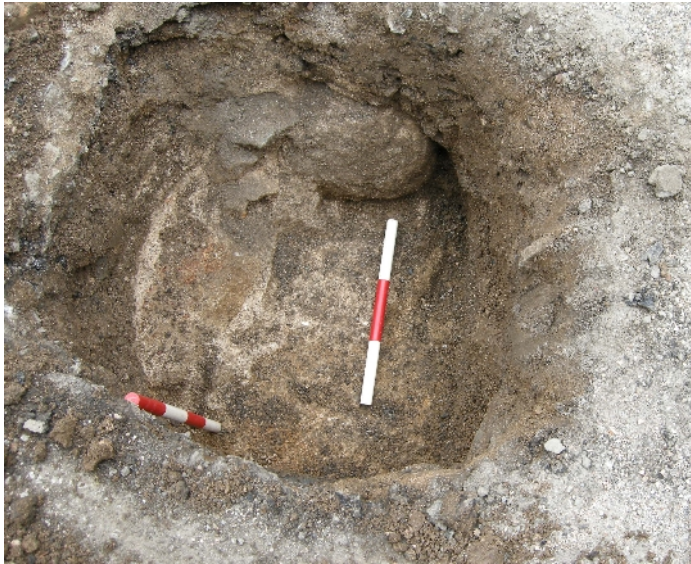
Trench 2 was excavated to cut and close off a water pipe into the nearby turret. A mortared wall foundation was revealed c 250mm below the surface of the tarred yard, this foundation extended down to c 500mm below the surface where it appeared to be built onto very hard stoney natural glacial deposits. The E side of the foundation had been cut by the now redundant water pipe. This foundation was in line with a vertical scar c 2.15m high and c 550mm wide on the W face of the turret.

**Illus 7 Wall foundation in trench 2**
