**CASTLE FRASER  
ABERDEENSHIRE  
LIGHTENING CONDUCTOR REPLACEMENT  
-Archaeological Watching Brief-**

**H K Murray and JC Murray**

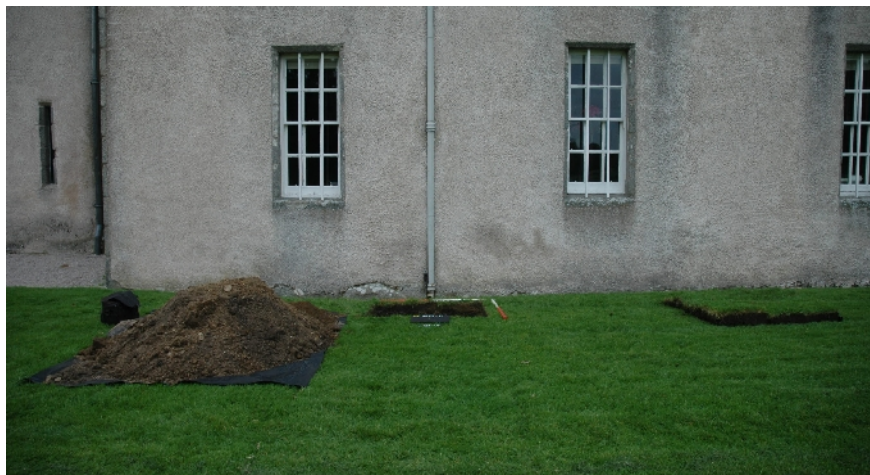
**Illus 1 Position LC 1**

Between 3.3m and 4.3m from the outer SE corner of the E wing and between 1m and 2m from the outer face of the E wall of the E wing. 1m square and 450-500mm deep.

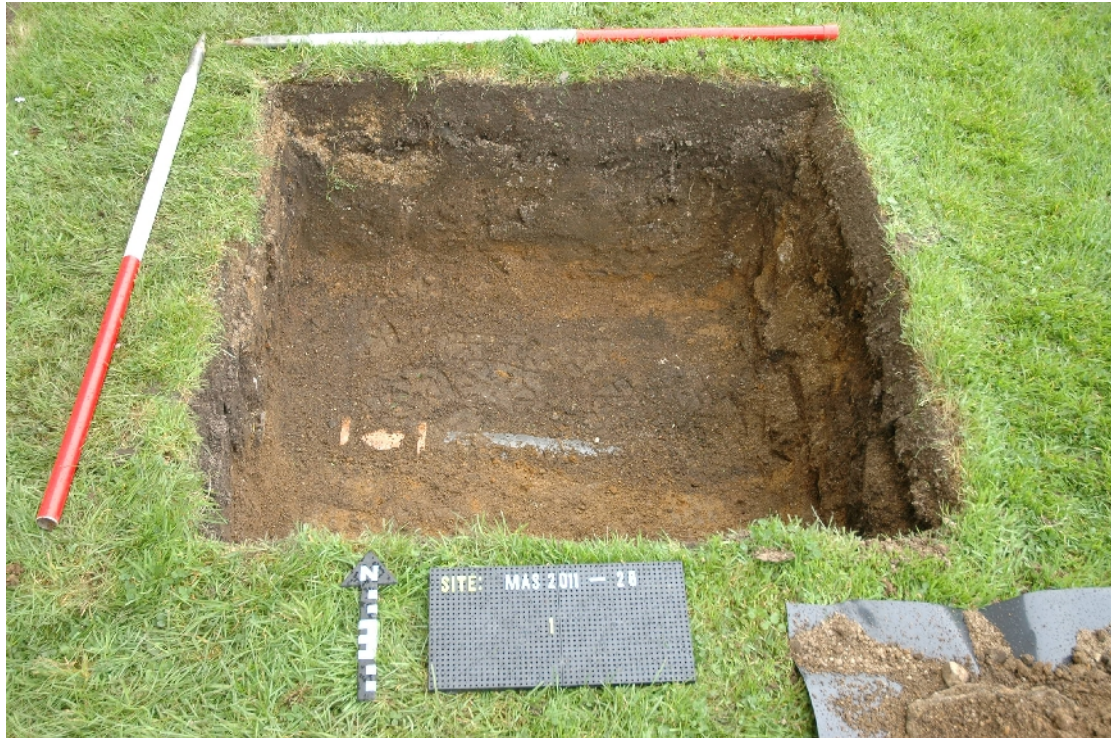
**Illus 2 Detail LC 1**

Some 200mm of sod and topsoil (1) lay over c 300mm of buried garden soil (2) above natural glacial deposits (3). Contexts 2 and 3 were cut by a trench 400mm wide for a plastic drain pipe (4), the top of which was c 450mm below the surface of the grass.

The buried garden soil (2) was very similar to the garden soils recorded during the excavation of the 17<sup>th</sup> century Privy Garden (Murray and Murray 2010 MAS 2010-18). It appears most likely that this would have been within the border apparent between the path and the wall of the castle (illus 3).

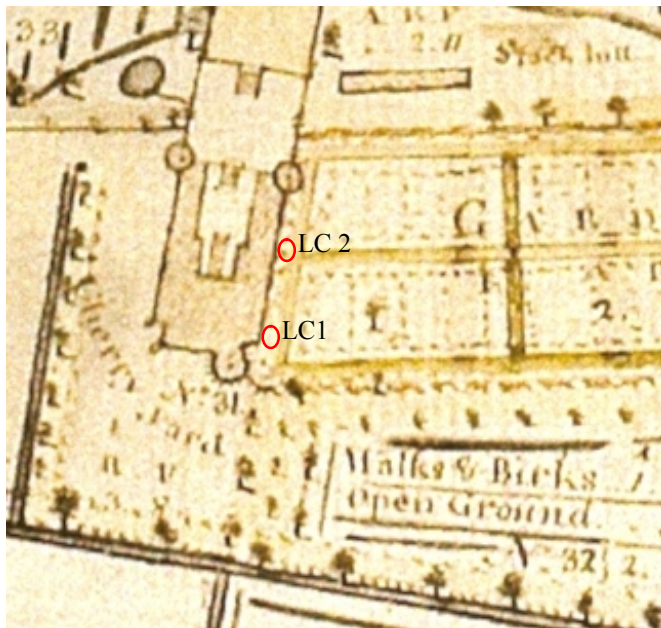
**Illus 3 Approximate positions of trenches LC1 and 2 in relation to the 17<sup>th</sup> century Privy Garden as shown on 1799 Estate Plan ©Copyright Aberdeen University. Reproduced with permission.**

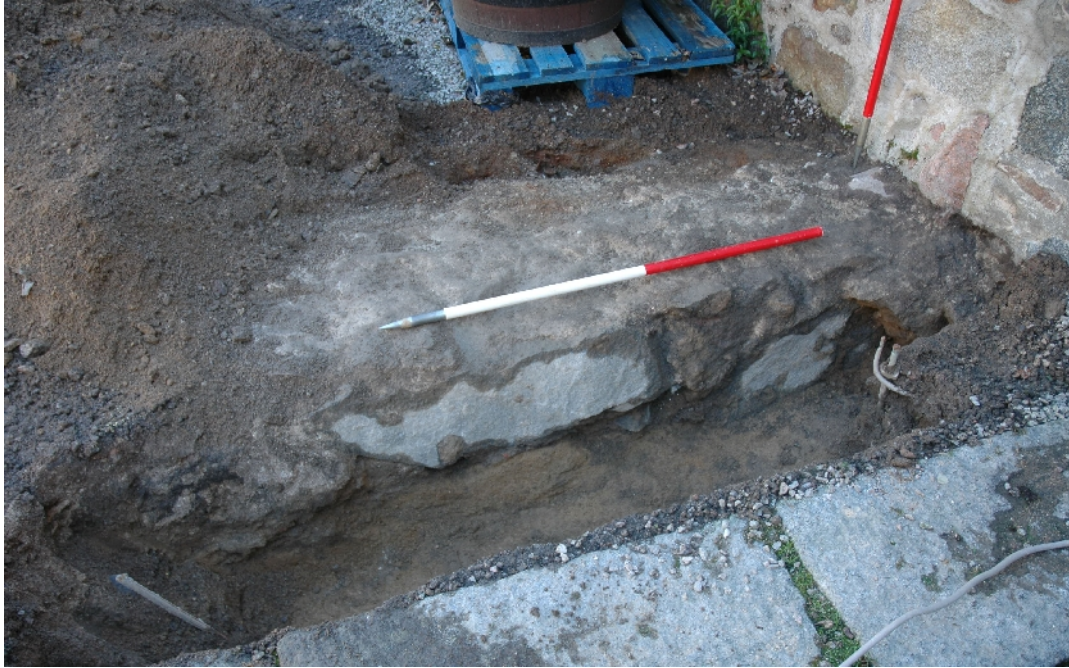
When the gravel was removed the foundations of a very substantial stone wall were discovered lying along the N side of the trench. The top of the wall was cleaned and a trench for the lightening conductor dug alongside it to the S.

The wall (3), which was only sealed by c100mm gravel make-up, was cut to a total depth of 300-420mm into the natural glacial gravels (4) and possibly into a layer of dirty sand with mortar fragments, 1 brick and occasional slate (2) ( although there was some ambiguity and this may have built up against it). Layer 2 extended below the paving and may represent construction related to the 19<sup>th</sup> century gallery alongside the inner face of the E wing.

The wall foundation was 650-700mm wide and c2m was exposed running E/W at right angles to the upstanding courtyard wall. A scar c 500mm wide in the upstanding N/S wall in line with the foundation suggests that both were walls of the same structure, the E wall of which was retained as the yard wall. Further confirmation of this can be seen in the difference between the predominantly red and yellowish stones in this wall compared with grey granite used in the infill of a gap between it and the main wall of the E wing (illus 5). Alternate stones in the scar on the face of the wall show rough dressing marks where the through stones of the corner had been cut back when the S wall of the structure was reduced to the foundation revealed in the excavation.

**Illus 4 Detail of wall (3) in LC 3**

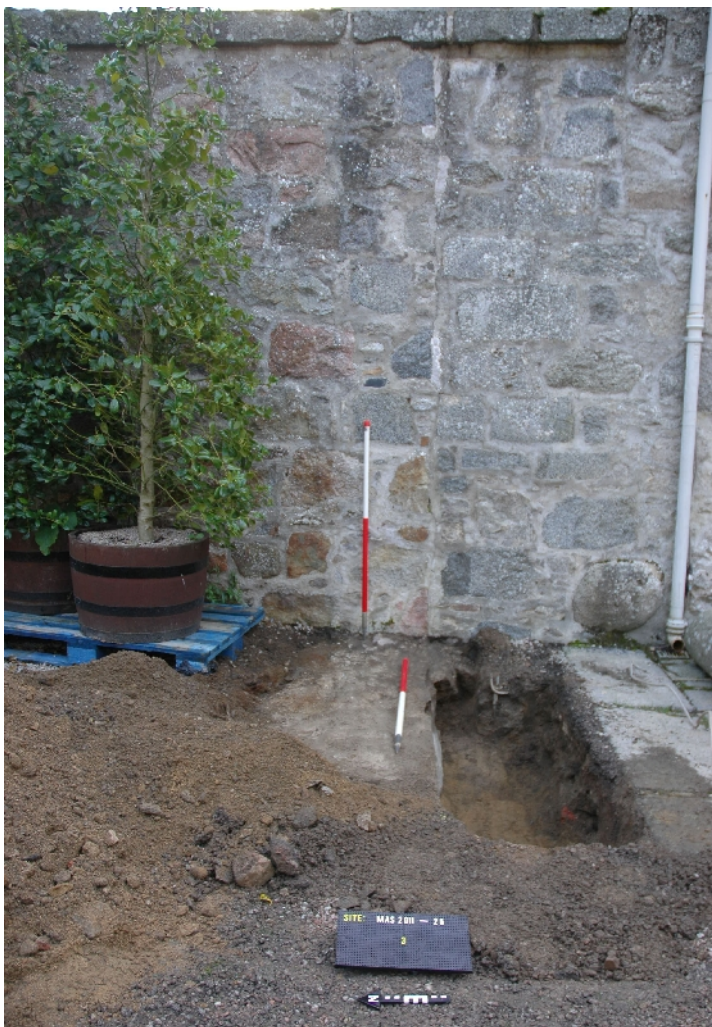
**Illus 5 LC 3 in relation to the courtyard wall. Ranging rod stands on line of scar. Grey infilling stones to RHS of scar**

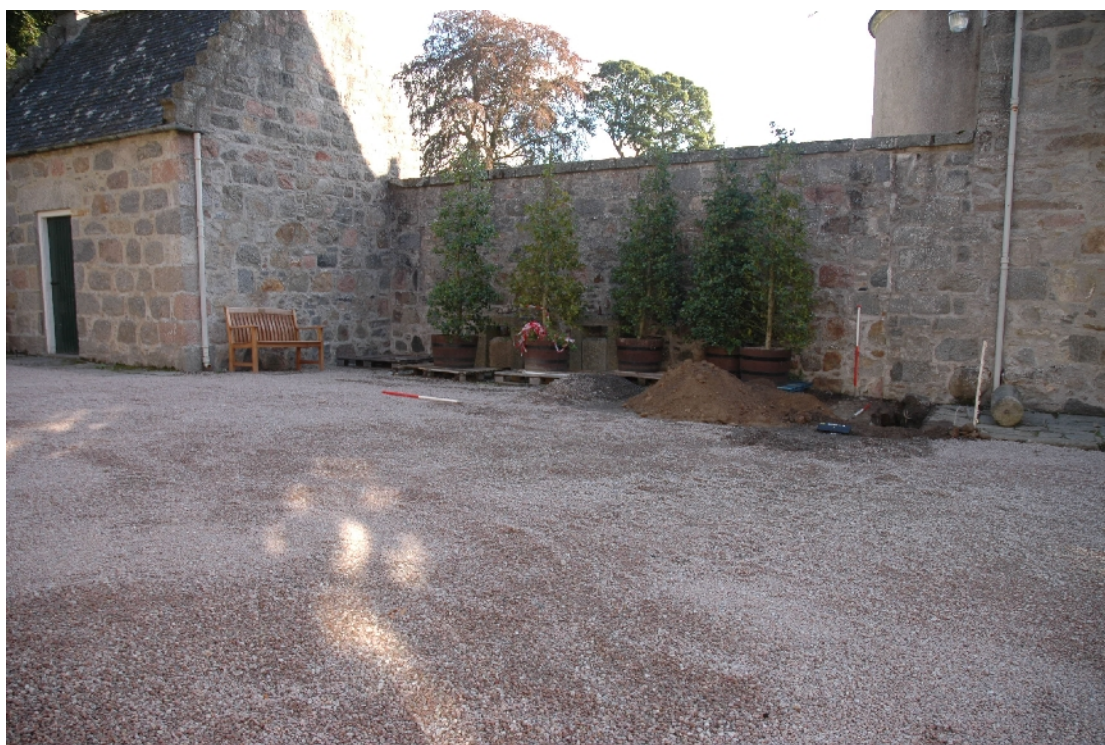
The position of this wall and its relationship to the E yard wall suggest that both were part of a rectangular building shown at the position on the the 1<sup>st</sup> edition OS map of 1864 and on an estate map dated either 1816 or 1846. A fragment of clay-bonded wall foundation found during a watching brief on drains undertaken by MAS Ltd ( Murray 2010 MAS 2010-24) may have been part of the same structure but appears to be just outside the wall line by an entrance – it may be a related feature such as a step or may be part of an earlier structure.

**Illus 6 The position of the wall in LC 3 in relation to the wall found in 2010 which is marked by horizontal ranging rod.**

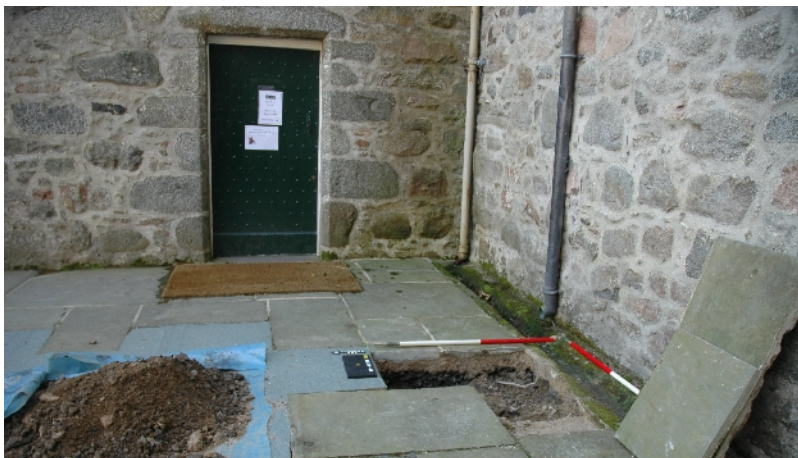
Illus 9 LC 5.

LC 5 was within the area of the excavation undertaken in March 2011 so no further archaeological recording was necessary.

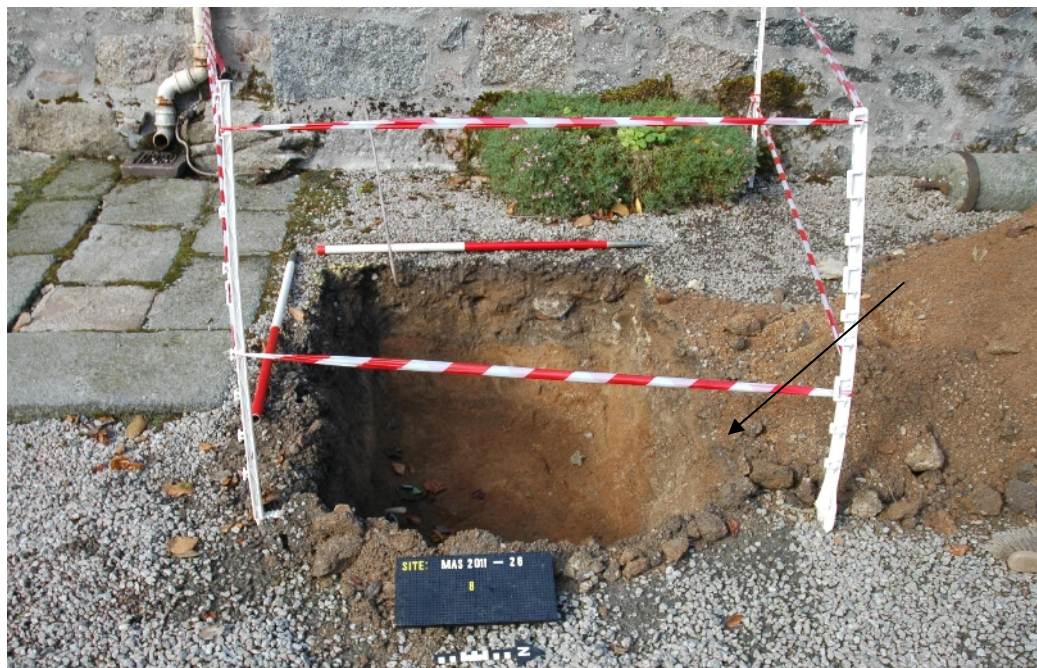
Some 60-100mm of gravel (1) lay over a layer (2) of stone and mortar rubble. At the W end this was c230mm but extended down into a cut (3) at the E end with a maximum depth of 450mm. The cut was into hard yellow glacial sandy natural.

**Illus 11 LC 8, looking W. Arrow shows the edge of robber trench**

The cut (3) may be the robbed out wall line of a small building shown on the W side of the courtyard on the 1<sup>st</sup> edition OS map of 1864 and on an estate map dated either 1816 or 1846. It is still extant on the 1899 2<sup>nd</sup> OS map and is shown in detail on Lorimer's drawing of 1923 (illus 10). Although the supposed robber trench is only c 1.50m from the face of the existing wall, this building is shown on the Lorimer plan as only c 1.75m in internal width.

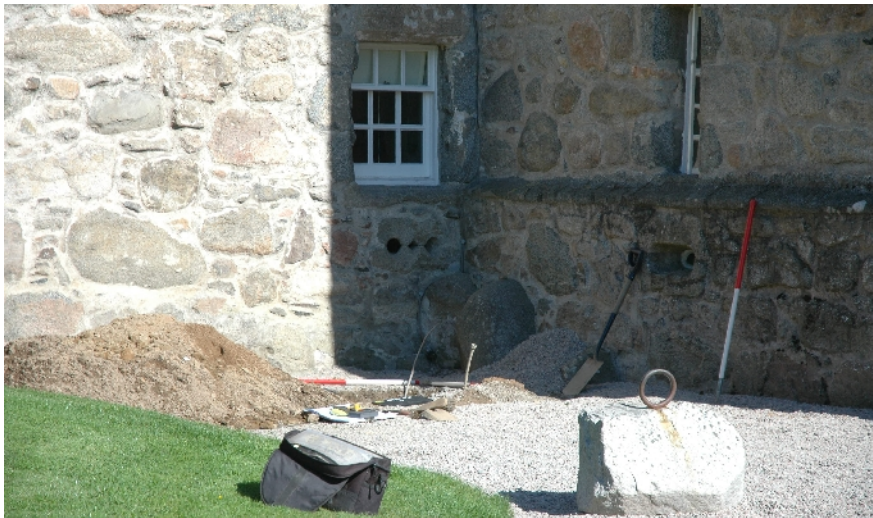
**Illus 12 Position of LC11**

Trench LC 11 was 1m x 1m with an E/W extension c600 x 400mm dug to isolate and put a new tap on a water pipe. The trench was within the SW angle at the front of the

building between the square tower and the main block of the castle. Depth: 500-550mm.

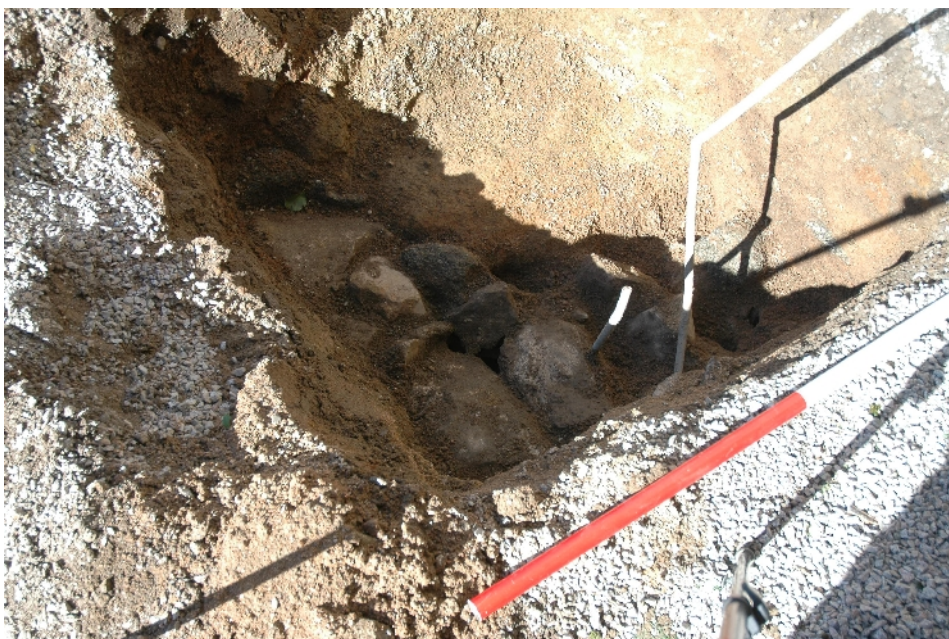
Below c 100mm gravel (1), there was an irregular layer of yellow sand (2) which appeared to be infill around an E/W water pipe. This was dug into a grey-brown gritty sand (3) which lay over a stone drain (4) cut into the natural yellow glacial natural (5). The drain appeared to run N/S from the S face of the square tower and then curved around to the W. The top was much disturbed by both the water pipe and by the original lightning conductor rod and it was collapsed. However it appeared to have capstones with some mortar on them resting on side stones with a void between. The full width was not exposed and the capstones were not removed.

**Illus 13 LC11 looking W**

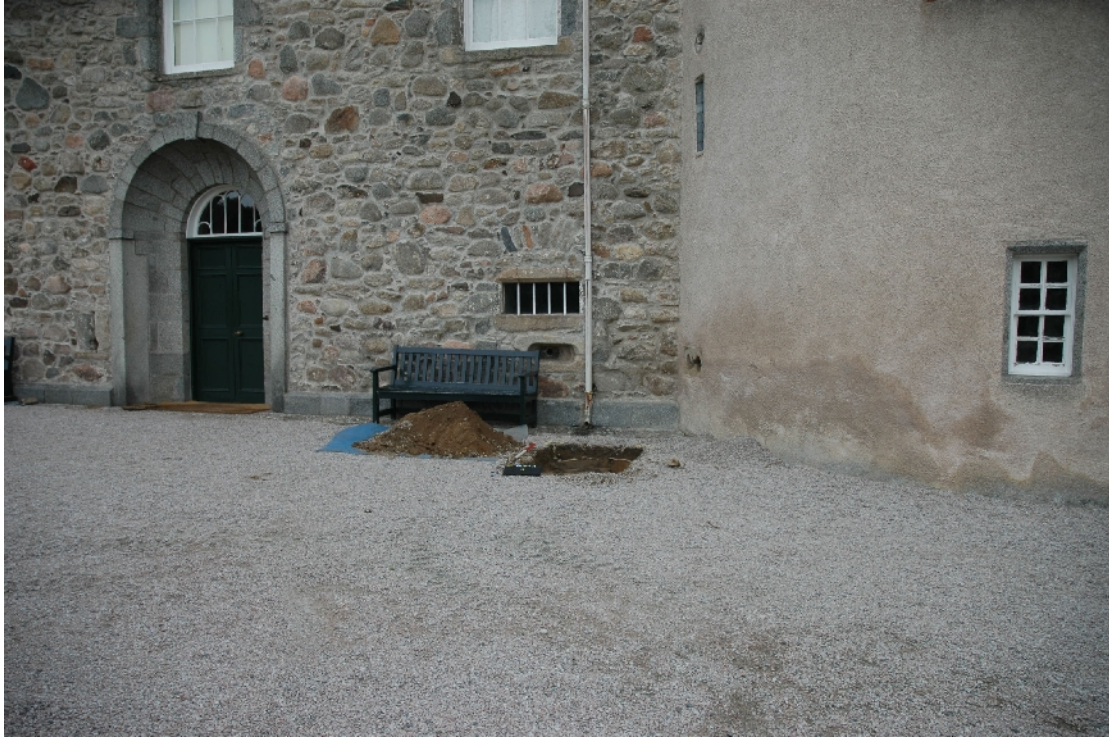
**Illus 15** Position of LC 12

Trench LC 12 was 1m x 1.7m with the long axis N/S at right angles to the outer face of the S wall of the main block of the castle, with the NE corner of the trench 1m S of the castle wall and 1m W of its junction with the round tower. Depth 250mm.

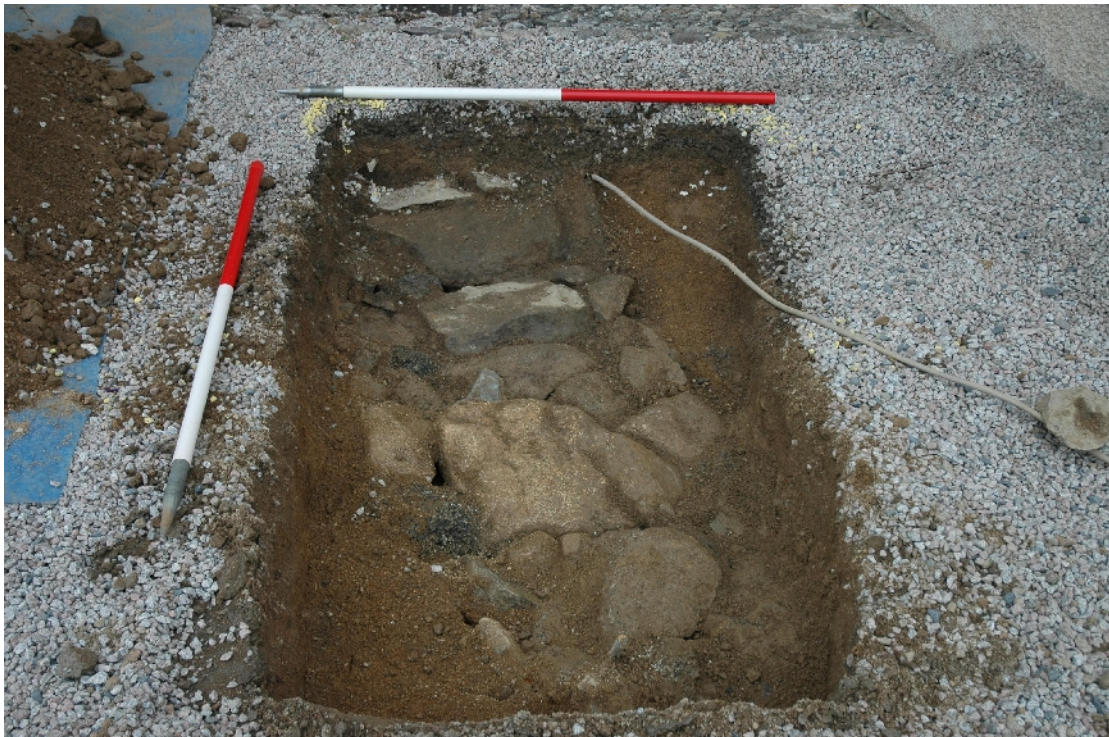
Below c50mm of gravel (1) there was a slightly brown humic sand (2) above natural (5). Both appeared to have been cut by a stone drain (4) which had a deposit of fine grey silt (3) directly over it. The drain runs NNW/SSE across the trench and 1.75m length was exposed. The width of the drain cut was 700mm. It appeared to have capstones resting on stone lined sides. No capstones were removed. There had been some disturbance by the original lightening conductor which had been driven through the drain.

**Illus 16** LC 12 looking N
