**NETHER LEASK STEADING**  
**SLAINS**  
**ABERDEENSHIRE**

**Standing Building Survey**  
Carried out January 10<sup>th</sup> 2012  
by  
**Murray Archaeological Services Ltd**

**Report No: MAS 2012-2**  
by  
H K Murray and J C Murray

## **- Standing Building Survey -**

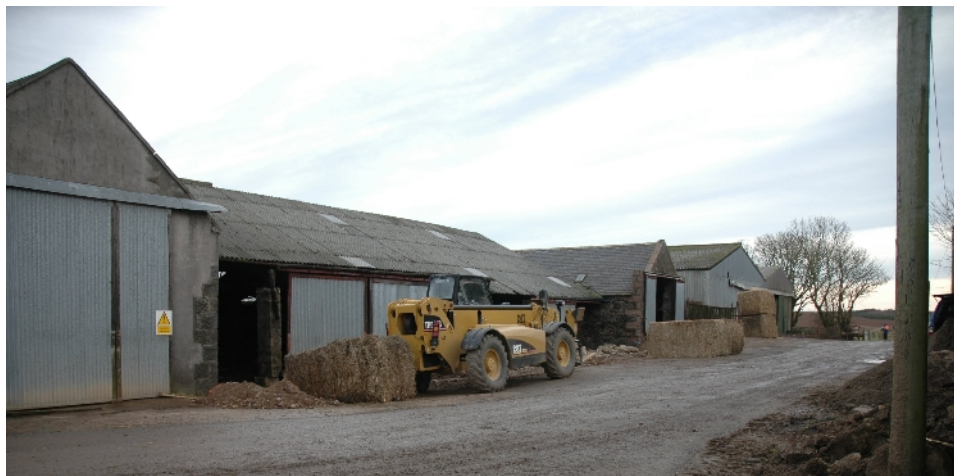
Illus 1 The site, general view from the NW

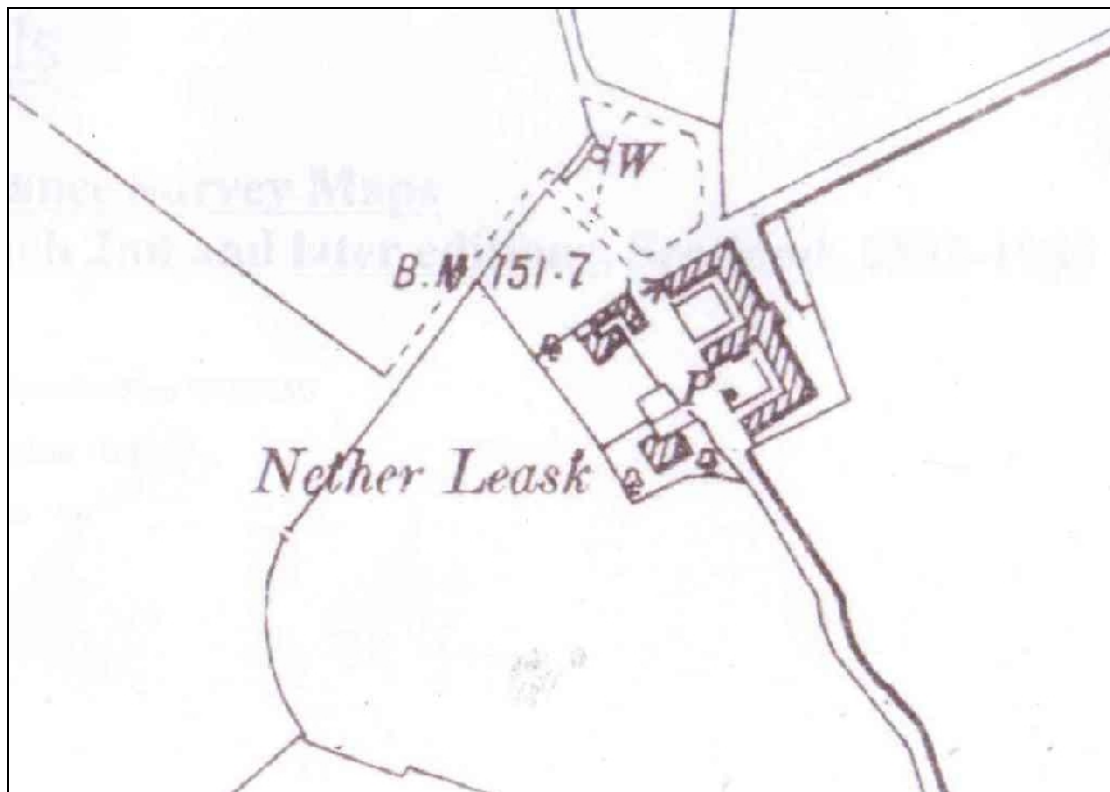
Illus 4 2<sup>nd</sup> edition 6"/mile Ordnance Survey of 1899 (pub 1901) ([www.nls.ac.uk](http://www.nls.ac.uk))

4.3 By the 2<sup>nd</sup> edition 6"/mile Ordnance Survey of 1899 (published 1901. Aberdeenshire Sheet XXXIX. SW) the additional buildings to the W of the road have been removed and replaced by a small rectangular range of buildings parallel with the Standing Building Survey

N range to the E of the road. To the E of the road a second U-shaped court has been formed by the addition of an L-shaped structure abutting the S/SE of the existing range.

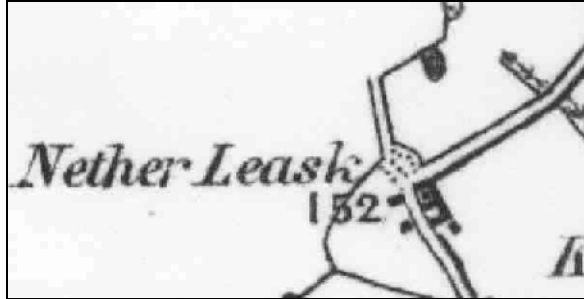
Illus 5 3<sup>rd</sup> edition 1”/mile Ordnance Survey of 1907 (pub 1910) ([www.nls.ac.uk](http://www.nls.ac.uk))

4.4 In the 3<sup>rd</sup> edition 1”/mile Ordnance Survey map of 1907 (published 1910. Peterhead. Sheet 87), the main steading block appears to have been unchanged but a small freestanding building, possibly the bothy that still exists, has been added to the S/SE of the steading, on the E side of the road..

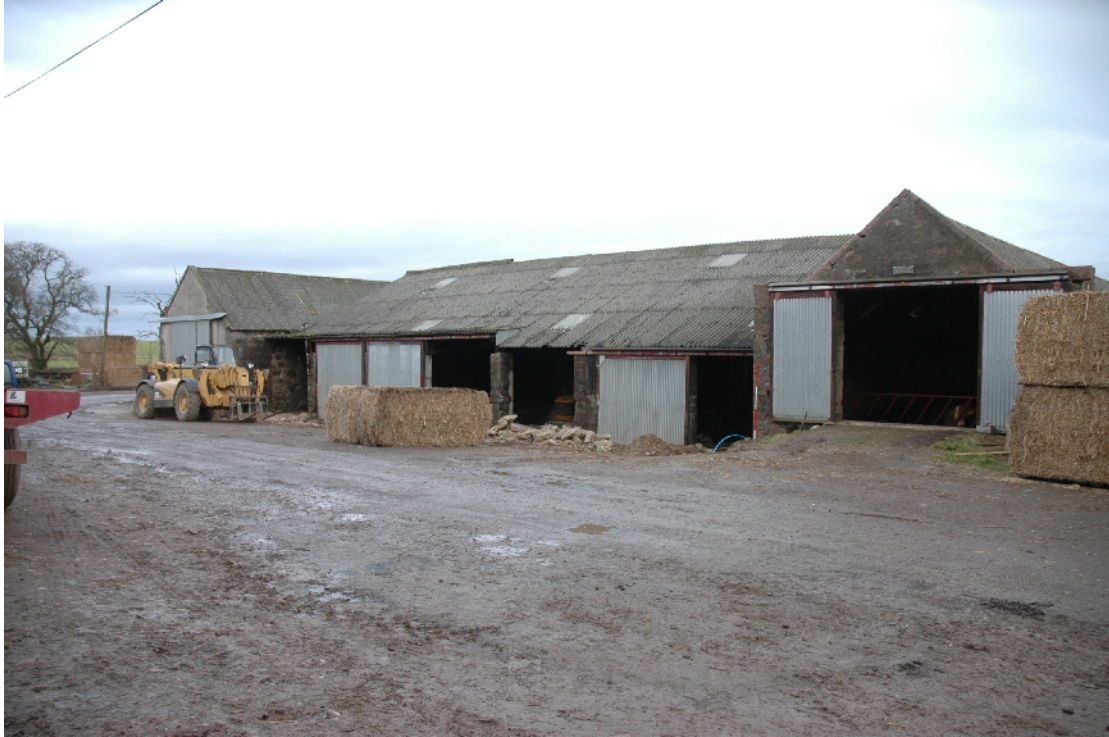
**Illus 6 Steading due for development looking NE**

Dimensions U-shaped steading around open dung court. Total width: N-S ext: 37m  
Maximum length E-W ext: 31m.

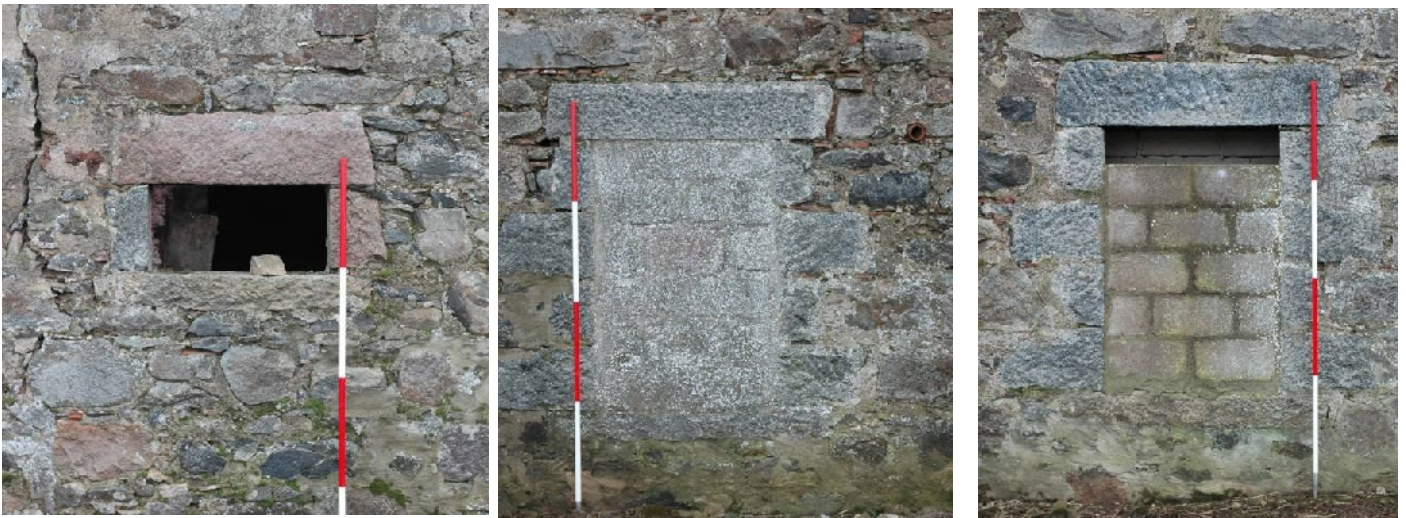
**W9** W: 840mm H: 420mm. pink granite lintel and 1 jamb, sill and 2<sup>nd</sup> jamb grey granite. Not blocked.

**W10** W: 920mm H: 1.4m. Grey granite lintel, sill and jambs. Concrete blocked.

**W11** W: 920mm H: 1.4m. Grey granite lintel, sill and jambs. Concrete blocked.

Illus 8 W9, W10, W11

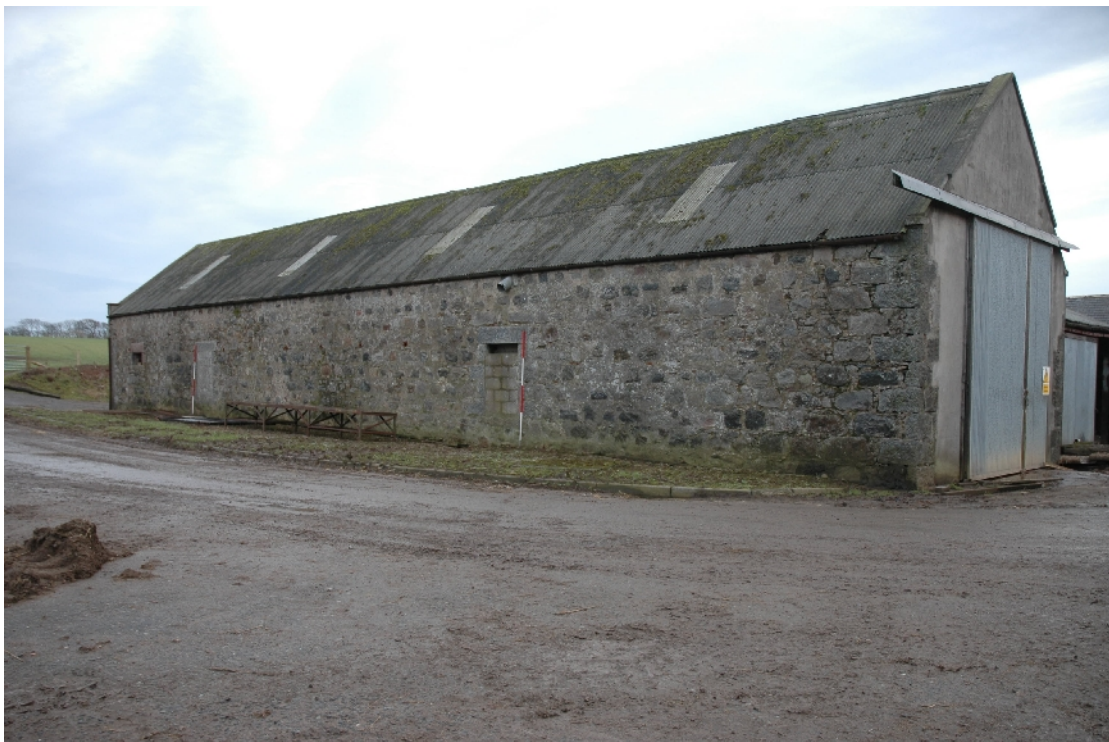
**Walls** Random rubble stone without very strong horizontal coursing. E gable rebuilt with concrete blocks. W gable corner rybats remain but top of gable and door opening rebuilt with concrete blocks.

Where rybats survive at W gable and openings they are all of grey granite with the exception of lintel and one jamb of W9 which are of pink granite.

Illus 9 N wall of N range looking to SE

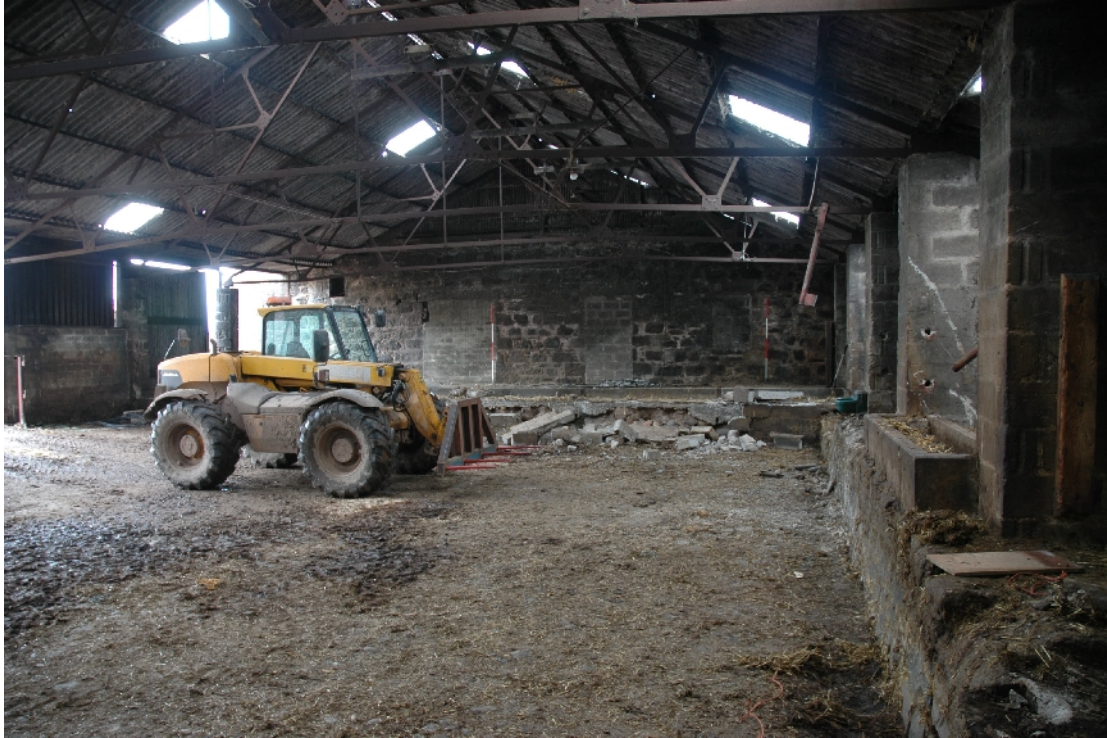
**D5** W: 2.15m H: 2.30m. Grey granite lintel and rybats. Concrete blocked.

**D6** W: 1.20m H: 2.30m. Grey granite lintel and rybats. Concrete blocked.

**W1** W: 0.95m H: 1.35m. Grey granite lintel and rybats. Concrete blocked.

**D7** W: 1.24m H: 2.30m. Grey granite lintel and rybats. Concrete blocked.

**Illus 10** S wall of N range in background looking N across the open court

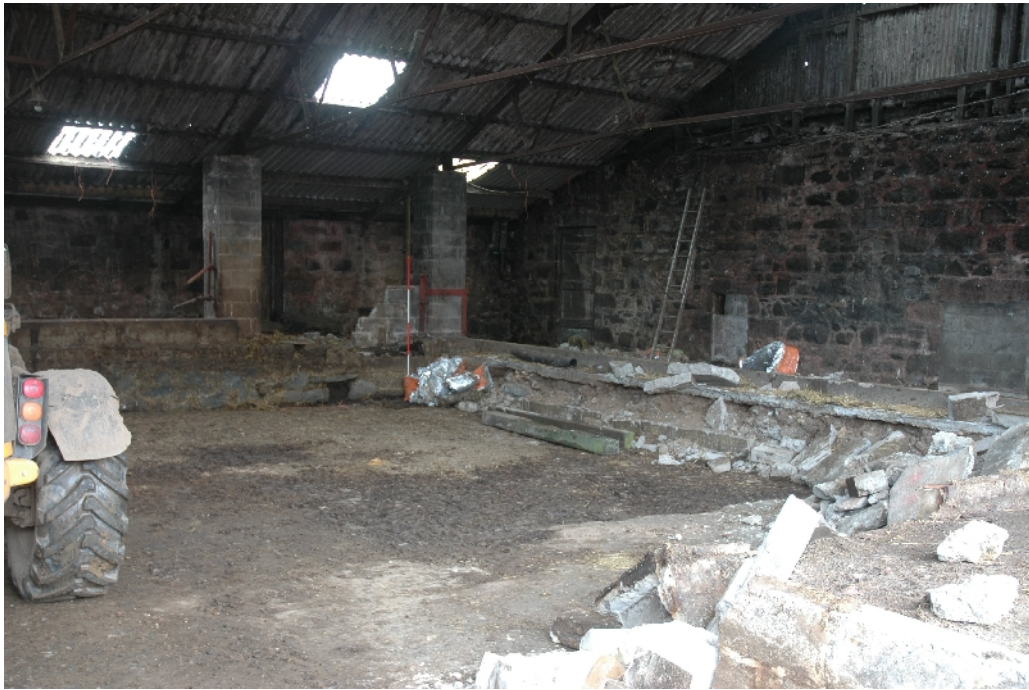
**W2** W: 750mm. H:1.10m. Pink granite lintel and rybats. Concrete blocked. Base of opening at level of walkway. As walkway is later than the S range this would have been a window initially, later it may have acted as ventilator to S range.

**Illus 11** N wall of S range, looking SE across central court. W2 visible beside ladder

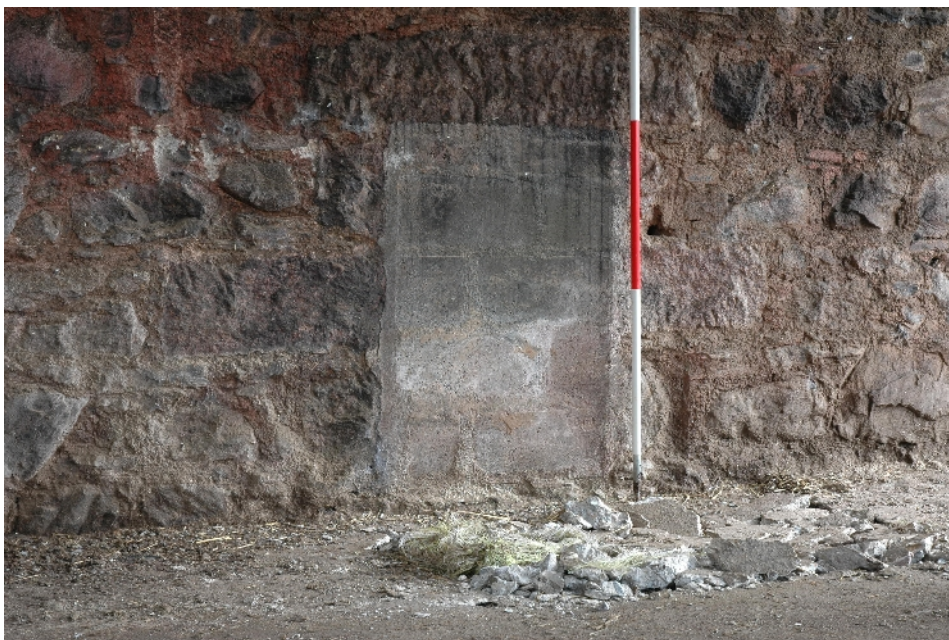
**W4** W: 750mm. H:1.05m. As W2.

**Illus 12** N wall of S range, Detail of W4, showing walkway has blocked base of wall, making window appear low.

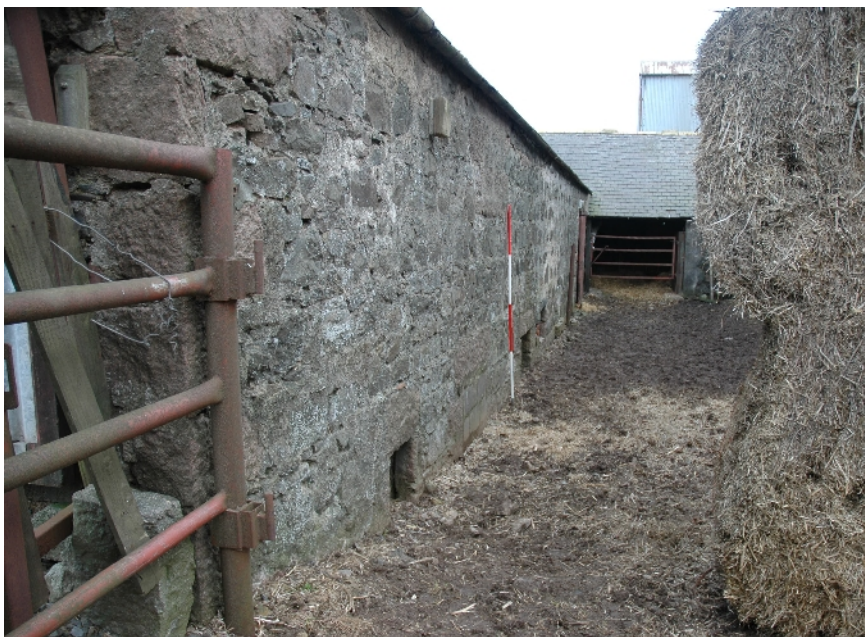
**W5** W: 470mm. H: 450+mm. Pink granite lintel and rybats. Concrete blocked, Ground level raised so original height not clear (internal side of wall concrete rendered obscuring detail).

**Illus 13** Oblique view looking E along S wall of S range. W5 in foreground

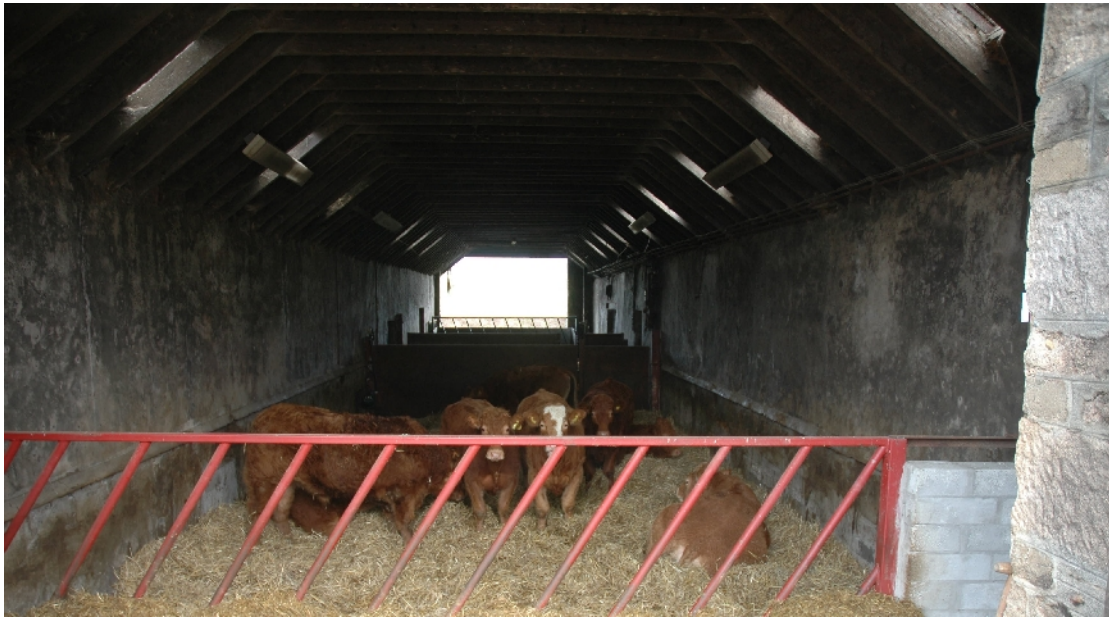
Much of interior was concrete rendered so no detail visible. Cattle were being in-wintered at time of survey.

**Illus 15** Looking into S range from W

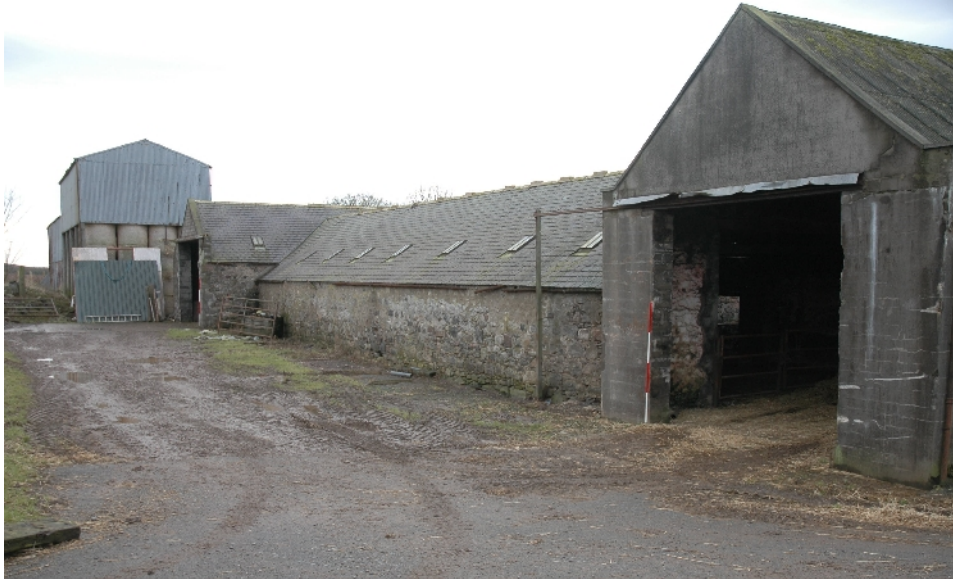
Rubble stone in rough courses. The N and S walls of the E range abut and are later than the walls of the S range.

**Illus 16 E range E wall looking S**

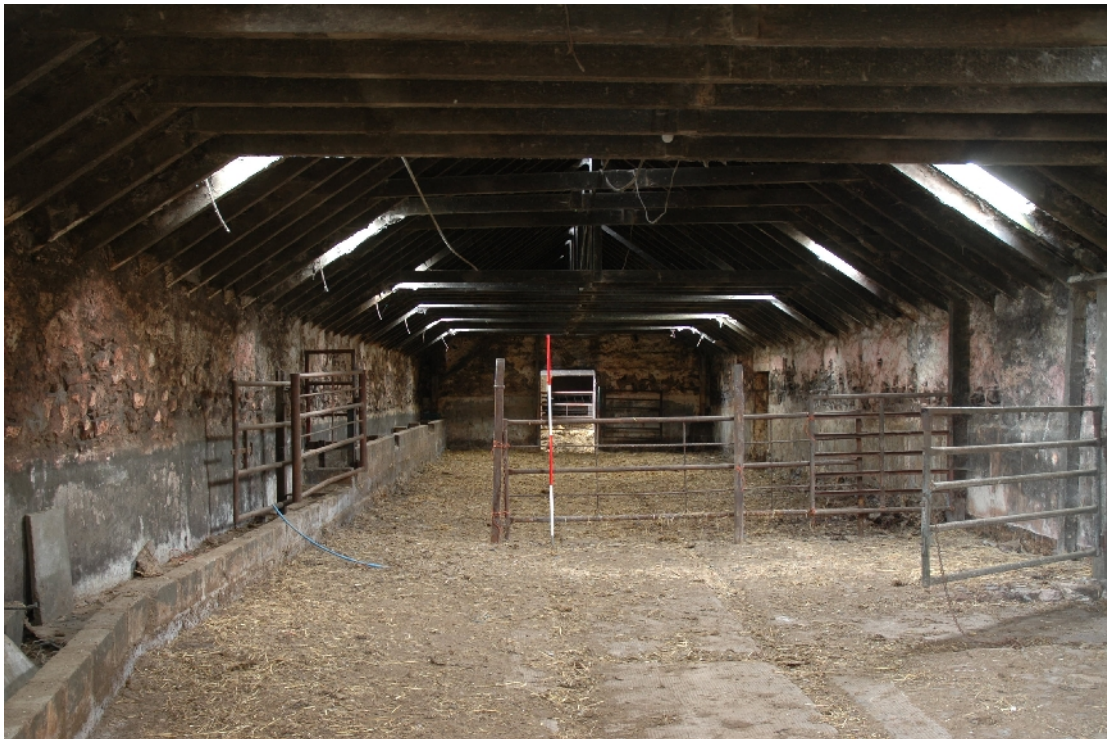
**Illus 17 Interior of E range central concrete drain and original cobbles just visible.**

Although the central drain along mid-line of floor had been concreted, the original cobbling survived over much of floor.

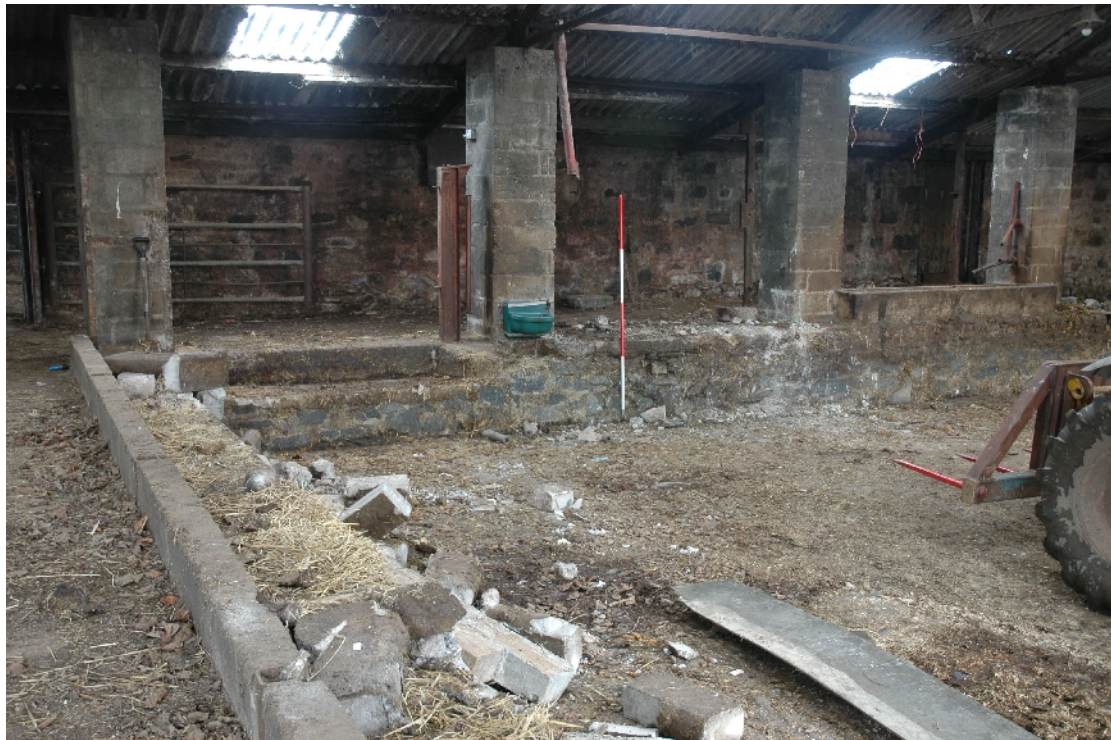
The central court was approx. 14 x 16m at a low level with a walkway around 3 sides. On the S and E sides the walkway was c.3-3.5m in width. On the N side it was c. 6.9m wide and appeared to have been widened. At the front the floor level was c. 700mm below the walkway, at the back it was c. 900mm below the walkway.

**Illus 18 View looking E across central court. Ranging rod stands beside revetting of E walkway**

Much of the floor of the lower area retained its original cobbles and can be regarded as the original level. The walkway beside the E range was at the same level as the floor cobbles within the E range and can therefore also be regarded as original. The W edge of the walkway on this side retained original stone revetting. This was not visible on the N and S sides. A possible drain through the revetting was photographed in the SE corner (Illus 19).

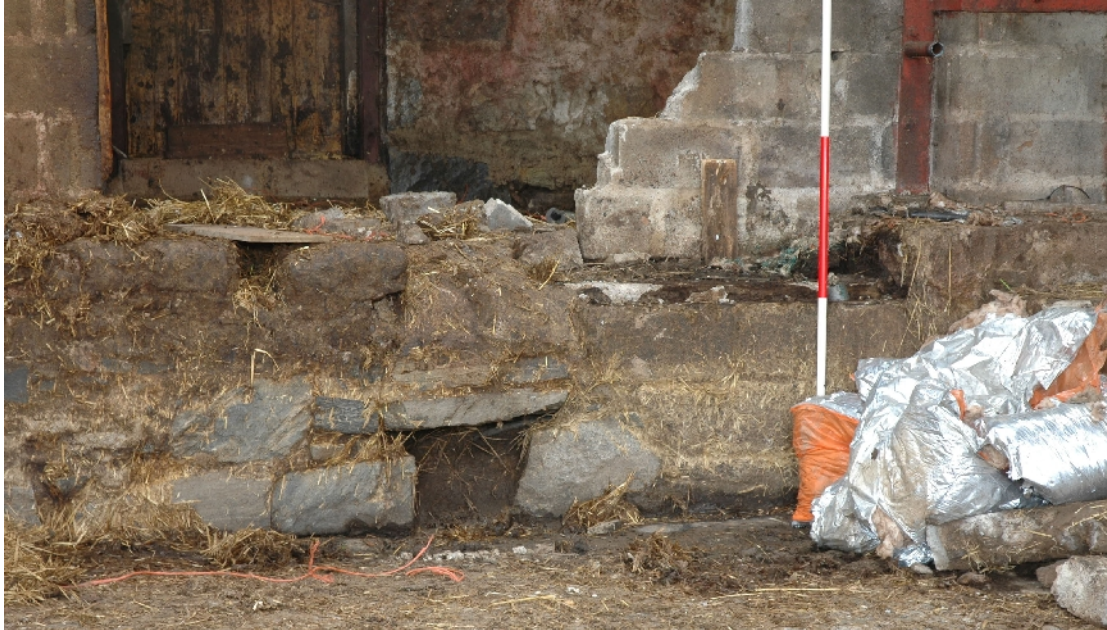
**Illus 19 Possible drain in revetting**

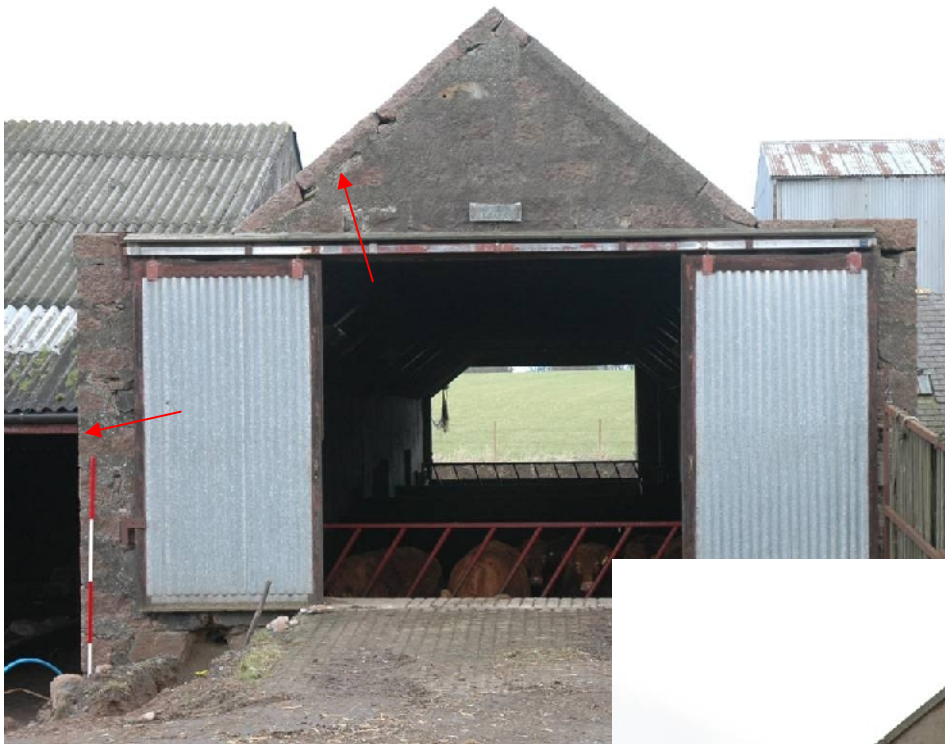
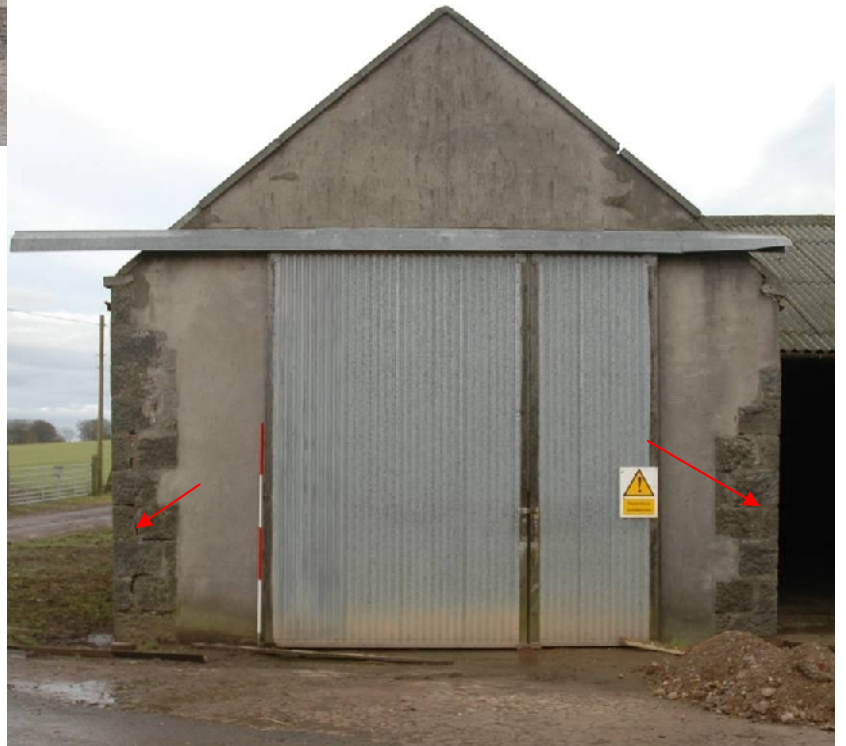
This U-shaped steading is shown on the 1867 1<sup>st</sup> OS map and is therefore of early 19<sup>th</sup> century date. Internal details such as the use of pink granite for all rybats and lintels in the S range and grey in the N range suggest a difference in date of construction.

**Illus 21 E gables of S range (top) showing pink granite rybats and of N range (below) showing use of grey granite rybats at corners**

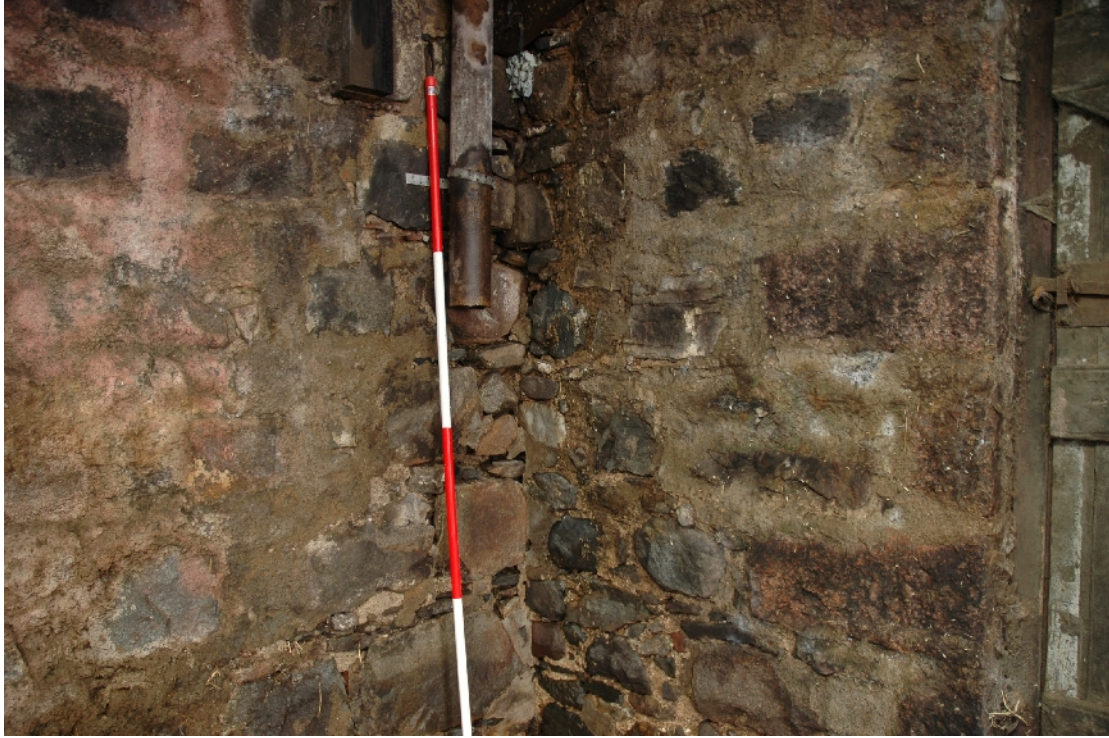
As the in-filling E range appears to abut the S range it is suggested that the S range is the earliest with the N and E ranges added.

**Illus 22 E side of E wall of E range abutting S range N wall**

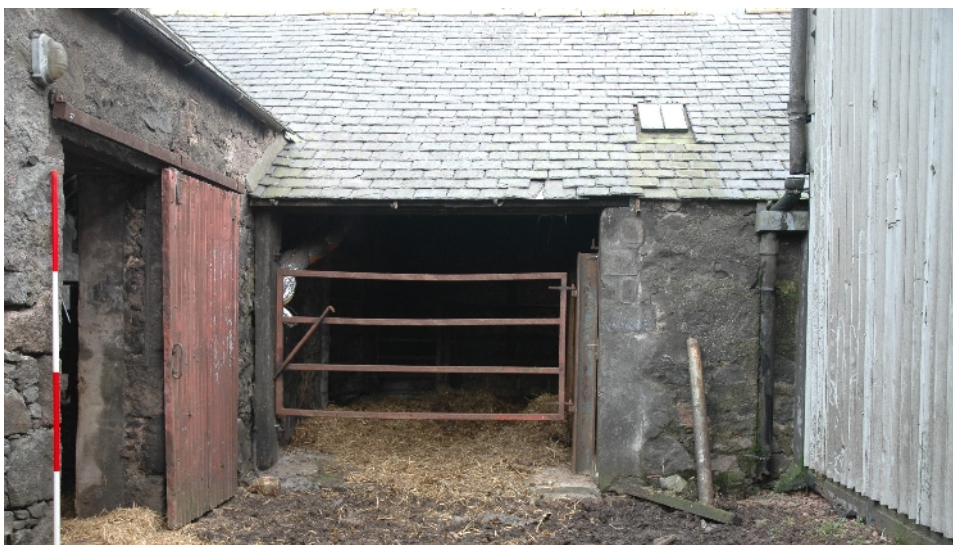
As shown in Illus 4 the documentary evidence shows that a second U-shaped steading was added between 1867 and 1899. The walls of this later court are preserved within a modern roofed building. Part of the original slated roof survives abutting the S side of the S range (Illus 23).

**Illus 23 Roof of later 19<sup>th</sup> century range of buildings abutting S range**

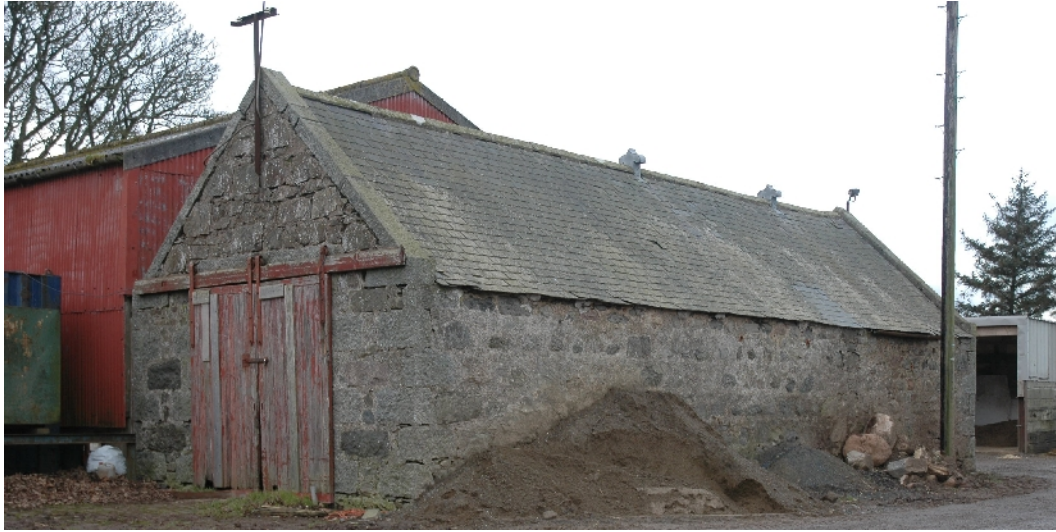
A smaller stone building to the W of the roadway (Illus 24) is also likely to be a remnant of the other later 19<sup>th</sup> century steading on that side of the road.

Illus 24 Later 19<sup>th</sup> century building to E of road.
