**MAINS OF PETMATHEN
STEADING
OLD RAYNE
ABERDEENSHIRE**

Standing Building Survey

Carried out 25th January 2012

Report No: MAS 2012-5

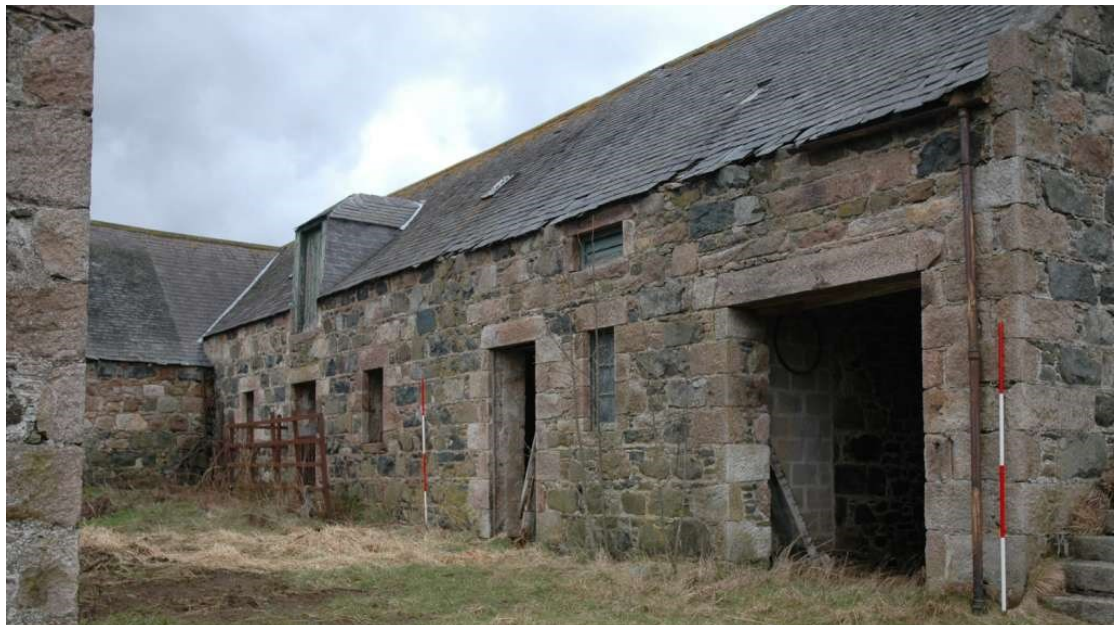
Illus 1 The site, general view of the N range

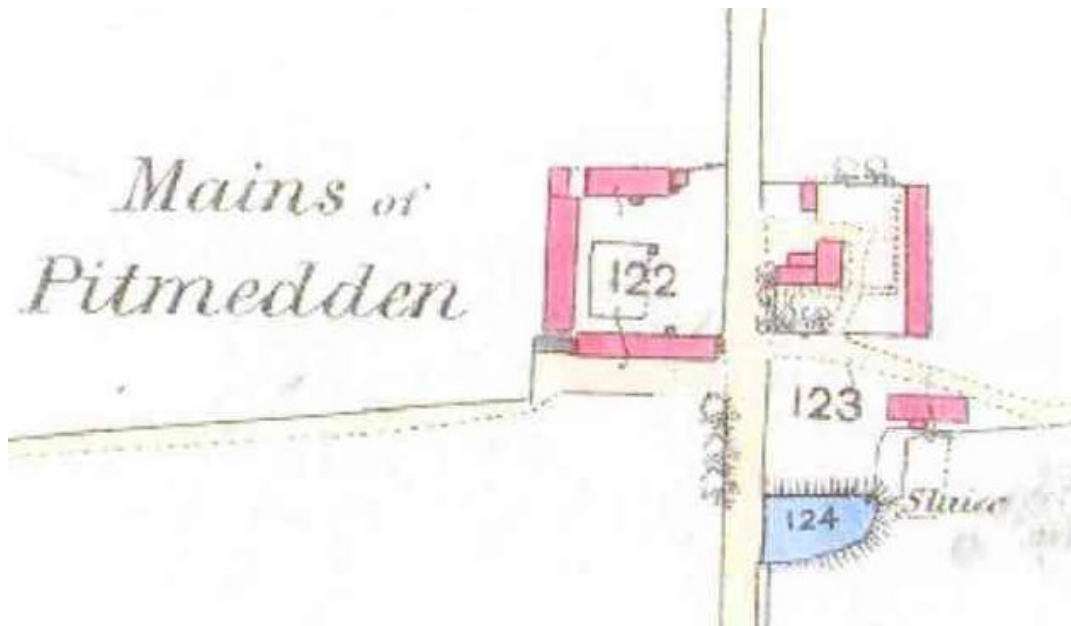
In 1867 the U-shaped steading is shown as three freestanding, separate buildings around a dung court.

Illus 2 1st edition OS map (25"/mile) surveyed 1867, published 1870 (www.nls.ac.uk)

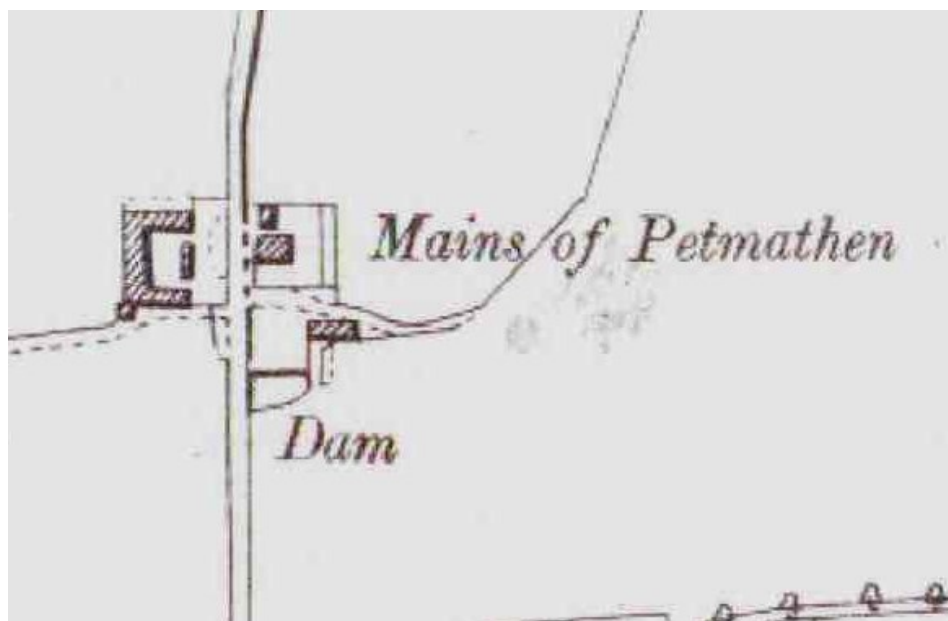
Illus 3 2nd edition 6"/mile Ordnance Survey of 1899 (pub 1901) (www.nls.ac.uk)

4.3 By the 2nd edition 6"/mile Ordnance Survey of 1899 (published 1901. Aberdeenshire Sheet XLIV.NE) the U-shaped steading appears to have been modified to form a continuous block of buildings, with the previously longer S range foreshortened to equal the length of the N range. A small freestanding structure forms a new E range (Illus 3).

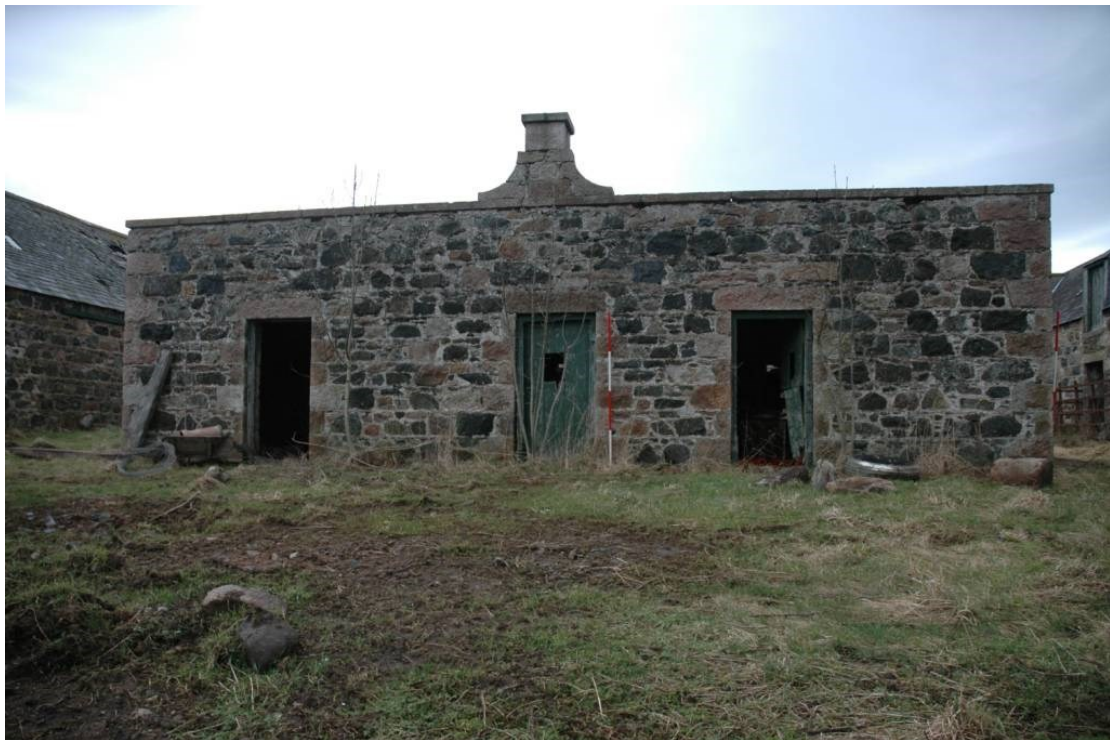
Walls Rubble stone in strongly horizontal courses. Stone colours from buff/pink to dark grey, with often angular faces. Rybats at corners and openings, wall head and skews of pink to buff granite. Vertical stacked pinnings by rybats at NE corner, N wall.

Roof Single pitch, sloping down to courtyard at W. Original slate at N end, replaced elsewhere by corrugated iron, now mostly displaced. Skew putts at NW (displaced) and SW moulded to an elegant curve to hold the skew stones.

Illus 6 E range from front (W face)

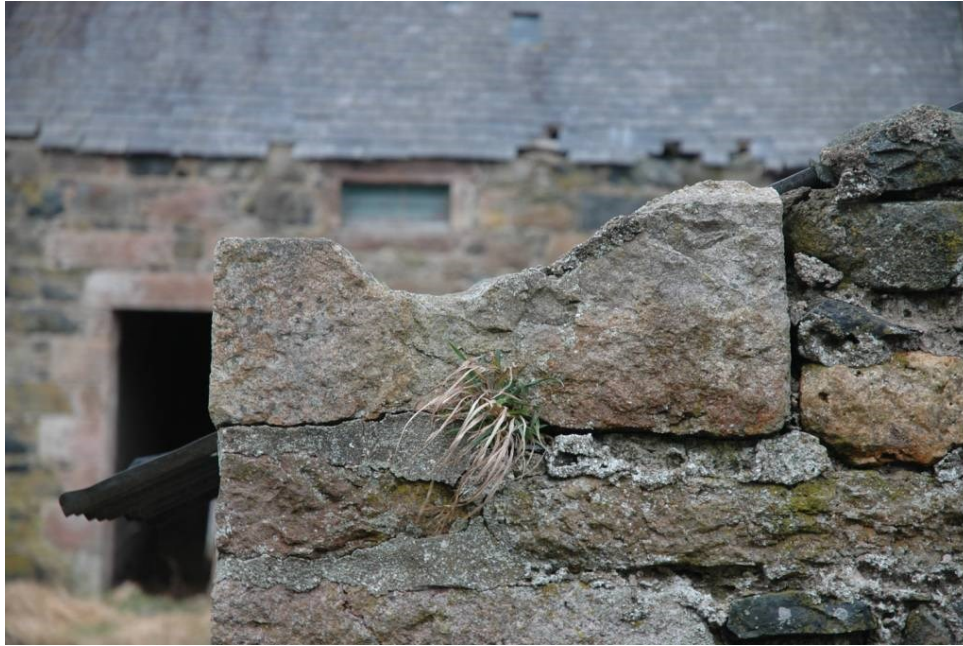
Illus 7 Detail of skew putt

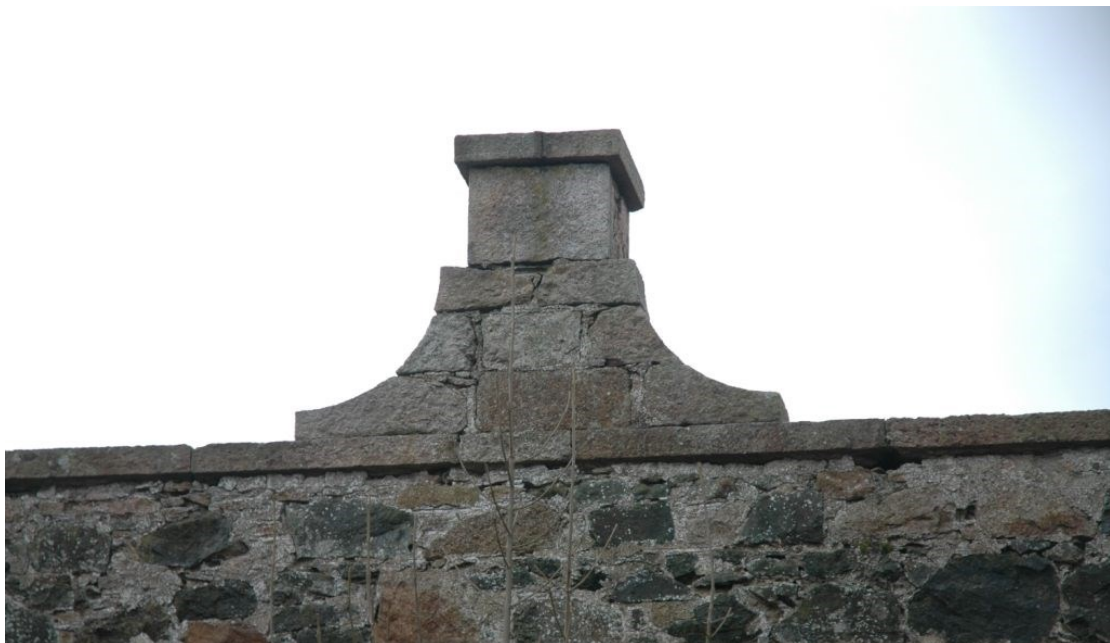
Chimney A square chimney was central to the front (E) facade. Moulded stones on either side curve down to the wall head.

Illus 8 Detail of chimney from the E

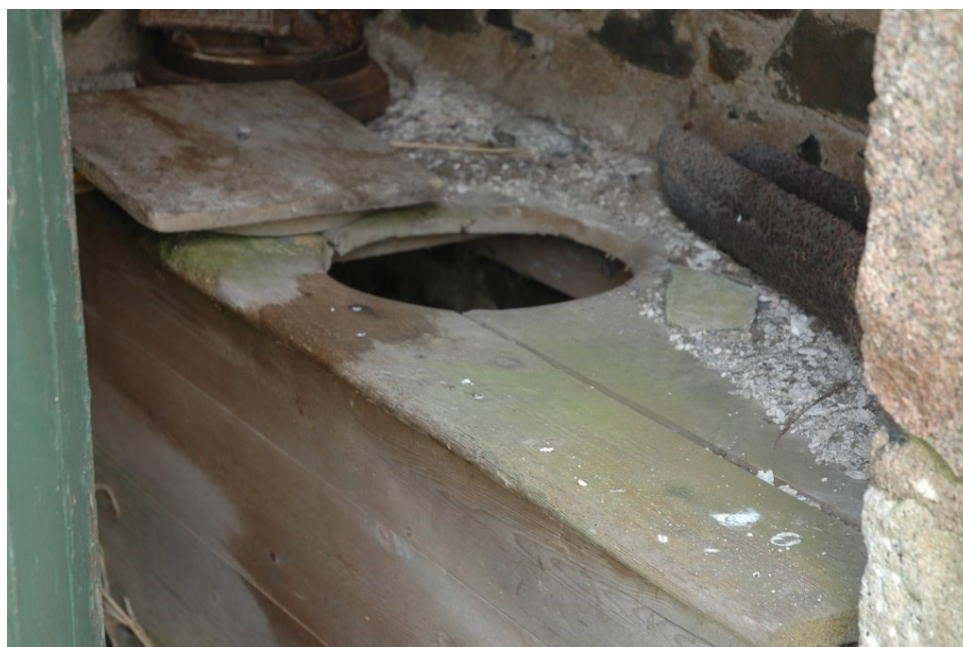
At the N end there was a small dry toilet with surviving wooden seat and box over a stone-built chute into the NW chamber which appears to have been a cess chamber with an access hatch with shutter (W1) for emptying and possibly with a drain through the W wall for liquid waste.

Illus 9 Toilet

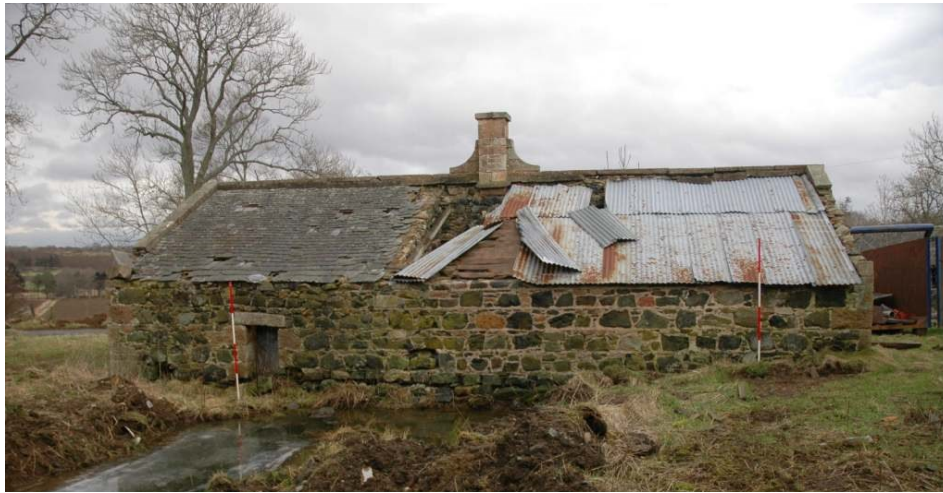
D5 W: 0.62m H: 1.05m. buff/pink granite lintel and rybats. Internally the top of this door is only 0.90m above floor level. It is possible that this was an access door for pigs to go out to the midden in the court.

Possible drain A break in the wall at the wall base at the N end may indicate the position of a drain for water waste from sewage from the cess chamber out into the midden.

Illus 10 W wall of E range

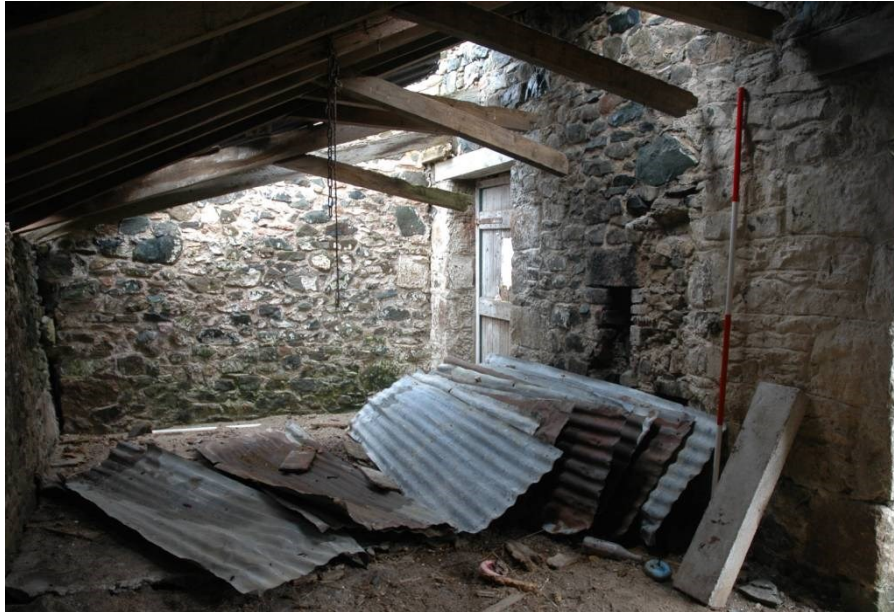
The S room appears to have been originally partitioned as suggested by the two doors. Holes in the inner faces of E and W walls probably held wooden timbers for a timber partition. The room to the N of the partition, accessed through D3 has a flue in the E wall. This is between 0.72m and 1.07m from the floor level and has a stone lintel. It was not directly below the chimney but the flue is angled with a ceramic pipe lining. The sides of the opening are partly bricked. A displaced iron chimney with small ventilating shutter stamped 'The Falkirk Iron Company', dumped in the toilet room, may have been part of the original boiler. The Falkirk Iron Company was established under that name in 1819 and continued in production until 1961 (although the name was changed for the years 1830-1849).

Illus 11 E range interior showing flue below dark coloured lintel in centre of wall. Ranging rod lies just to RHS of former partition.

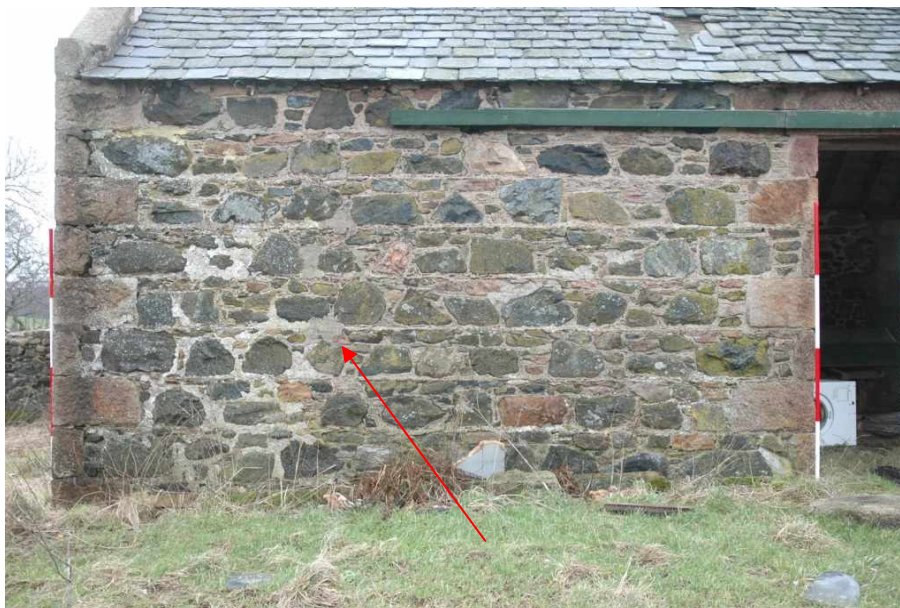
Walls Rubble stone in good horizontal courses. The E gable appears to incorporate a greater quantity of dark grey stones with angular outer surfaces than are apparent in the N and S walls. This may reflect a partial re-building of the S range between 1867 and 1898 during which period the map evidence shows it was foreshortened to match the length of the N range. In both the N and S walls the line of this rebuilding is clear in the stonework. Rybats and lintels of pink-buff granite.

Illus 12 S range. Detail of E end of N wall. Arrow marks the rebuild.

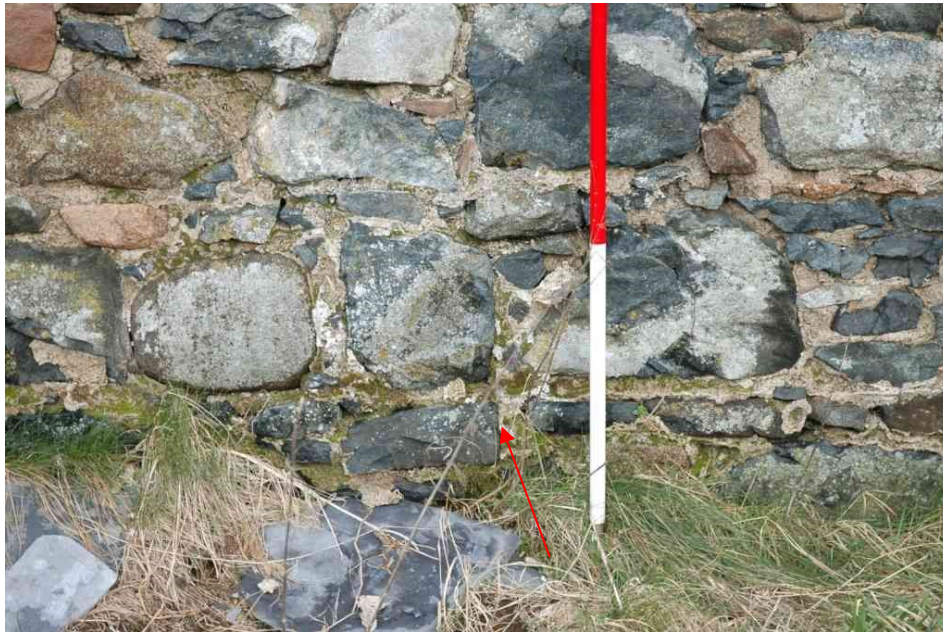
Illus 13 S range. Detail of E end of S wall. Arrow marks the rebuild.

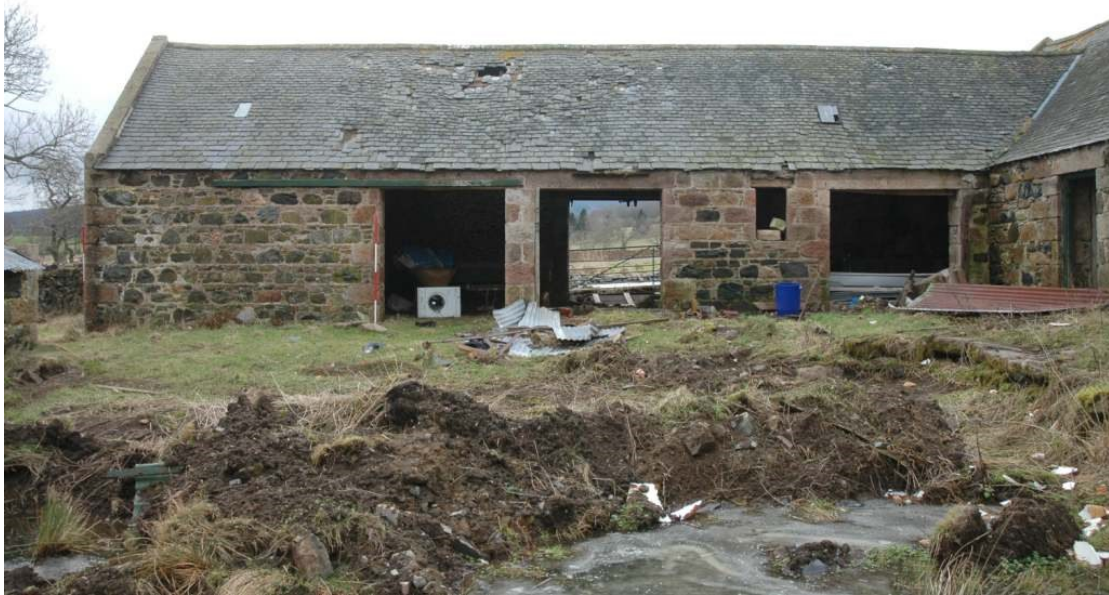
D7 W: 2.24m H: 2.47m. buff/pink granite lintel and rybats. Cart bay with more recent sliding door rail.

D8 W: 2.25m H: 2.34m. buff/pink granite lintel and rybats. Cart bay.

D9 W: 2.37m H: 2.05m. buff/pink granite lintel and rybats. Cart bay. Floor raised by concrete. Not original height.

Illus 14 N wall of S Range showing cart bays. Dung pit in foreground

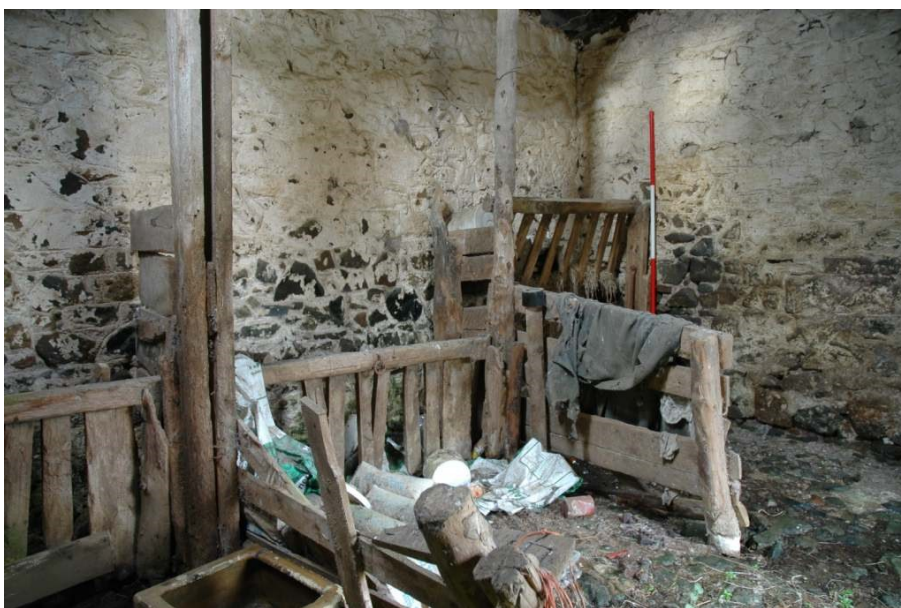
The E end was a stable, entered through D6, with wooden trevise and hay racks for three stalls (Illus 15). The cobbled flooring survives with a N-S drain in the cobbles behind the stalls.

Illus 15 Stable interior

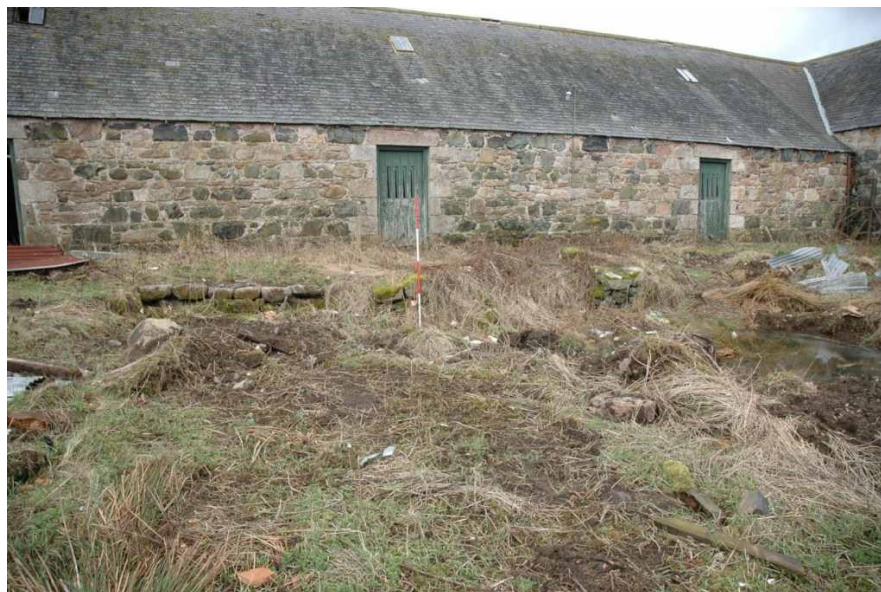
Illus 16 View looking W across dung pit to E wall of W Range (revetment of dung pit visible to LHS of ranging rod)

Walls Rubble stone with good horizontal courses. E and S walls show predominance of buff-pink, fairly weathered stones (similar to N range). This is less clear in W wall which has been considerably affected by a fire. Rybats of buff-pink granite.

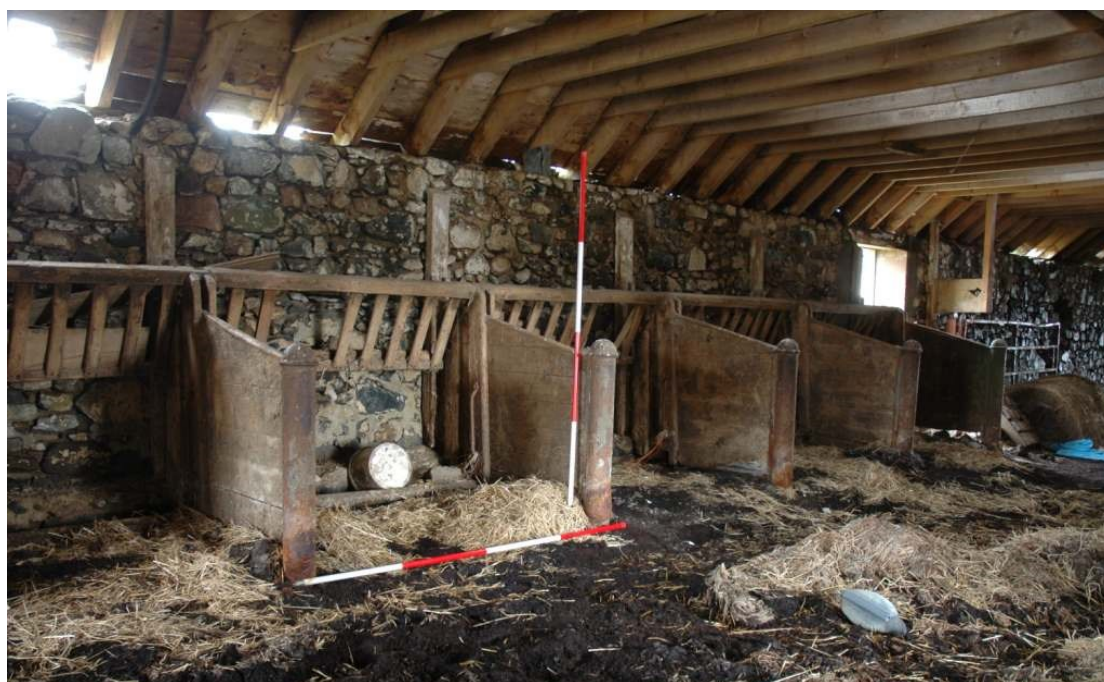
This was built as a cattle shed and retains many original fittings (Illus 17). Much of the S end retains the tied cow stalls with original wooden trevises fitted to cast iron end posts. The stalls along the W wall (Illus 5: A-E) were 1.75-1.85m wide and were double stalls, with metal tying brackets and cow chains remaining. Wooden hay hakes were fixed above feeding troughs, the further edge of which was a widening of the base of the wall to avoid erosion of the wall itself.

The stalls along the E wall (Illus 5: F-H) were identical except that they were wider, being between 2.0 and 2.03m. The extra width may suggest that these were stalls for cows with young calves at foot. There was no evidence to indicate if the stalls originally continued to the S gable, although this could have been an area for calves or a turnip store.

Illus 17 Interior of W Range showing tied cow stalls on W wall

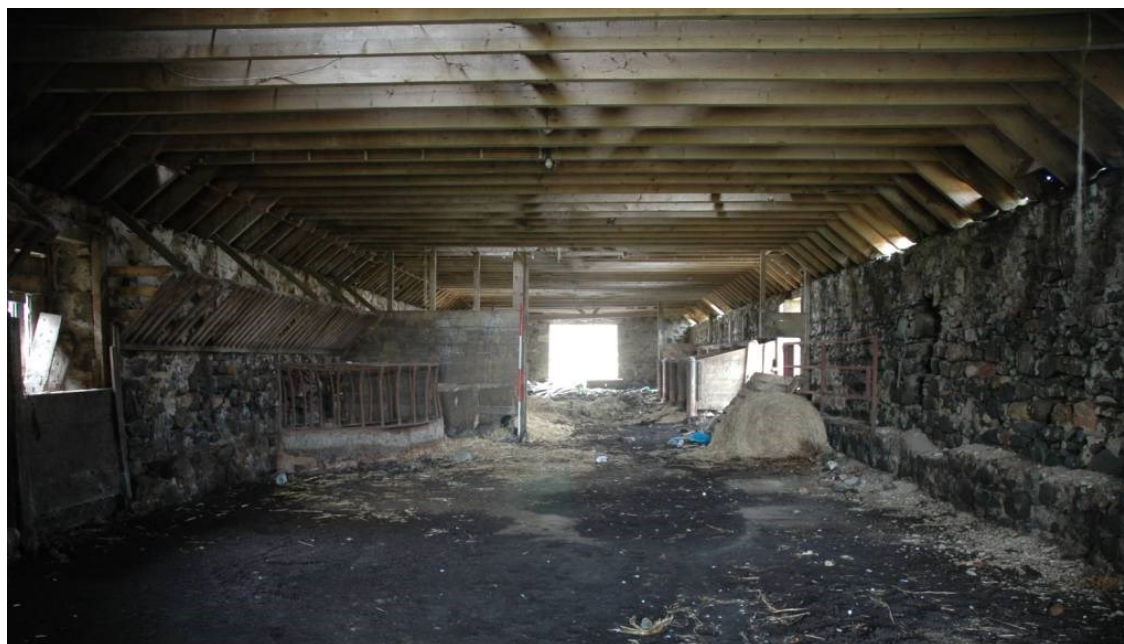
The N half of the building, accessed through D14, was divided off from the S end by wooden partitions with a gate between. This appears to have been an open shed for store cattle with wooden hay hakes along the inner face of the E wall and the widening of the wall base on both E and W walls suggesting a similar trough arrangement to that seen in the individual stalls. Illus 18.

Illus 18 Looking S through W Range with open cattle area in foreground with hay hakes showing on LHS. Wider footings on both sides for feed trough. Tied cow stalls in background.

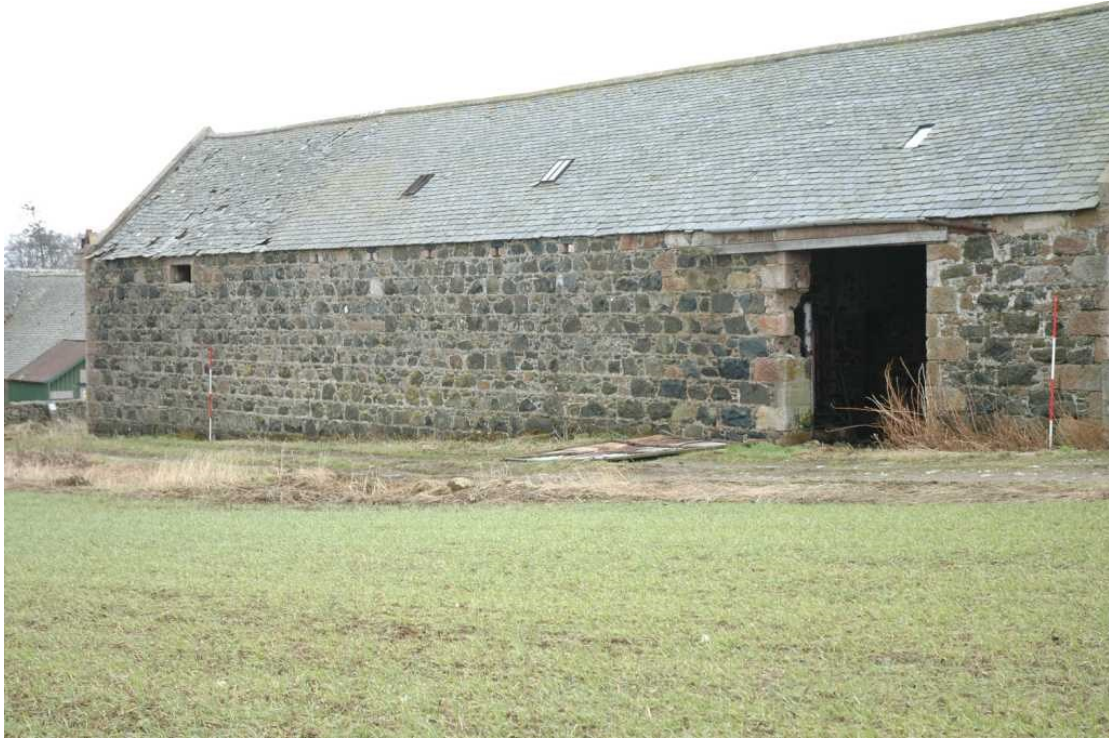
Walls Rubble stone with good horizontal courses. Predominance of buff-pink, fairly weathered stones (similar to W range). More grey stones in outer, N wall, so the use of pink/buff for the walls facing the inner court and road may have been a deliberate choice. Rybats of buff-pink granite.

Illus 19 N wall of N Range

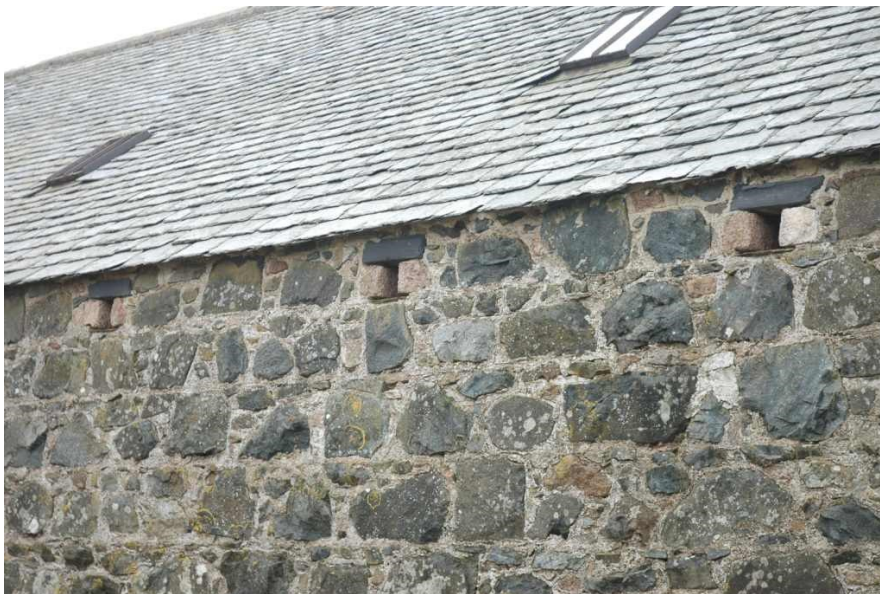
Vents 5 small vents along the top of the wall (not measured). These are angled down through the wall into the central byre (Illus 20, 27).

Illus 20 N wall of N Range. Detail of ventilators for byre. These go down diagonally through the wall to avoid draughts.

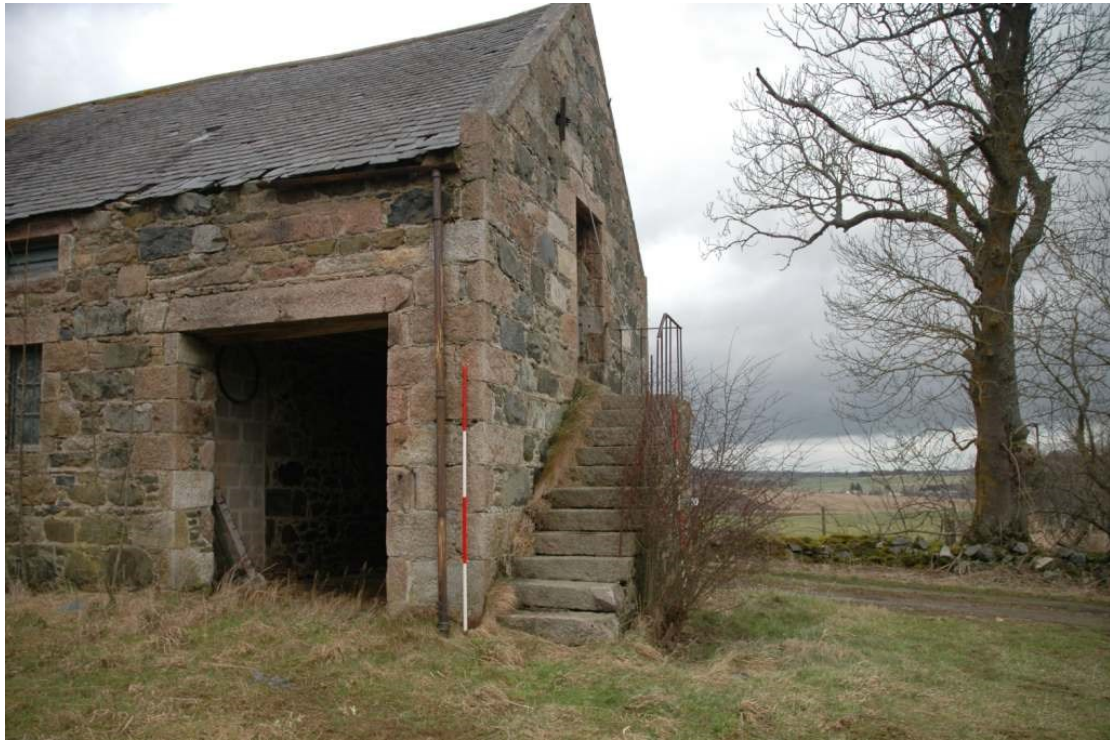
D23 (First floor) W:1.08m. H: 1.98m. Entered up flight of stone steps with iron railing. Steps 1m wide with treads 0.26m deep and 0.17m high. A small opening on the N side below the stairs was 400mm wide and 570mm high with a granite lintel and sides. There was no other access and it is possible that this was shelter for a dog.

Illus 21 N Range showing steps up to loft at E gable

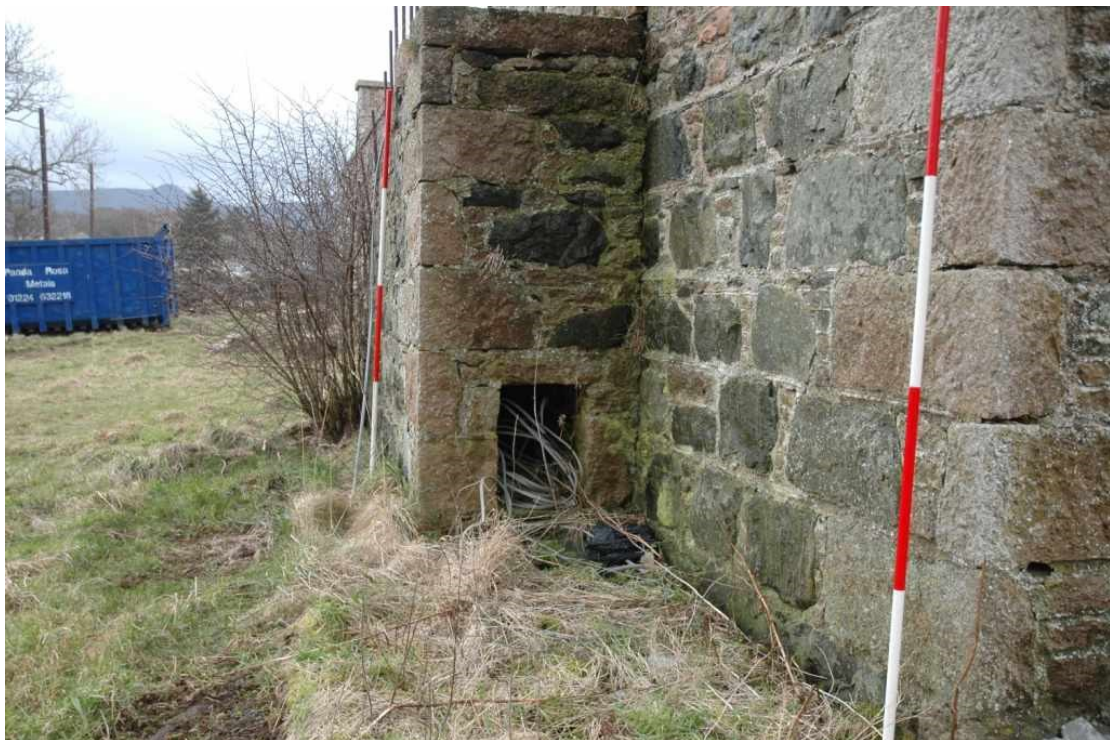
Illus 22 Steps in E gable of N Range. Small opening below steps- possibly for a dog?

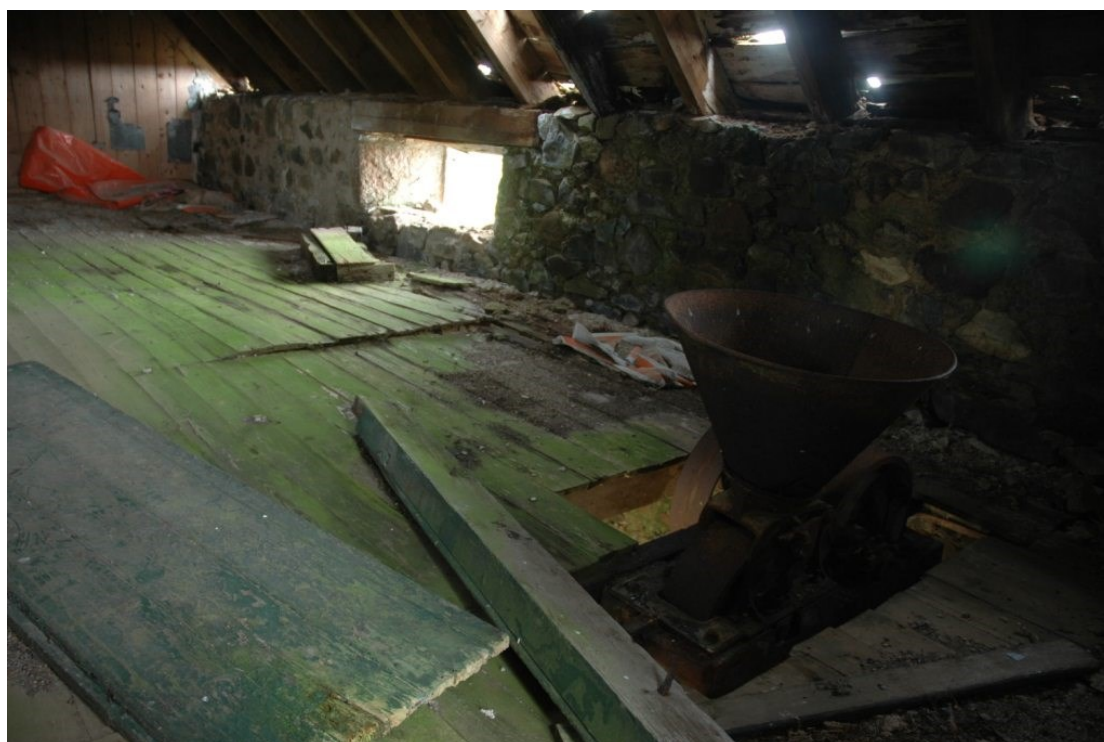
This was the only two-storied part of the steading. The loft floor was over the three E rooms, but the W room was open to the roof with a wooden partition at first floor level between it and the loft. There was a door (not measured) in this partition. The first floor could not be entered on safety grounds, but was photographed through D23 (Illus 23). The E end would have been the grain store and a small bruiser for crushing grain survived, with a wooden chute down into the E room below. Threshing would also have taken place here with a wooden chute for the chaff also remaining in the E room below. The E end of the loft was lit by two small windows.

Illus 23 View into loft from door in E gable. Note bruiser on RHS.

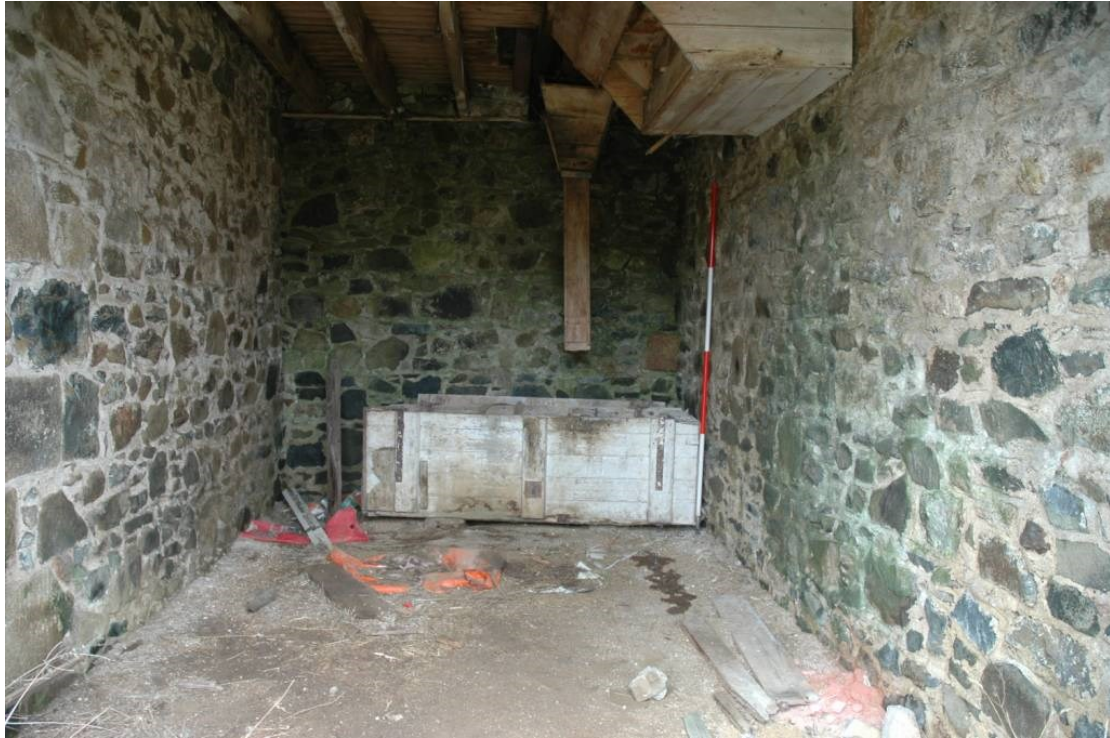
Illus 24 N Range E room with chutes for grain from bruiser (background) and for chaff from thresher (roof foreground)

The E room contained the chutes from the grain loft for both crushed grain from the bruiser and for chaff from the thresher (Illus 24). The quite small scale of this may suggest that this was a secondary use of this end of the loft as it could be expected that the threshing and bruising would originally have been undertaken by the water-powered mill on the opposite side of the road, beside the farmhouse. This smaller arrangement may have been run off a tractor belt or electric engine.

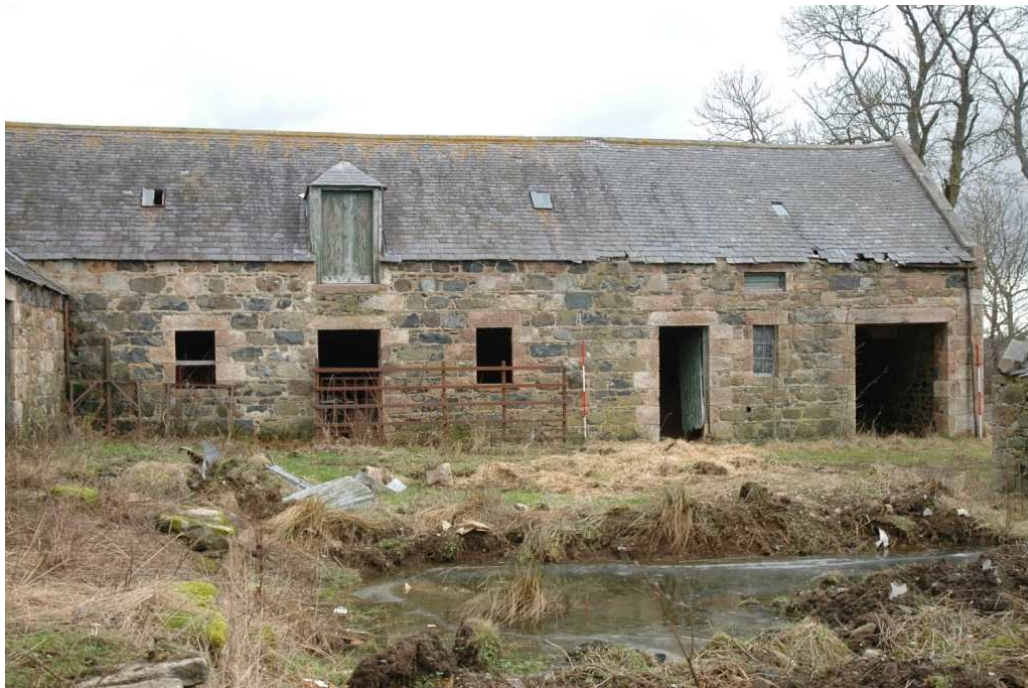
The W end is likely to have been a hay loft, loaded from the door D26 at first floor level (Illus 25) and forked down into the W end of the building through the 1st floor door in the wooden partition (Illus 26). This would have allowed easy access to feed cattle both in the byre in the N range and in the W range.

Illus 25 S wall of N Range, showing door to hay loft

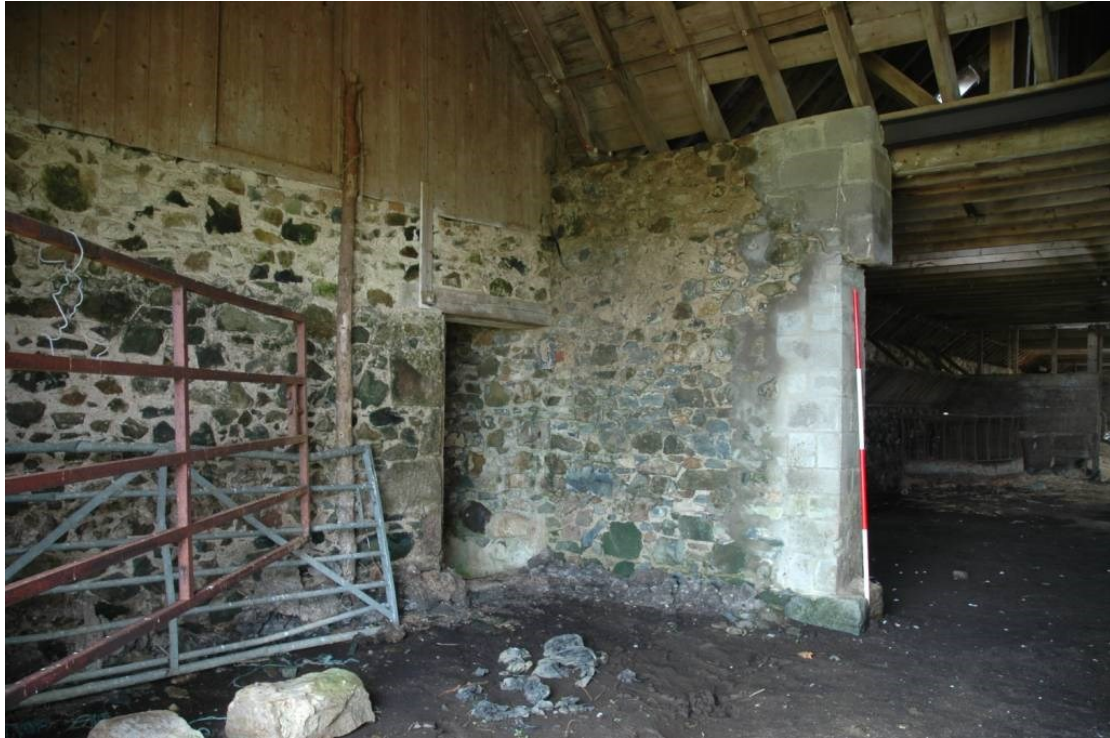
Illus 26 W end of N Range, looking SE showing door to byre and door to hayloft above in wooden upper partition (just L of vertical timber)

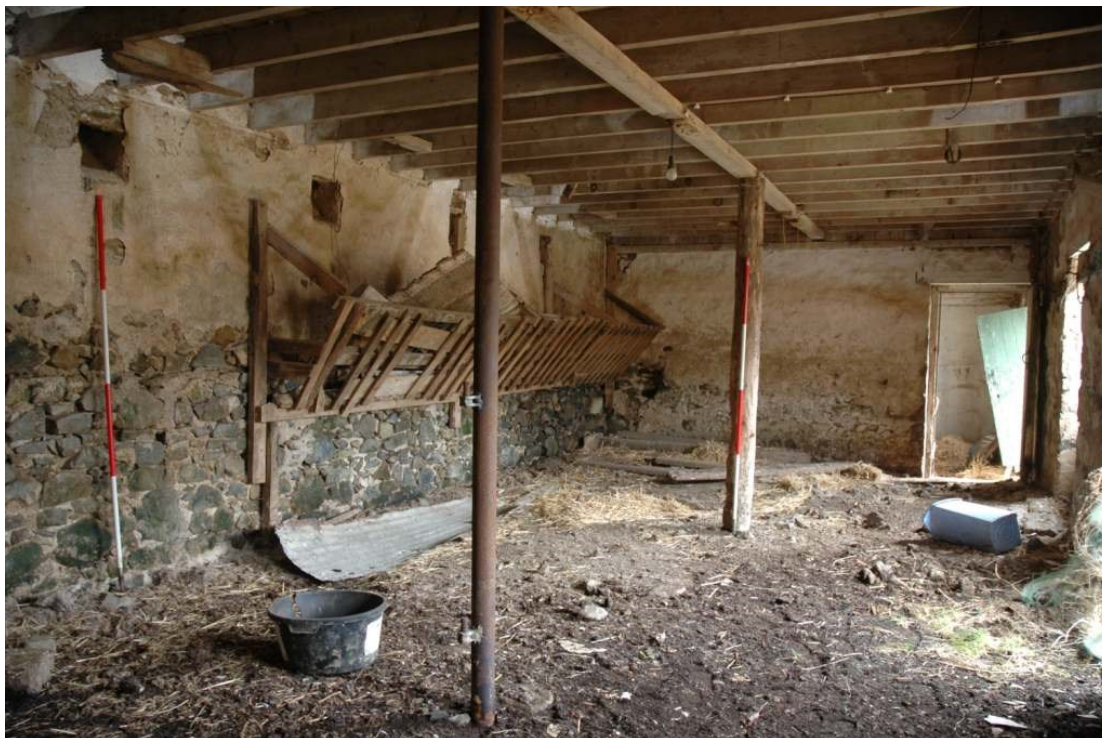
This area opened into a byre with 5 pad stones in the floor, each 2.65m S of the N wall and spaced to divide the interior into 6 bays, each 1.88m wide. The pad stones may have held trevis end posts that have since been removed, or may have been supports for the centre of the loft floor. This area was certainly intended for cattle/livestock as there were 5 vents angled up through the wall to keep the air fresh (Illus 27).

Illus 27 N Range byre. Note the inside of the ventilation shafts in N wall (LHS).

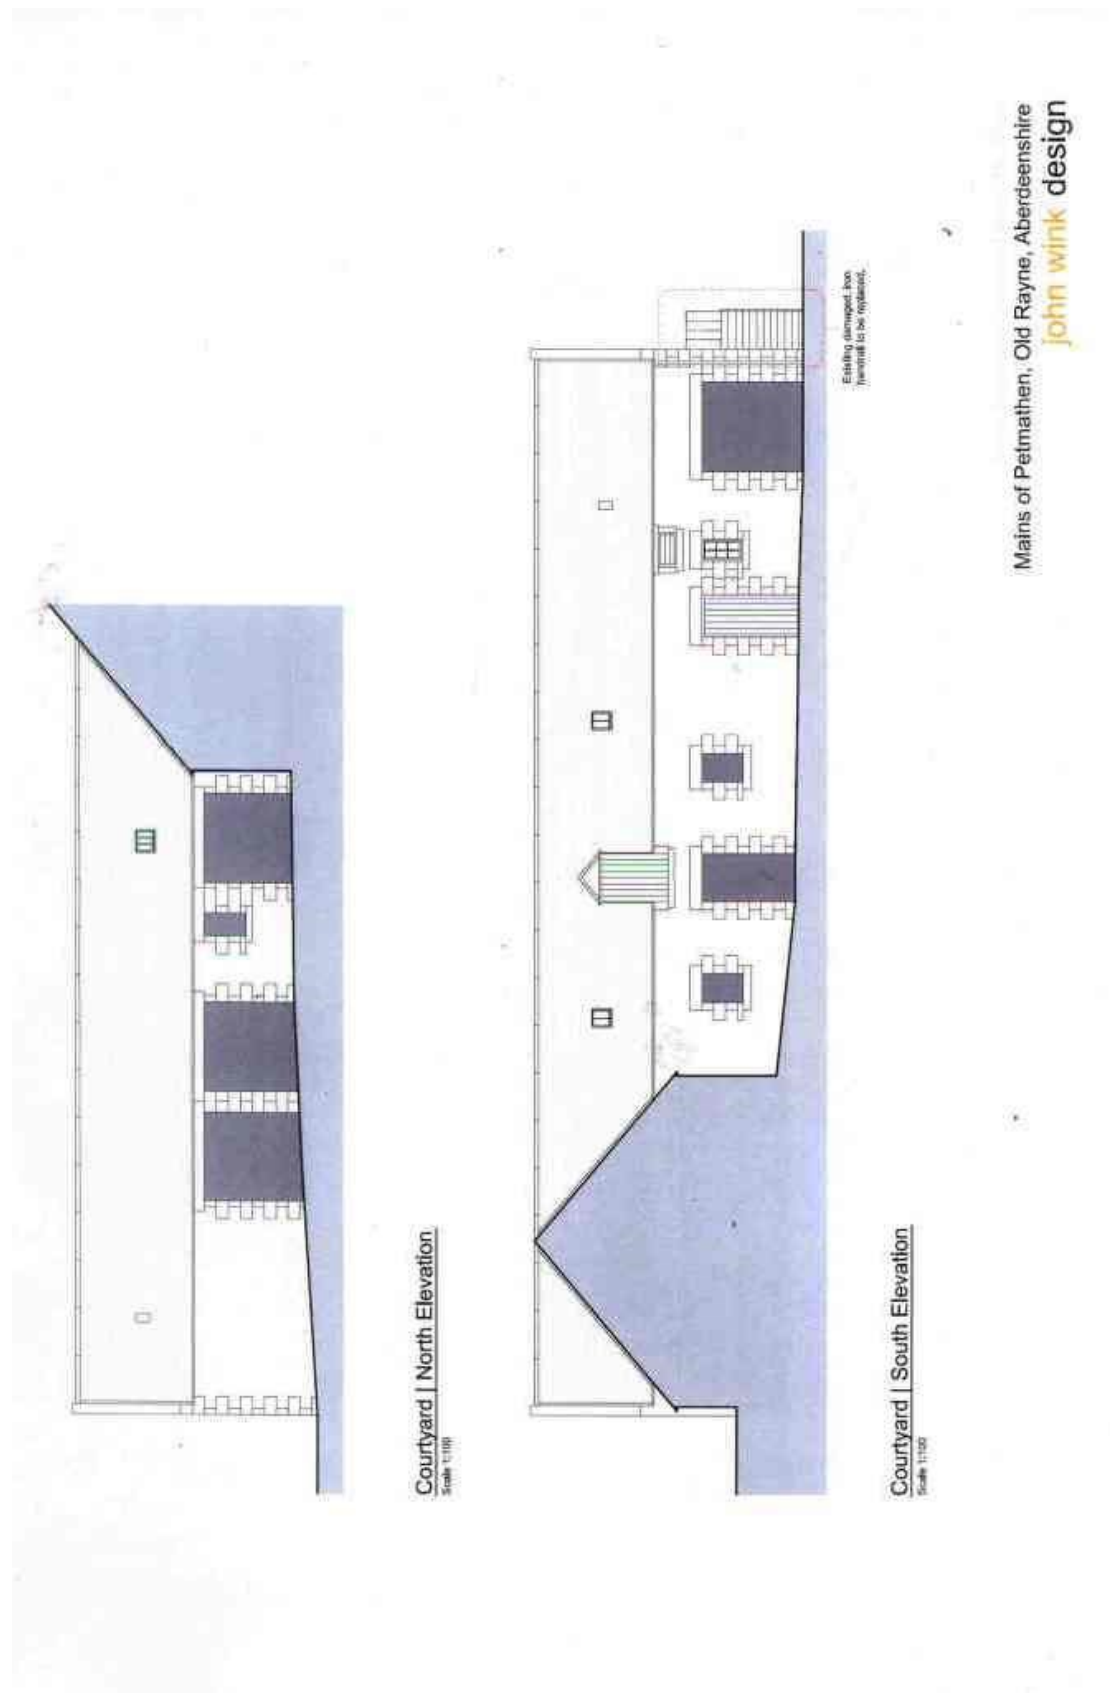
Illus 32 Elevations of N wall of S Range with cart bays(Courtyard N Elevation) and of S wall of N Range (Courtyard S Elevation.) (Drawings courtesy of John Wink Design).
