# CHAPEL FARM BUCKSBURN ABERDEEN

**- Archaeological Watching Brief -**  
Carried out 22nd February 2012  
by  
**Murray Archaeological Services Ltd**

**Report No: MAS 2012-6**  
by  
H K Murray & J C Murray

## **-Archaeological Watching Brief-**

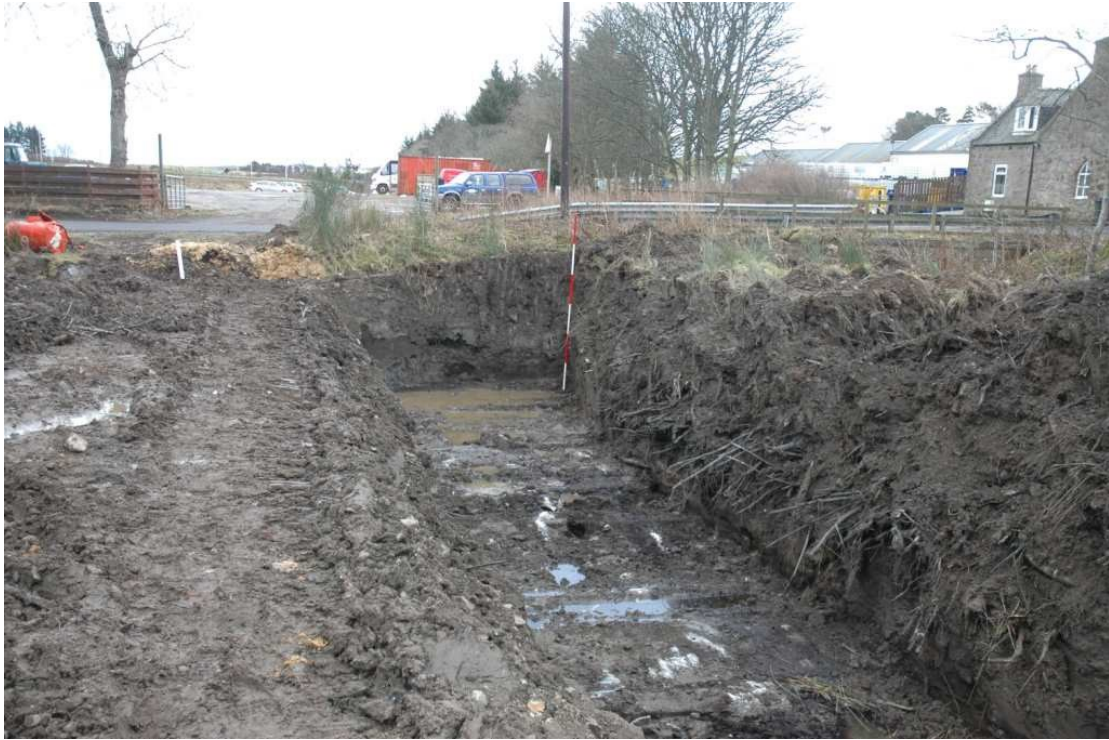
Before excavation began a large pile of tree debris was removed. The trench was excavated to natural ground at a depth of 2.5m at the E end and c. 2m at the W end. There was a uniform thickness of c.1.20m depth of dumped gritty earth and stone with occasional brick and occasional pieces of non-organic rubbish (1). This is the material dumped on the site c. 30 years ago.

For c. 10m from the E end of the trench this overlay up to 0.80m of stable straw and some brushwood (2). This would appear to have been dumped shortly before the site was levelled as the straw had not rotted fully due to the anaerobic conditions.

Illus 4 Trench looking E towards road

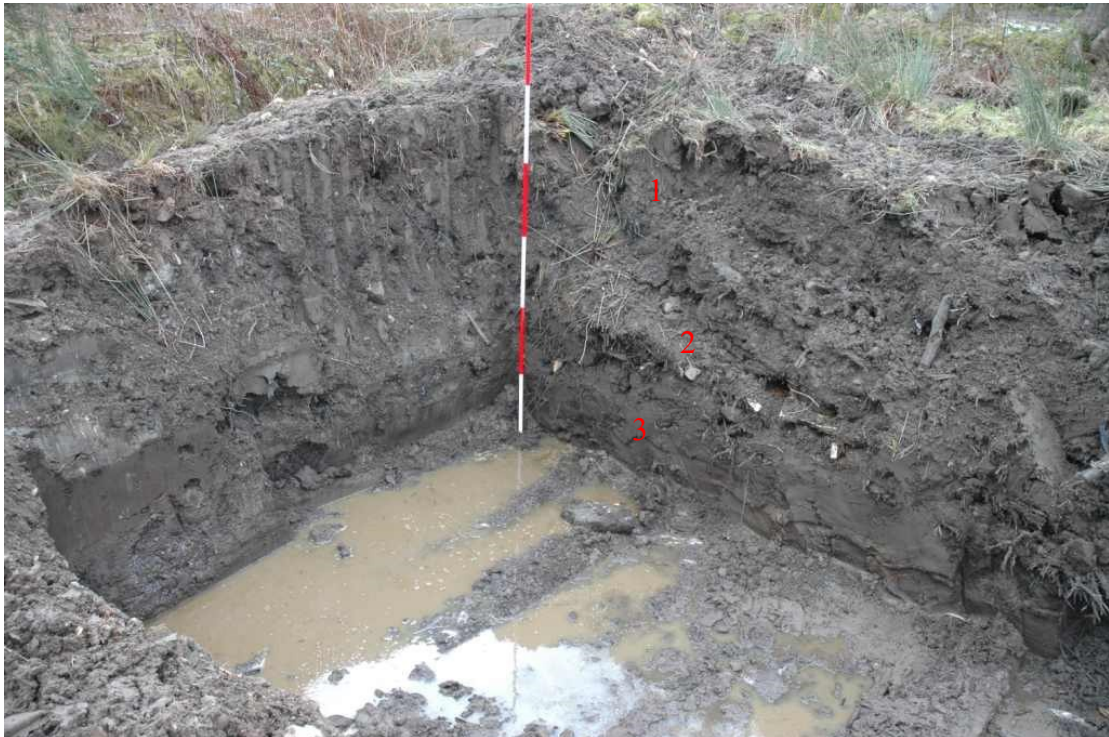
Below this there was c. 0.50m of fine grey silt (3) which appeared to be slightly thicker at the E end. This can probably be interpreted as the silting accumulated at the base of the mill pond. No artefacts were observed.

Over most of the trench the natural was compact boulder clay with large boulders in it (4). This was patchily covered by a thin skim of brown peat (5), possibly accumulated when this natural hollow was waterlogged.

Illus 5 S section E end. Darker silt at base. Layer numbers in red.
