BLAIRS ABERDEENSHIRE

Part 1: Historic Landscape Survey

Carried out March 2012
by
Murray Archaeological Services Ltd

Report No: MAS 2012-08
by
H K Murray and J C Murray

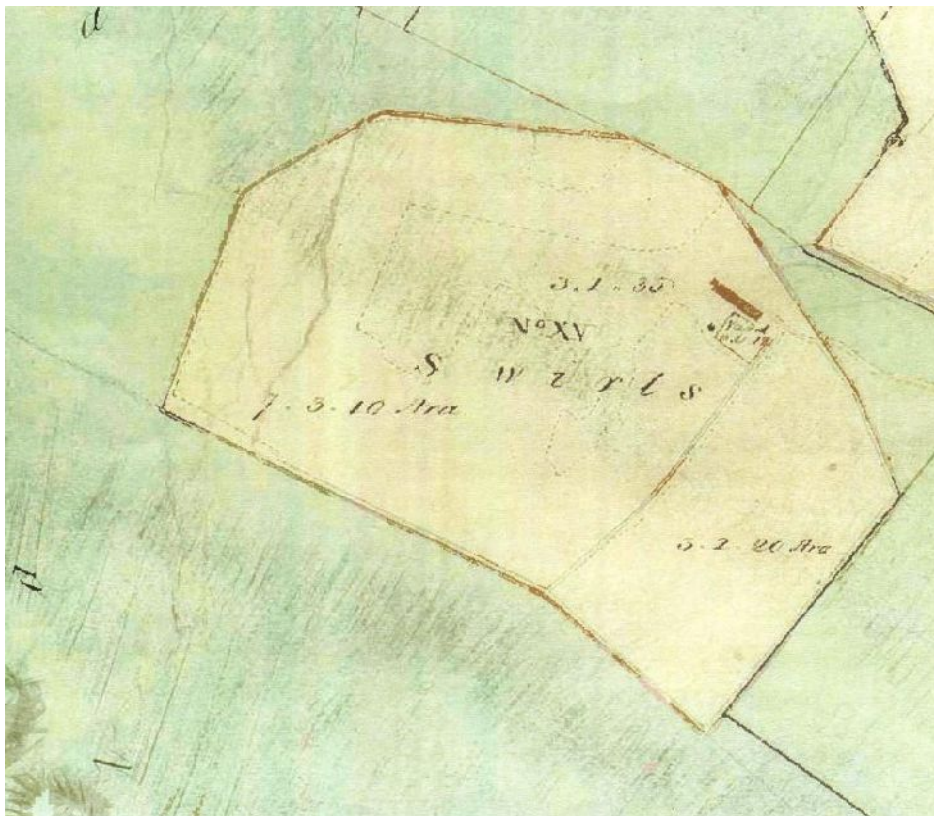
Illus 4 Swirls on 1842 estate map (Muir Group)

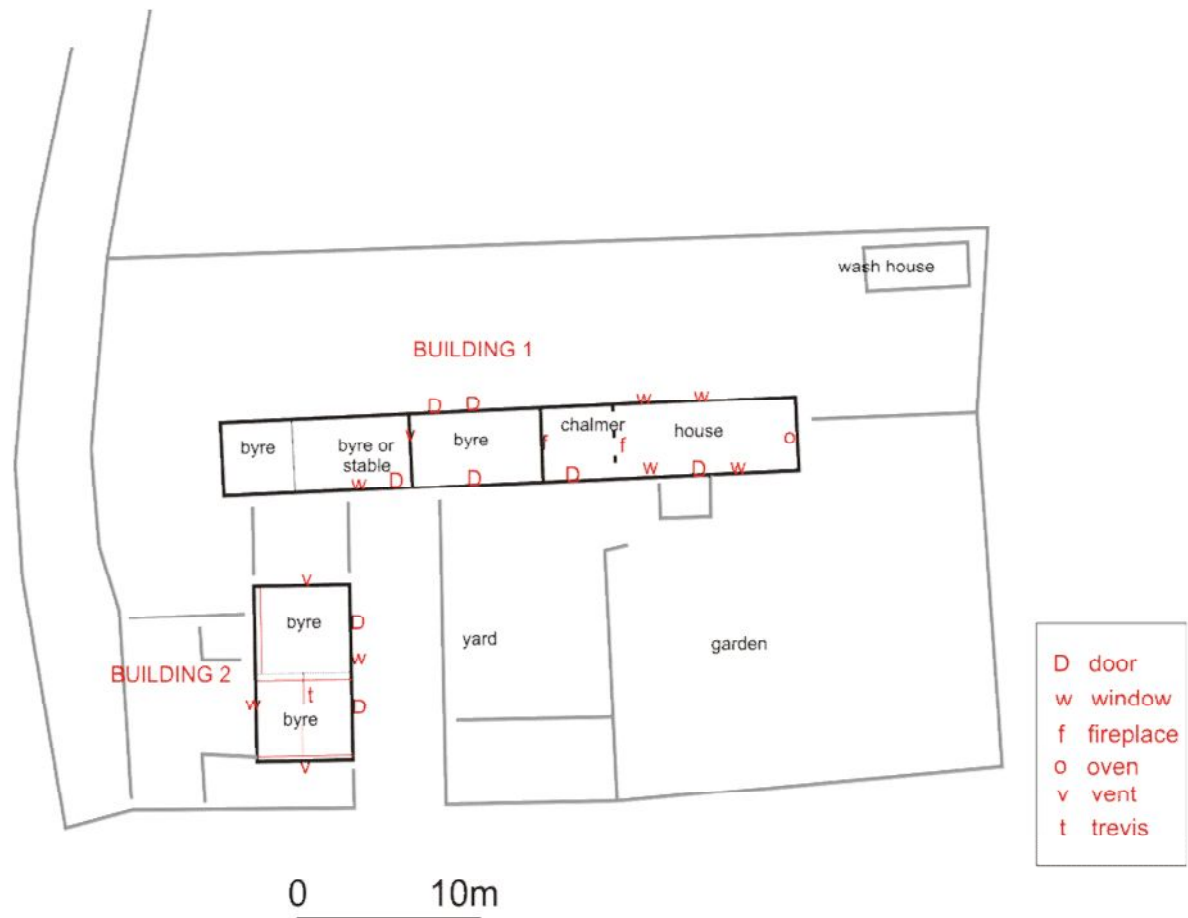
Illus 5 Swirls: annotated plan

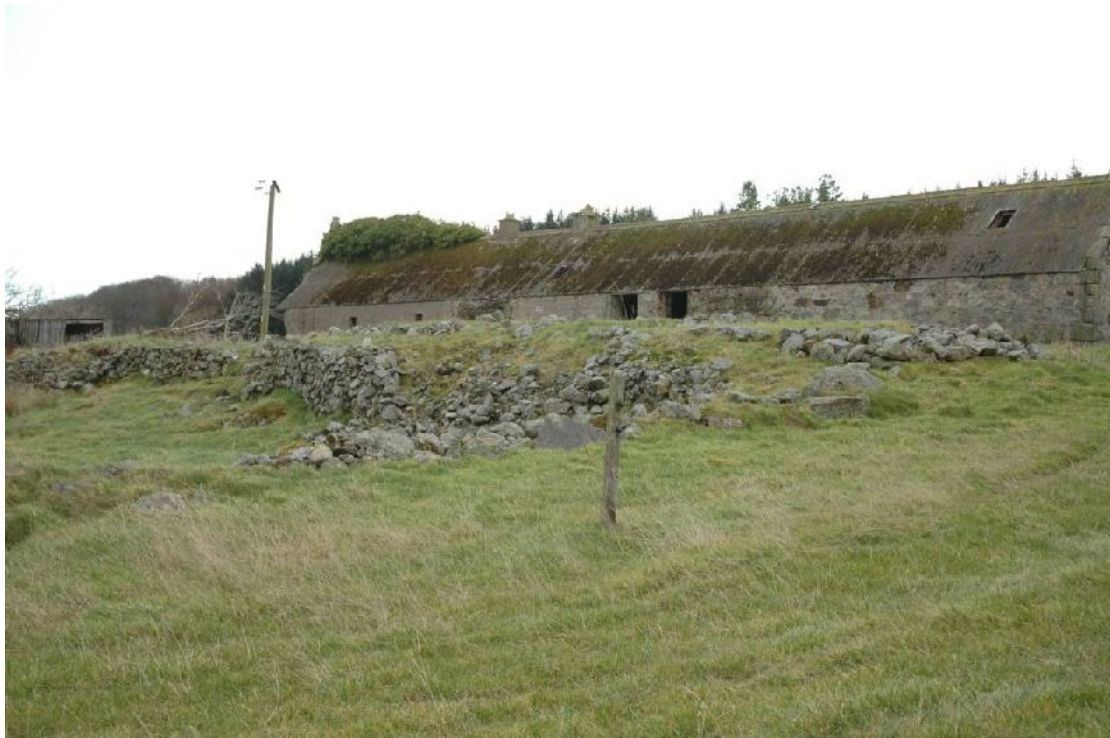
Illus 6 Swirls seen from the NW, Building 1.

Dimensions 23.8 x 5.3m total externally

Original Use Dwelling to E, byres to W

Walls Rubble stone, partially harled at E end.

Roof Corrugated asbestos.

This building appears to have developed in three stages. The E comprised a dwelling to the E and byre to the W. Before 1842 this had been extended to the W by a second byre and between 1865 and 1899 it had been extended further to the W to its present length.

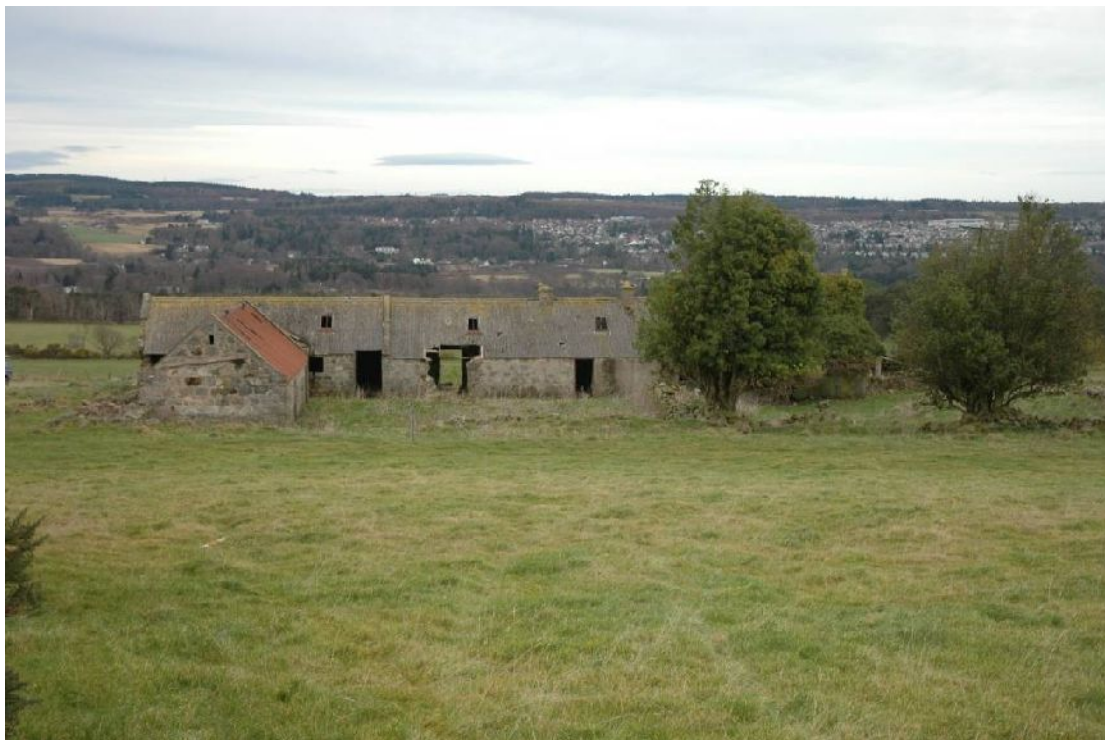
Illus 7 Swirls seen from the higher ground to S with Building 2 (red roof) to LHS and Building 1 behind.

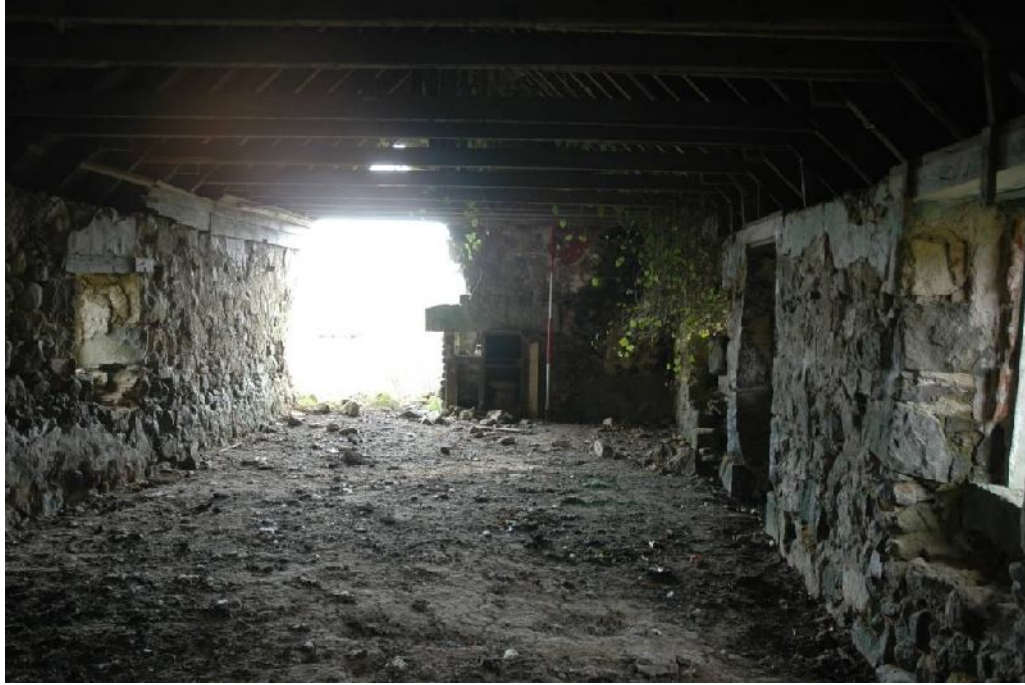
The E dwelling end is now a single open area with only the chimney stack and raggles on the N and S walls indicating that it had originally been a main dwelling to the E and a separate room for a single worker to the W with both ends having separate doors in the S wall into the garden and yard respectively.

The main dwelling area has an oven in the E gable and a fire at the missing W wall. The oven was secondary built in with bricks below the original granite lintel, it was the same as those at Braeside Cottages and may have been an estate improvement.

The door was central in the S wall, flanked by two windows. A porch is a late addition. There were two windows in the N wall, one opposite the door, one further W. Traces of plaster were coloured deep green and deep red.

Illus 8 Inside Building 1, looking E from room 2 to room 1

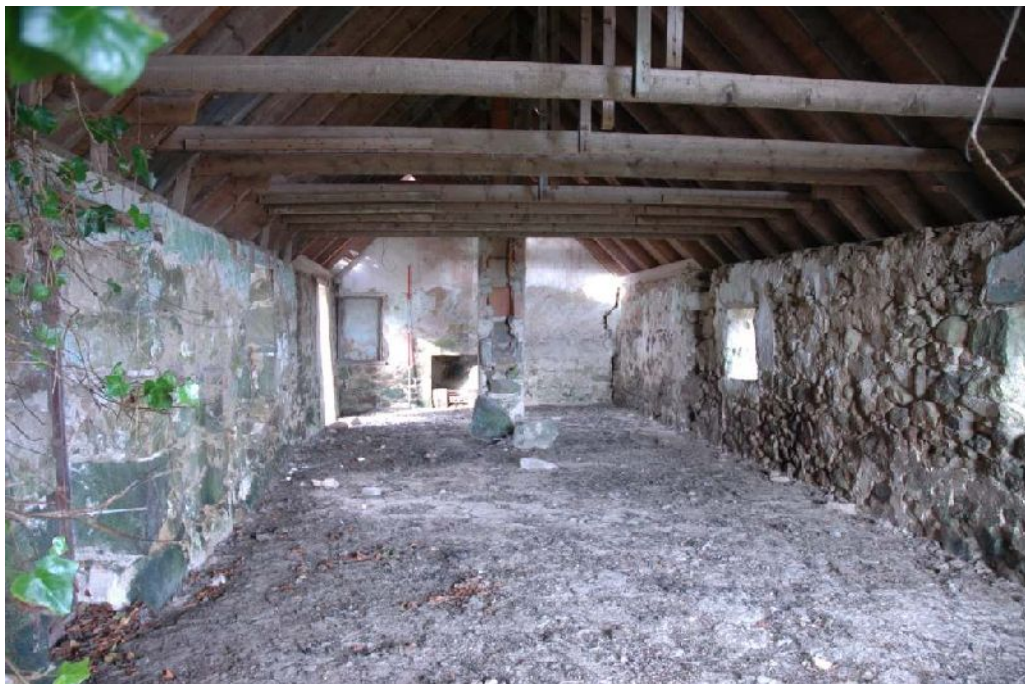
The W room had a door into the yard and a fireplace in the W wall with a cupboard (possibly originally a window) to the LHS. This end had been reroofed and had a roof-light.

Illus 9 Inside Building 1, looking W from room 1 to room 2. The scar of the intervening wall can be seen to the RHS of the remains of the chimney in centre.

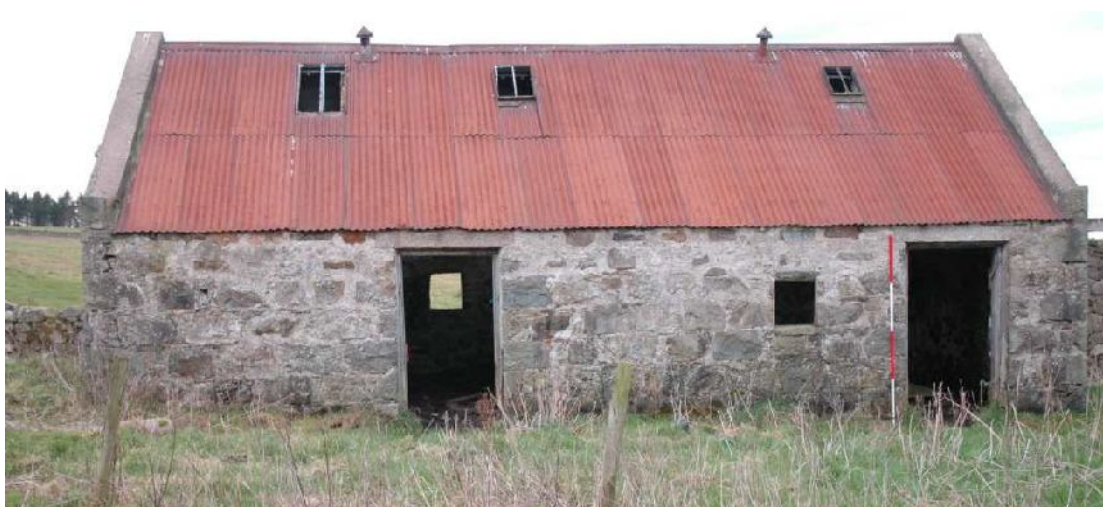
Illus 10 Building 2, looking W

Dimensions 10.35 x 5.10m externally. This is divided by a wall to head height into two equal compartments, each with a door in the E wall into the yard. The S compartment had a window facing W, the N compartment had a window to the E. There were blocked air vents in both gables.

Original Use Cattle byre

Walls Rubble stone with roughly squared rybats.

Roof Corrugated iron with metal skylights and vents.

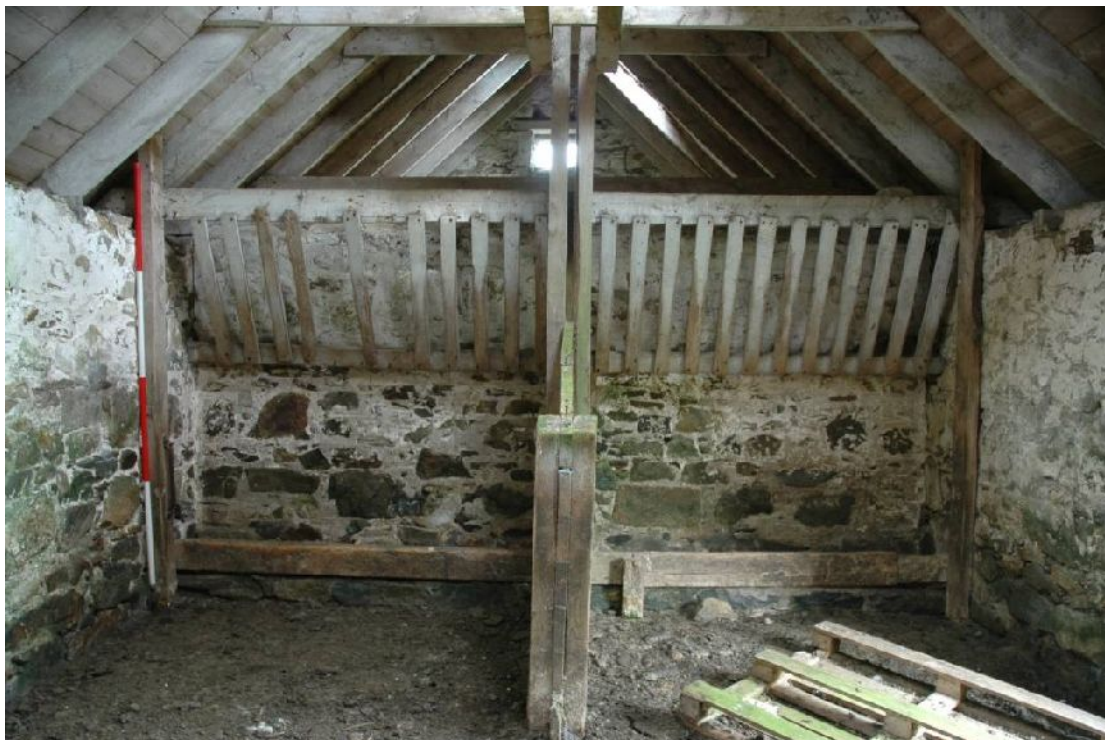
Interior The S compartment had floor level troughs along the N and S walls with timber hay hakes above. Fixings for cow neck chains remained and on the N side a timber trevis survived. Traces of a matching trevis at the S remained as scars on the floor. The floor was cobbled. This would have held 8 tied cows.

Illus 11 Detail of byre in Building 2, S compartment showing trevis with standing for two cows either side

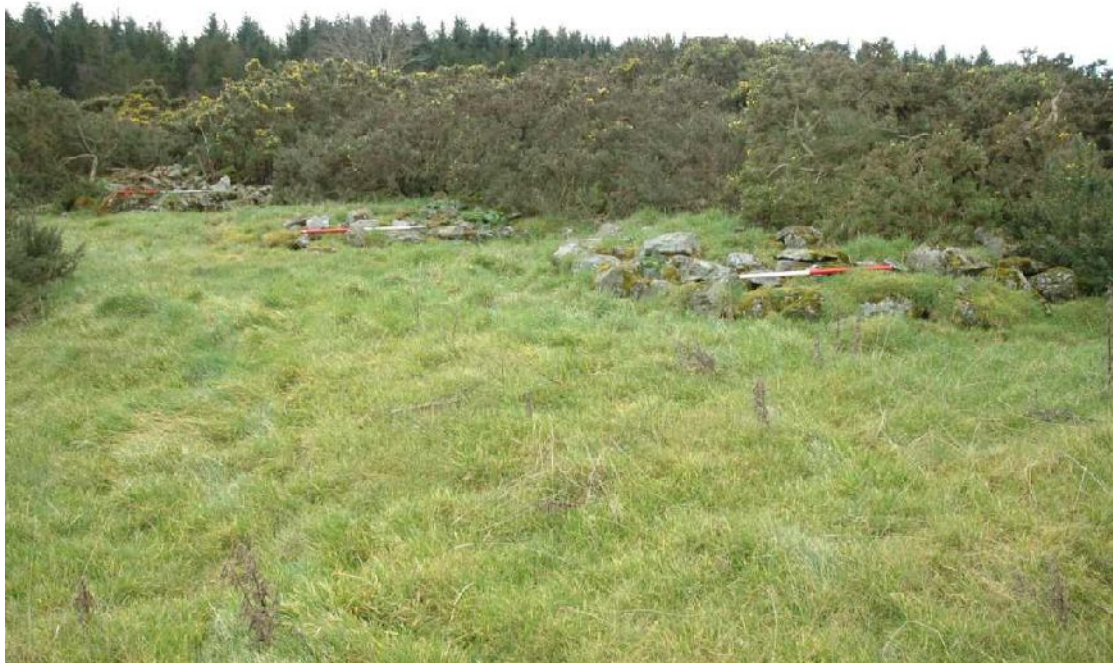
The yard had been enclosed with the stackyard c. 50m SSW up the hill (centred at 387696, 800017). Five stack bases 3.5-4m in diameter and c. 300-500mm high were identified; others may remain under the dense gorse.

Illus 12 Stack bases S of Swirls

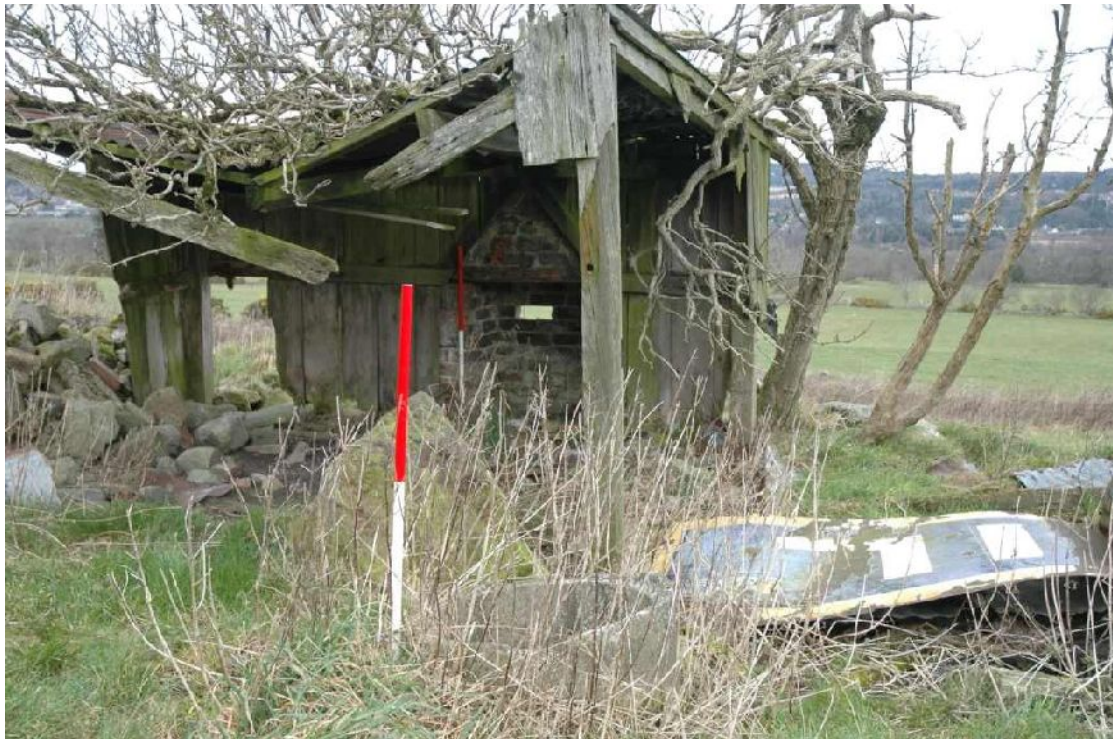
Directly to the N of the E end of Building 1 there was the well (now a concrete ring construction but on the location marked from 1865). Beside this a small tin-roofed

timber lean-to, 3.6 x 2.8m, with a brick-built fireplace can probably be identified as the wash house. Stone rubble suggests this had replaced a slightly larger stone walled structure.

Illus 13 Wash house at Swirls

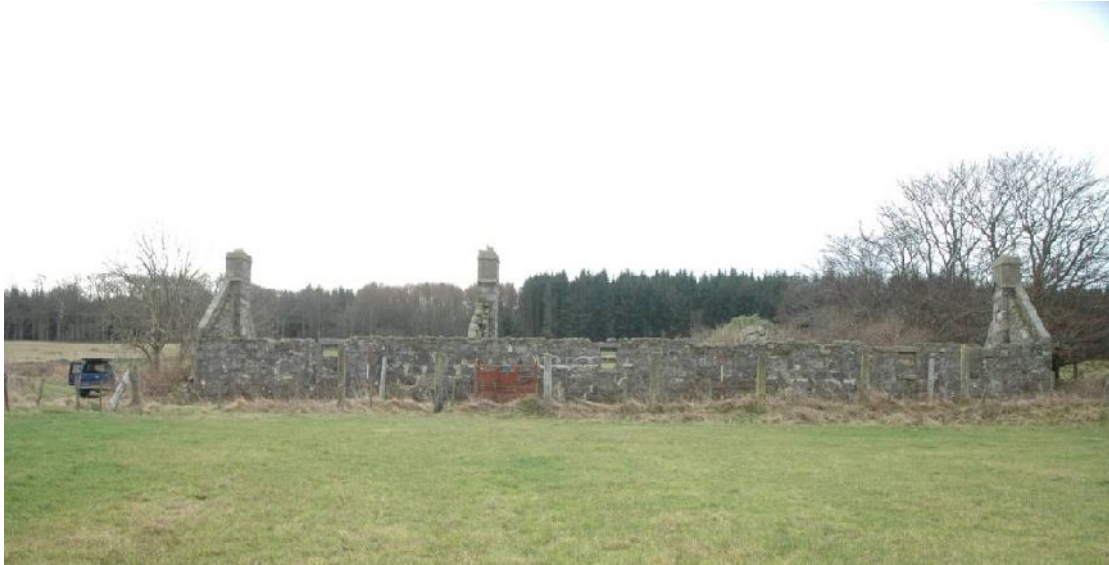
Illus 15 Braeside looking S.

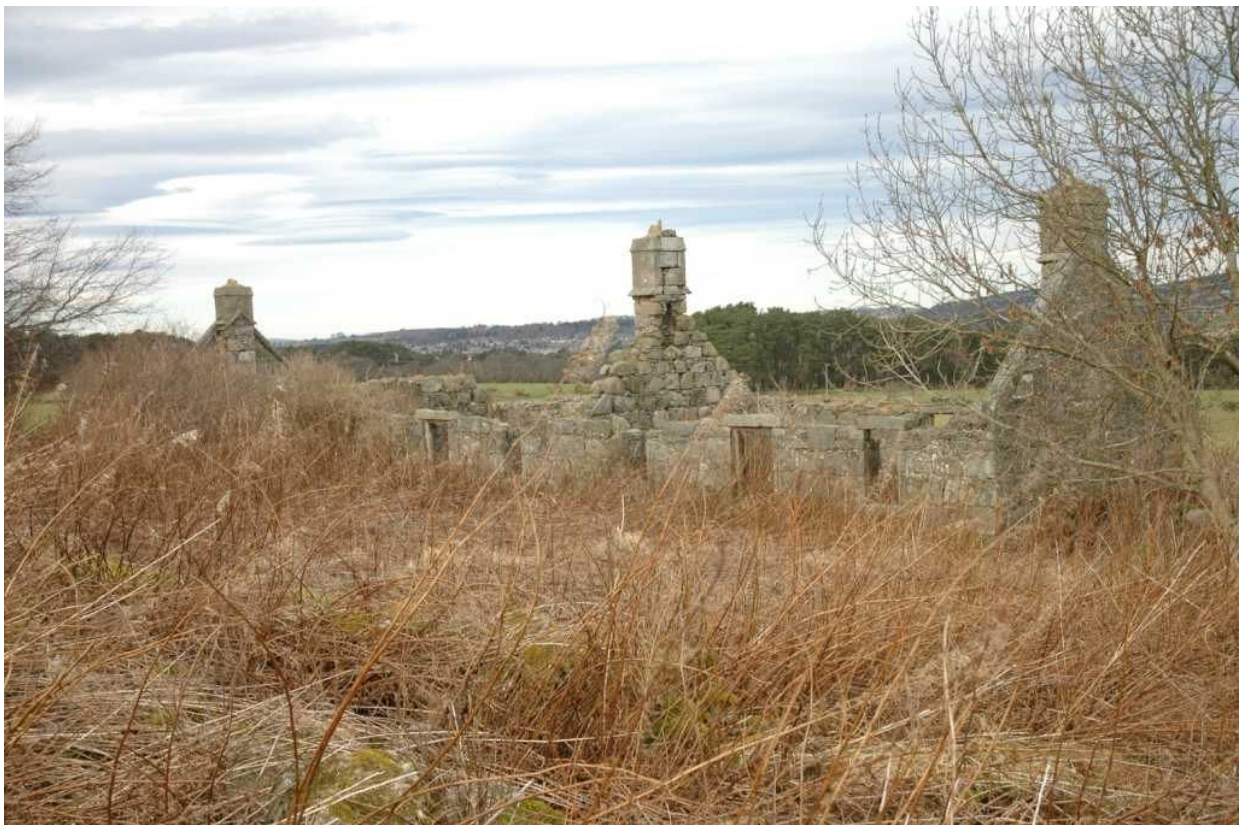
Illus 16 Braeside looking N at S frontage

The walls are of rubble stone with rybats, lintels and sills roughly dressed. Collapsed slate suggests the last roof was of slate, although it may originally have been thatched. The three surviving chimneys were of granite of same design (Illus 17) as those on the Menzies House and related buildings (see Part 2).

Each unit had a central door in the S face, flanked by two windows. A third window faced the door in the N wall. There were chimneys at each gable and in the dividing walls and each unit had a fireplace at one end and a cast iron oven at the other, with a cupboard alcove to one side. No internal wooden walls survived but the arrangement suggests a division into a bed room with a fireplace and a kitchen/living room with an oven, both opening off a central lobby, possibly with a cupboard/ small room with the central N window.

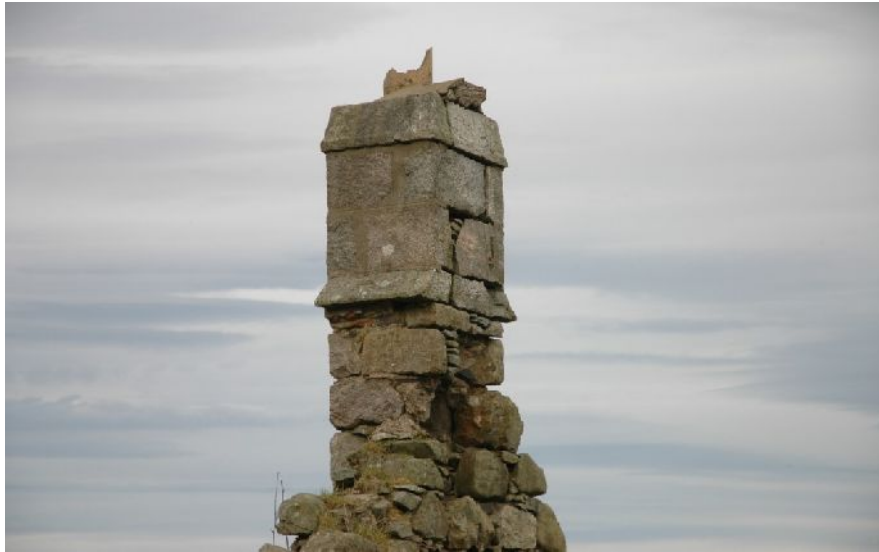
Illus 17 Braeside. Above: detail of chimney stack

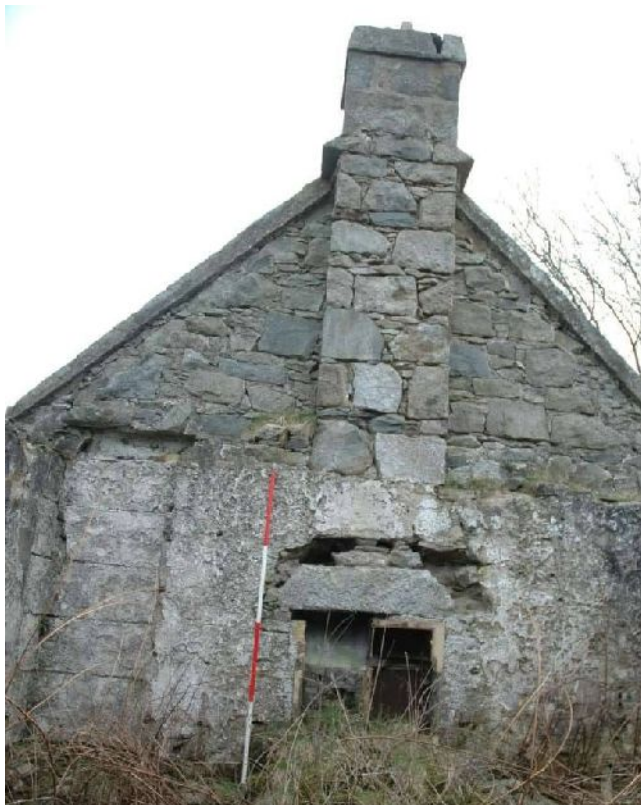
**Illus 18 Braeside. Right: interior showing oven and cupboard
oven and cupboard.**

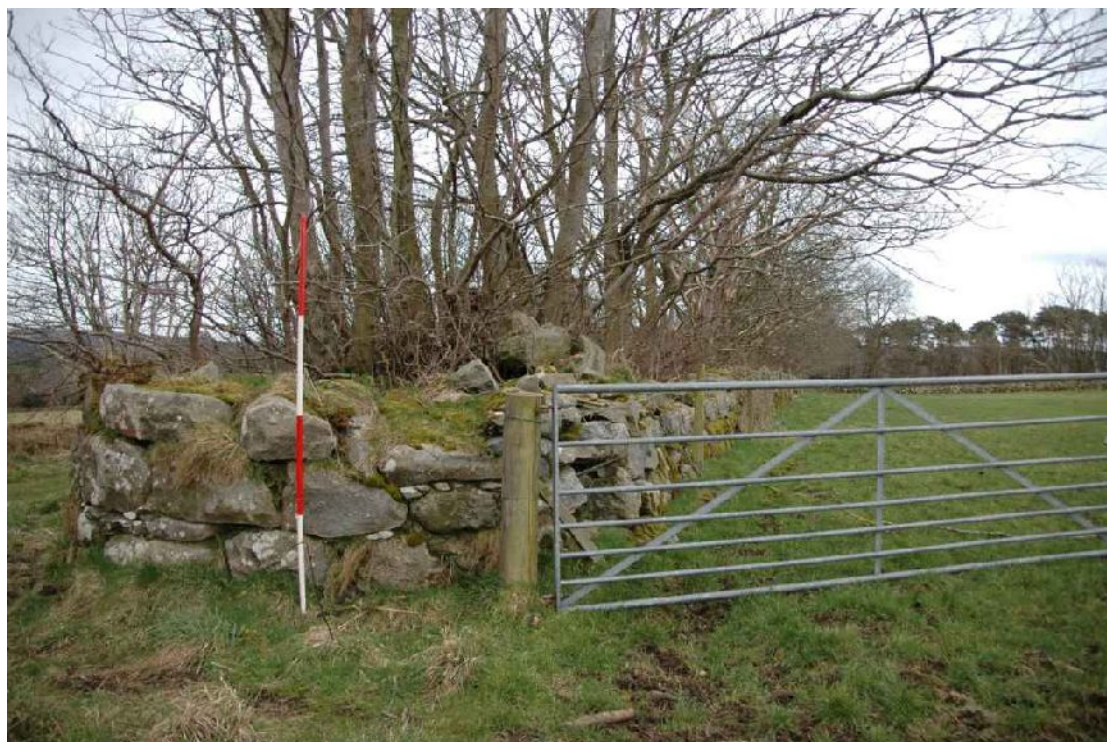
Most of the original field gateways from the main E/W stock road survive in good condition; these are clearly shown from the 1842 map onwards. All are of fine drystone construction with elegantly rounded corners allowing smooth movement of livestock. The internal gap is 3m (10 foot).

Illus 20 Rounded dyke at field gateway

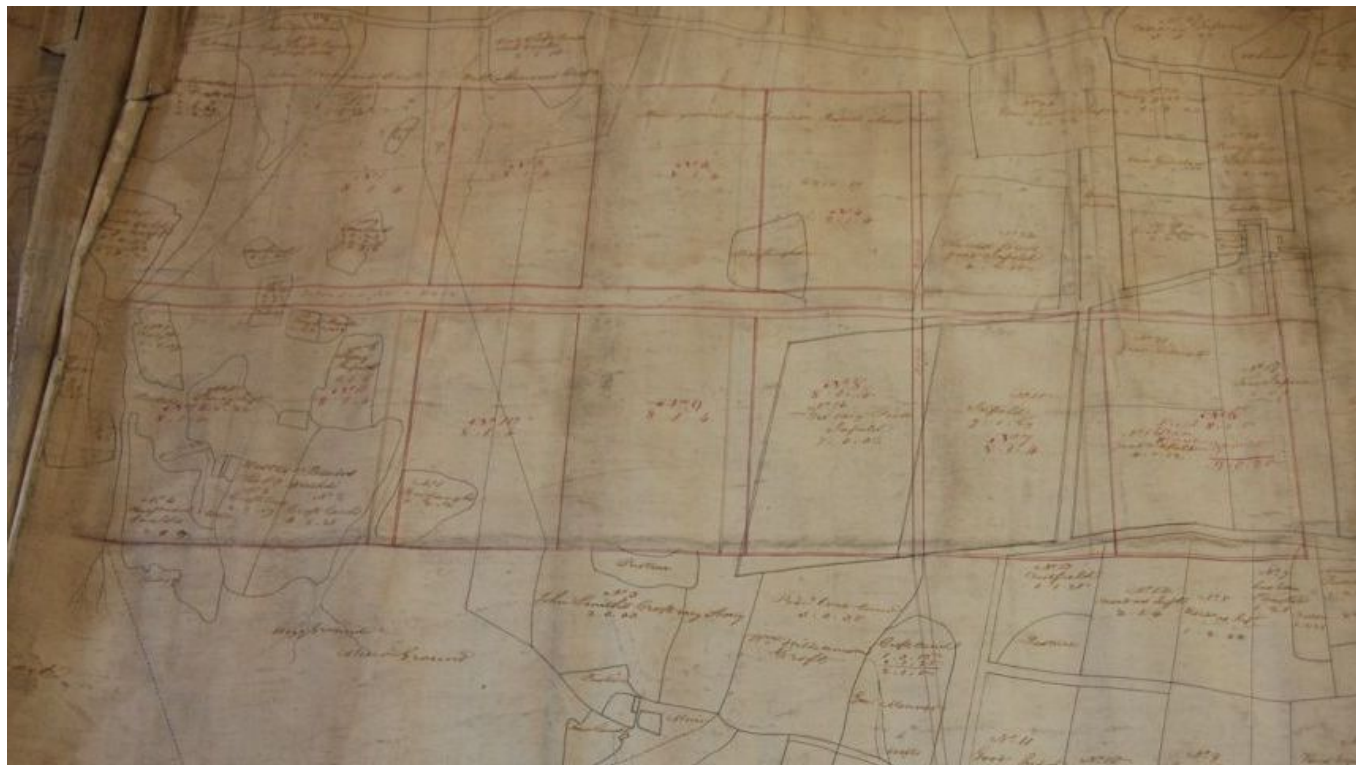
The main late 18th century Improvements drawn in red ink and pencil on the late 18th century map, show the grid pattern of enclosed fields extending E/W from the mansion and steading, with the stock road realigned to approach the steading from the S. The mill system has not been developed but is planned as one park is marked to have the dam. Several changes to the steading are marked in pencil.

Illus 21 New grid pattern (red) superimposed on earlier field system. Late 18th century estate map. (Blairs Museum T6270 BLRBM)

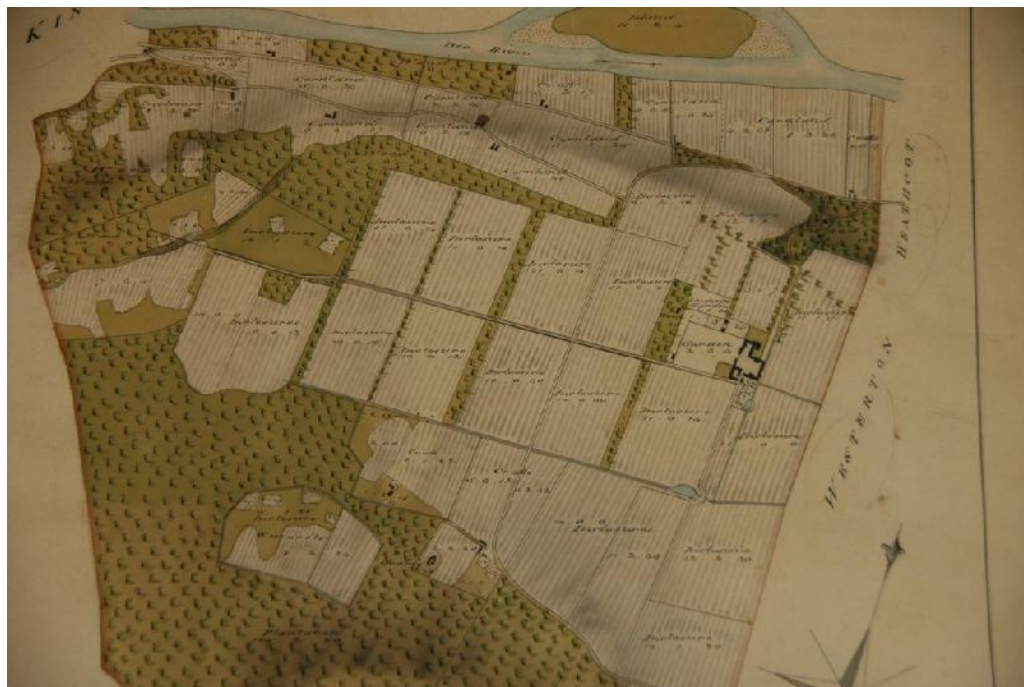
Illus 22 1830 estate map (Blairs Museum T6589 BLRBM)

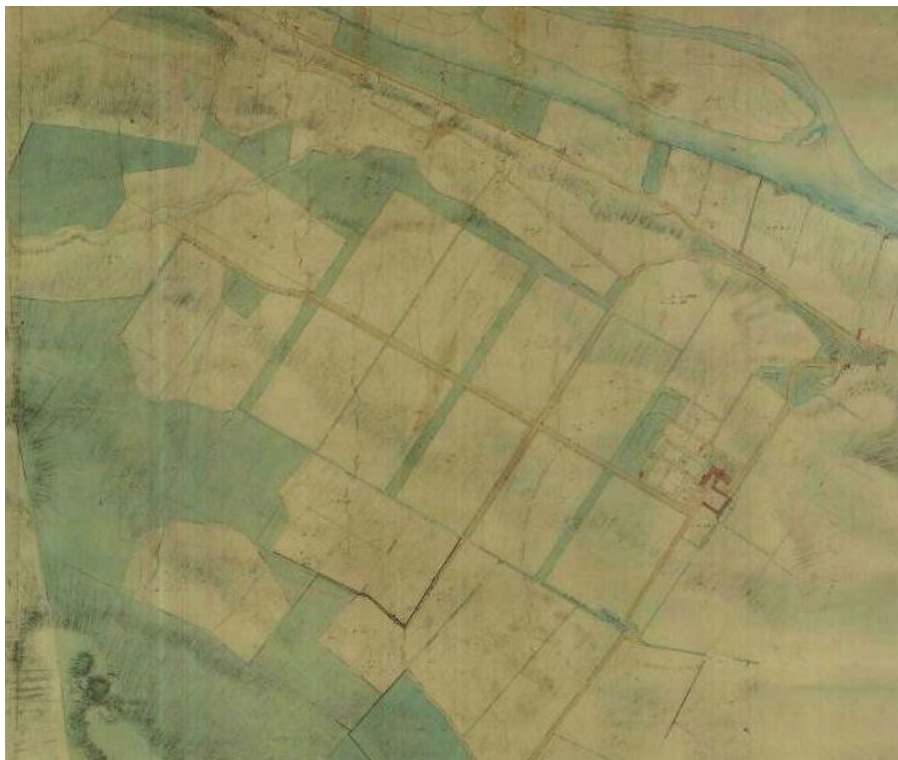
Illus 23 1842 estate map (Muir Group)

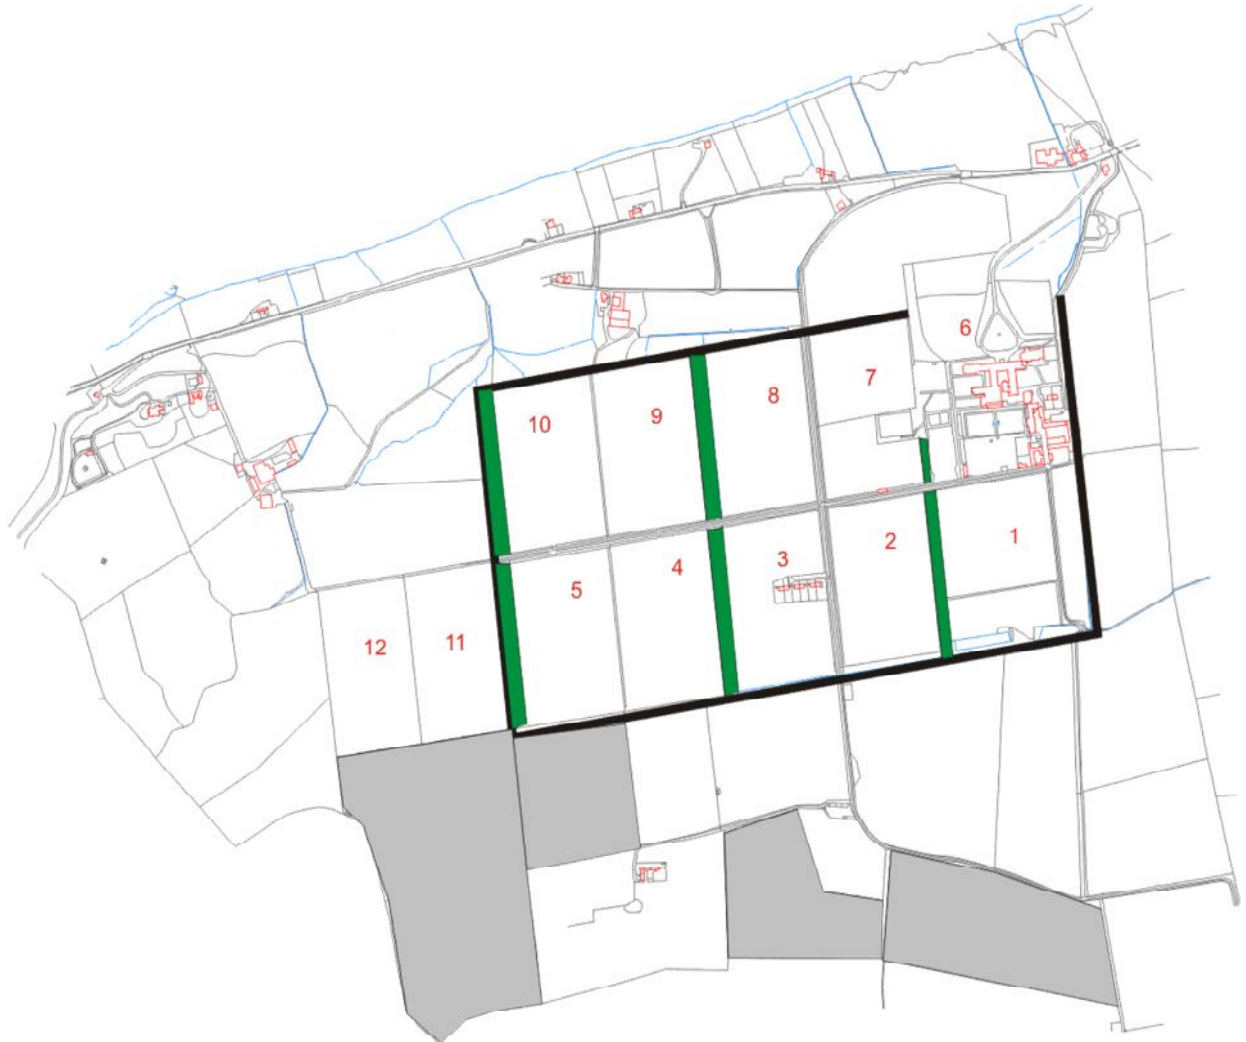
Illus 24 Estate showing the late 18th century grid layout. Grey shading denotes land in plantations for most of the 19th century but in cultivation by 1899. Based on OS. Reproduced from Ordnance Survey digital map data, © Crown Copyright, All rights reserved. 2012. License No 0100031673)

By 1899 further land has been brought into cultivation in areas near Swirls and Braeside shown earlier as plantations (grey on Illus 24) and at the same time the former irregular field pattern in this area has been changed to a more or less rectilinear layout. The farm at Maidenfold shows additional improvements with a new house and an additional steading building erected. Only minor changes are shown to the other crofts.
