MAINS OF BALQUHAIN CHAPEL OF GARIOCH, INVERURIE ABERDEENSHIRE

- Archaeological Watching Brief -
Carried out 7th May 2012
by
Murray Archaeological Services Ltd

Report No: MAS 2012-14
by
J C Murray

-Archaeological Watching Brief-

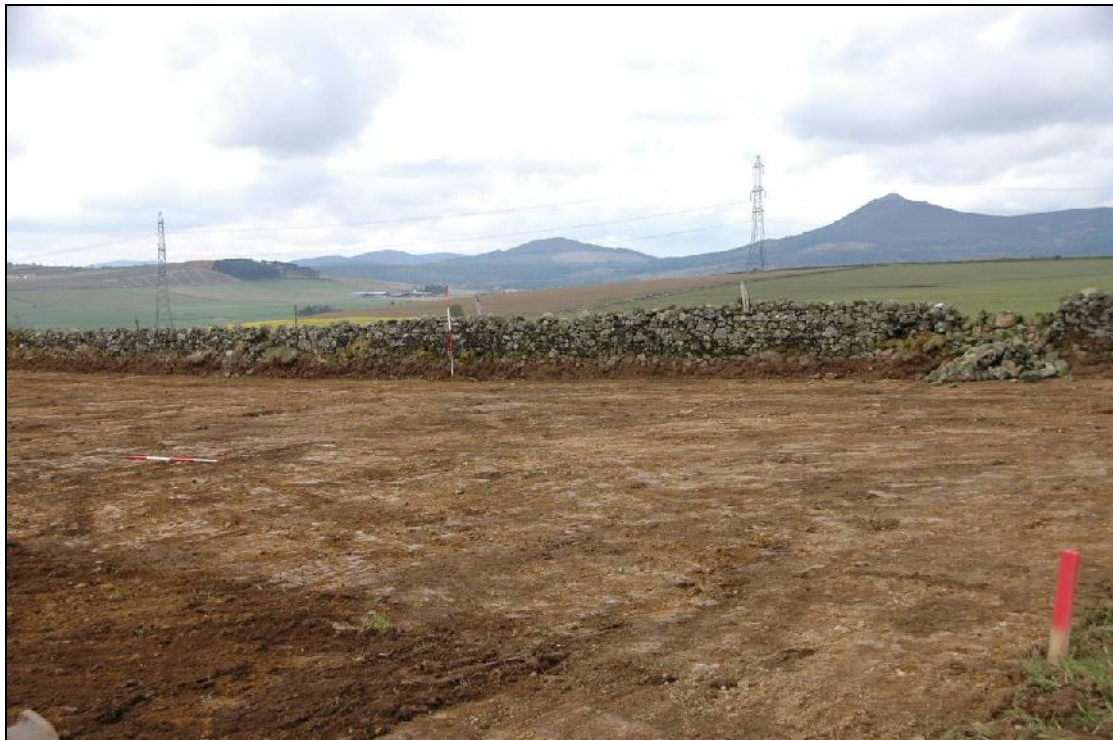
- 4.2 Area of Turbine Base and Hard Standing: Located at the summit of the hill, this area measured 43.5m (N-S) x 30m (E-W). In general, the depth of dark brown ploughsoil removed was c.250-260mm, except on the N side of the area where it was as little as 180mm (see Illus 6). The soil overlay yellow hard sandy natural.
- 4.3 With the exception of modern plough marks and a single modern field drain, no other features were present.

No archaeological features or finds were evident.

Illus 5: General view across the area of hard standing to Bennachie, looking SW
