**OLD SAWMILL,
CAMBUS O'MAY
BALLATER
ABERDEENSHIRE**

Standing Building Survey

Carried out July 5th, 2012

Murray Archaeological Services Ltd

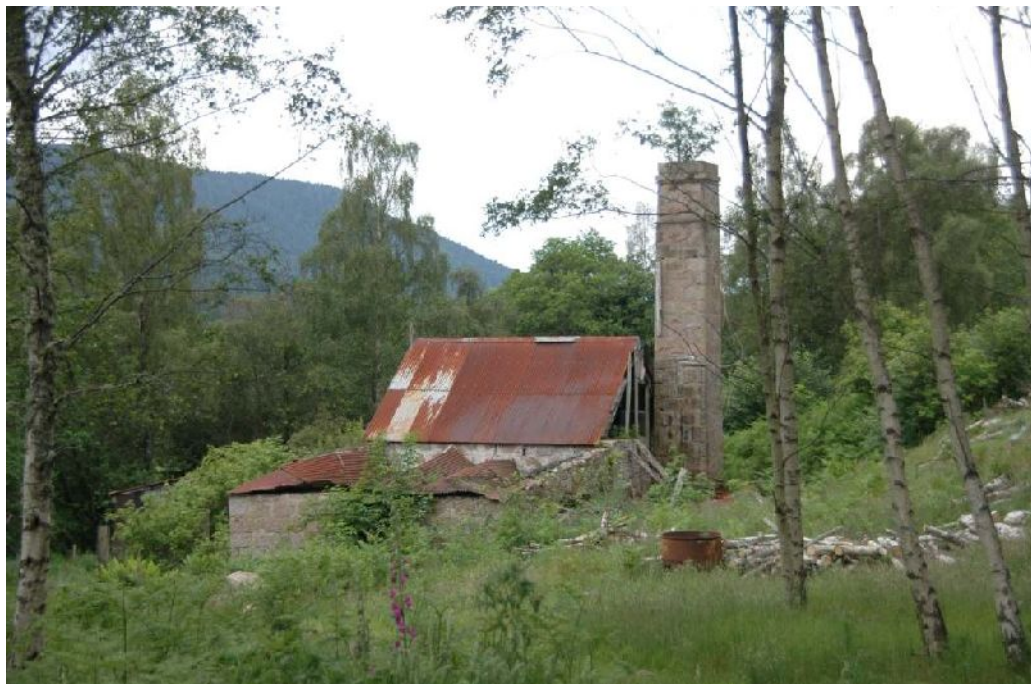
The site lies on the N bank of the River Dee, between the river and the A93 Aberdeen to Ballater road, some 2 miles E of Ballater. The buildings are tucked into a steep slope up from the river (Illus 1), with the Culsten Burn to the NW.

Illus 1 The site, general view looking W

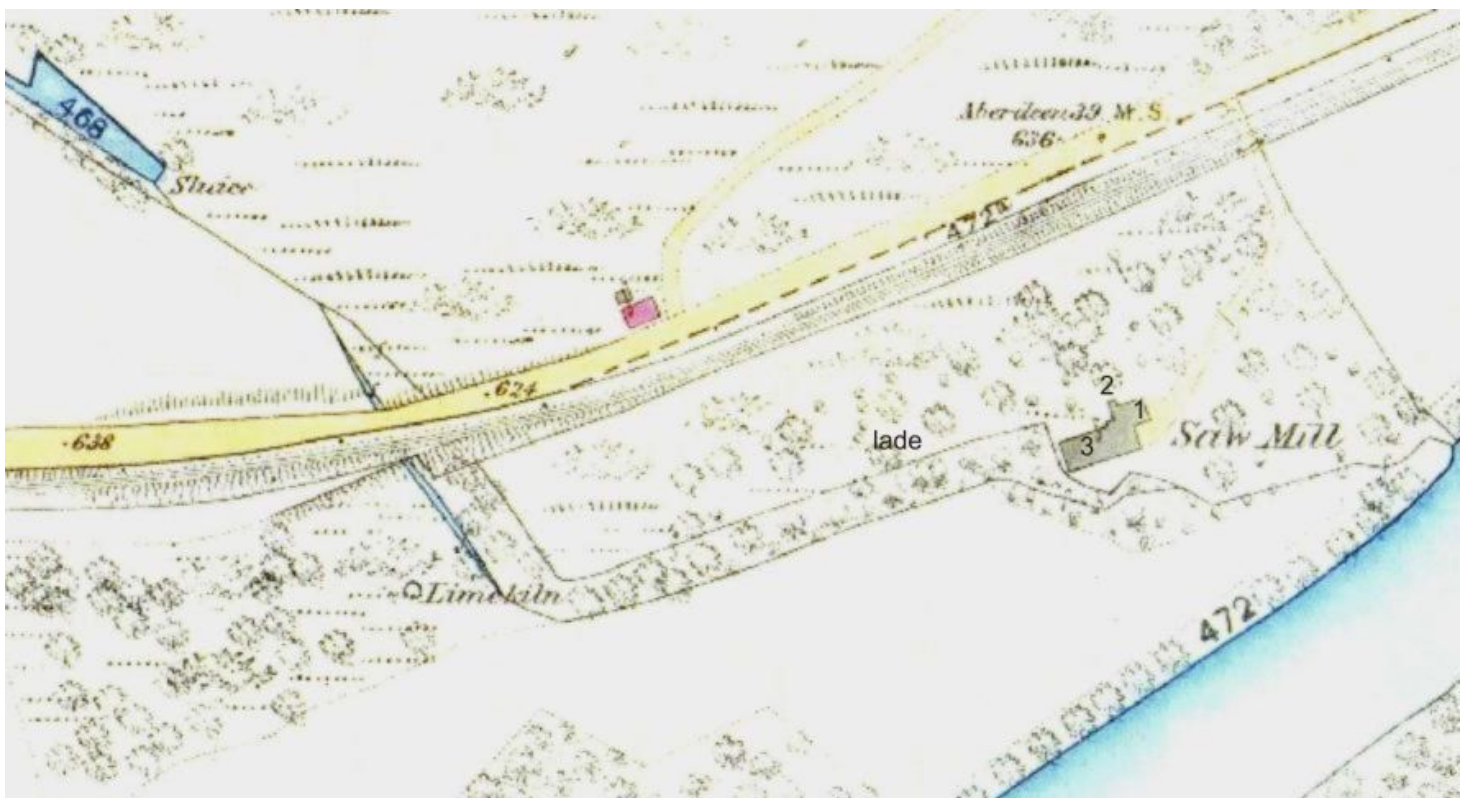
4.2 The 1st edition Ordnance Survey 25"/mile map, surveyed in 1867 (published 1869. Aberdeen Sheet XCII.1 (Glenmuick, Tullich and Glencairn)) shows the mill, named as 'Saw Mill'. At this stage there is a small, almost square E building (1) with the chimney (?) at the NW corner (2). Attached to and slightly overlapping the SW corner of this building is a larger rectangular block (3) that lies at right angles to a lade shown coming from a sluice on the N side of the road, past the W end of the building and running SE to flow into the River Dee.

Illus 2 1st edition Ordnance Survey map (25"/mile) surveyed 1867, published 1869
(www.nls.ac.uk) Overlay shows site numbers

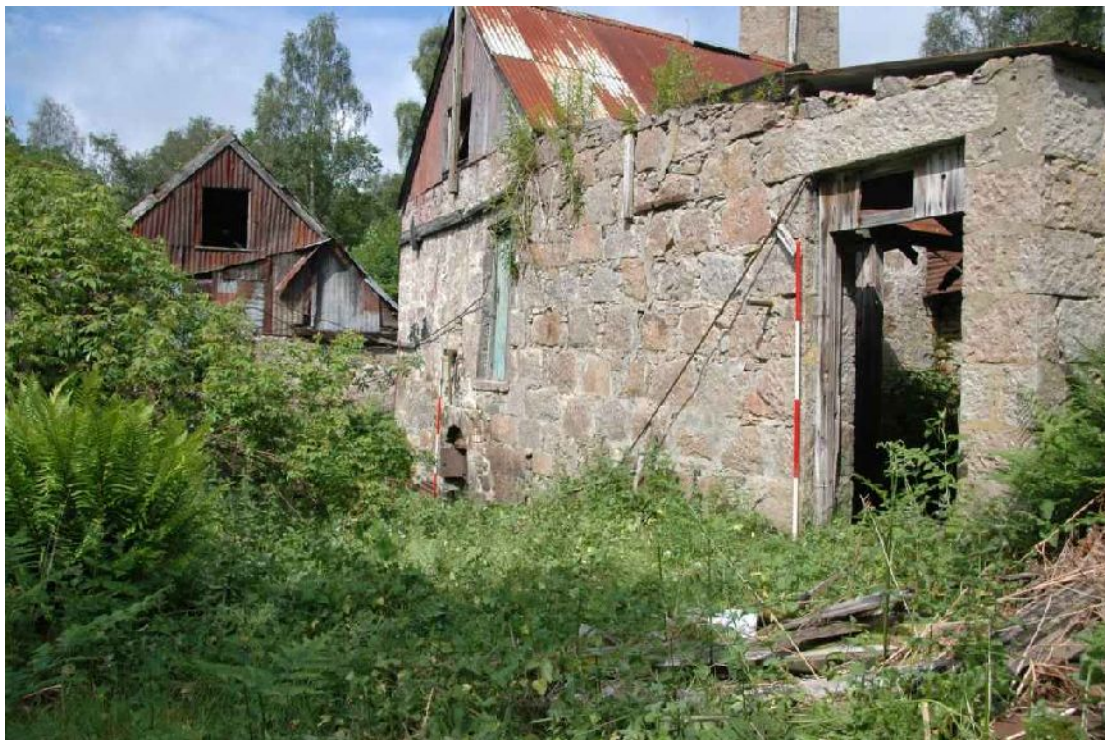
Illus 4 General view S wall Building 1

S WALL

D1 W: 1.22m H: 2.4m. Grey granite lintel. Wooden door. Opens into the E 'store'

D2 W: 840mm H: 1.8m. Grey granite lintel, pinkish granite threshold at 1.66m above ground level. Wooden door. Opens into the 1st floor of the building, beside the boiler.

Opening 3 W: 870mm H: 1.22m. Arched stoke hole with iron doors of stoke hole and ash rake out below. This is a secondary break-through with bricks built around it.

W5 W: c. 900mm H: c. 600mm. Opens into loft floor .

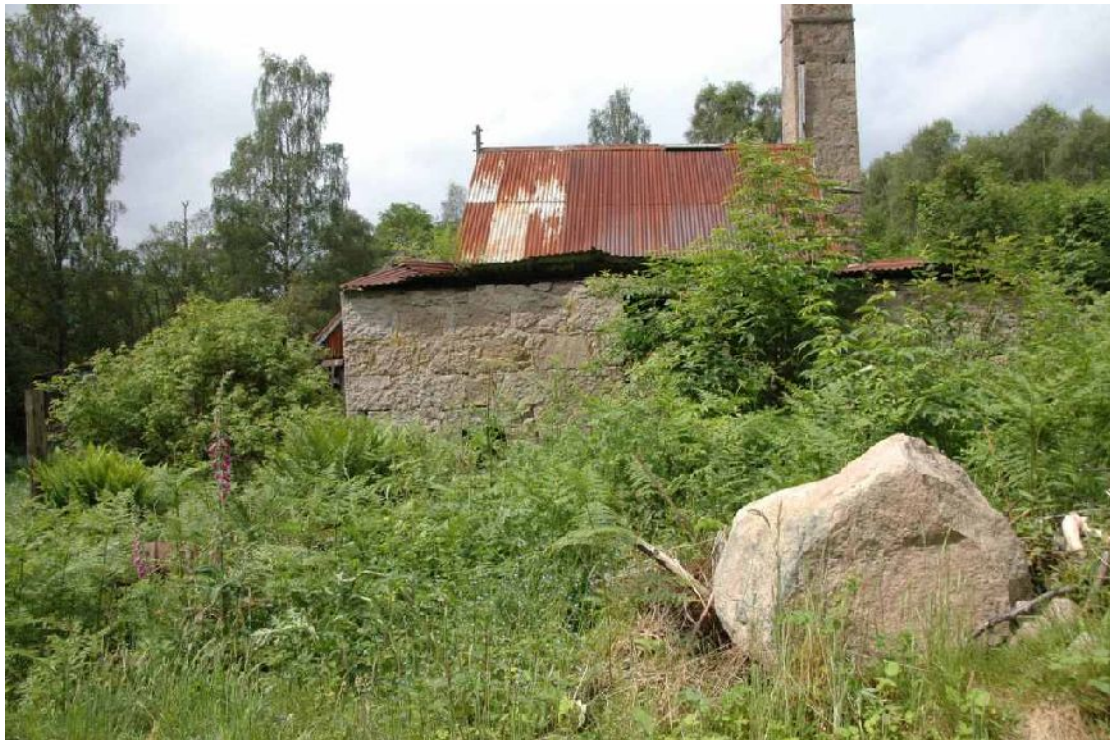
Illus 5 General view E wall Building 1

E WALL

W6 W: 450mm H: 450mm. Internal splay. Granite lintel and sill.

W7 W: 1.22m H: 1.69m. Internal splay. Granite lintel and sill.

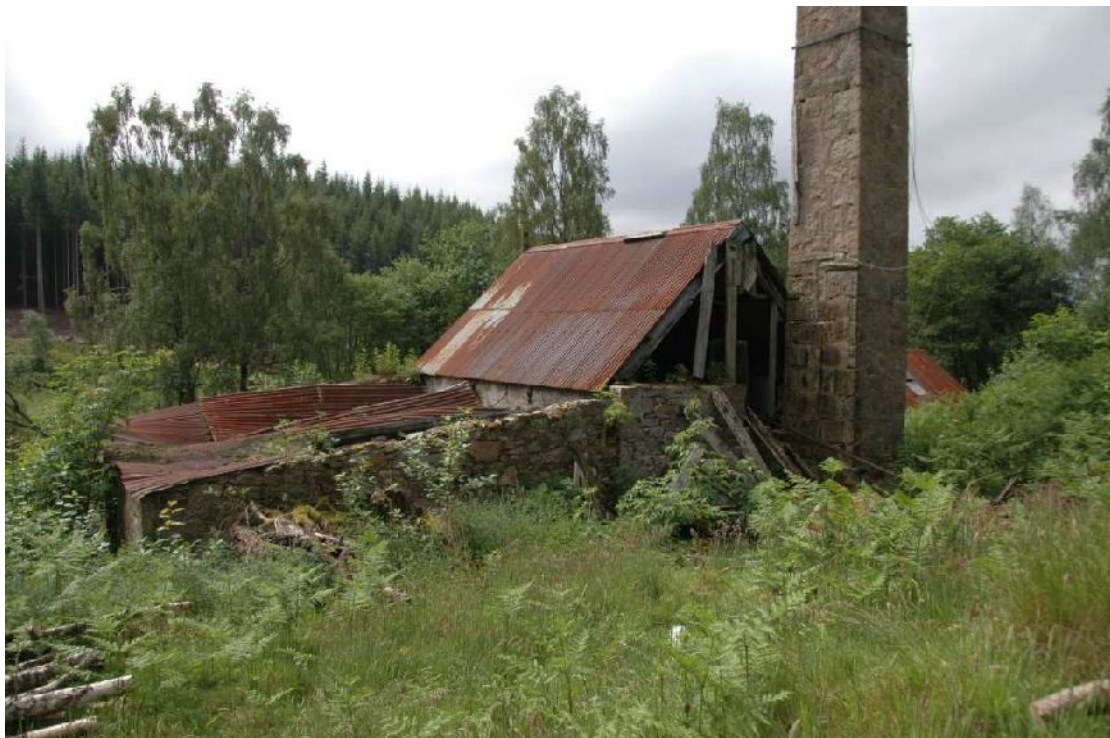
Illus 6 General view N wall Building 1

N WALL

D13 W: c. 950mm H: c.1.8m (From elevation drawn 2008- this has since dilapidated considerably.) This appears to have given access from the loft to the now collapsed building to the N.

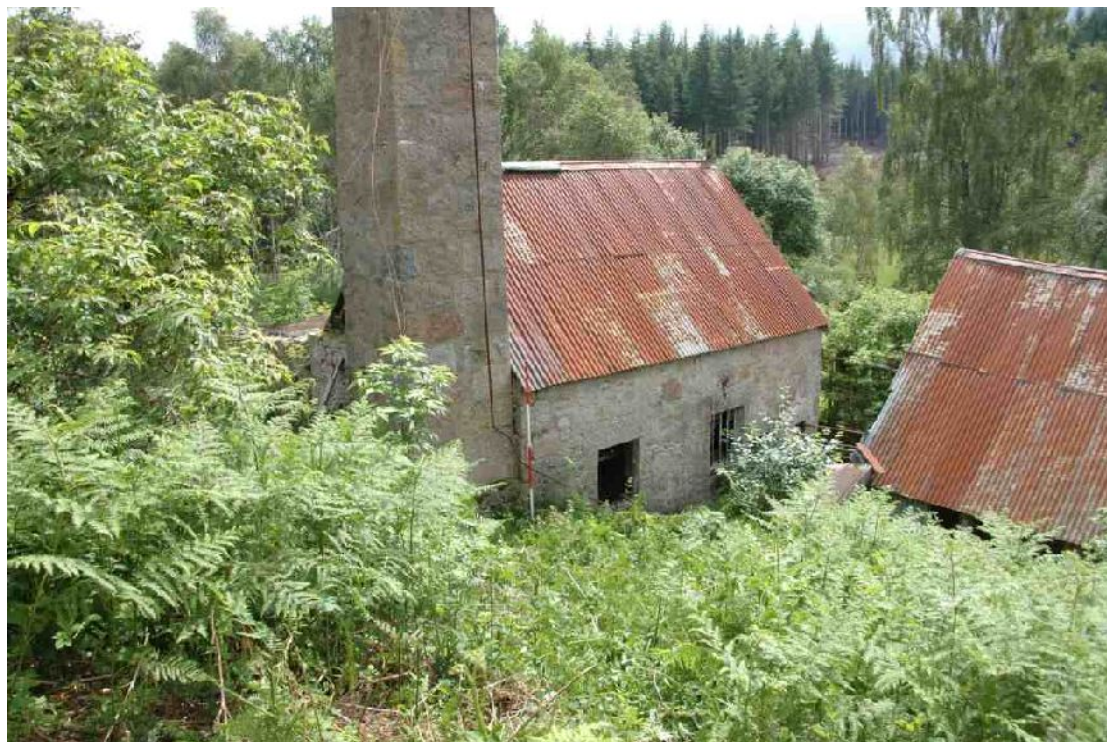
Illus 7 General view W wall Building 1

W WALL

W9 W: 750mm H: 920mm

W10 W: 760mm H: 930mm. Some remnants of glazing.

W11 W: 500mm H: 470mm. Some remnants of glazing.

Opening 12 Irregular break-through for steam pipes.

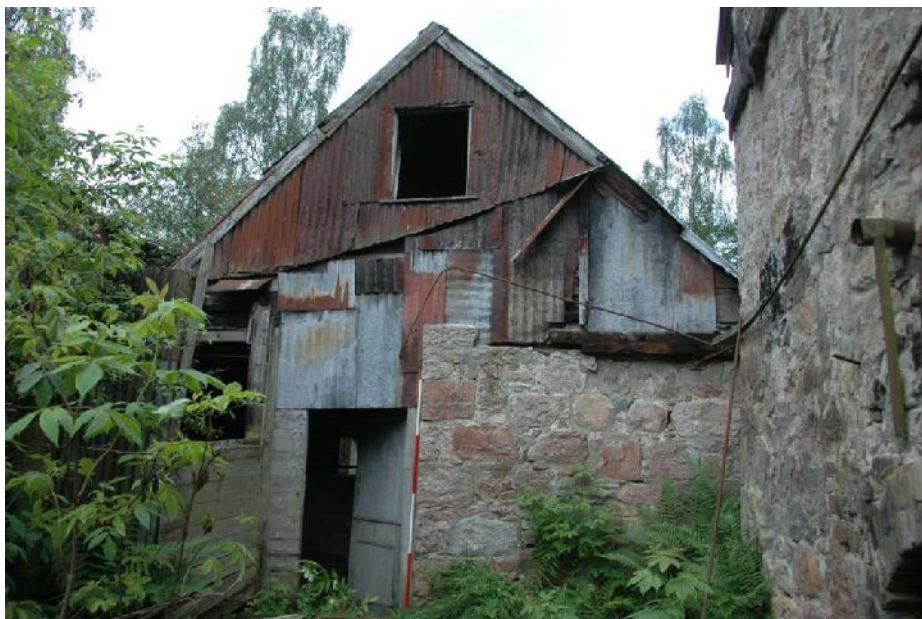
Walls The walls are of concrete blocks with the exception of a short section of the wall at the E end (illus 8) and the base of the wall at the W end (illus 9); these are of coursed granite and appear to be part of the original 19th century building. The wall fragment at the W end extends down to the base of the mill lade and this may have been the original wall where a water wheel was fixed- there is however no surviving evidence of the wheel fixings.

Illus 8 Building 3 E wall, showing fragment of original stone wall

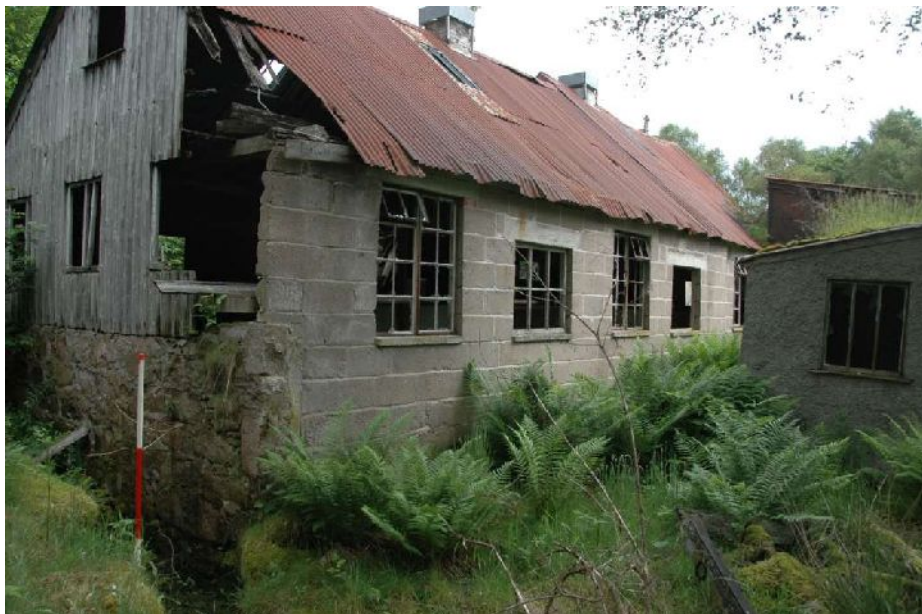
Illus 9 Building 3 SW corner showing fragment of original wall and mill lade

This would appear to be an interesting example of a water-driven sawmill that has been adapted to use a steam-powered engine. The mill lade, shown on the 1st and later OS maps would indicate that the water wheel was at the W end of the original Building 3- only a wall fragment of which survives incorporated into the recent piggery.

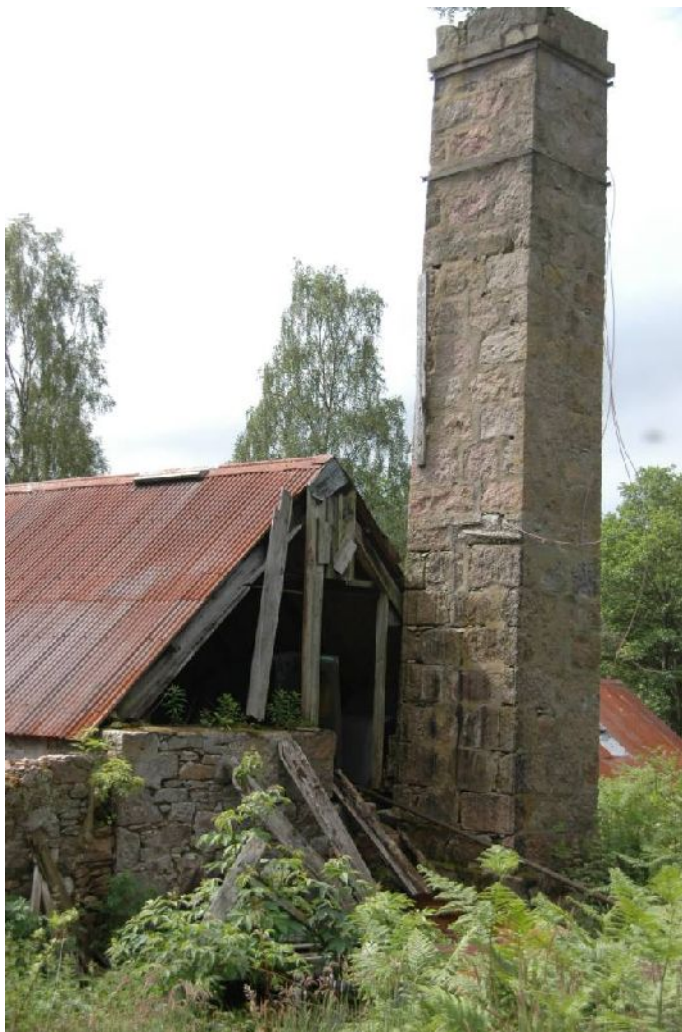
Chimney The chimney is c. 8.5m high and 1.38m square externally over a base c. 1.60m square. It is built of squared pinkish granite blocks with a projecting stone band just below the top. The SW corner of the chimney clearly abuts the end of the W wall of Building 1 (illus 11); however the SE corner of the chimney (internal and external) is abutted *by* the N wall of Building 1 (illus 12).

Illus 10 Detail of the chimney

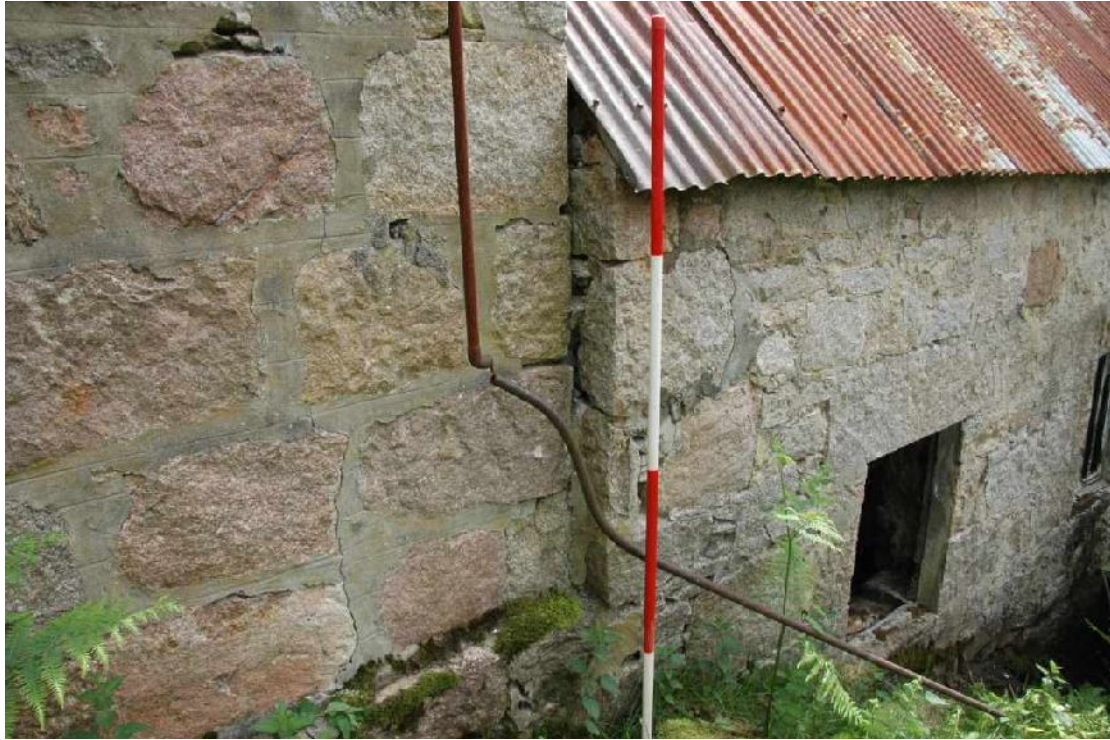
Illus 11 Chimney abutting W wall of Building 1

Illus 14 Horizontal boiler running full length of Building 1 1st floor. Seen through window W9
The brick- built flue and ash pit in the S wall of Building 1 indicate a secondary break-through, as do the smaller break-throughs for the iron steam pipes. This would indicate that Building 1 (W end) may have pre-dated the use of steam power and been adapted in the mid-19th century. The SW corner of the chimney abuts Building 1 W

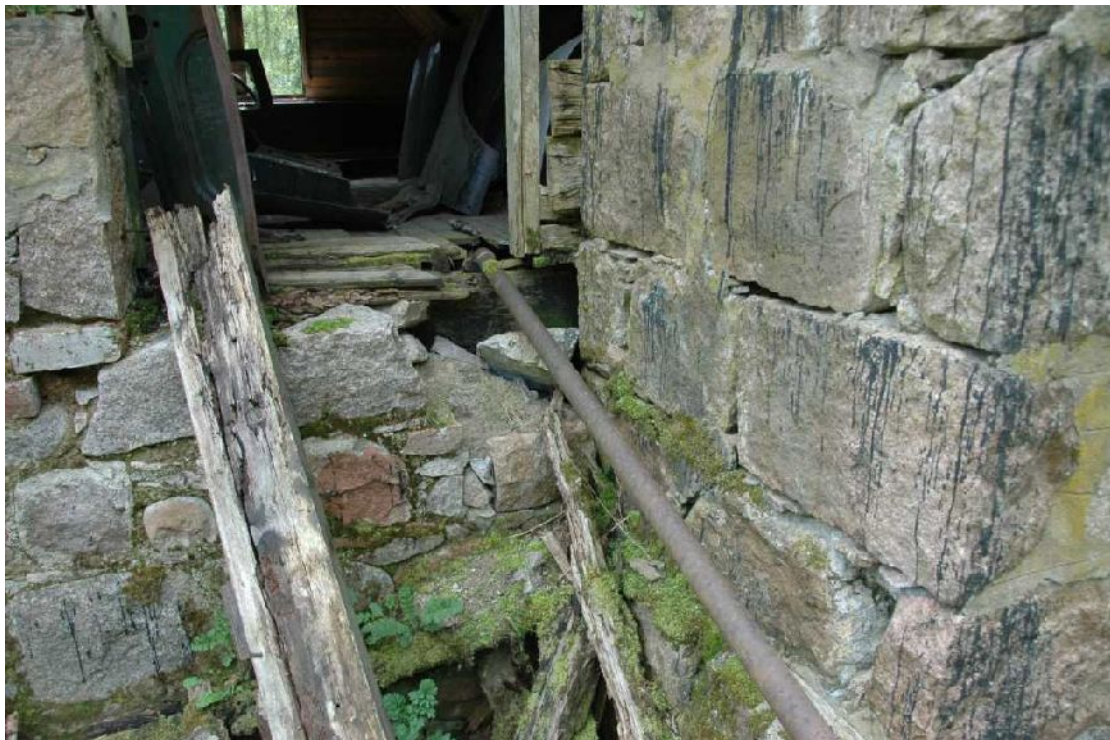
Illus 12 Chimney abutted by N wall Building 1

wall which supports this argument- but there appears to have been re-structuring of the N wall of Building 1 where the chimney has been incorporated.

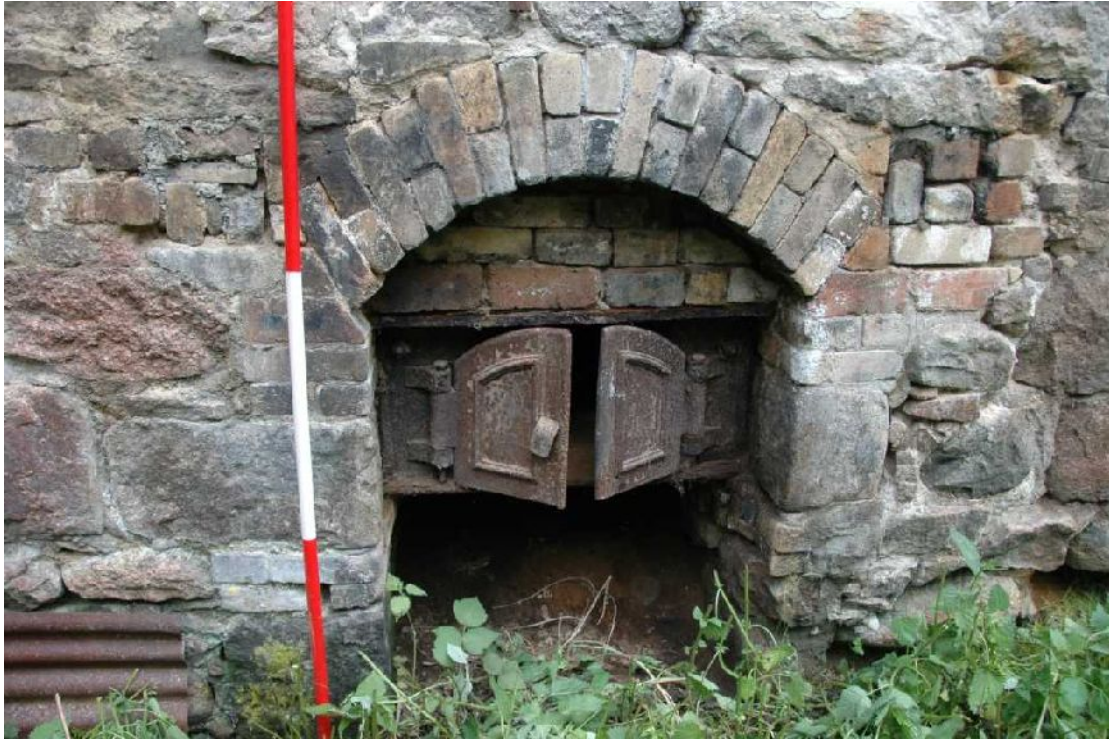
Illus 13 Stoke hole and ash pit (3) in S wall Building 1
