**MILNE'S CROFT
HUNTLY
ABERDEENSHIRE**

Standing Building Photographic Survey

Carried out July 31st, 2012

Report No: MAS 2012-24

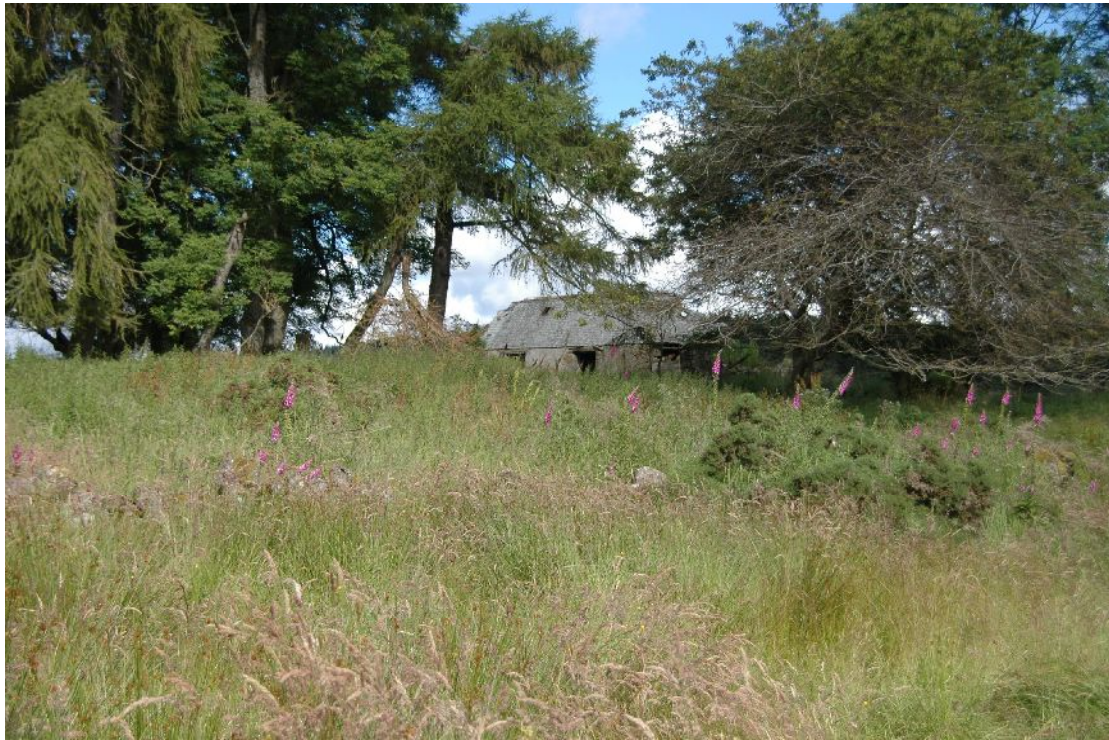
- 1.5 The buildings comprised a cottage (11 x 5m) lying E/W and the foundations and part of the walls of a steading 22.3 x 5m lying E/W. These would appear to be the two buildings shown on the 1888 OS map according to the SMR. The steading was SW of the house and 22.7m from the SW corner of the house to the NE corner of the steading. The cottage was lacking most of the E gable

and could not be entered. Interiors were photographed through the door and windows. The steading was mostly only a foundation but parts of the N and W walls remains to a maximum of 1.75m. It had originally comprised a structure c13m long, with an additional 9m long addition added to the E end. No openings were visible.

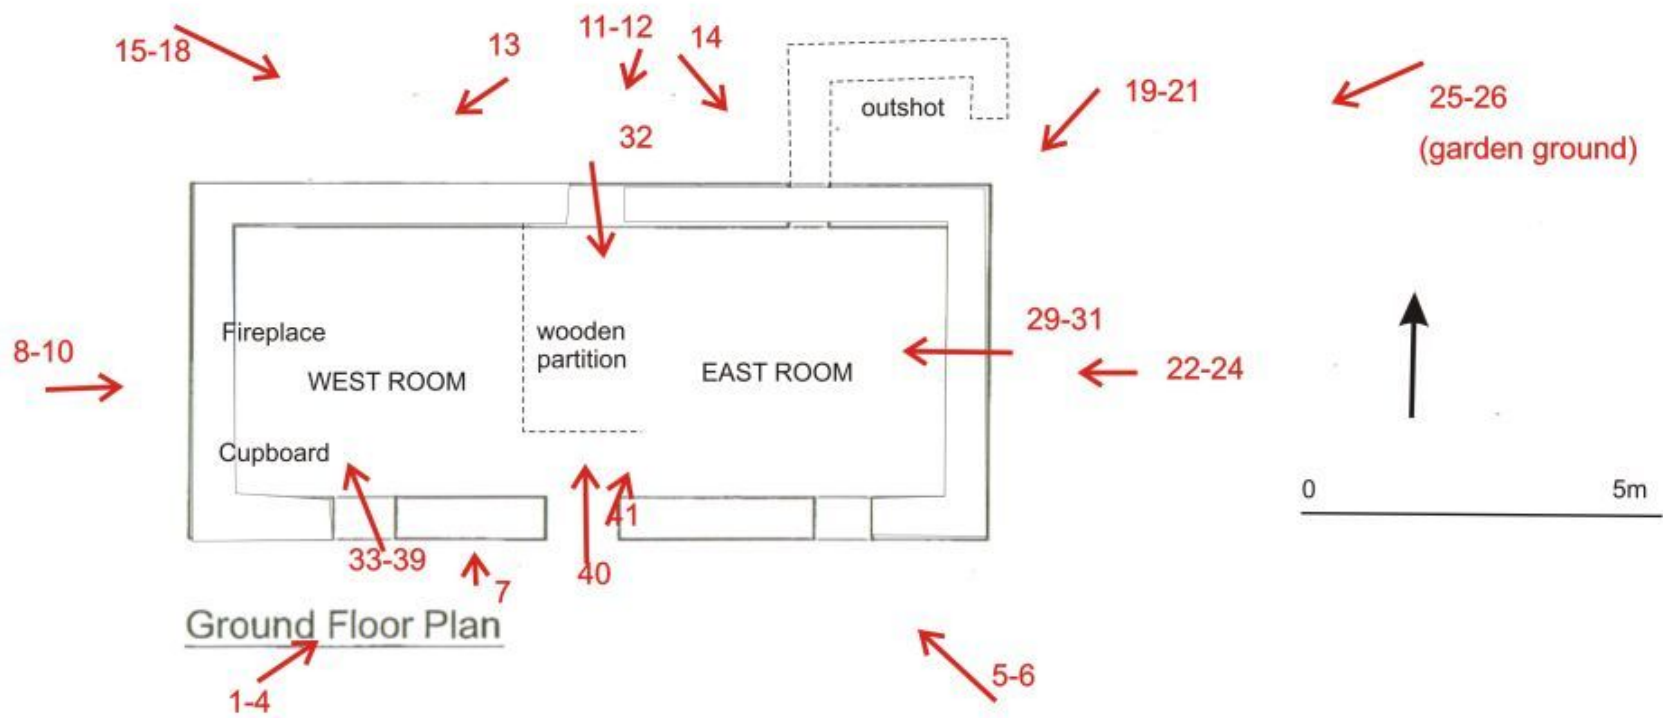
Illus 1 Annotated plan with photograph numbers (Based on plan supplied by courtesy of John Wink Design)

The positions of all photographs are indicated on Illus 1 and in the catalogue below.

Digital frame	Content
1-4	S elevation from SW
5-6	S elevation from SE
7	S elevation, W window and door
8-10	W elevation
11-12	N elevation from NE
13	N elevation, W end
14	N elevation, E end
15-18	N elevation from W including outshot
19-21	E elevation from N
22-24	E elevation from E
25-26	Garden enclosure to E of E gable
27-28	Setting of cottage from E looking SSW. The ruined steading in trees marked by ranging rods
29-31	Interior E room from E gable looking W
32	E room looking S through N window
33-39	Interior of W room through W window in S wall. Shows fireplace with swey and cupboard

40	Interior through door looking N showing wooden partition
41	Interior through door looking NE
42-47	Ruined steading from N
48-49	Ruined steading NW corner
50	Setting of steading with house behind and Bin Forest in background
51-52	Cottage setting, from SE
