REDCRAIGS STEADING
BRIDGE OF DEE
ABERDEEN

Standing Building Survey

Carried out November 14th 2012

Report No: MAS 2012-32

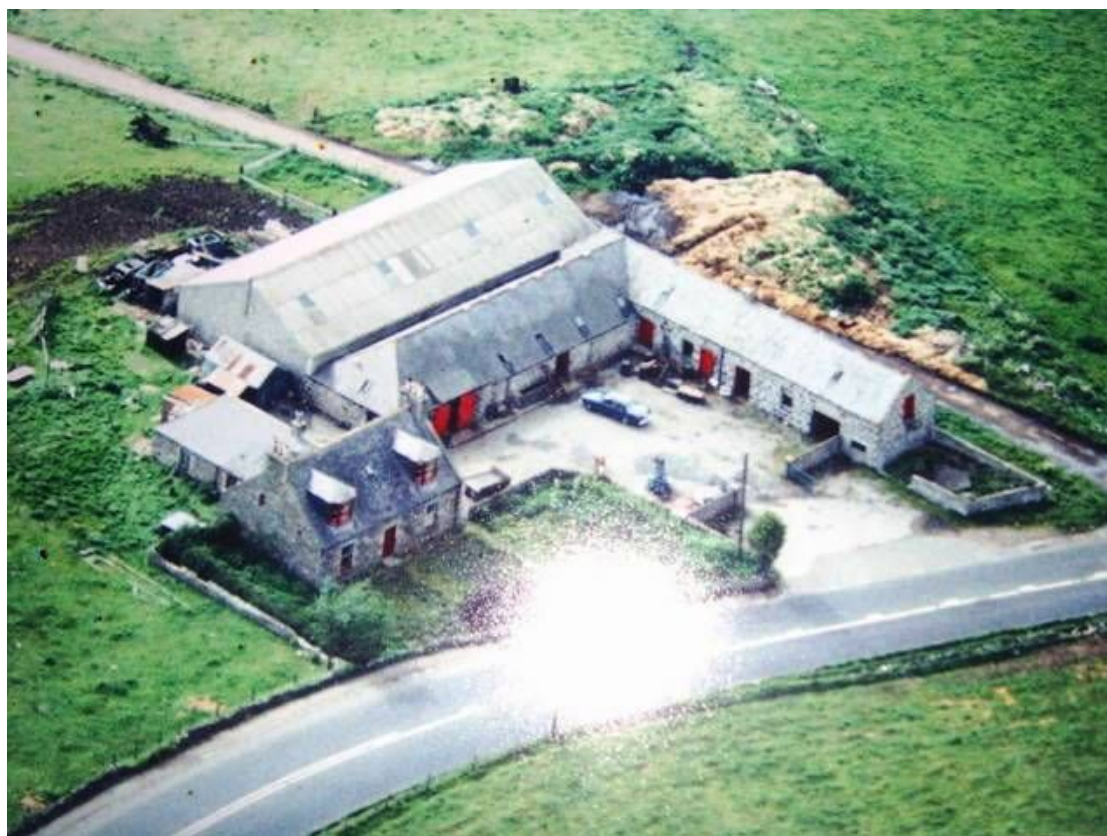
Illus 2 Aerial photograph c. late 1980s. (Photograph supplied by Cobban Architecture Ltd, courtesy of the owners).

4.7 An aerial photograph of the farm (Illus 2) shows the complete steading with the addition of a large agricultural shed abutting the W wall of the W range. The date

of the photograph is unknown but appears to pre-date the A90 widening in the late 1990s - this section of road was formerly part of the A92. (Photograph supplied by Cobban Architecture Ltd, courtesy of the owners).

This is useful as it predates the insertion of new doors and windows in the surviving range and shows some details of the now demolished N range.

The W range (building 2) is shown as abutting the narrower N range (building 1). Both are clearly stone-walled with slate roofs.

In the W range, door D3 is shown at its original width below the raised part of the roof (see below). Door D4 is shown in its present form. There appear to be two possible windows/blocked doors to either side of D4. One of these has subsequently been replaced by window W1.

The S wall of the N range is shown with three small doors (comparable to D4) and a wider, possible cart door near the E end. There are three vents/windows. At 1st floor level in the E end of the N range there is a door that would have given access to the grain loft. The small walled yard at this end of the steading may have been a stack yard.

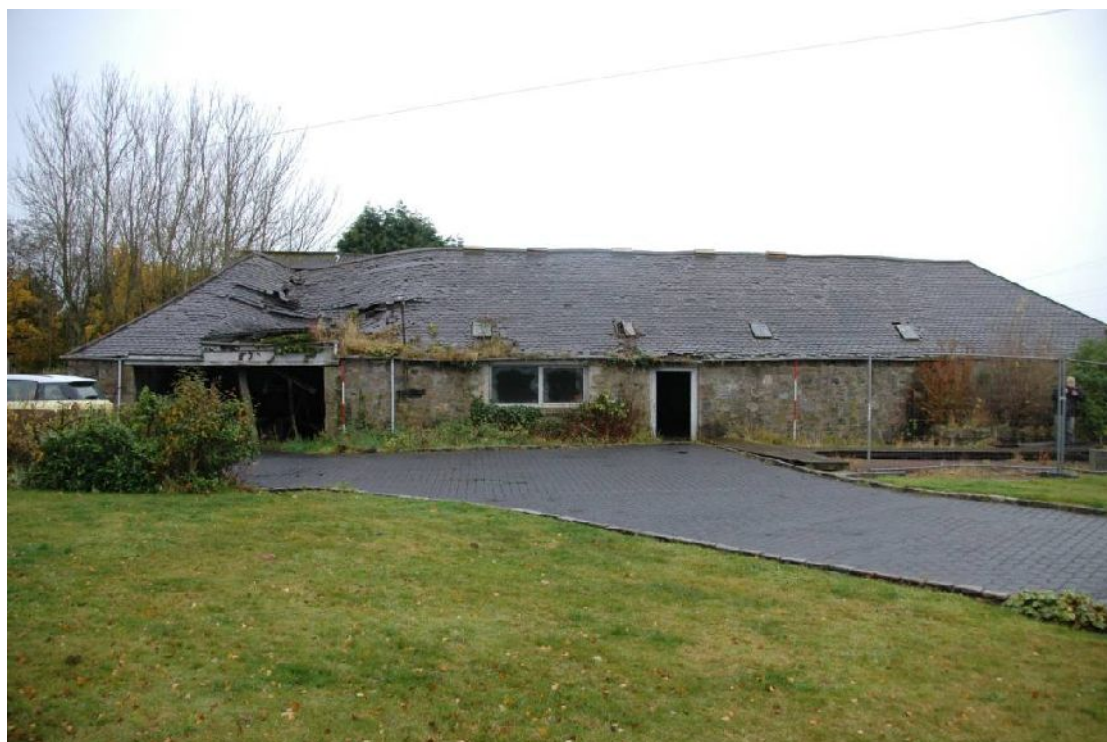
Illus 3 E facade of steading

At the time of the survey, only the W range of the steading remains with few original features and substantially altered in places. The interior had been concrete rendered, obscuring details of blocked openings on the inner faces of the walls. The roof of the S end above door D3 has suffered recent collapse, limiting access to part of this area (Illus 3).

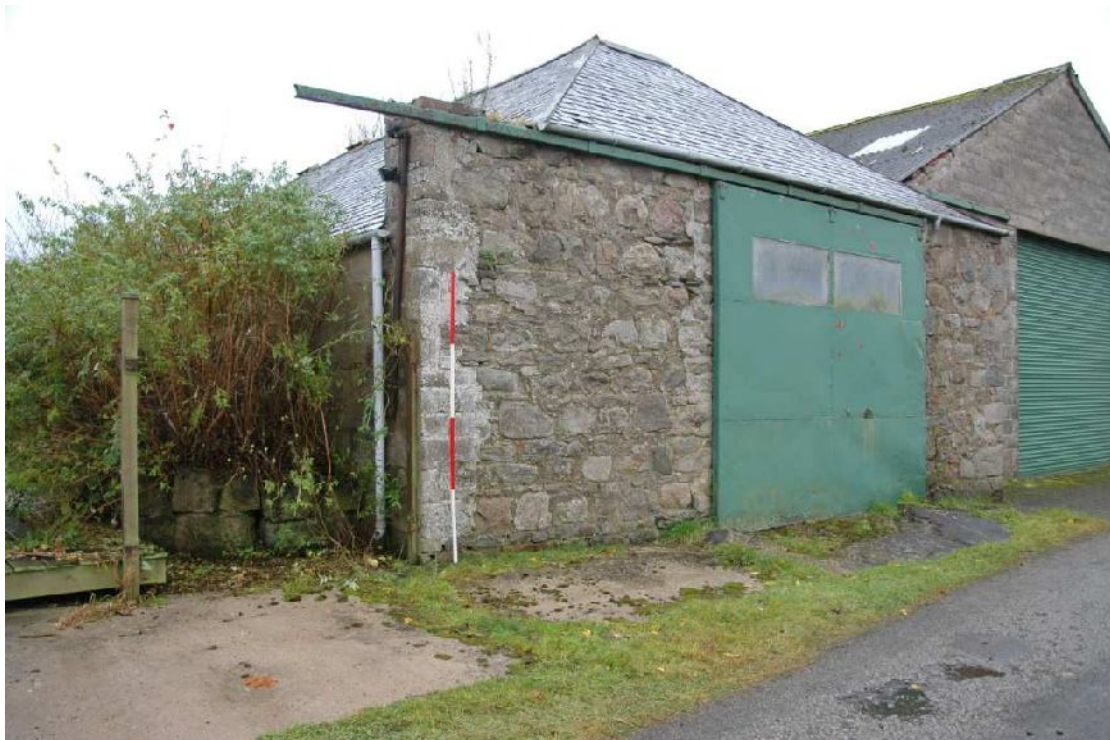
Illus 4 N wall of steading showing concrete block work where the N range had been demolished

Walls The steading had good horizontally coursed rubble with some granite rybats remaining at the SE corner. The N end of the E wall had been rebuilt with concrete blocks when the N range was demolished (Illus 4 & 7: blue on plan and section)

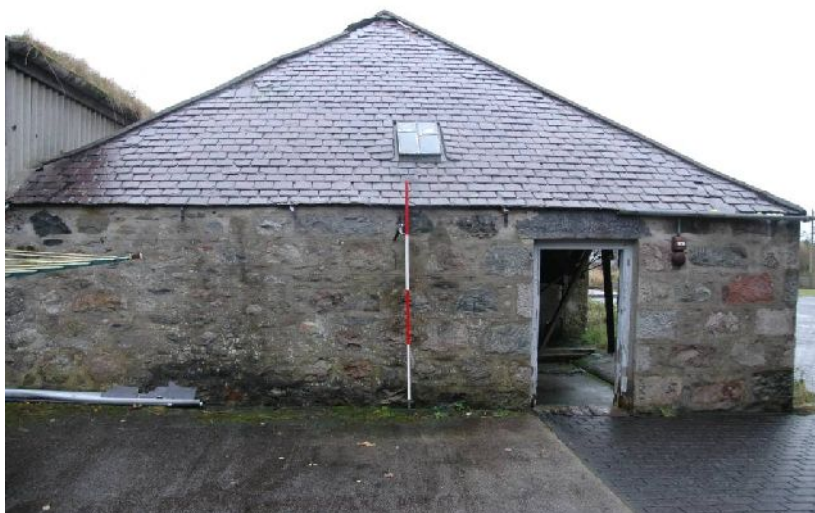
Illus 5 S wall and door D1

D1 W: 1.07m H: 1.96m internally with step up to yard (Illus 5). Granite lintel and rybats. Inner lintel timber.

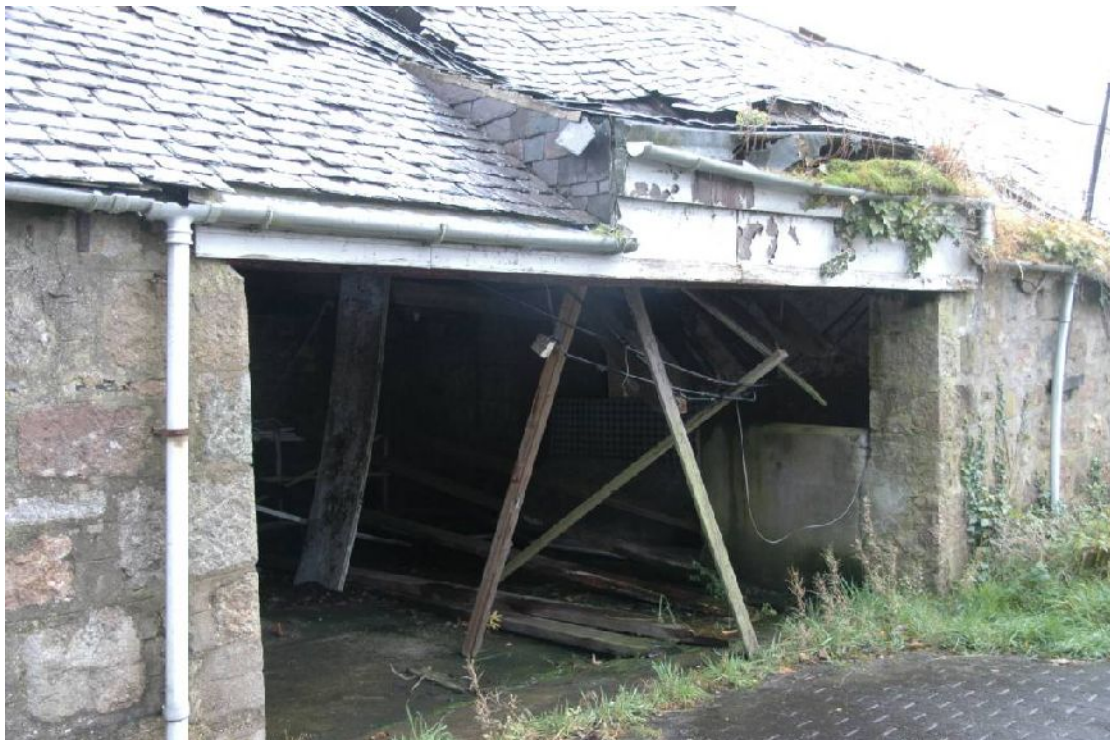
Illus 6 E wall door D2 showing the higher roof over original cart door.

- D2** W: 4.75m H: 1.90m with steel lintel (Illus 6). This appears to replace two doors but is a modern widening. To the N there had been a cart door with raised roof over the lintel W 2.95m. This can be seen on the late 1980s photograph (Illus 2) with double wooden swing doors. The granite rybats of the N side of this door remain. Granite rybats on the S side of the present opening probably indicate the former position of a narrower door at this point. This area is masked on the aerial photograph.
- W1** W: 2.4m. H: 1.09m. Modern insertion with brick and concrete surround. The late 1980s photograph appears to show an original narrower window at this point.
- D3** W: 1.23m H: 1.93m with step c. 250mm up from yard. Granite lintel and rybats. Modern door.

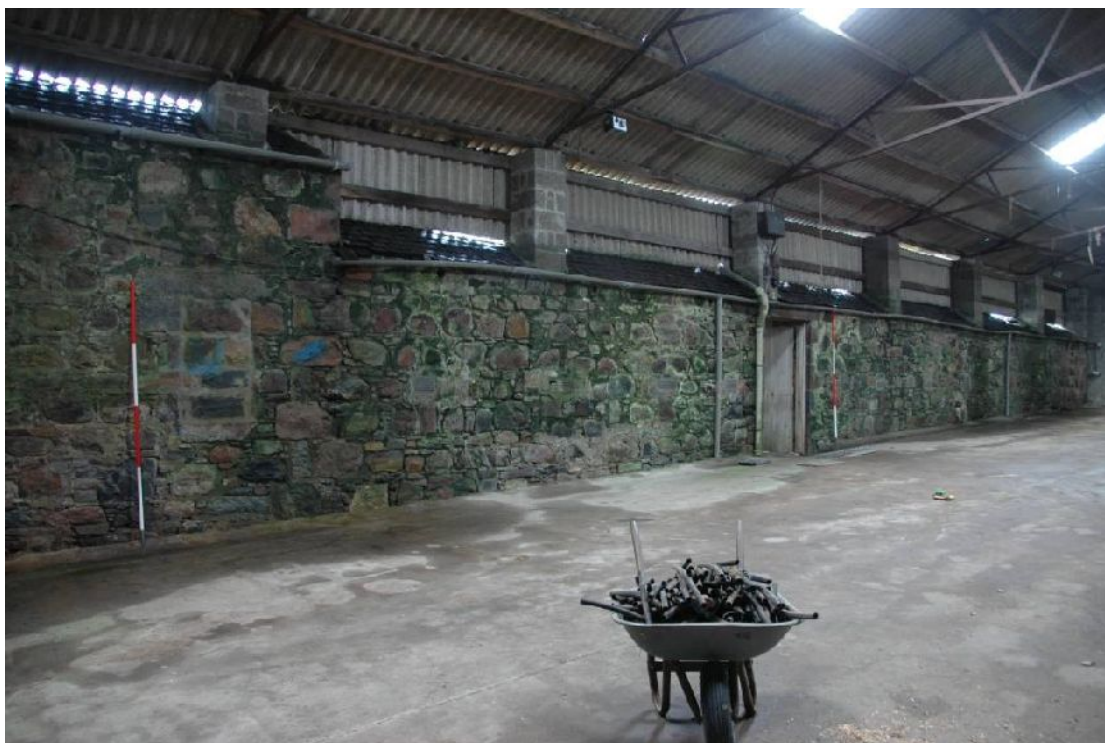
Illus 8 W wall from inside modern shed. Ranging rod in foreground beside W2. Ranging rod in centre beside D5

A modern agricultural building has been constructed against the back of the steading and the outside of the W wall can be seen from inside the modern shed (Illus 8).

D5 W: 1.23m H: 2.13m. Granite lintel and rybats. Inner lintel timber.

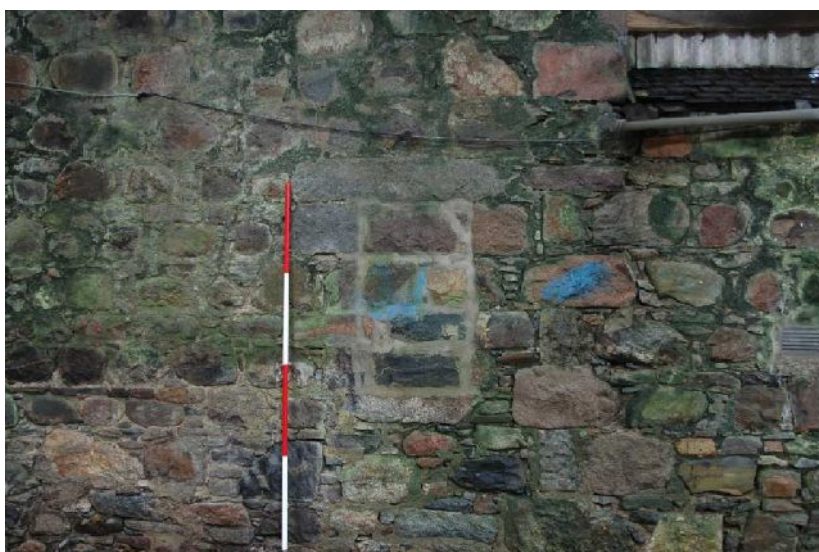
Illus 9 Detail of blocked window W2

W2 W: 0.67m. H: 1.06m. Base of window 0.93m above the modern shed floor. Blocked with stone. This would originally have opened into the W end of the N range. (Illus 9).

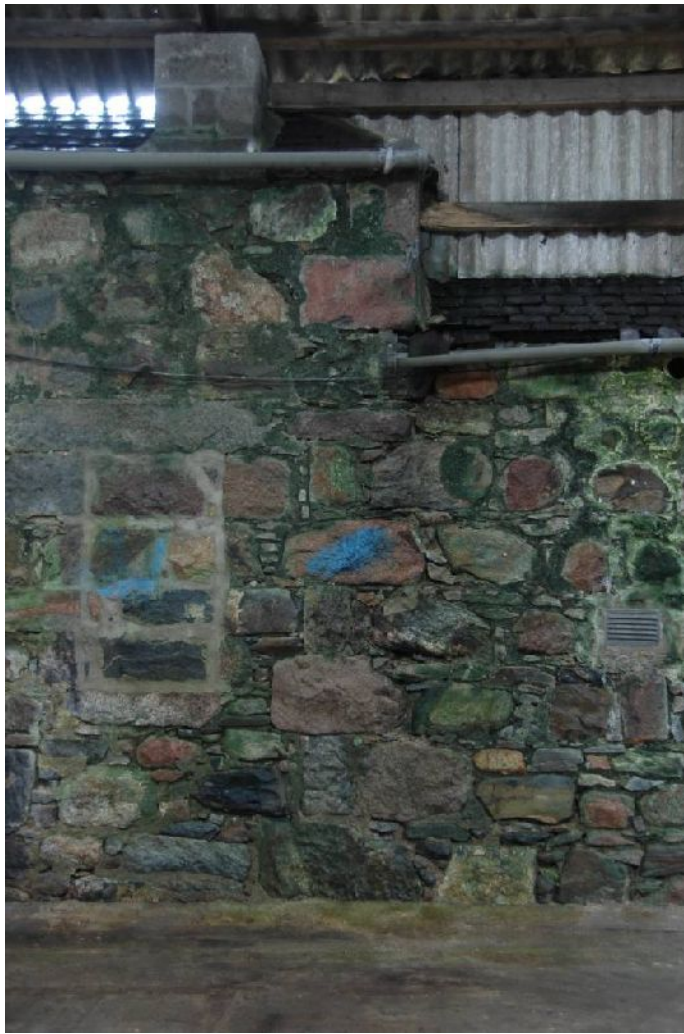
Illus 10 Detail of rybats of original SW corner of N range

The rybats of the original SW corner of the N range can be seen beside the blocked window W2 (Illus 10). They demonstrate that the N range was built before the existing W range.

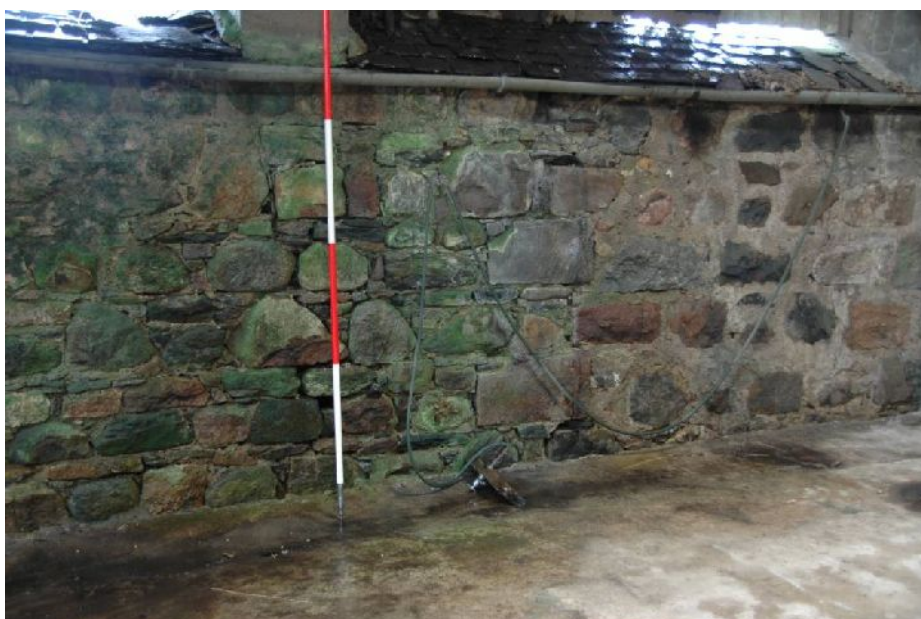
Illus 11 Blocking at S end of W wall

A second blocking at the S end of this wall (11.9m from the S side of D5) is unclear due to concrete rendering over the stonework (Illus 11) but appears to coincide with the position of a small outshot shown on the 1901 and 1923 Ordnance Survey maps. There is no indication of its function.

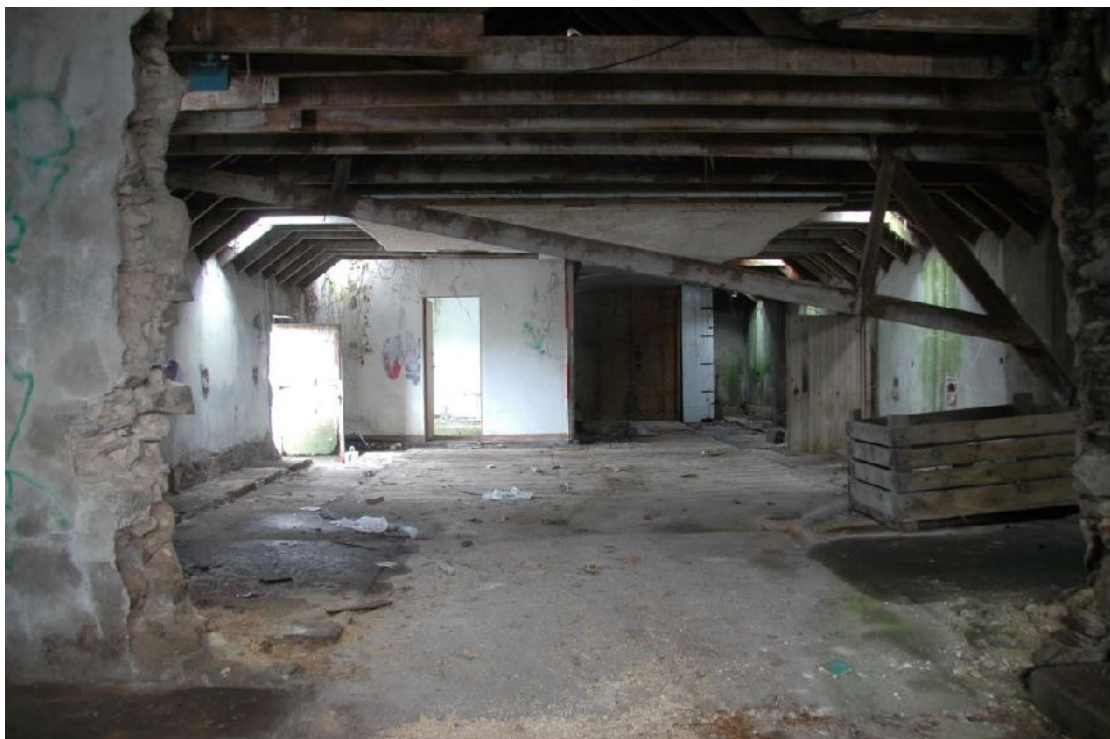
Illus 12 Interior looking S

The central and N areas of the interior (Illus 12) had been concrete rendered and a concrete floor had been laid. The central area appeared to have been concrete slats- possibly over a slurry pit but this could not be verified as the slats had been filled in with concrete. Alongside both the long walls there were traces of fittings for troughs/waterings. Ventilators had been inserted through the walls at intervals. This would suggest the building had been used for cattle. At some later time a timber and plasterboard walls had been put in (over the infilled slats) to make a small room or office.
