# DUNNOTAR CASTLE STONEHAVEN ABERDEENSHIRE

**Archaeological Watching Brief -**  
Carried out 14<sup>th</sup> – 15<sup>th</sup> January 2013  
by  
**Murray Archaeological Services Ltd**

**Report No: MAS 2013-5**  
by  
J C Murray

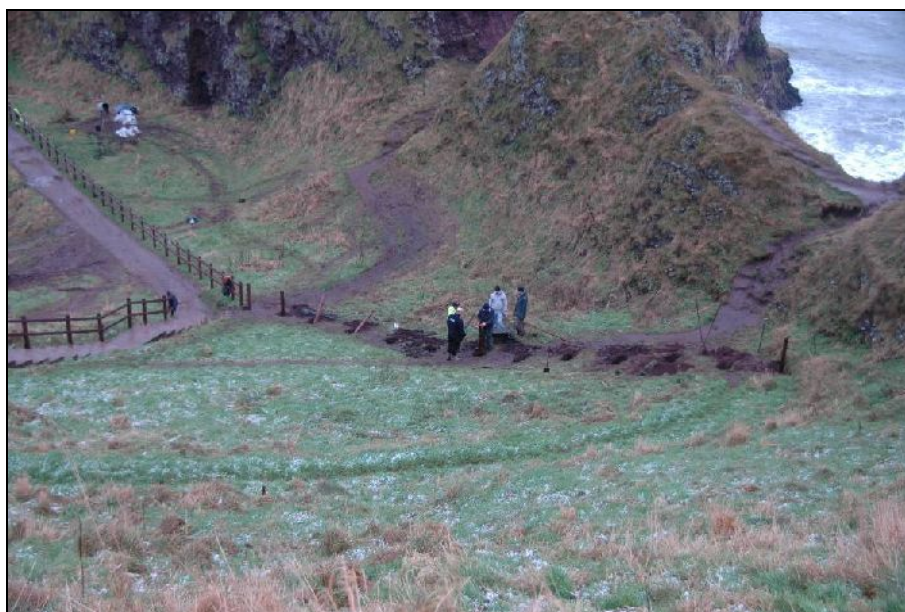
**Illus 2: Fence 1, looking E**

run from the W end of the 2009 fence to run WSW to the base of the narrow isthmus linking the castle promontory to the higher ground to the W – Fence 1 (Illus 1 and 2) and from the base of the steps leading to the castle entrance to the entrance itself – Fence 2 (Illus 3).

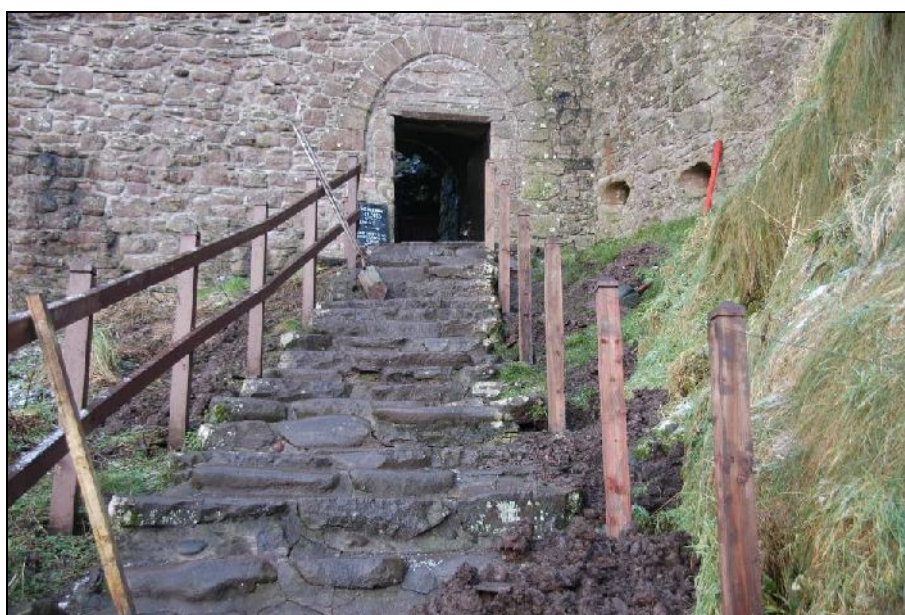
**Illus 3: Fence 2, looking towards castle entrance**

4.2 Fence 2: Fence 2 consisted of 12 posts beginning at the base of the steps up to the castle entrance on the SW side for a distance of c.13m (Illus 3). They were placed at intervals of 1.4m to 1.5m and were dug in hard up to the sides of the steps. The holes measured c.350 – 400mm x c.500mm and were generally 400 – 500mm deep. The fill of the postholes consisted entirely of soil mixed with stone and some mortar and was part of the material used in the construction of the stone steps.

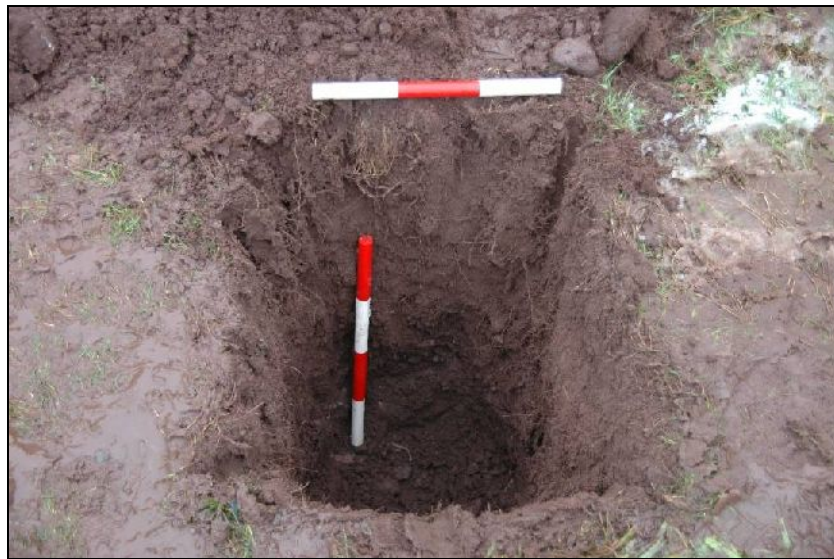
- 4.1 Fence 1: Fence 1 consisted of 14 wooden posts placed at intervals of c.1.5m from centre to centre and extended for some 18m. The holes excavated measured on average c.400 x500mm and were c.500mm deep. The fill of each hole was homogenous, being a mix of dark soil and fairly tightly packed stone and small rock. It would appear to be made-up ground with a now disused pathway running across the line of the fence.

**Illus 4: Typical fill of post hole**

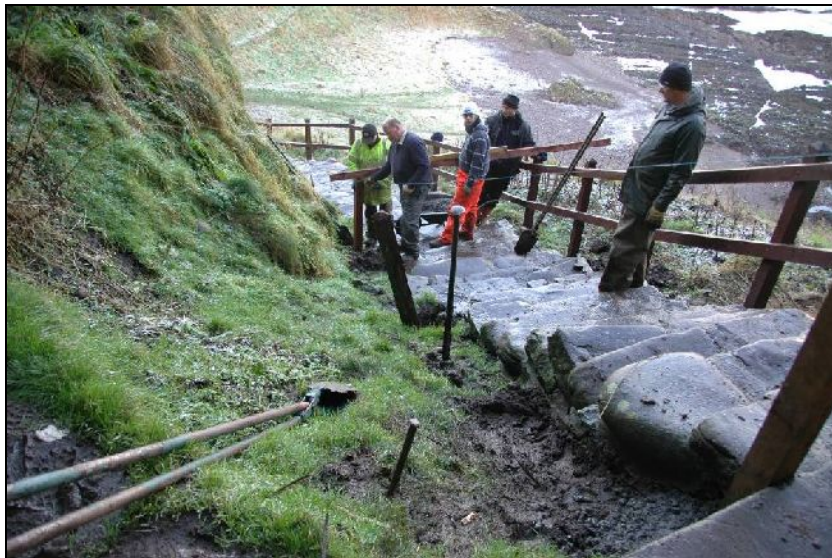
**Illus 5: Installation of posts, looking NW**

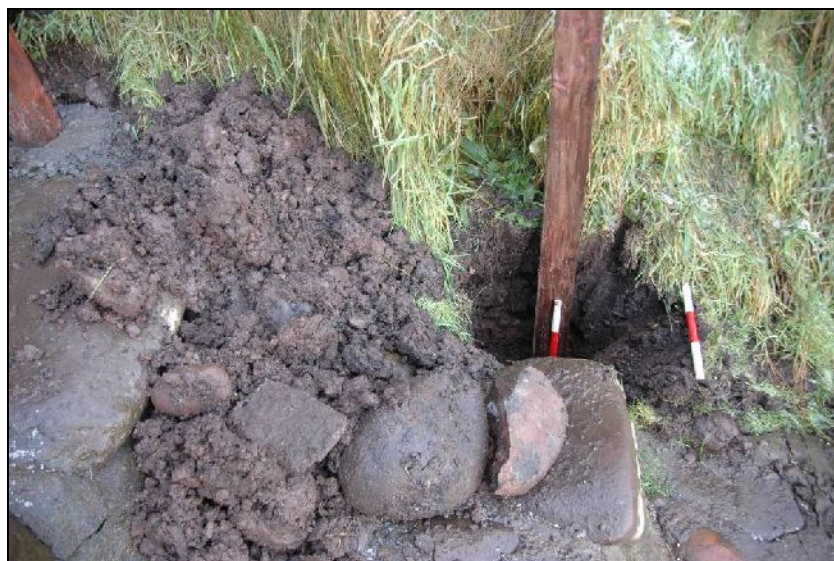
**Illus 6: Typical posthole fill**

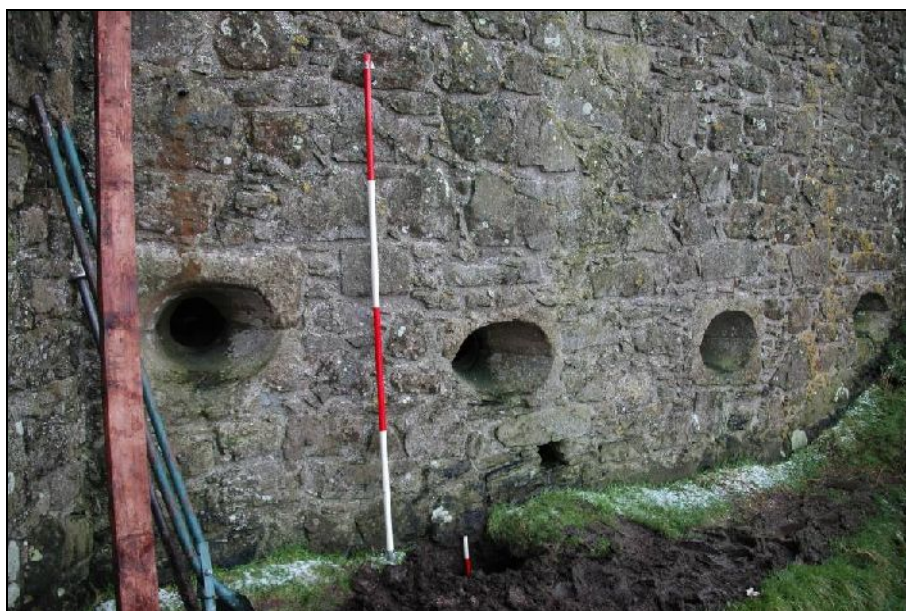
- 4.3 At the top of the steps the fence turned at 90 degrees towards the castle wall where two further posts were required, one of which was hard up to the wall (Illus 7-8, below).

**Illus 7: Position of posthole to the left of the central gun loop**

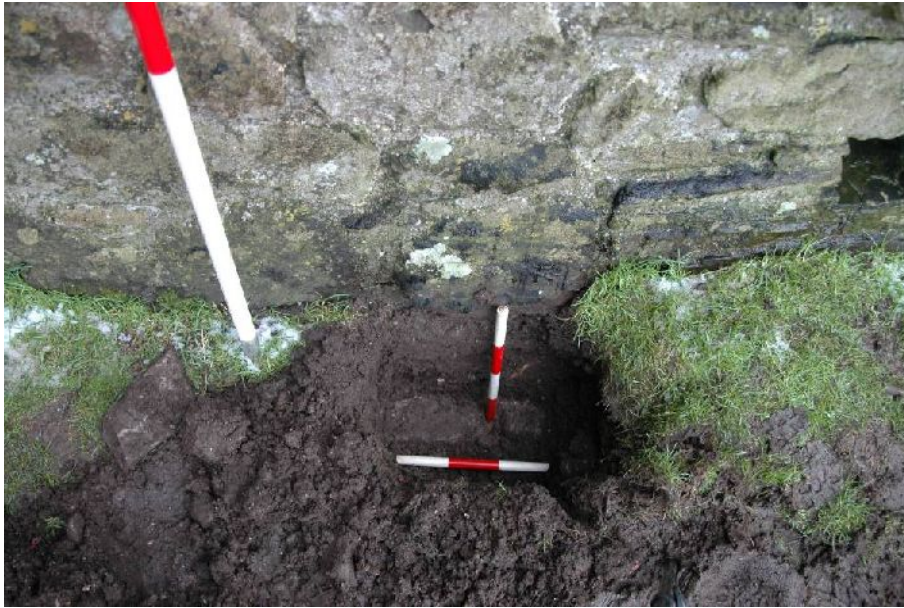
**Illus 8: Posthole with the foundation stones visible**

The posthole is 1.3m SW of the angle in the outer wall and measured 400mm x 450mm. At a depth of c.400mm below the surface two rectangular possible foundation stones of the castle wall were exposed (Illus 8, above). These extended c.100mm out from the wall and c.100mm of one and only 70mm of the other was exposed. The hole was extended a further 50mm out from the wall so that the post would not interfere with these stones or the castle wall. The posthole was lined with plastic to protect them from the concrete poured to fix the post in position.
