6 -7 THE CROSS FORFAR ANGUS

- Archaeological Watching Brief -
Carried out 28th – 29th January 2013
by
Murray Archaeological Services Ltd

Report No: MAS 2013-7
by
J C Murray

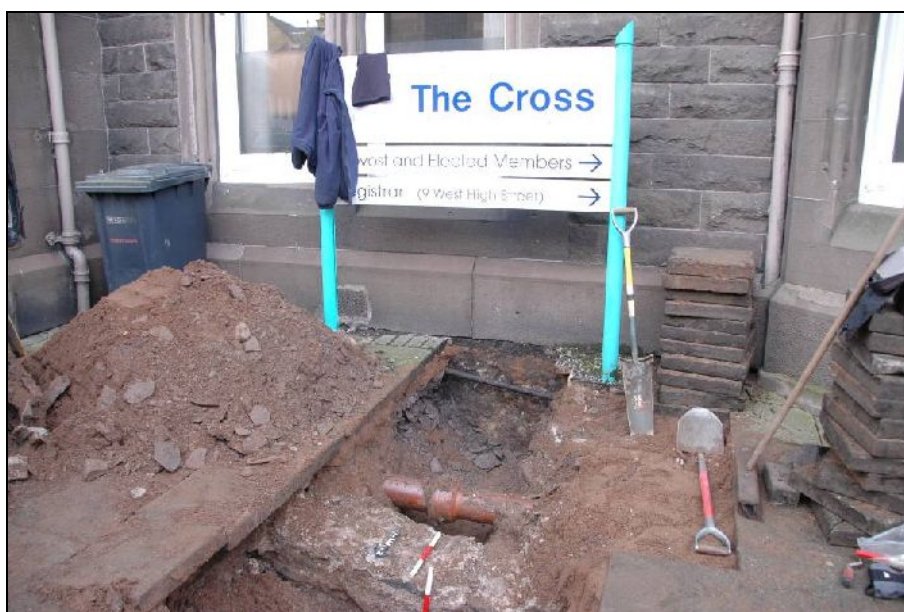
- 4.1 The trench for the new electricity cable extended for 19m along the pavement from c.1.5m W of the doorway into 6 The Cross, to the entrance into Osnaburg Street. For the most part it was 600mm wide and excavated to a general depth of 500-600mm. At the E end, at Osnaburg Street, the trench was opened up to c.3m square for connection purposes to existing electricity cables.

Illus 2: W end of trench showing existing services and stone wall, looking S

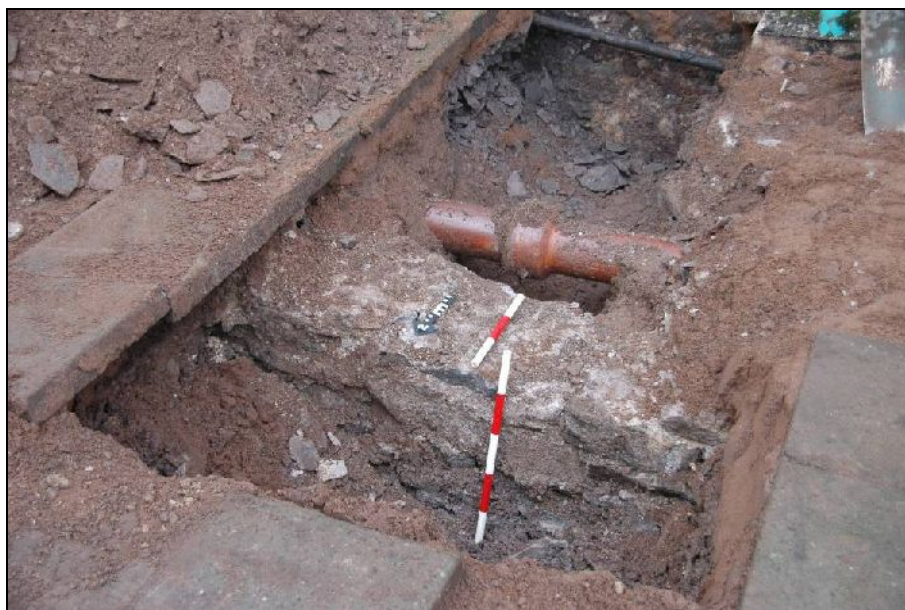
- 4.2 Below the pavement slabs was a 180mm depth of clean sand which overlay granite and stone aggregate mixed with brown soil to the full depth of the trench.
- 4.3 At the W end, a stone wall was encountered running E-W, c.1.4m N of the N wall of 6-7 The Cross. The wall was 350mm thick and extended down to the full 500mm depth of the trench [Illus3]. It is possible that the wall relates to a building that predates the current building, now Angus Council offices, but formerly the National Bank built in 1862.

Illus 3: Wall at W end of trench, looking SE

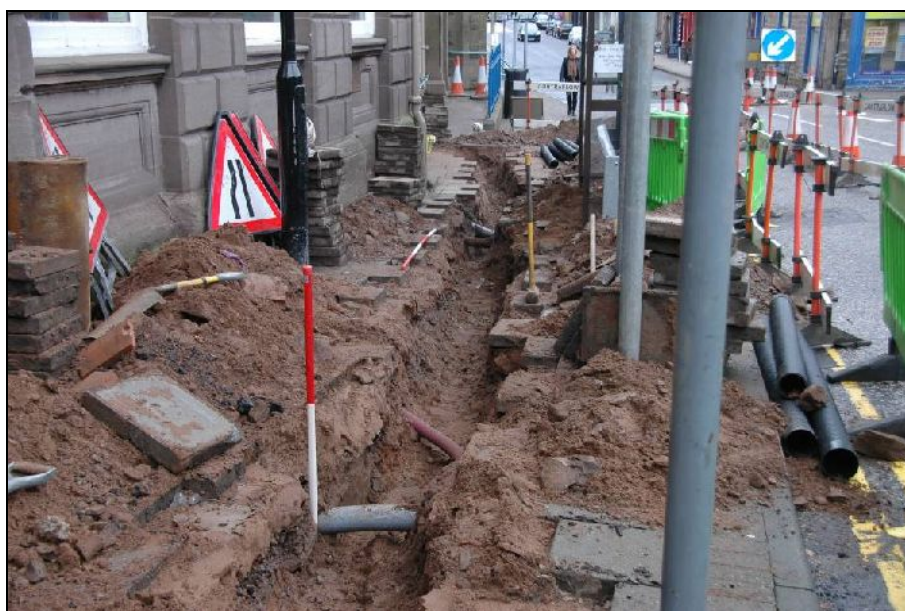
- 4.4 Excavation of the trench eastwards showed the area to have been heavily disturbed by services, including telecom ducts, street lighting conduits, gas mains and sewerage pipes [Illus 4].

Illus 4: Cable trench, looking W, showing earlier services

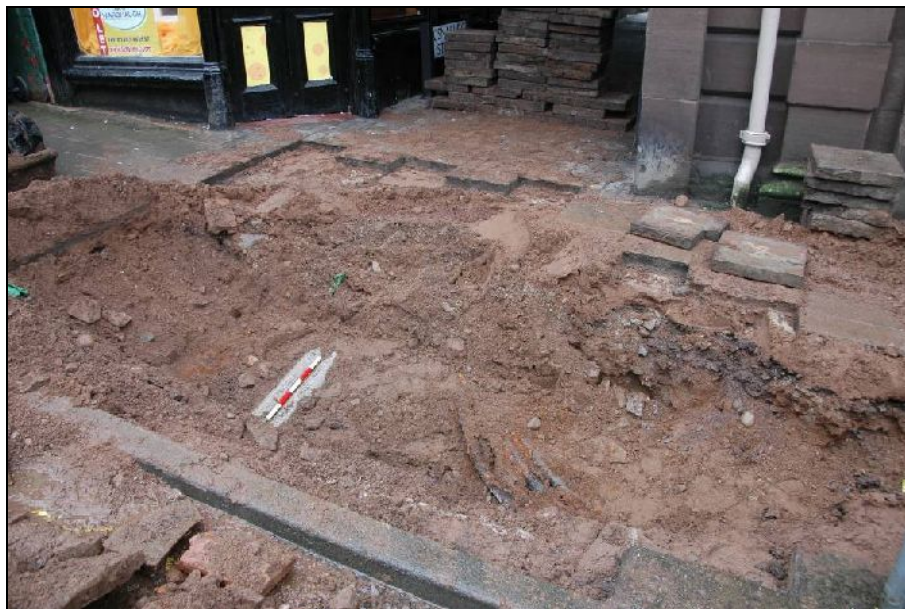
- 4.5 The trench terminated and was expanded to a 3m square at the entrance to the pend into Osnaburg Street. This area was also heavily disturbed by a mass of services.

Illus 5: E end of trench at Osnaburg Street, looking S
