**WESTERTON
GLENBUCHAT
STRATHDON
ABERDEENSHIRE**

Standing Building Survey

Carried out June 12th 2013

Report No: MAS 2013-16

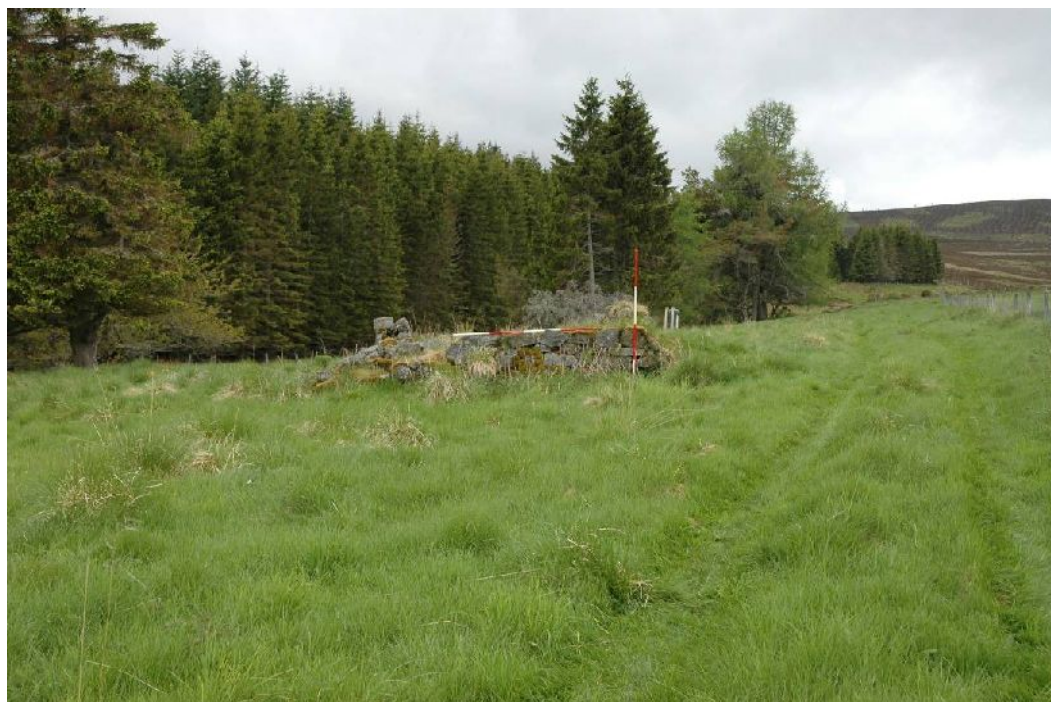
Illus 1 The site, general view looking W, Building 1 in foreground

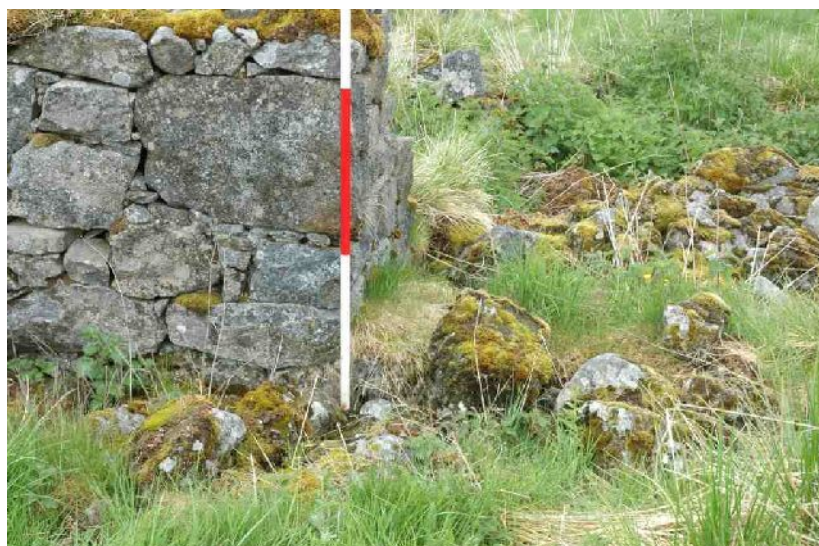
Illus 3 N wall of B1b abutting NW corner of wall of B1a

Building 1 appears to be the building shown on the OS map of 1900, lying on the N side of the c 1900 track. Building 1 must have been constructed between 1867 (the date of the 1st OS map) and 1900; however, the E part of the building (B1a) had clearly been constructed earlier than the W half (B1 b) which had been built abutting its W gable.

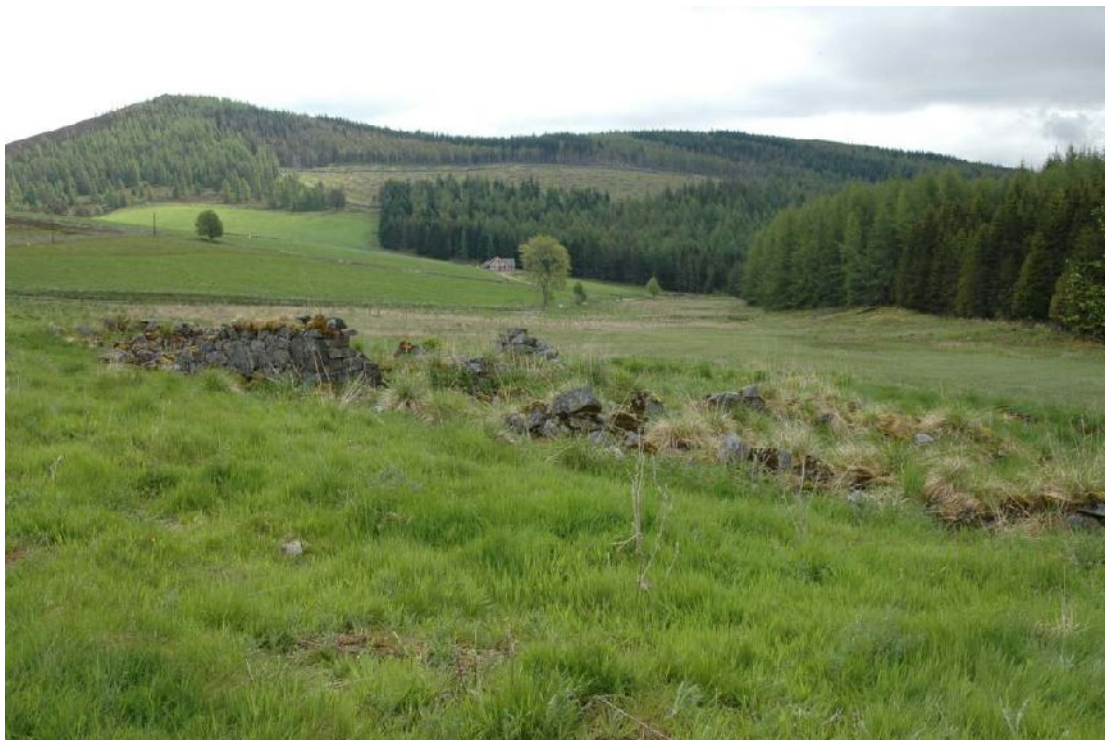
Illus 5 Building 1 looking E

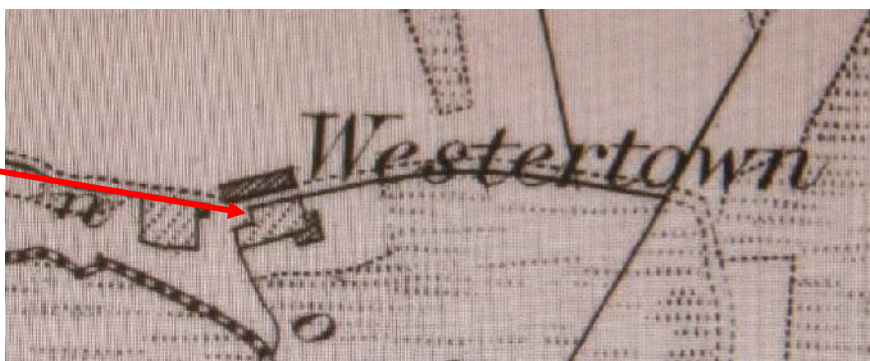
Illus 6 Detail of 1900 OS map. Arrow indicates position of Building B2 (www.nls.ac.uk)

Building 2 lay to the S of the c.1900 track but is not shown as a building on the 1900 OS map. It appears to have been constructed in the angle of the walls of an enclosure shown at this point on the 1900 OS map and must therefore post-date 1900 (Illus 6). RCAHMS (visited 1998) described this as a triangular enclosure but the present survey indicates a rectilinear form, possibly with an open W end, or possibly rubble along the W end may indicate a wall line. There appeared to be a narrow opening (W: c. 0.70m) in the N wall.

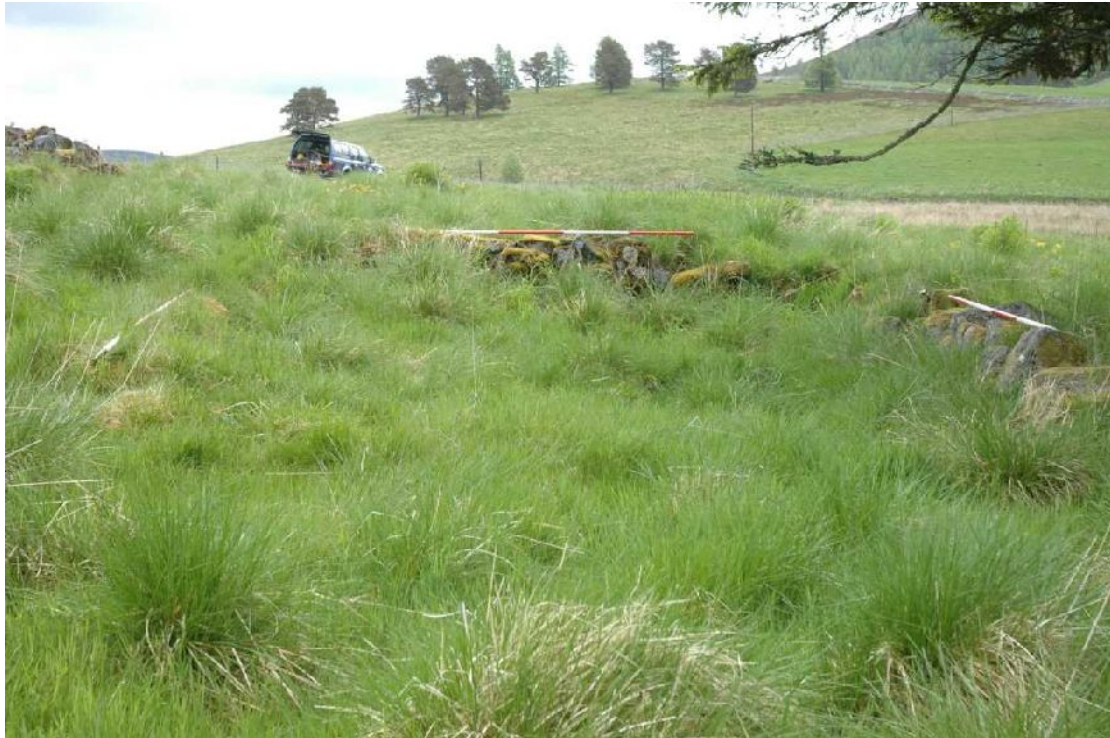
Illus 7 Building 2 looking E

Rubble stone (W: c. 0.50m) surviving to 4 courses.

E-W: 6.5m x N-S: 4.5m

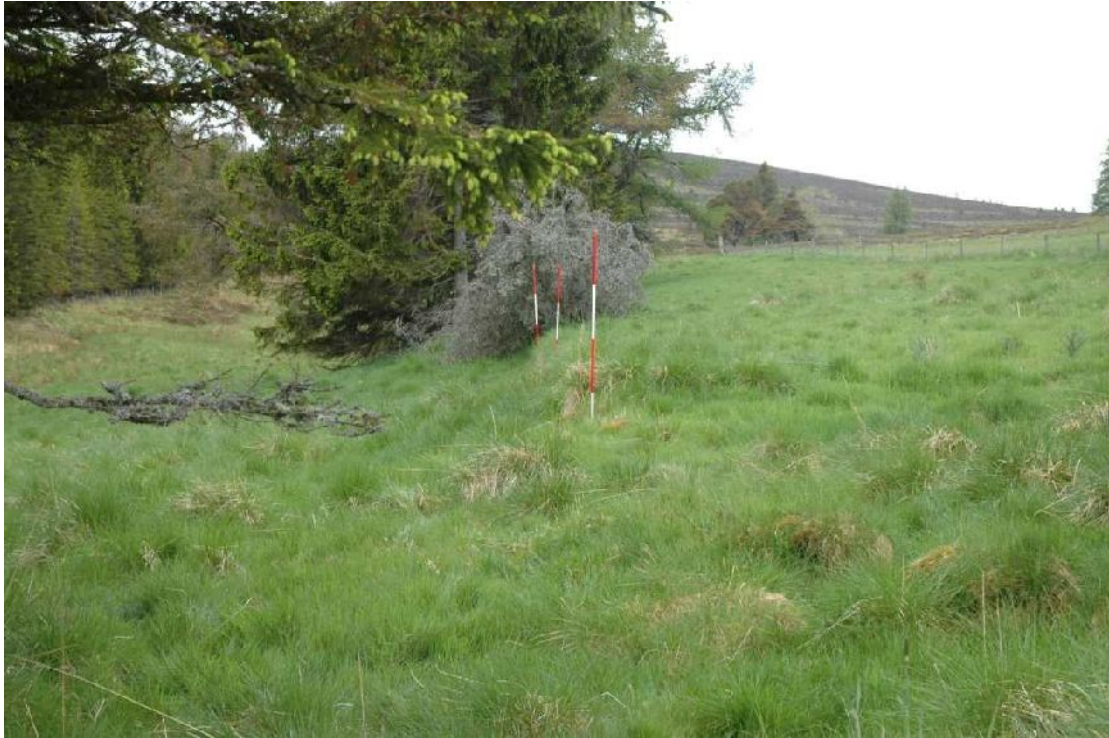
Illus 8 Wall 1, looking W from B2

Some 20m of an E-W wall lying W of the surviving ruins appears likely to be the N wall of the enclosure shown on the 1867 OS map. It survives to 4 courses and c. 0.80m in height, revetting the S side of the higher ground to the N.
