BRAEMAR CASTLE ENVIRONS ABERDEENSHIRE

Archaeological desk top and walkover survey

Report No: MAS 2013-17
by
H K Murray and J C Murray

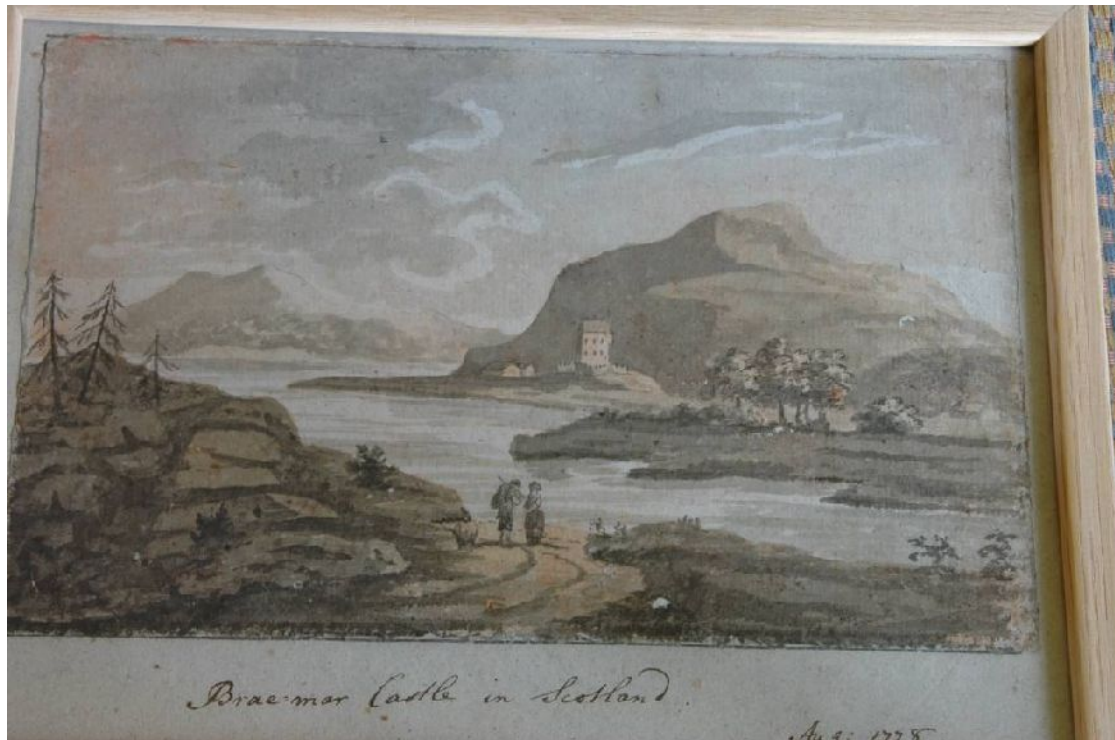
Illus 1 Ink and watercolour titled: Brae-marr Castle in Scotland. Aug: 1778. (Braemar Castle Morning Room).

This appears to be copied from the view from the print in the same room (see below), although the figures at the ford have been changed and some details obscured.

Both 5.8 and 5.9 show a view of the castle from the ford on the old road. The castle is shown on its mound with the curtain wall around it. Two single storey rectangular

buildings lie to the E outwith the castle wall. Chimneys are shown at the near gable of each building.

No trees are shown around the castle. Trees are shown to the S of the chapel at the W (LHS) side of the picture.

present authors to be a possible copy of it (Doc 5.8) dating to 1776. Two features are worth noting. They show the castle on the bare mound with no trees nearby; this would appear likely to be accurate as it would be strategically good practise for the castle to have had clear views. They also show two rectangular buildings to the E of the castle; these appear to be single storied, possibly of stone and with a chimney at least on the more northerly building. It is of course possible that these are entirely imaginary structures! As the perspective is somewhat odd, they might be interpreted as part of the settlement on the slopes of Creag Choinnich, although this might be expected to be depicted nearer to the site of the chapel which is also shown. However it is also worth considering that there was no apparent accommodation within the curtain wall for horses and it is probable that at least the officers should have had horses. Regardless of the possible veracity of the documentary evidence, there is the possibility of ancillary structures from the 18th century use of the castle.

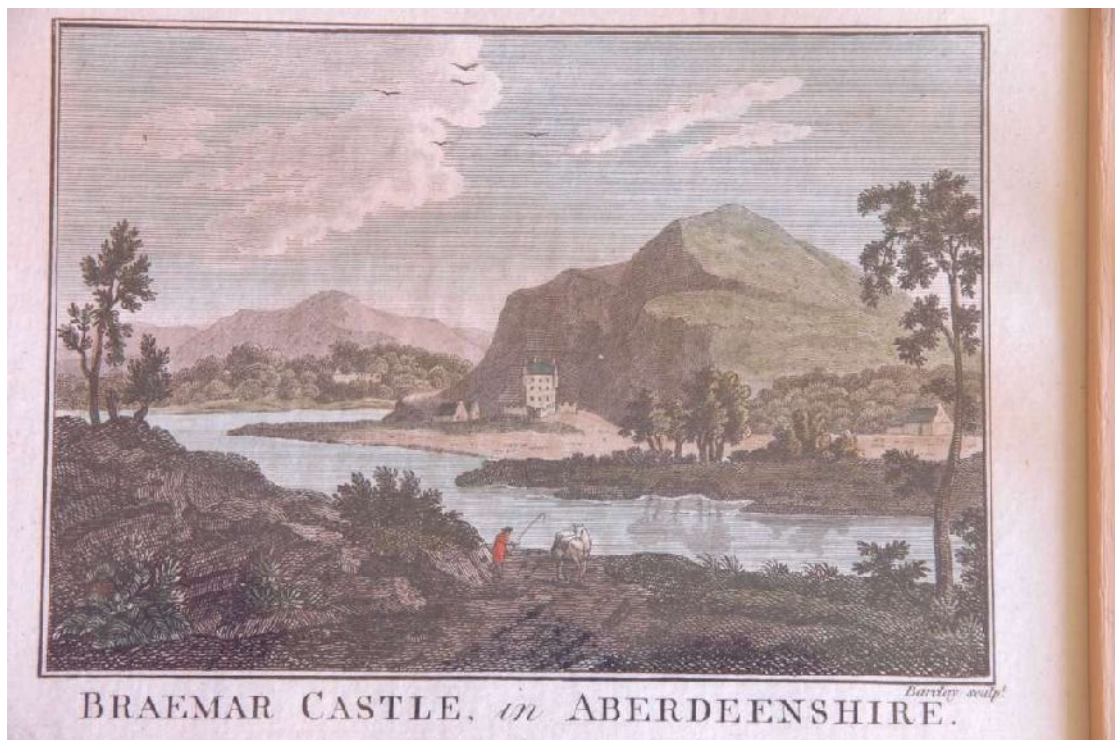
Illus 2 Print of etching titled: Braemar Castle in Aberdeenshire. Barclay sculpt. (Braemar Castle Morning Room).

No visible date as framed. However an uncoloured print of same etching (www.sandersofoxford.com) was printed by Alexander Hogg No 16 Paternoster Row. (floruit 1778-1824). With reference to the painting (5.8 above) a date in the 1770s appears probable for the original of the print.

Apart from the plans from 1748-1750, the only representations of the castle at the time are a romanticised engraving (Doc 5.9) and a watercolour considered by the

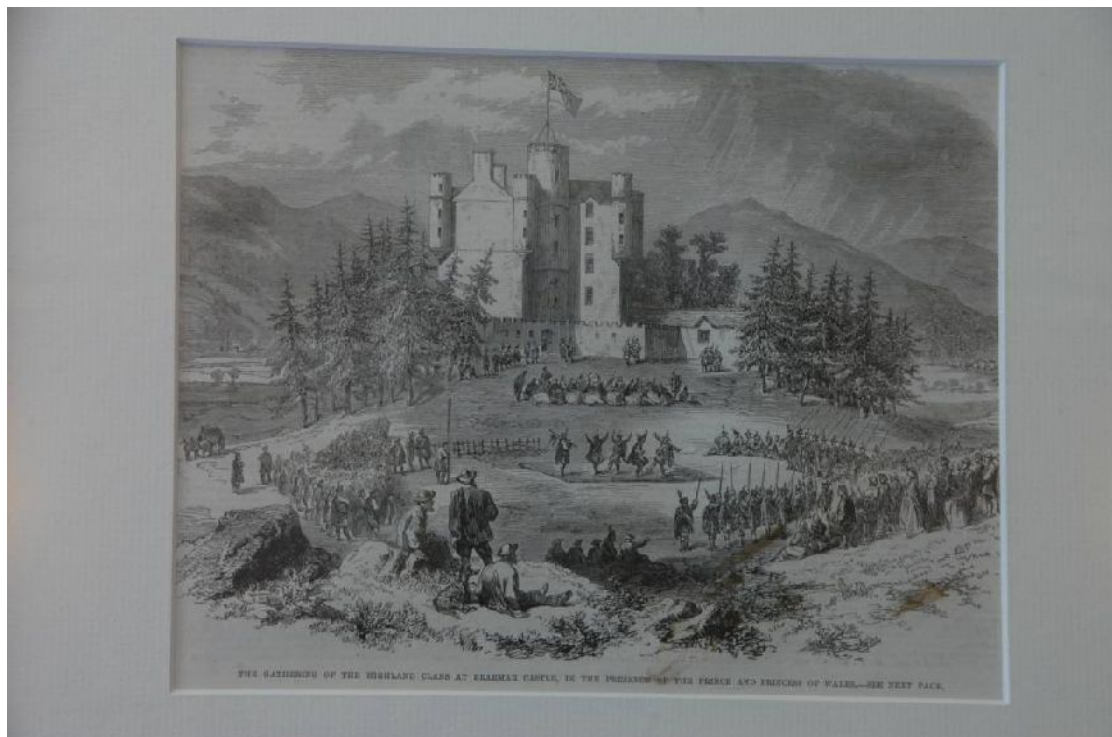
Illus 3 Copy of newspaper print titled: *The gathering of the highland clans at Braemar Castle in the presence of the Prince and Princess of Wales.* (Braemar Castle Drawing Room). 1864.

Although no date shown on this, the print can be dated to 1864 and was published in the Illustrated London News for Sept 17th 1864

This is a view of the castle from the S, showing highland dancers on the flat area of grass S of the castle. A rectangular outshot building appears built across the curtain wall on the E side of the castle.

Trees are shown E and W of the castle (conifers) with more trees behind (broad-leaved). No trees are shown S of the lawn.

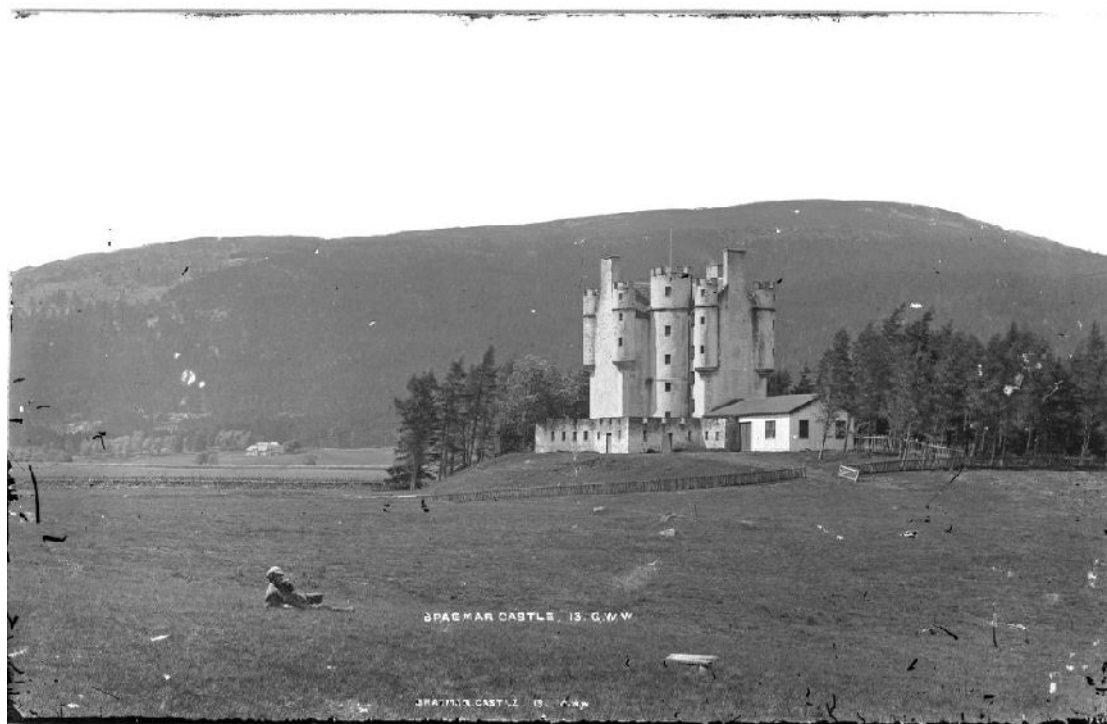
Illus 4 George Washington Wilson. Listed in GWW 1877 catalogue. (Aberdeen University collection. GB0231 MS3792/E2730. <http://abdn.ac.uk>).

Castle seen from the SSW. Rectangular outshot on E through curtain wall. Zoom allows detail of the outshot- it was of vertical timber construction with a possible slate roof and was built incorporating the curtain wall and abutting the castle wall across the courtyard. A paling of vertical timbers with top and base timber bars is shown around the base of the mound. Zoom allows detail of the fence which was in poor repair with many gaps. Rock outcrops visible in field S of mound.

Trees behind castle to E and W. Ground to S of castle no trees.

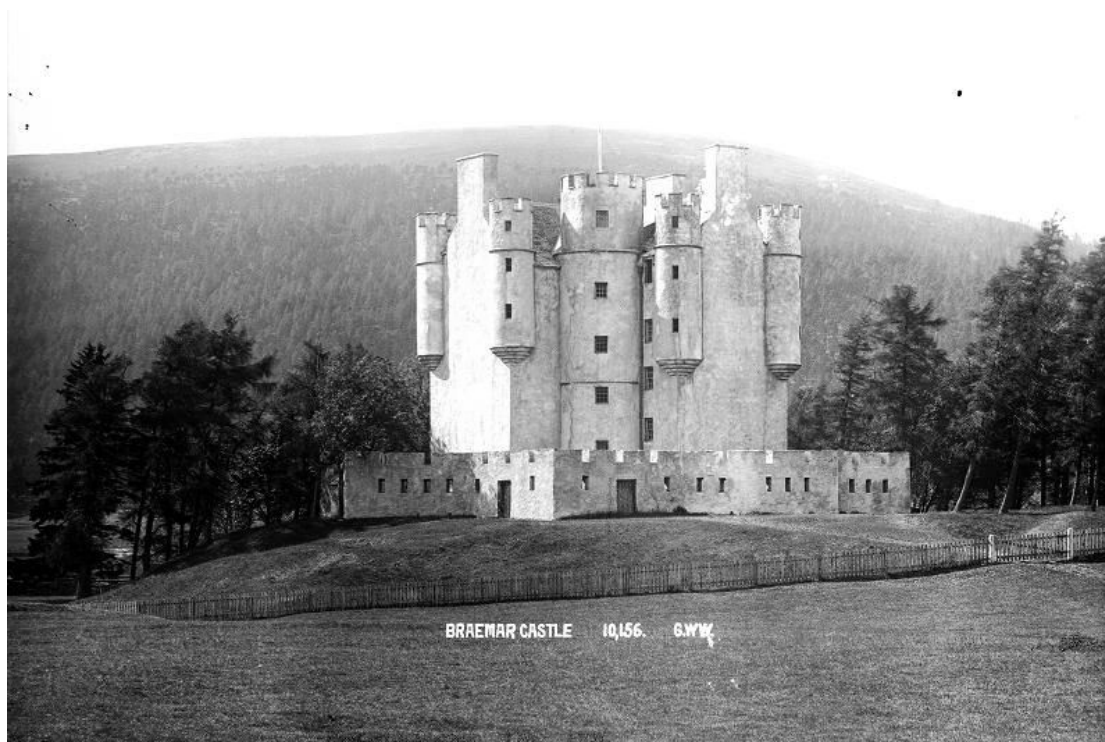
Illus 5 Photograph Titled *Braemar Castle*. George Washington Wilson. Registered 1899. (Aberdeen University collection. GB0231 MS3792/C0905. <http://abdn.ac.uk>). Doc 5.15.

Major changes and renovations are clear. The E outshot has been removed from the castle and curtain wall. Both the castle and curtain walls appear to have been re-painted (or possibly re-harled). They appear clean and pale whereas in the earlier photographs there are distinct damp stains down the towers and along the top of the curtain wall. Zoom allows detail of fence around base of the mound, which has been replaced or repaired; it is still a paling fence with top and base bars. The trees remain behind castle to E and W. The foreground is grass but does not extend far enough S to be sure if there are trees on this side by this time.

By 1899 however, there appears to have been a further stage of renovation. The rather ugly E outshot has been removed and both curtain wall and the castle have clearly been reharled or re-painted. Even the fence has been repaired or replaced

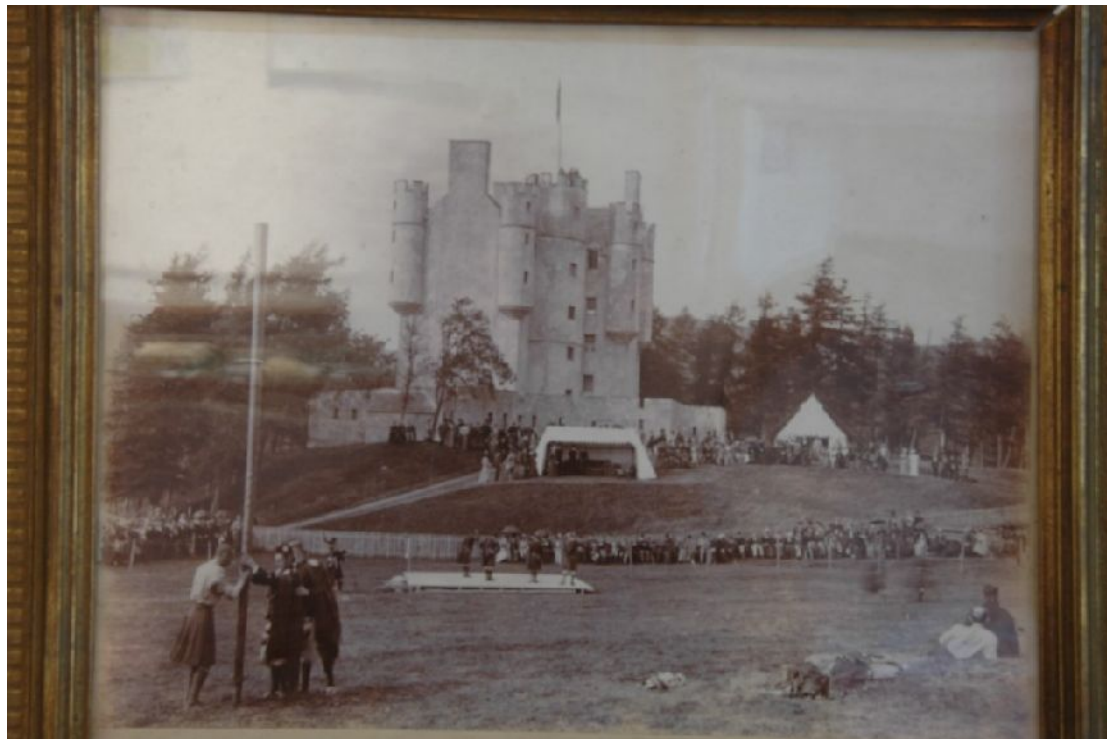
Illus 6 Photograph of the Braemar Gathering. (Braemar Castle, Exhibition room). Possibly 1893-95. Doc 5.18.

No date but appears to be shortly after the renovations noted by 1899 (above) as the castle is clean and pale and the E outshot is not present. Small roofed lean-to (extant) against W side of curtain wall; this is shown on 1900 OS map. The Braemar games were not held at the castle after they moved to their permanent grounds in Braemar village in 1906. Possible date range 1890s-1906. Probable 1893-95 (see below 5.19)

Paling fence around base of mound. Path clear to SW angle of curtain wall. Curved path on E side of mound/lawn ? Trees to E and W behind castle. Two small trees quite near curtain wall on W.

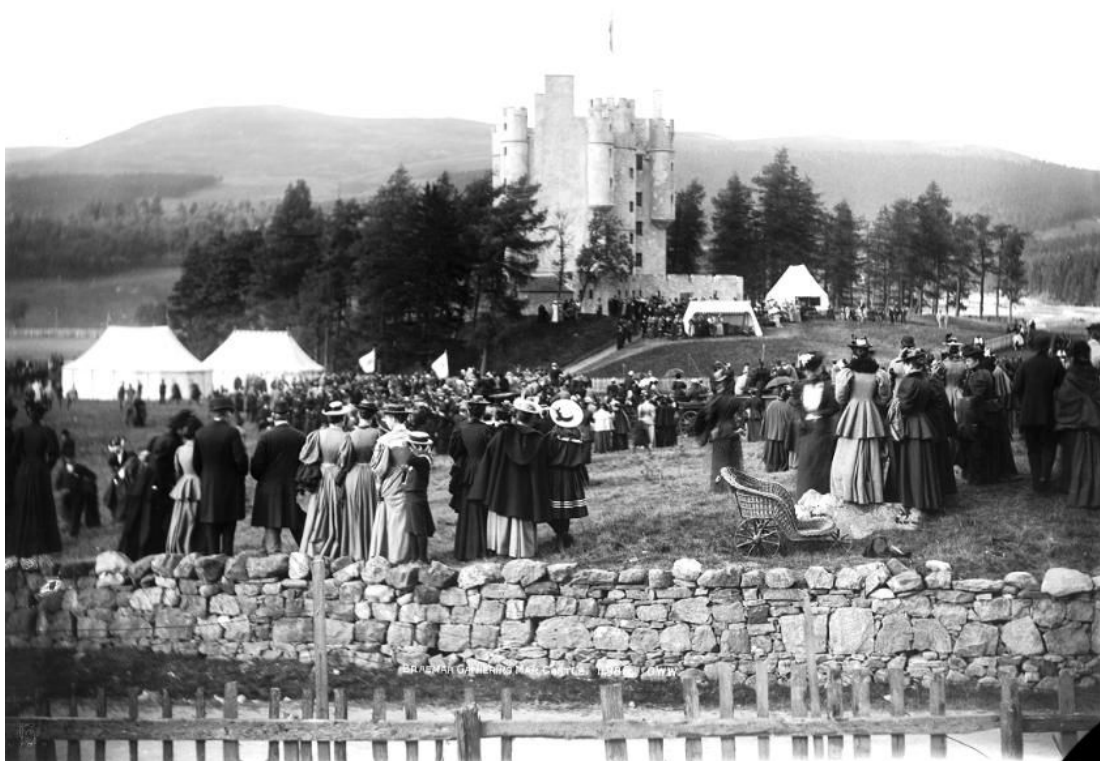
Illus 7 Photograph Titled Braemar Gathering. Mar Castle. George Washington Wilson. Listed in 1904 catalogue (Aberdeen University collection. GB0231 MS3792/A0091. <http://abdn.ac.uk>). Doc 5.19.

Aberdeen University archive notes that Braemar gathering was held at the castle in the years 1893-95. The clothing suggests mid to late 1890s. Details of the position of the tents, the size of the two small trees at SW corner of curtain wall suggest this was taken in the same year as 5.18 above.

The interest in this photograph is that it is taken from the Aberdeen to Braemar road (A93) with the drystone dyke (extant) in foreground. It clearly shows that at this stage the woodland between the road and the lawn had not been planted.

The trees are still limited to the areas behind and flanking the castle, with the ground to the S remaining clear. One photograph of the Braemar Gathering probably dating to the mid-late 1890s (possibly 1893-95, years when the games were held at Braemar Castle) is taken from the road (A93) and shows the roadside drystone dyke, with grass between it and the castle.

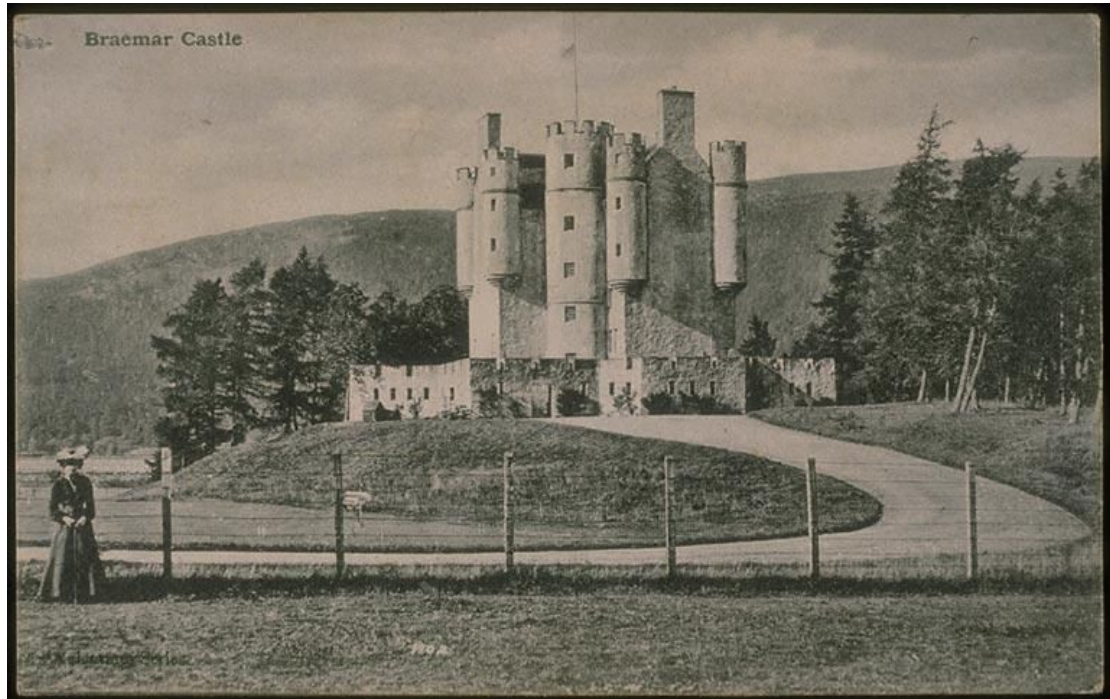
Illus 8 Photograph Braemar Castle. Post card. Valentine collection. St Andrews University Photographic Collection ID JV-1702. (www.st-andrews.ac.uk) Doc 5.21.

5.21 *Photograph Braemar Castle. Post card. Valentine collection. St Andrews University Photographic Collection ID JV-1702. (www.st-andrews.ac.uk) . Illus 8, 9.* The collection date the creation of photograph as 1878 but internal evidence suggests it is later. As Vanessa Stephen noted (pers comm.) the dress of woman in foreground appears Edwardian. The photograph also post-dates the removal of the E outshot (c 1899) and is later than the Washington Wilson prints as the curved path is now very

clear and there is a post and wire fence to the E of it. Probable date c. 1900 or soon after.

A photograph (Doc 21) probably dating to c 1900 shows the curved driveway, with a post and wire fence to the E. Other later developments include the summer house (Gazetteer No 6) and the possible flower bed around one of the rock outcrops in the S lawn (Gazetteer No 12a).

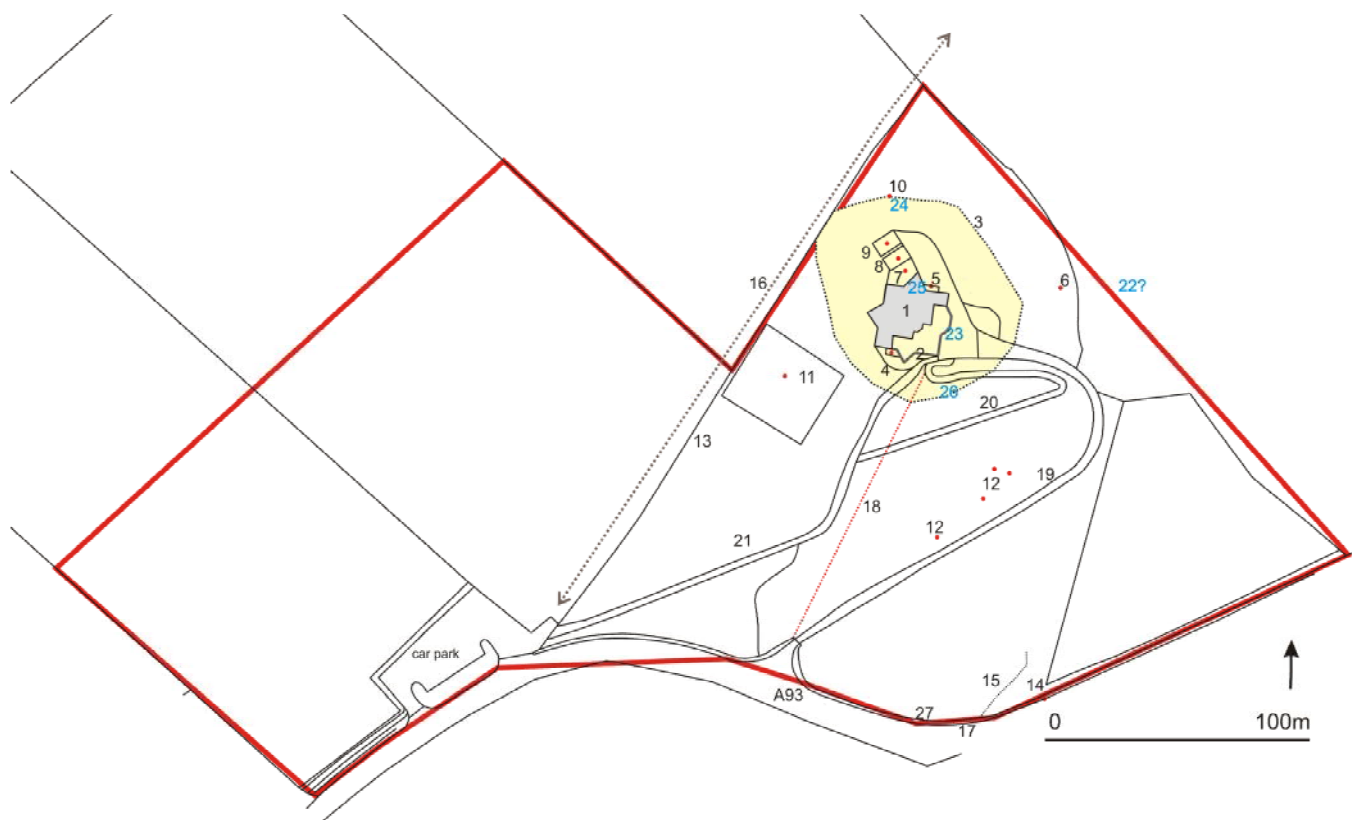
All the sites in the Gazetteer are fully described in Appendix 2 at the end of this report, with tabulated reference to the changes on each of the maps consulted. Site numbers refer to the Site Nos in the Gazetteer in Appendix 2 and on the map Illus 10 below and in larger format Illus 15.

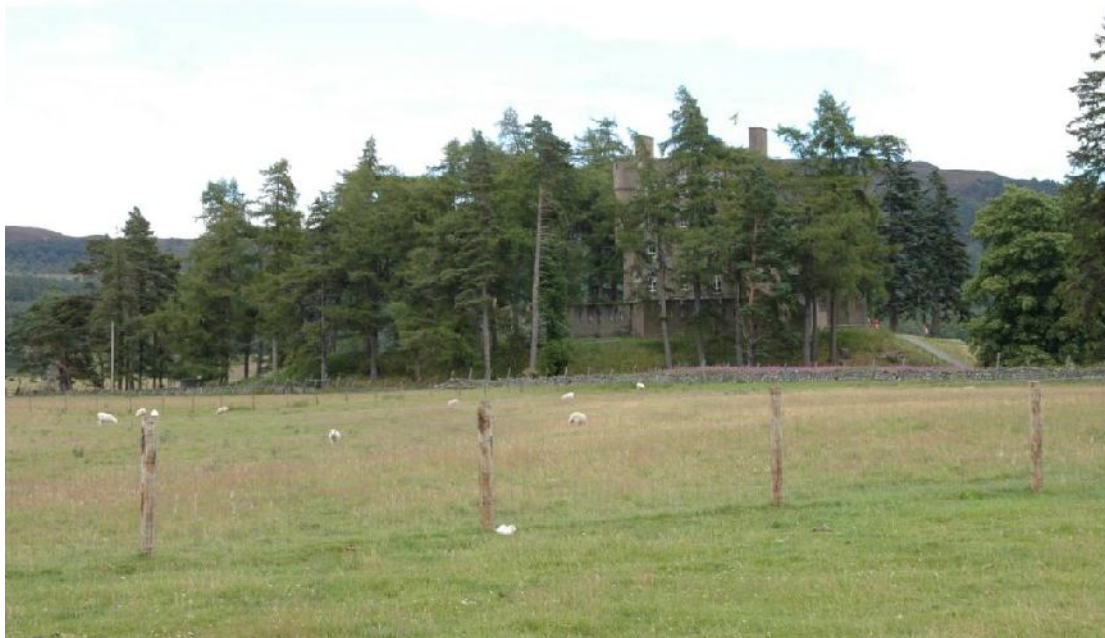
Illus 11 Mound as seen from field to W

There is no reported documentary or artefactual evidence of a medieval motte on the site. However, the form of the mound (Illus 11), although of natural origin, appears possibly scaped on the N and E faces and as a result Yeoman (1988, 130) included this as a possible motte in his summary of Aberdeenshire motte sites. It is perhaps significant that Yeoman considers that many of the NE Scottish mottes had links with hunting reserves.

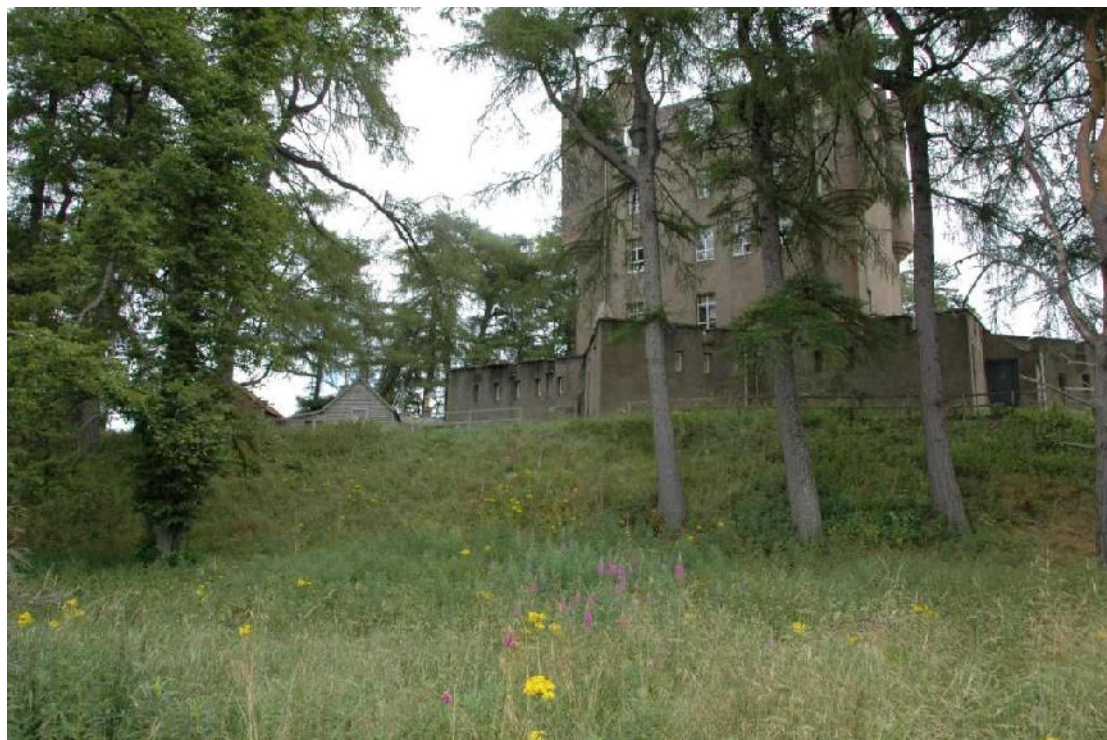
Illus 14 Base of mound W side. Dark green of nettles suggest possible ditch

On the W/SW side of the base of the mound, between it and the former kitchen garden, there is a wide area of nettles, which might indicate the possibility of a partial ditch around the mound base.

Any ground work in this area could have archaeological implications. Not only is there a faint possibility of a ditch or partial ditch, but there is also the possibility of identifying peripheral structures, middens, wells etc. If trees are to be removed it

would be preferable that the roots are not disturbed. It should be noted that the roots will have damaged potential archaeology to some extent.
