# LEITH HALL COURTYARD KENNETHMONT ABERDEENSHIRE

## - Archaeological Watching Brief - Carried out 16<sup>th</sup> July 2013 by Murray Archaeological Services Ltd

**Report No: MAS 2013-21**  
by  
J C Murray

**-Archaeological Watching Brief-**

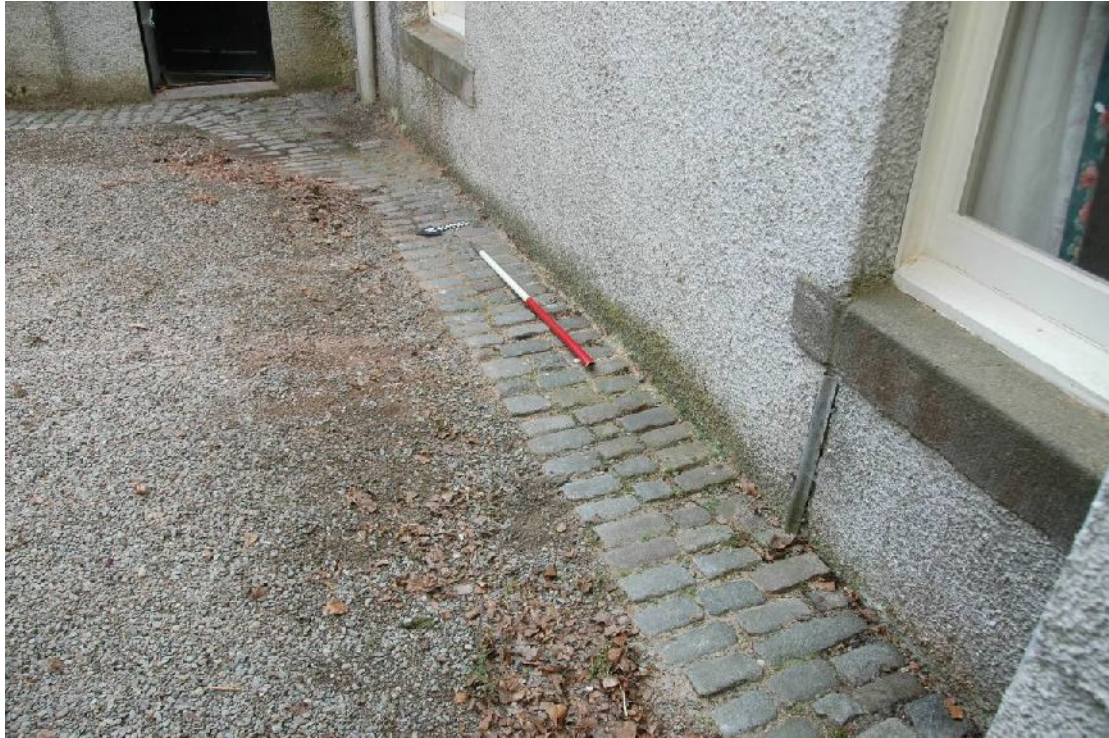
**Illus 1: Granite setts along the S side of the courtyard**

- 3.1 Granite setts bordering the S and E sides of the courtyard were lifted by hand and carefully set aside so that they could be replaced on completion of the work. The setts extended out from the courtyard walls for c.460mm and were laid in rows of three. Their average size was 150mm wide x 75-80mm across x 145mm deep (Illus.1).

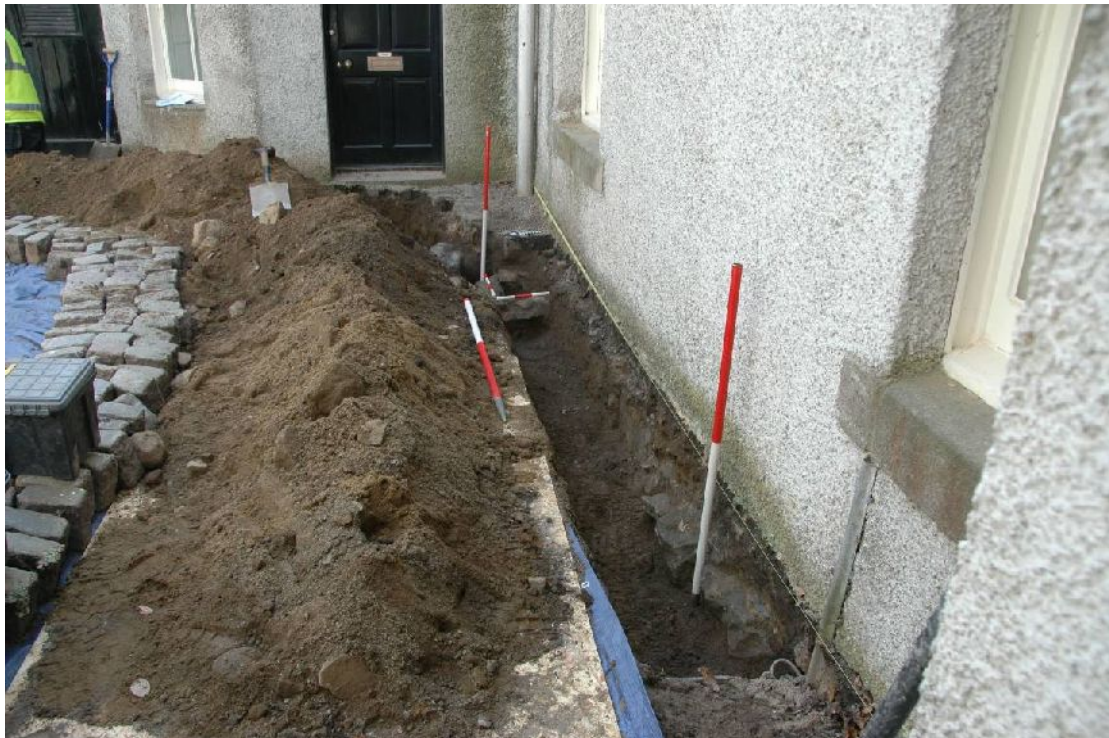
**Illus 2: Trench on S side after excavation**

- 3.2 The setts were bedded in a mixture of dark brown soil and sand and had been lifted as the installation of modern services required. The trench for the new cable duct was c.500-600mm wide and c.500mm deep.

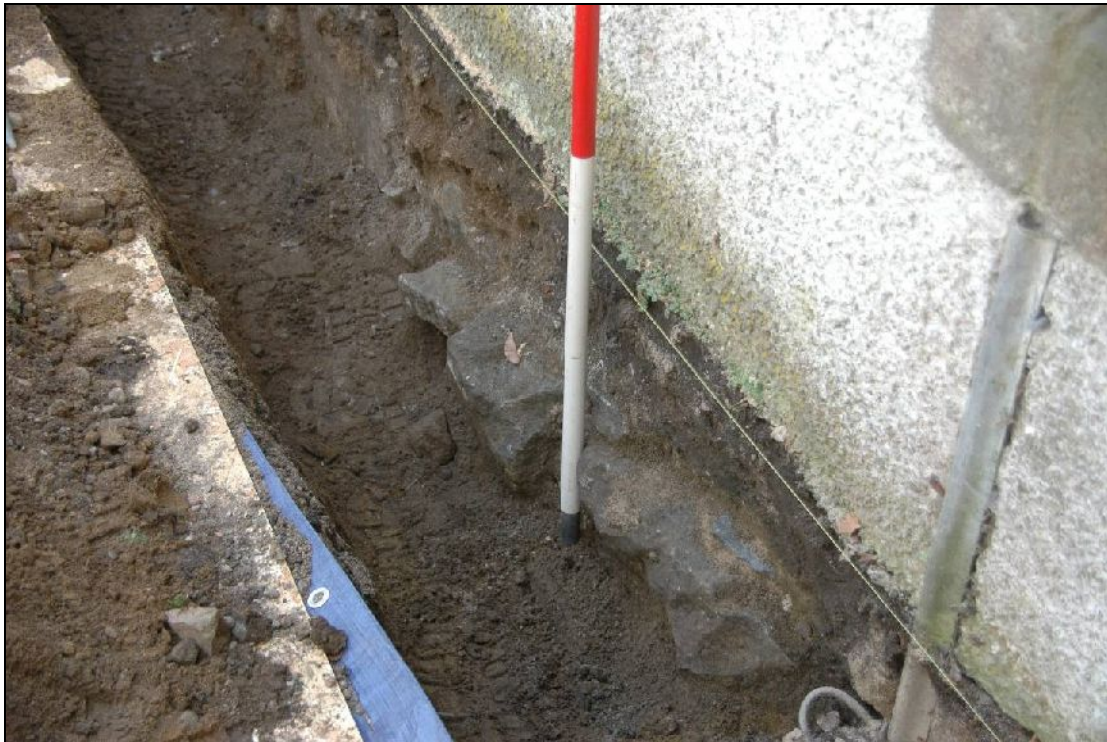
**Illus 3: Wall foundation in SW end of trench**

- 3.3 At 1.04m E of the doorway in the SW corner of the S range a number of stones which may possibly be associated with the main wall projected some 100mm into the trench. The possible foundation was c.1m wide and was made up of three stones varying in width between 180mm and 420mm and did not extend to the N side of the trench [see No.1 on Site Plan, Illus.9].

- 4.1 With the exception of the possible wall foundation located the W end of the E-W trench no other structural evidence was present.

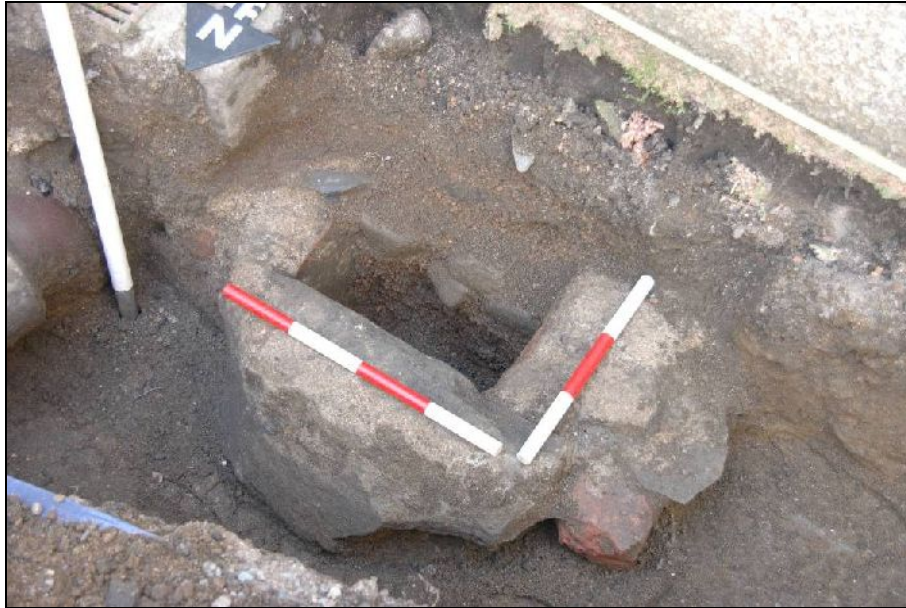
**Illus 4: Stone and brick drain at E end of trench**

- 3.4 At c.1.4m W of the E range a square stone and red brick drain was located. Projecting into the trench c.500mm from the S wall the drain was 300mm wide and c.260mm deep on the W side. It was filled with pea gravel to a depth of c.300mm but the bottom was not reached [see No.2 on Site Plan, Illus.9].

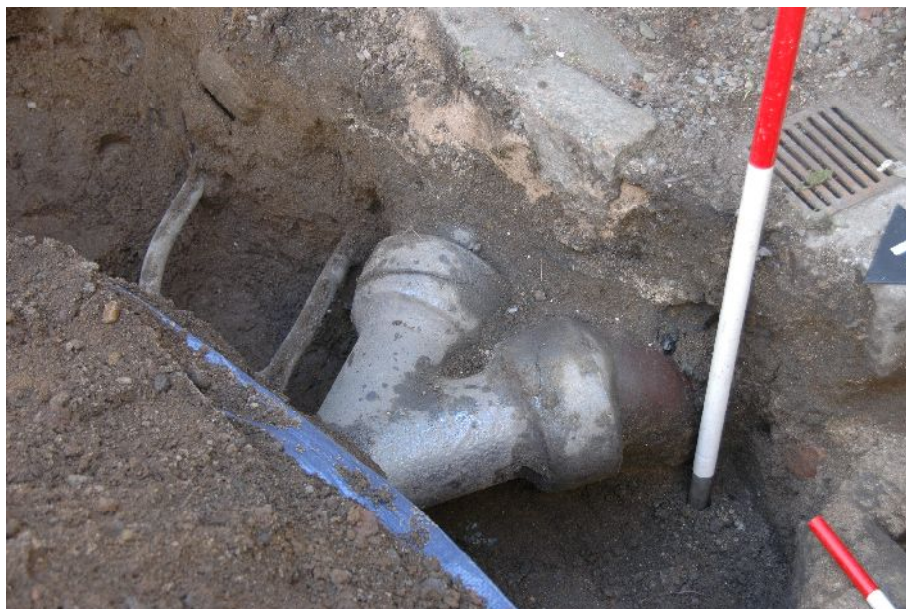
**Illus 5: E end of trench showing the pipes and water pipes**

- 3.5 At the E end of the trench two further services were located; being a 'V' jointed sewer or waste water pipe and two lead water pipe running SE to NW across the trench [see No 2 on Site Plan, Illus.9]

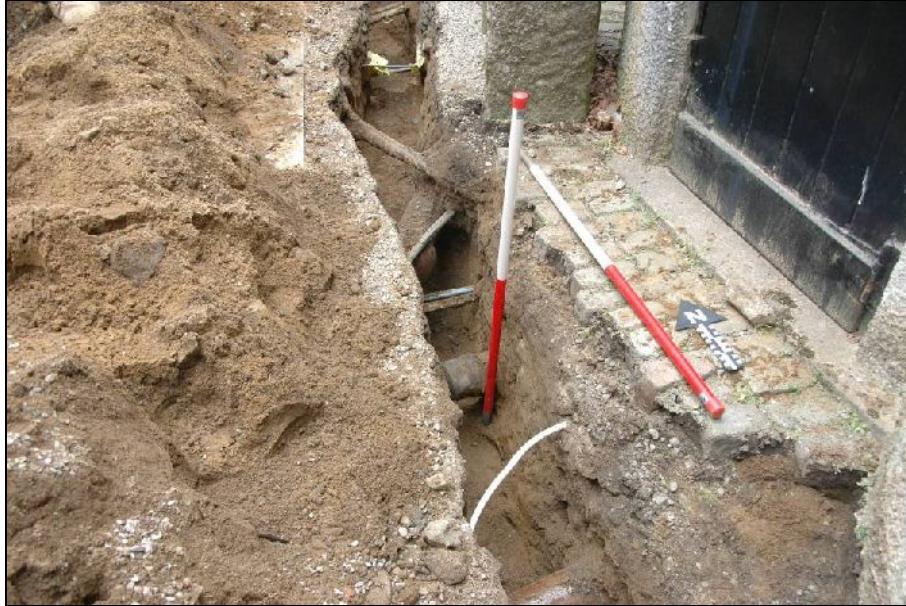
**Illus 6: Services in front of Boiler Room door**

- 3.6 The continuation of the cable trench running N-S across the E range of the courtyard was also heavily disturbed by services. In front of the Boiler Room door eight services were located. These consisted of three waste water pipes

and five smaller services placed above the water pipes. At this point the depth of the trench was deepened to 800mm to allow the new cable duct to pass below the existing services [see No.3 On Site Plan, Illus.9].

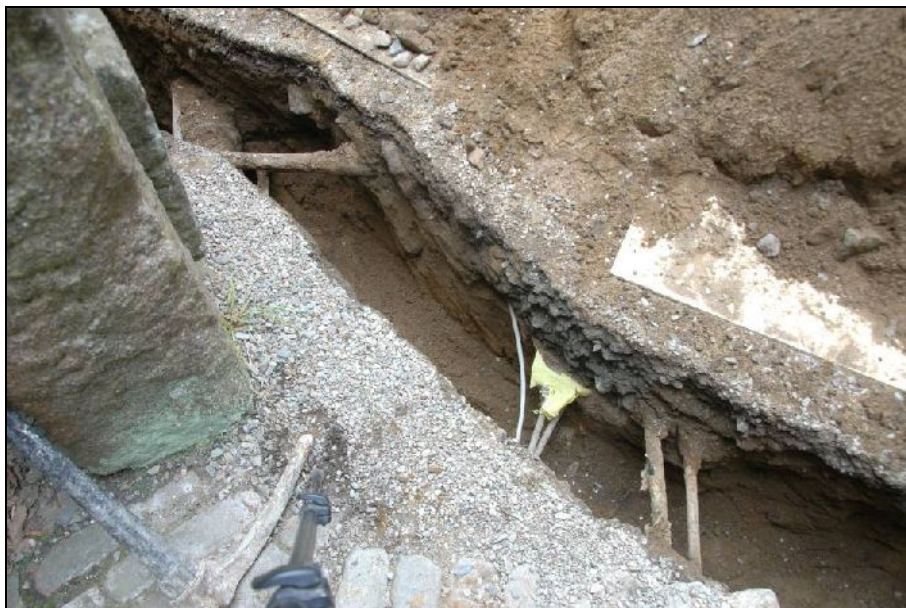
**Illus 7: Services N of the Boiler Room**

- 3.7 Between 1.5m and 2m N of the Boiler Room door a further five services including power and old water pipes were located [see No.4 on Site Plan, Illus.8].

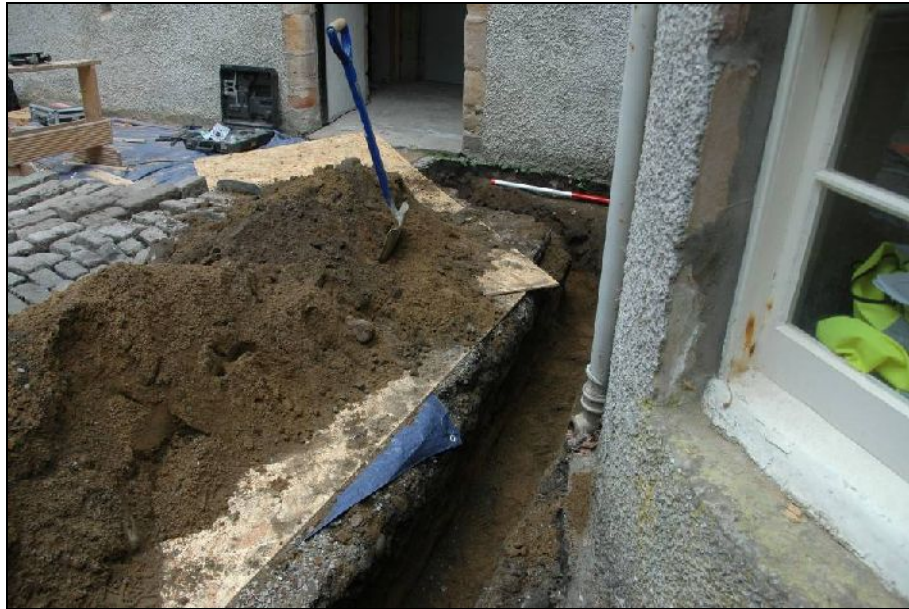
Illus 8: N section of trench to vestibule door

- 3.8 From the end of the services to the N wall of the courtyard and around the E side of the vestibule door the fill of the cable trench consisted of c.400mm of clean beige sand below the setts with no further disturbances.
