**NEW PETERHEAD COUNCIL OFFICES  
ST PETER STREET  
PETERHEAD  
ABERDEENSHIRE**

**- Archaeological Watching Brief -  
Carried out 21<sup>st</sup> April – 1<sup>st</sup> May 2014  
by  
Murray Archaeological Services Ltd**

**Report No: MAS 2014-6  
by**

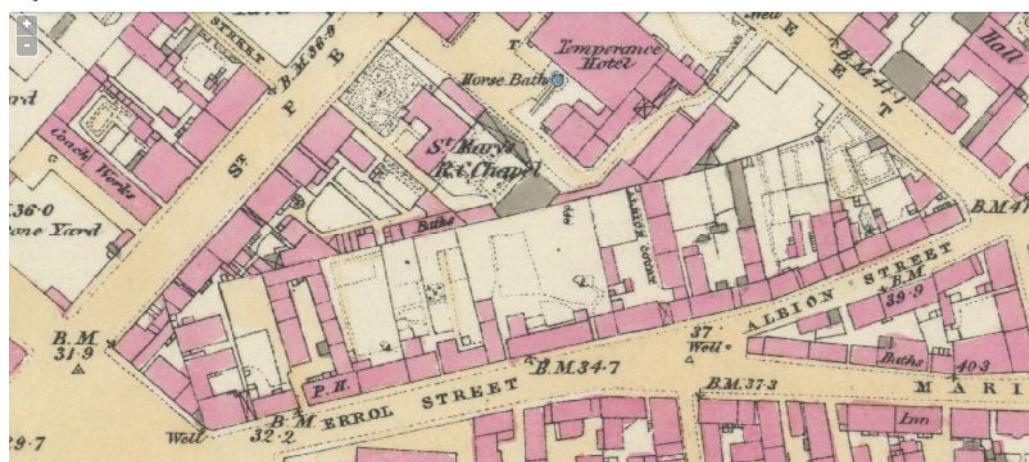
Illus 4 Detail of site from 25"/mile OS map. Aberdeen sheet xxiii.7 (Peterhead) 1868 (Published 1872) [www.nls.ac.uk](http://www.nls.ac.uk)

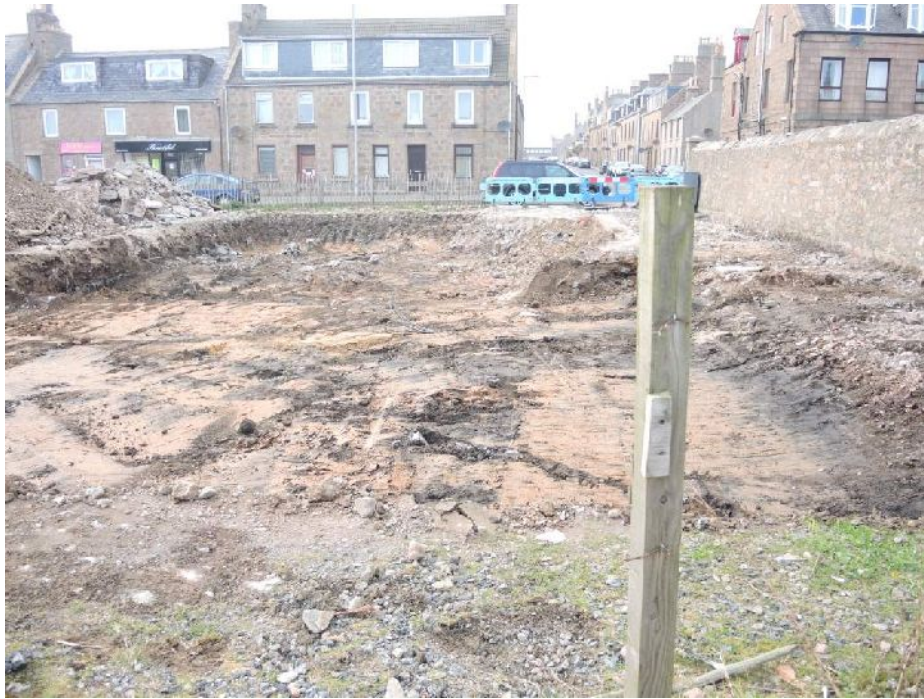
- 3.1 The soil strip was carried out using a full slew mechanical digger with a 2m wide bucket.
- 3.2 Over the footprint of the site there was < 200mm hardcore above a thick deposit of redeposited grey earth with much crushed stone and some brick. In most areas this went to a depth of between 0.6 and 1.0m on to natural clay, this was deeper on the Erroll Street frontage, which may have been cellared. Around the perimeter there was a concrete ring-beam at the pavement edges that would have been part of the construction of the flats and there were many re-enforced concrete piles dug into the clay in all areas, also from the flats. The fill all appeared to be clean backfill after demolition.

**Illus 5 NE sector. Post-demolition fill removed to natural clay. Piles from flats visible**

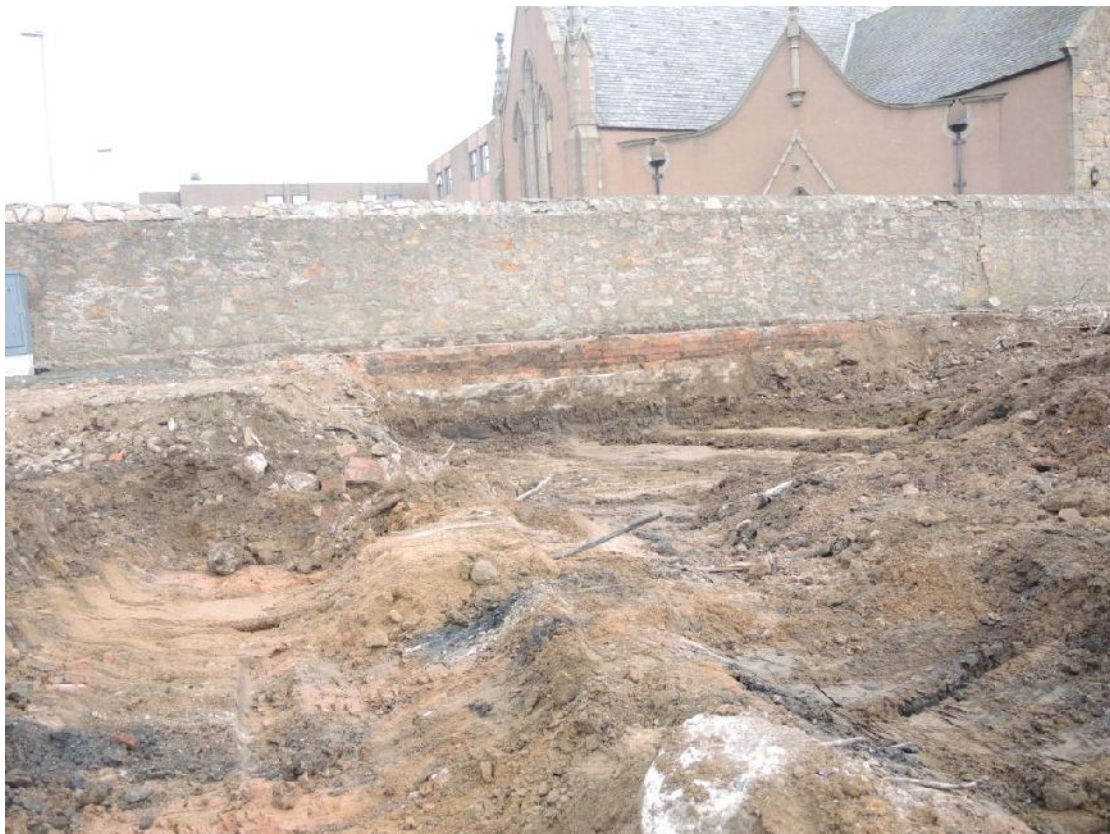
**Illus 6 NE sector. Piles and concrete ring beam from 20<sup>th</sup> C flats**

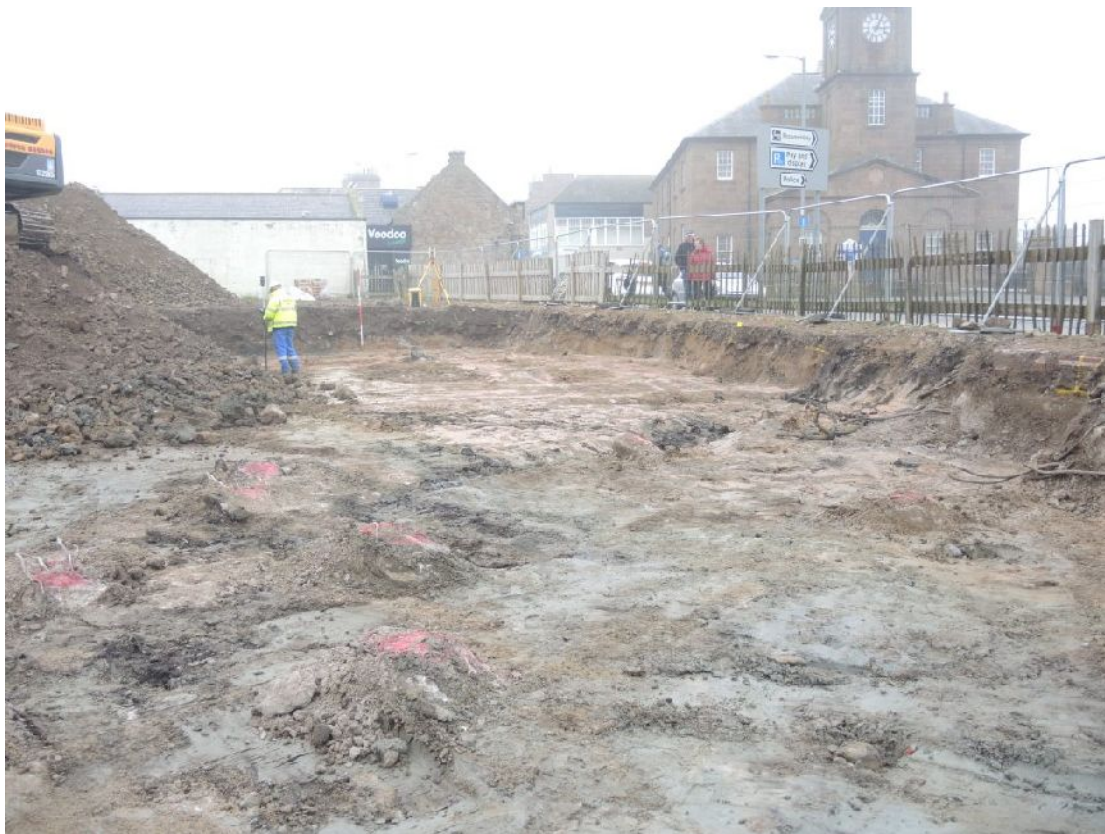
**Illus 7 W sector general. Red marks indicate concrete foundations in natural clay**

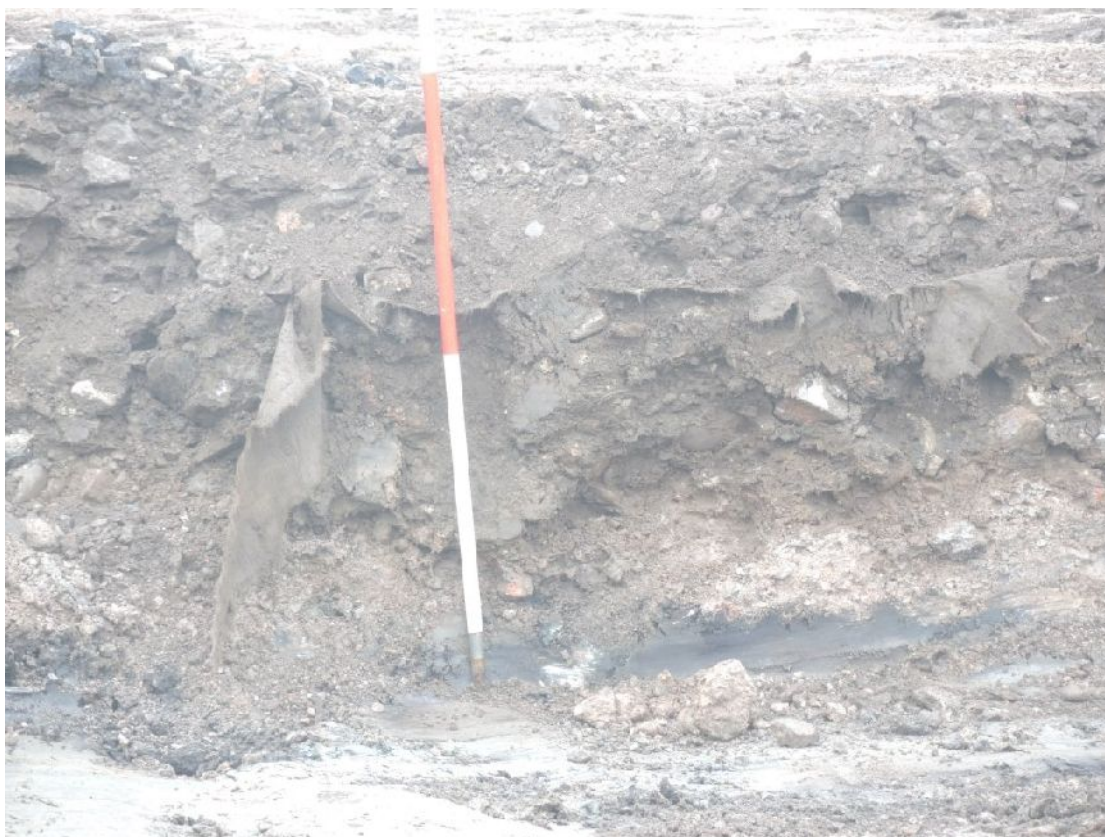
**Illus 8 W sector detail of fill**

3.3 No undisturbed ground was observed above natural.

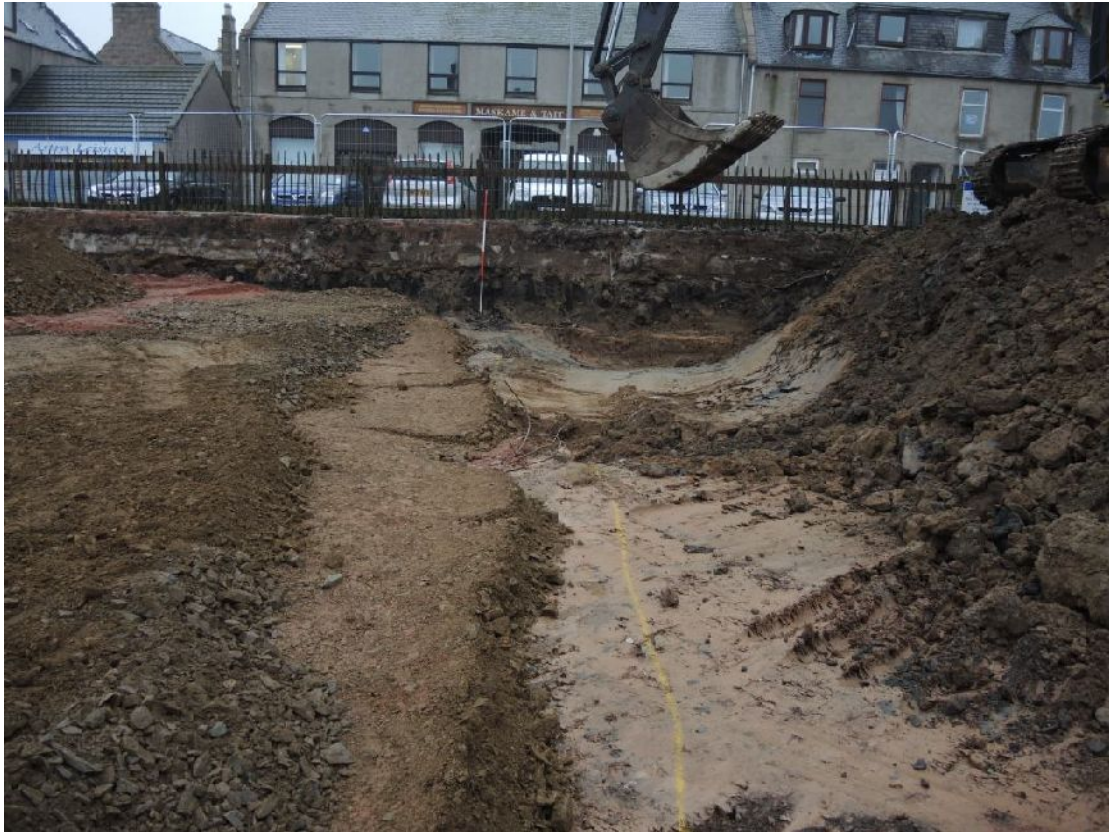
**Illus 9 NE sector showing clean hardcore put in to new building level**

- 3.4 No archaeological features or finds were evident.
- 3.5 After removal of the post demolition fill to the natural clay, levels were backfilled with clean hardcore to the level of the new building foundations. There is therefore no further archaeological potential in this site.
