**KINSTAIR STEADING**  
**ALFORD**  
**ABERDEENSHIRE**

**Standing Building Survey**

**Report No: MAS 2014-13**

**- Standing Building Survey -**

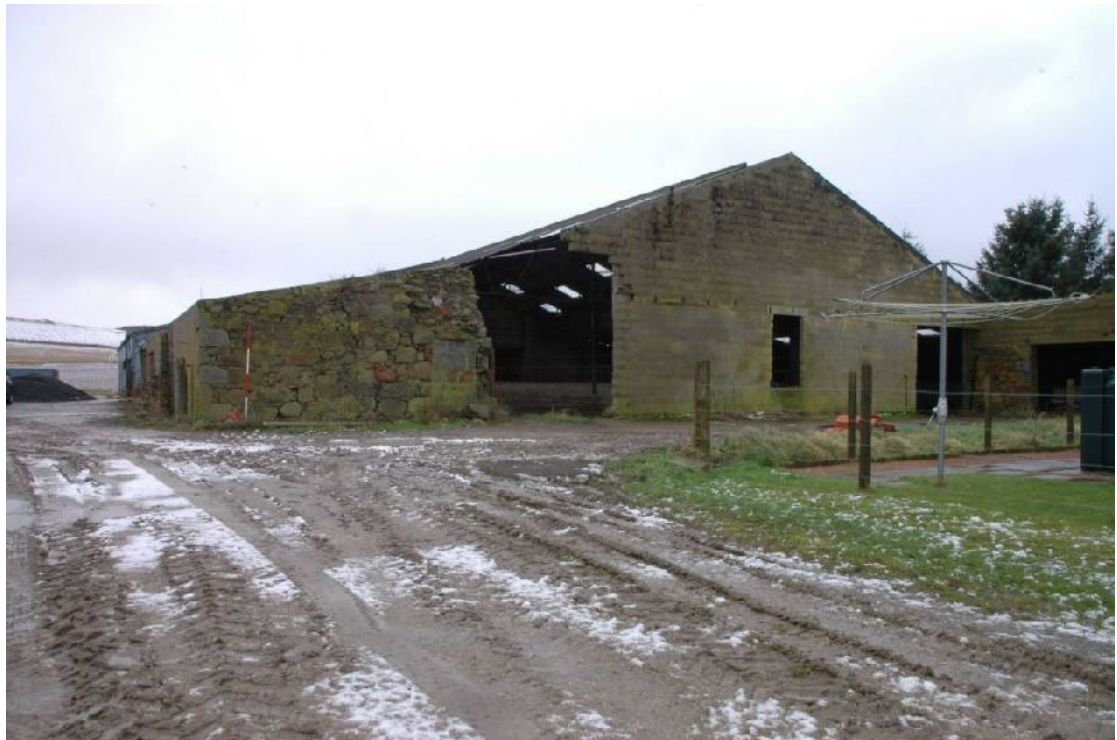
**Illus 1** The site, general view looking SW. Shows E wall of original S range (C) and infill building (D)

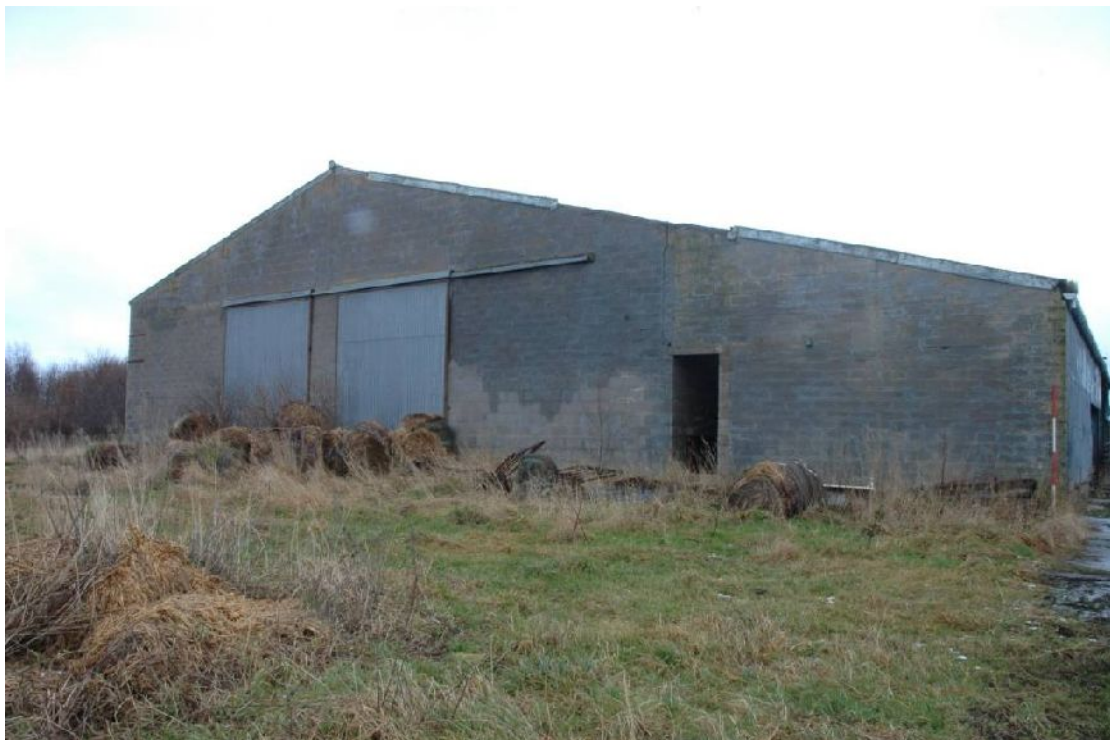
Walls Concrete block walls with corrugated tin sheeting on upper parts of S and E walls.

*W wall* Narrow doorway.

*W wall* Two wide machinery doors with sliding corrugated iron doors.

Illus 4 W wall of Buildings A and B

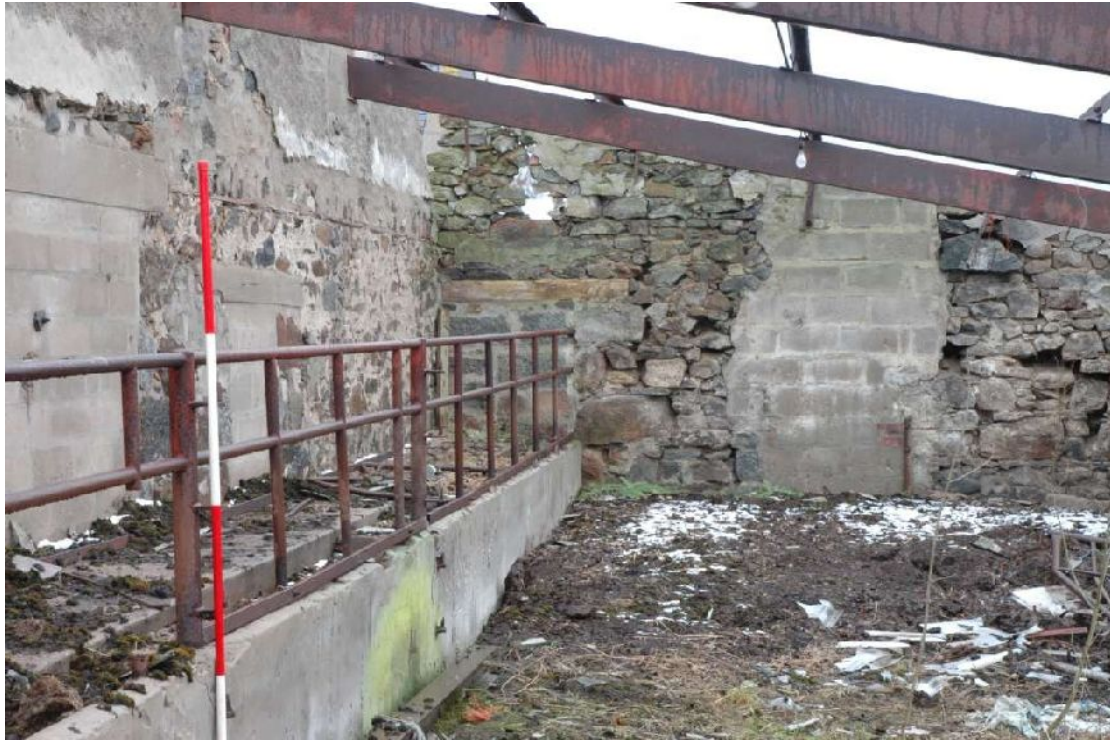
Interior Divided into two by concrete block wall. C2 used for cattle with feed pass along inside of N wall with access from C1.

Illus 5 View of interior of C2 looking E

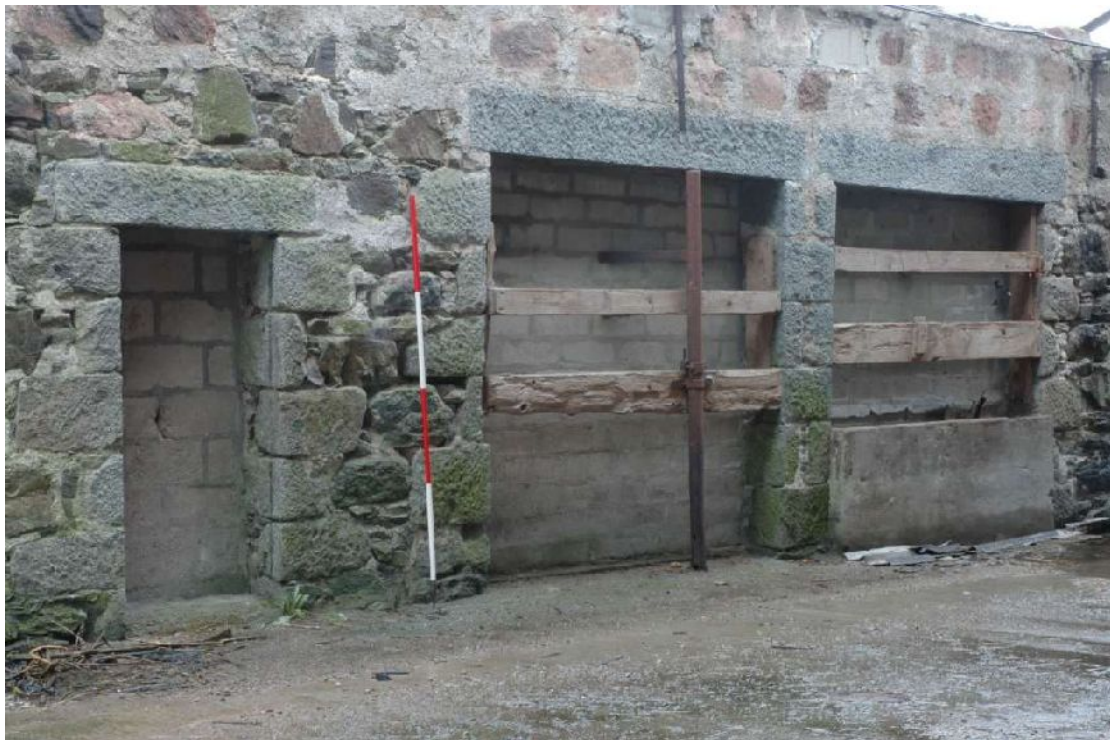
*N wall* Door D2 Original door with dressed granite lintel and rybats. W: 0.85m. H: 1.95m. Blocked with concrete blocks on inner face.

Door D3 and Door D4. Both original cart bays with dressed granite rybats and lintels and dressed granite blocks on pier between them. W: 2.45m. H: 2.4m. Blocked with concrete blocks on inner face.

**Illus 7 N wall of S range. Detail of D2 and cart bays D3 and D4**

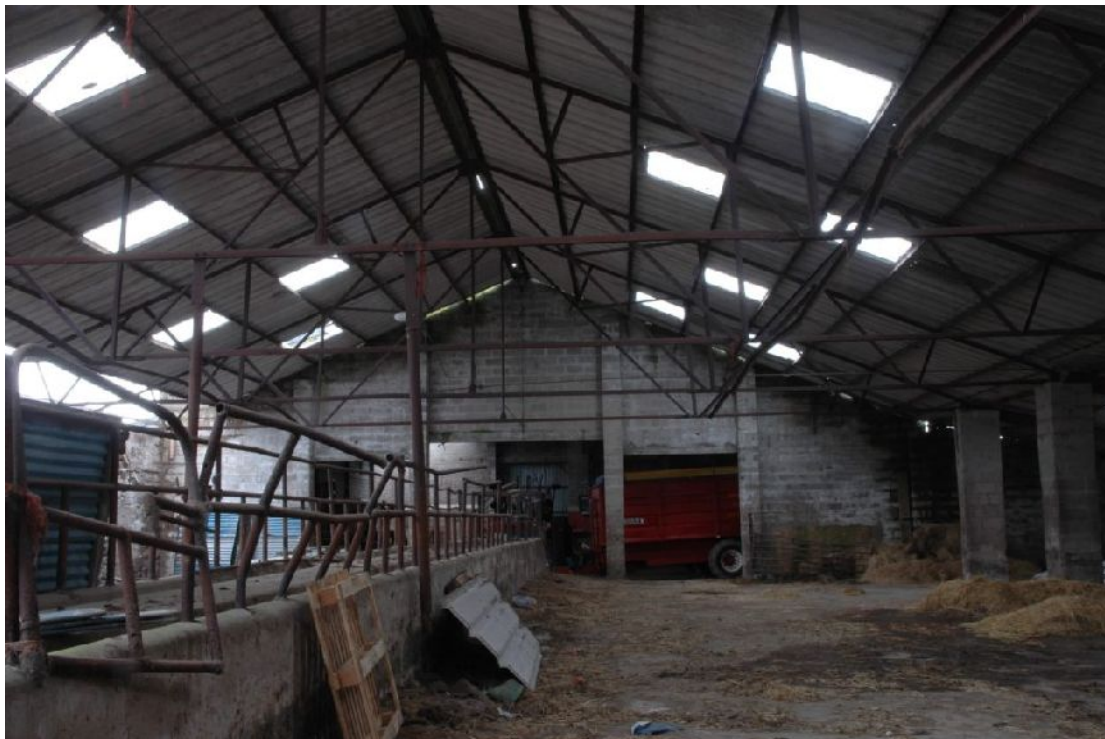
**Illus 8 Looking W along Building D with central feed pass on LHS**

Walls E wall of concrete blocks. W wall concrete block walls on either side of wide central opening with weight bearing concrete block pillars either side of central axis.

S side uses N wall of S range. N side, the S wall of N range replaced by concrete block pillars c 600mm square to bear roof weight.

Interior Divided into two cattle courts by concrete feed pass running E/W along central axis.

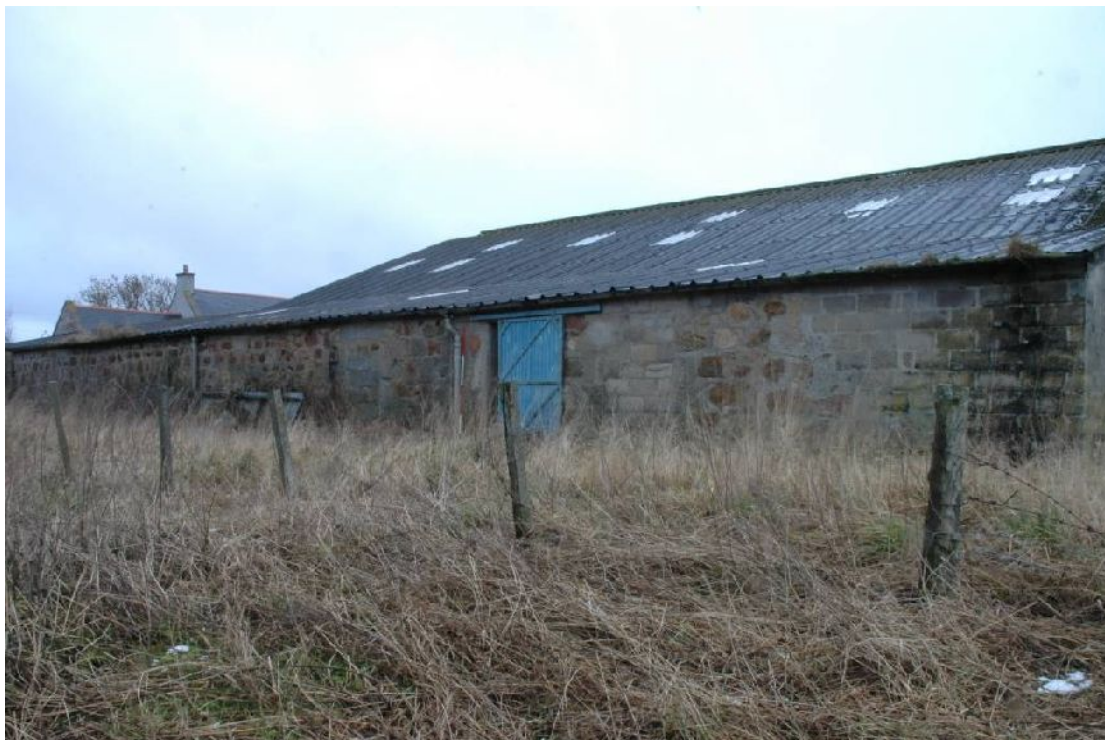
**Illus 9 Original N wall of N range**

*N wall* Door D6. Original door with dressed granite rybats and lintel. W:1.2m H: 2m. Concrete blocked.

Door D7. Either a widening of an original wall or a break-through. Concrete sides and lintel. W: 1m. H: 2m.

Door D8 Original door with dressed granite rybats and lintel. W:1.1m H: 2m. Blocked with dressed granite.

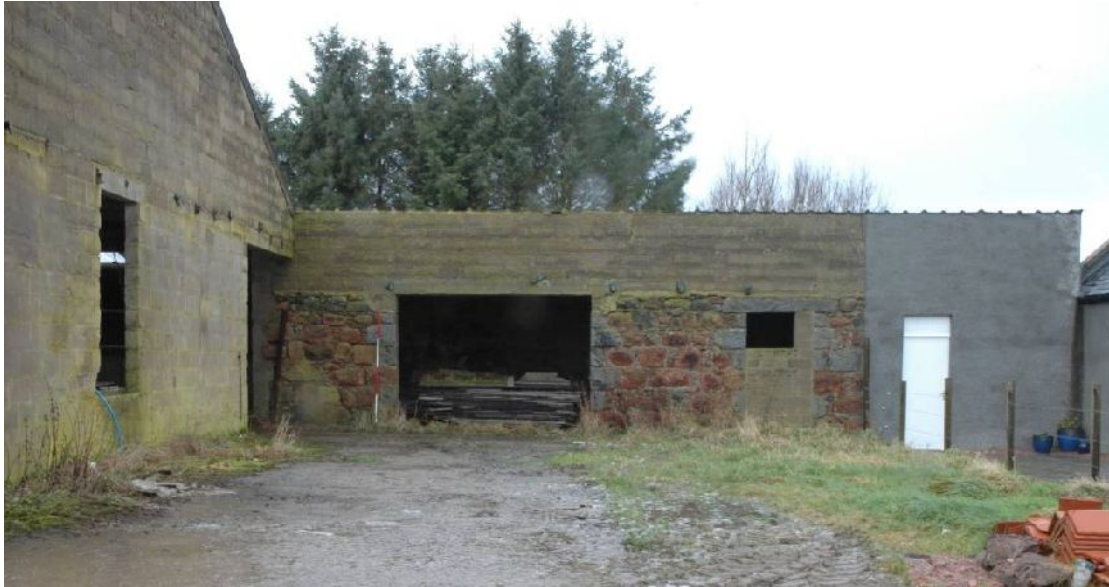
*S wall- E end.* Door D9. Granite rybats but concrete lintel. W: 3.5m. H: 2.5m. Width suggests this may have been a break-through of two narrow doors. Fittings for sliding door.

Door D10. Original door with dressed granite rybats and lintel. W: 1.2m H: 2.2m. Blocked with concrete blocks. Fittings for sliding door.

**Illus 10 E surviving end of S wall of original N range, with D9 and D10**
