HILLHEAD FARM STEADING
BIELDSIDE
ABERDEEN

Standing Building Survey

Carried out February 6th-7th 2014

Report No: MAS 2014-15

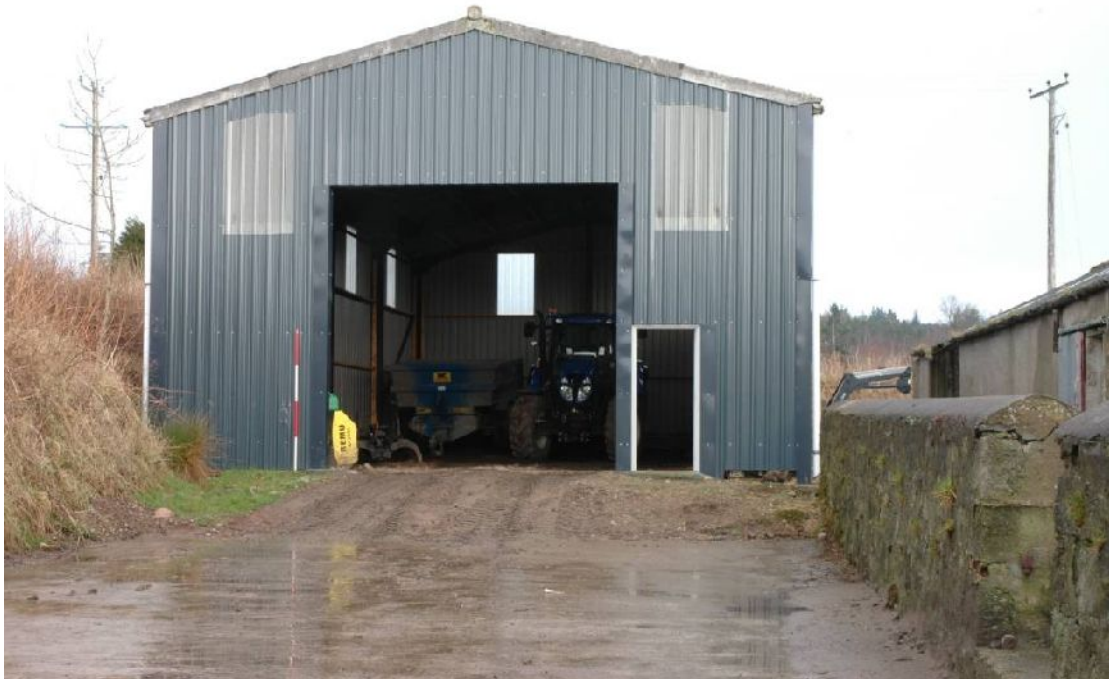
Illus 5 Building 1 from S

Dimensions Width ext: 9.25m Length ext: 18m

Walls Very recently re-clad with box-section tin sheeting onto existing steel framework.

Roof Corrugated asbestos on steel frame, roof not replaced when walls re-clad.

Function Machinery shed.

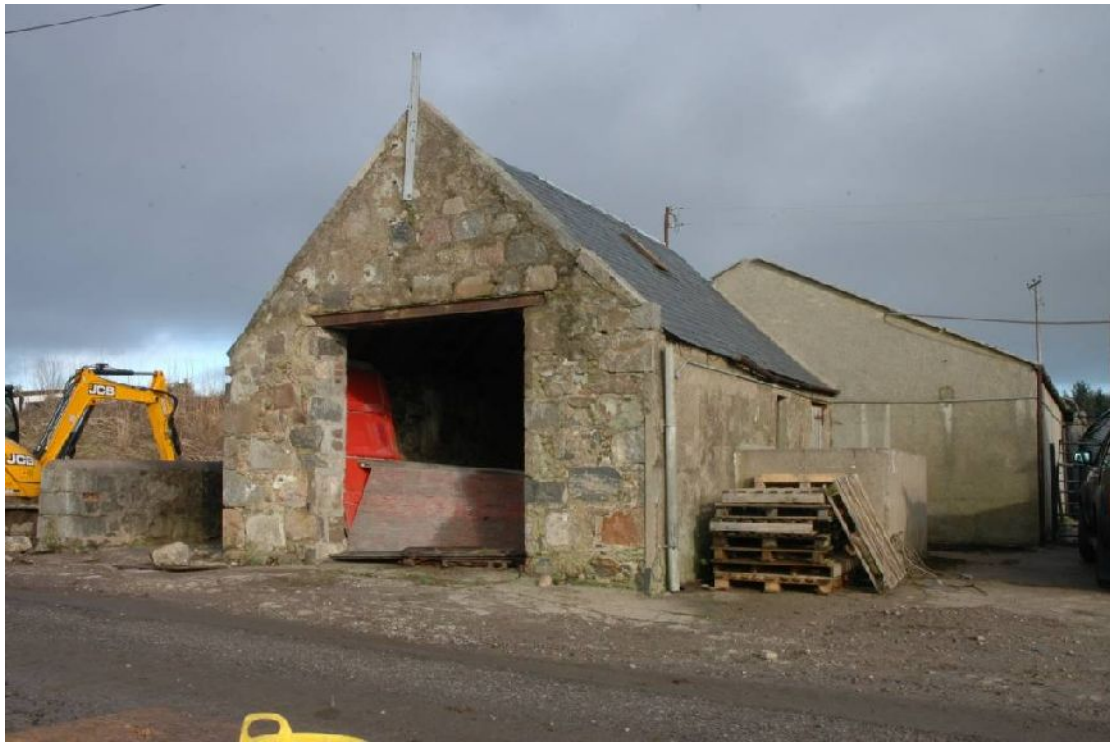
D1 W: 2.62m H: 2.64m. Steel lintel. Roughly dressed granite rybats suggest an original cart entry.

Illus 7 B2 S wall of 2A – part of 19th century W range.

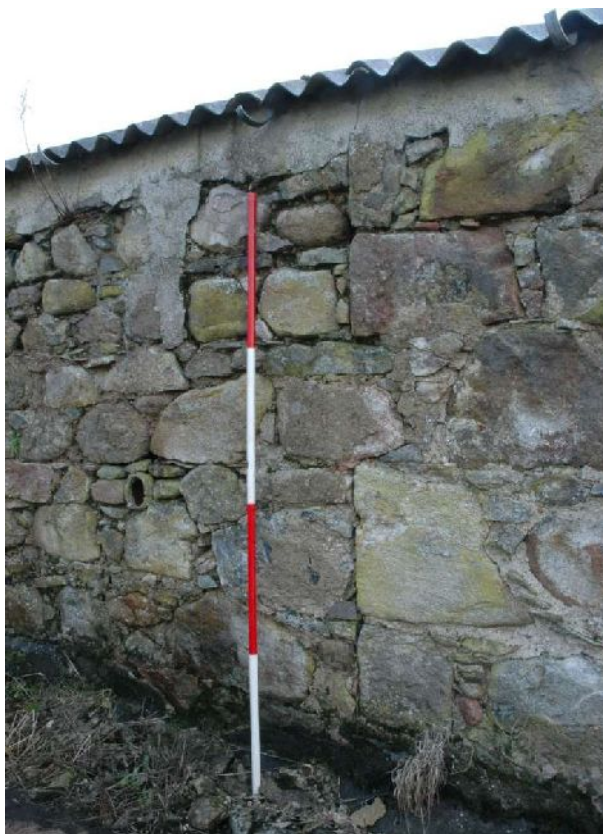
F1 Vertical line showing two different rubble wall constructions; this seemed to be an original phase of extension as there was no indication of a blocked doorway.

Illus 8 Building 2 W wall, feature F1

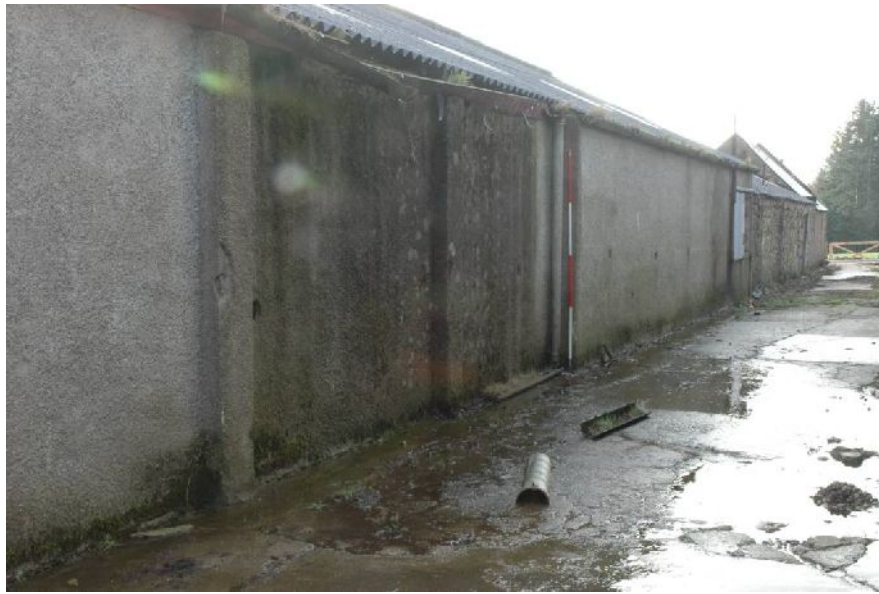
F4 Point at which wall thickness changes from 500mm (stone) to 350mm (concrete blocks).

Illus 9 B2 Looking S along W wall. Ranging rod marks point where wall changes thickness (F4)
The differences in roof height and material are visible.

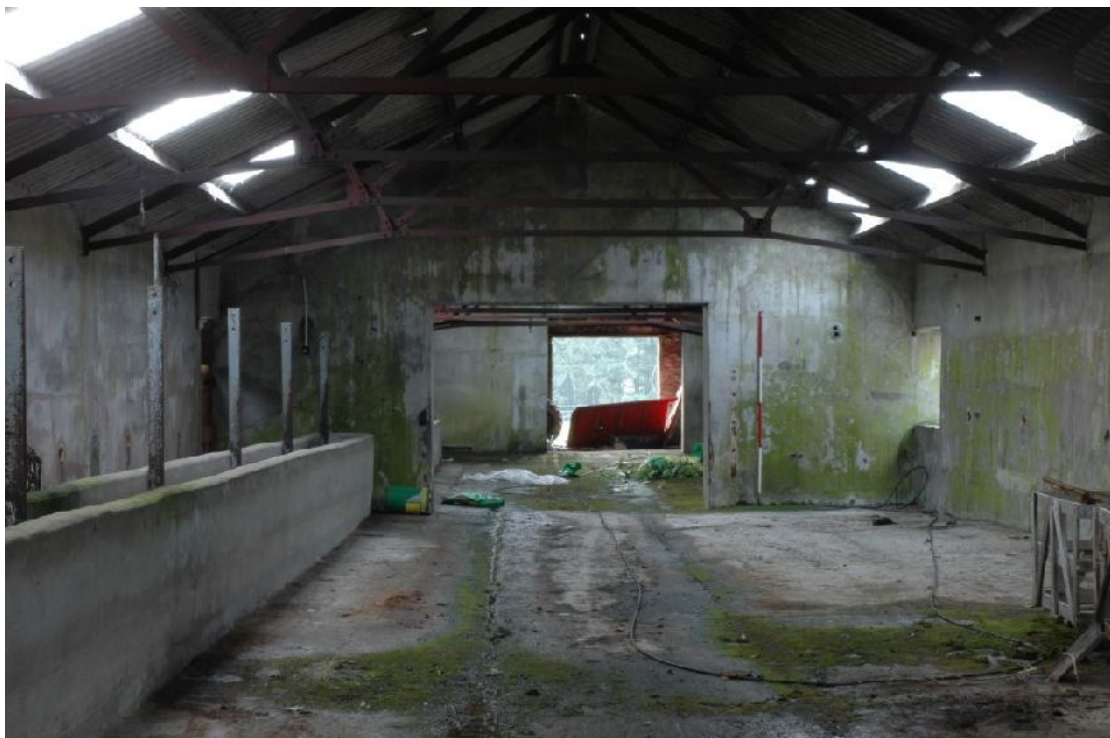
Interior Feed trough with feed pass beside E wall, access from D7.

Illus 10 Interior of 2B looking S to 2A

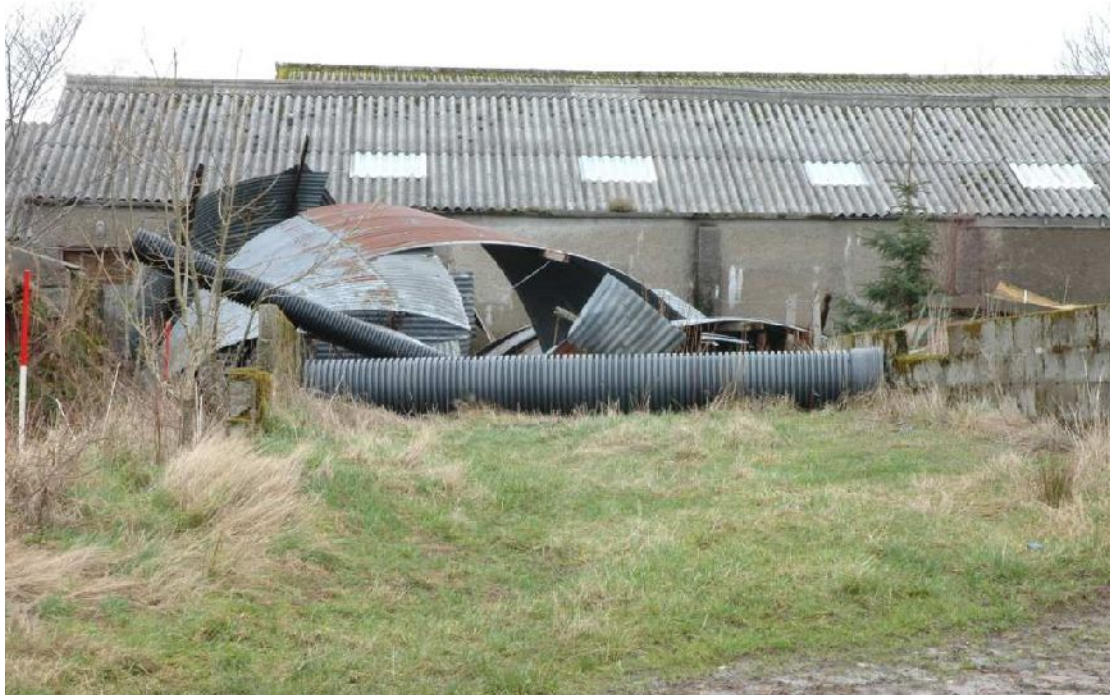
Building 3 was almost completely collapsed. Only the concrete floor and parts of low concrete block walls remained in situ. The roof of the E end had gone and the roof of the W end was a tangle of corrugated iron.

Illus 14 Building 3 looking W

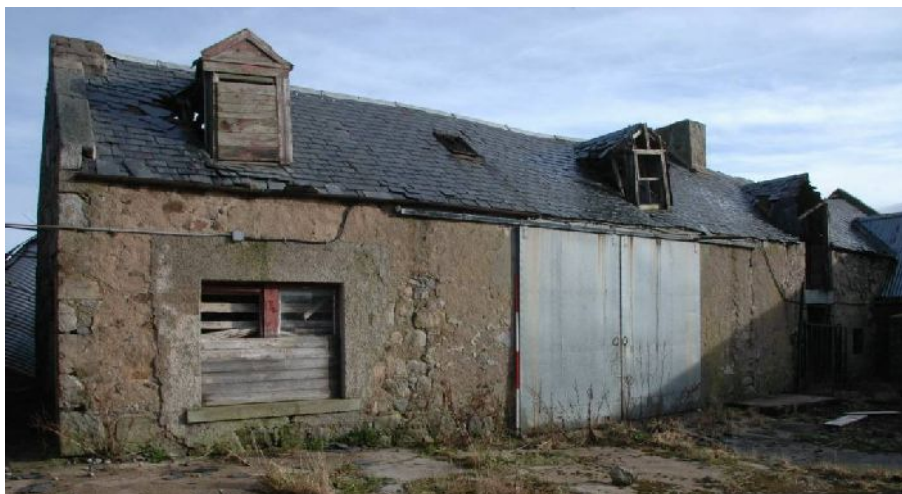
Illus 15 S facade of 4A- the original farmhouse

Walls Rubble stone construction 500-600mm thick. External surfaces harled in part. Granite rybats are visible at W end.

Roof Slated roof over A-framed couples. The skews are of dressed granite. Squared chimney of dressed granite at E end. Chimney at W end has been reduced and blocked. Two dormer windows in S facing slope of roof.

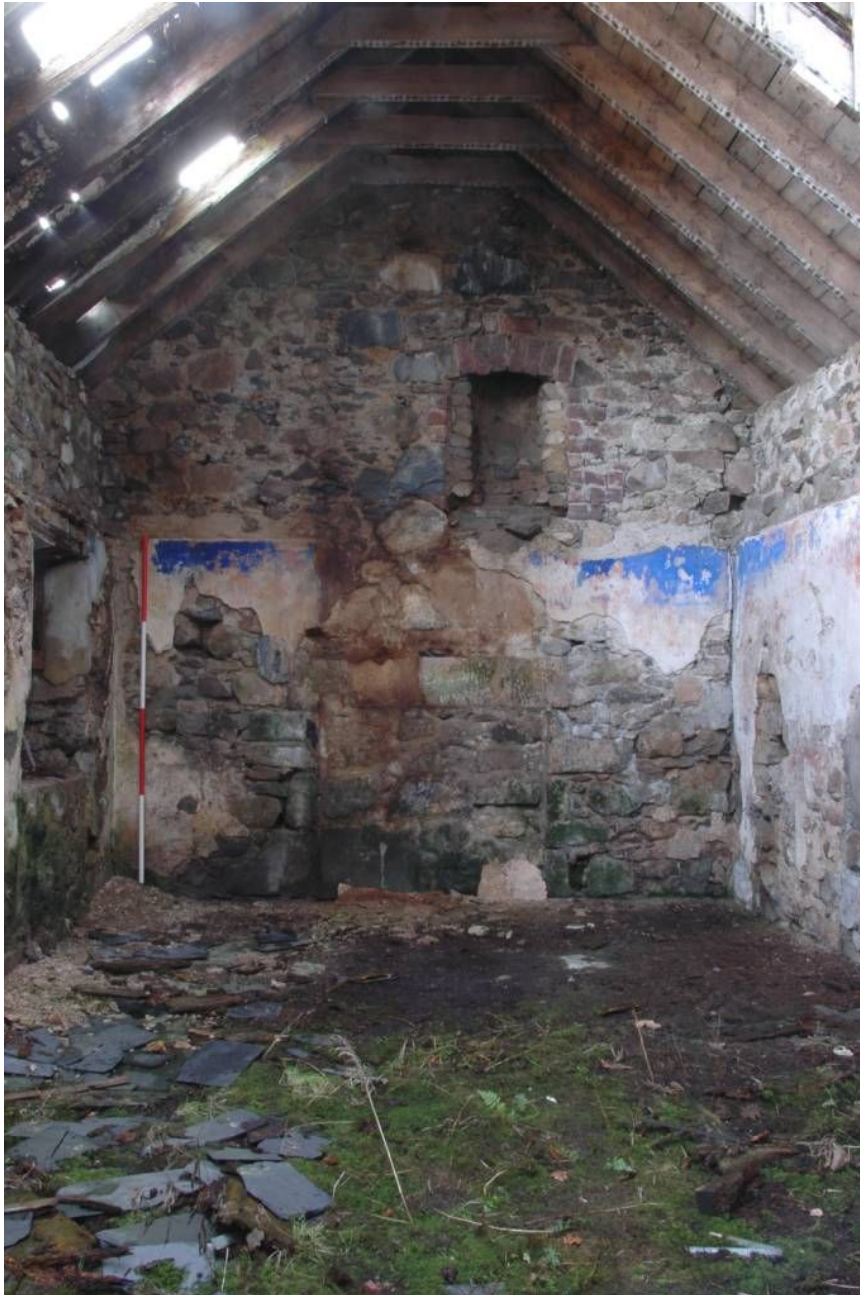
F1 Fireplace at ground level. W:1.2m. H: 1.1m. Stone blocked.

Fireplace at attic level, Secondary inset with brick arched fireplace and brick lining. Int. width :0.70m. Int H: 0.90m

Illus 17 4A. Interior view of E wall with blocked ground level fireplace and brick fireplace at attic level

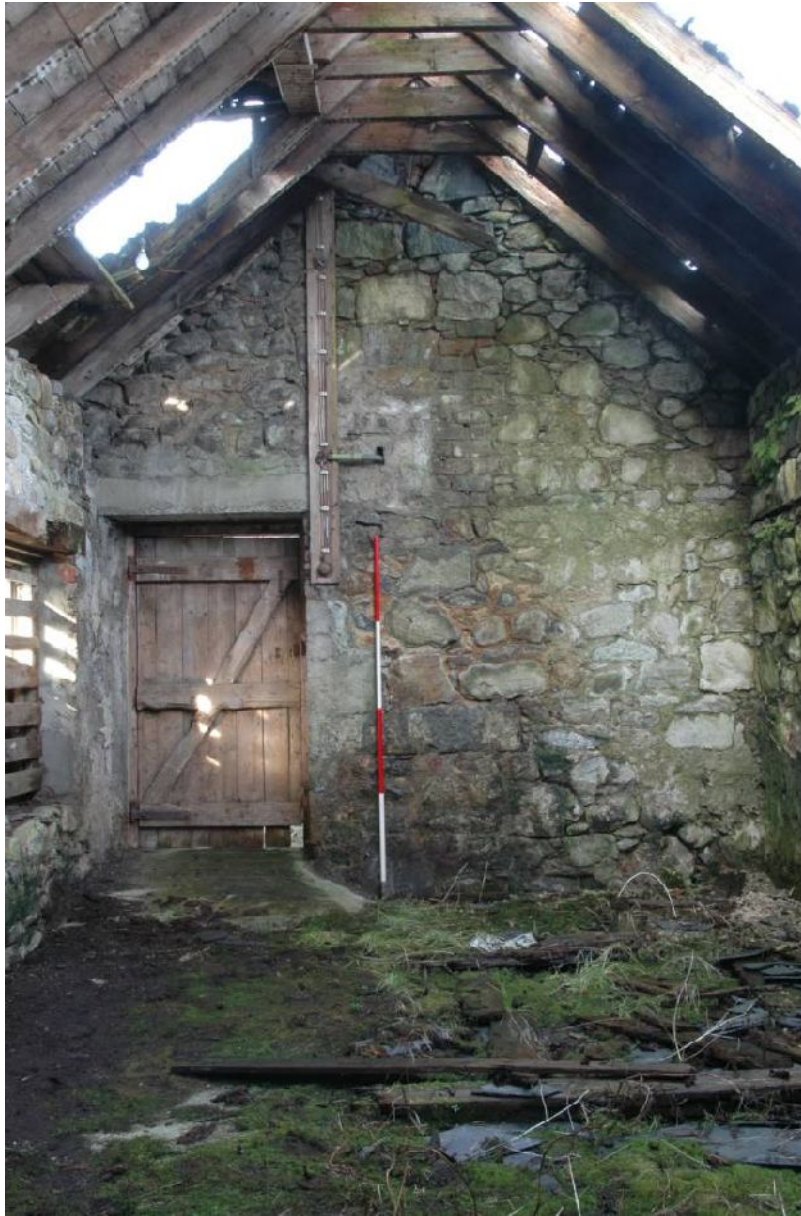
Traces of blocked arched brick fireplace at attic level. No obvious fireplace at ground level.

Illus 18 4A internal view of W wall showing blocked fireplace at attic level. Note at RHS the original, lower roof pitch.

The interior had been stripped out when the house was converted for livestock but a raggle and the level of surviving plaster showed the position of the former attic floor. A building line in the W gable (Illus 18) shows that the roof was originally lower. It would appear that it was raised, probably at the same time as the dormers were inserted and the secondary brick fireplaces built.

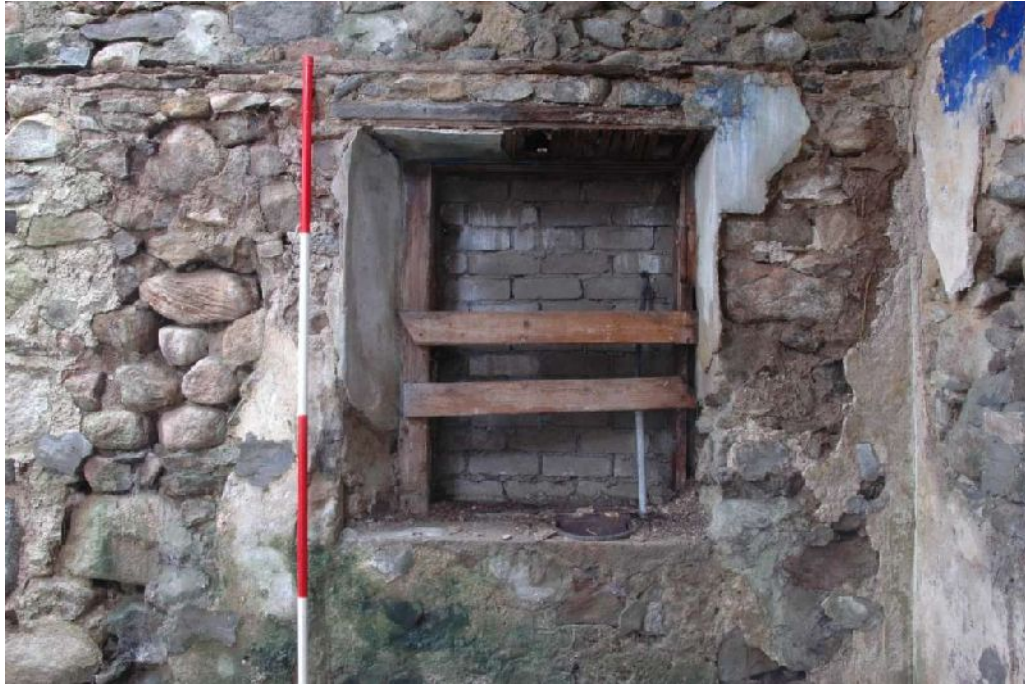
W5 W: 1.07m int. H: 1.19m. Blocked externally with brick. A cattle drinker had been built into the window sill after conversion of the building for livestock.

Illus 19 4A: window W5 with cattle drinker inserted into sill.

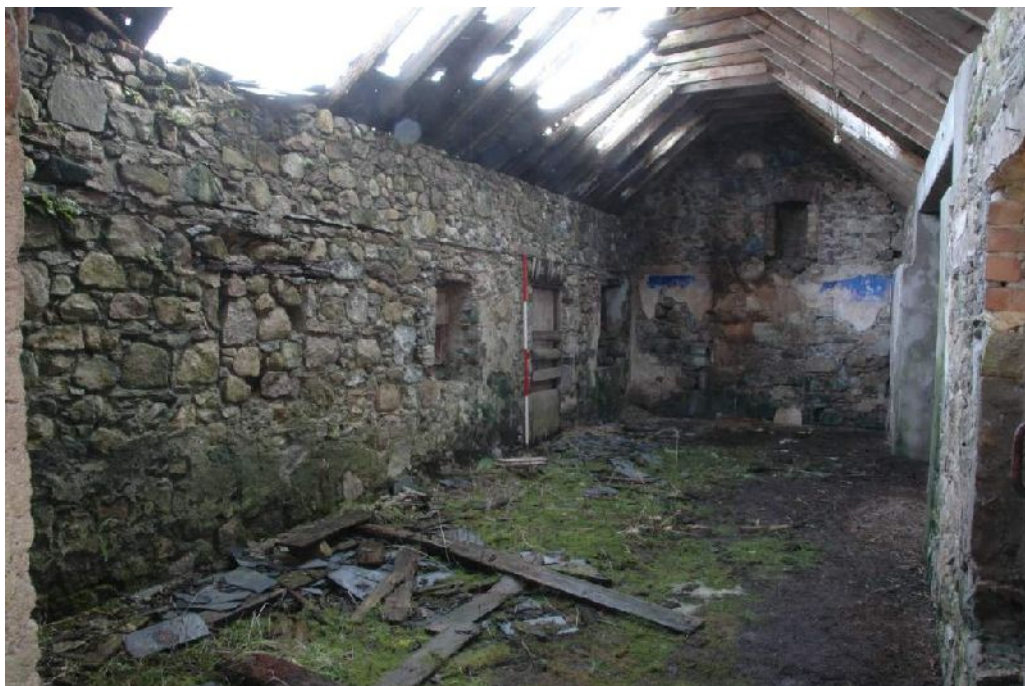
Illus 20 4A: Interior view looking E, showing back (N) wall).

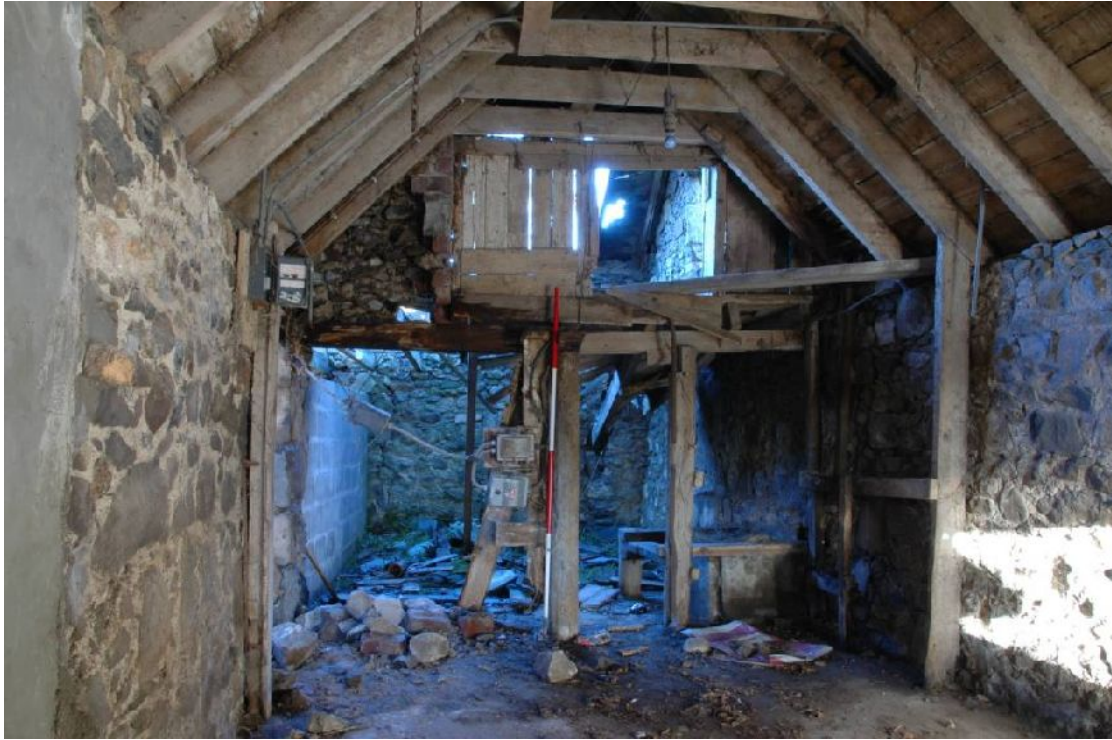
The original mill was in very unsafe condition so internal details of E end were not available. The interior had been divided into two roughly equal parts with a concrete block wall. The S wall of the E end had been removed leaving a timber post propping up the loft floor and wooden loft partition between the mill and building 4C.

Illus 22 E end of mill (4B), looking N from 4C

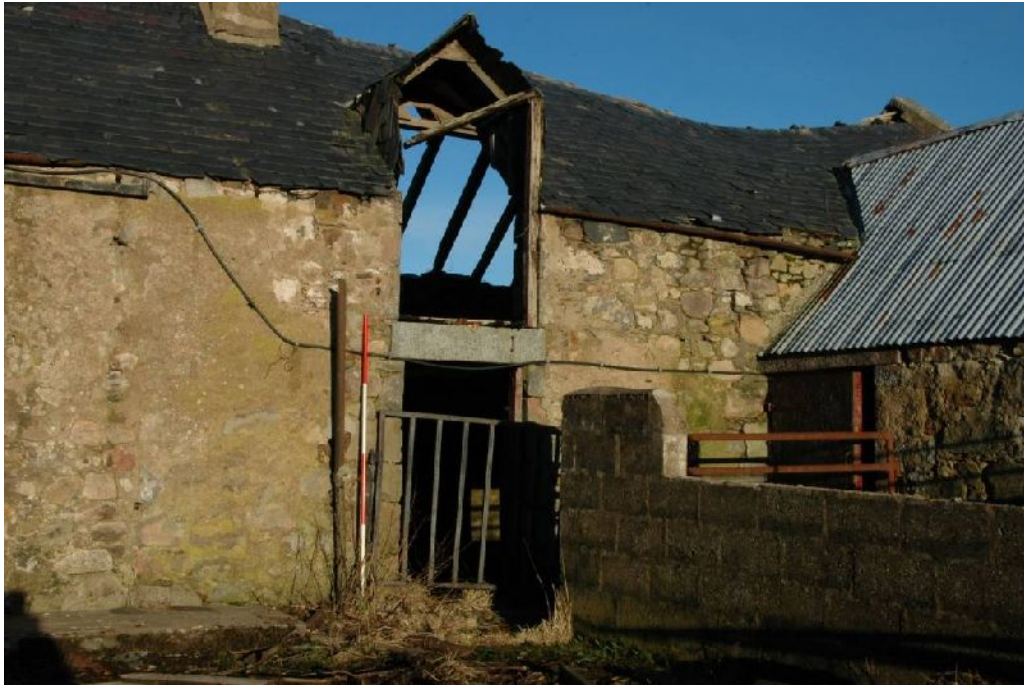
D2 W:1.0m H: 1.85m. Granite lintel also forms sill of grain loft door above.

Loft door. W: 1.1m. H: top dormered into roof. Dressed granite rybats.

Illus 23 S wall of mill. Door D2 and loft door above

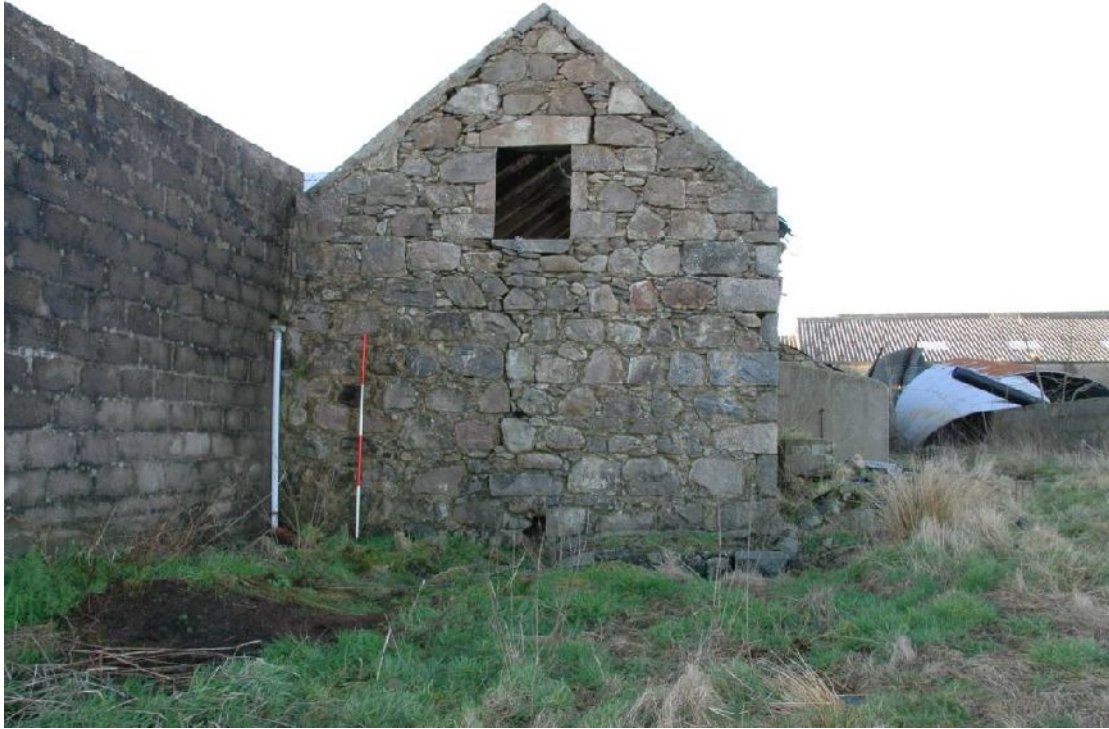
F2 Hole for wheel shaft visible on external face. (Illus 24, 25)

Illus 24 E gable of mill (4B) with wheel shaft hole (F2) in centre of base of wall.

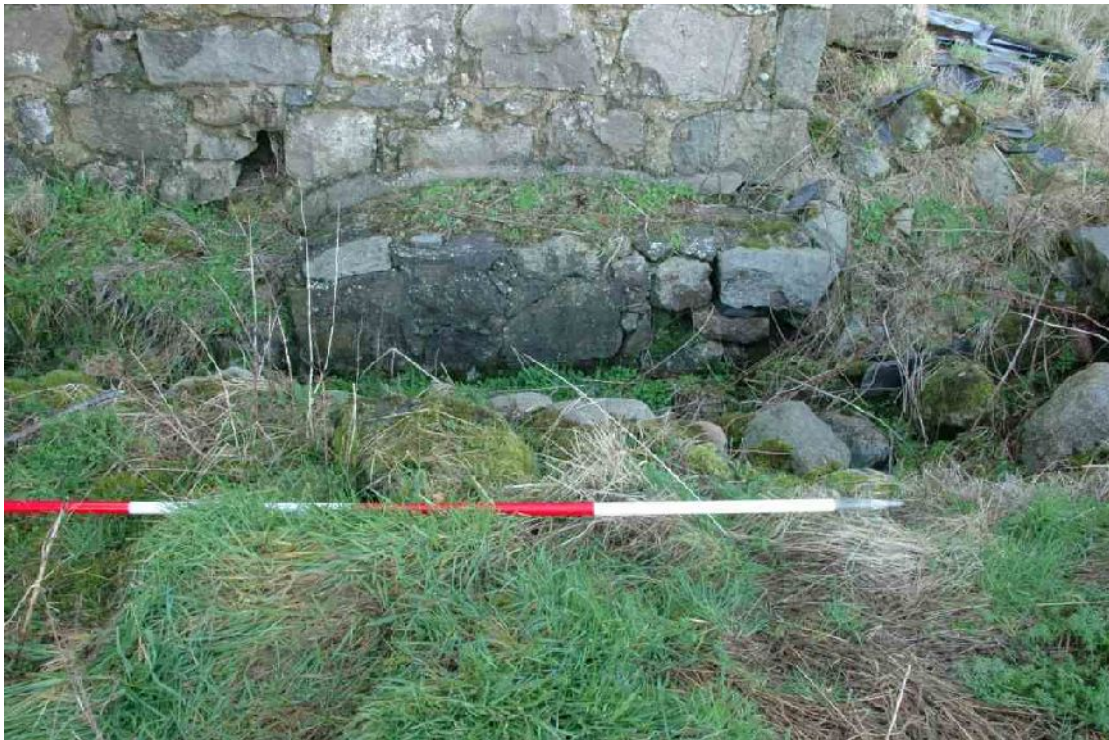
No trace of wheel but there was a partly infilled wheel pit with stone lining. Water ingress from N (where mill pond was- now filled in) and outlet to S/SE.

Illus 25 Detail of mill wheel pit and wheel shaft hole (F2)

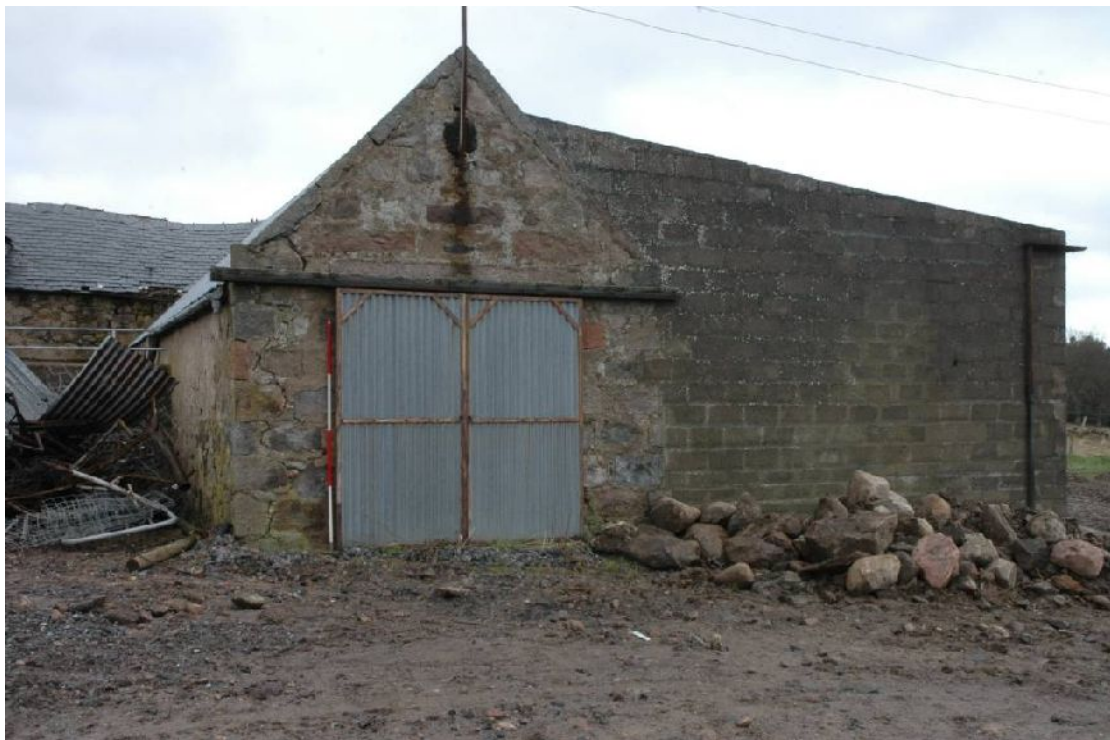
Walls Rubble stone construction 500-600mm thick. Granite rybats and skewes are visible at S end. Abutts the mill (4B)

Illus 26 4C: S gable, with S wall of B7 abutting it.

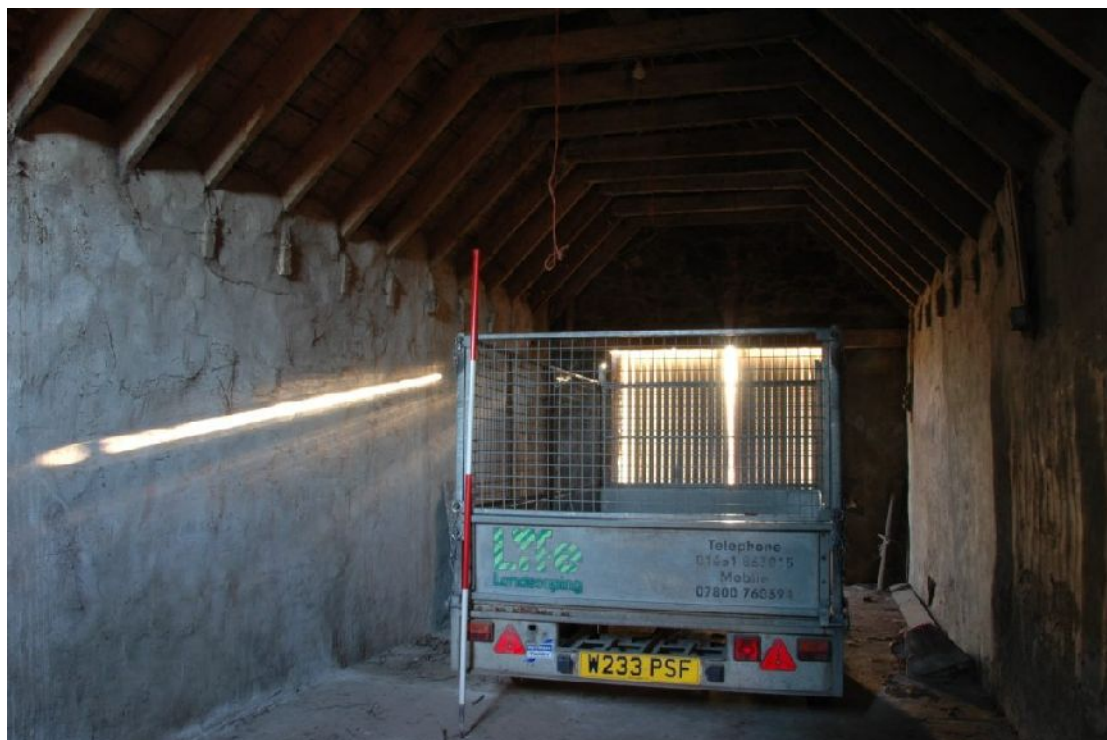
Traces of a partition. Stubs of joists at S end suggest there was a loft here.

Illus 27 4C: Interior looking S.

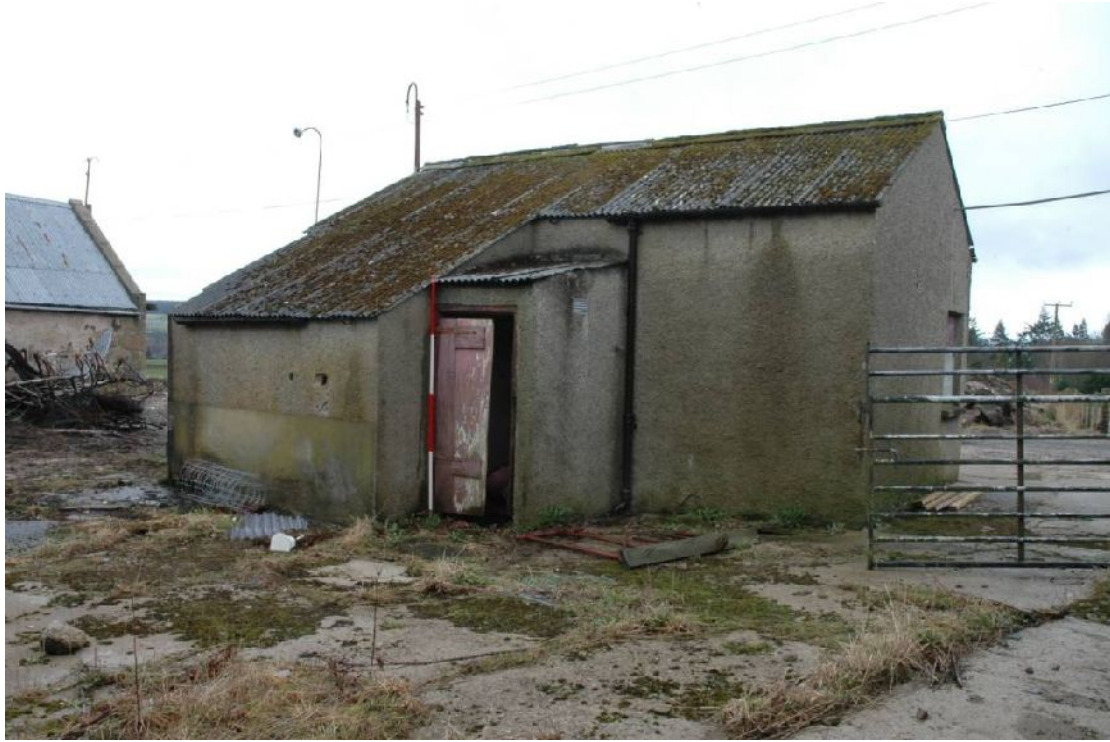
Illus 31 B6 N wall with outshots

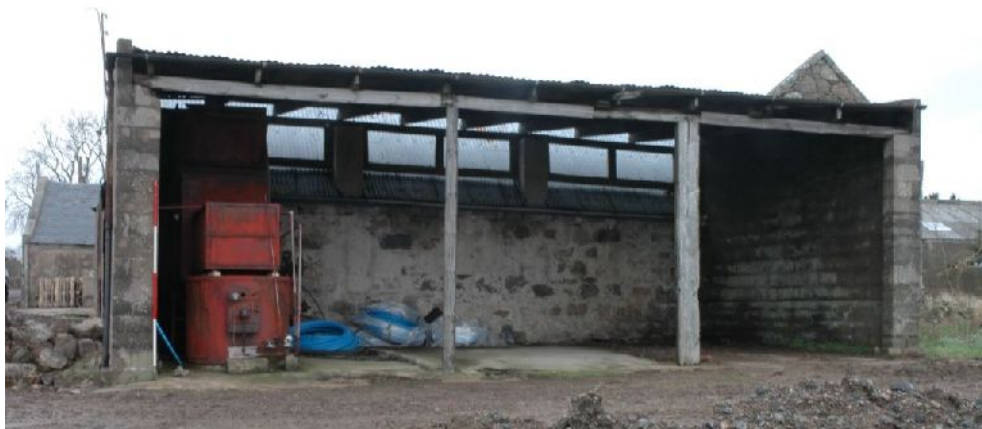
Walls The W side was formed by the E wall of 4C, the N and S walls were of concrete block construction. The E side was open with the roof supported by a wooden pole and a squared timber.

Roof Lean-to roof of corrugated iron on timber framework.

Illus 32 Building 7 looking W

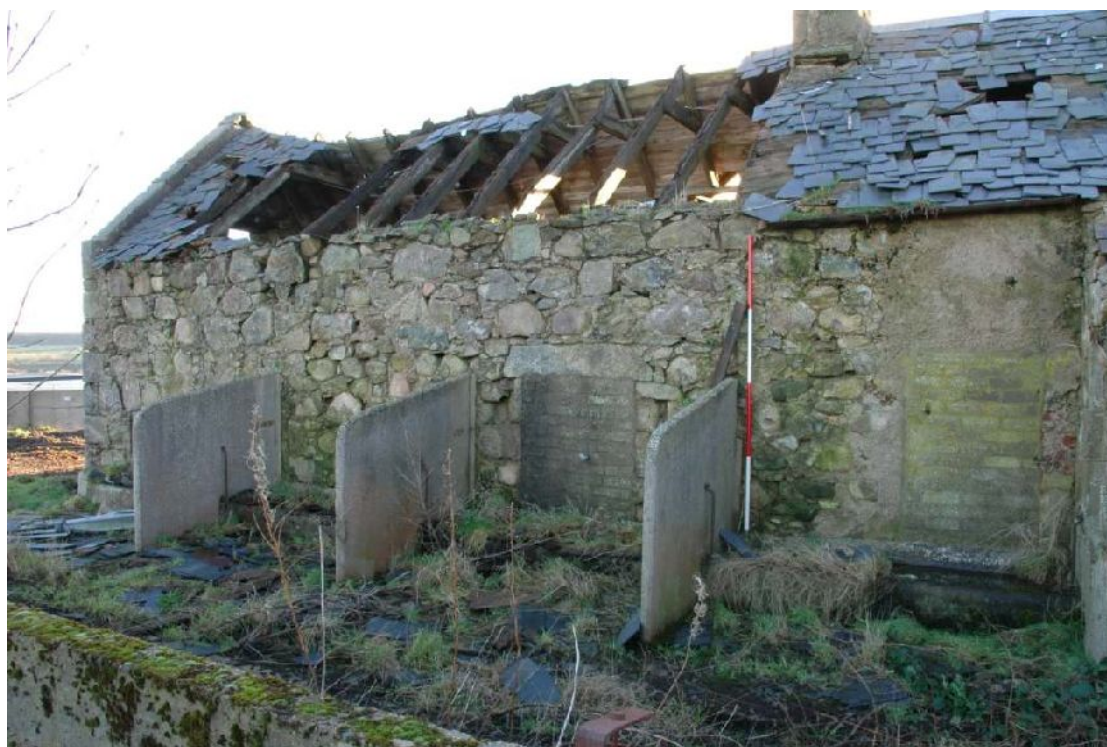
Interior Four double tied cow stalls with concrete trevices and concrete troughs stood along N side. Cow tie bars remained. Dung channel in concrete floor.

Illus 33 Building 8 showing cow stalls.

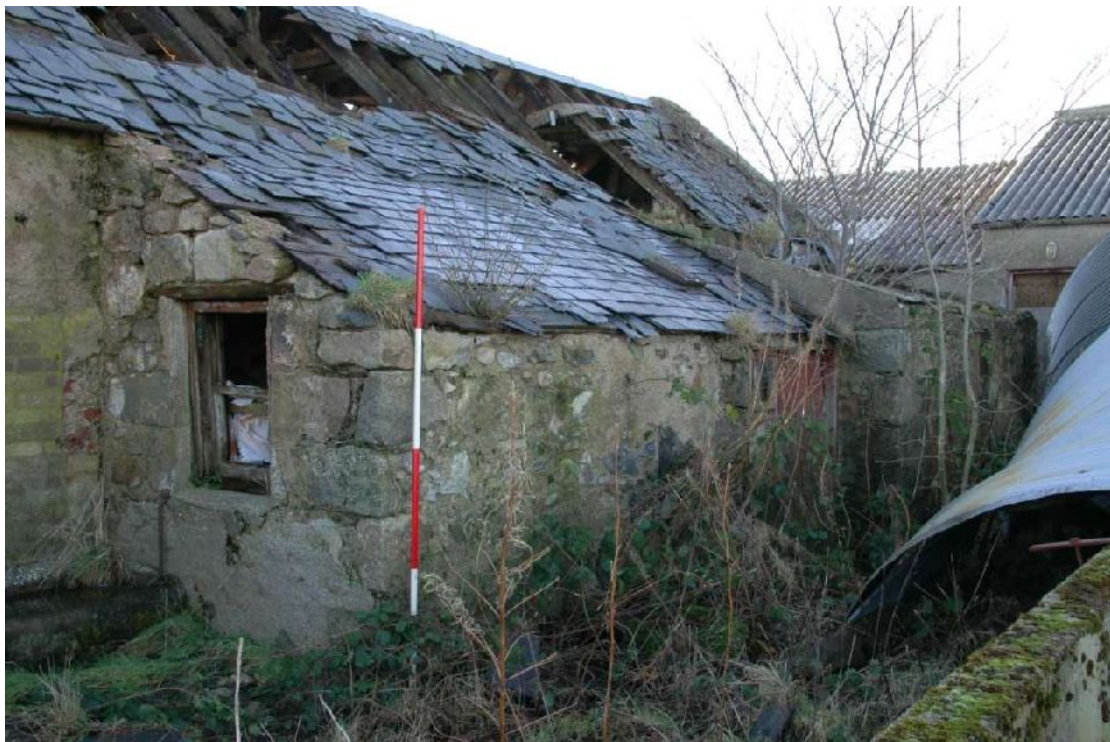
Walls Stone wall 300mm thick.

Roof Lean-to with slate roof. 1 glass roof light.

Illus 34 Buildings B9 and B 10 looking SW

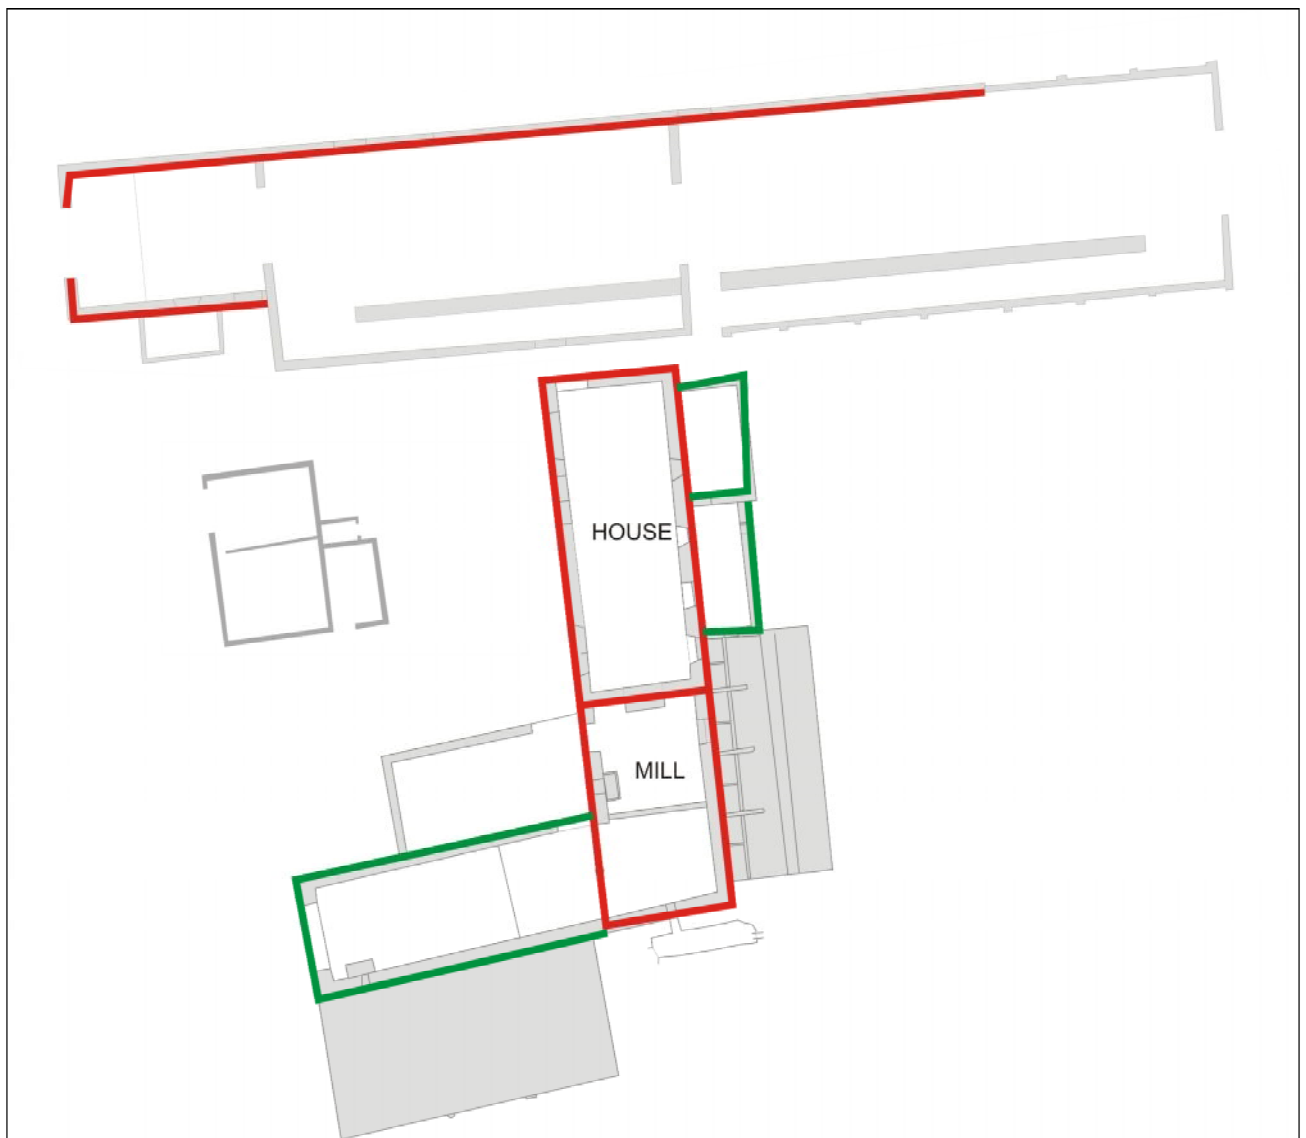
Illus 35 Interpretation of original features built by 1865 (red) and secondary features built by 1899 (green)

By 1865 the mill (4B) and house (4C) were built and although much altered these remain. The N range (2), also built by 1865, only partially remains, having been widened and much extended in the 20th century. Changes in the E wall structure

The E range (4C) was built between 1865 and 1899 and remains but without any internal detail. The lack of blocked windows or ventilation suggests this may have been for storage, and possibly a cart at S end, rather than livestock.

Outshots B9 and B10 were also built between 1865 and 1899; both were lean-tos against the back wall of the house (4A) and presumably gave extra accommodation, possibly a pantry/milk room as they were on the cool N side of the building.
