**FYVIE CASTLE
FYVIE
ABERDEENSHIRE**

- Archaeological Watching Brief -

Carried out 17th March 2014
by
Murray Archaeological Services Ltd

Report No: MAS 2014-18
by
H K & J C Murray

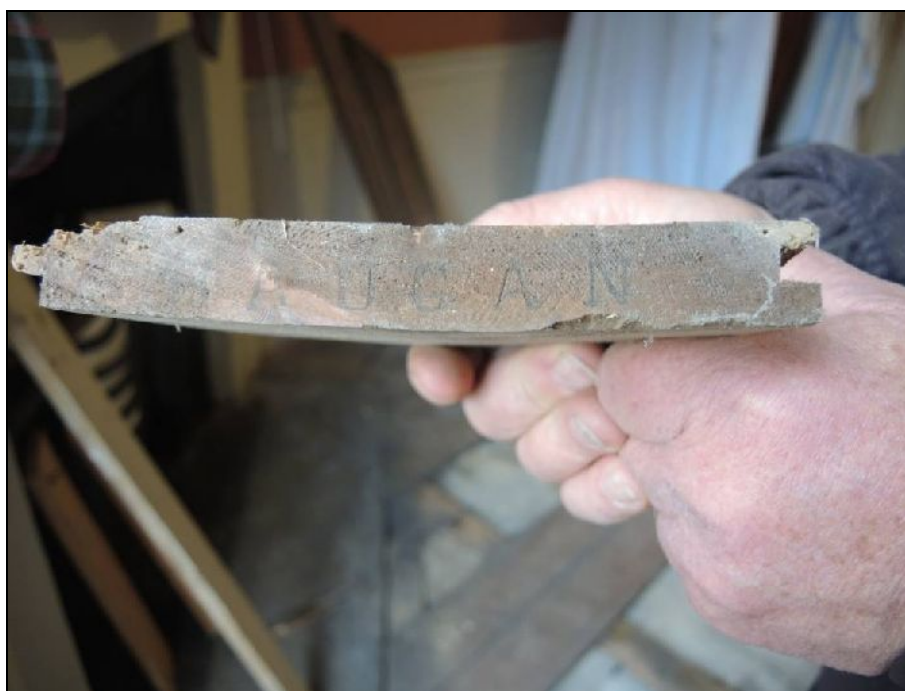
- 3.2 It is assumed that the stone flags are the original flooring in a ground floor barrel vaulted room.
- 3.3 It was observed that the end of one of the tongued-and-grooved timbers was stamped with the name 'HAUGAN'. This would appear to be the stamp used by O. Haugan & Co, timber exporters of Dranimen, near Oslo, Norway. Such stamps are common on imported timber from the Baltic and Scandinavian countries (Ref: <http://chestofbooks.com/architecture/Building-Construction->

[2/Marks-And-Brands-Upon-Timber-Continued.html](#)). Marks differed according to the quality of the wood used and it would appear that the stamp 'HAUGAN' (sic) was used on cheaper 3rd rate timber. The importation of timbers for use in Scottish buildings over an extended period is recently documented (Crone and Mills, 2012).

Illus 3: Flooring timber with 'HAUGAN' stamp.

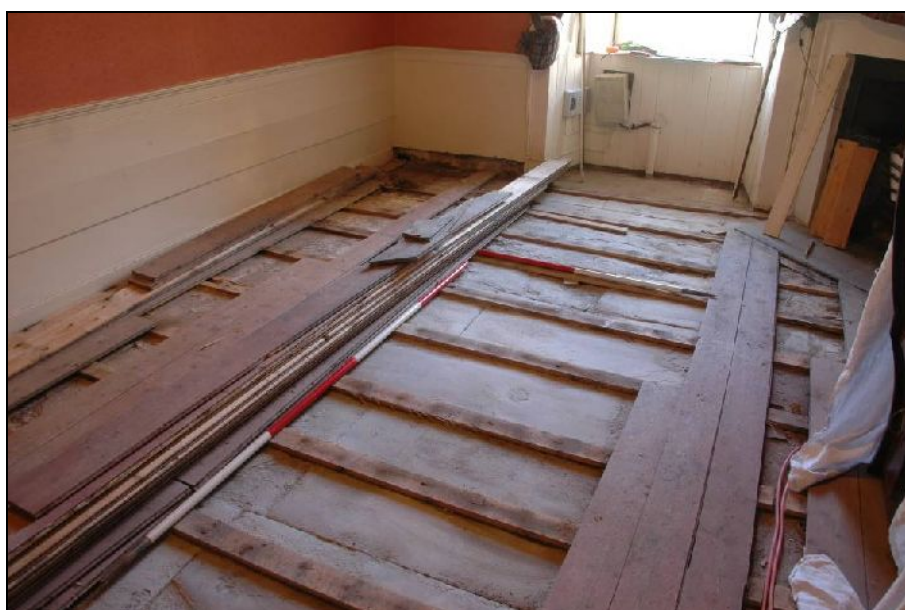
Illus 4: General view of room, looking W.

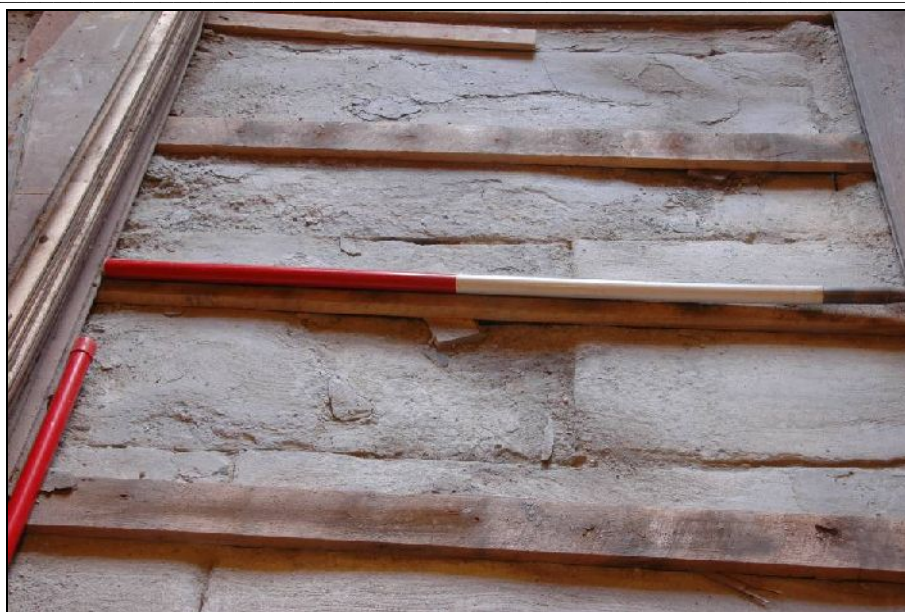
The timbers were pine and were c.140mm wide and c.20mm thick. They were laid directly on thin battens c.750mm wide x 20mm thick. The battens, in turn, overlie an earlier flagstone floor and were spaced at between 400 – 480mm. Where necessary, they were supported by thin wedges to level the floor.

The stone flags were laid N-S across the room and varied in length between 1m and 1.2m and in width to between 370mm to 530mm in width. At the only point possible to take a measurement, the flags appeared to be 20mm in

thickness. The stones appear to be a schist-like friable material with considerable signs of wear.

Illus 5: Detail of flagstones below the wooden flooring. Note the wedge below the batten in the centre.
