**WENDY HOUSE  
HADDO HOUSE  
ABERDEENSHIRE**

**- Building Recording -**  
Carried out 3<sup>rd</sup> April 2014  
by  
**Murray Archaeological Services Ltd**

**Report No: MAS 2014-19**  
by  
H K Murray and J C Murray

## -Building Recording-

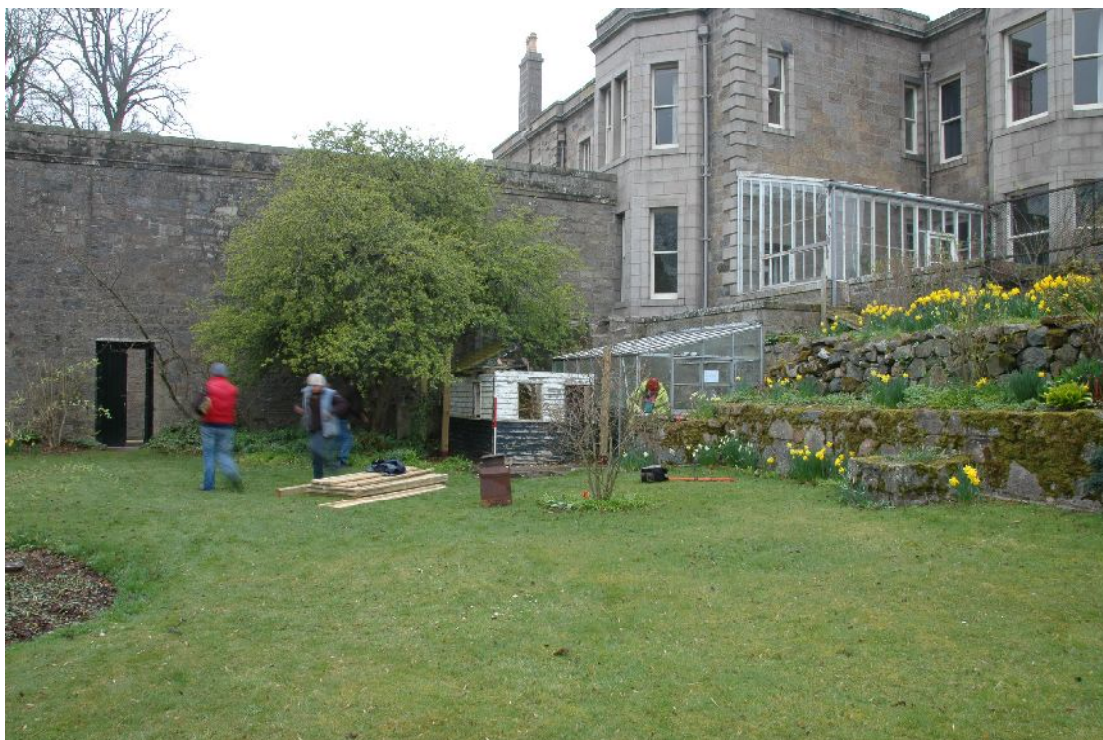
Illus 1 Location of the Wendy House

The Wendy House is situated in the NW corner of the private garden of the S wing of Haddo House (Illus 1). At the time of the recording on 3<sup>rd</sup> April 2014, the Wendy House was semi-derelict with the roof collapsed into the interior.

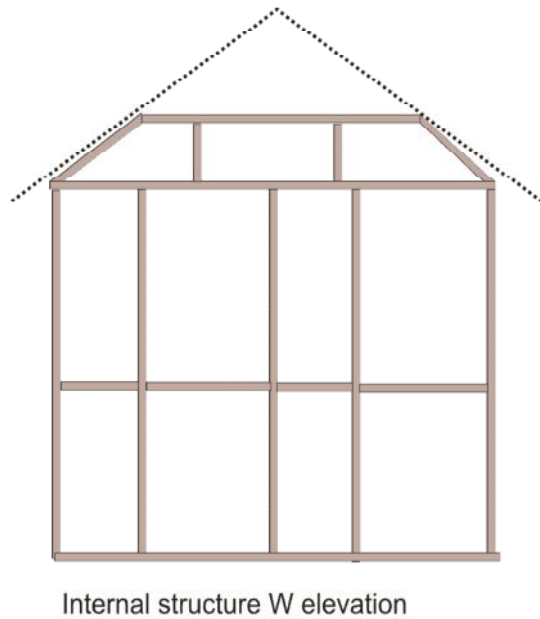
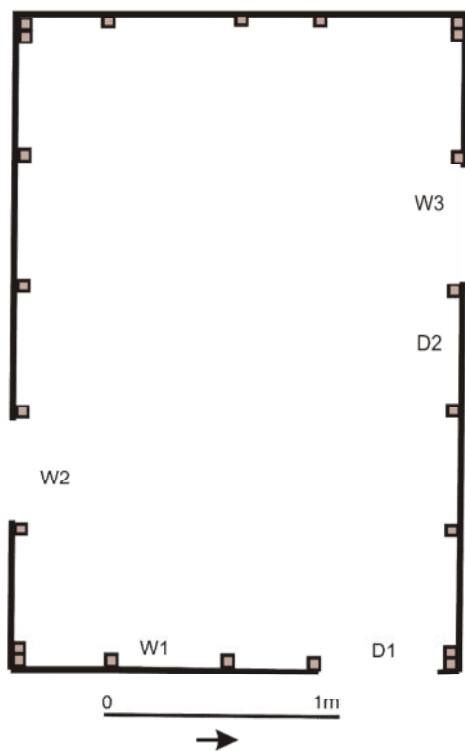
**Illus 2 Plan and internal elevation of W wall with approximate roof line added from NTS surveyor's elevation drawing.**

The structure is rectangular, 2.81m E/W and 1.90m N/S externally with gables to E and W (Illus 2).

The surviving structure has weather boarded walls, 1.56m high, each on a rectangular framework of vertical studs c30x50mm (1 ½ x 2 inch) jointed at top and bottom (bottom rail not visible) into horizontal rails. Additional horizontal spacer rails were set between the vertical studs and nailed/screwed into position at c730mm above floor level. At the better preserved W gable, there was an additional framework to a height of 1.88m.

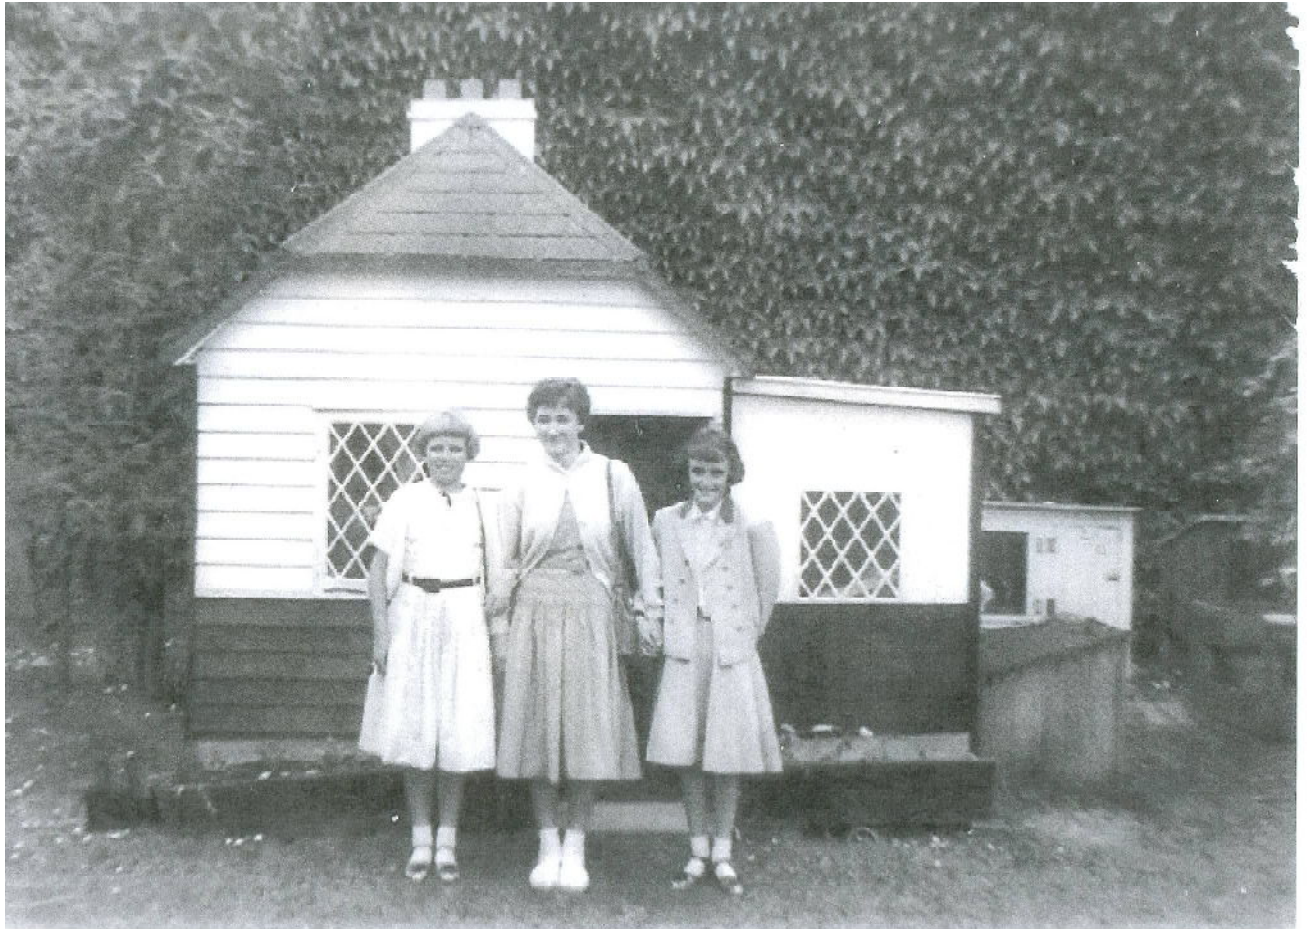
**Illus 3 Wendy House in the 1950s, looking at the E elevation. (A copy of the photograph is in the possession of the Haddo House gardeners who were given it by a member of the public who played there as a child)**

A 1950s photograph (Illus 3) shows that, at that time, there was a secondary flat-roofed extension on the N side, presumably accessed through D2. No trace remains of this extension and D2 is now a dummy door.

The N extension (Illus 3) appears to have had a different structure, with no sign of weatherboarding.

The windows were all missing although one of the window frames survived- it was hinged on one side and had a latch bar for opening. The photograph (Illus 3) shows diamond-latticed windows and NTS staff remember this as leaded.

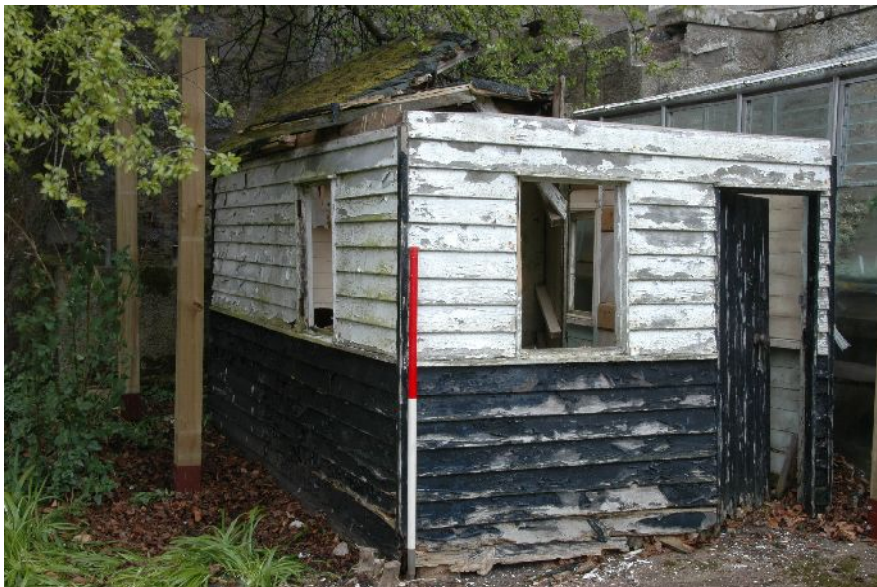
**Illus 4 E elevation in 2014**

Externally painted black for the lower part of the wall and white above with black doors (Illus 4-6).

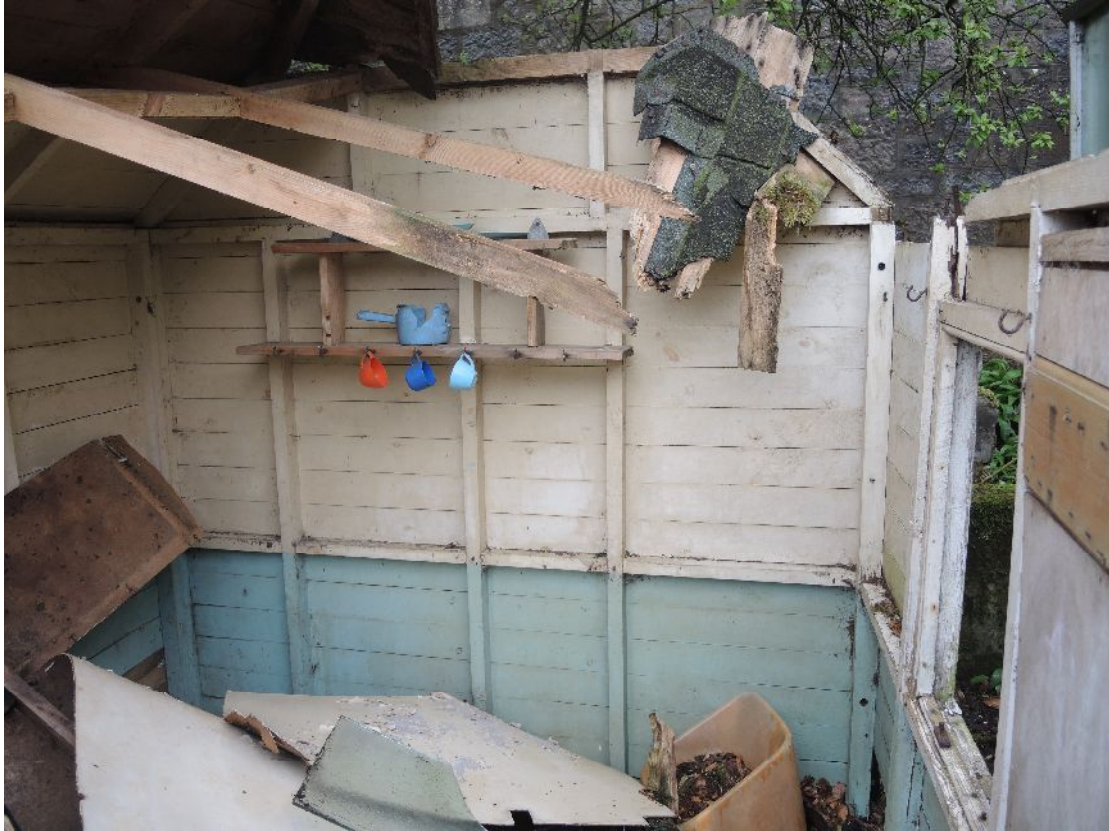
**Illus 7 Internal view of W wall 2014**

Internally, painted blue for lower wall and cream above (Illus 7-9).

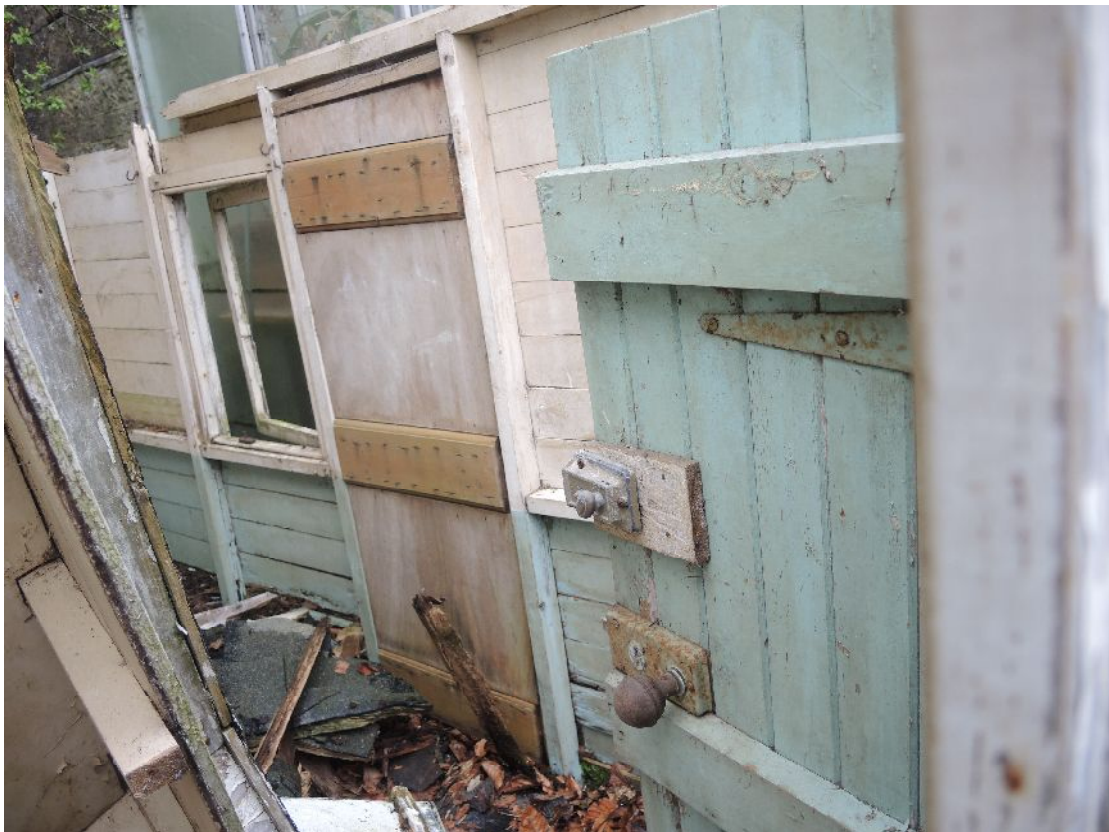
**Illus 8 Internal view of N wall 2014. Open door D1 in foreground. Dummy door D2 and W3 in background**

D2 W: 500mm H: 1.28m. Although painted externally to look like a door this was a dummy (Illus 8). It is probable that it had been cut through to give access to the N extension and later blocked when the extension was removed.

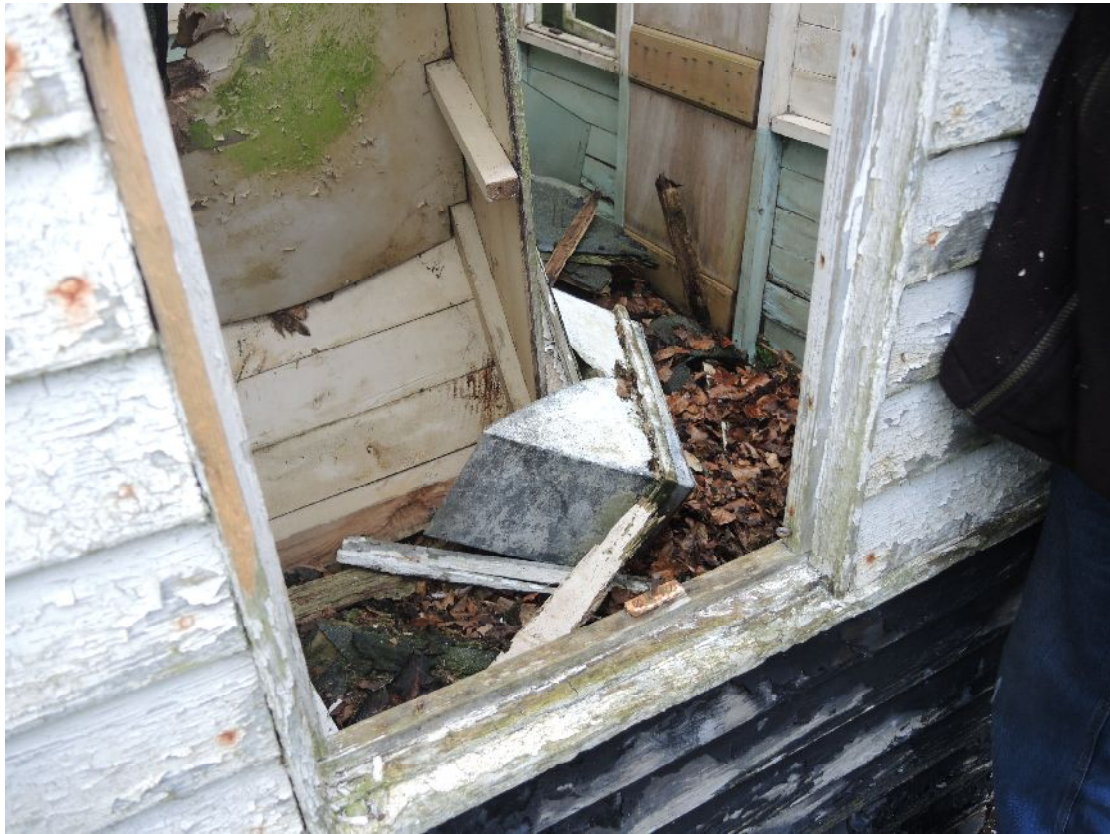
**Illus 9 Chimney visible in debris on floor 2014**

The chimney (see Illus 3, 9) was lying on the floor and had a covering of tin.
