**SILLYFLATT FARM  
(HALLGREEN CASTLE STABLES)  
INVERBERVIE  
ABERDEENSHIRE**

**Standing Building Survey**

Carried out 14<sup>th</sup> April 2014

**Report No: MAS 2014-20**

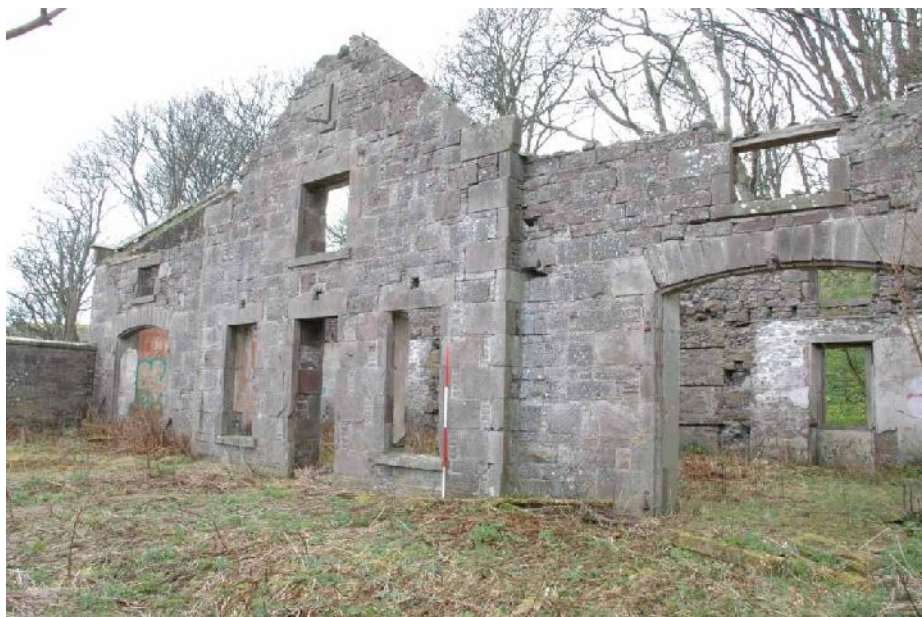
Plan Rectangular with a gablet projecting 0.30m in the centre of the front (E) elevation above a central door flanked by windows. The central door was tall, allowing access for horses. Arched cart/ carriage entries flanked the central gablet.

**Illus 1 East elevation**

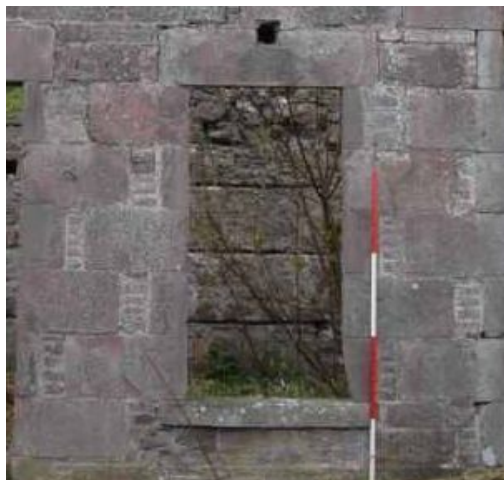
Walls External faces of the walls are of dressed ashlar blocks with stacks of small pinnings. Dressed sandstone detailing. Internal faces of the walls of rubble stone. Width: 0.55m

**Illus 3 Detail of wall structure in E facade**

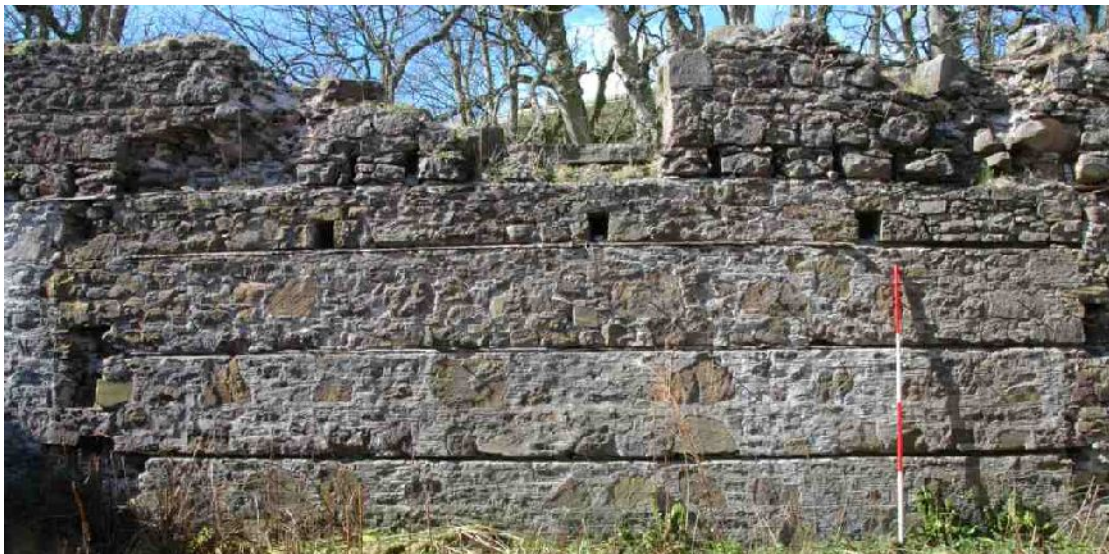
Internally the walls of the N and S 'rooms' were plastered (red on plan illus 2) but the inside of the W wall of the central 'room' had three horizontal timbers inserted into the wall at 0.69-0.75m spacings; these would have held timber lining for the horse stalls. A small area of similar timber in the E wall of the S 'room' may have been for fixing a cupboard, pegs for harness, or some other similar fitting.

**Illus 4** Detail of inside of W wall in central 'room' showing fixings for timber lining and ventilation holes D-F. The raggles of the former internal partitions can be seen on either side of the picture.

Internally the ground floor appears to have been in three 'rooms'. The central area seems to have had timber lining for the stalls on the W wall. Although no sign of the trevise survive, the width suggests four stalls (illus 2: dotted lines), each some 1.8m wide. The small ventilation holes (A-F) provided fresh air for the horses. The tall central doorway (D2) is fairly typical of stable doors which required the additional height. The N and S 'rooms' would have provided space for one or possibly two carriages, harness etc. The loft area would have given space for the storage of hay. There is no indication of accommodation for a groom as there is no evidence of a chimney. The small outshots at the back- a central one on the 1864 OS map and two, one at either end, on the 1903 map ( of which the N outshot survives) – may have been kennels.

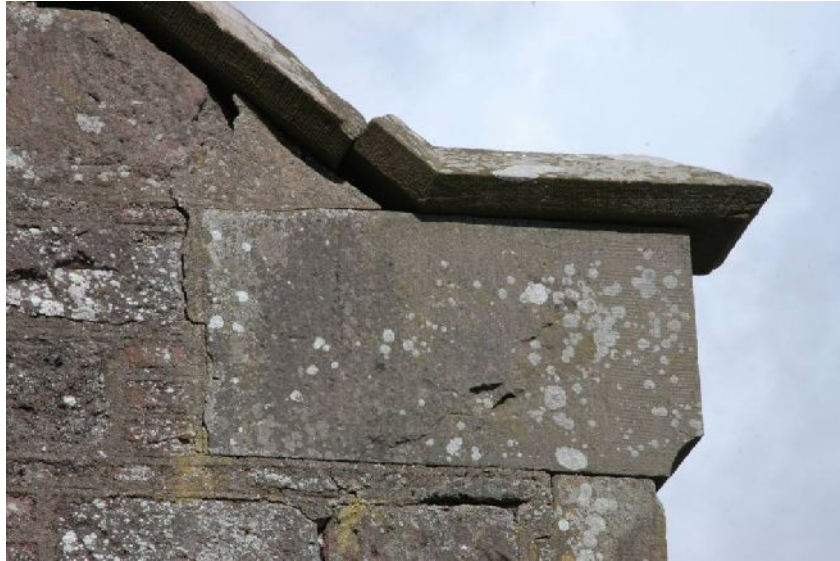
Roof The roof had collapsed but slate debris on the floor indicates it had been slated. The skewputts were gently curved, with a skew cope above. Internally, joist holes show the presence of an attic floor, with an additional low 'attic' at the top of the E gablet.

**Illus 5 Skewputt at SE corner of the stables**

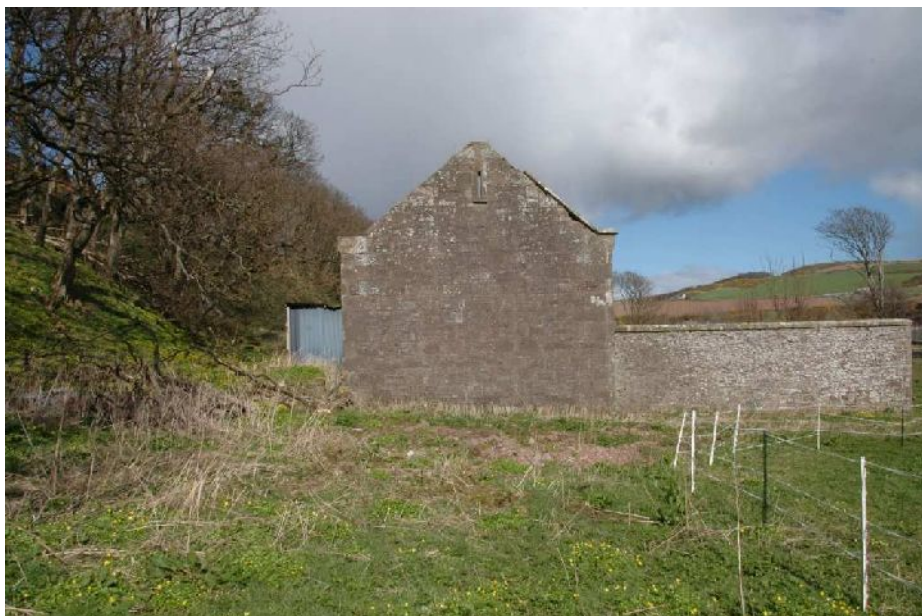
**Illus 8 S gable**

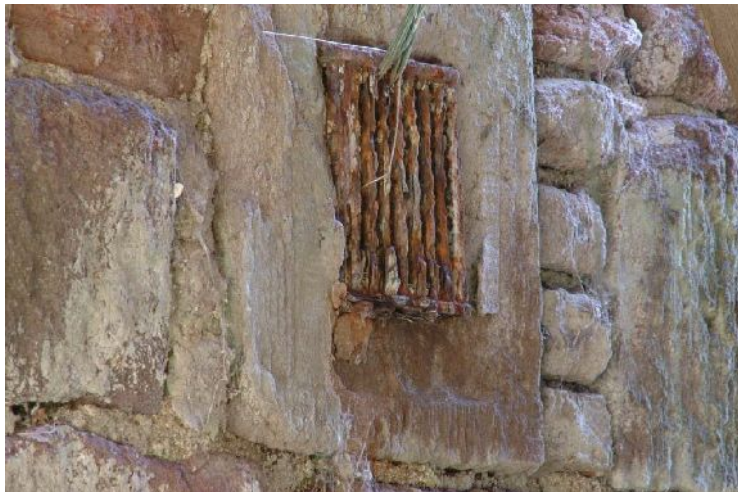
D-F: Small square ventilation holes, c 150mm square, with well dressed sandstone surround. External iron grids survive on two.

**Illus 10** W elevation. Vent F

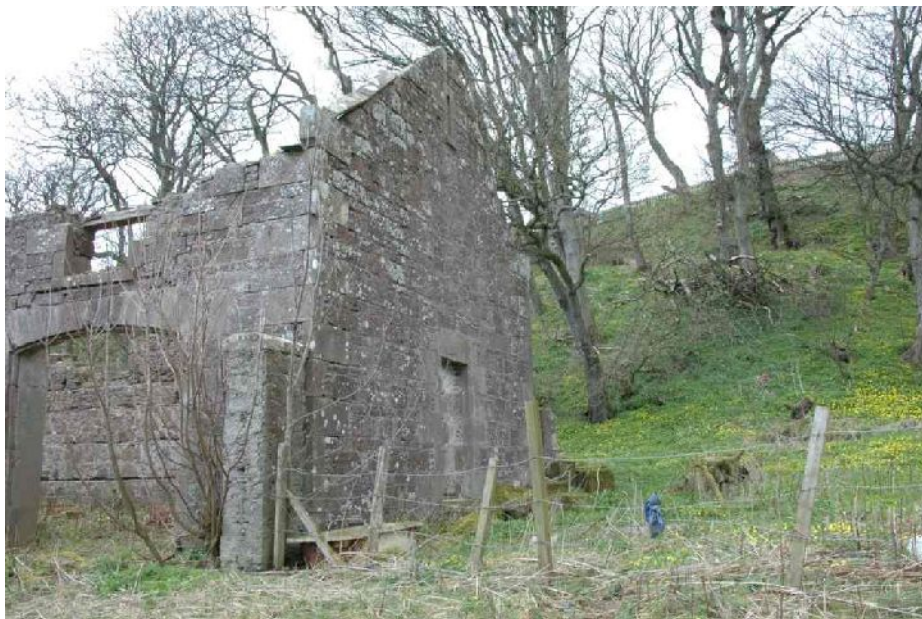
**Illus 12 N gable**

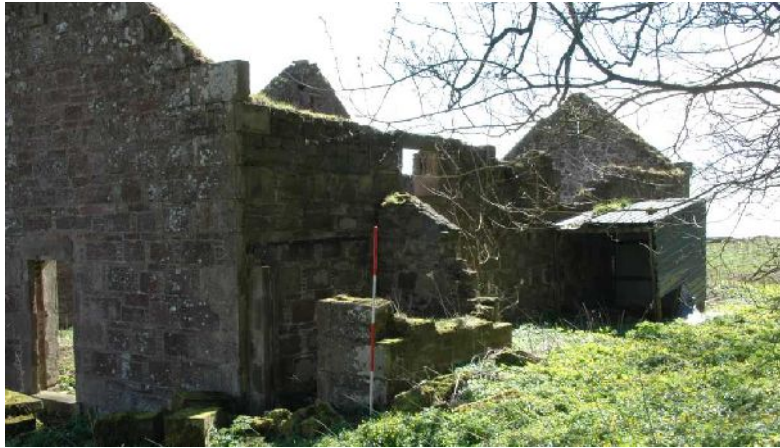
There was evidence of three small outshot structures abutting the back of the W wall.

Outshot 1 was of stone with dressed stone at the doorway and can be identified as the

N outshot shown on the 1903 OS map. It was 2.15 x 1.6m with walls 380mm thick. It had had a lean-to roof abutting the main building. Outshot 3 only survived as a stone foundation but is probably the remains of the S outshot shown on the same map.

**Illus 13 View of NW corner with outshot 1.**

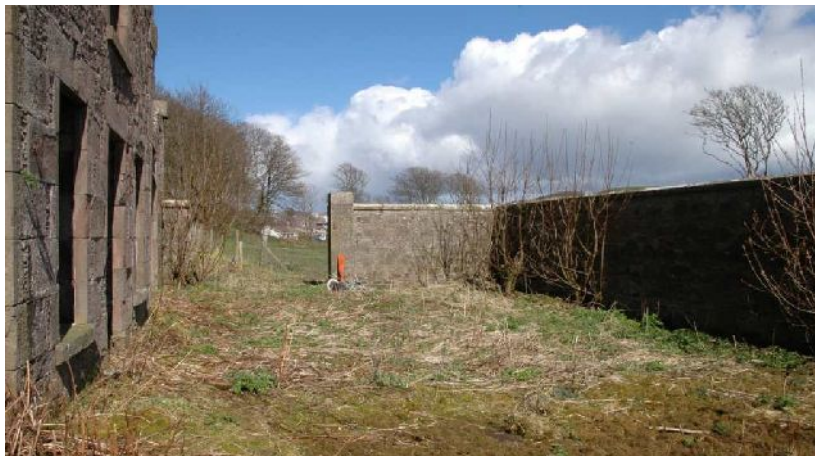
A yard, 18m x 8m internally, was surrounded by a well-built stone wall, 0.45m thick and 2.30m high with a cope. A gateway at the N end opened to the former carriageway to Hallgreen Castle. This was built between 1864 and 1902 and would have provided much needed shelter from on-shore winds.

**Illus 14 Looking N across the yard towards Hallgreen castle.**
