**HOME FARM STEADING
PARK HOUSE
DRUMOAK
ABERDEENSHIRE**

Standing Building Survey

Carried out 9th May 2014

Report No: MAS 2014-22

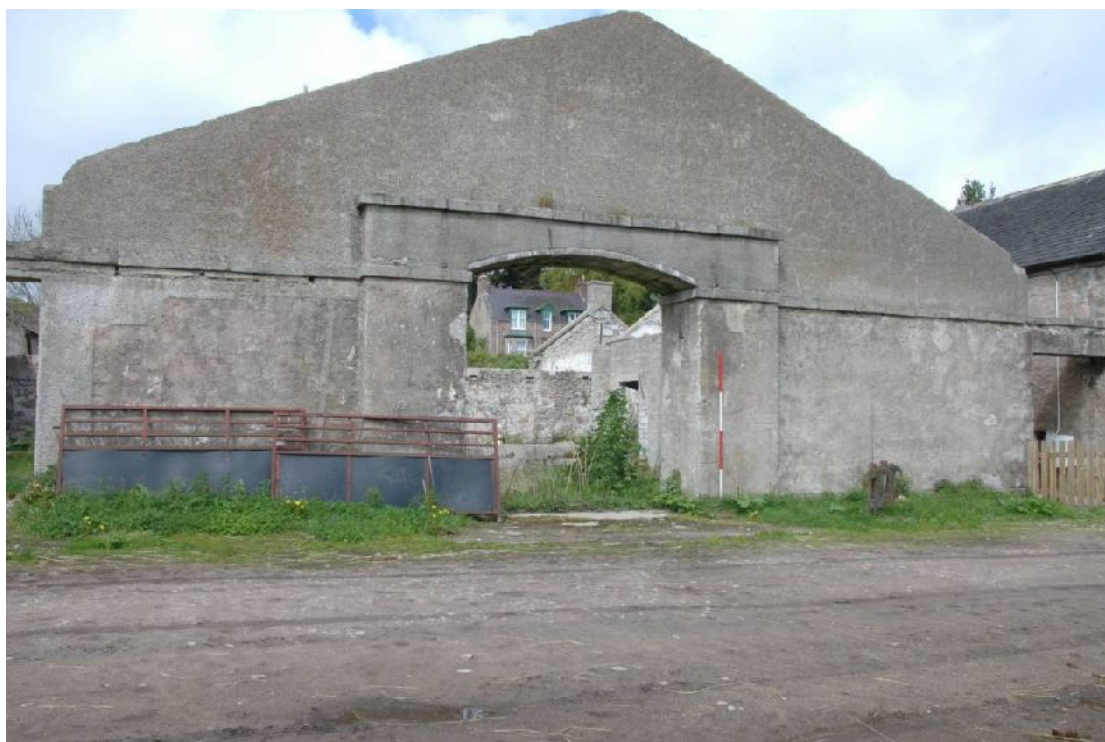
Illus 4 S wall of East Court showing the original 19th-century stone wall with concrete above from the 20th century infill.

The East Court comprises N, E and W ranges set on three sides of what would have been an open court with a wall and decorative gateway on the S side, which would have been the side visible from the roadway leading between the Home Farm and Park House. A raggle along the E wall of the West range of this court shows the former presence of a lean-to building, possibly that shown on the 1899 OS map (Illus 2). During the 20th century, as was common with many of the traditional steadings, the open court was infilled as a roofed building. The infill roof has since been removed and only the concrete foundations (Illus 3: shown blue) remain. At this time, the S wall was raised, with concrete blockwork above the original stone entry wall (Illus 4).

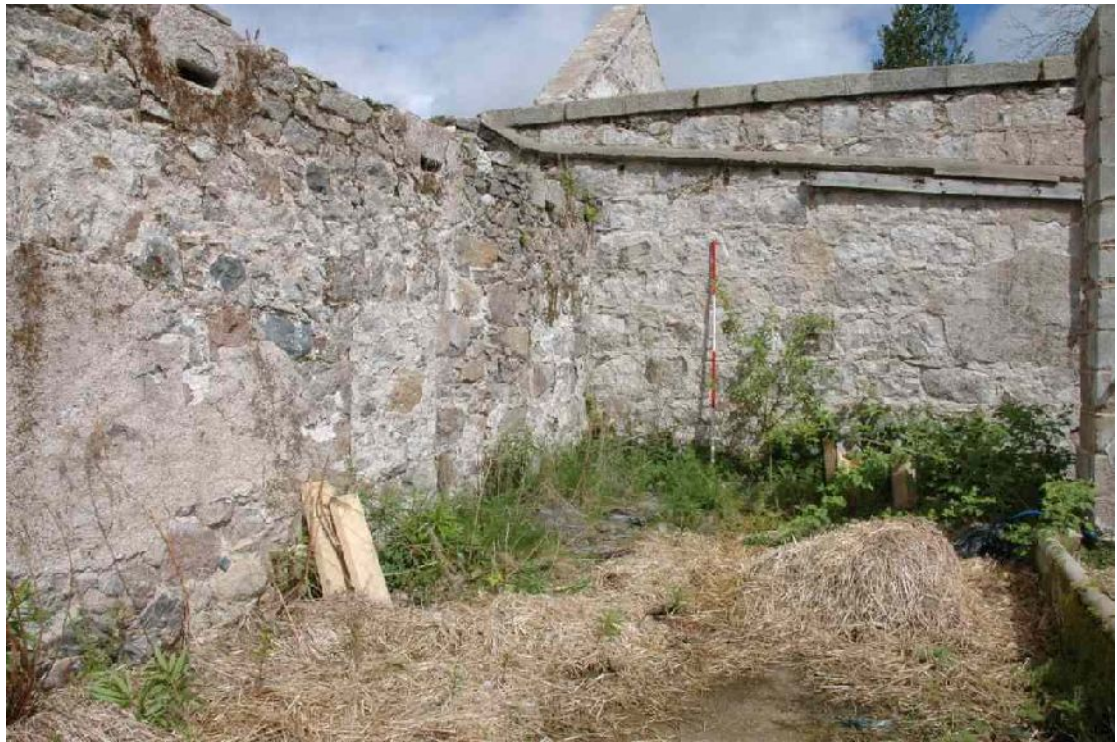
Illus 5 Stonework in NW corner between N and E ranges of East Court

Walls Harled stone. In the NW corner between the N and E ranges, the stonework is exposed and shows the E range to have been built using larger, more squared stones.

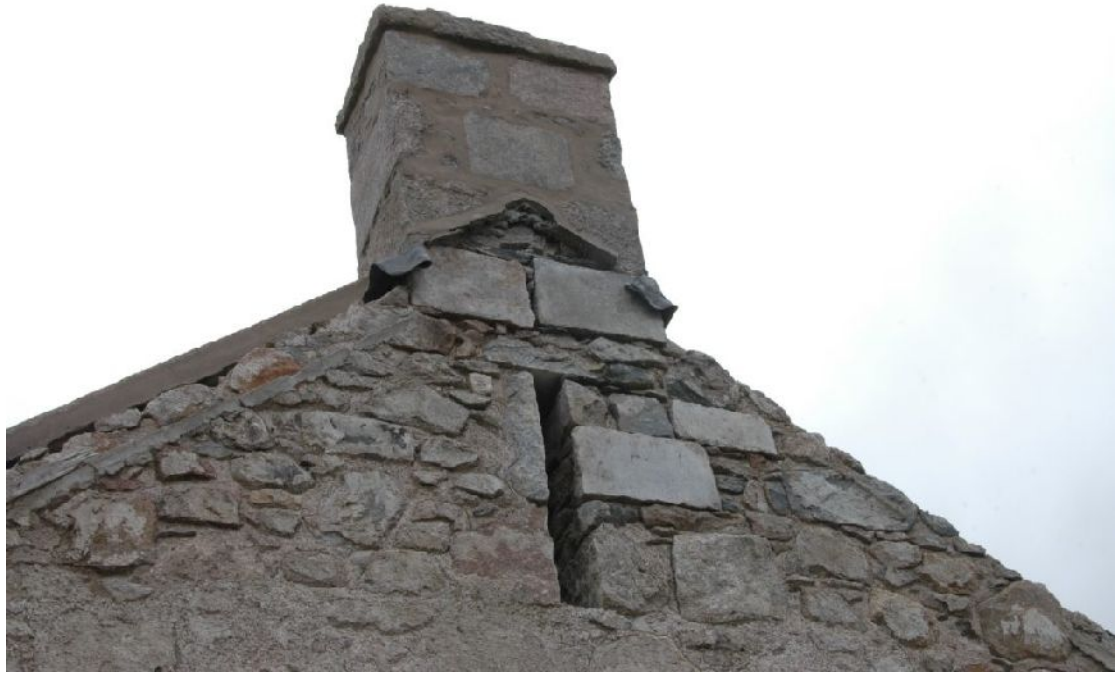
Illus 6 False chimney in N end gable E range, East Court.

The chimney at the N end of this range is a 'false' chimney with no flue, presumably built to balance the E facade. The slit vent below it indicates this area was always used for livestock.

Chimneys House: Granite rectangular stacks with flat topped table. Ceramic pots. N end gable: false chimney (Illus 6).

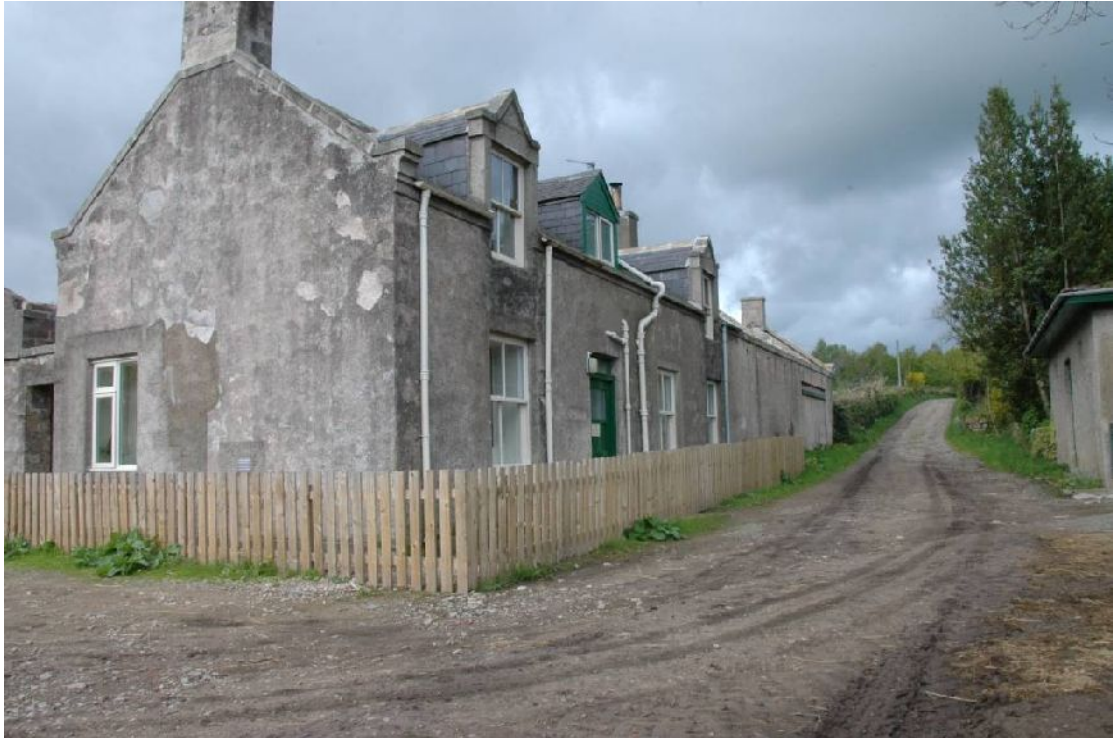
Illus 7 The house, looking NW

House: The house was not surveyed in detail as it was occupied. There were no openings in the N or W walls. A single large window in the S wall is clearly a later replacement or addition. In the E wall, facing the roadway there were three sash windows on the ground floor. The door has a glazed light in the top panel and a glazed light above the door. The outer two dormers on the attic floor have dressed granite rybats and triangular pediments; these are likely to be original. The central dormer, with two sliding windows in a wooden frame appears secondary, probably inserted when an internal bathroom was added.

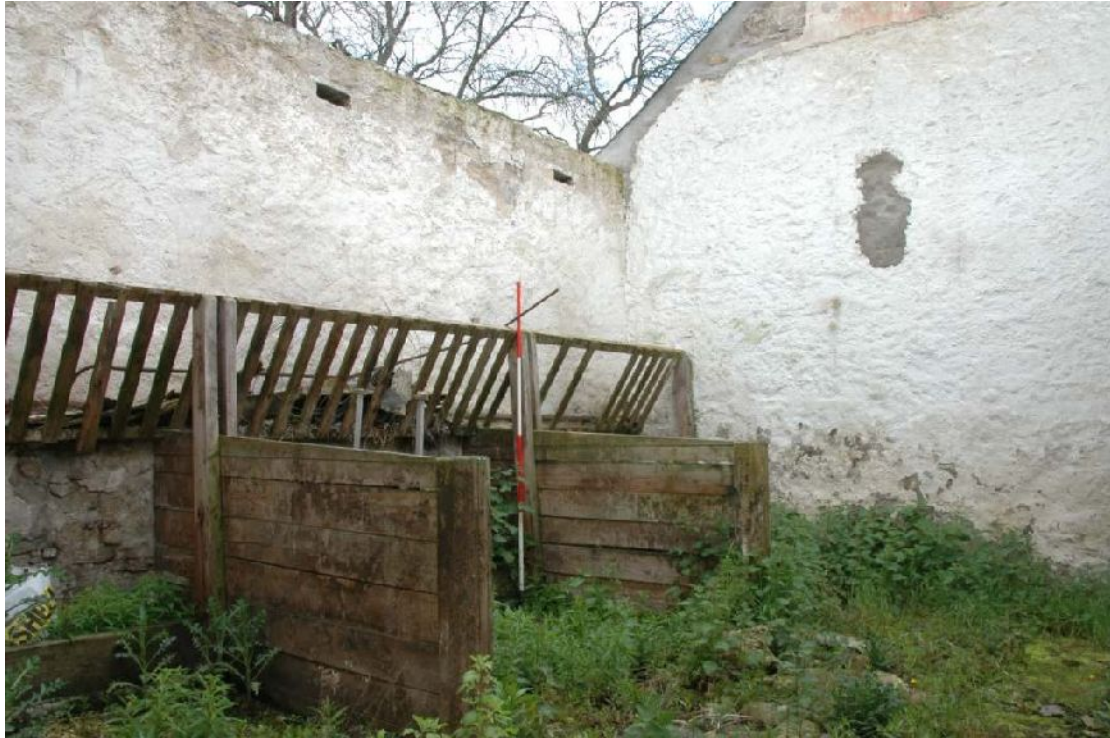
Illus 8 Tied cow stalls with vents above, in central part of East Court, E range.

Small vents in upper wall for original livestock use (Illus 8).

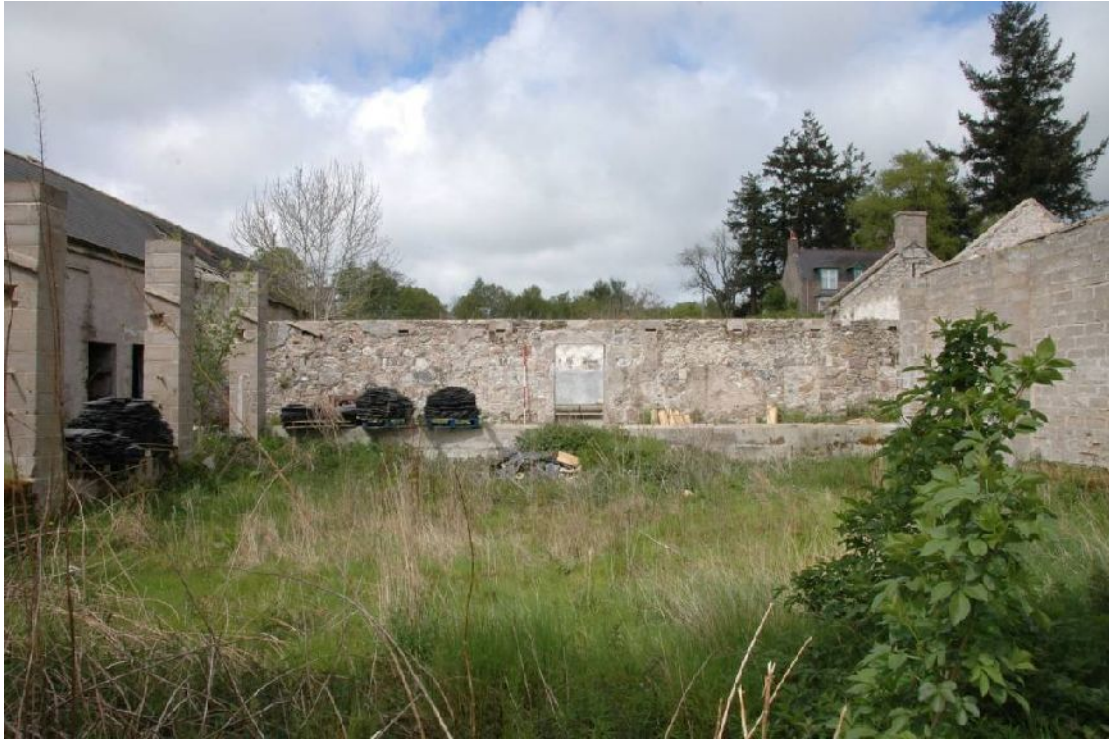
Illus 9 Looking N across East Court to S wall of N Range, some of blocked windows visible.

S wall Central door (D22) opening into original court, flanked by four windows on each side (W10-W18), all blocked with stone.

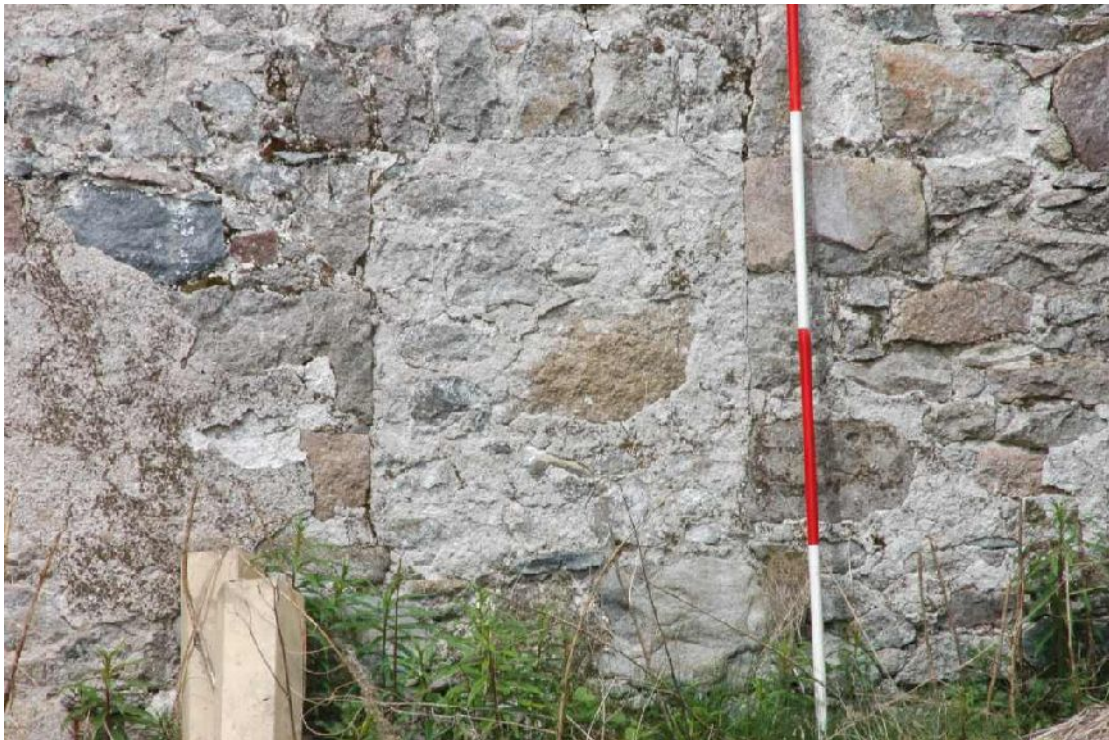
Illus 10 detail of blocked window in S wall of N Range, East Court

W10-W18 W: 0.92m H: 1.00m Sills 0.55m above ground (to concrete). All with rubble stone arched openings. All stone-blocked.

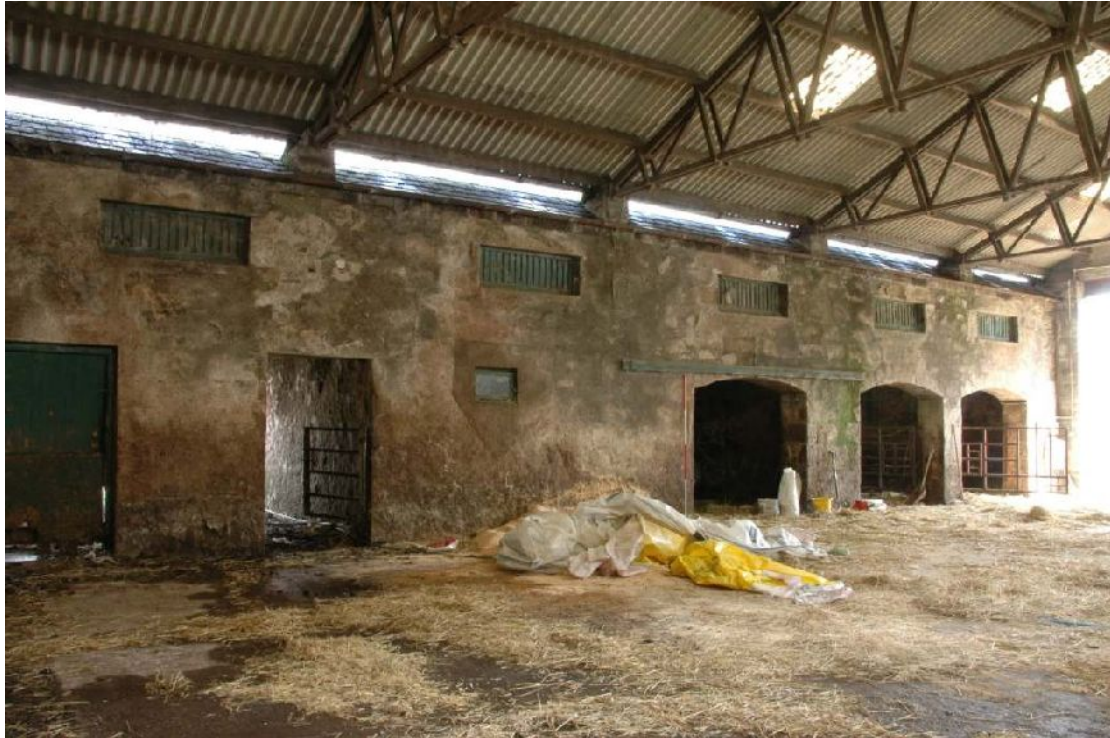
Illus 11 W wall of W range of original East Court

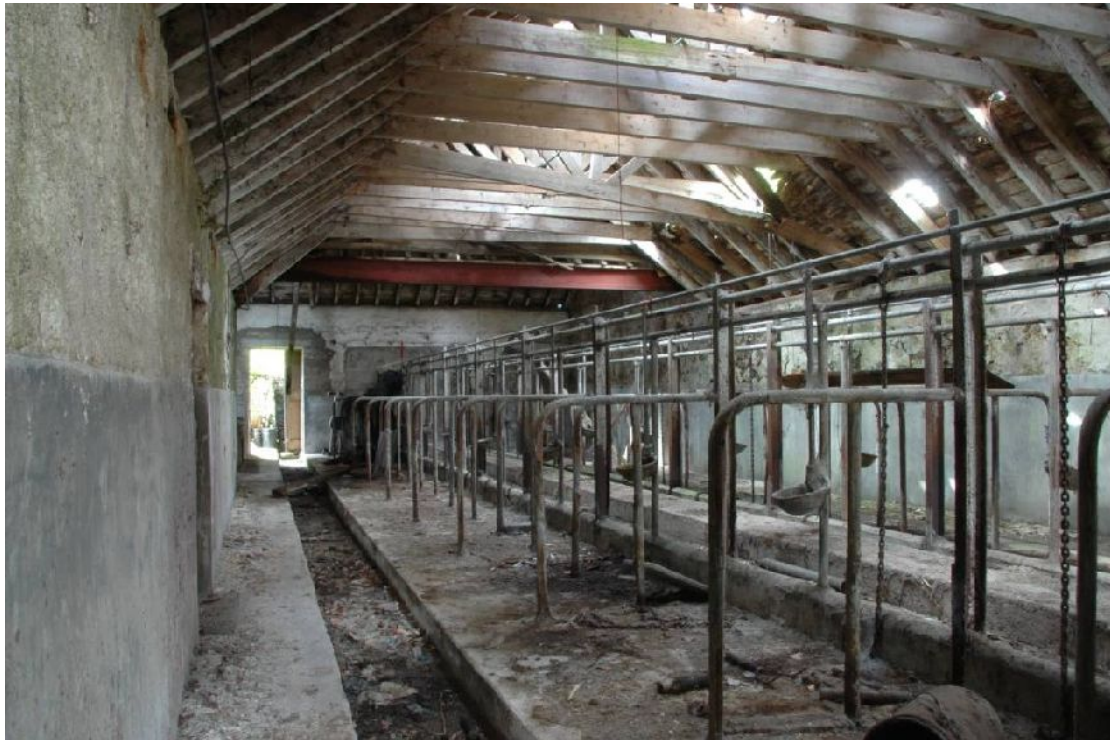
Illus 12 N range of West Court, looking W. Interior.

Cattle. Tied stalls with metal trevises, concrete feed pass and concrete slatted (removed) dung channel. 10 double stalls (total 40 cattle in this wing and 40 cattle in N range of East Court.

Roof Slate, mostly removed, timbers collapsing.

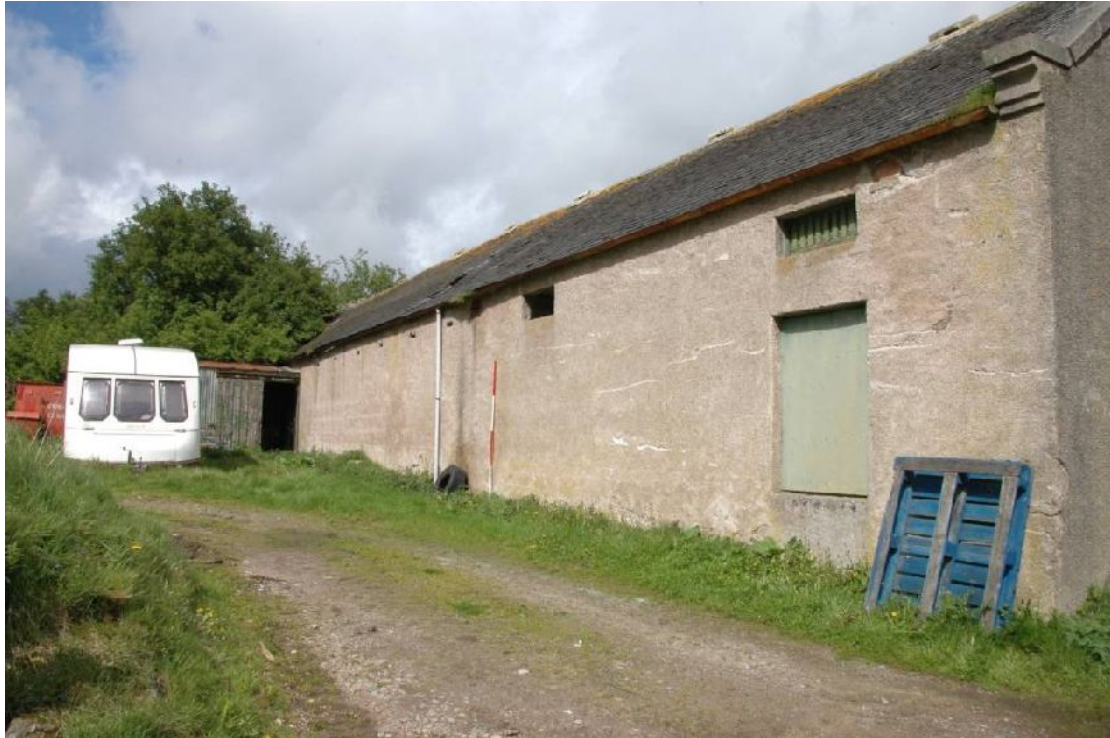
Illus 13 W wall of W range of West Court from outside, looking N. Ranging rod indicates the probable position of the wall between the bothy with loft above at S end and the stalls with vents at N end.

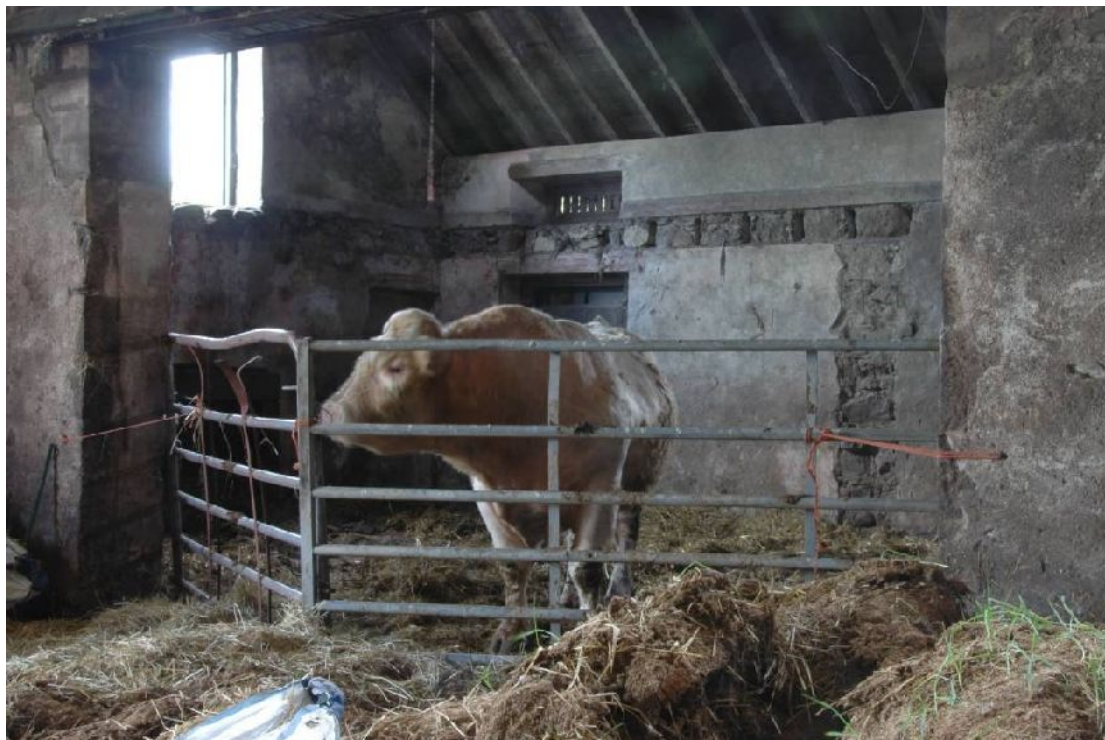
Illus 14 Looking through D30 to S end of interior of West Court W Range. On wall to LHS blocked door and central fireplace visible. On far wall raggle of loft floor and of internal partition wall of bothy.

Original use The S end of the W range was originally a bothy as there is a chimney with flue in the S gable and a fireplace could be seen in the inner face of the S wall (not measured as this area could not be entered). There also appeared to have been a blocked door in the W side of the S gable (not visible on outside because of harling). This end had had an upper floor or loft, with narrow loft windows (W18, W19. Illus 13, 24). Raggles on the inner face of the W wall indicated the position of the end wall of the bothy and the position of an internal wall. The N end of the range had originally been used for livestock as indicated by the line of vents at the top of the wall and the raggles of six stalls each corresponding to one of the vents.

Internal fireplace at S end. Not measured. (Illus 14)

Possible blocked door. Not measured. (Illus 14)

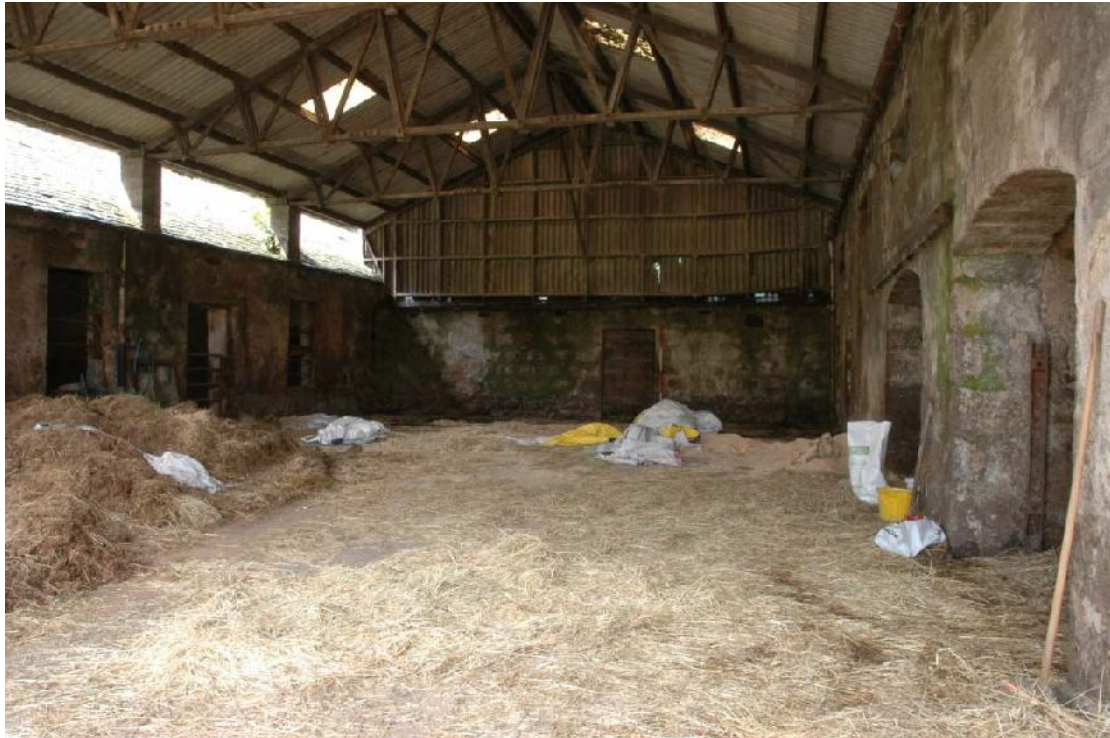
Illus 15 Infill of West Court, looking N

Roof : Corrugated asbestos on wooden spans.

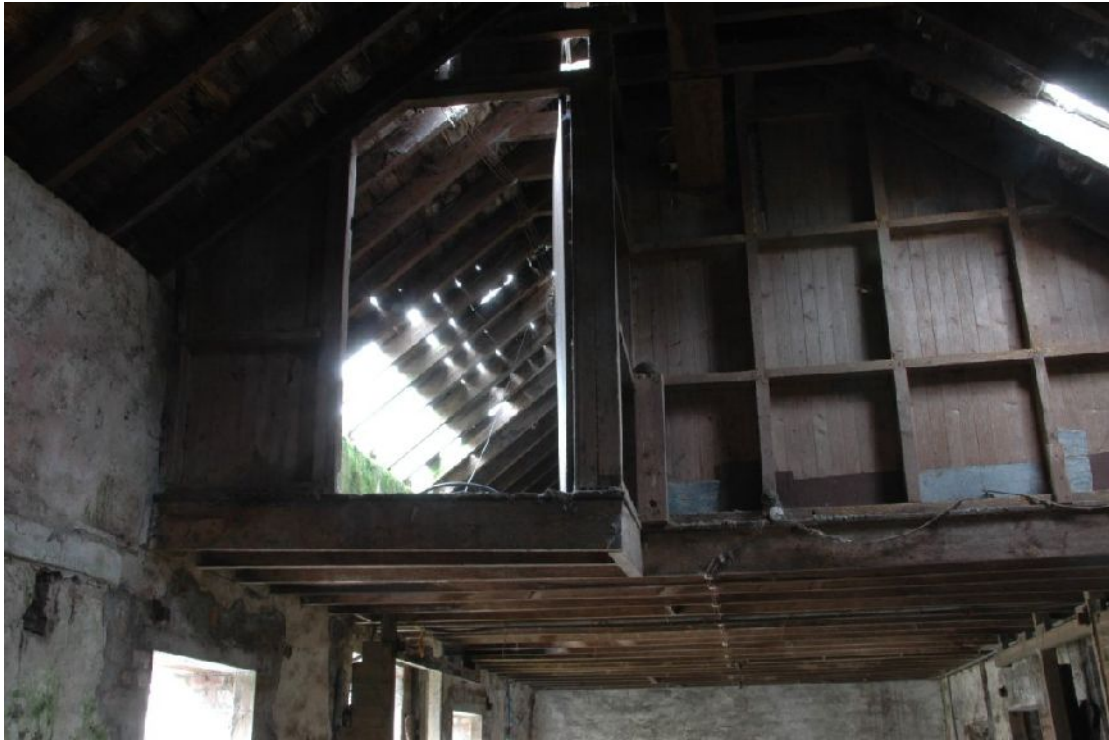
Illus 16 Looking S from mill at loft over W range of East Court

Timber holes in the S end of the E wall are likely to have held a wooden stair up to the doorway in a wooden partition wall at the end of the loft which

extended over the length of the W range of the East Court (Illus 16). The loft was not accessible.

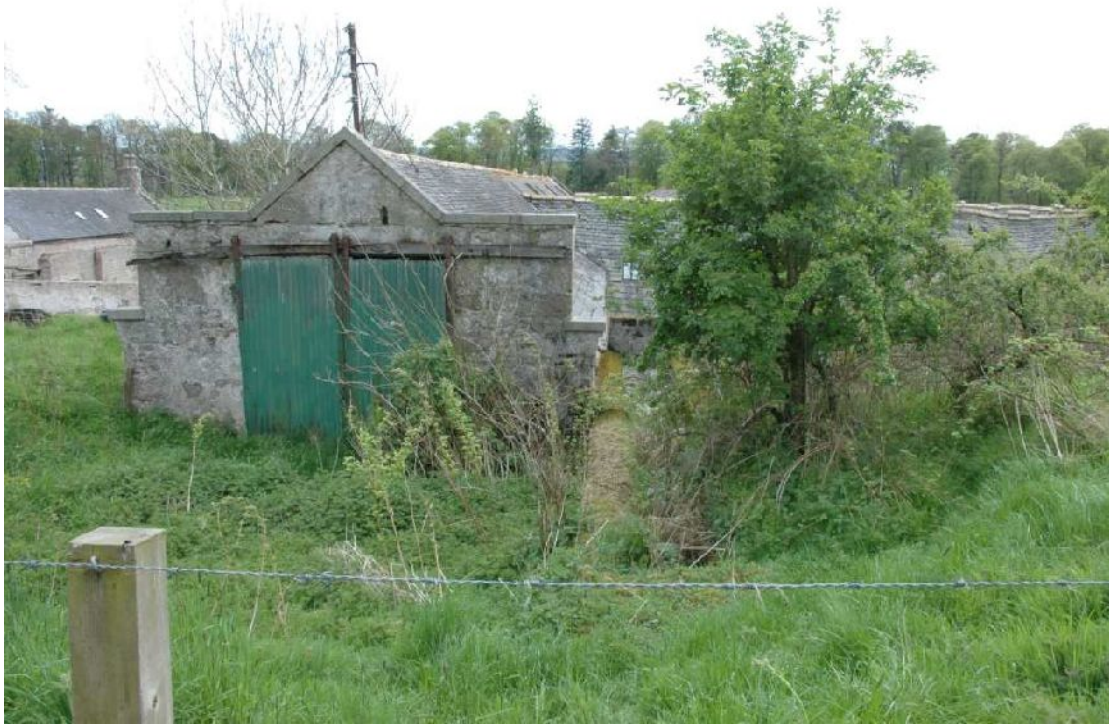
Illus 17 Mill from the N showing false front at gable. Lade visible on RHS.

The wheel pit was not accessible due to debris and dense vegetation (Illus 17). The architect's notes indicate that it is 5m deep and has a granite retaining wall. The lade (Illus 18. W: 800mm) ran to the wheel pit from 6.7m the N, where the OS maps (Illus 1, 2) show the Mill pond. The outflow from the lade appears to run below the West Court and out to the W along a wide ditch along the S side of the roadway.

Externally the N gable of the mill has a pedimented false front and skewputts to match the rest of the complex (Illus 17).

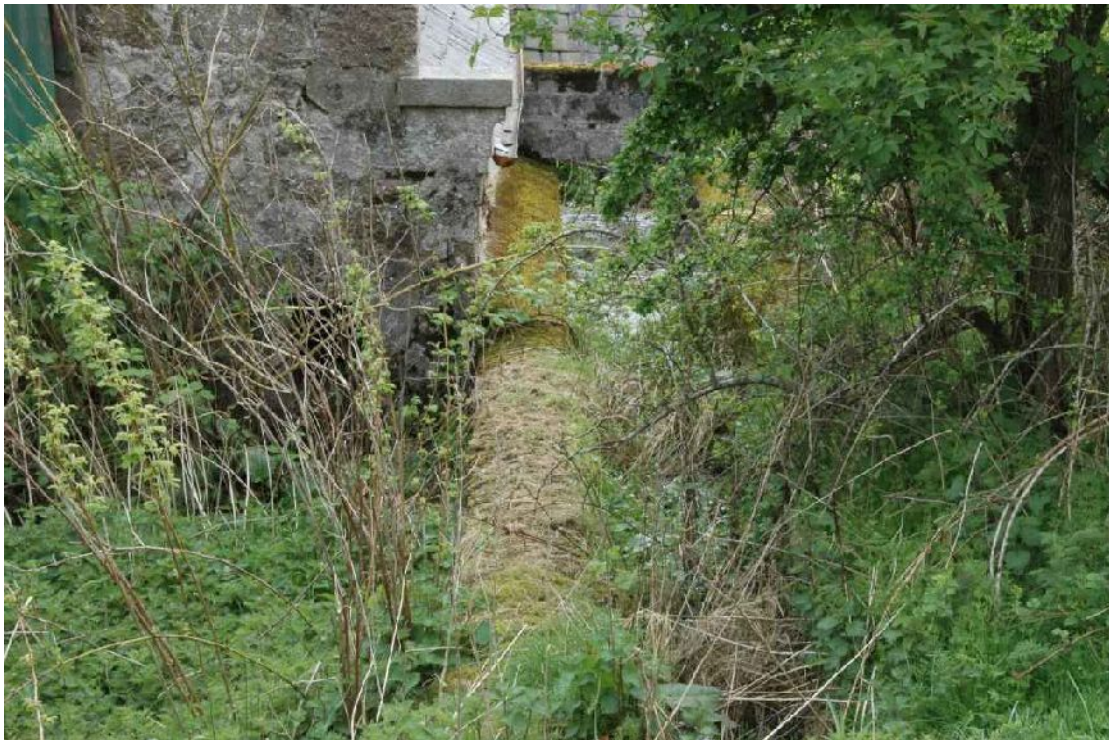
Illus 18 Mill lade and wheel pit from N

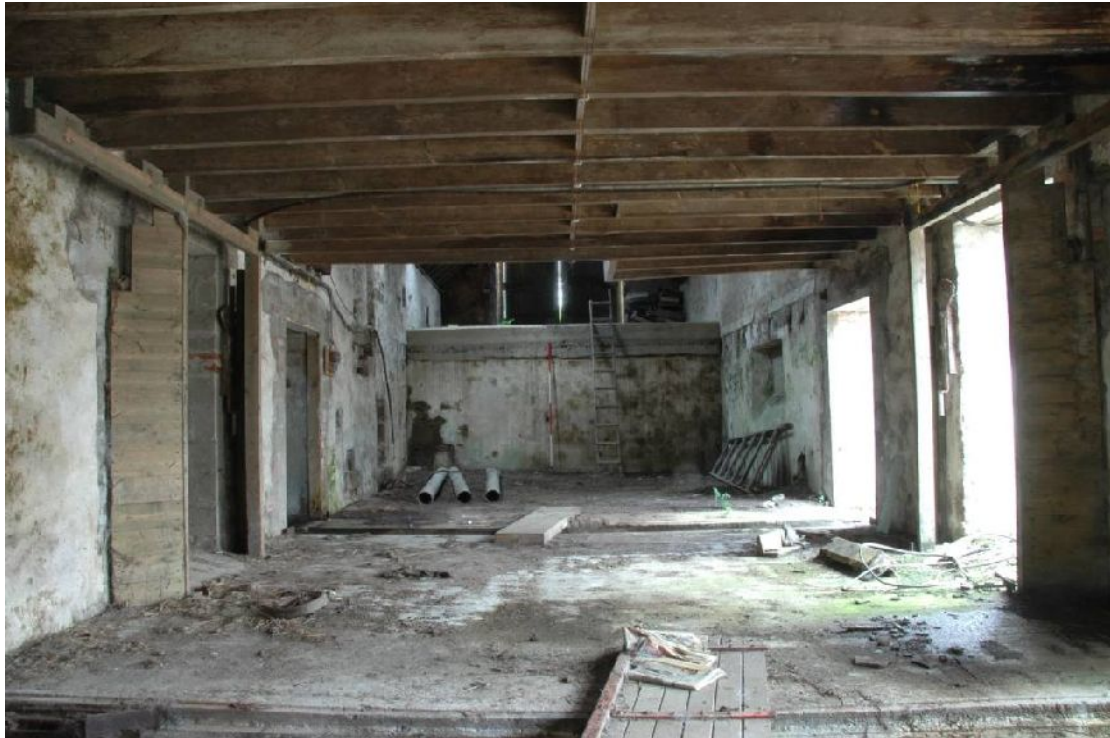
Illus 19 Interior of mill from below loft of East Court, W range (by D7)

The mill block abutts the N end of the W range of the East Court. It is divided internally into two areas by a stone wall 1.85m high with an added 0.50m of concrete blockwork at the top, with a wooden floored loft open to door D21 in the N gable (Illus 19). There is no obvious access to the area below this loft.

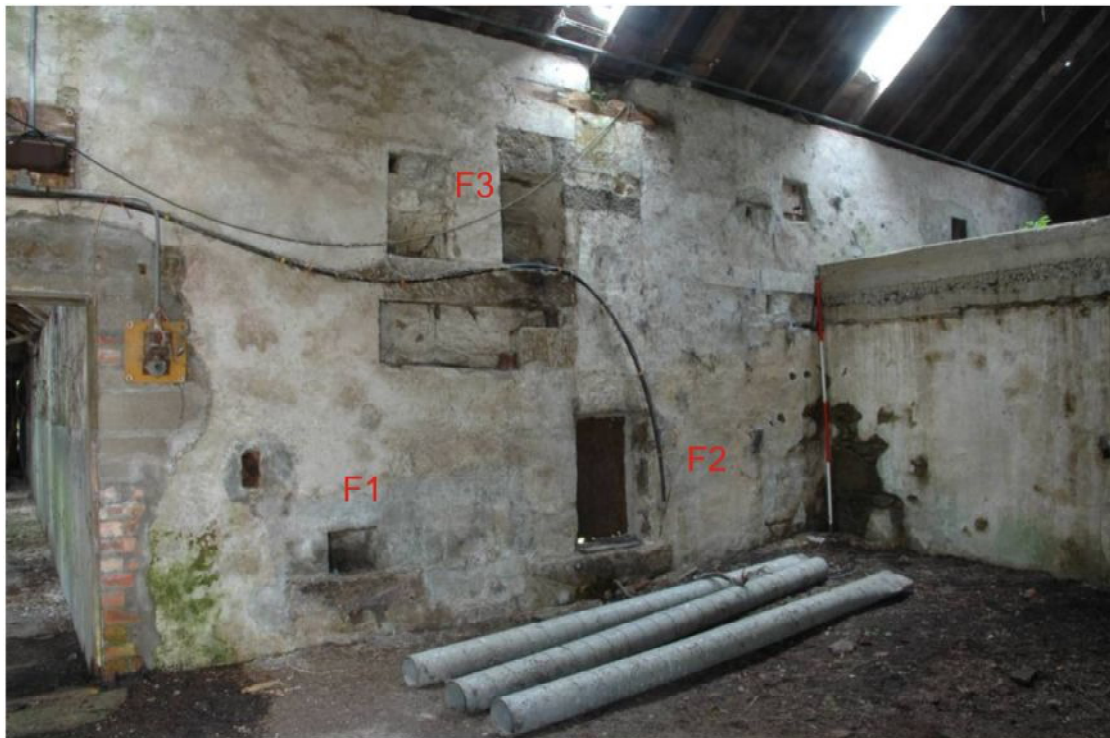
Illus 20 Inside of mill showing inner face of W wall with blockings F1-F3

The S area was open to the roof. The wheel pit is alongside the W wall and the blocked openings related to the wheel shaft are visible on the inside of this wall (Illus 20). On the opposite (E) wall there had been a large window giving light into the area.

F1 Shaft hole for wheel shaft W:300mm H: 280mm heavy granite sill.
Blocked.

F2 W: 600mm H: 900mm. Heavy granite sill and lintel. Blocked with metal.

F3 W: 1.4m H: 1.25m with heavy granite lintels. Partly brick blocked.

Two small, blocked loft windows can be seen on the inside of the upper end of the N end of the W wall (Illus 20).
