FORDYCE PARISH CHURCH
WEST CHURCH STREET
FORDYCE
ABERDEENSHIRE

Standing Building Survey

Murray Archaeological Services Ltd

Report No: MAS 2014-23

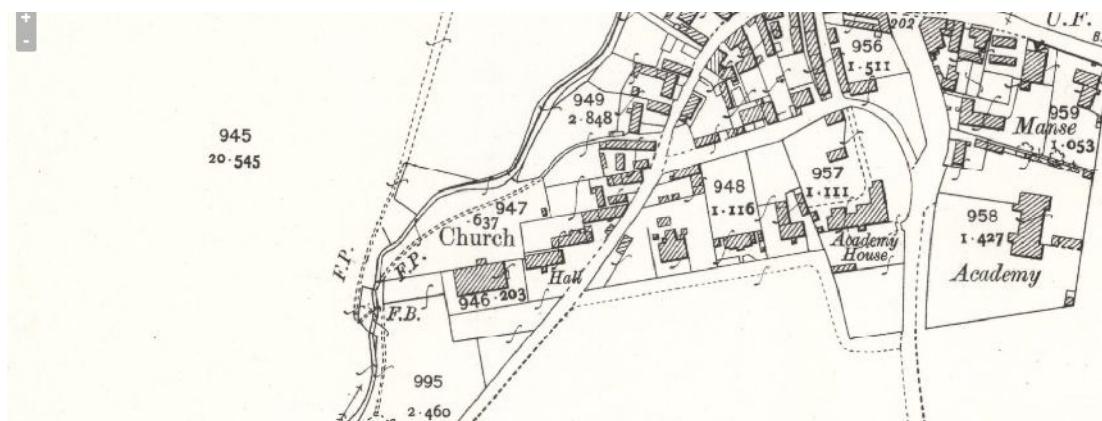
Illus 2 2nd edition 25"/mile Ordnance Survey of 1902 (pub 1904) (www.nls.ac.uk)

4.4 By the 2nd edition 25"/mile Ordnance Survey of 1902 (published 1904. Banffshire Sheet 003.15) the church is shown with the outshot on the N wall (Illus 2).

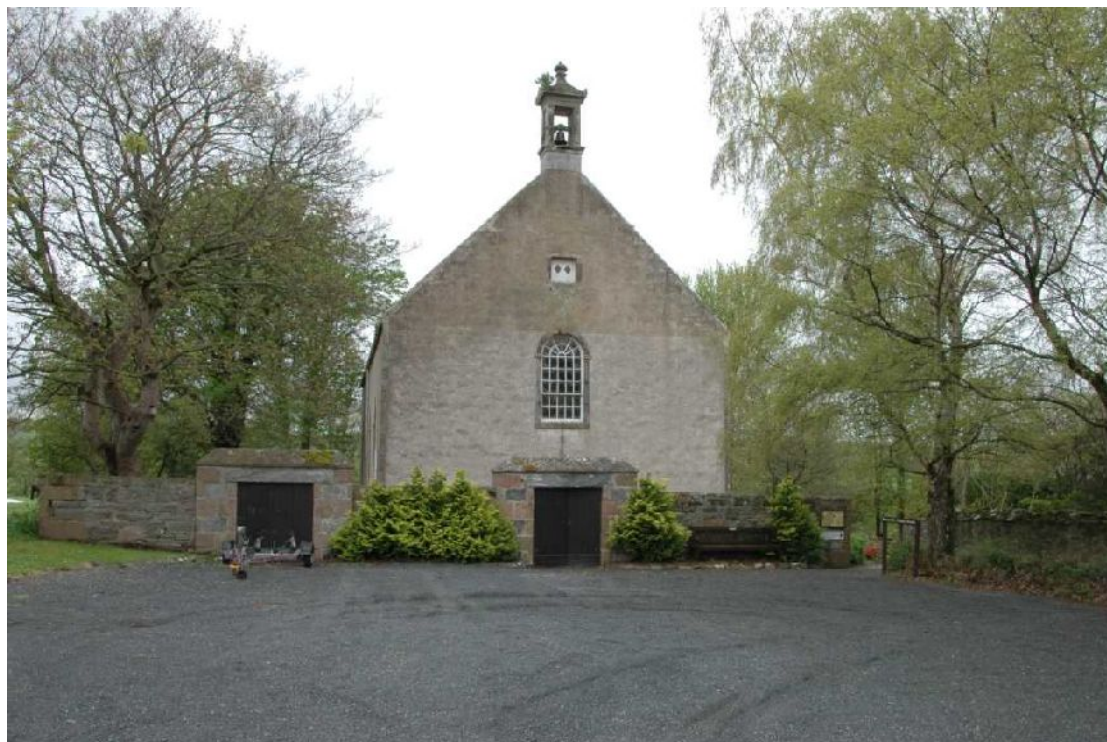
Illus 4 Fordyce Church viewed from the E.

The church is an imposing, but plain, rectangular block set E/W with round arched doorways in the E and W gable walls with large round arched windows above.

Matching round arched windows light the S wall. A rectangular bellcote thought to date to c 1830 is on the apex of the E gable; the bell itself is dated 1702 and was re-used from the old Fordyce church.

Walls Concrete harling (buff/pink) with sandstone ashlar at corners and openings. As the building is on a slight slope down to the W, there is a rubble stone foundation at the W end, at the base of the wall.

Roof Steeply pitched, slated. Small metal skylight at E end of N aspect. Bellcote at E gable apex. Plain ball finial at W gable apex.

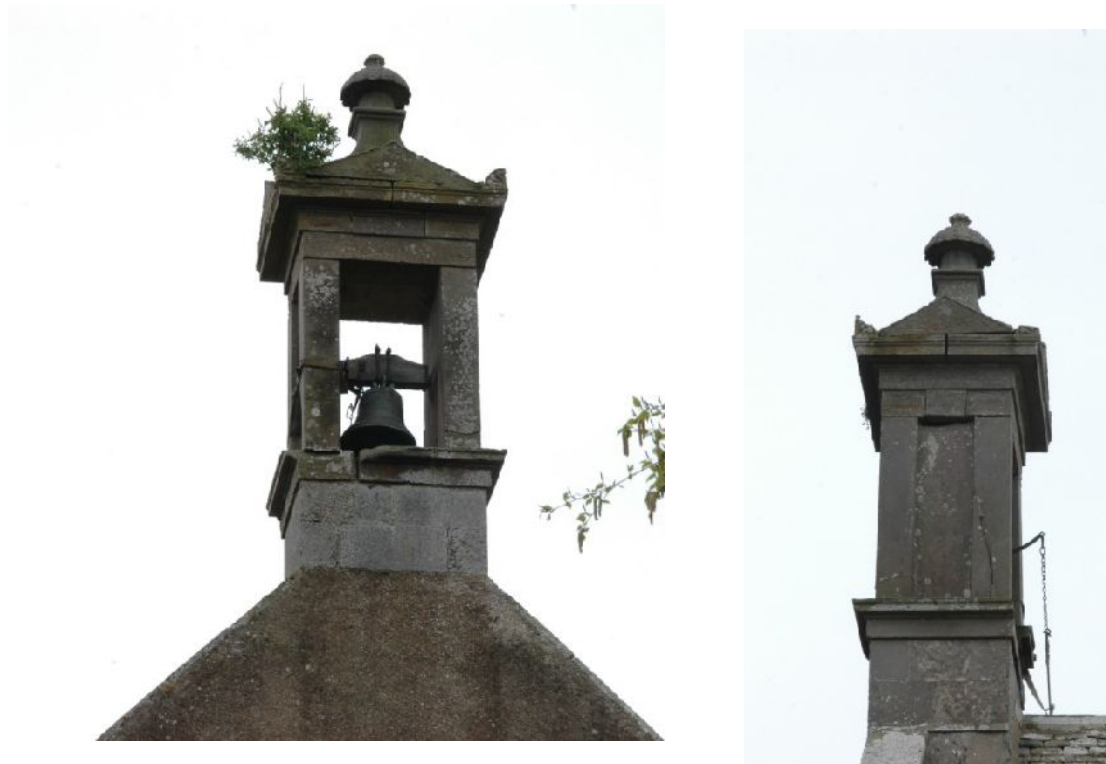
Rectangular, open to E and W, with solid sides to N and S with pyramidal top and ornamental finial. Some visible damage to the stonework, with iron strapping from the bell support to the S side.

Illus 5 Bellcote from E (above) and from N (RHS).

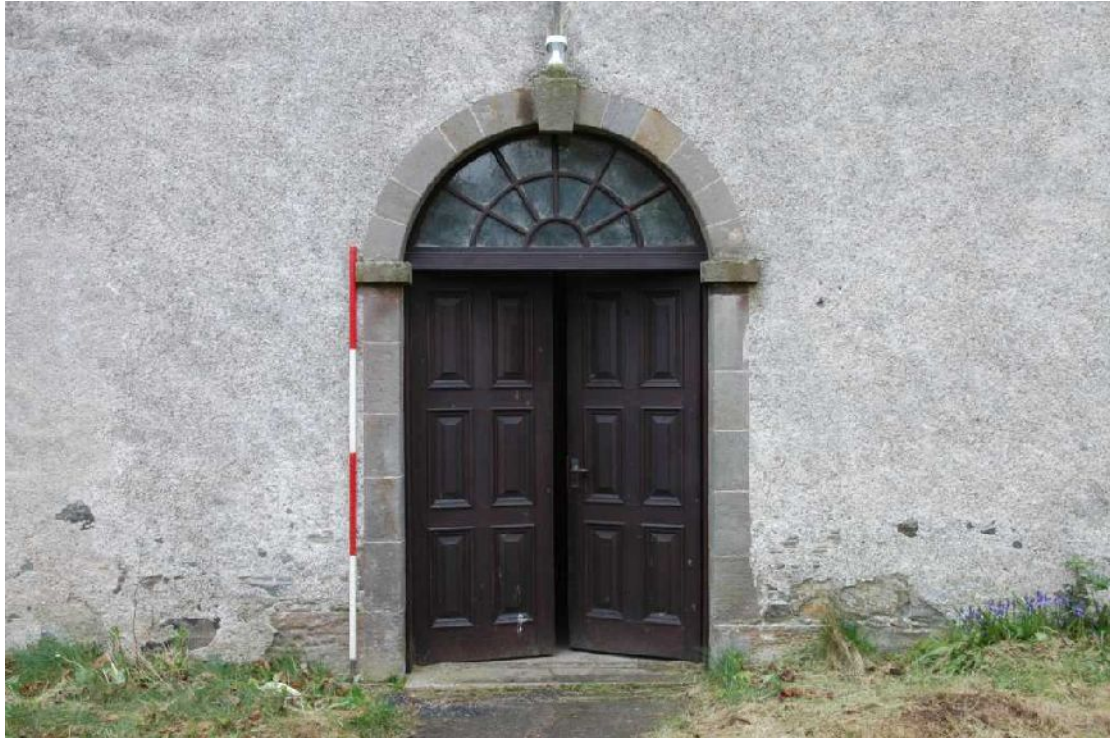
D1 W: 1.53m. H: 2.01m from lintel to ground. Round-headed arch with projecting key stone and impost. Fanlight above doorway. Double doors. (Illus 7)

Illus 7 Door D1

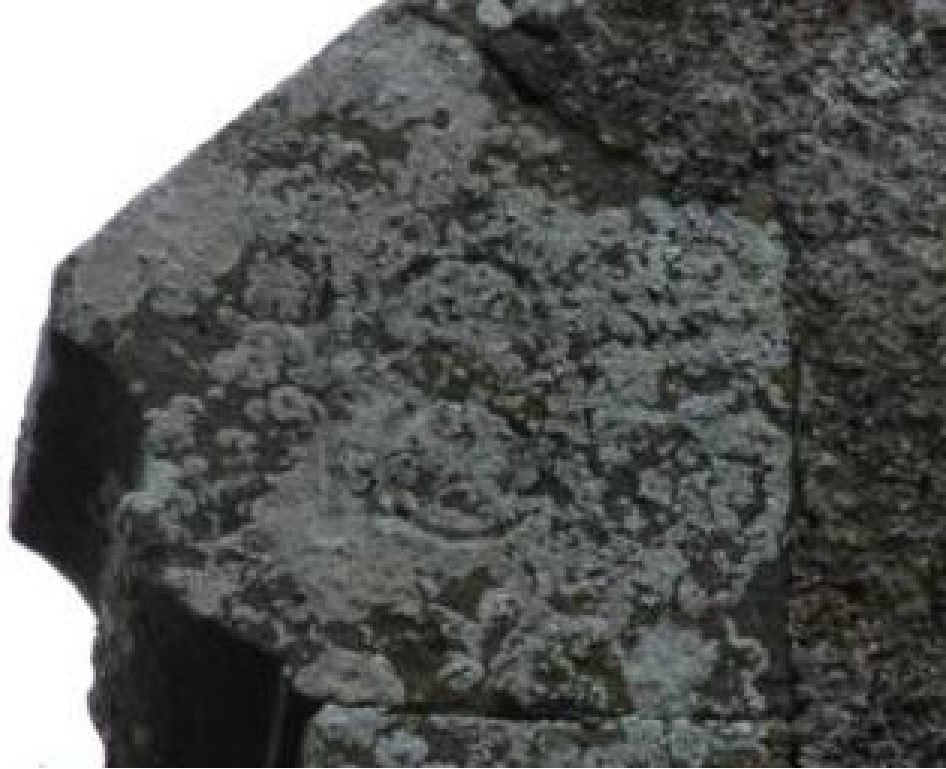
Skewputts with gently rolled moulding and with the date of the church (1804) on the front (E) face being '18' on the S skewputt and '04' on the N skewputt. (Illus 9, 10).

Illus 9 Skewputt at S side of E gable with date numbers: 18

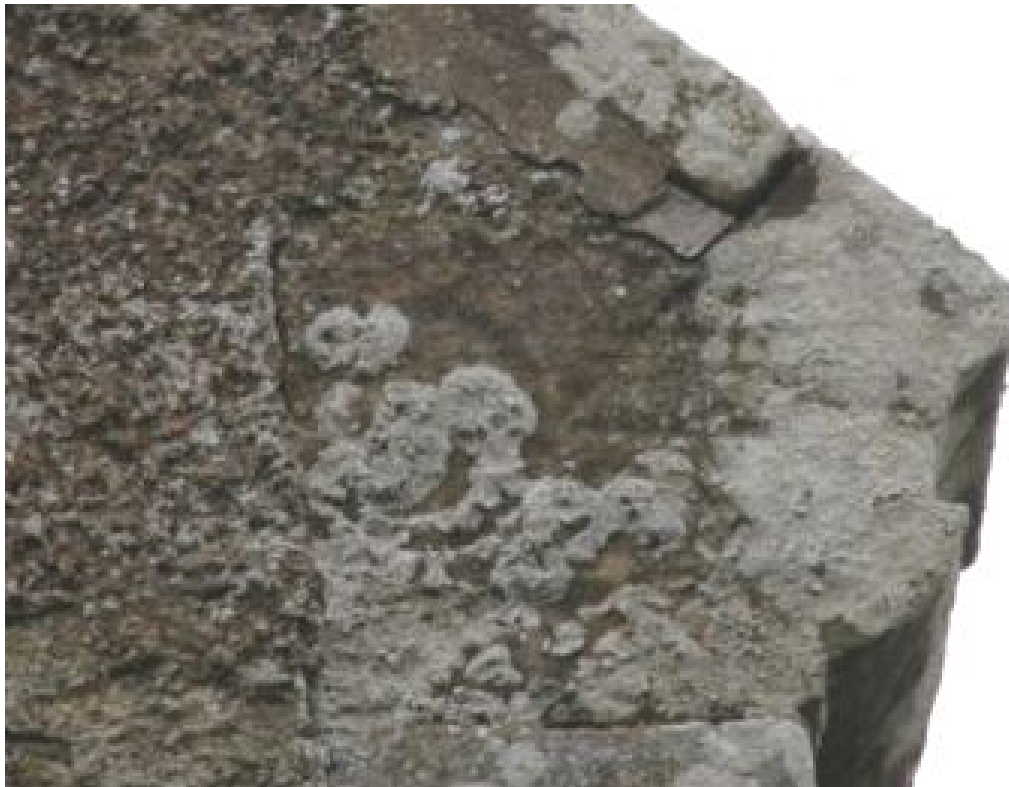
Illus 10 Skewputt at N side of E gable with date numbers: 04

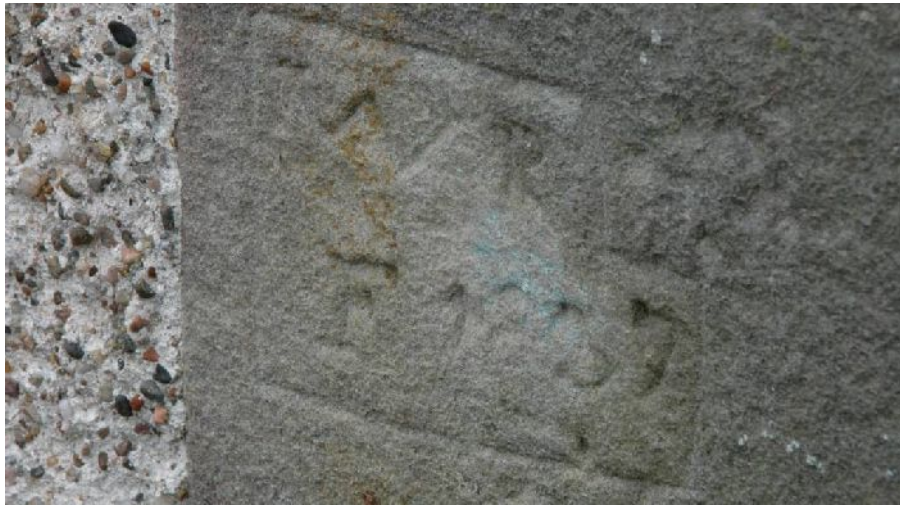
F1 At c1m above ground level a small panel is incised in the face of one of the sandstone corner stones (Illus 12). It appears to be chisel cut and reads:

WR
F 1837

While this is most likely to be graffiti and is just around the corner from graffiti F2 in the S wall- it is possible that it may relate to William Robertson, the architect to whom the bellcote is attributed c 1830. It would however appear very unusual to have the attribution distant from the bellcote.

Illus 12 Graffiti on stone F1 in W gable

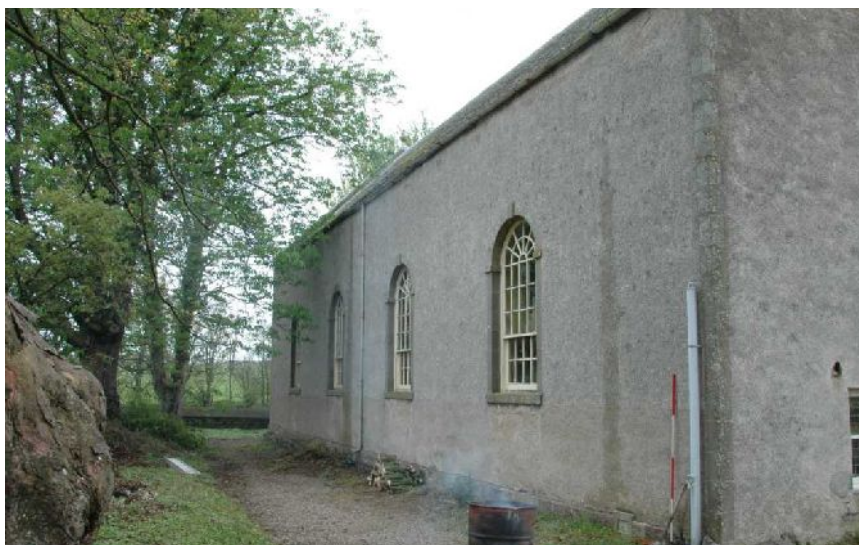
The S wall is punctuated by four identical windows (W1-W4). A cast iron down-pipe runs down the middle of the wall. (Illus 13).

Illus 13 Looking W along S wall

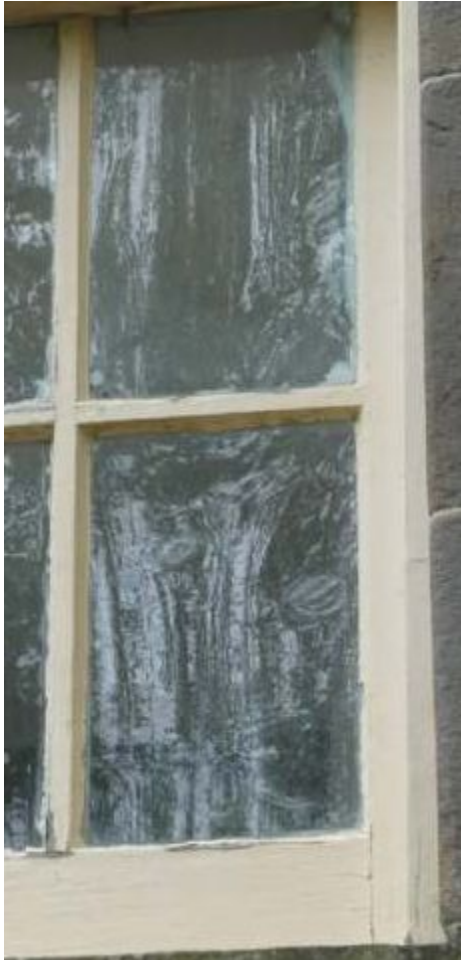
W1-W4 Same style as W7 and W8, but slightly taller. W: c1.45m H: c3m (from elevation). Round-headed arch with projecting key stone and imposts. Lower sash window with 5 over 5 panes. Upper window of 3 rows of 5 panes. Fanlight in arch. In some of the panes, the glass is clearly the original early 19th-century glass, with clear ripples and occasional bubbles which typify the cylinder sheet and patent plate glass which began to be used at this period (Historic Scotland, 2008, 1). (Illus 15).

Illus 15 Detail of window W1 in S wall, bottom E panes to indicate glass ripples and bubble

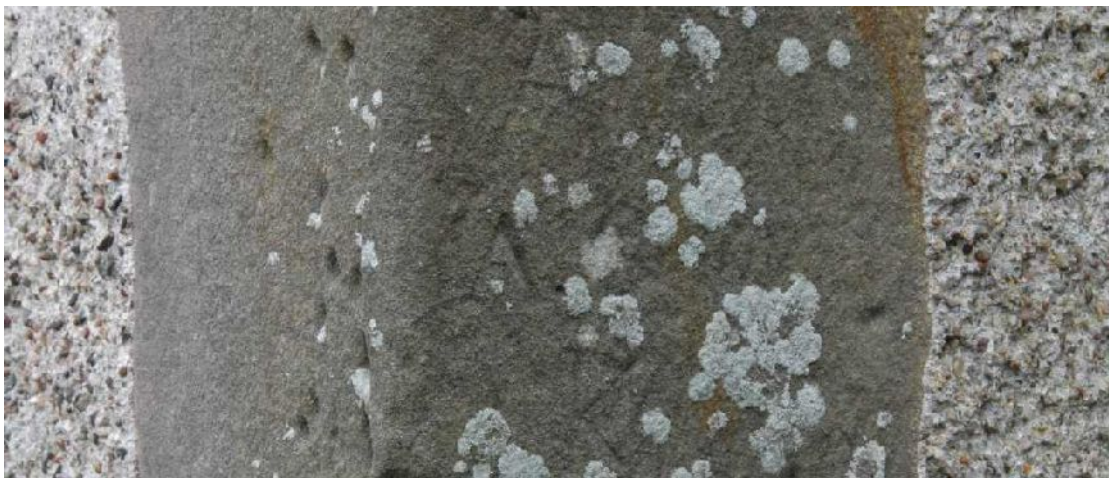
F2 and F3 Graffiti on S face of lower corner stones at W end. F2: On the 2nd stone from base there appears to be a knife or chisel cut A, A (Illus 16).

Illus 16 Graffiti F2

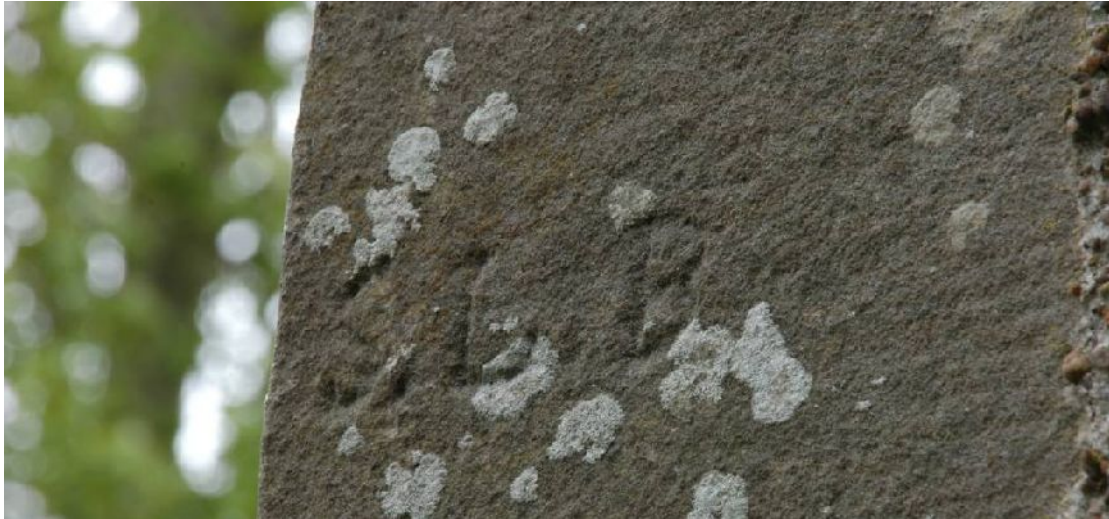
F3: On the 4th stone up there appear to be the pocked initials SLB. (Illus 17).

Illus 17 Graffiti F3

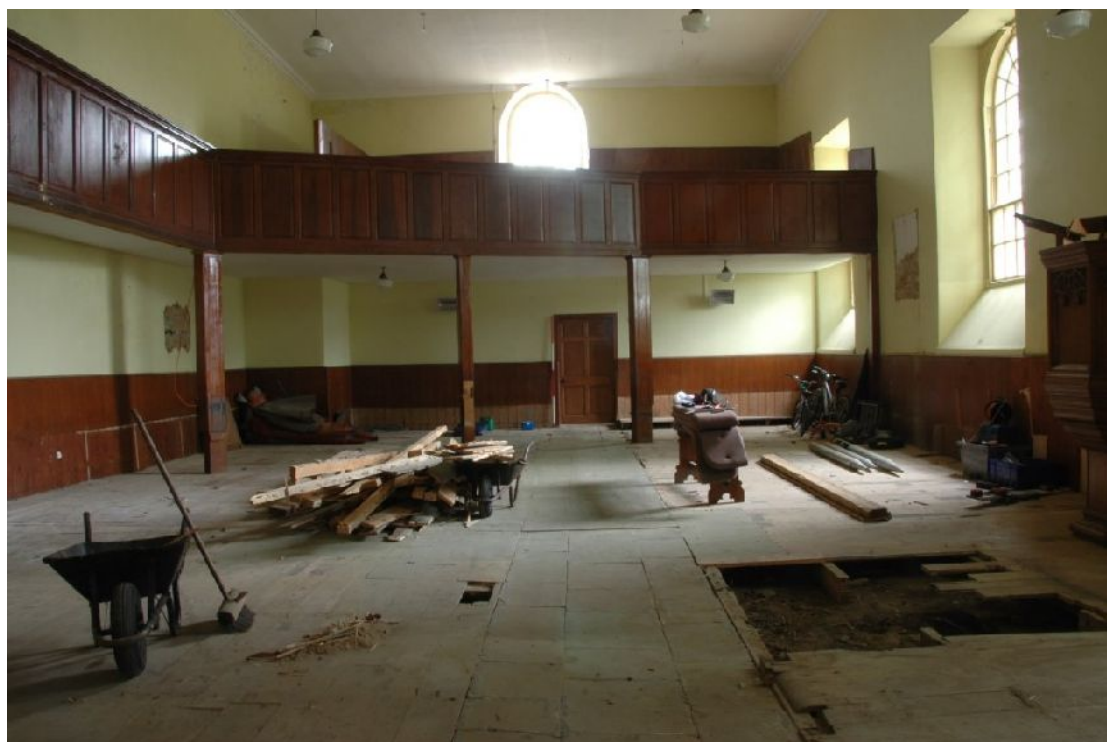
Illus 19 Interior looking E

There was a band of stone flooring, 1.2m wide, extending E/W along the centre of the floor, along the edge of where the ground floor pews would have been. The original panelling, 1.25m high, survives on the N, S and E sides, with plaster above. Five of the Gallery pillars (Illus 3: F5) are still visible; they range in size between 190 x

130mm and 190 x 270mm. They are of rough timber, clad with pitch pine to match the panelling. (Illus 19).

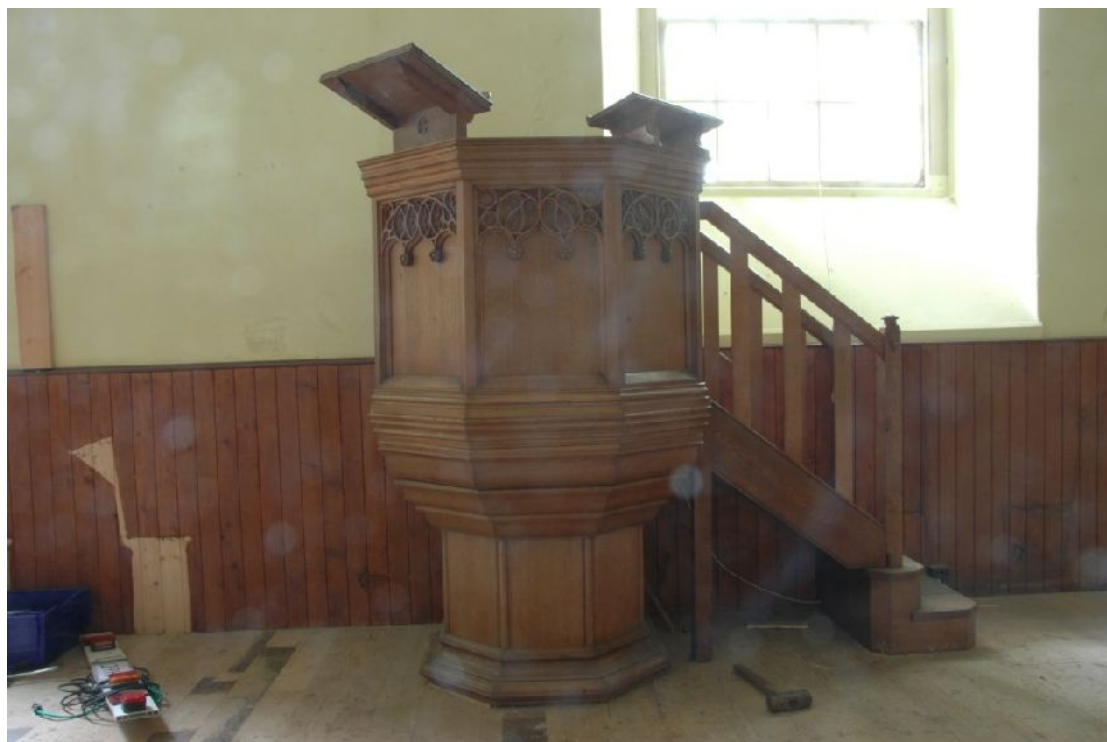
The octagonal pulpit stood beside window W2, with steps to it from the W (Illus 20).

Illus 20 Pulpit below window W2

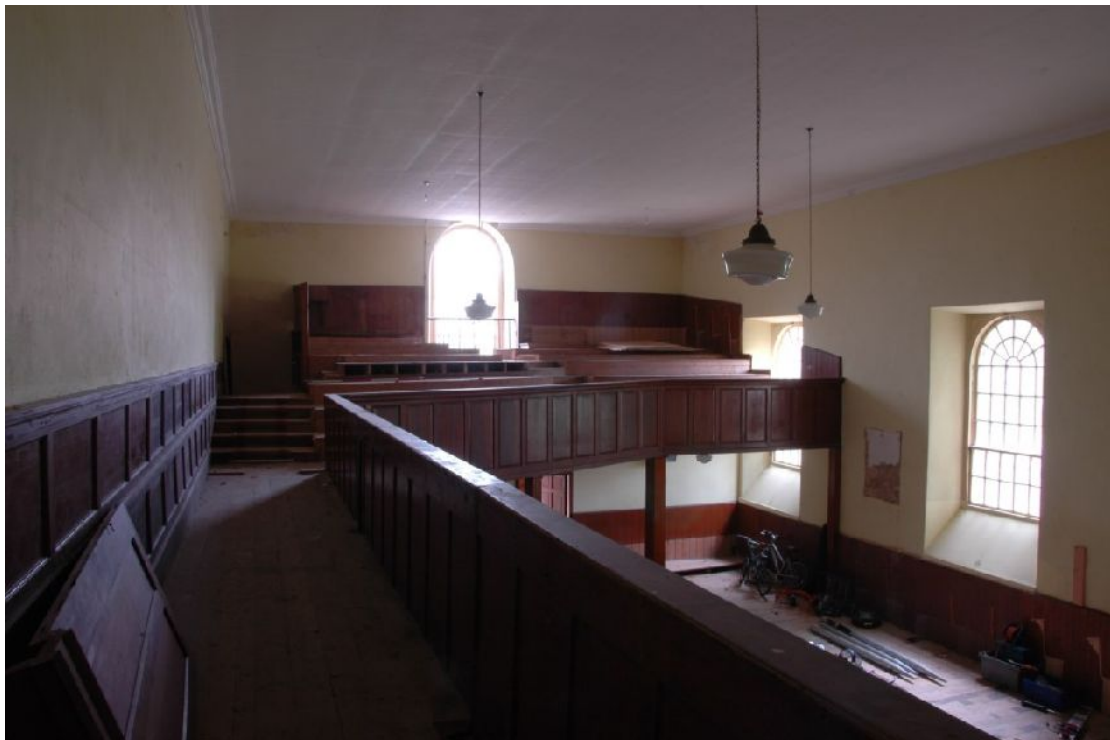
The inside of E window W8 had a wooden railing; traces of a similar railing were visible beside the W window W7. The rope for the bell hangs down beside window W8.

Illus 21 Gallery looking E towards window W8. Note the hanging lights.

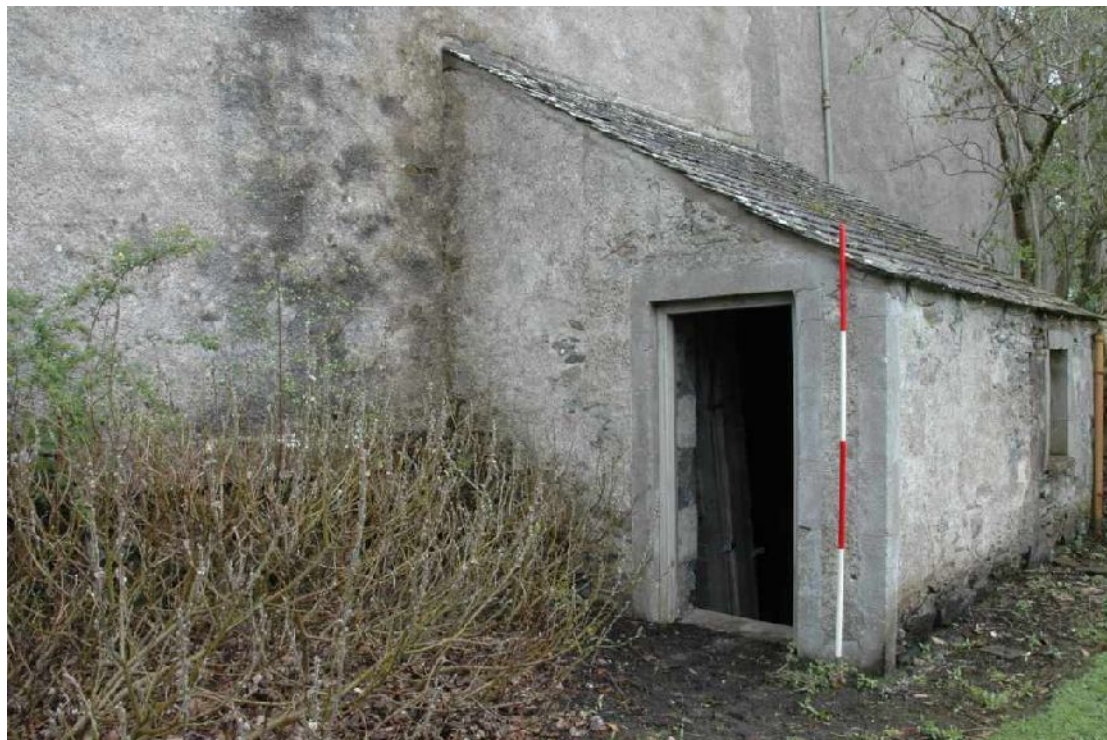
Small lean-to outshot, 3.2 x 4.6m.

Walls: Harled rubble stone with concrete blocks around door and window.

Roof: Slate.

Illus 23 Lean-to outshot

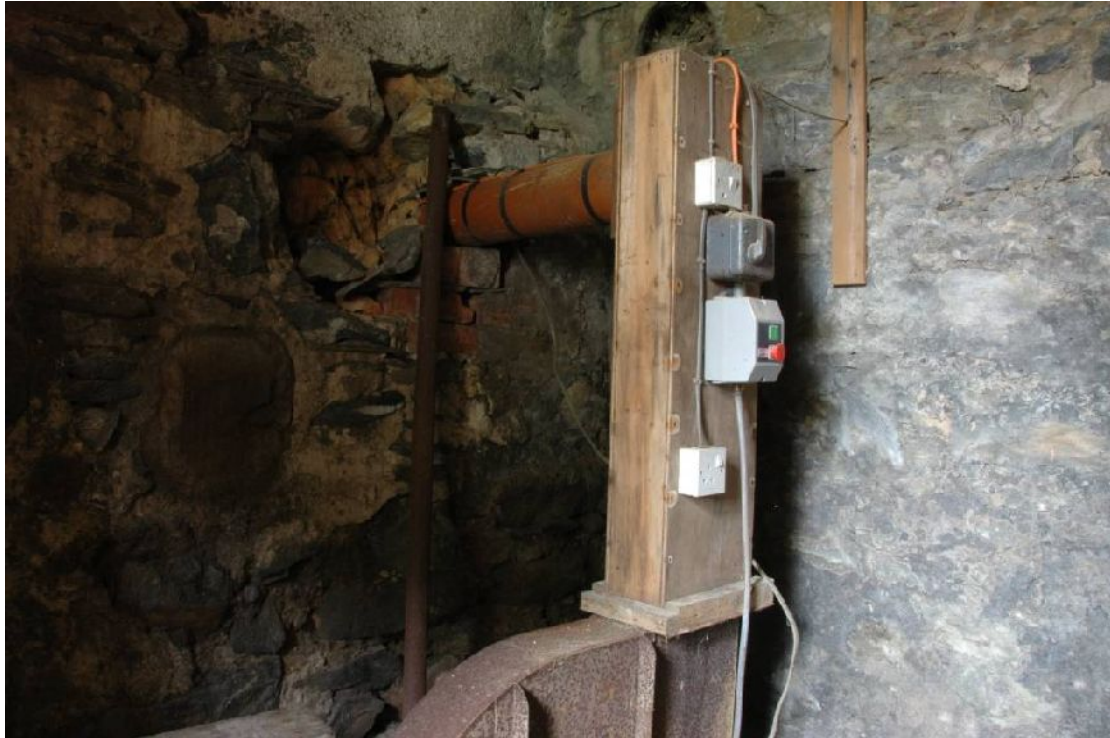
However, in the Owner's Deeds, there is a Certificate of the Sheriff dated October 1932, under the Church of Scotland (Property and Endowments) Act of 1925 which details the boundaries of the church lands and refers to this building as the 'Heating Chamber'. So it is probable that its original function was as a furnace house. This is probably the explanation of two blocked holes, one through the church wall and one to the W (Illus 24).

Illus 24 Drive for organ bellows with vent through pipe in wall. Note earlier blocked openings for heating.

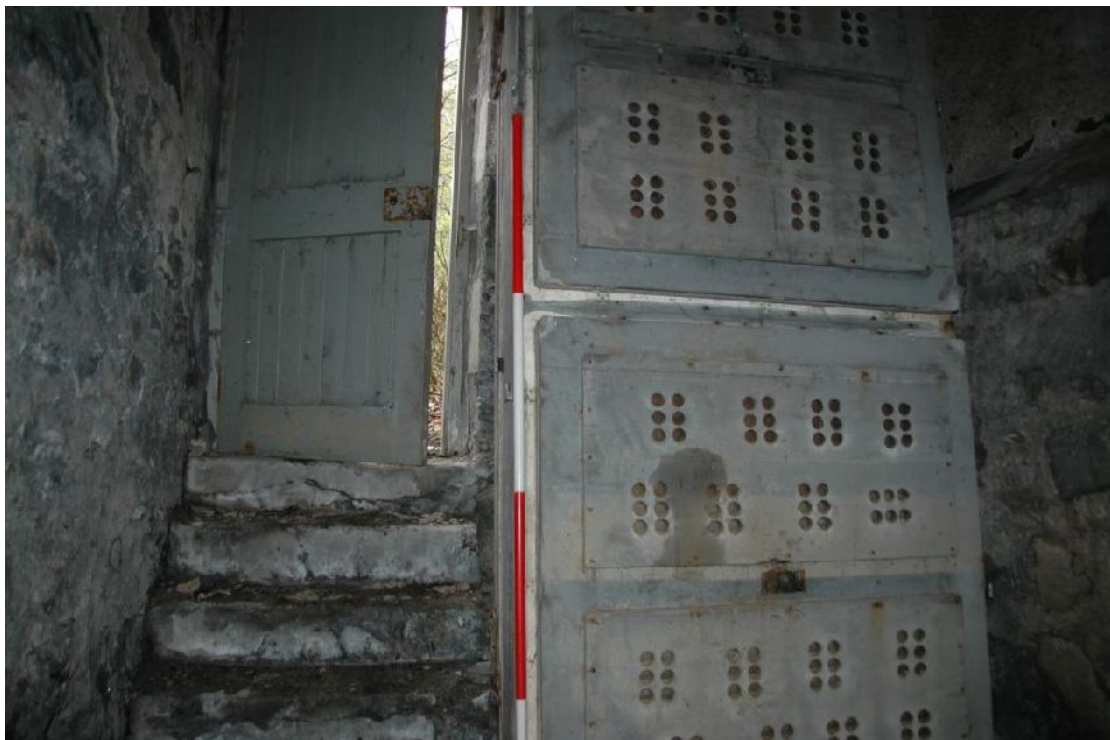
Internal: The floor is cut down c 1.1m below the external ground level, with 7 steps down inside door D3. This structure is not on the 1866 OS map, but is on the 1902 OS map, so it is probably part of the 1894 renovation. Most recently it was used to house the electric motor and drive for the bellows for the organ and a spare organ bellows is fixed against the wall (Illus 25).

Illus 25 Inside the outshot, looking E to stair. Spare organ bellows to RHS.
