FARM STEADING
MEIKLE ARDO
METHLICK
ABERDEENSHIRE

Standing Building Survey

Carried out 22nd September 2014

Report No: MAS 2014-38

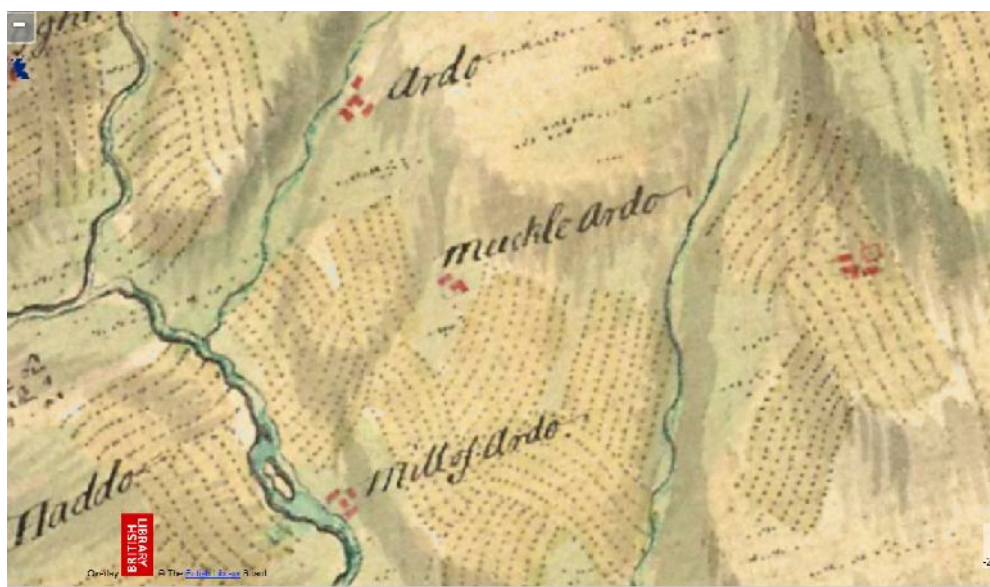
- 4.1 **Roy's Military map of Scotland 1747-55** shows two buildings at Muckle Ardo (*sic*) one rectangular, the other L-plan. The area S of the buildings is shown as rig and furrow but to the N is unimproved ground.

Illus 1 Roy's Military map of 1747-55 www.nls.ac.uk

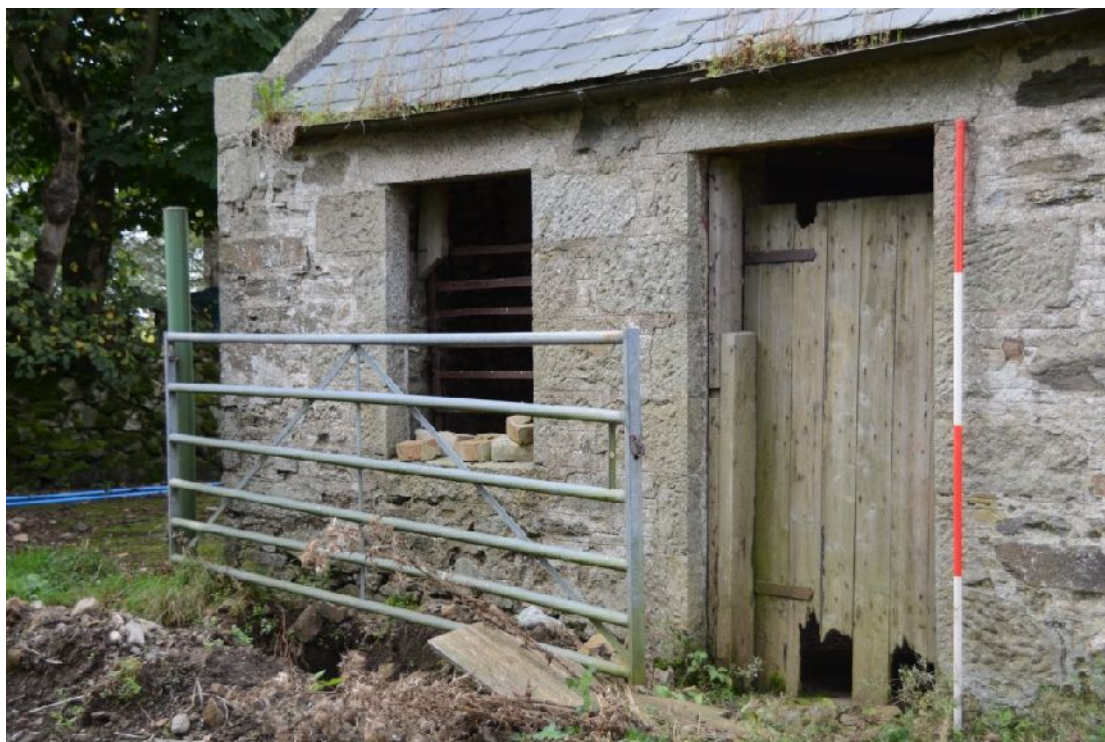
The S end of this range with door D8 and window W3 had been a bothy with a small fireplace remaining in the gable. The partition wall had been removed but the base of a brick foundation was visible.

Illus 5 Door and window of bothy

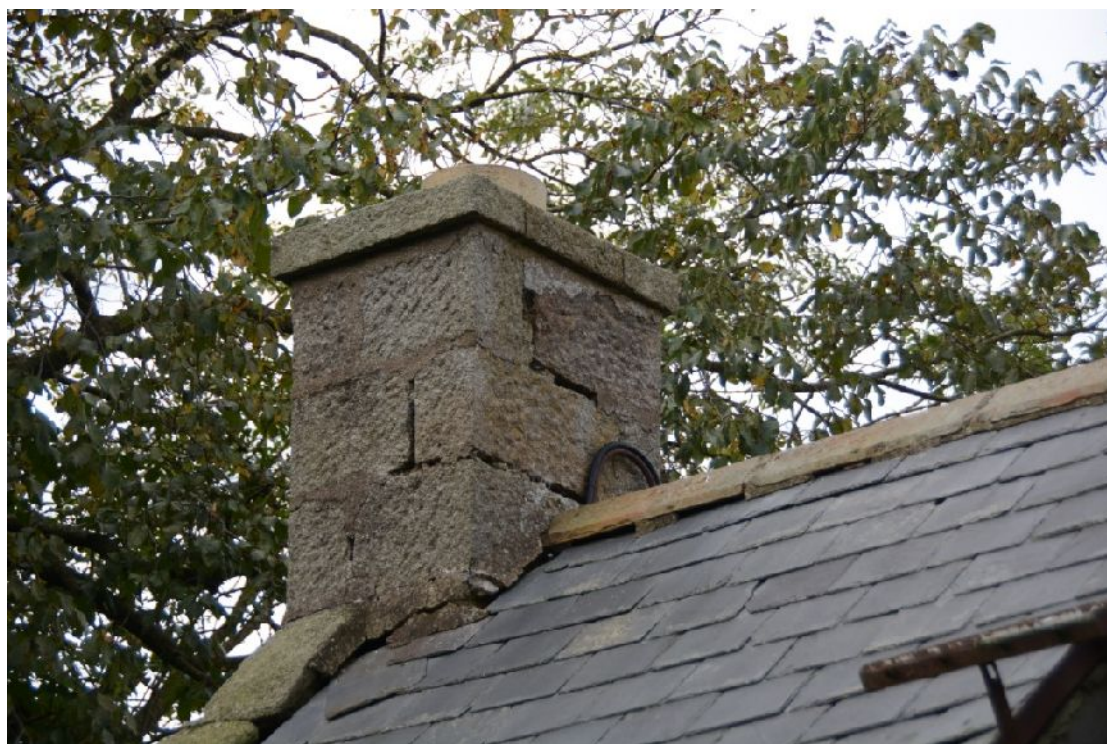
Chimneys rectangular of dressed granite blocks with plain table. Ceramic pot.

Illus 6 Chimney of bothy

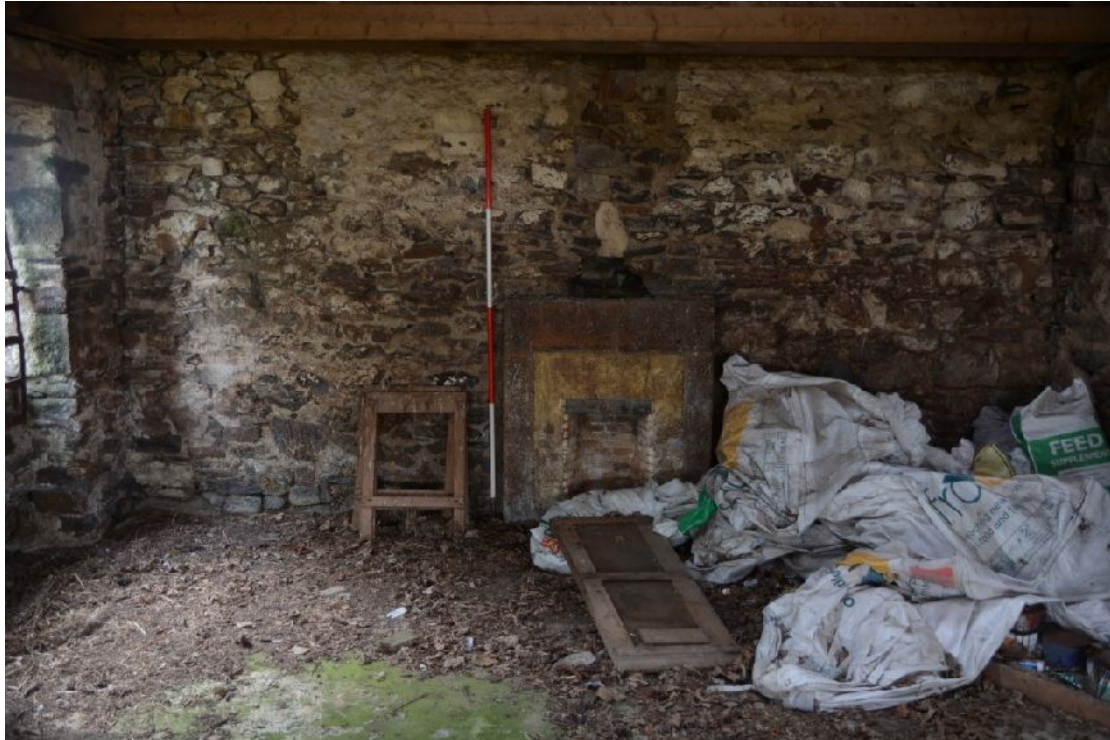
Illus 7 Fireplace of bothy

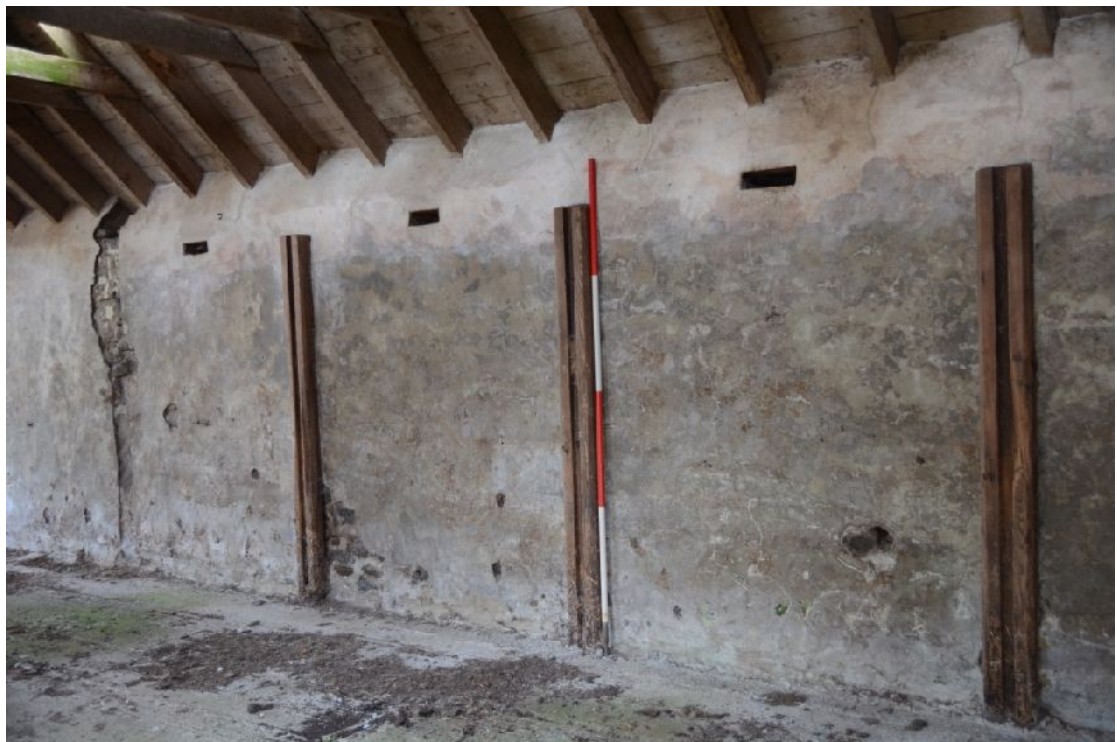
Most internal features had been stripped or obscured but there were the remains of the vertical timbers of trevis partitions set into the inner face of the E wall.

Illus 8 Remains of trevis partitions on E wall of E range

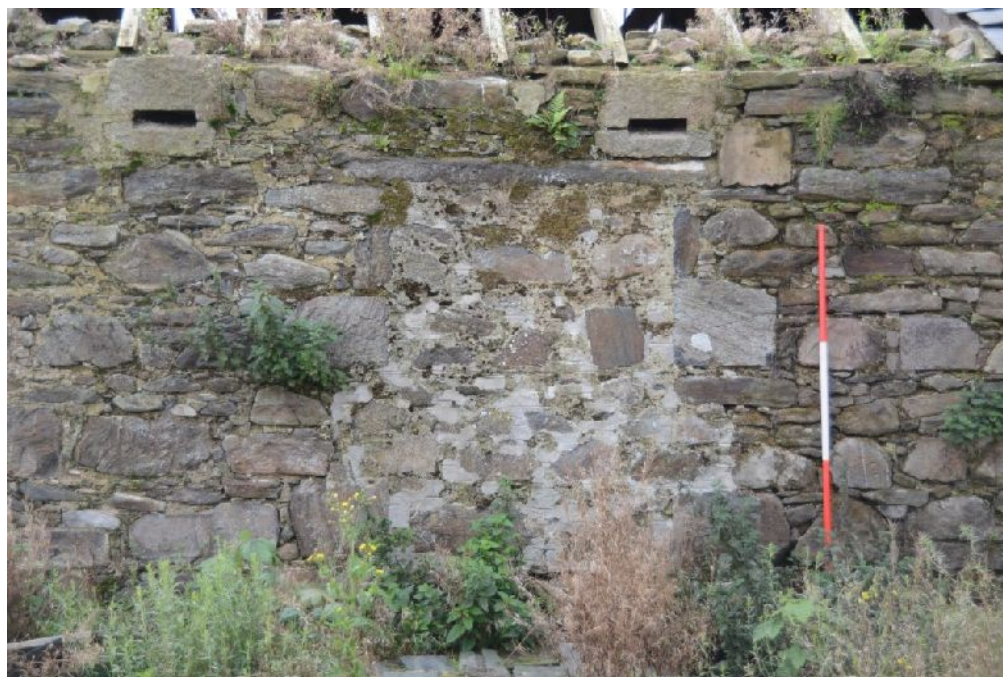
F5 Blocked doorway with stone lintel and rubble stone rybats W:1.2m H: 1,70m. Stone blocked. (illus 9)

Illus 9 N wall N range. Blocking F5 to LHS of ranging rod. Vents F4 above

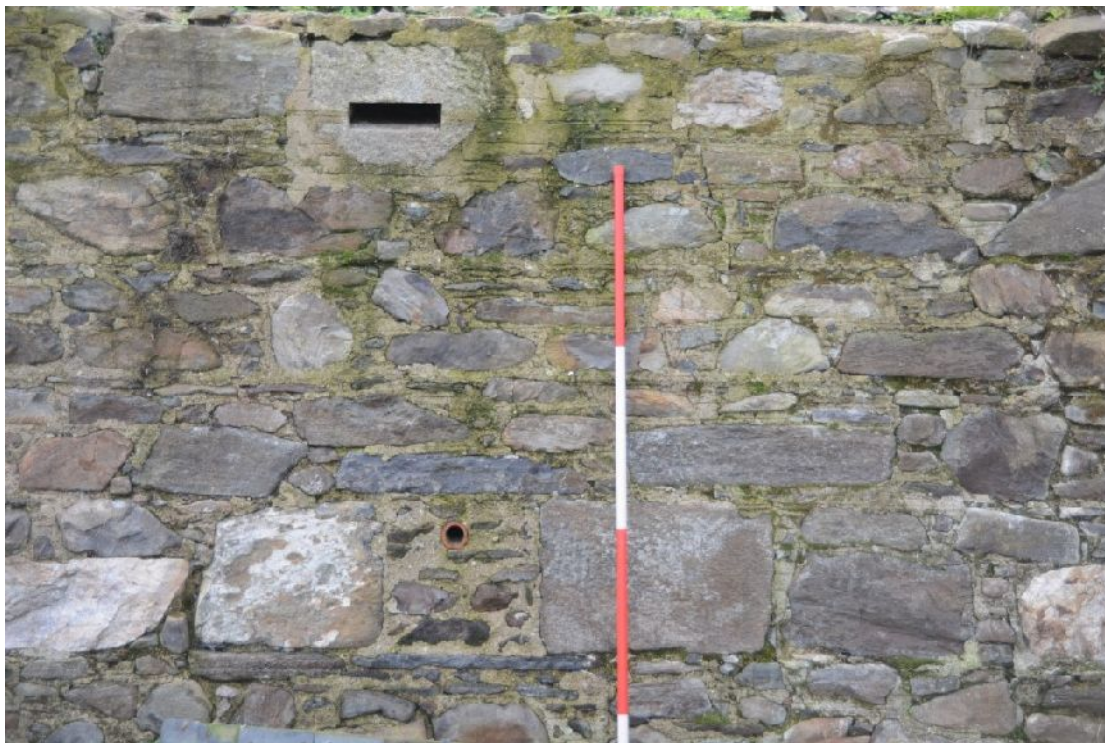
F4 Ten vents in top of wall; each c 80mm high x 220mm wide, formed of two notched stones set one over the other to form an upward slanting vent (illus 10)

F6-F8 Blocked rectangular openings near base of wall. 450x450mm to 500 x500mm. Stone blocking with ceramic pipes built in for ventilation.

Illus 10 N wall N range. Blockings F4 and F6

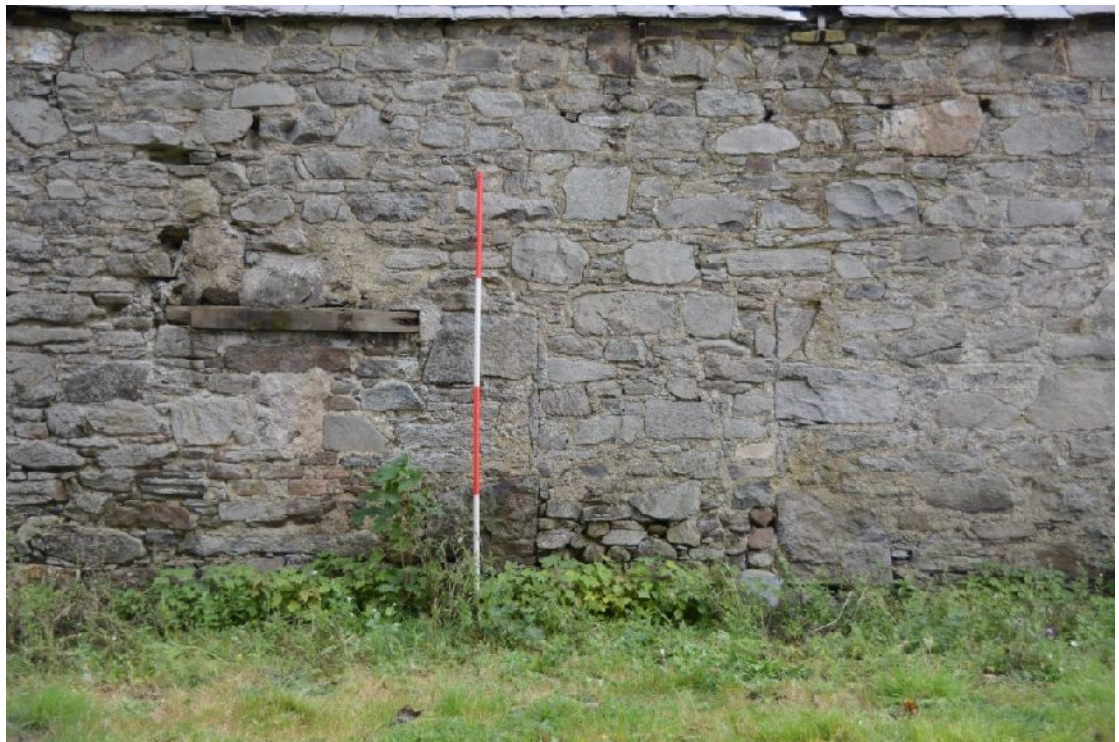
F1 W:1.14m H: 1.47m. Former opening. Stone blocked.

F2 Horizontal timber 1.15m long x 100mm. At 1.32m above ground level.

F1 and F2 (illus 11) coincide with the position of the horse mill shown on the
1st and 2nd edition OS maps; they are probably related to the mill fittings.

Illus 11 W wall W range. Blocking F1 and timber F2; possibly associated with the horse mill

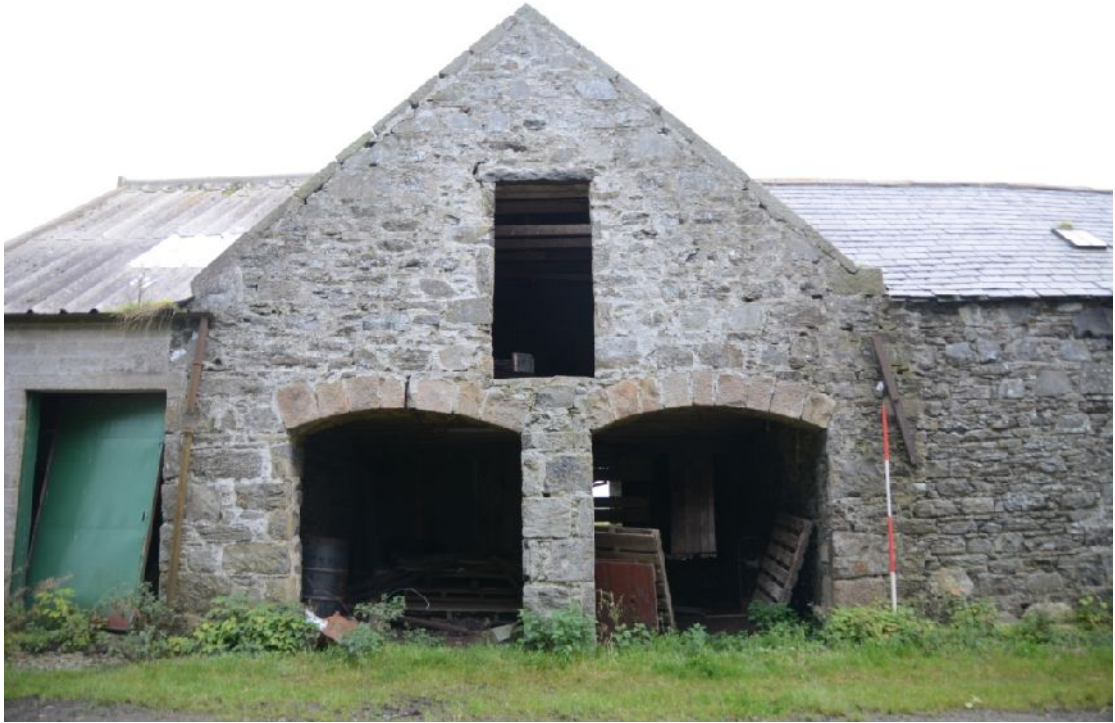
- D1 W:1.06m H:1.78m. Rough stone lintel (not granite). Plank door.
- D2 & D3 Cart bays with arches W: 2.17m H to apex : 2.25m. Granite arch stones. Central pillar rough dressed rybats.
- D4 Loft door above cart bays. Not measured. Stone (not granite) lintel and sill. Two rings below sill probably for ladder attachment.

Illus 12 Cart bays in N end of W range with loft door above

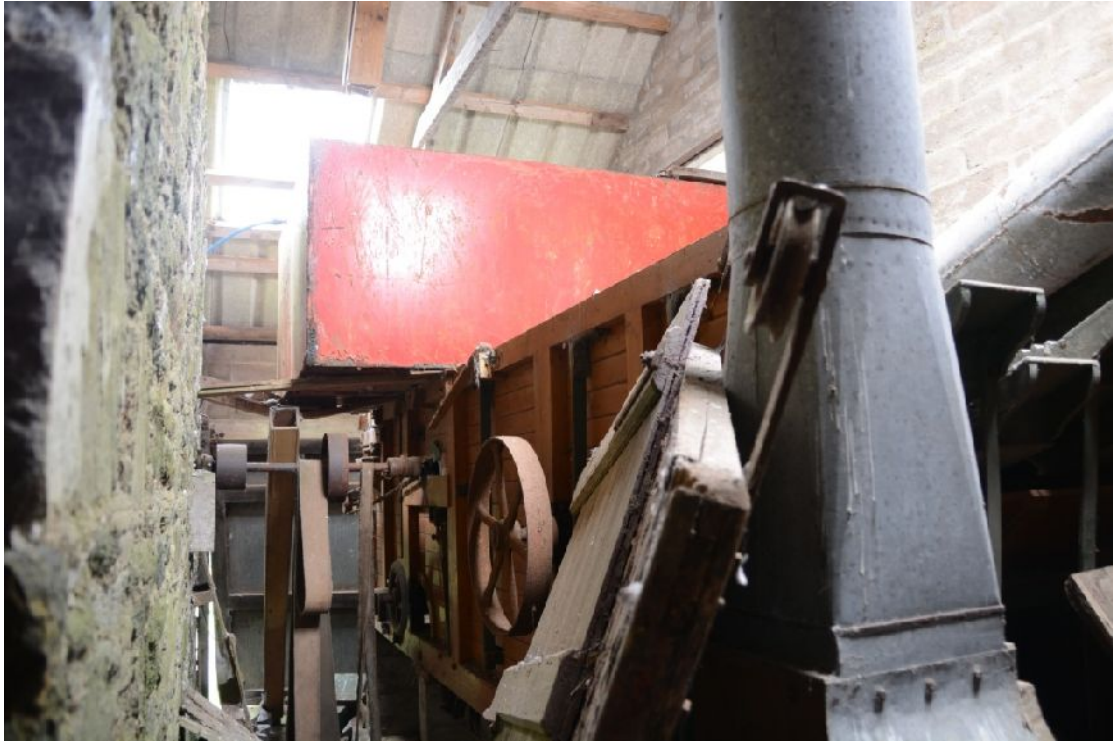
A concrete addition abutts the N end of the W range. It appears to have been built to house a thresher with a loading opening on the N wall which is since

Illus 13 View of thresher inside NW outshott

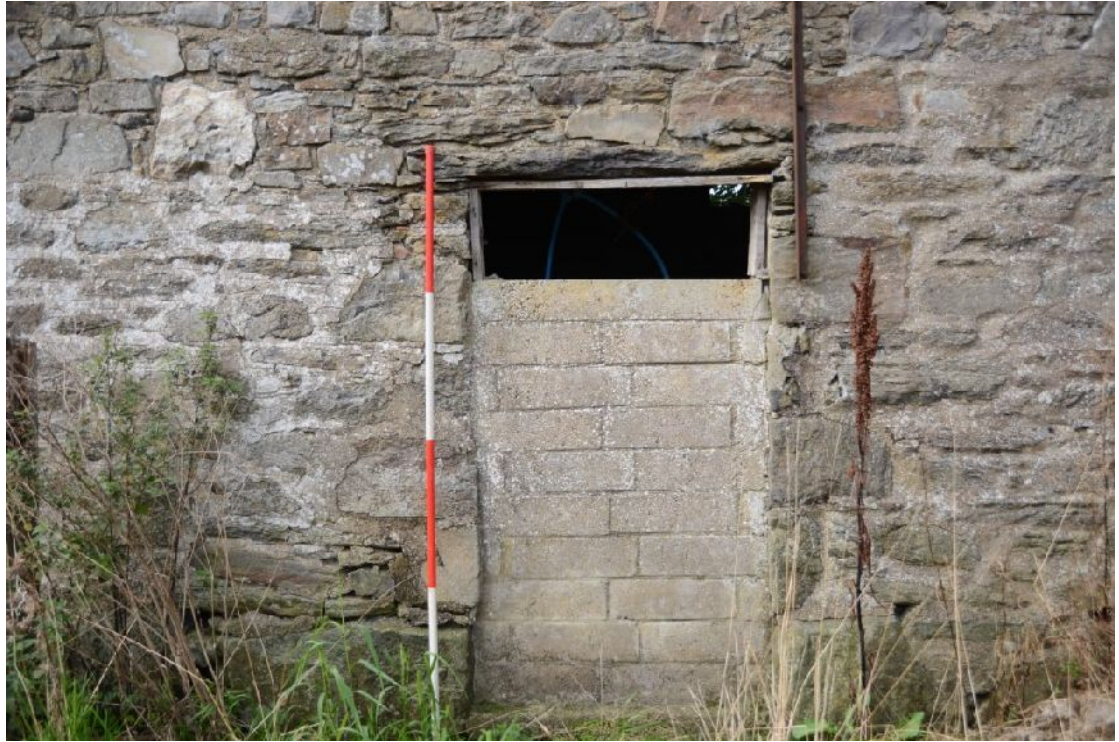
D17 W: 1.06m H: 1.80m Stone lintel (not granite) and rubble stone rybats.
Concrete blocked.

Although both the N and E ranges and the narrower W range appear on the 1869 map, they are clearly built at different times as the W range doorways have rougher stone lintels and rybats (illus 15) as opposed to the dressed granite of the N and E ranges (illus 16). It is tempting to suggest that the W range, which as the OS maps show had a horse mill outside the W wall, may have been earlier but this is speculative. Indeed the apparent widening of this range on the 2nd OS map might indicate that the rougher lintels were secondary. The N end of the W range, filling in the odd gap at the corner, was built between 1869 and 1899 according to the map evidence. Some dressed granite was used in the arch construction (illus 12) of the cart bays.

Illus 15 D17 in the W range with stone lintel and rough rybats

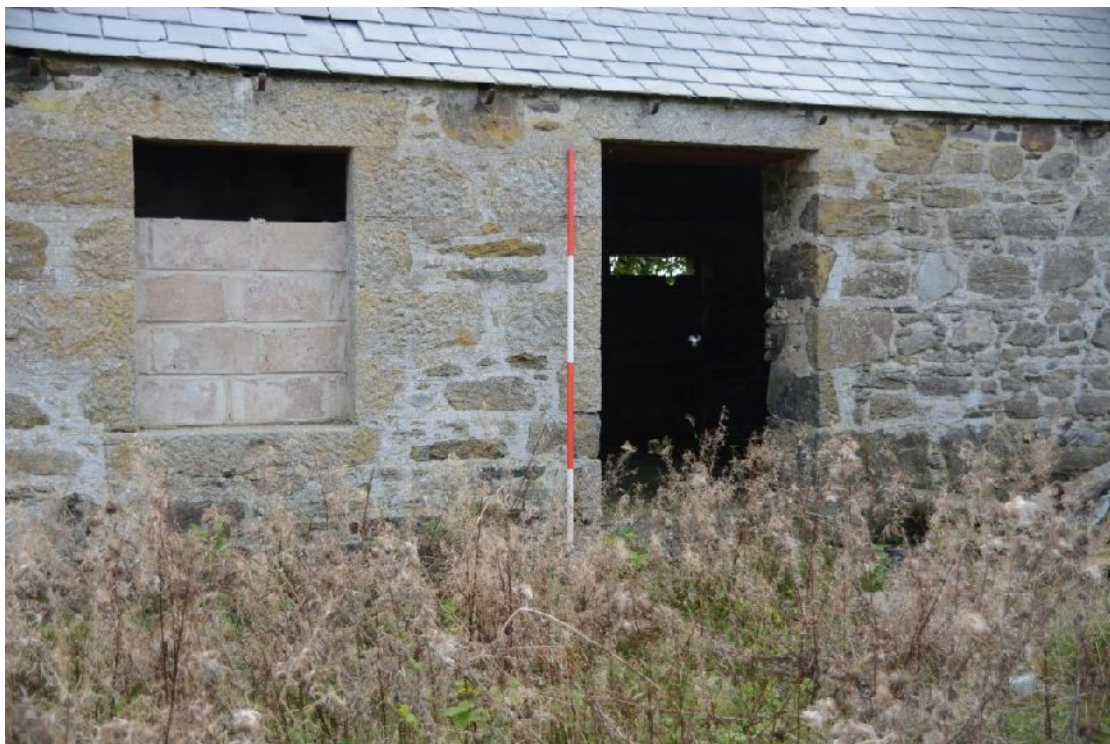
D9 W 1.23m H:2.15m, dressed granite lintel and rybats

W4 W:0.92m H: 1.23m, dressed granite lintel, sill and rybats

Illus 16 D9 and W4 in the E range with dressed granite lintel and rybats.
